**INTERNAL MEMO**  
**CALIFORNIA REGIONAL WATER QUALITY CONTROL BOARD**  
**895 Aerovista Place, Suite 101, San Luis Obispo, CA 93401**

**SUBJECT: Assessment of Sediment Conditions and Possible Impacts to Beneficial Uses from Sediment on the Kelegian and Pierson Properties**

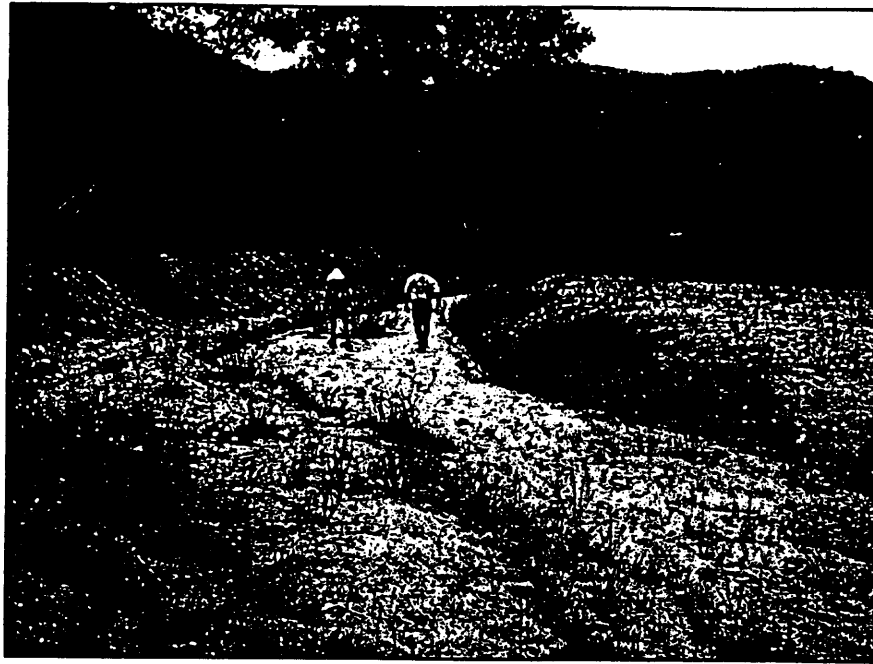
I observed freshly deposited, as well as previously deposited sediment in the lower reach of the unnamed tributary (see Figure 2 and Figure 3). The lower reach is defined as the area downstream of a section of steep bedrock channel and upstream of the confluence with the Middle Branch of Huerhuero Creek, and is approximately 1000 feet long. Unconsolidated sediment depths ranged up to 16 inches in the area depicted in Figure 2 and up to 10 inches in the area depicted in Figure 3. The width of sediment deposit in Figure 2 is approximately 21 feet and in Figure 3 is approximately 4.5 feet. Just downstream of the of the bedrock channel, there is an area that exhibited sediment deposition with subsequent downcutting (see Figure 4). The original deposition was 20 inches deep and 6.5 feet wide and was subsequently downcut a depth of 14 inches and a width of 5 feet.

**Figure 2 Pierson Property - Sediment deposition in unnamed tributary just upstream of confluence w/Middle Branch Huerhuero Creek (looking upstream)**

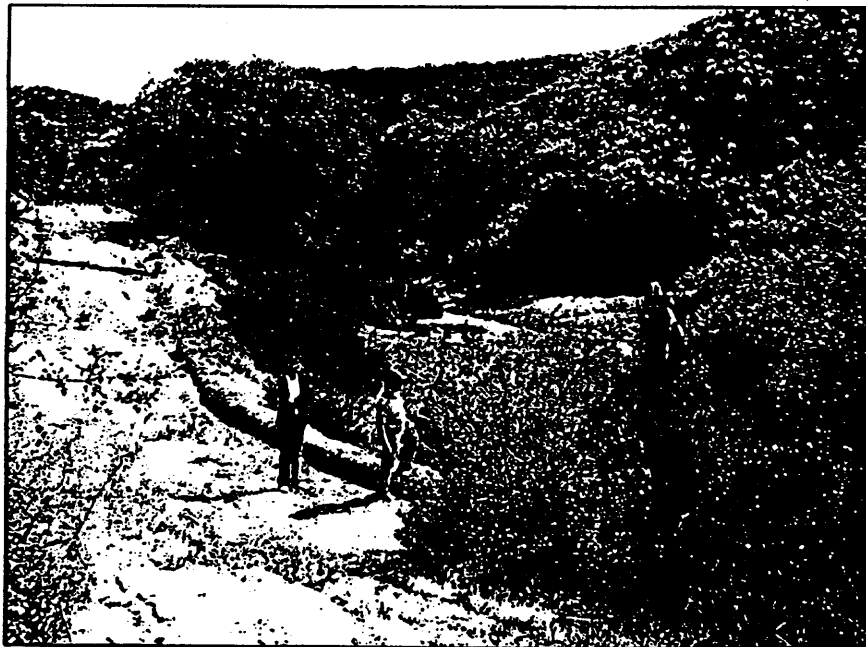
**Figure 8 Pierson Property - Looking SE into unnamed tributary (former stock tank in middle distance)**

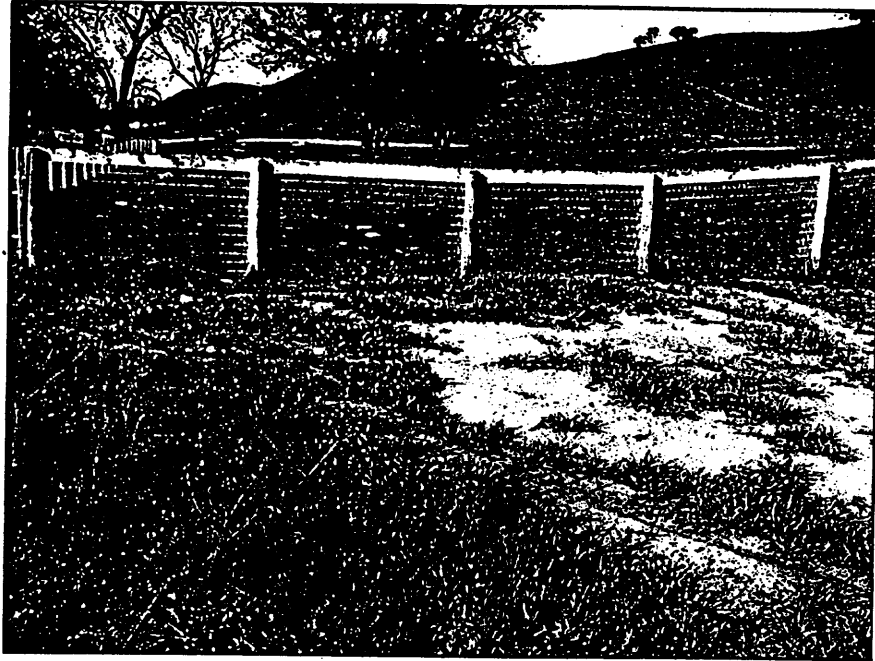
I observed sediment deposits upstream of the fence (see Figure 11) located along the property line. It appears that organic matter was lodged against the fence and acted as a fairly effective barrier to sediment transport. Very little sediment was noted on the adjacent property north of the fence. The sediment deposit is fan shaped with the base located along the fence with a width of approximately 35 feet. The sediment deposit extends uphill from the fence approximately 300 feet (see Figure 12 for upper extent of deposition). Small areas of sediment deposition were observed in the swale above the larger deposit shown in Figure 11 and Figure 12. An example of the grubbed area upstream of the swale, as it appeared prior to revegetation is shown in Figure 13.

**Figure 11 Kelegian Property - Sediment deposition along fence line, looking north to adjacent property  
(Photo: Ryan Lodge March 3, 2003)**

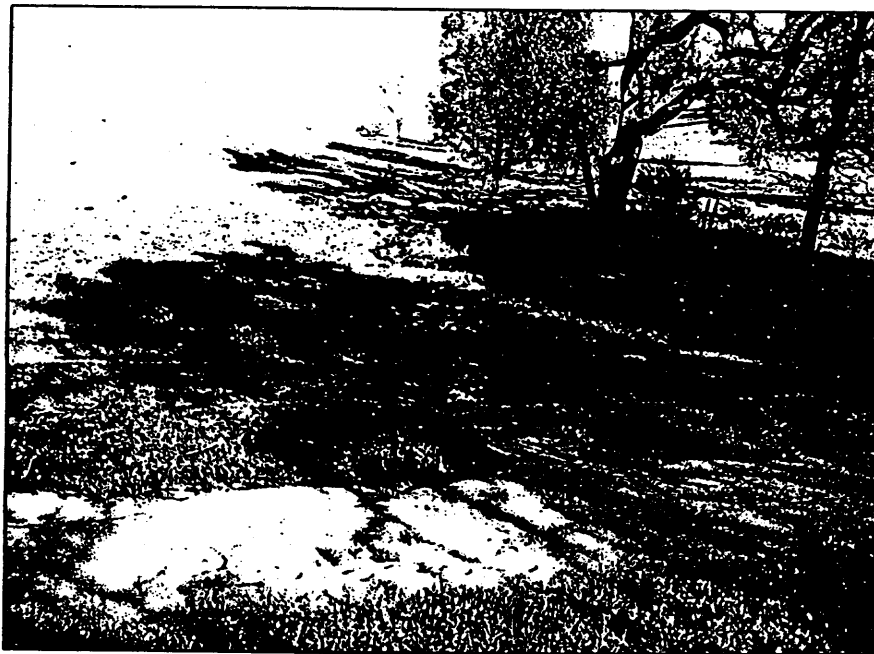
**Figure 12 Kelegian Property - Swale upstream of fence line  
(Photo: Ryan Lodge March 3, 2003)**

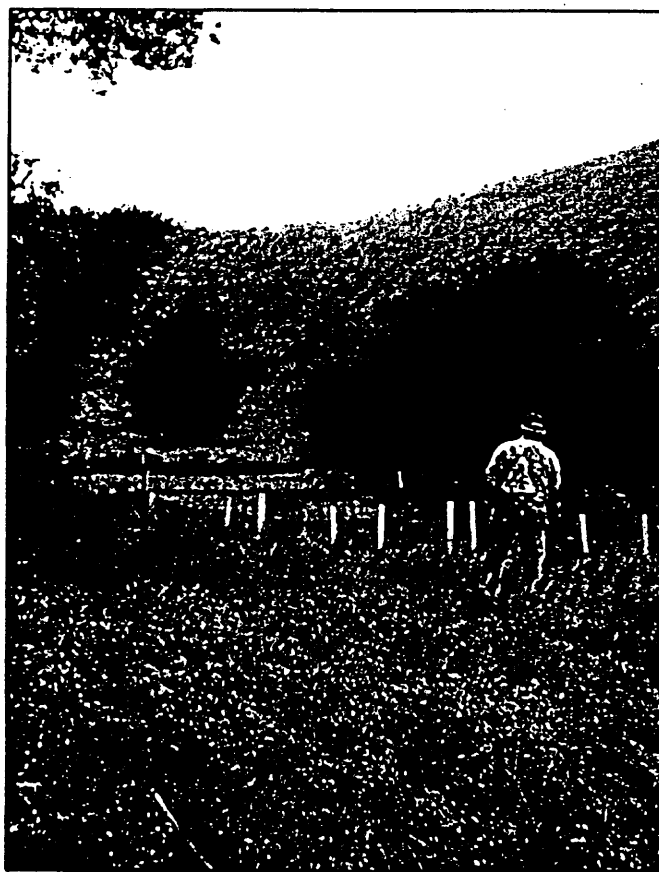
The steep slope that drains into the Middle Branch of Huerhuero Creek (see Figure 14) has been revegetated by the owner and a series of straw bale check dams have been installed to capture sediment prior to its entering the creek. No discernible impacts from this grubbed area were observed in the creek. A small length of vertical stream bank along the road below this area has failed, but this is not unusual in this type of system and it does not appear to be associated directly with the grubbing activity on the slope above.

**Figure 14 Kelegian Property - Grubbed area on steep slope**
