INTERNAL MEMO
CALIFORNIA REGIONAL WATER QUALITY CONTROL BOARD
895 Aerovista Place, Suite 101, San Luis Obispo, CA 93401

SUBJECT: Assessment of Sediment Conditions and Possible Impacts to Beneficial Uses from Sediment on the Kelegian and Pierson Properties

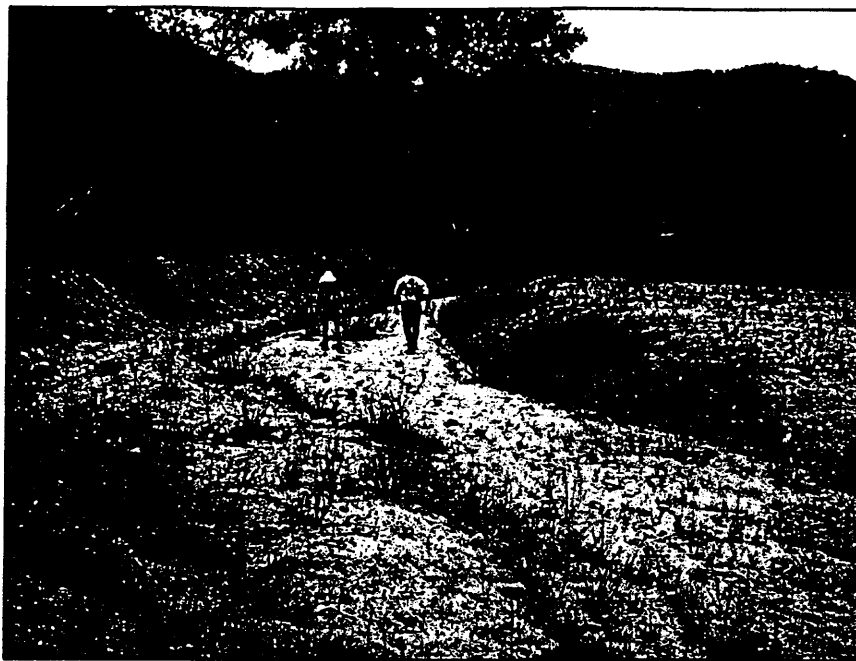
I observed freshly deposited, as well as previously deposited sediment in the lower reach of the unnamed tributary (see Figure 2 and Figure 3). The lower reach is defined as the area downstream of a section of steep bedrock channel and upstream of the confluence with the Middle Branch of Huerhuero Creek, and is approximately 1000 feet long. Unconsolidated sediment depths ranged up to 16 inches in the area depicted in Figure 2 and up to 10 inches in the area depicted in Figure 3. The width of sediment deposit in Figure 2 is approximately 21 feet and in Figure 3 is approximately 4.5 feet. Just downstream of the of the bedrock channel, there is an area that exhibited sediment deposition with subsequent downcutting (see Figure 4). The original deposition was 20 inches deep and 6.5 feet wide and was subsequently downcut a depth of 14 inches and a width of 5 feet.

Figure 2 Pierson Property - Sediment deposition in unnamed tributary just upstream of confluence w/Middle Branch Huerhuero Creek (looking upstream)

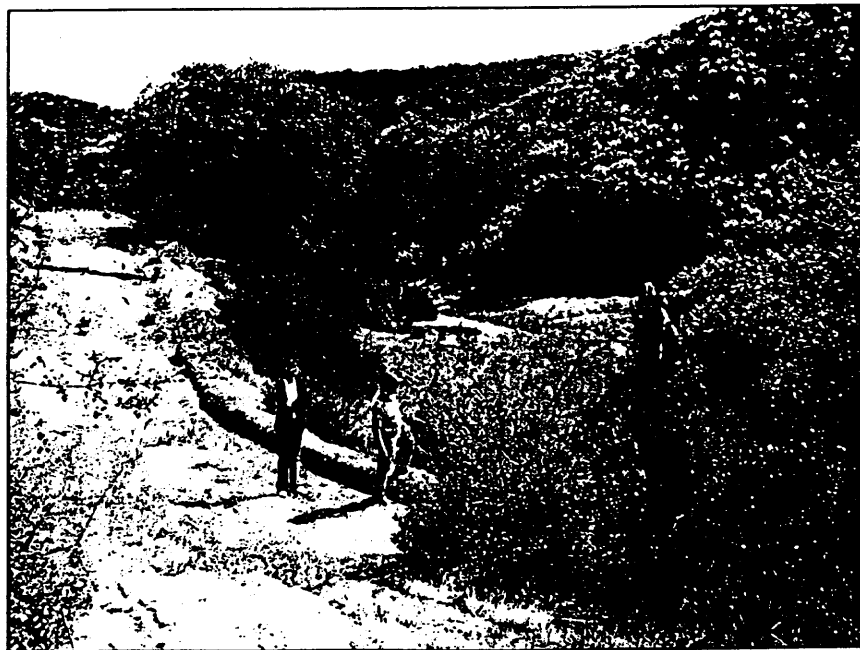
Figure 8 Pierson Property - Looking SE into unnamed tributary (former stock tank in middle distance)

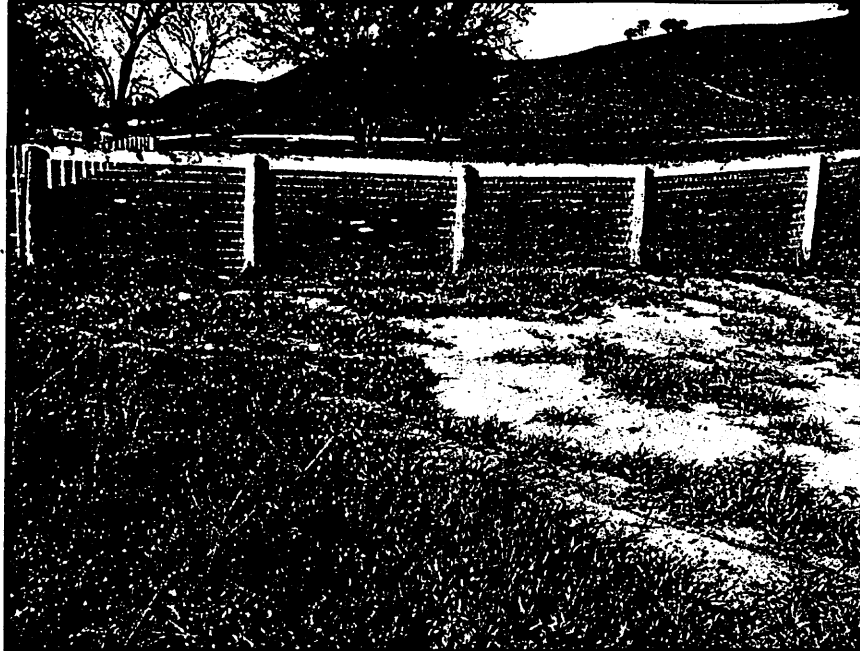
I observed sediment deposits upstream of the fence (see Figure 11) located along the property line. It appears that organic matter was lodged against the fence and acted as a fairly effective barrier to sediment transport. Very little sediment was noted on the adjacent property north of the fence. The sediment deposit is fan shaped with the base located along the fence with a width of approximately 35 feet. The sediment deposit extends uphill from the fence approximately 300 feet (see Figure 12 for upper extent of deposition). Small areas of sediment deposition were observed in the swale above the larger deposit shown in Figure 11 and Figure 12. An example of the grubbed area upstream of the swale, as it appeared prior to revegetation is shown in Figure 13.

**Figure 11 Kelegian Property - Sediment deposition along fence line, looking north to adjacent property
(Photo: Ryan Lodge March 3, 2003)**

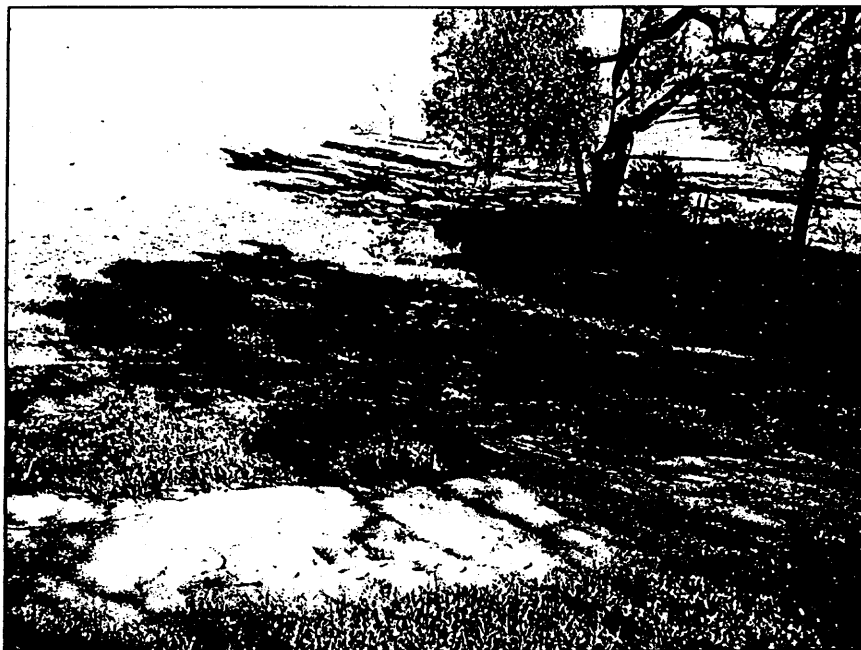
**Figure 12 Kelegian Property - Swale upstream of fence line
(Photo: Ryan Lodge March 3, 2003)**

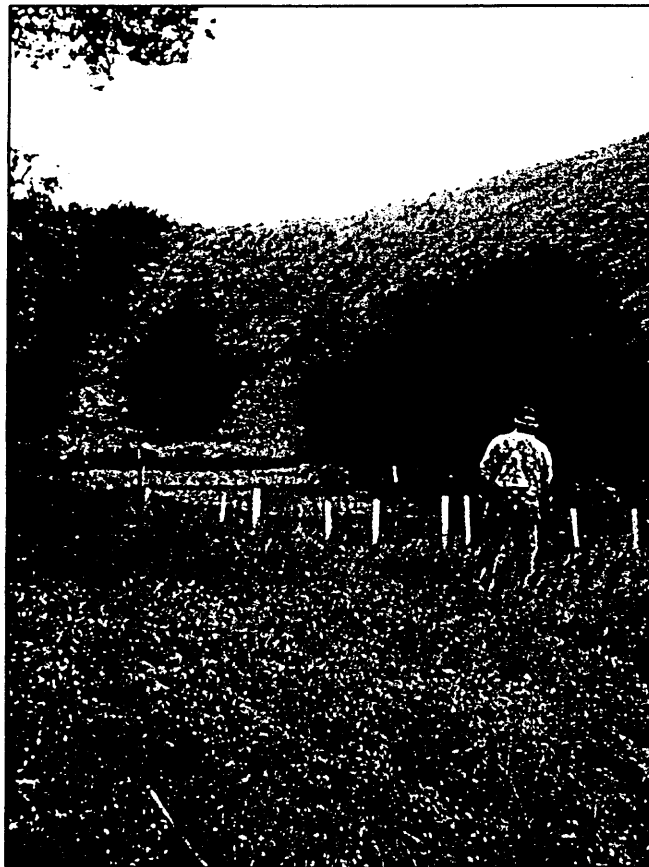
The steep slope that drains into the Middle Branch of Huerhuero Creek (see Figure 14) has been revegetated by the owner and a series of straw bale check dams have been installed to capture sediment prior to its entering the creek. No discernible impacts from this grubbed area were observed in the creek. A small length of vertical stream bank along the road below this area has failed, but this is not unusual in this type of system and it does not appear to be associated directly with the grubbing activity on the slope above.

Figure 14 Kelegian Property - Grubbed area on steep slope
