RE: Erosion Control Review of property east of Santa Margarita, near Highway 58

INTERNAL MEMO
CALIFORNIA REGIONAL WATER QUALITY CONTROL BOARD
895 Aerovista Place, Suite 101, San Luis Obispo, CA 93401

SUBJECT: Assessment of Sediment Conditions and Possible Impacts to Beneficial Uses from Sediment on the Kelegian and Pierson Properties

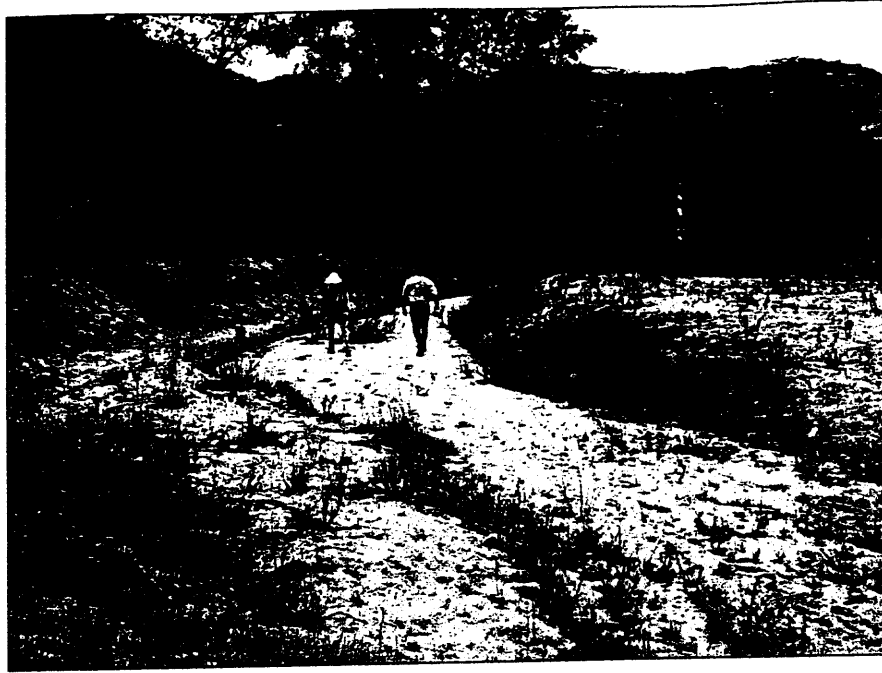
I observed freshly deposited, as well as previously deposited sediment in the lower reach of the unnamed tributary (see Figure 2 and Figure 3). The lower reach is defined as the area downstream of a section of steep bedrock channel and upstream of the confluence with the Middle Branch of Huerhuero Creek, and is approximately 1000 feet long. Unconsolidated sediment depths ranged up to 16 inches in the area depicted in Figure 2 and up to 10 inches in the area depicted in Figure 3. The width of sediment deposit in Figure 2 is approximately 21 feet and in Figure 3 is approximately 4.5 feet. Just downstream of the of the bedrock channel, there is an area that exhibited sediment deposition with subsequent downcutting (see Figure 4). The original deposition was 20 inches deep and 6.5 feet wide and was subsequently downcut a depth of 14 inches and a width of 5 feet.

Figure 2 Pierson Property - Sediment deposition in unnamed tributary just upstream of confluence w/Middle Branch Huerhuero Creek (looking upstream)

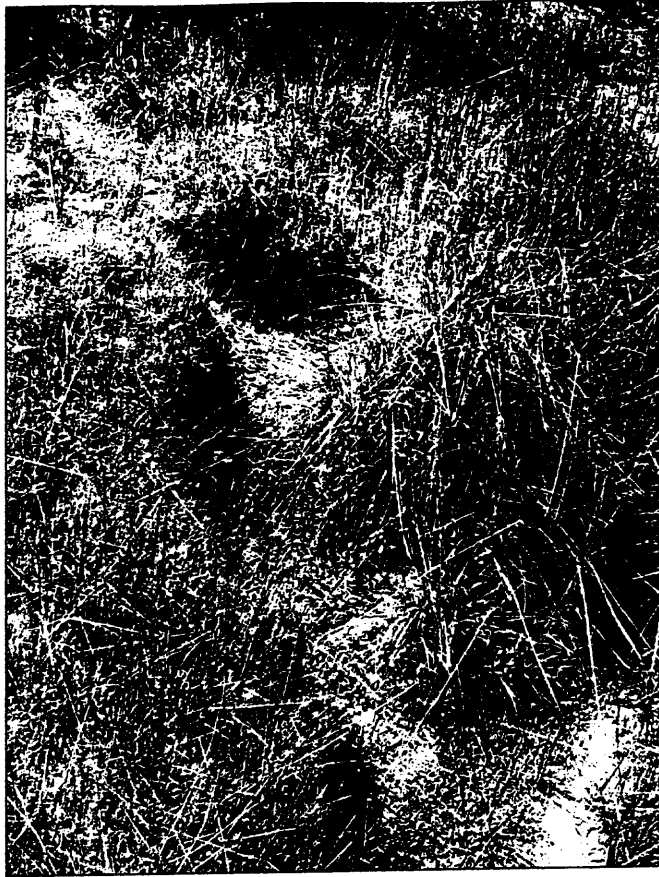
In the area of the former stock tank, I noted sediment deposition in the unnamed tributary (see Figure 6) as well as a side drainage that drains part of the grubbed area (see Figure 7). A ranch road that runs parallel to the watercourse and two steep side roads intersect the main road adjacent to the stock tank (see Figure 8) contribute to the sediment load. A small gully system with headcuts has developed in the old sediment deposits within the former stock tank. The gullies form as the watercourse adjusts to a new base level caused by the breaching of the old earthen dam (see Figure 9).

Figure 6 Pierson Property – Small gully with headcut in former stock tank with some sediment deposition in foreground.

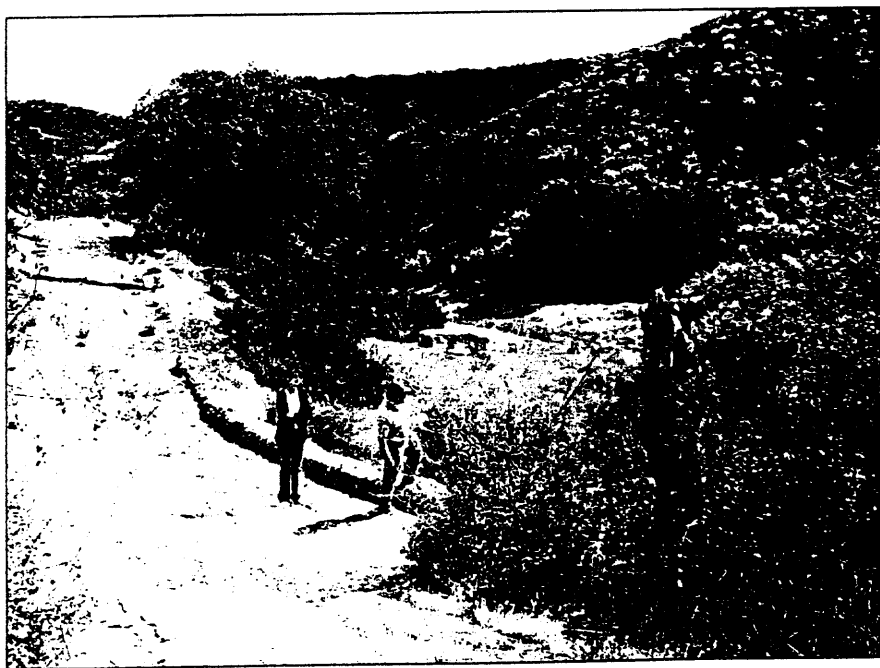
Figure 8 Pierson Property - Looking SE into unnamed tributary (former stock tank in middle distance)

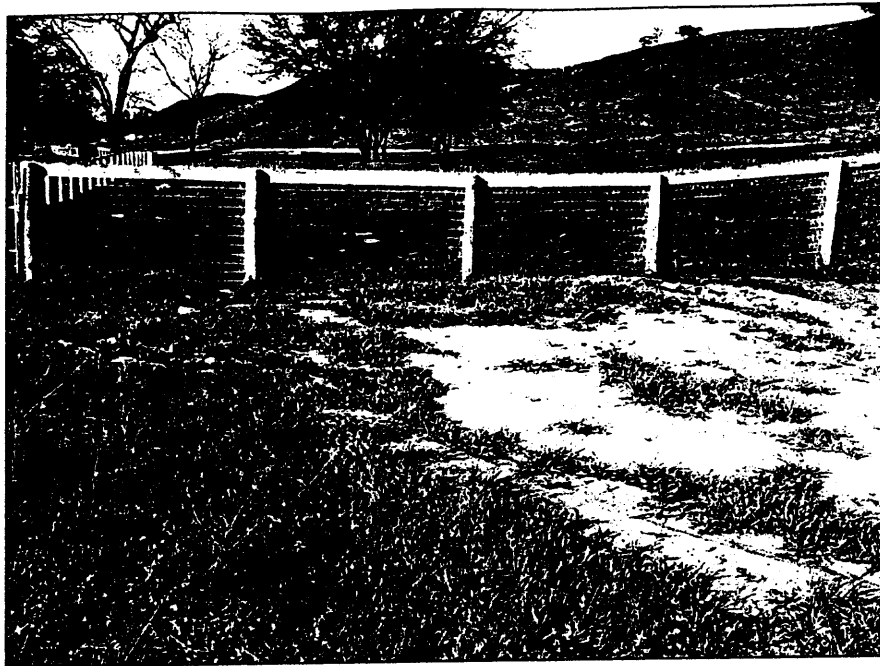
I observed sediment deposits upstream of the fence (see Figure 11) located along the property line. It appears that organic matter was lodged against the fence and acted as a fairly effective barrier to sediment transport. Very little sediment was noted on the adjacent property north of the fence. The sediment deposit is fan shaped with the base located along the fence with a width of approximately 35 feet. The sediment deposit extends uphill from the fence approximately 300 feet (see Figure 12 for upper extent of deposition). Small areas of sediment deposition were observed in the swale above the larger deposit shown in Figure 11 and Figure 12. An example of the grubbed area upstream of the swale, as it appeared prior to revegetation is shown in Figure 13.

**Figure 11 Kelegian Property - Sediment deposition along fence line, looking north to adjacent property
(Photo: Ryan Lodge March 3, 2003)**

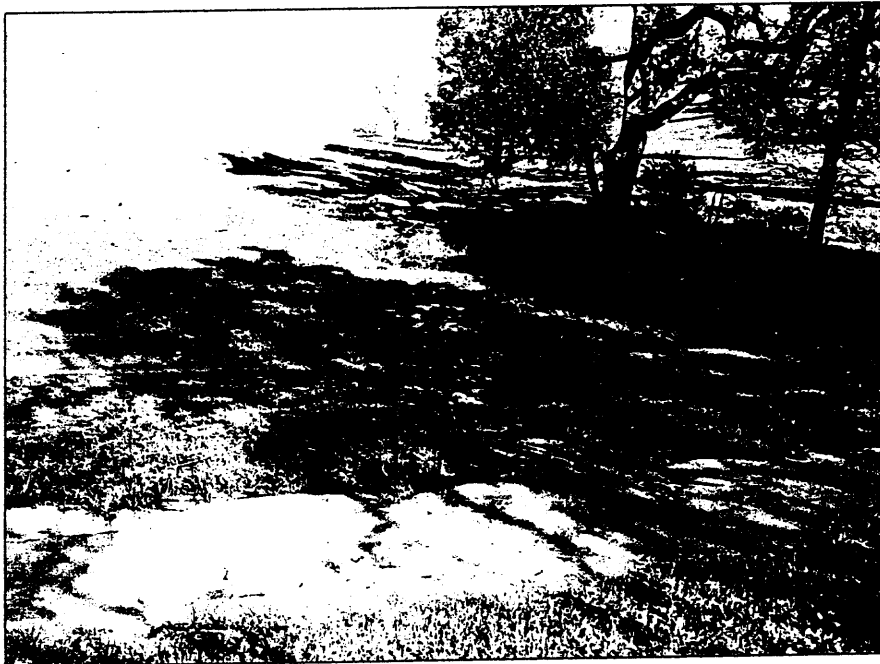
**Figure 12 Kelegian Property - Swale upstream of fence line
(Photo: Ryan Lodge March 3, 2003)**

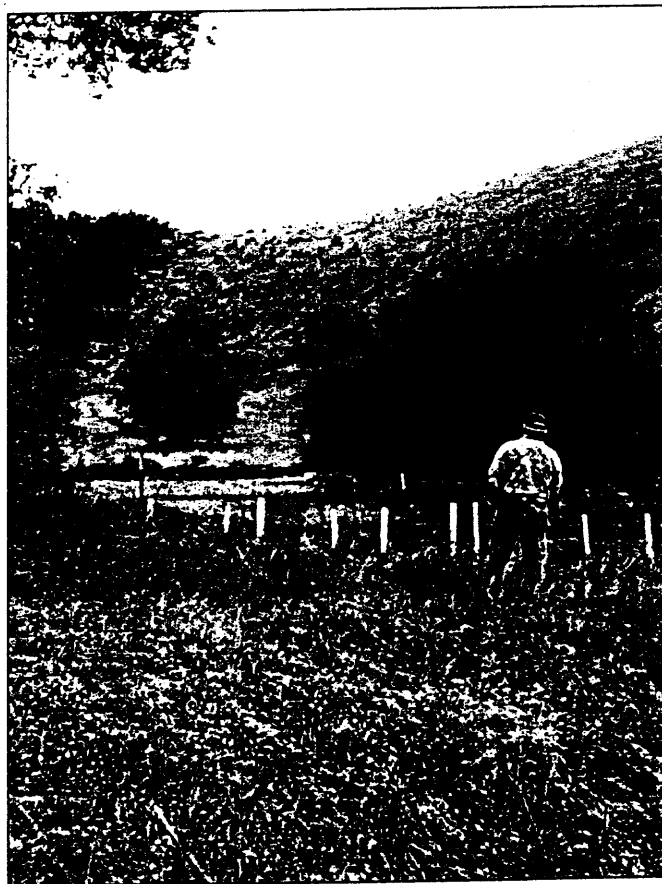
The steep slope that drains into the Middle Branch of Huerhuero Creek (see Figure 14) has been revegetated by the owner and a series of straw bale check dams have been installed to capture sediment prior to its entering the creek. No discernible impacts from this grubbed area were observed in the creek. A small length of vertical stream bank along the road below this area has failed, but this is not unusual in this type of system and it does not appear to be associated directly with the grubbing activity on the slope above.

Figure 14 Kelegian Property - Grubbed area on steep slope

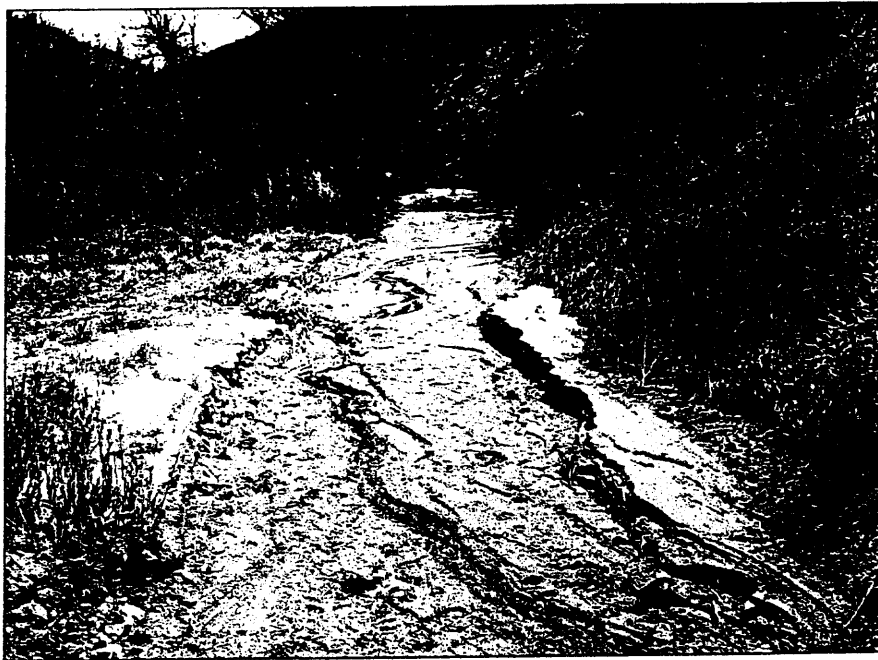
Figure 15 Side drainage on south side of State Route 58 showing deposition and subsequent downcutting (sediment from burn area)

Although speculative in nature, some aquatic organisms may be adapted to a disturbance regime that includes periodic inputs of sediment. The area where these properties are located is subject to extremely high natural sediment inputs, especially after fires (see Figure 15 and Figure 16). Therefore, excessive sediment may cause a shift in the aquatic community in favor of those organisms that require a sandy substrate in order to flourish.

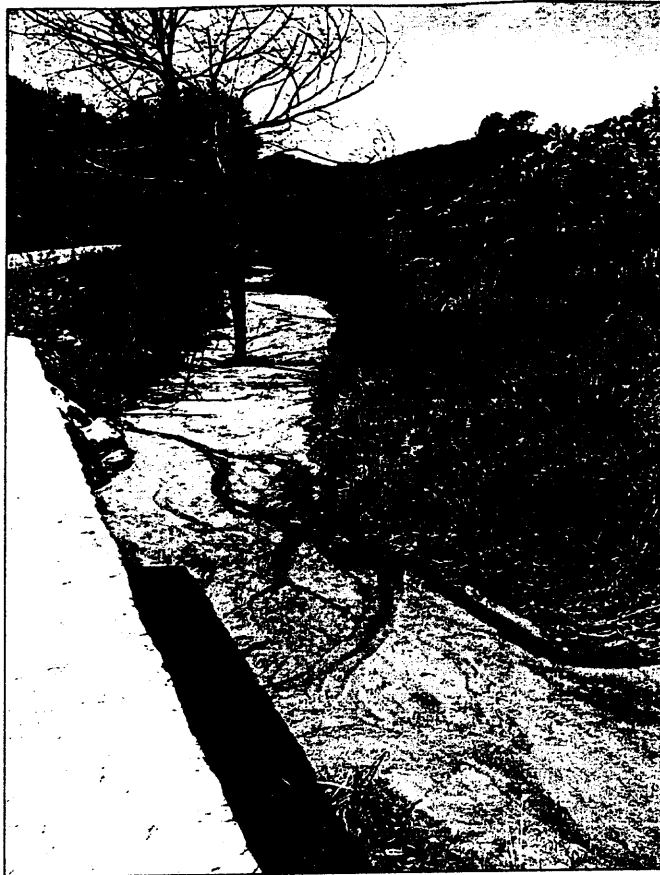
Figure 16 Sedimentation in channel adjacent to Route 58 at road crossing to side channel in previous picture
