Re: City of Monterey Municipal Separate Storm Sewer System (MS4) Compliance Audit Report

**MUNICIPAL SEPARATE STORM  
SEWER SYSTEM (MS4)  
COMPLIANCE INSPECTION**

**EVALUATION CONDUCTED:  
September 21–22, 2009**

**CITY OF MONTEREY, CALIFORNIA**

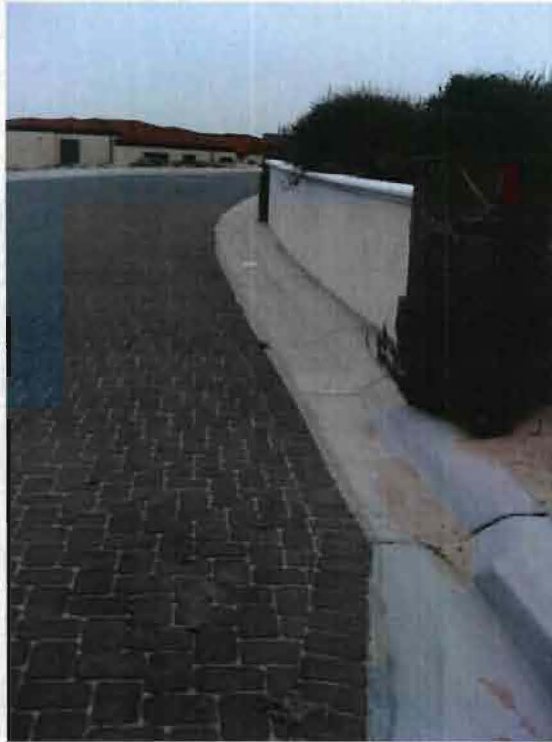
**Photograph 1.** 125 Spray Avenue – Sand accumulation in curb and gutter flowline.

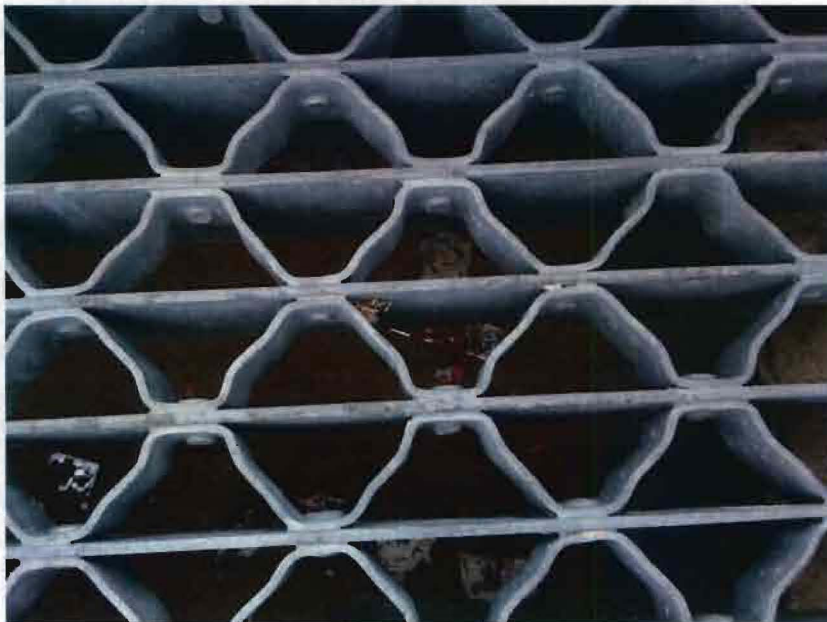
**Photograph 2.** 125 Spray Avenue – Sand accumulation within storm drain catch basin.

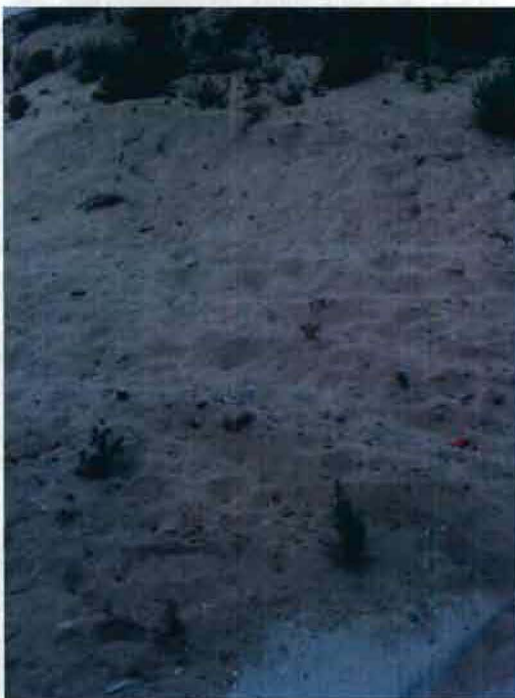
**Photograph 3.** 125 Spray Avenue – Example of construction waste and debris on the ground surface at the site.

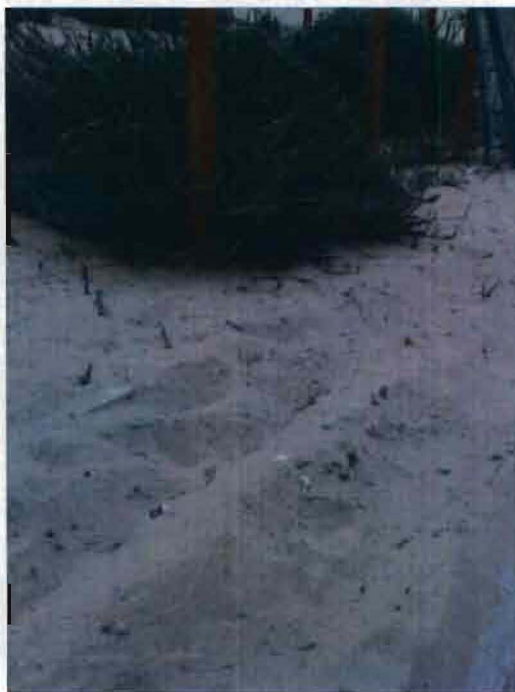
**Photograph 4.** 125 Spray Avenue – Another example of construction waste and debris on the ground surface at the site.

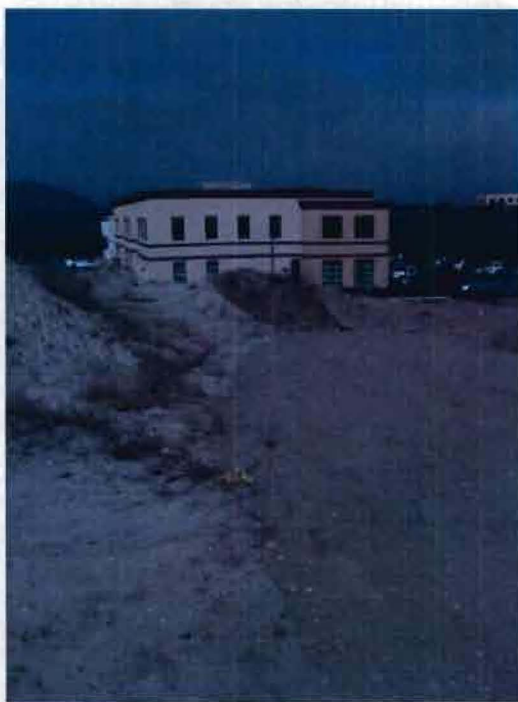
and straw wattles implemented at various areas of the site had not been properly installed or maintained. Specifically, several lengths of silt fence were not entrenched into the ground to retain sediment and prevent failure (see attached Photograph 6); straw wattle BMPs had been crushed which significantly reduced their effectiveness (see attached Photographs 7 and 8); and the silt fence had collapsed in several areas (see attached Photographs 9 and 10). Additionally, large expanses of sediment were disturbed but no BMPs had been implemented for temporary or permanent stabilization (see attached Photograph 5). The yet-to-be developed parcel had several areas of exposed and barren soil, and a large section of the parcel was being used as a soil stockpile for excess fill removed during the office building excavation (see attached Photograph 5).

**Photograph 5.** 30/40 Ryan Ranch Court – Areas used as soil stockpile for excess fill material on yet-to-be developed parcel of land at the development.

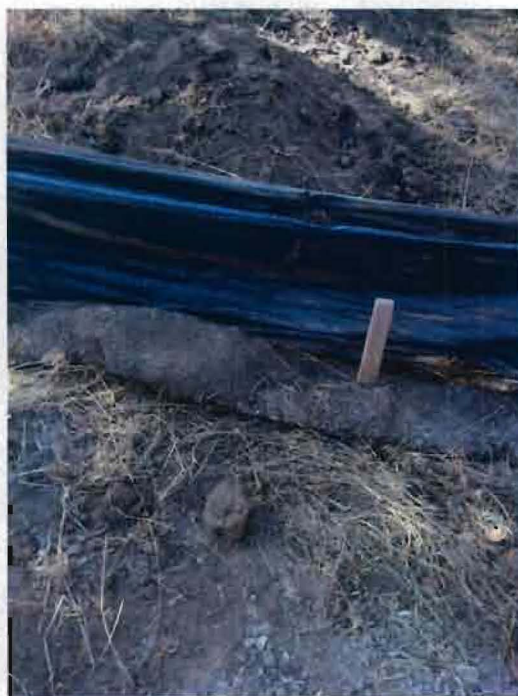
**Photograph 6.** 30/40 Ryan Ranch Court – Example of silt fence BMP not entrenched into the ground.

The City must require the implementation of adequate nonstructural and structural BMPs and proper maintenance to prevent the discharge of pollutants from public and private construction sites located within the City's jurisdiction. *The EPA Inspection Team strongly recommends that the City encourage the implementation of temporary stabilization practices at private construction sites to reduce the amount of sediment discharged from sites that are not actively being graded. Given the small number of active construction sites, the EPA Inspection Team further recommends that the City regularly inspect all active and inactive sites and require the installation and maintenance of sediment control BMPs. Furthermore, the City should provide routine oversight of all public projects regardless of the presence of private contract inspectors.*

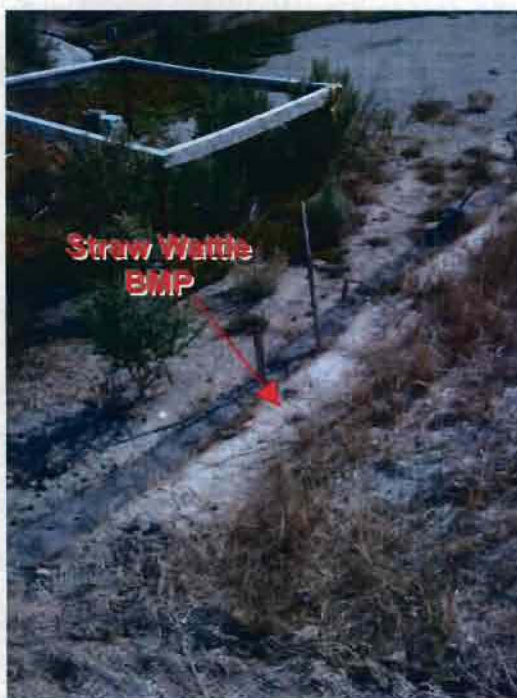
**Photograph 7.** 30/40 Ryan Ranch Court – Example of crushed straw wattle BMP.

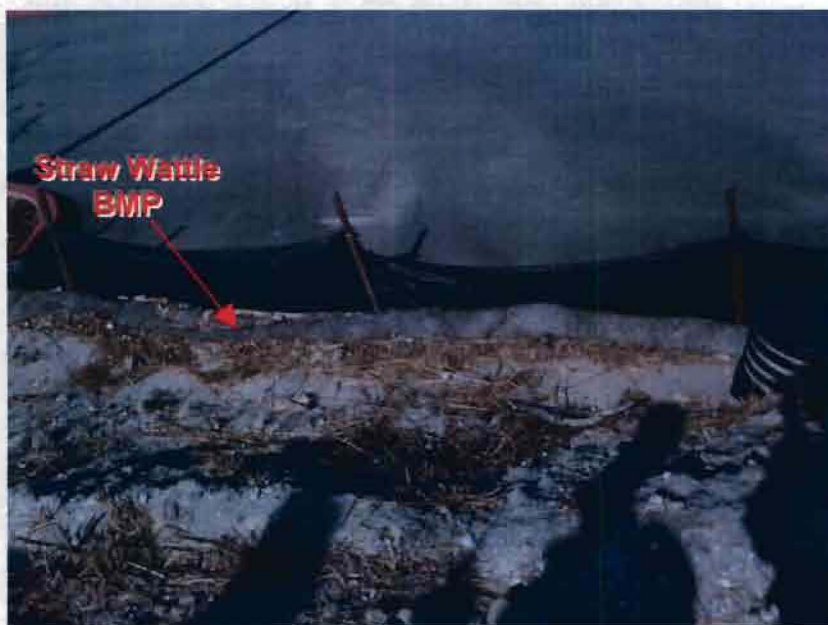
**Photograph 8.** 30/40 Ryan Ranch Court – Another example of crushed straw wattle BMP adjacent to silt fence.

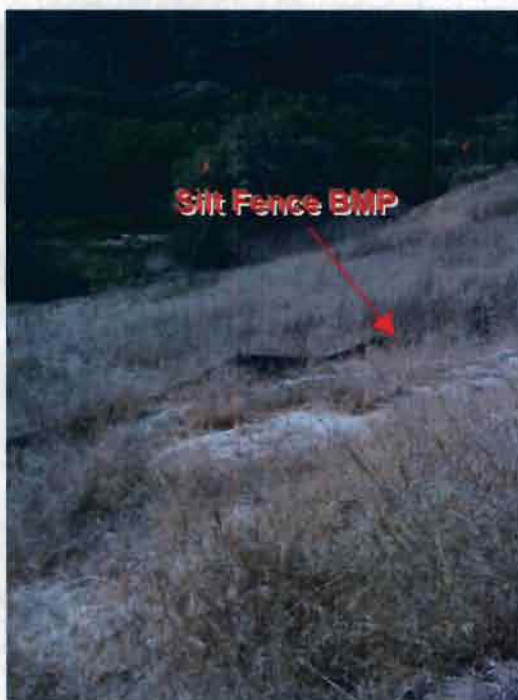
**Photograph 9.** 30/40 Ryan Ranch Court – Example of collapsed silt fence BMP.

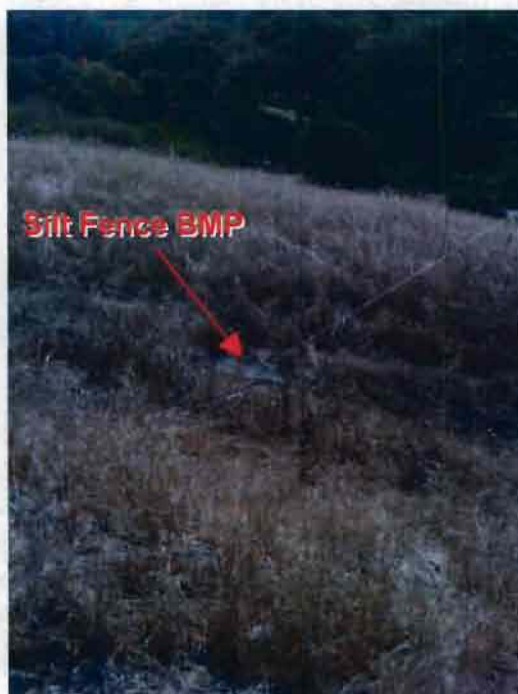
**Photograph 10.** 30/40 Ryan Ranch Court – Another example of collapsed silt fence BMP.

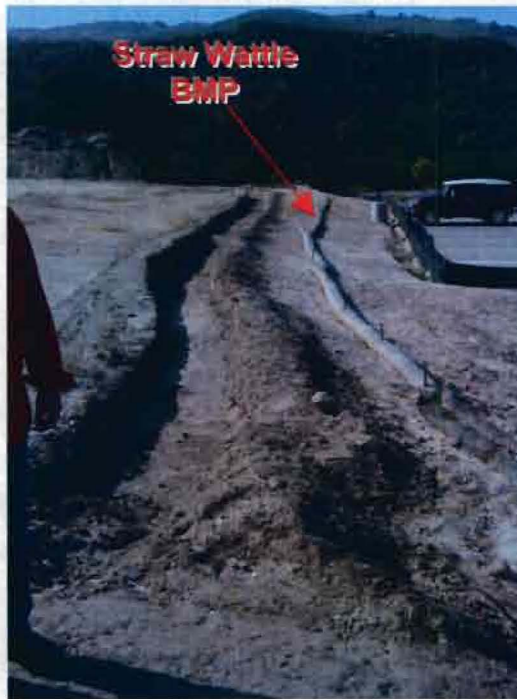
**Photograph 11.** 30/40 Ryan Ranch Court – Drainage ditch intended to direct storm water runoff flow off-site. (Note: Straw wattle BMP installed downgradient of drainage ditch)

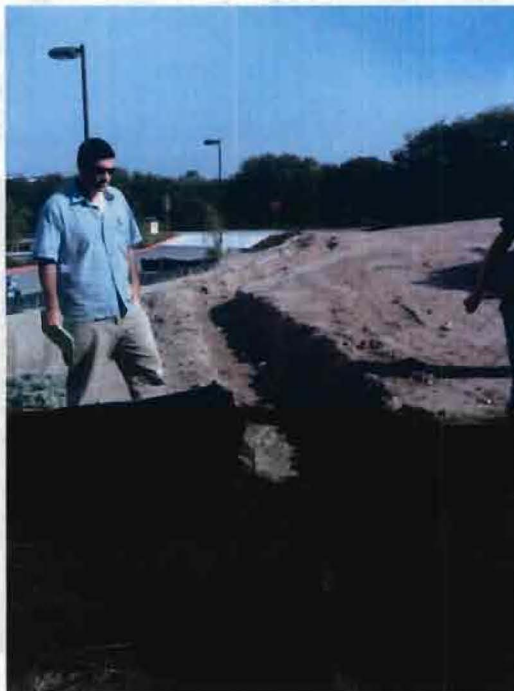
**Photograph 12.** 30/40 Ryan Ranch Court – Another view of drainage ditch.

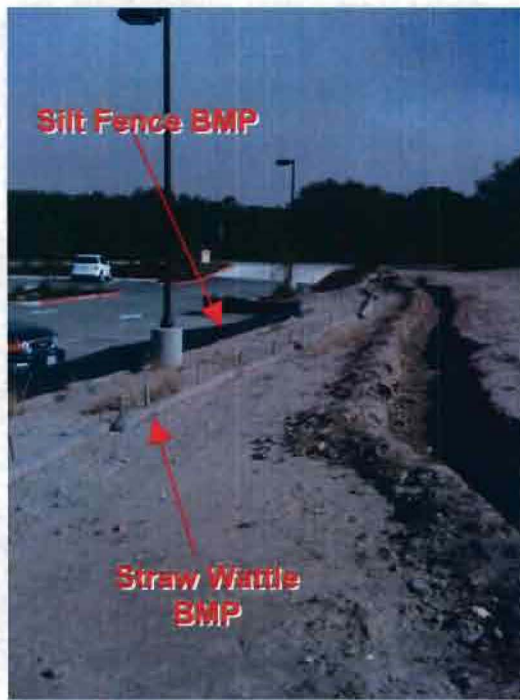
**Photograph 13.** 30/40 Ryan Ranch Court – Another view of drainage ditch. (Note: Straw wattle and silt fence BMPs installed downgradient of drainage ditch)

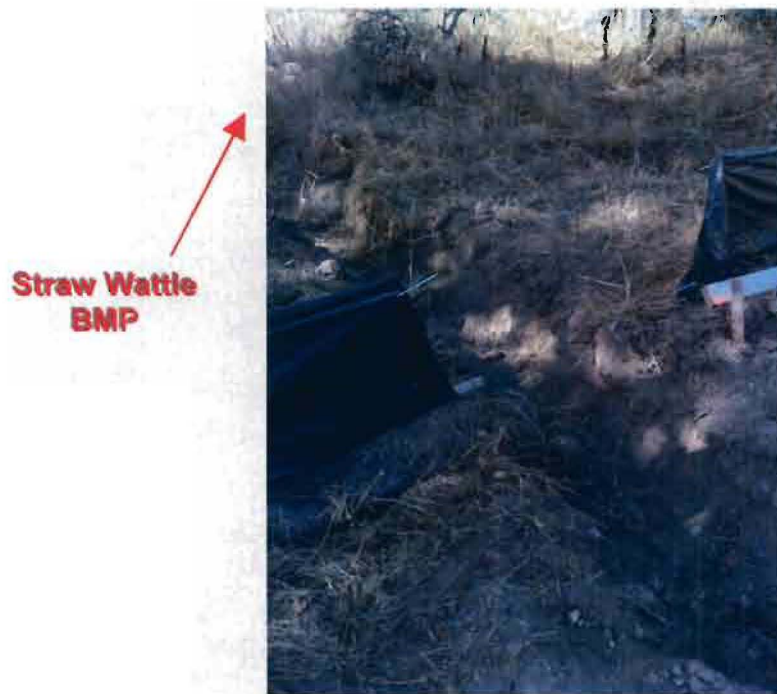
**Photograph 14.** 30/40 Ryan Ranch Court – A single straw wattle BMP had been installed to dissipate flow from drainage ditch. The wattle is not visible in this photo.

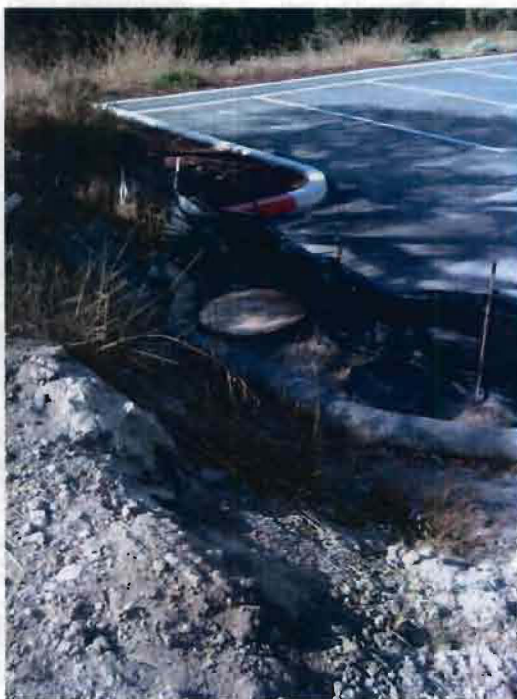
**Photograph 15.** 30/40 Ryan Ranch Court – Wattle and silt fence used to prevent runoff from entering parking lot. Exposed soil also present.

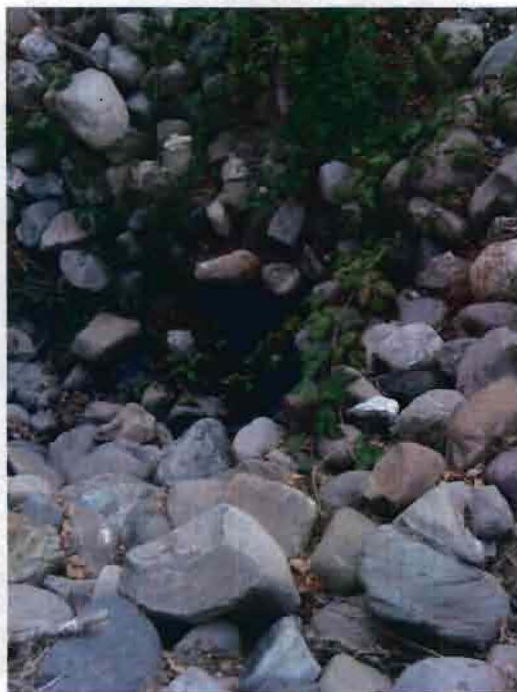
**Photograph 16.** 30/40 Ryan Ranch Court – Rip-rap surrounding outflow from 30/40 Ryan Ranch Court.

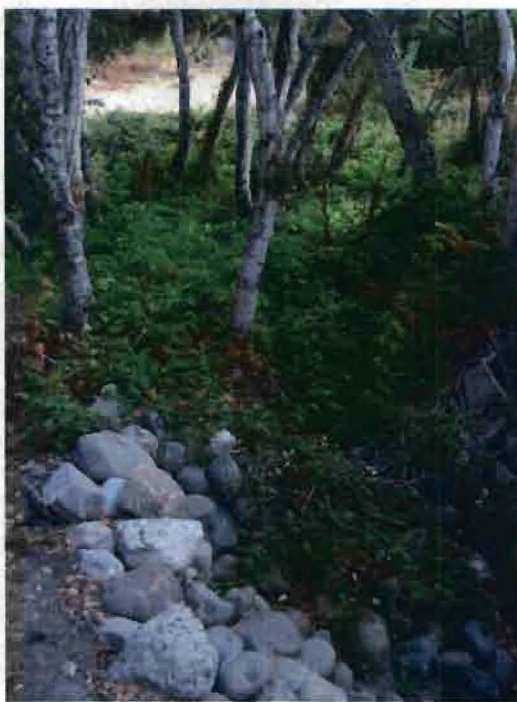
**Photograph 17.** 30/40 Ryan Ranch Court – Discharge into natural drainage area above detention basin.

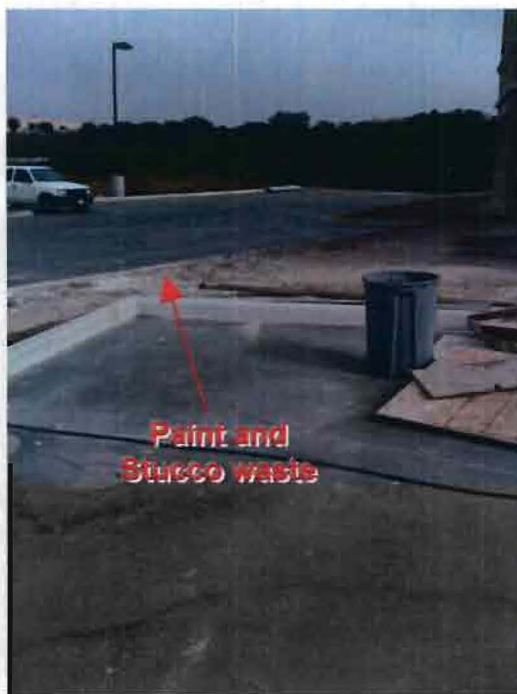
**Photograph 18.** 30/40 Ryan Ranch Court – Stucco and plaster waste on ground surface.

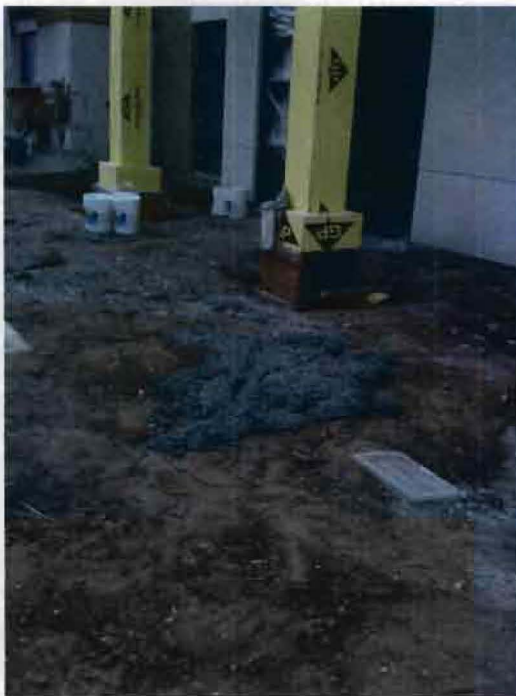
**Photograph 19.** 30/40 Ryan Ranch Court – Spilled concrete on ground surface.

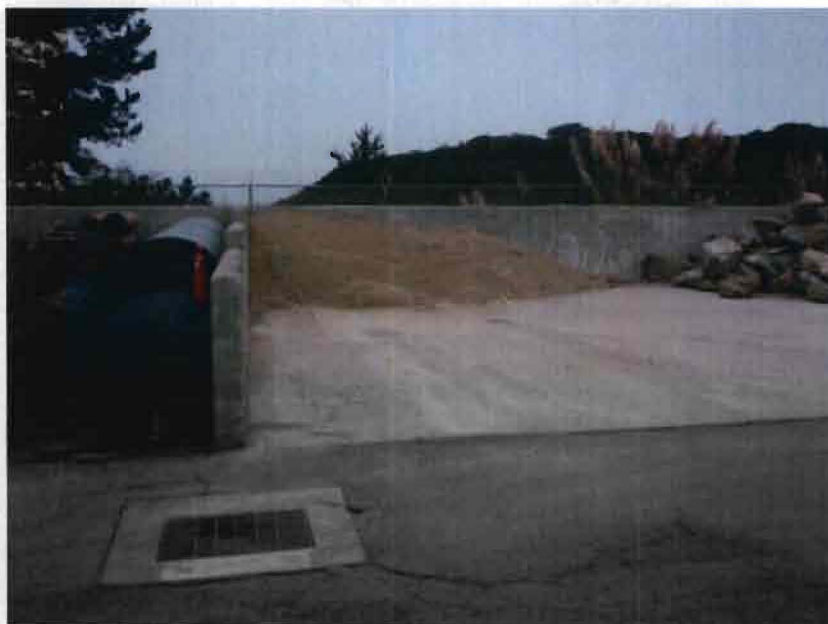
**Photograph 20.** Corporation Yard at Ryan Ranch – Example of storage of unconsolidated materials adjacent to storm drain inlet without BMPs for inlet protection.

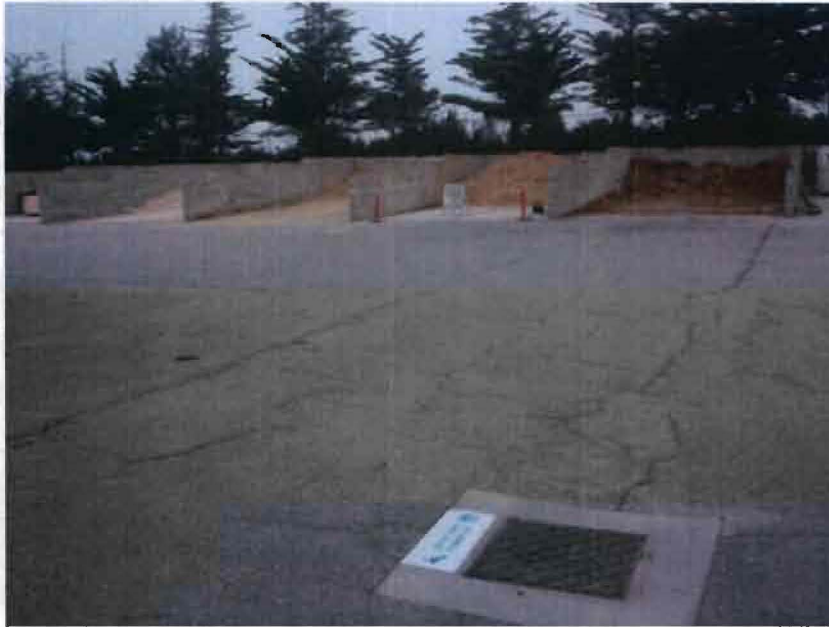
**Photograph 21. Corporation Yard at Ryan Ranch – Another example of storage of unconsolidated materials adjacent to storm drain inlet without BMPs for inlet protection.**

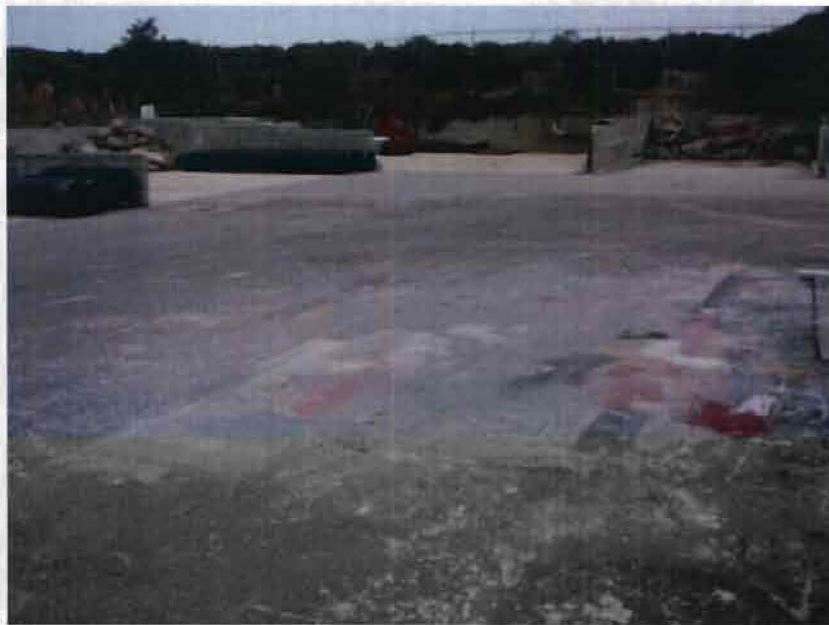
**Photograph 22. Corporation Yard at Ryan Ranch – Debris and dried paint on ground surface in the paint truck refill area.**

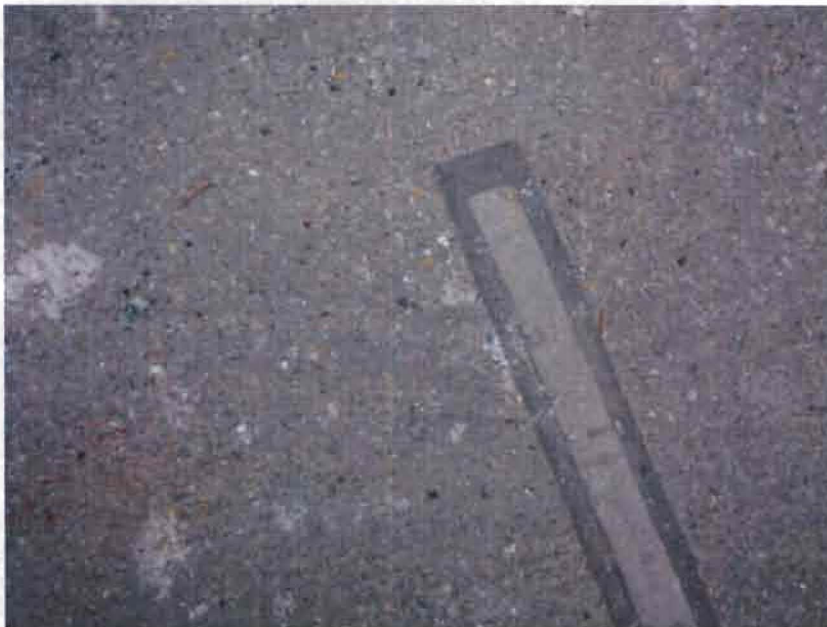
**Photograph 23.** Corporation Yard at Ryan Ranch – Close-up of debris on ground surface in the paint truck refill area.

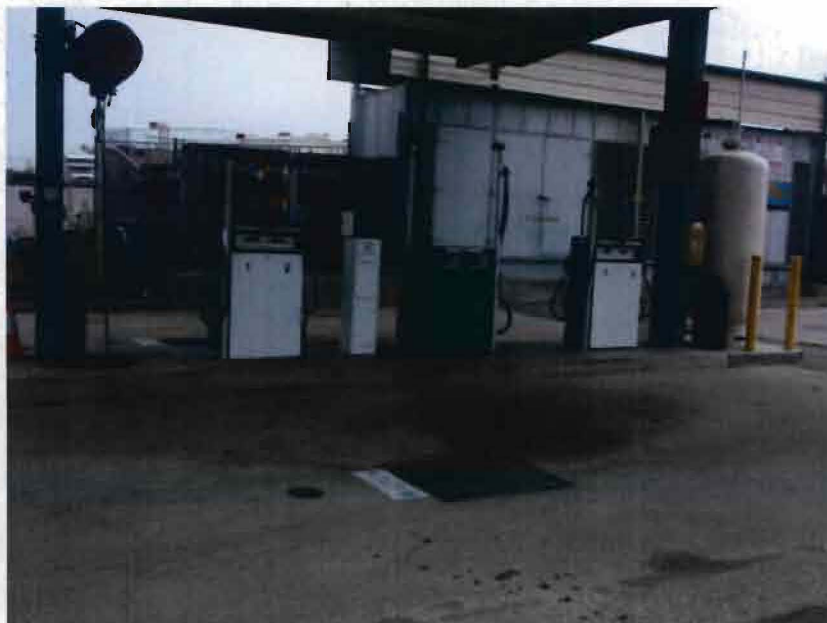
**Photograph 24.** Corporation Yard at Ryan Ranch – Vehicle fueling area at facility without spill response kit in immediate vicinity. (Note: Staining adjacent to storm drain inlet)

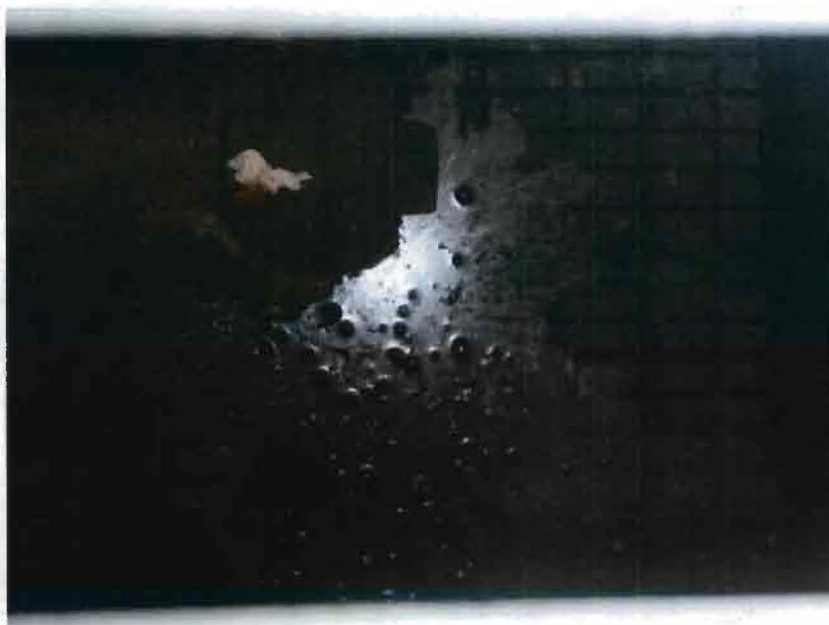
**Photograph 25.** Corporation Yard at Ryan Ranch – Close-up view into storm drain inlet pictured above. (Note: Oily sheen on water surface)

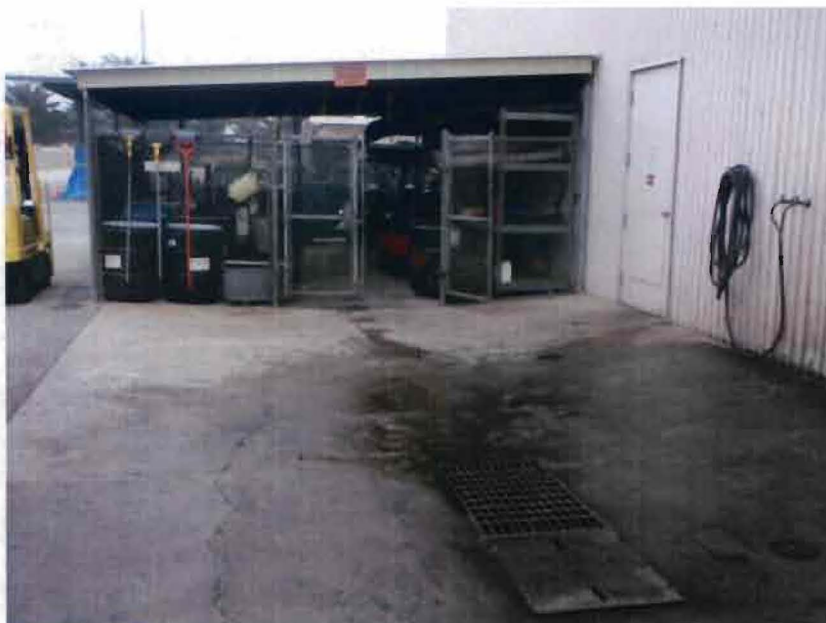
The EPA Inspection Team noted that the covered materials storage area at the rear of the facility, adjacent to the vehicle wash rack, contained several 55-gallon drums of liquid chemicals that were not within secondary containment (see attached Photographs 26 and 27). As a result, there was a potential for the discharge of spilled chemicals to the sanitary sewer.

**Photograph 26.** Corporation Yard at Ryan Ranch – Covered materials storage adjacent to vehicle wash rack that drains to the sanitary sewer. (Note: Several 55-gallon drums are not within secondary containment)

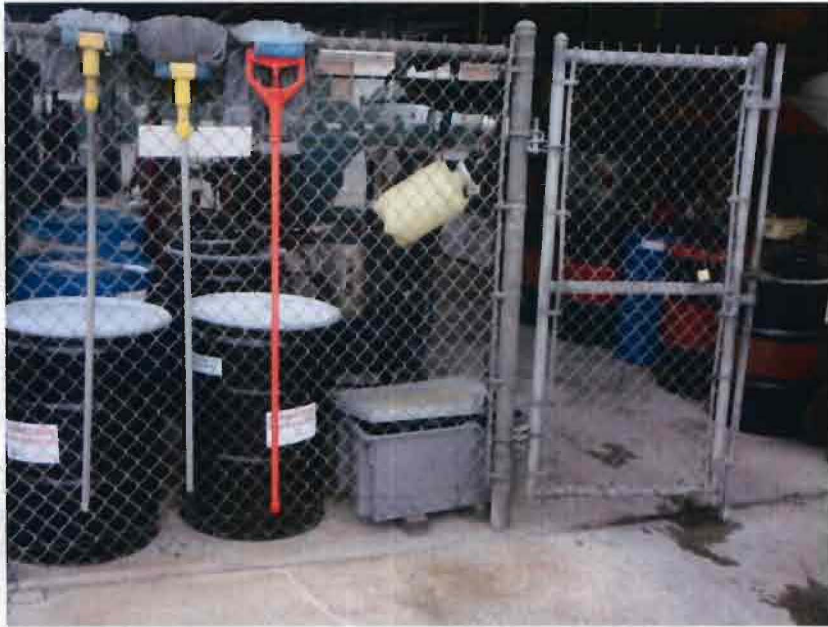
**Photograph 27. Corporation Yard at Ryan Ranch – Close-up view of 55-gallon drums not within secondary containment, adjacent to drain to sanitary sewer.**

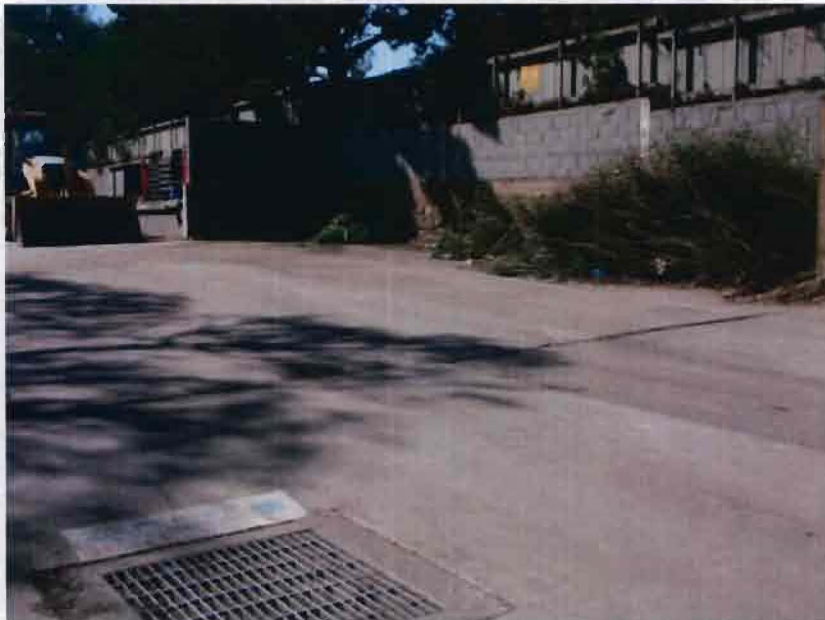
**Photograph 28. Cemetery Corporate Yard – Example of storage of unconsolidated materials adjacent to storm drain inlet without BMPs for inlet protection.**

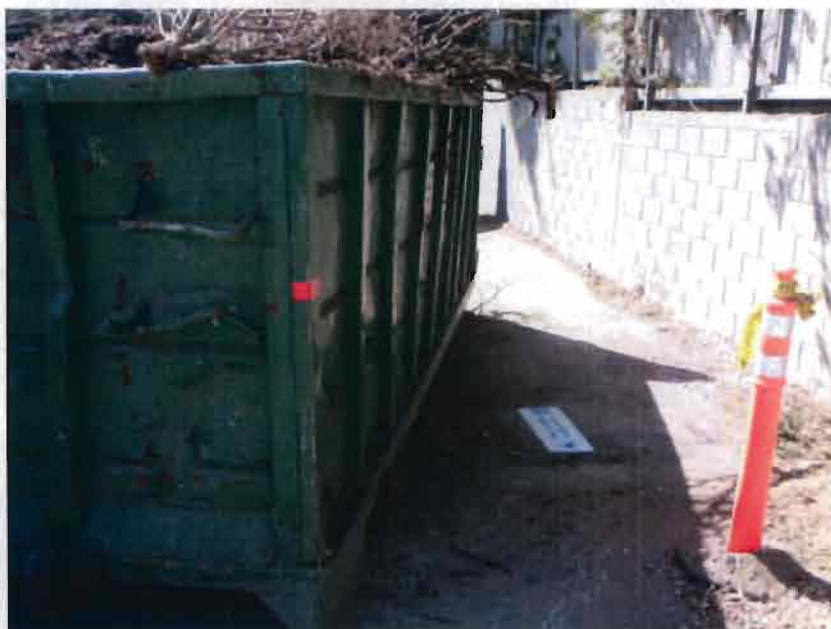
**Photograph 29. Cemetery Corporate Yard – Example of storage of unconsolidated materials in trash bin adjacent to storm drain inlet without BMPs for inlet protection.**

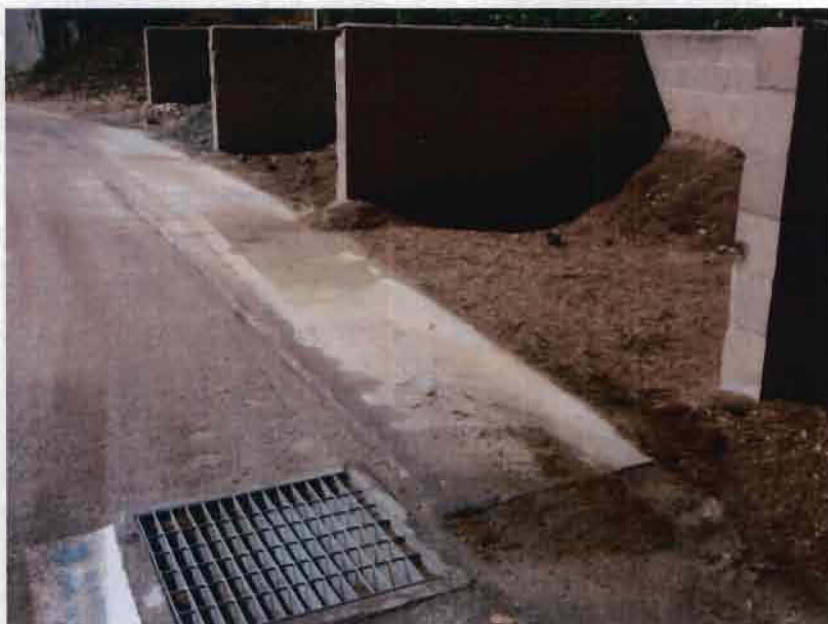
**Photograph 30. Cemetery Corporate Yard – Another example of storage of unconsolidated materials adjacent to storm drain inlet without BMPs for inlet protection.**

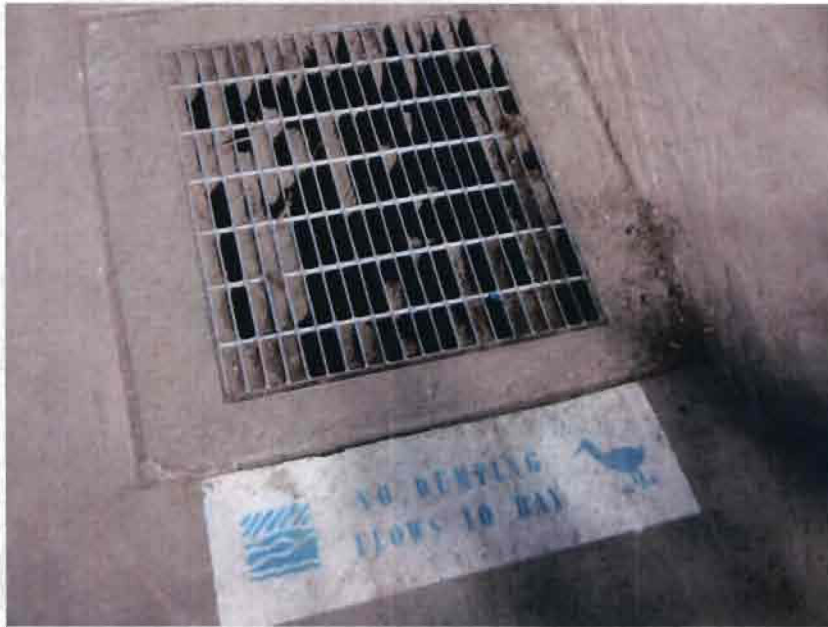
observed material within several storm drain inlets (see attached Photographs 31 and 32), which indicated that an unknown quantity of sediment has likely been discharged to the MS4 and there was a potential for the subsequent discharge of pollutants off-site.

**Photograph 31. Cemetery Corporate Yard – Example of unconsolidated materials within storm drain inlet.**

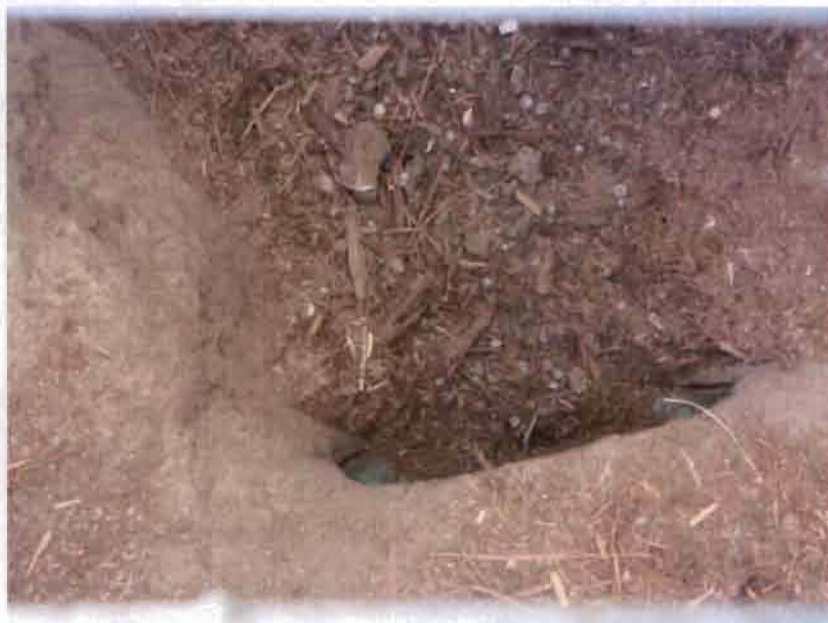
**Photograph 32. Cemetery Corporate Yard – Close-up view into storm drain inlet pictured above in Photograph 30. (Note: Accumulation of mulch in storm drain inlet)**

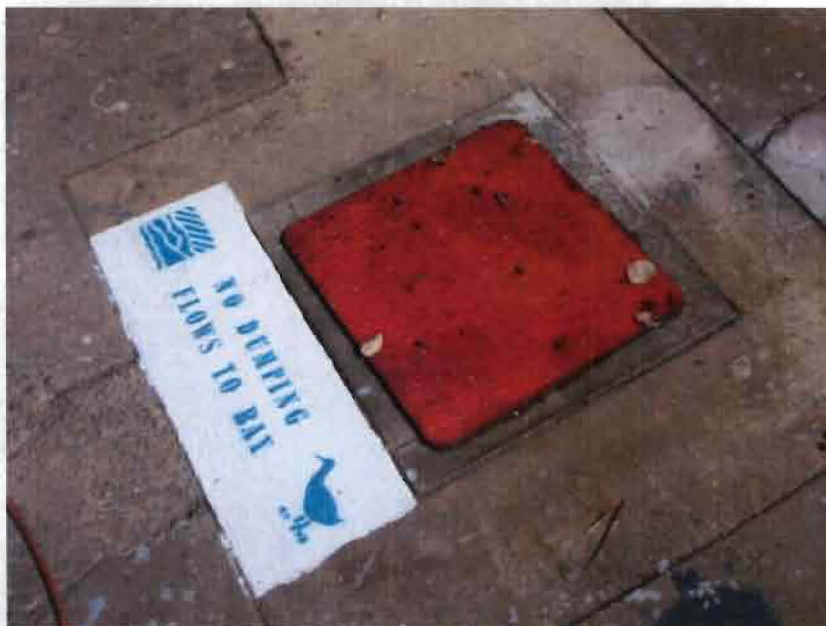
**Photograph 33. Harbor Maintenance Corporate Yard – Example of cover placed on storm drain inlet when work is being performed outside in the area of the storm drain inlet.**

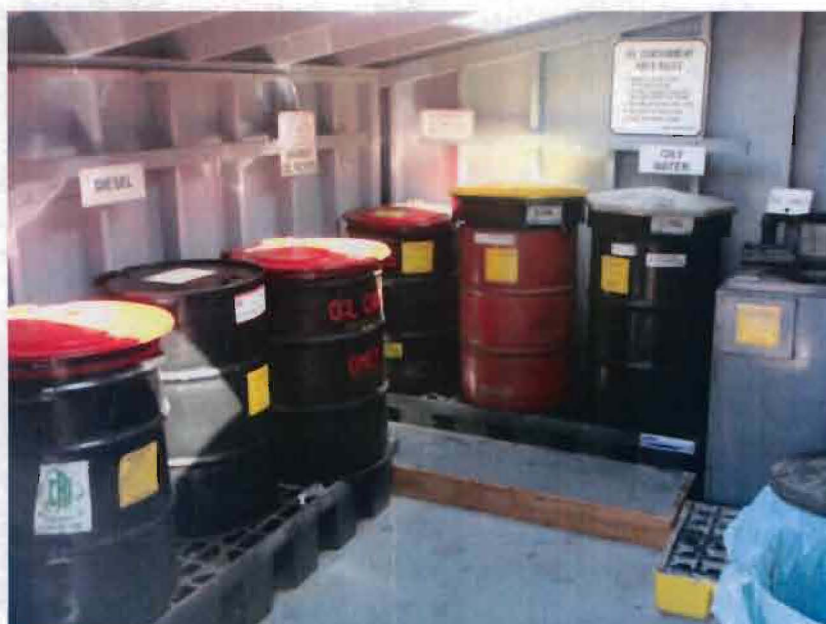
**Photograph 34. Municipal Harbor and Marina – Example of disposal facility provided for patrons at the Municipal Harbor and Marina.**

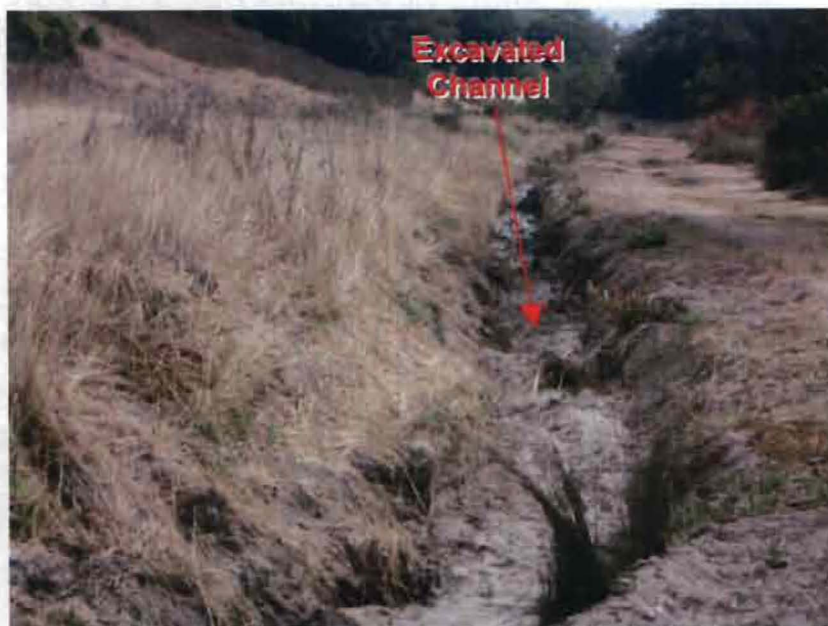
**Photograph 38. Highway 68 Detention Pond – Excavated channel to detention pond.**

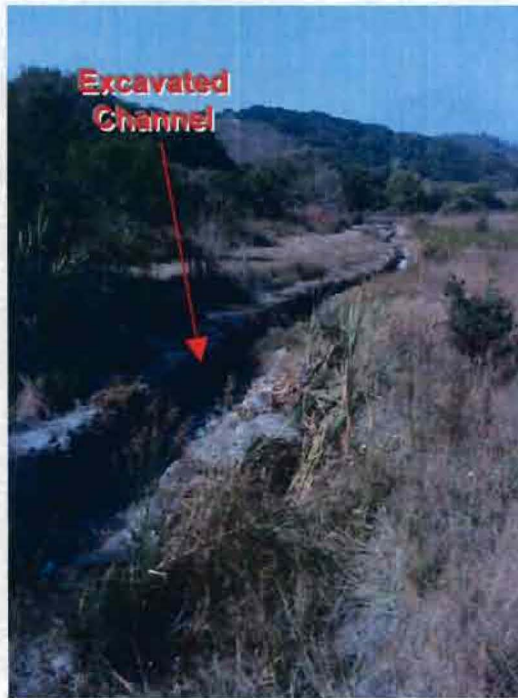
**Photograph 39. Highway 68 Detention Pond – Another view of excavated channel to detention pond.**

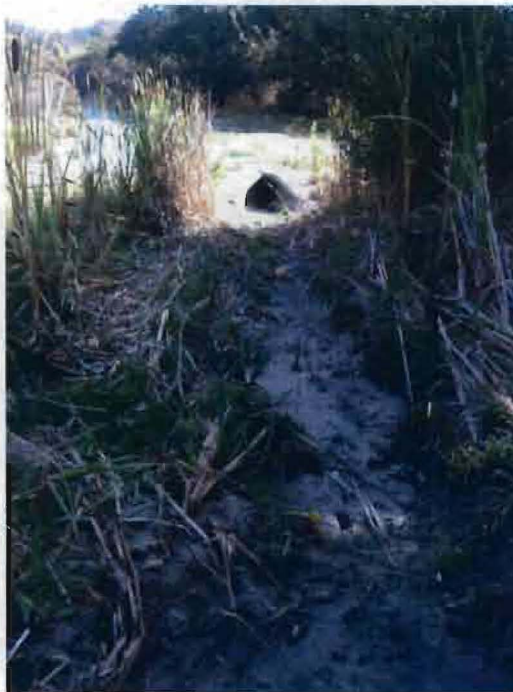
**Photograph 40. Highway 68 Detention Pond – View upstream of dredged channel to detention pond.**
