City of Gardena Semi-Annual Non-Stormwater Monitoring Report Results: 2016-2017

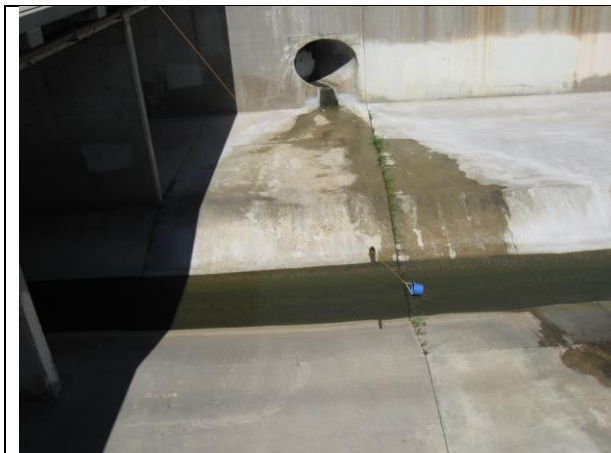
Outfall Flap Gate

The City is aware that it must conduct grab samples of non-stormwater outfall discharges to determine compliance with TMDLs and Municipal Action Levels (MALs). According to Regional Board stormwater staff, a grab sample is to be taken when outfall flow is equivalent to what is normally discharged from a garden hose. The City has not observed outfall flow to that extent that would trigger the need for a grab sample. As explained in previous written communication to Regional Board staff, all of the outfalls from Gardena's catchment areas are fitted with flap-gates that minimize the discharge of outflow to what would be discharged from a standard garden hose. The picture below on the left shows the outfall flap-gate (Western and Artesia). The picture was taken three days after a storm event. A sample bucket was used to take an ambient sample from the Dominguez channel low flow slot. The discharge spillage on the northern side of the channel floor is a remnant of the preceding storm event. The picture to the right was taken in the spring. It shows no outfall discharges.

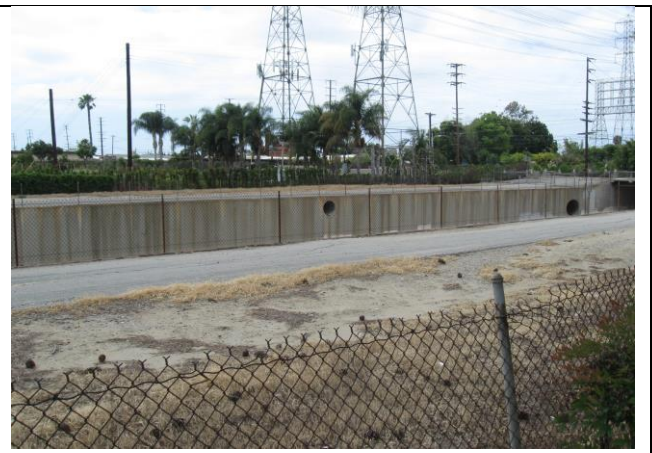
Outfalls Along Dominguez Channel (Above Vermont)

This is typical of all Gardena outfalls, except following storm events when residual stormwater flow manages to produce enough head to push the flap gates open to release pent-up flow (see picture below).
