**EVALUATION OF TREATMENT PLANT OPERATION AND
POTENTIAL CAUSES OF TREATMENT PLANT EFFLUENT
LIMITATION VIOLATIONS (April to June 2004) FOR THE CITY
OF ESCONDIDO HALE AVENUE RESOURCE RECOVERY
FACILITY**

**Boris Trgovcich
Water Resources Control Engineer
Compliance Assurance and Enforcement Unit
State Water Resources Control Board**

April 7, 2005

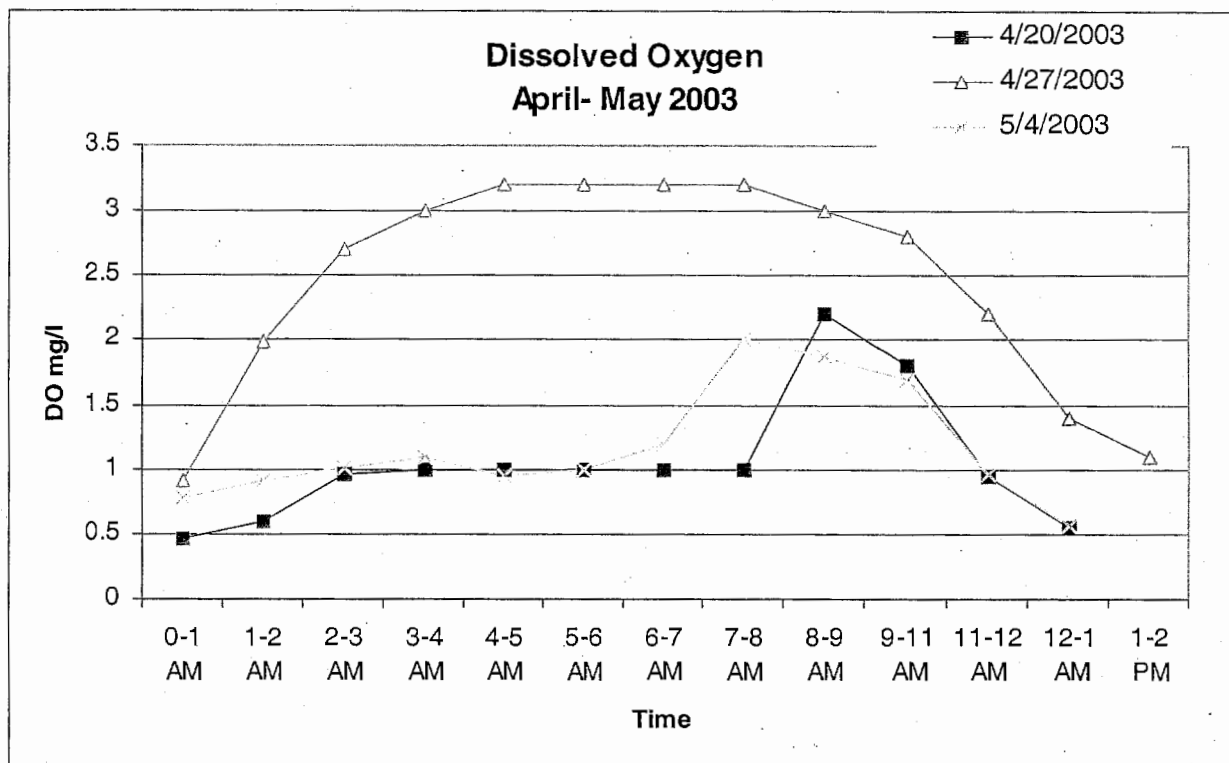
noticeable effect on the plant performance. For example, **Figure 1** shows DO “spikes” at this facility for selected days during three consecutive weeks, one year prior to the alleged April –June upset. During that three week period the plant experienced was no appreciable decrease in performance and no documented effluent limit violations.

Figure 1 – Example of DO “spikes” at HARRF during three days, one week apart in April-May 2003. The average DO concentration for the remainder of each day was approximately 1 mg/l.
