Appendix F

ASHBY USA, LLC

Ref: WPN: 10-3020657.02, 18-2001091.02:schwk
NOV No. R9-2006-0135

Subject: Required Technical Report

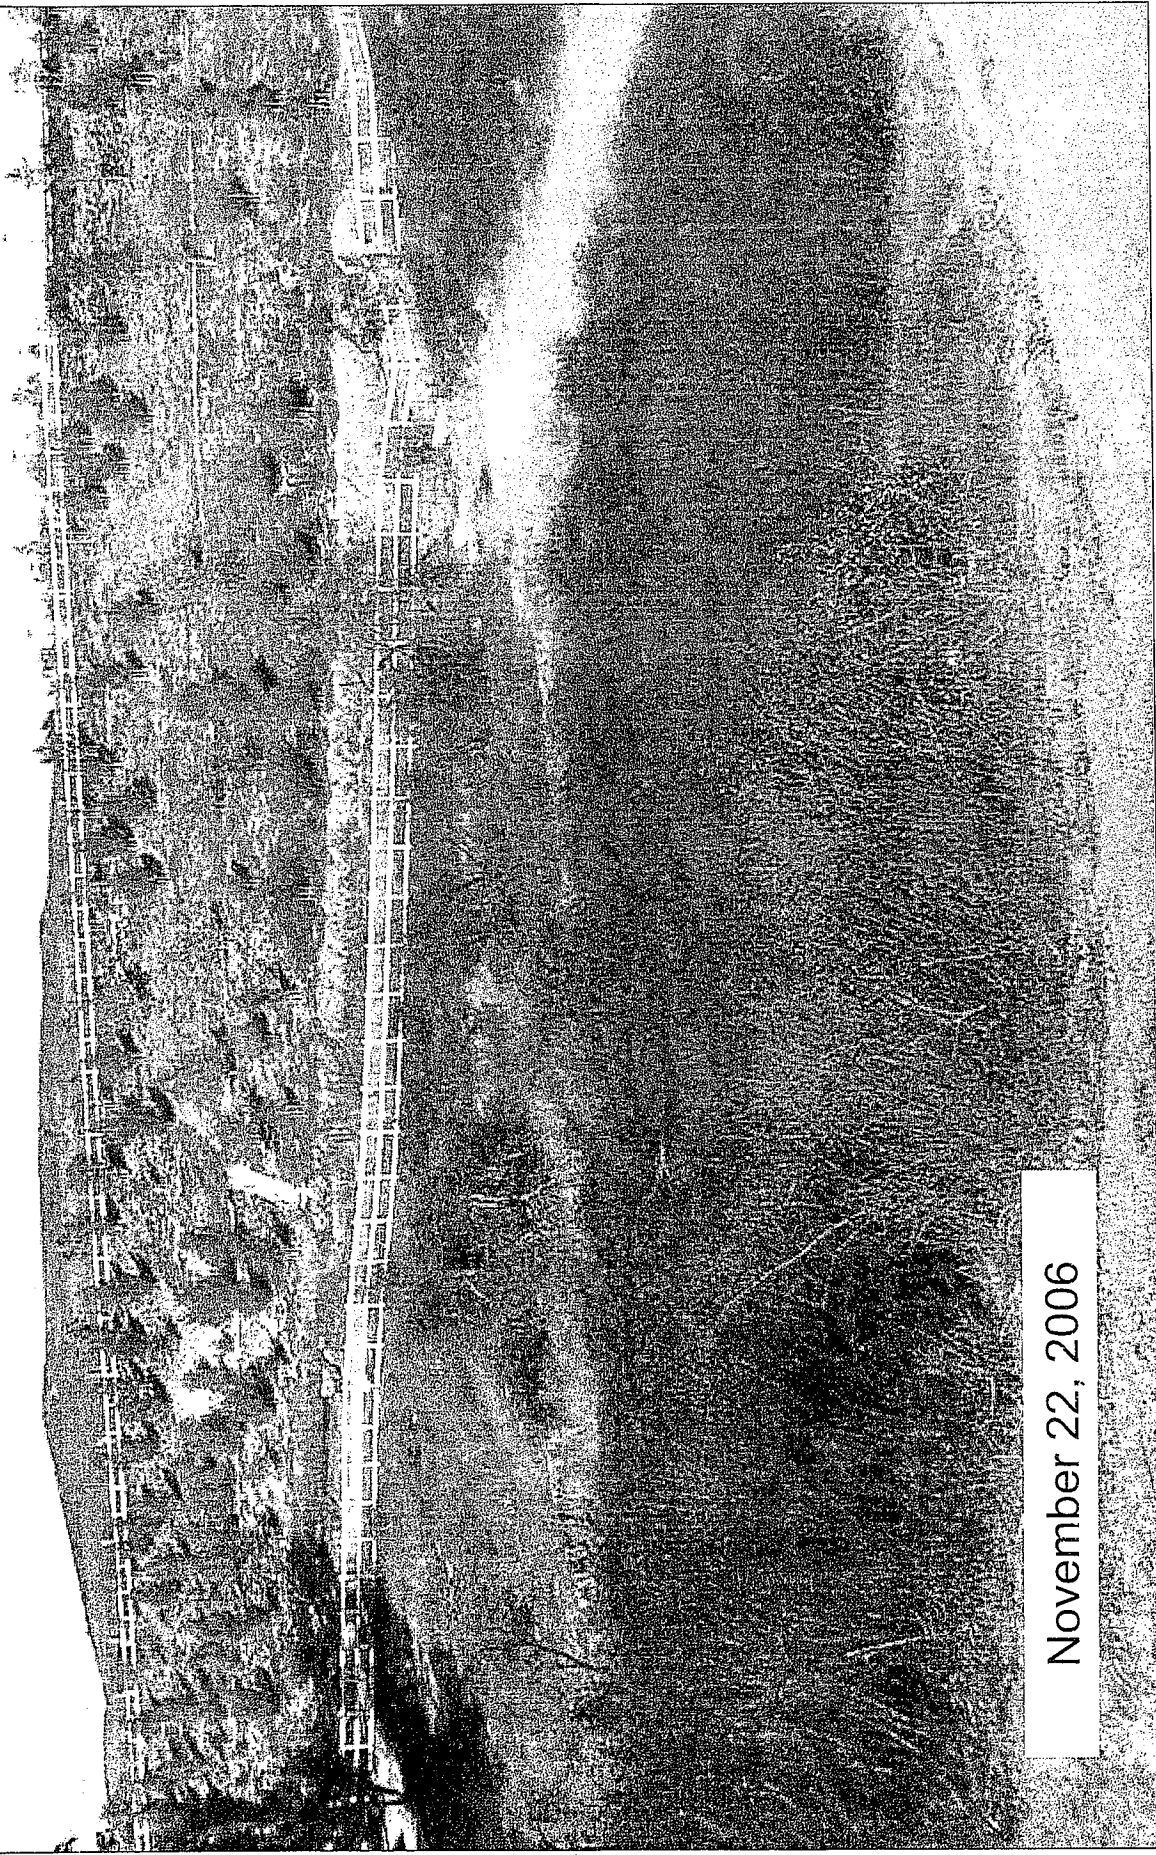
Disturbed road leading to tributary to Santa Gertrudis Creek and head wall
from sediment basin from Prairie Area.

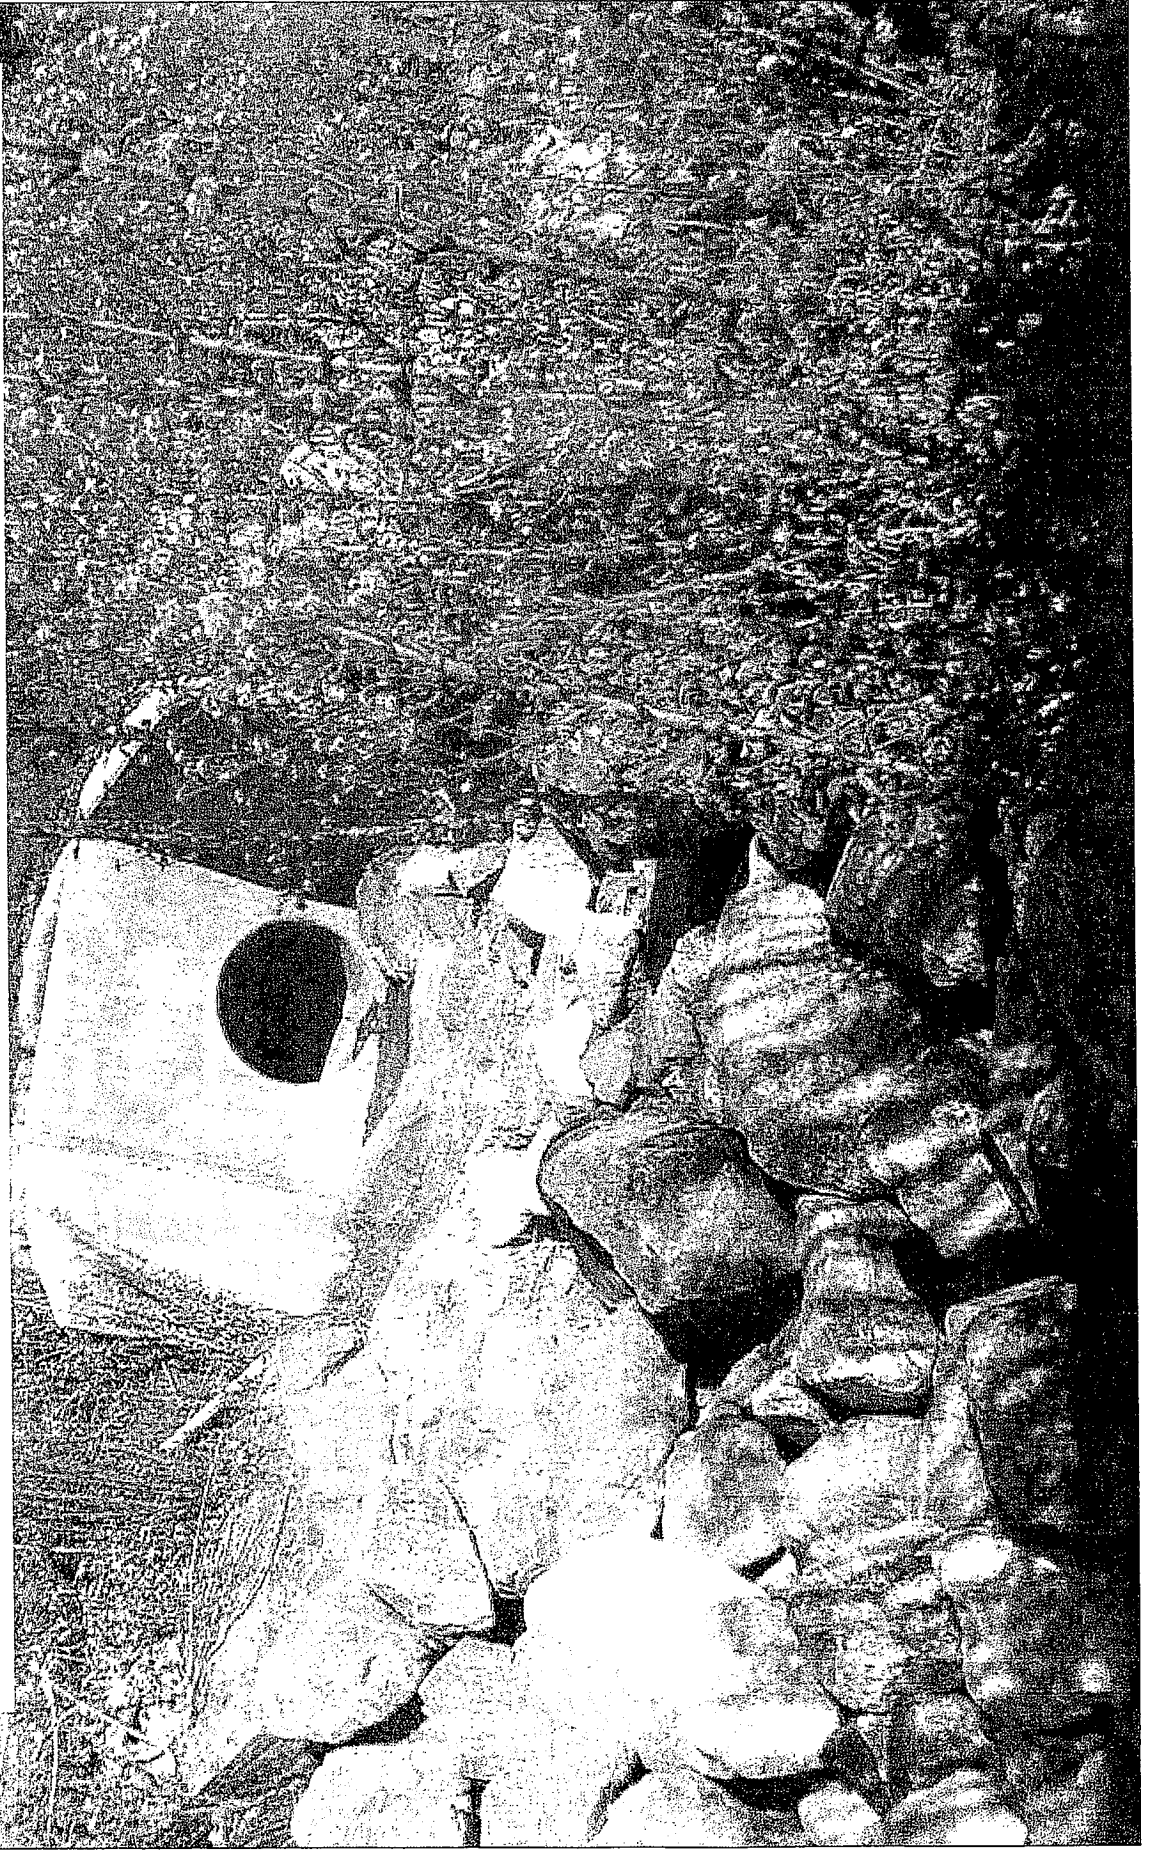
The rip rap at the headwall appeared ineffective in minimizing downstream erosion. The rip rap was covered with sediment eliminating its usefulness in reducing the velocity and energy of concentrated storm water flows from the sediment basin.

Outfall headwall from sediment basin with rip rap for Phases 1-5

These impacts were addressed in NOV R9-2003-0197 issued April 22, 2003, NOV R9-20030392 issued on November 4, 2003, and ACL Order R9-2003-0302 issued on November 12, 2003. As a result of these violations, the following significant construction and post construction BMP's were installed per the direction of the City of Temecula, the discharge point was reduced to a 6" opening; the rip rap at the discharge point was increased. As well as the fact that all season BMP's on the plateau include Silt fencing and wattle on all lots, Storm Drain inlet protection with filter fabric with gravel bag dams. Photo 10 of the inspection report is inaccurate, as shown in the photos in exhibit "A" it is clearly identified that the outlet of the detention basin is on the Roripaugh Ranch Property, photo 10 from the NOV identifies an abandoned check dam that was placed in 2003 and it is not on the Roripaugh Ranch Project as located by the proximity of the property line fence in the background (white rail fence). As directed by the City of Temecula a secondary downstream rip rap area was added to further reduce velocity. Gravel bag check dams have also been placed between the primary and

secondary rip rap to reduce velocities for any additional seasonal flow. Please see the photos in exhibit "A" to view existing conditions.

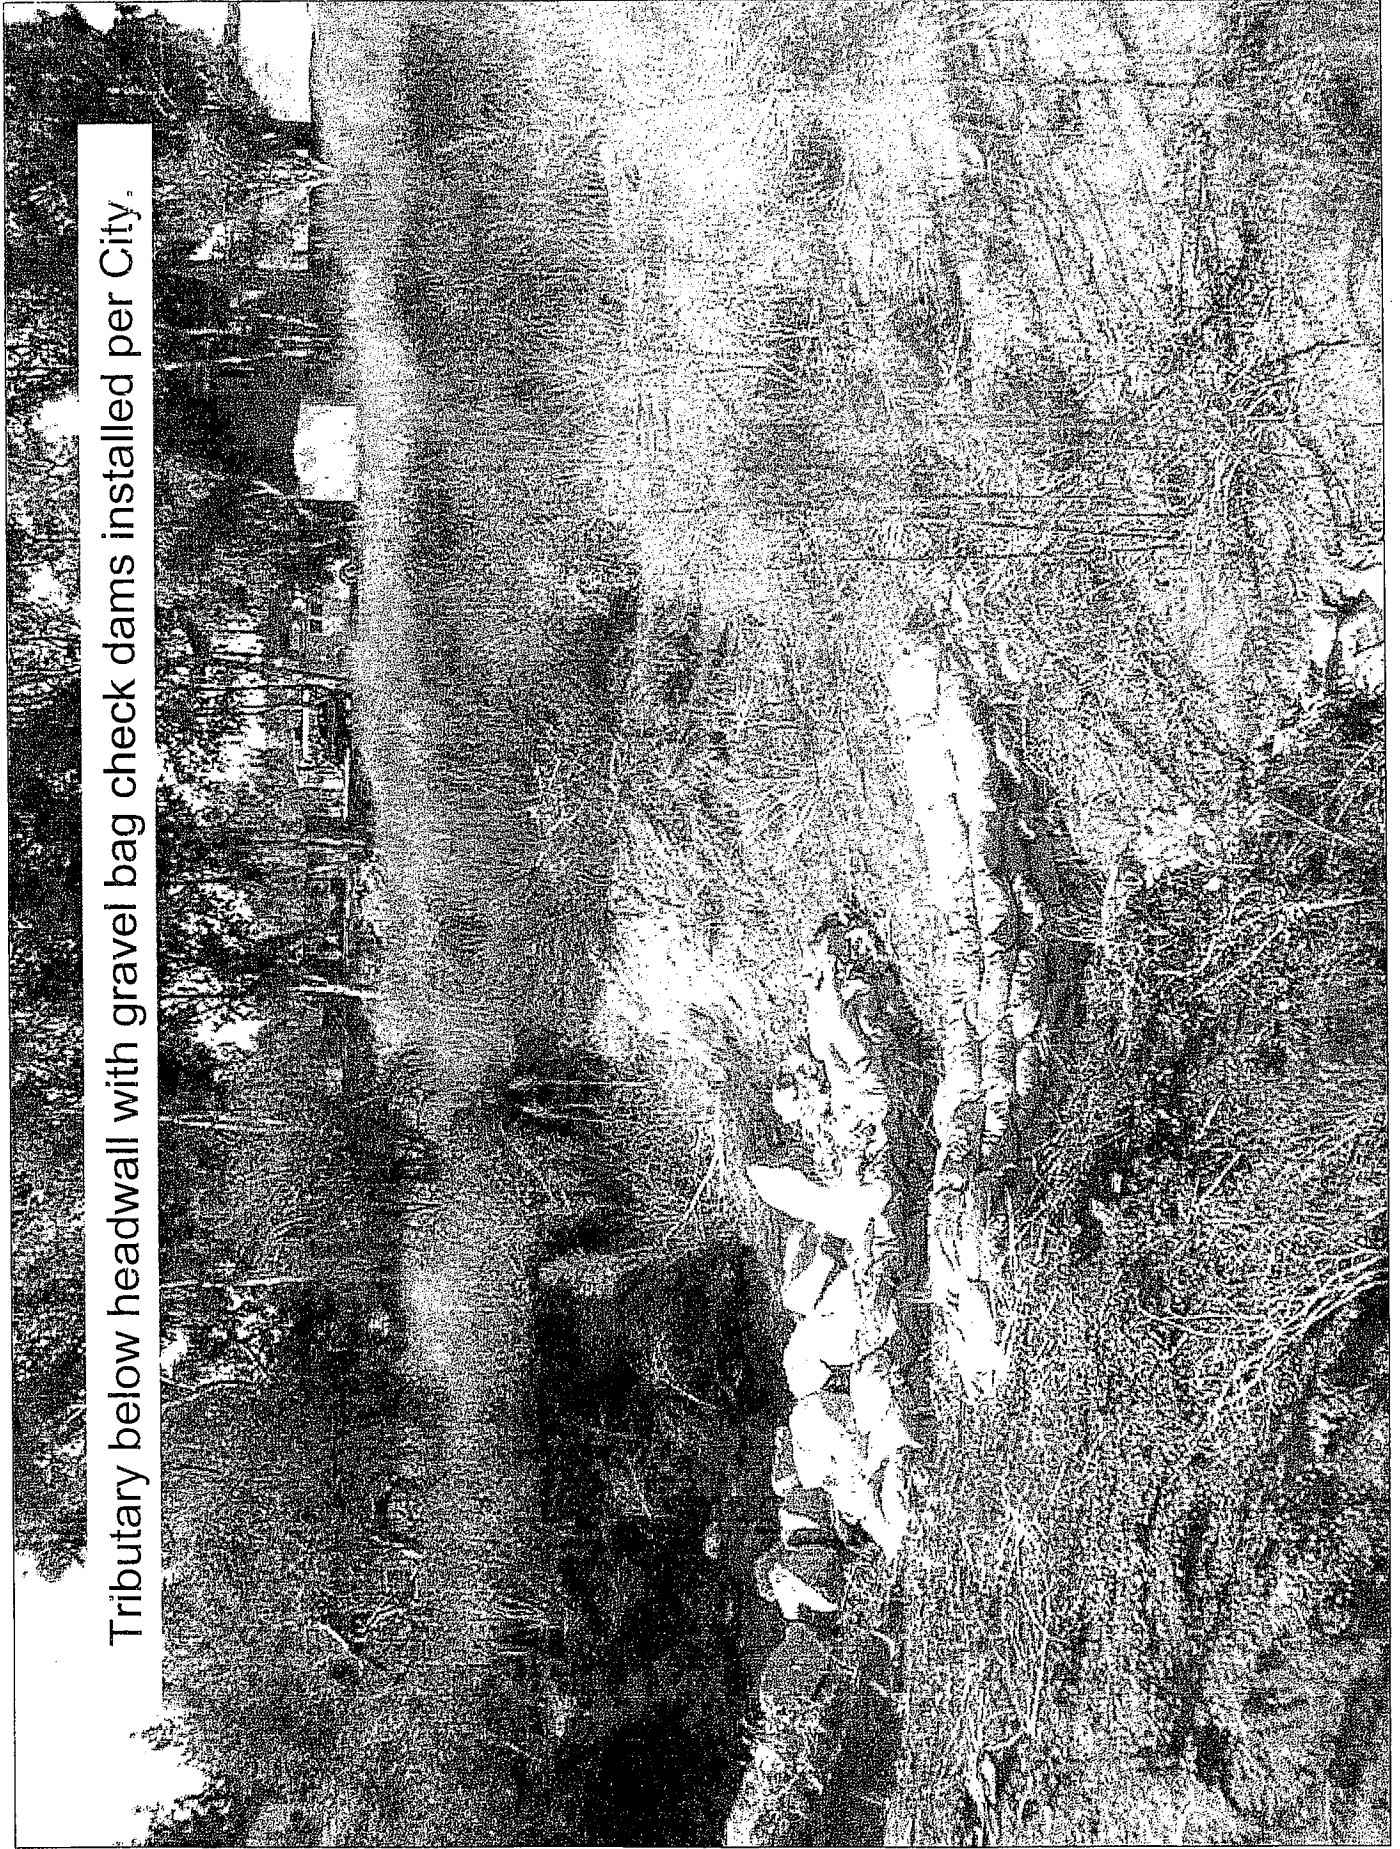
Tributary below headwall with gravel bag check dams installed per City.

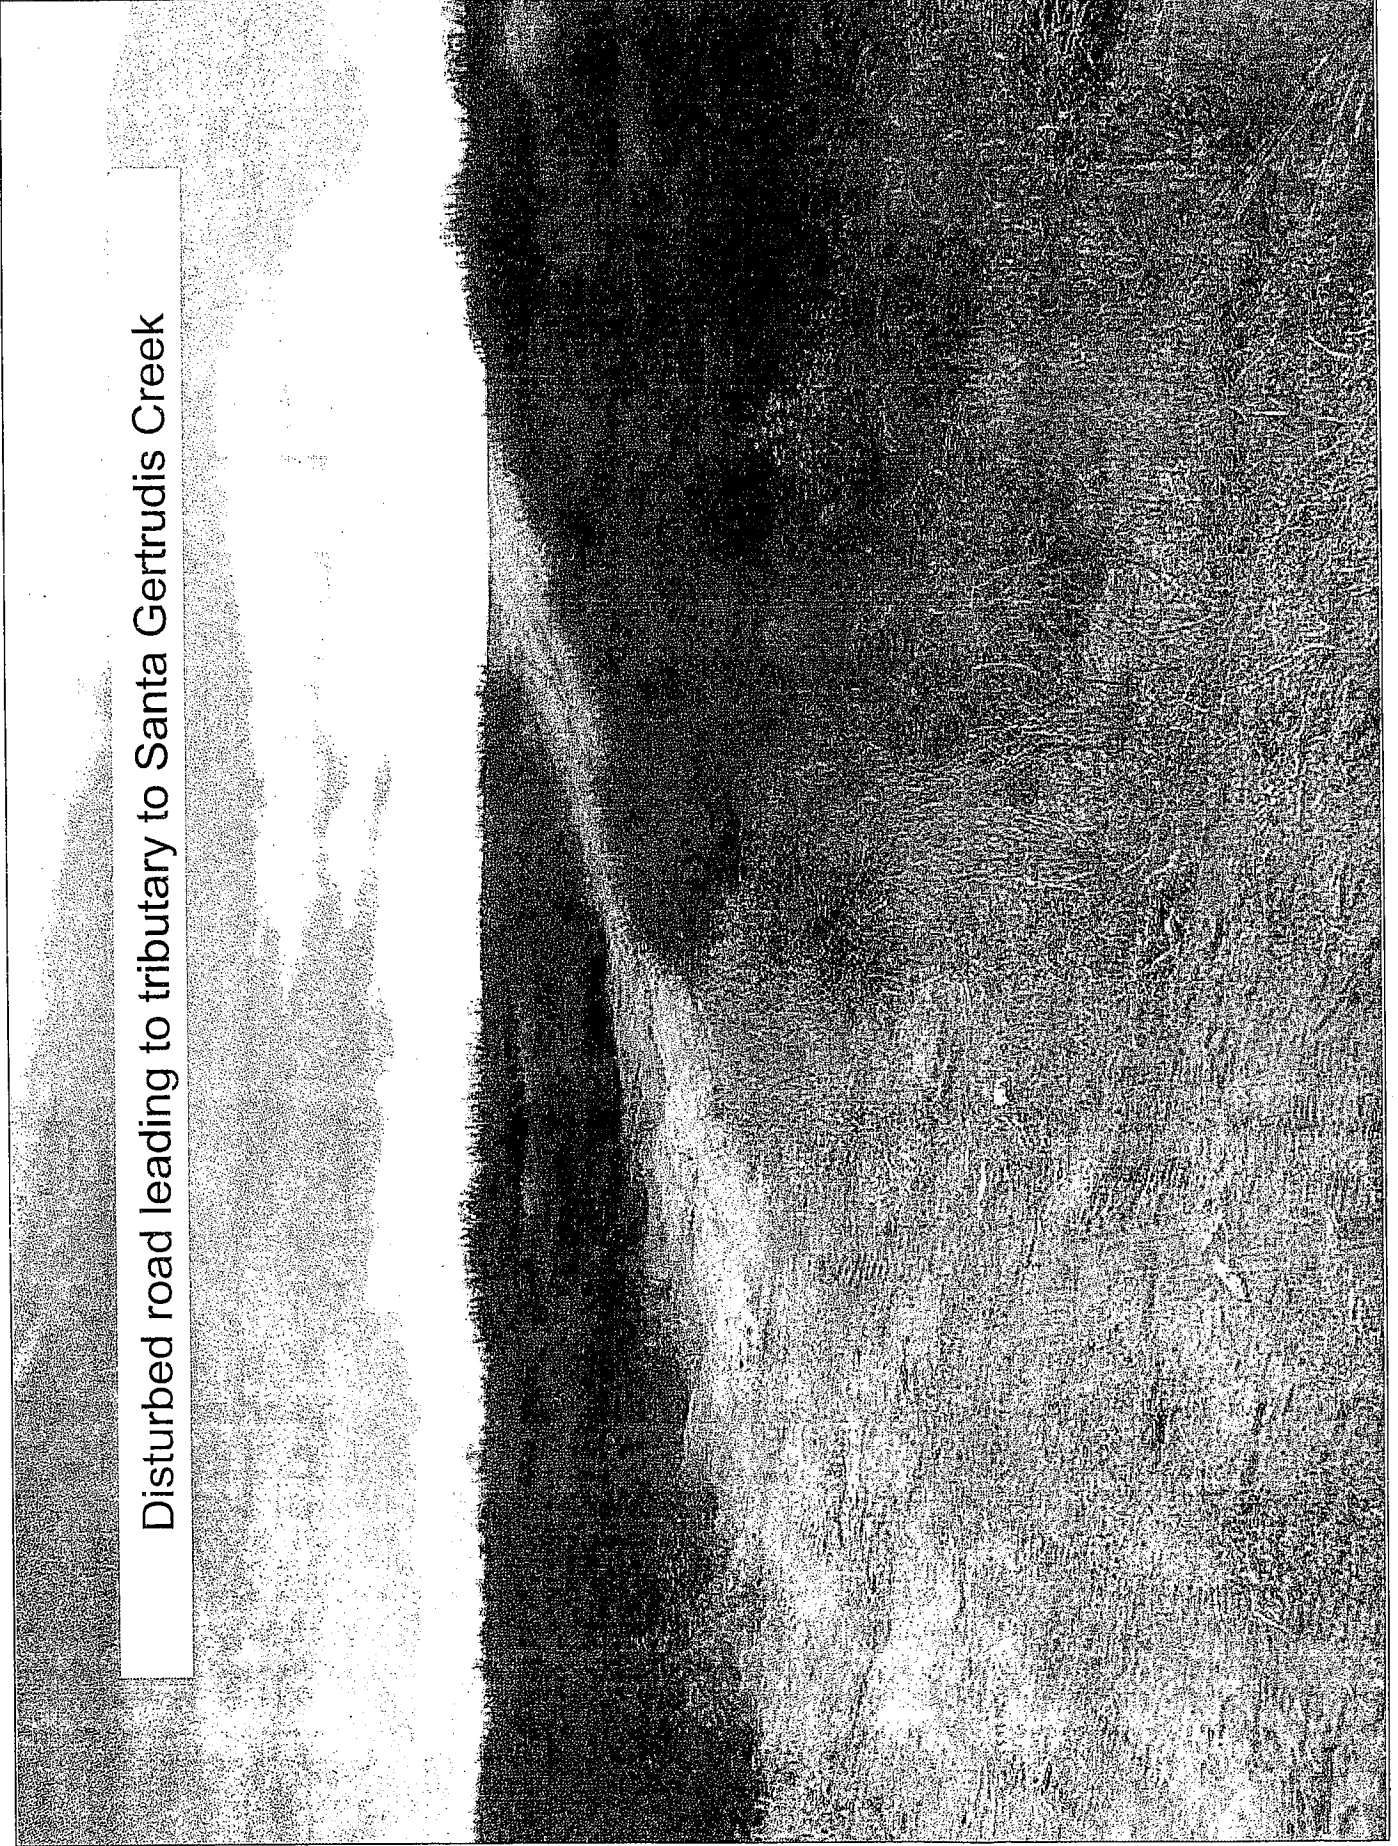
Disturbed road leading to tributary to Santa Gertrudis Creek

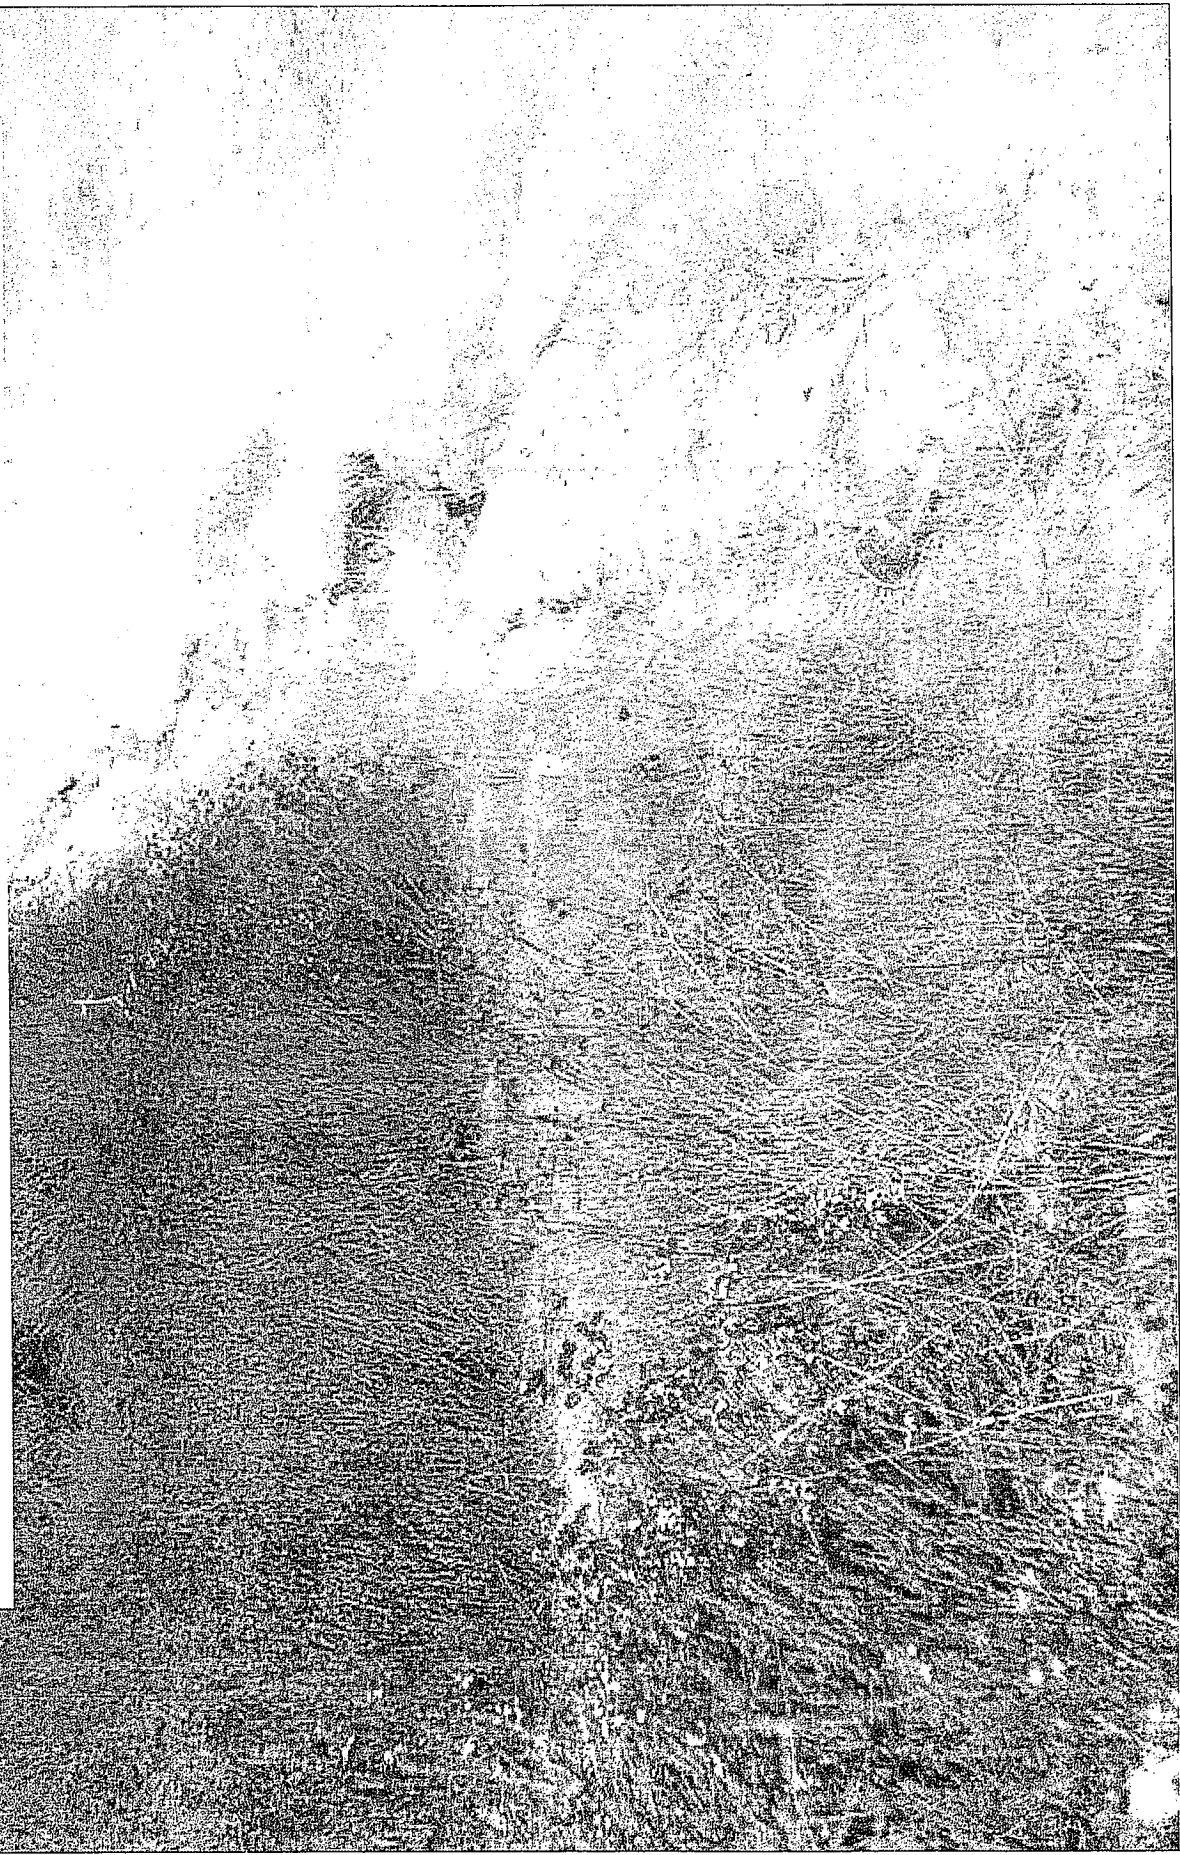
Rills from storm water runoff on disturbed road leading to tributary to
Santa Gertrudis Creek

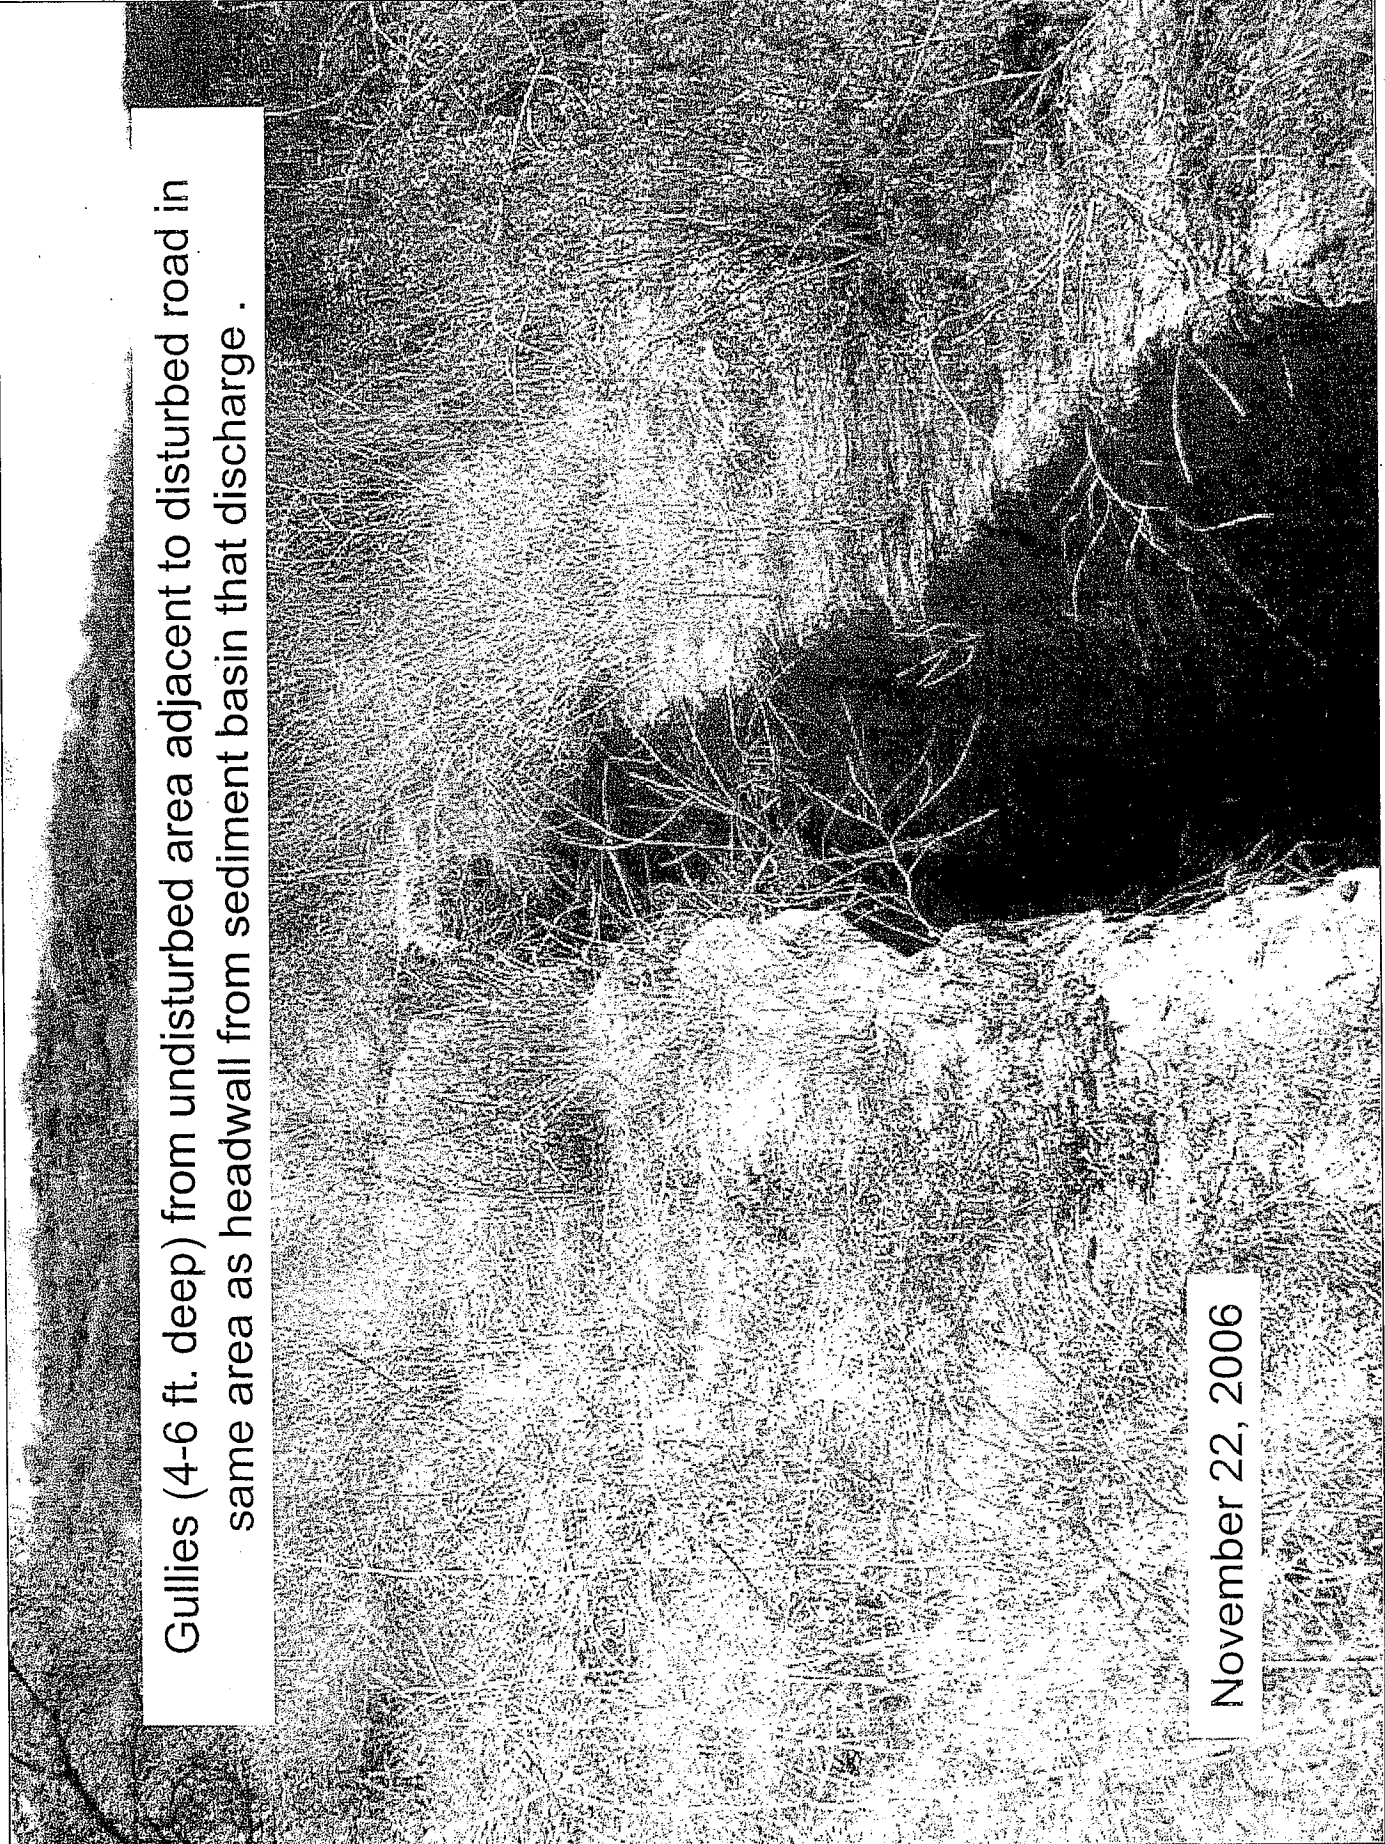
Gullies (4-6 ft. deep) from undisturbed area adjacent to disturbed road in same area as headwall from sediment basin that discharge .

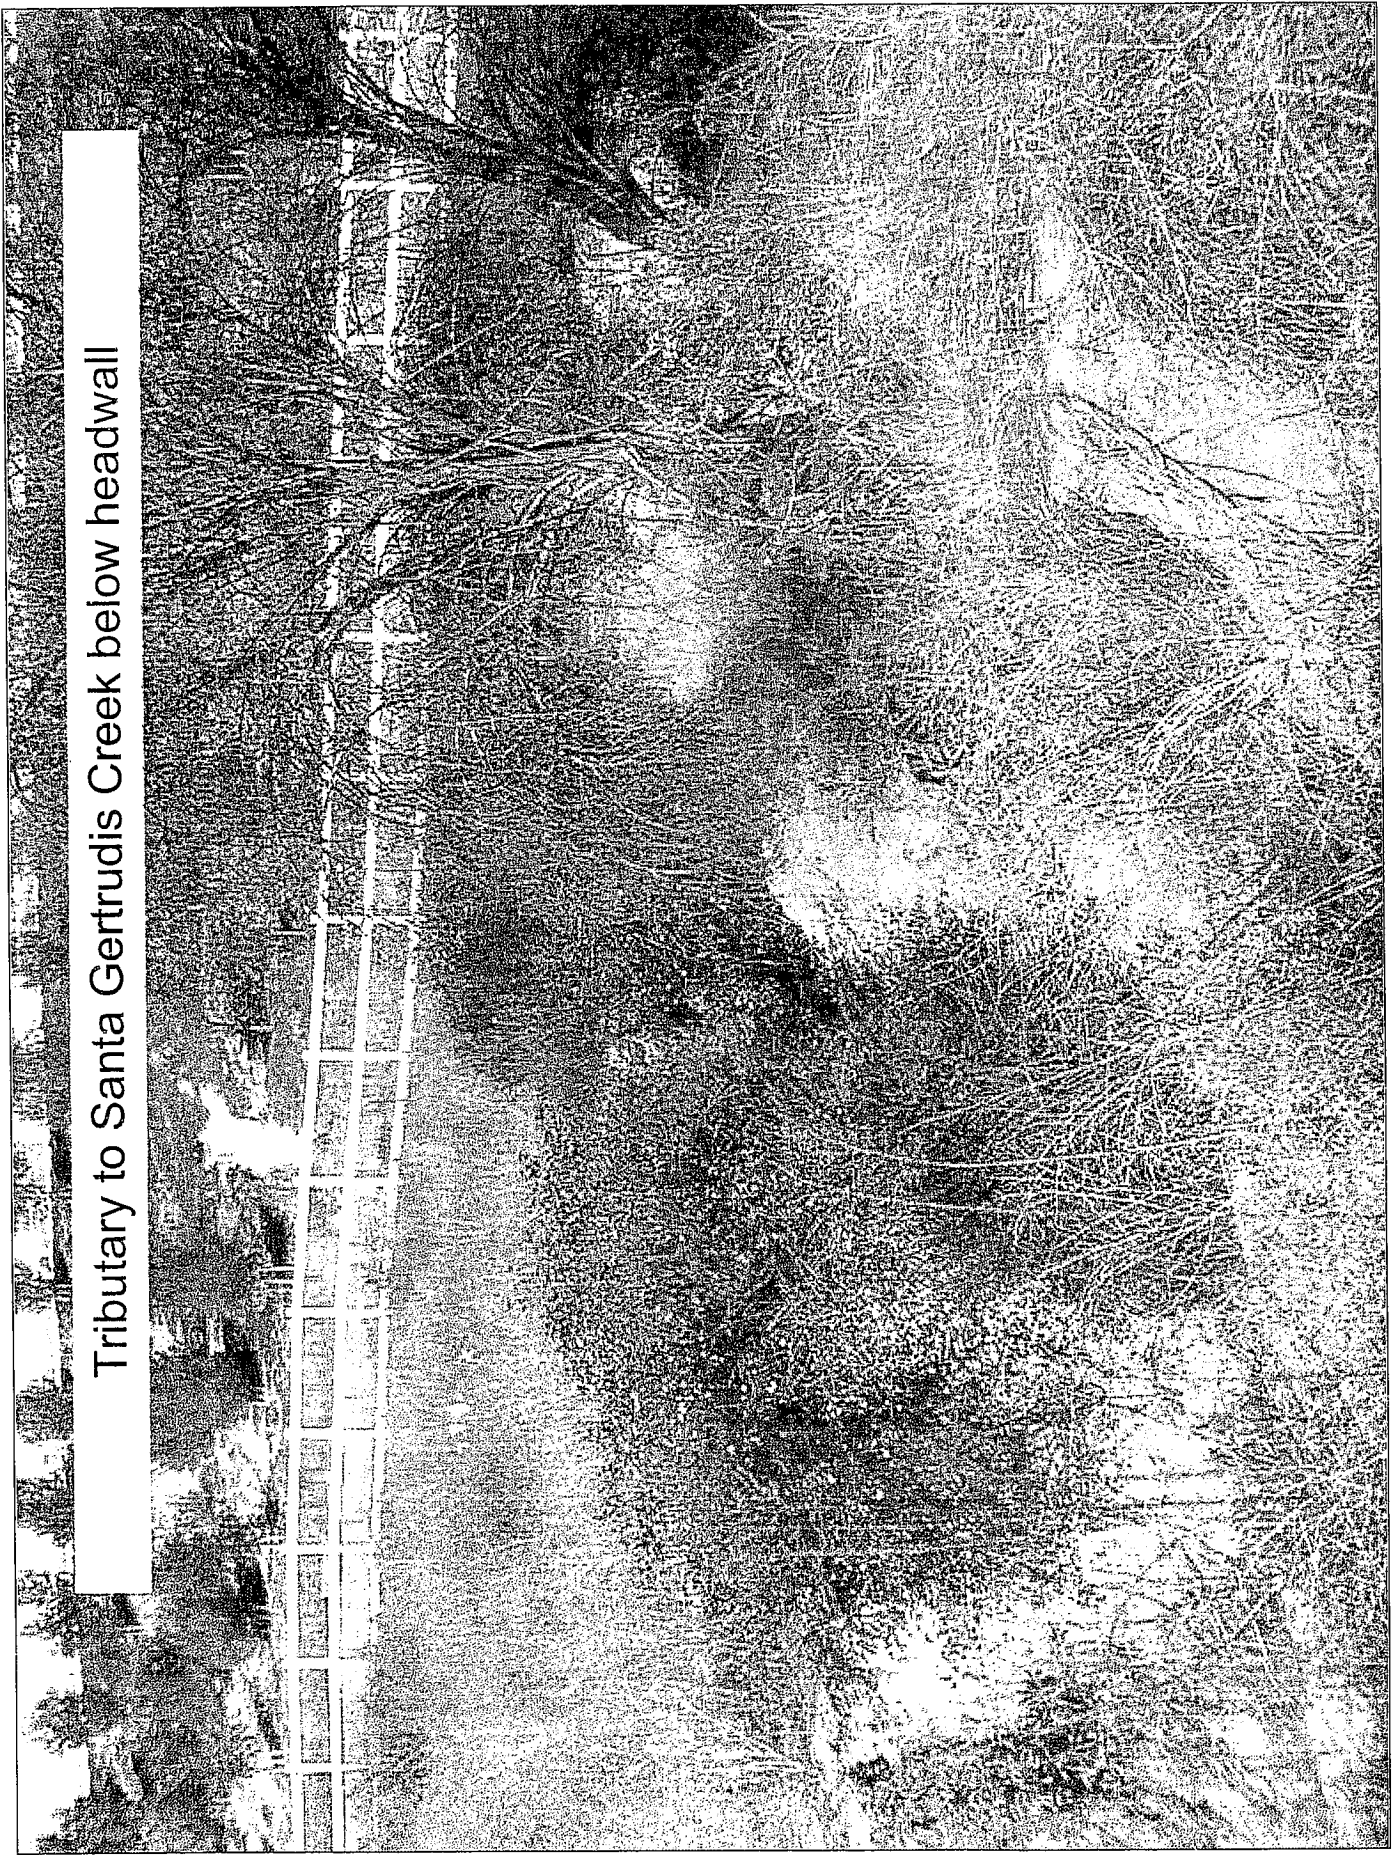
Tributary to Santa Gertrudis Creek below headwall

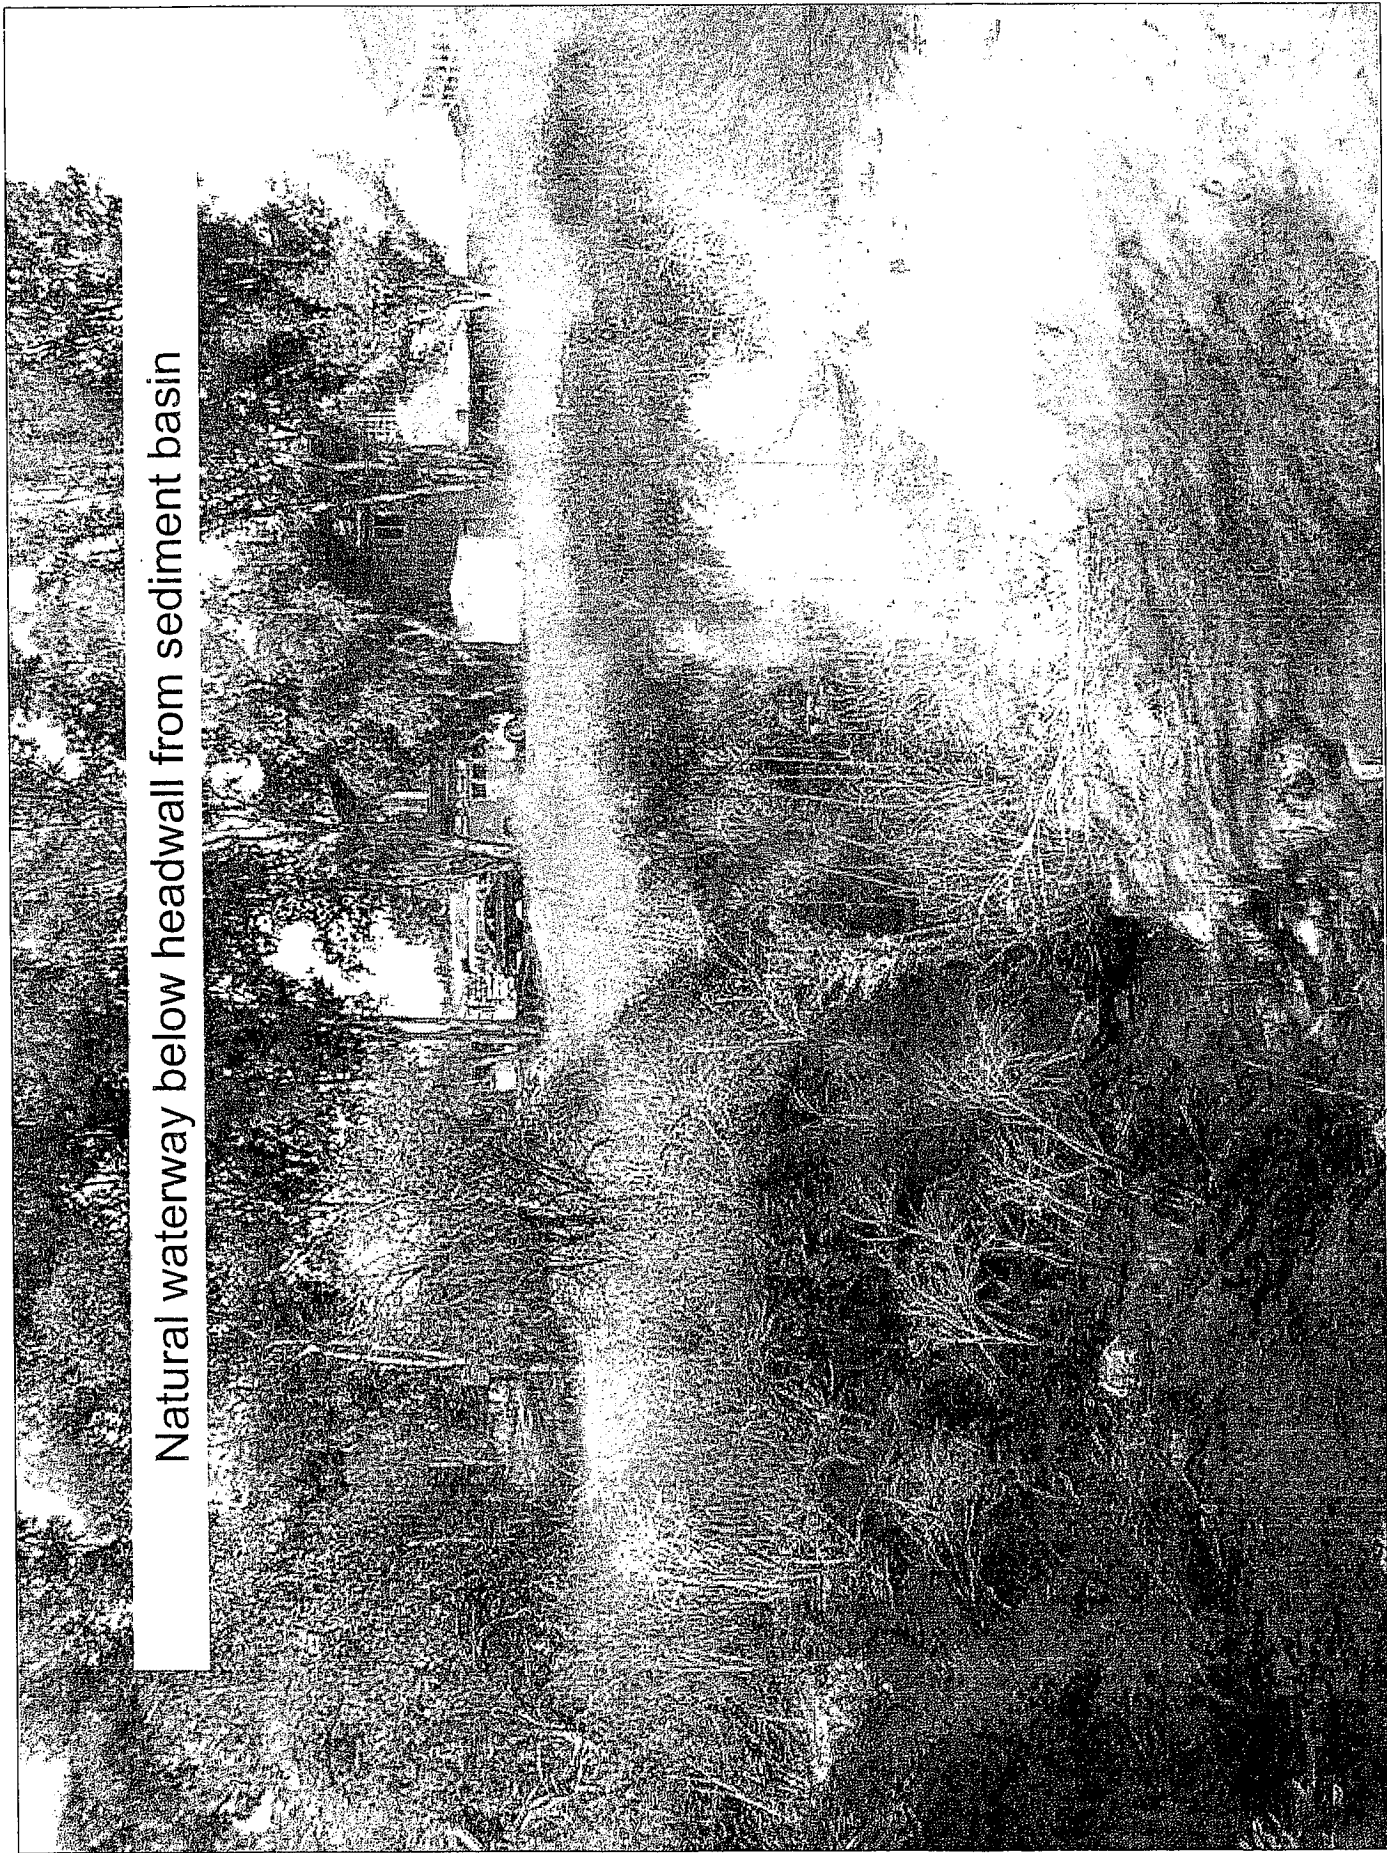
Natural waterway below headwall from sediment basin

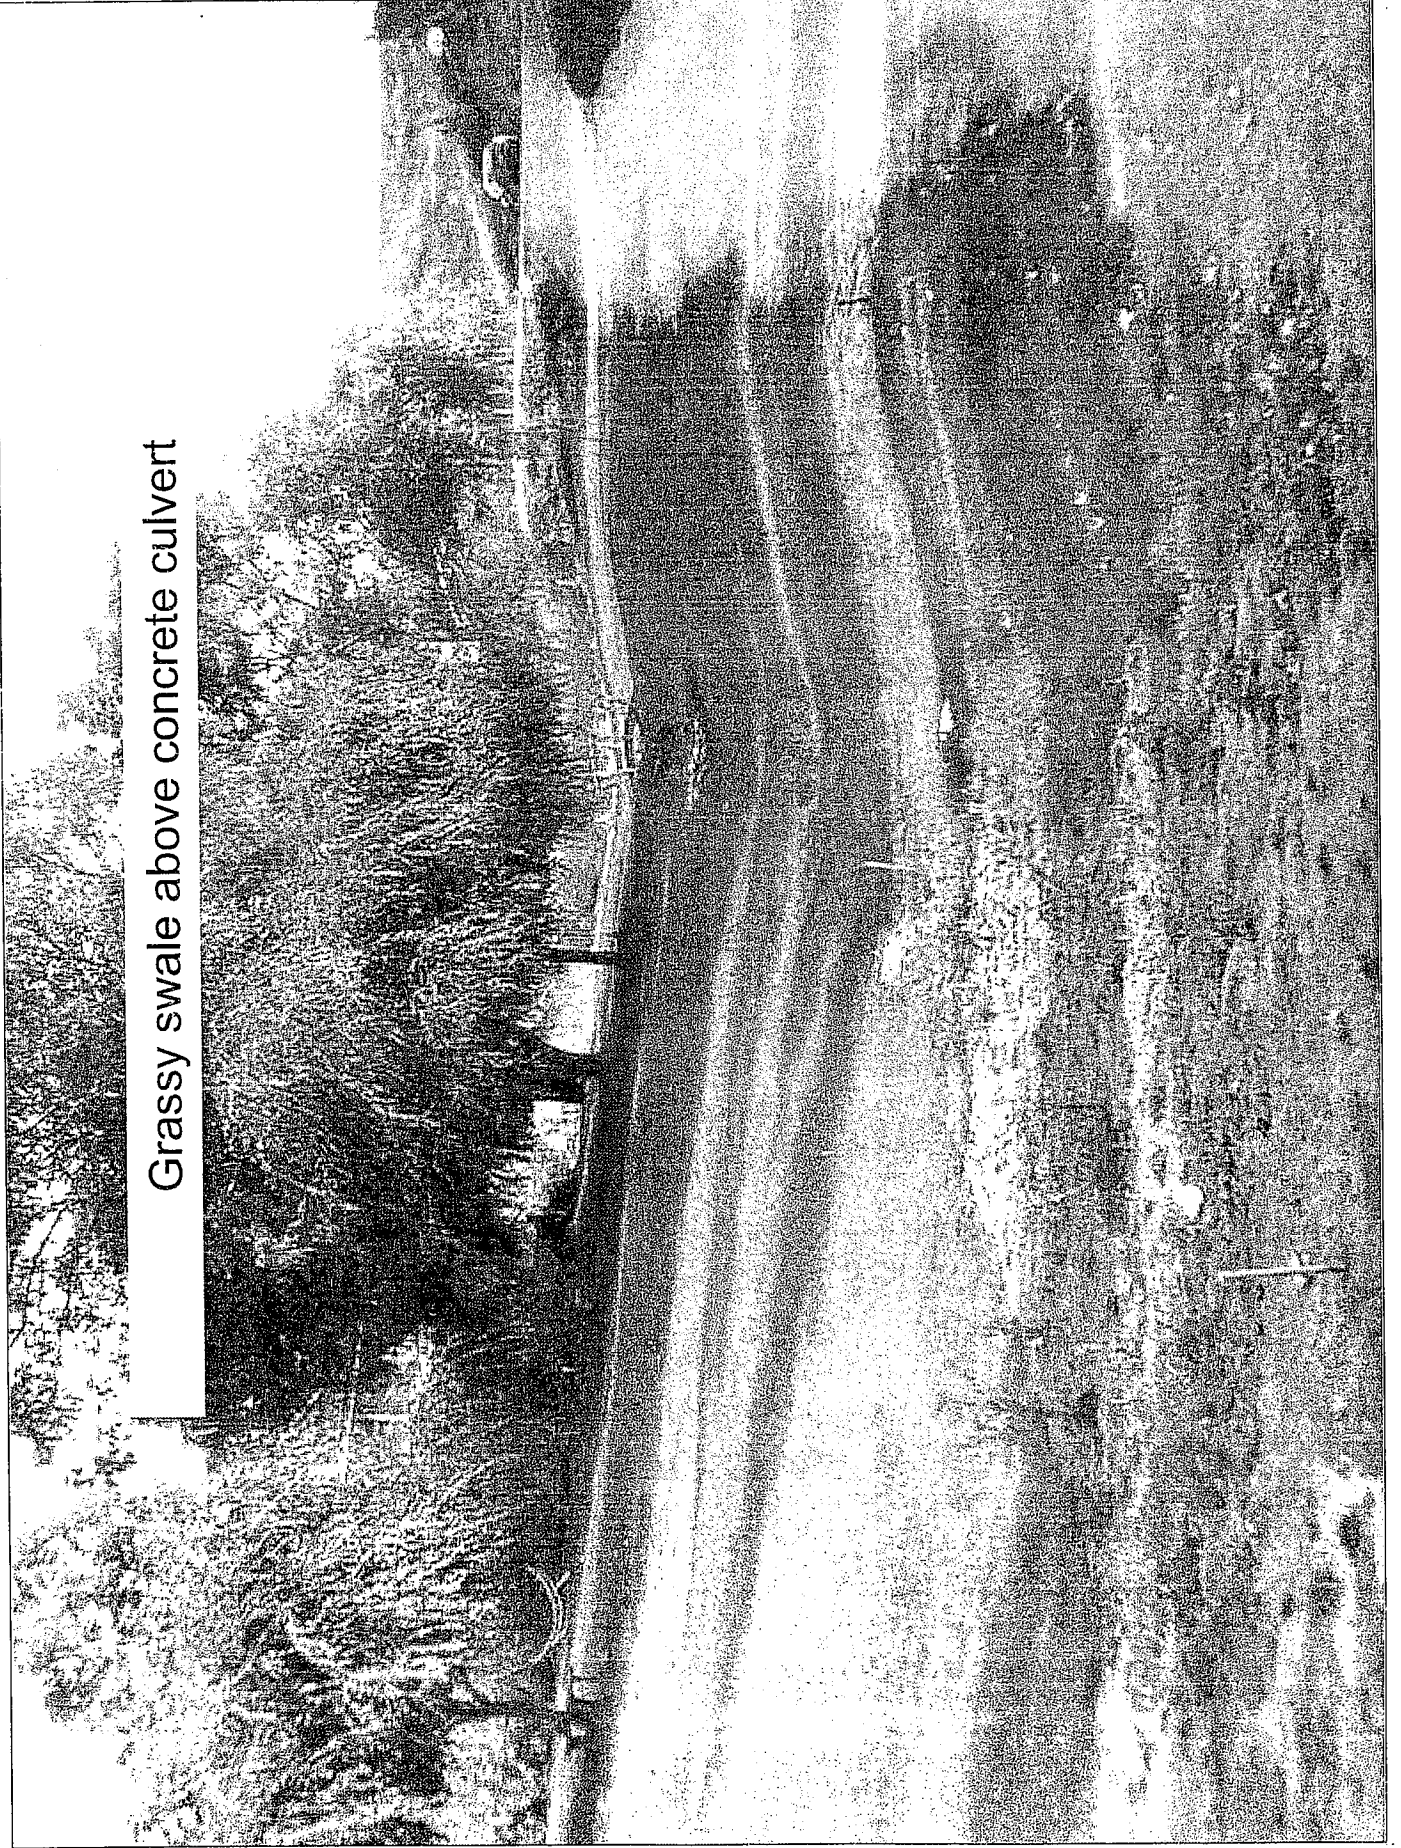
Grassy swale above concrete culvert
