Appendix F

ASHBY USA, LLC

Ref: WPN: 10-3020657.02, 18-2001091.02:schwk
NOV No. R9-2006-0135

Subject: Required Technical Report

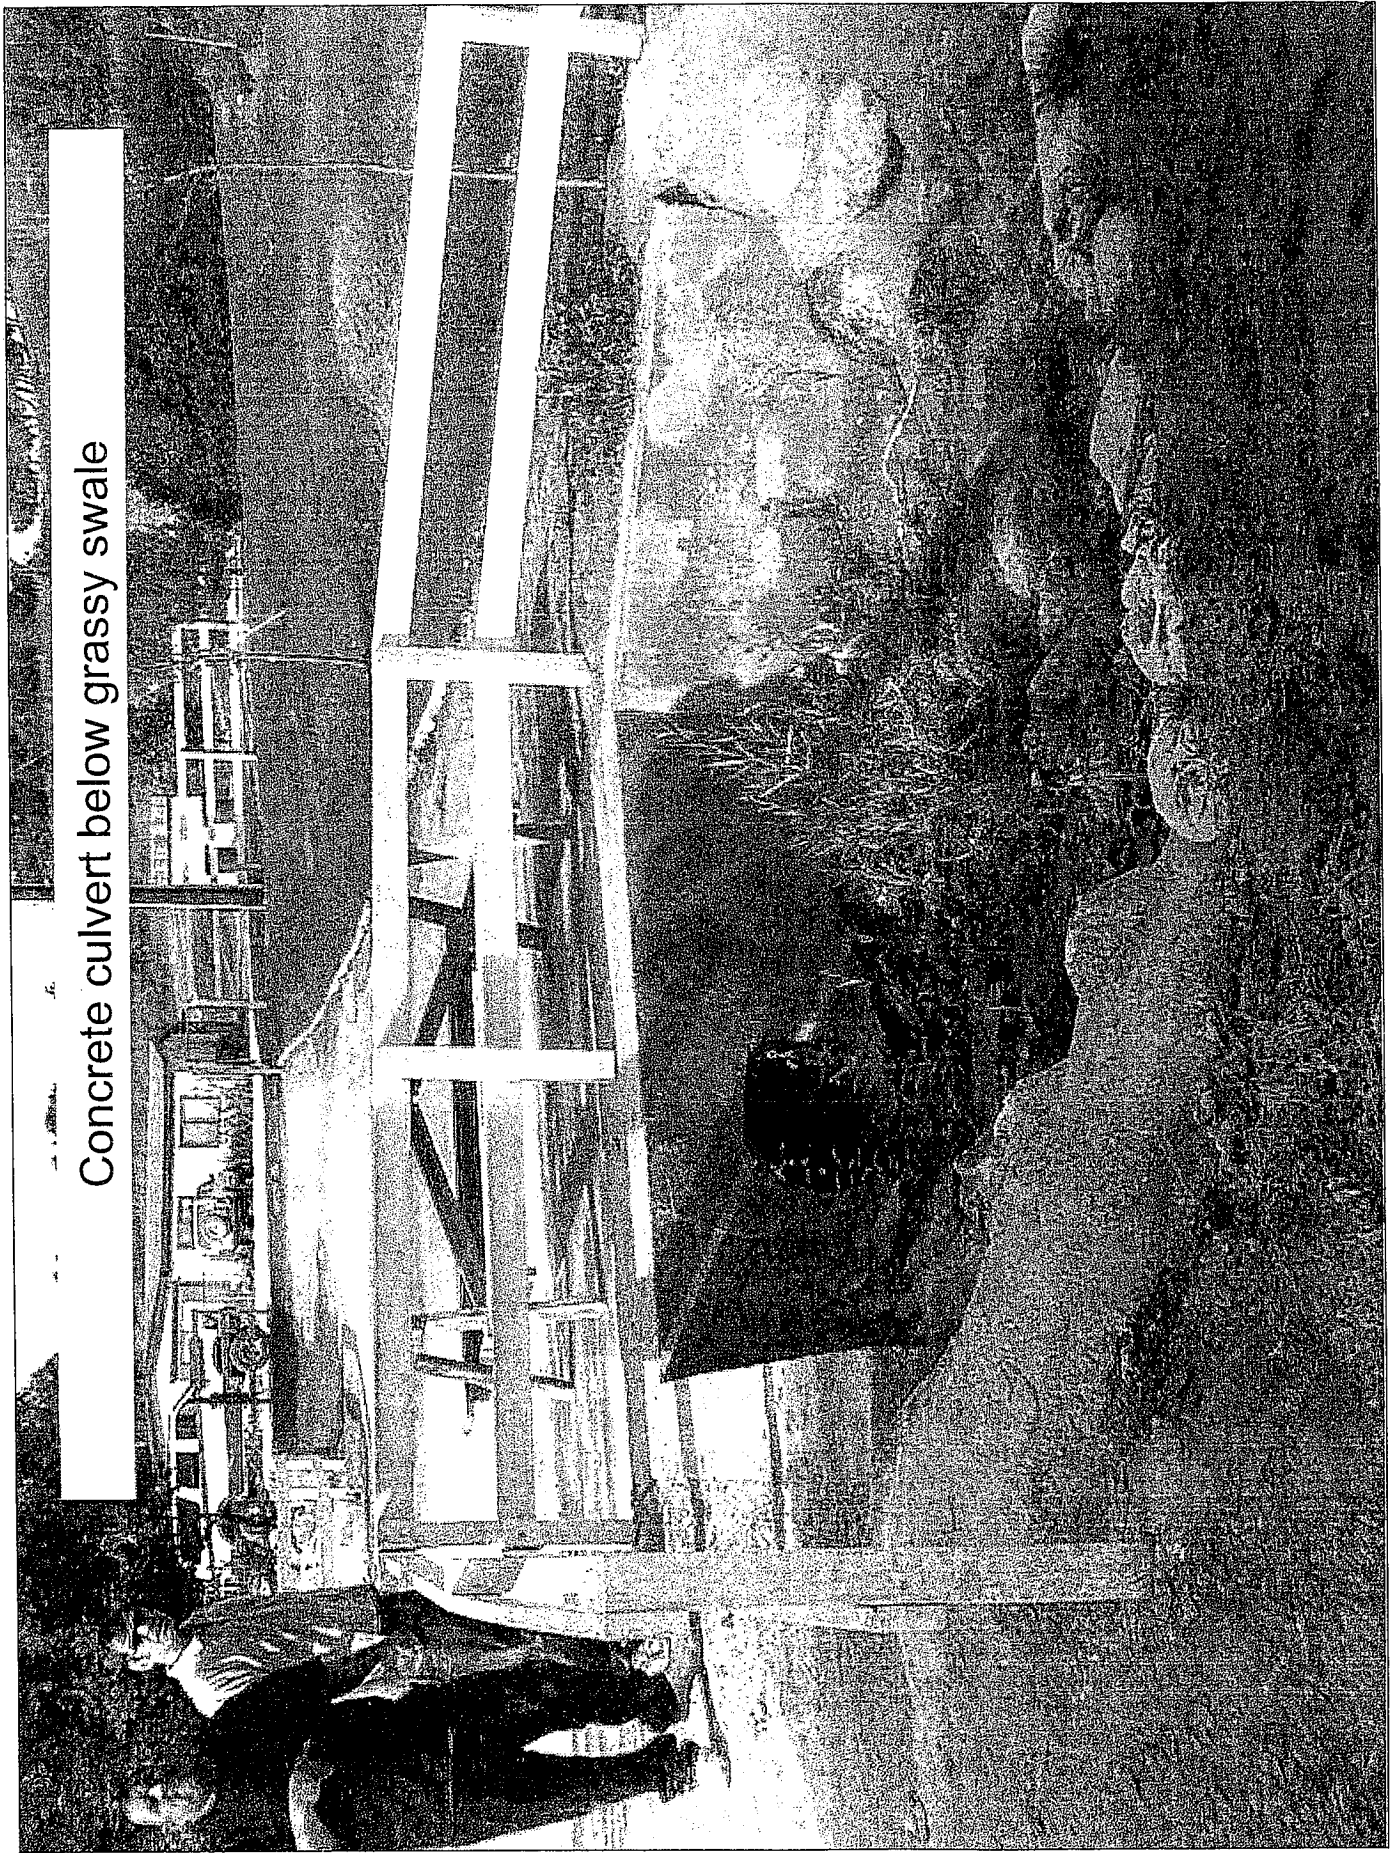
Concrete culvert below grassy swale

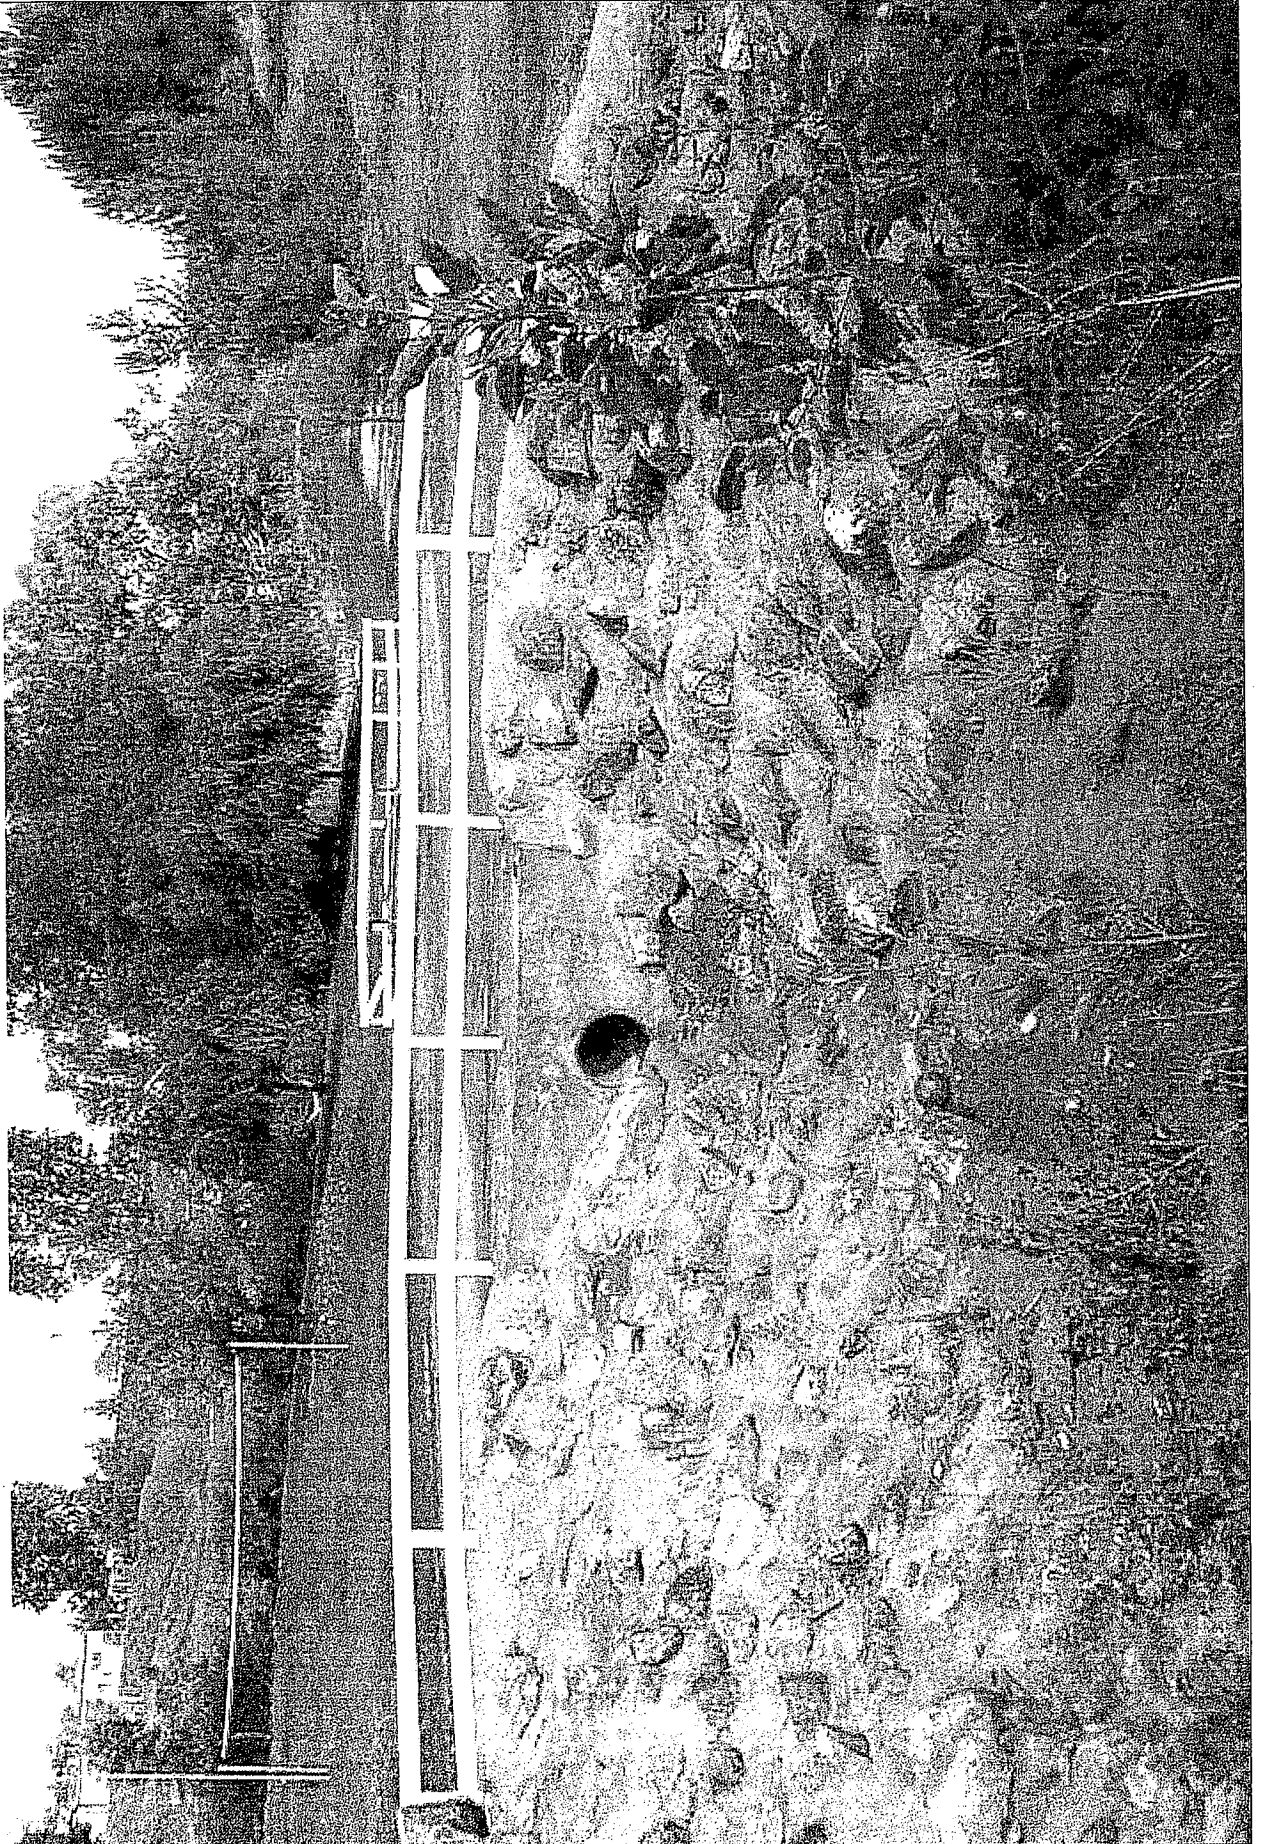
Concrete outfall from grassy swale

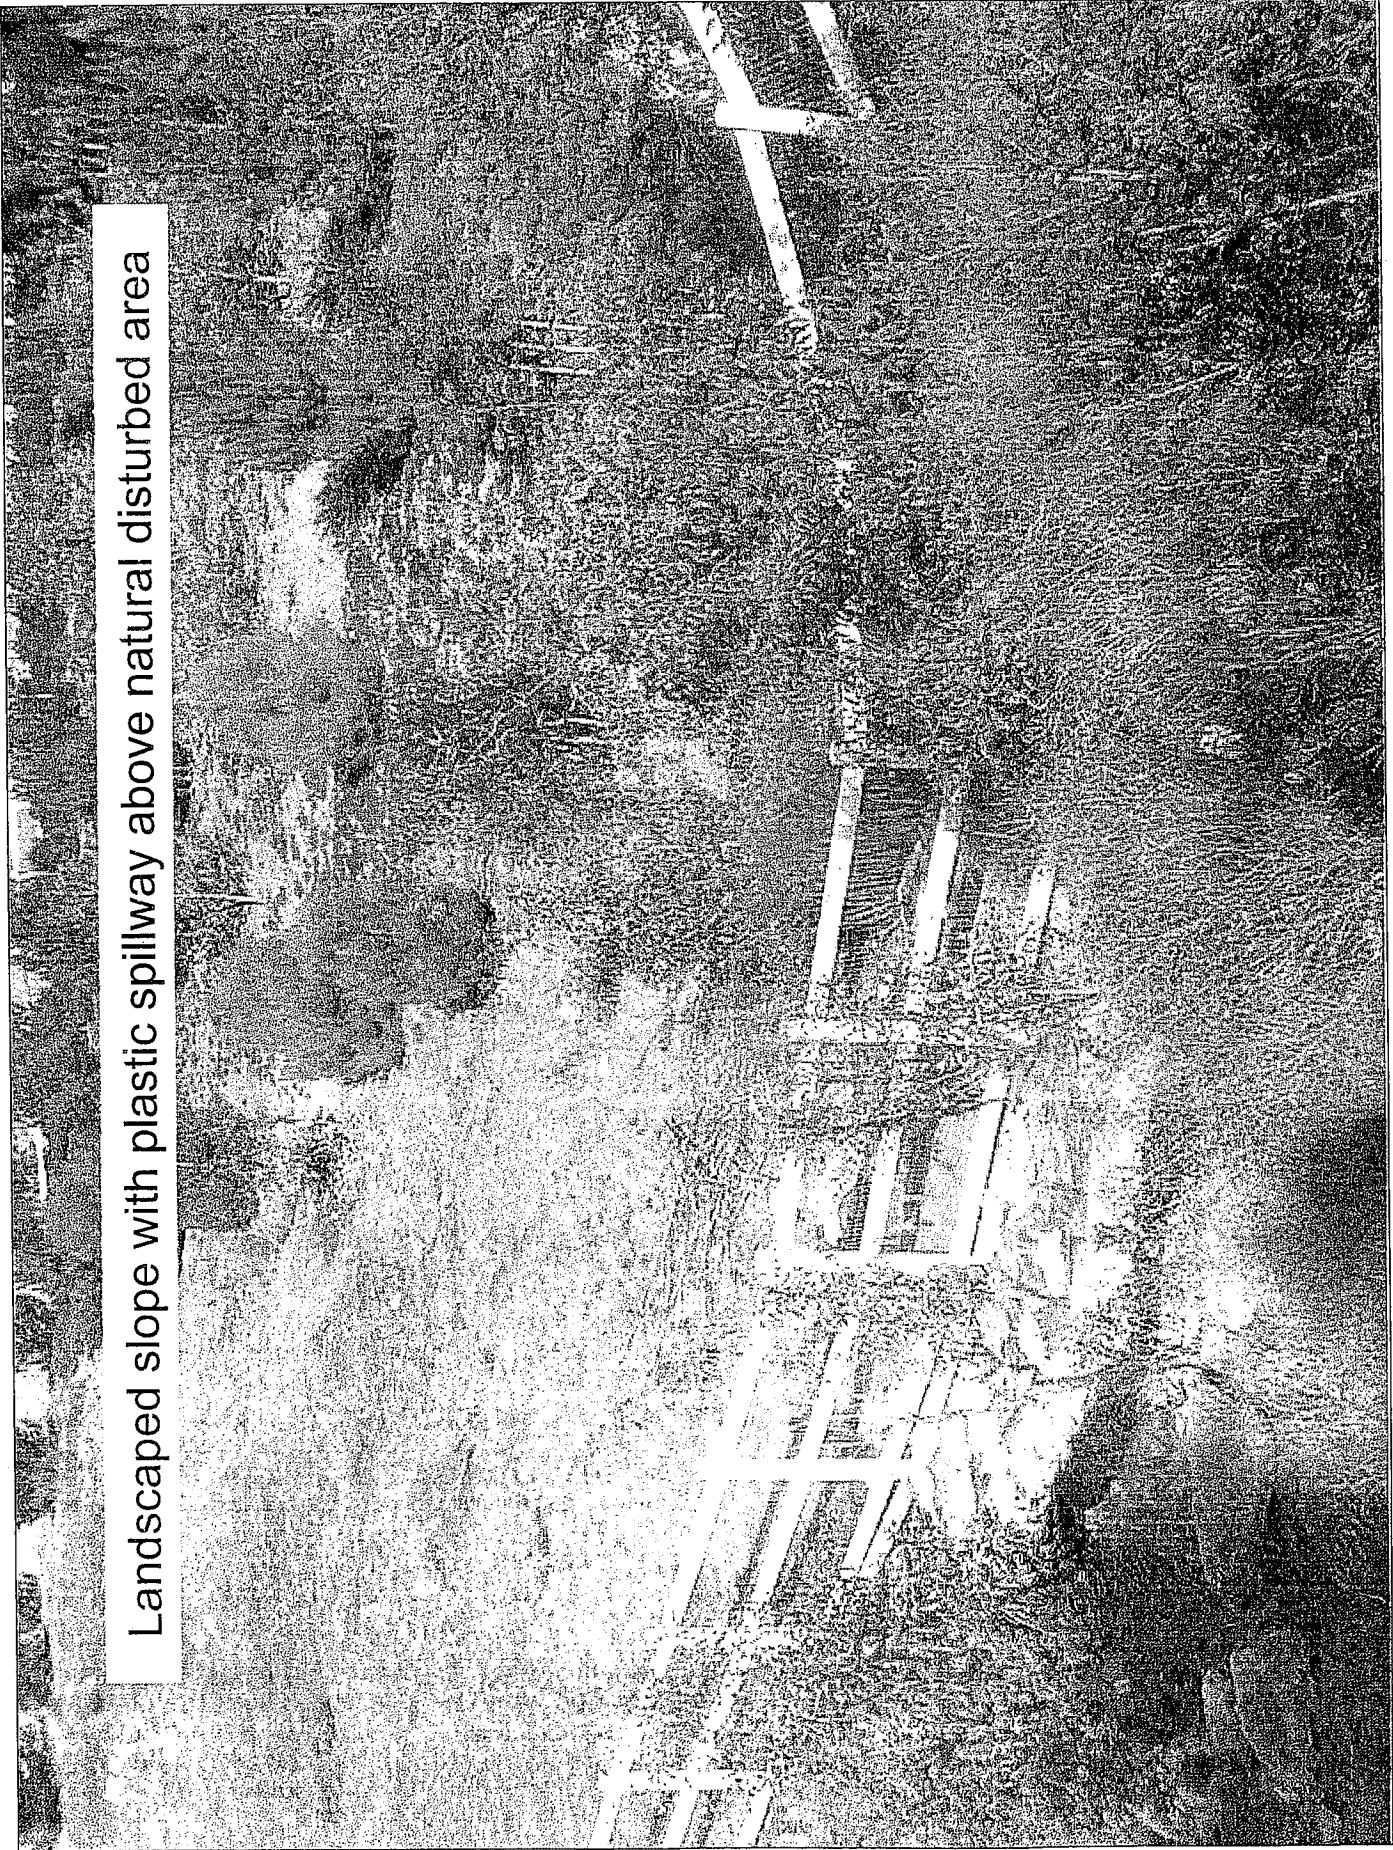
Landscaped slope with plastic spillway above natural disturbed area

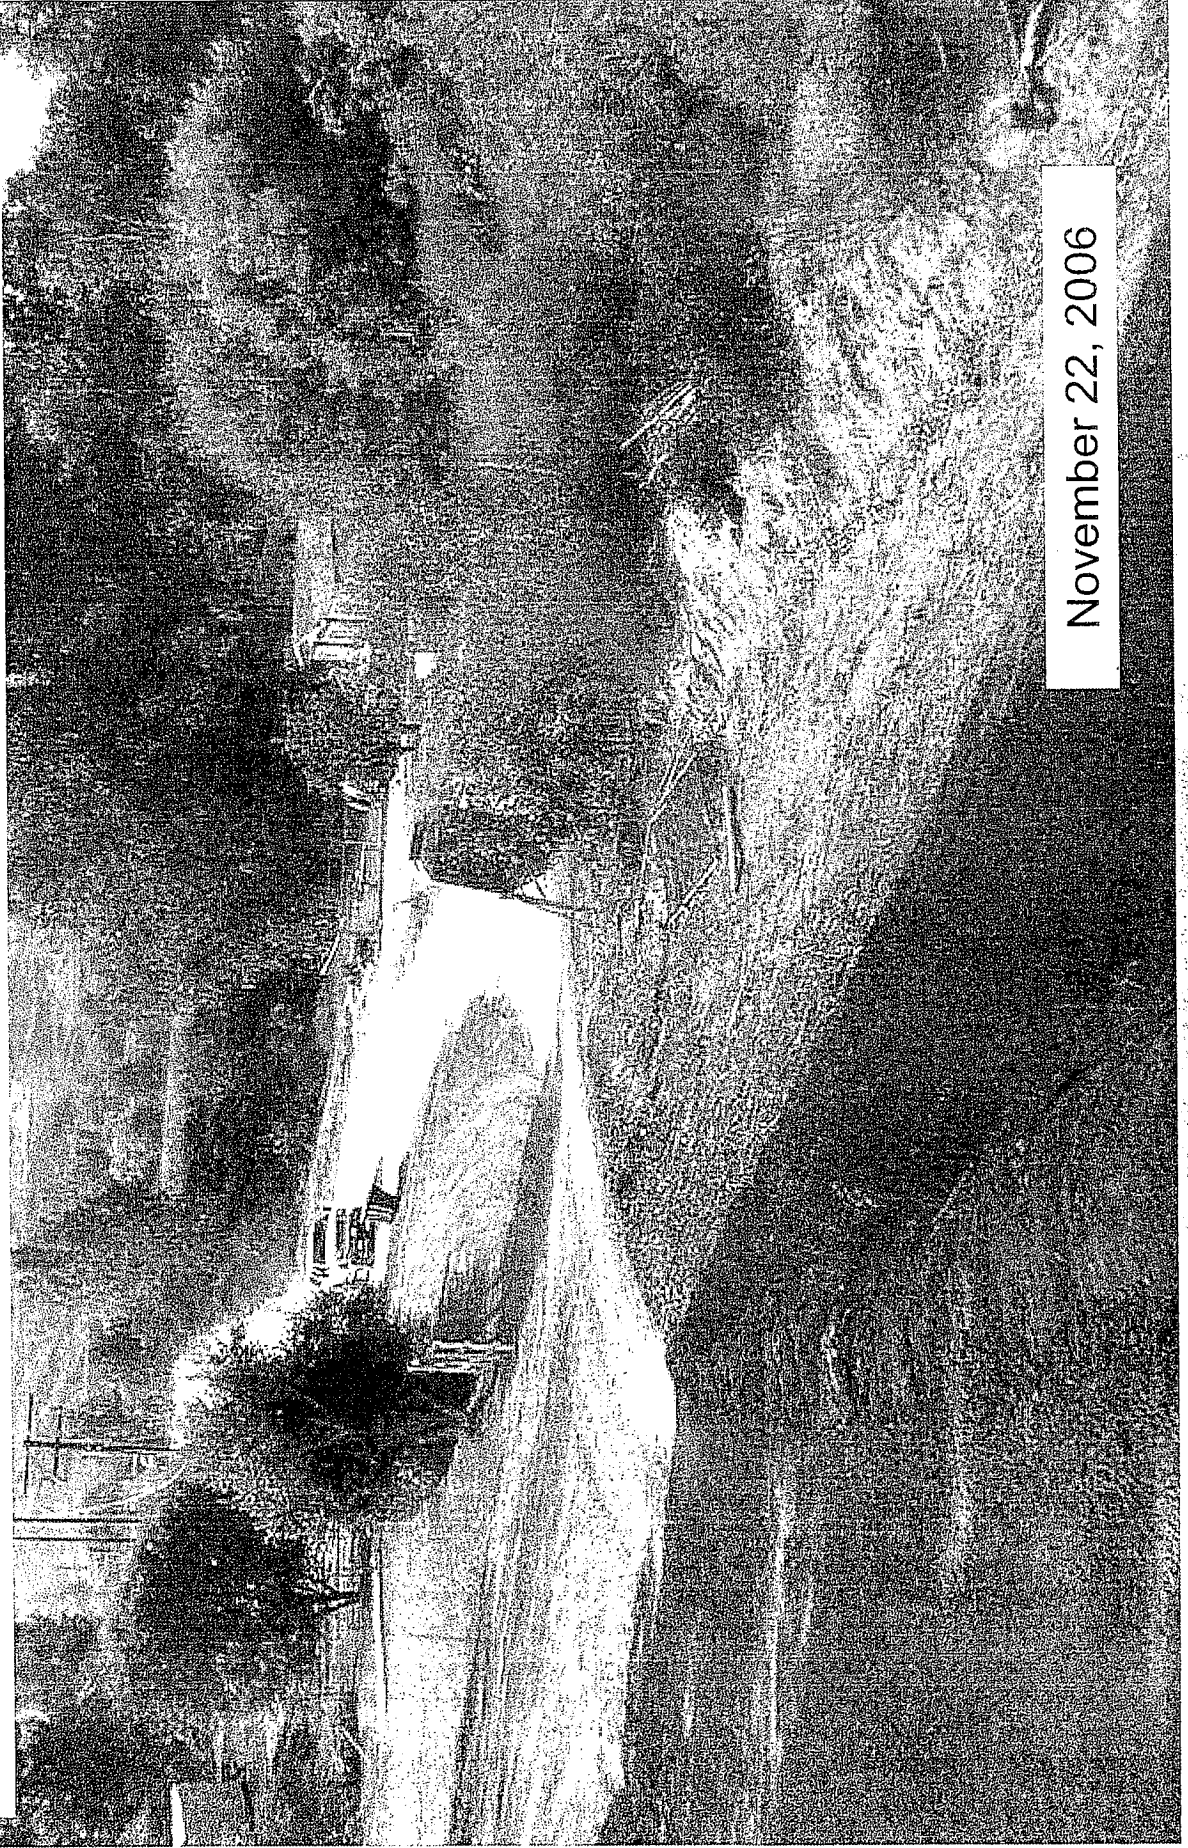
Unpaved road and naturally disturbed area that storm water flows to tributary to Santa Gertrudis Creek potentially causing erosion

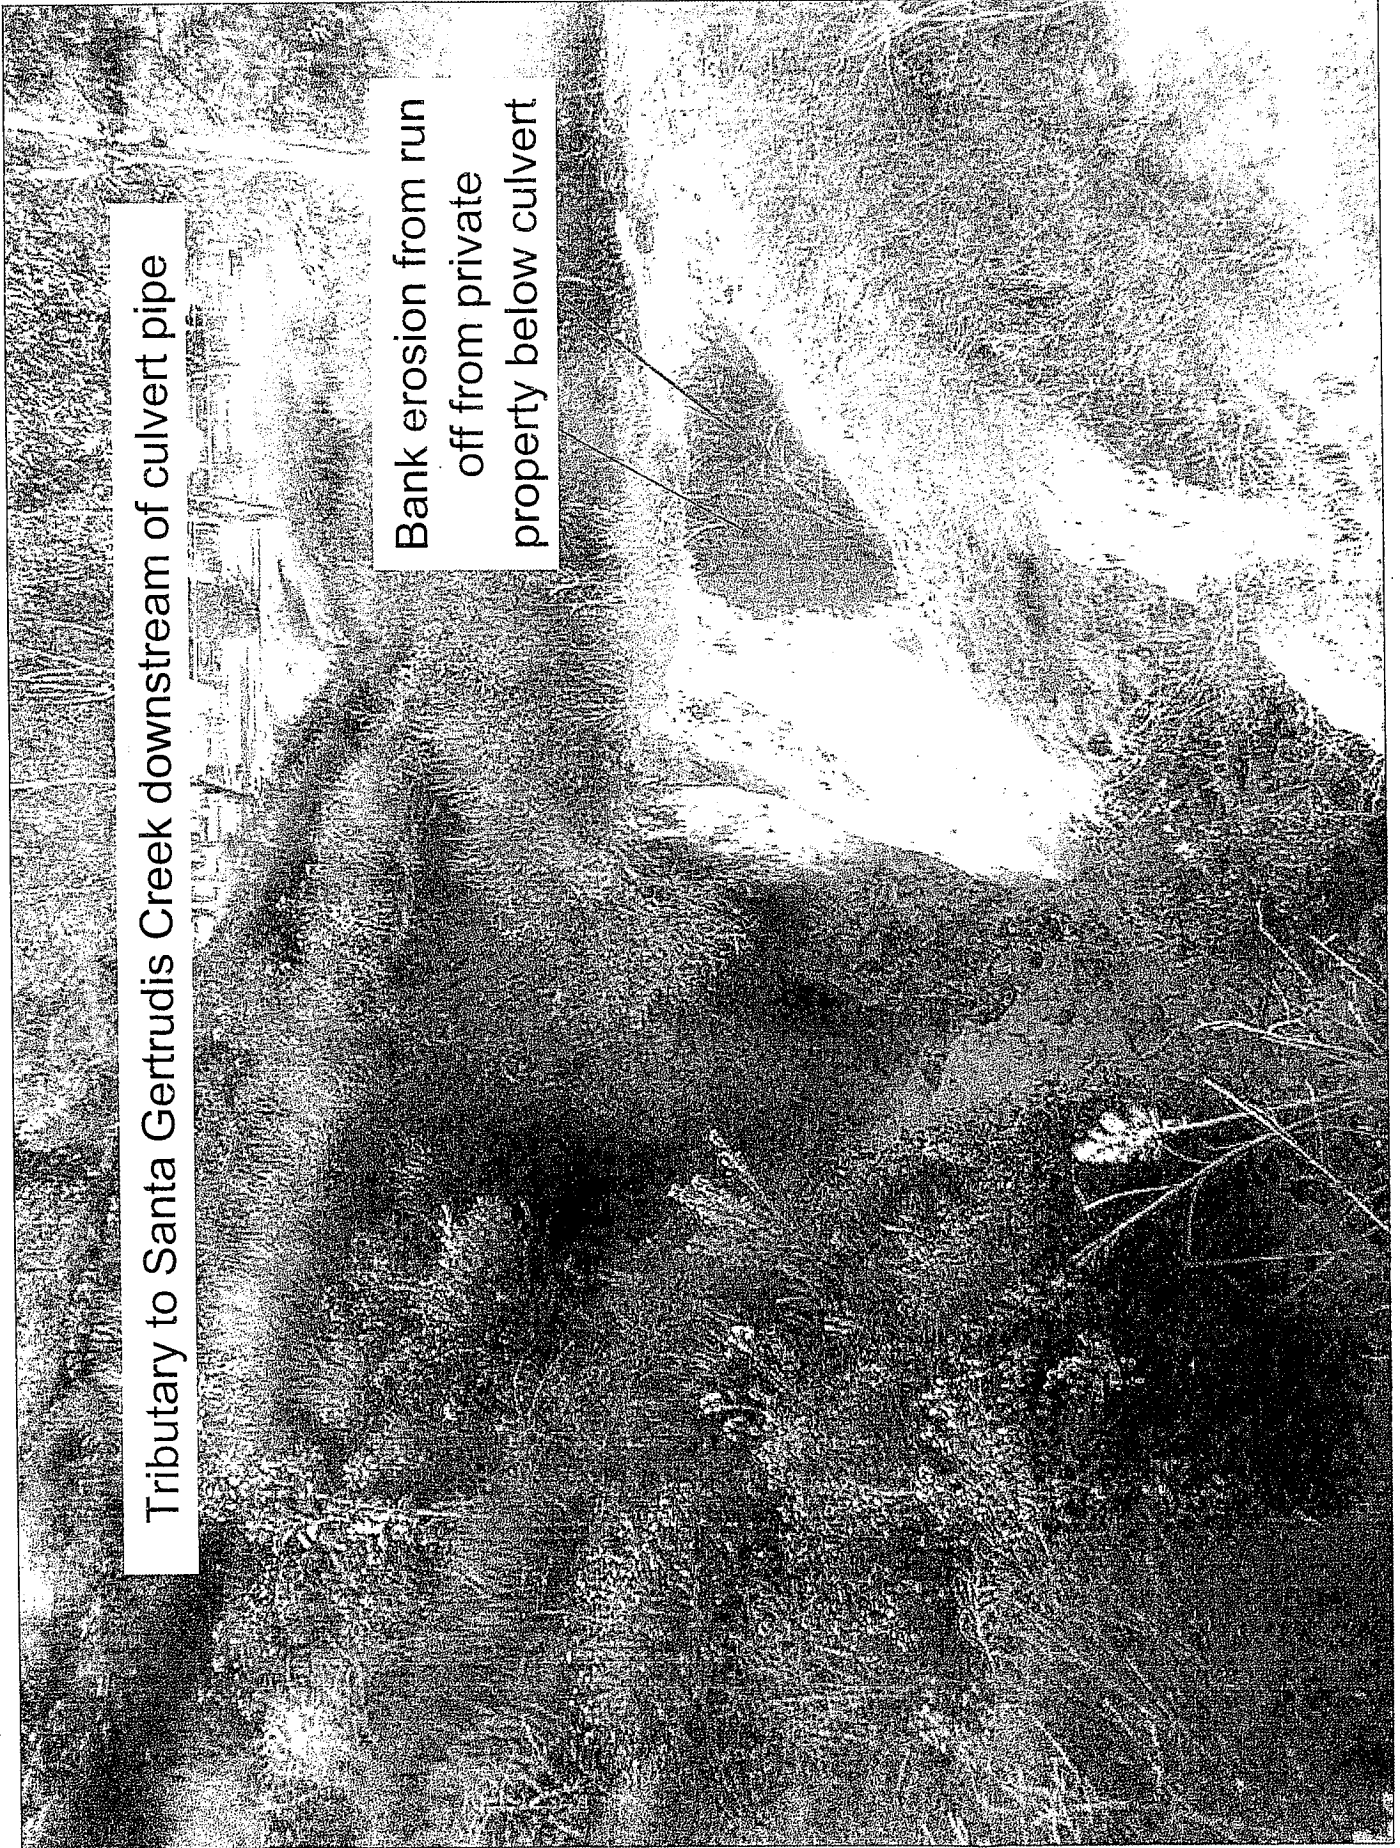
Tributary to Santa Gertrudis Creek downstream of culvert pipe

Bank erosion from run
off from private
property below culvert

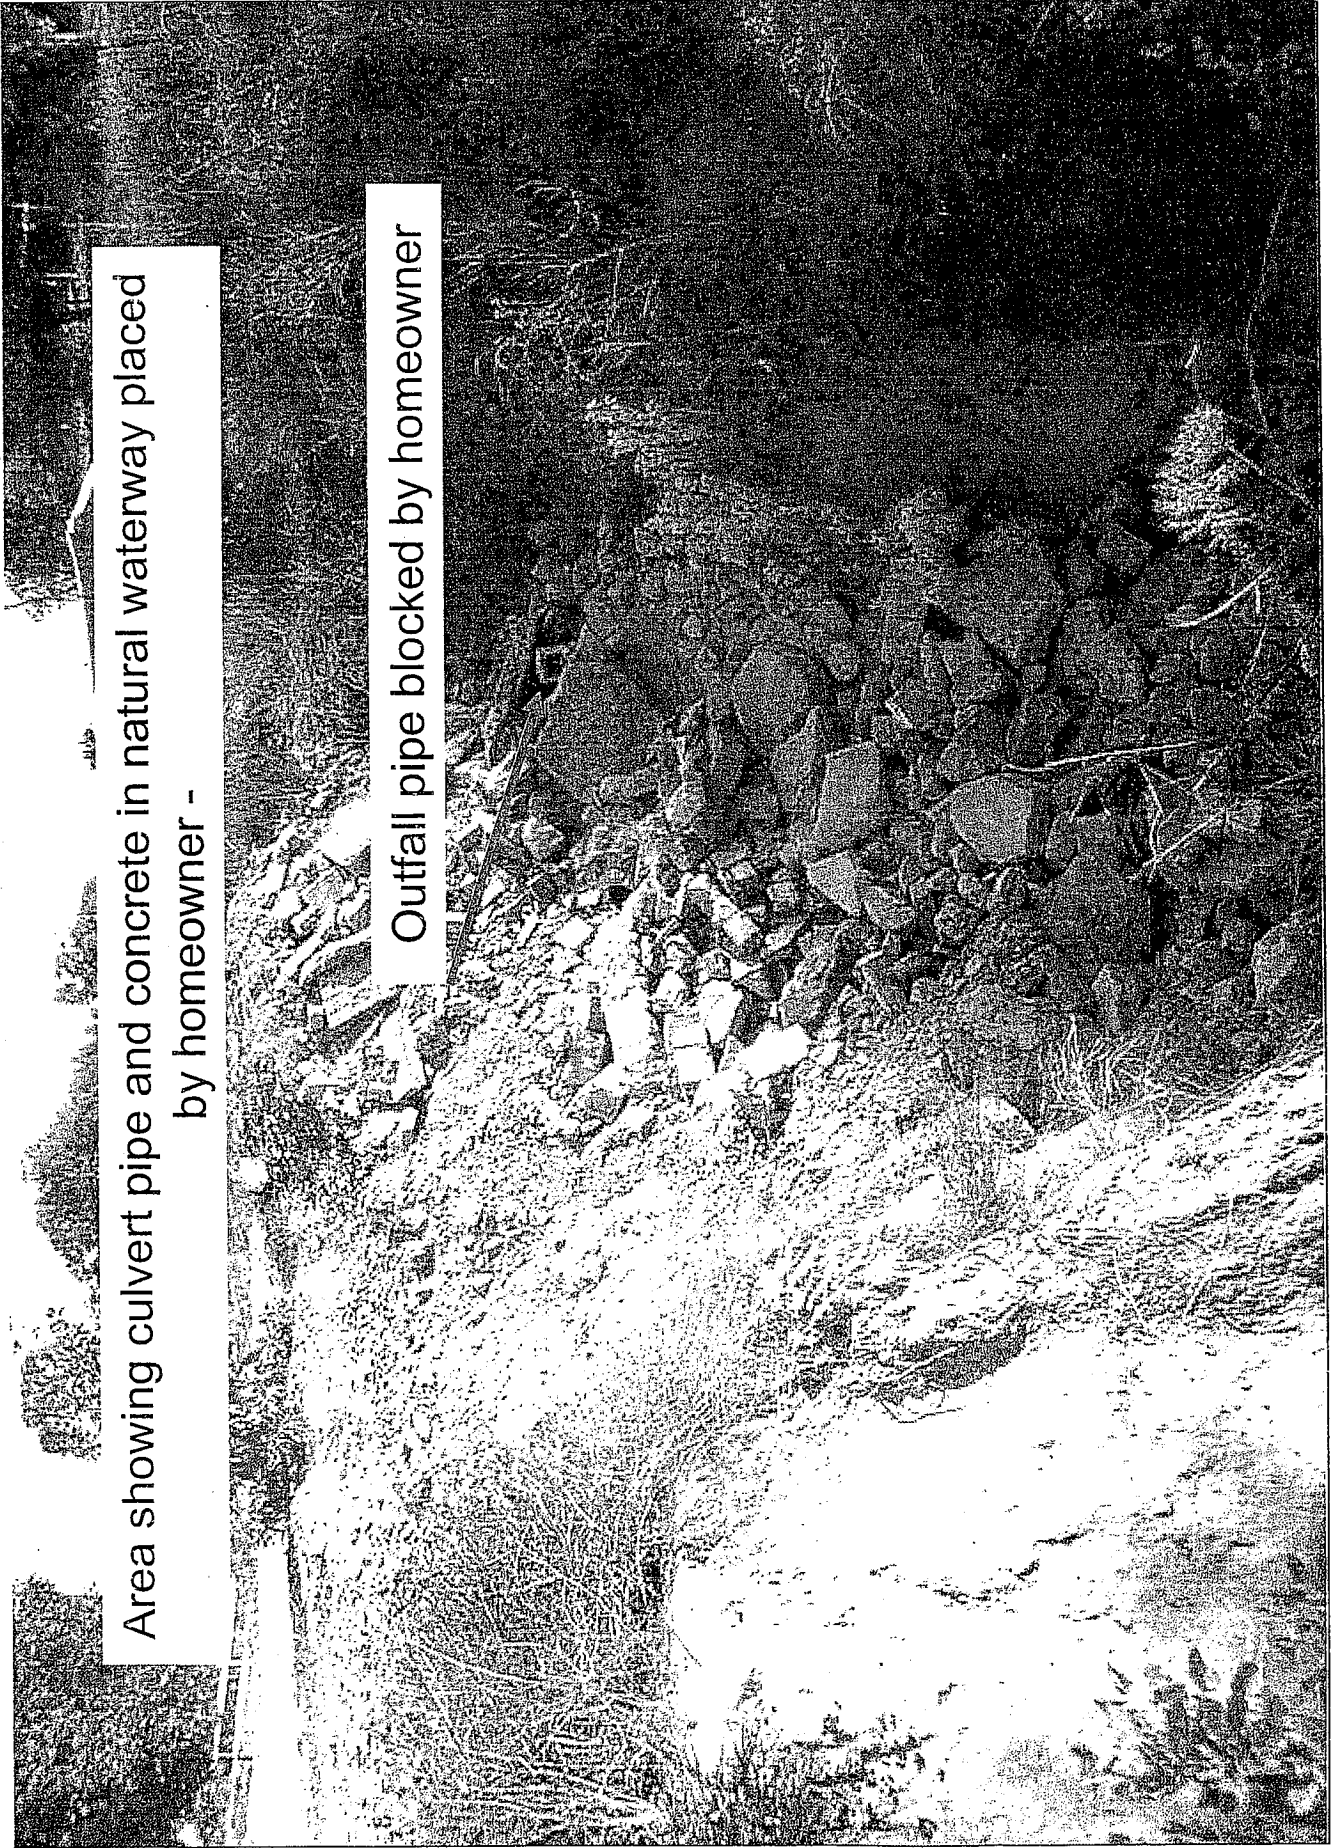
Area showing culvert pipe and concrete in natural waterway placed
by homeowner -

Outfall pipe blocked by homeowner

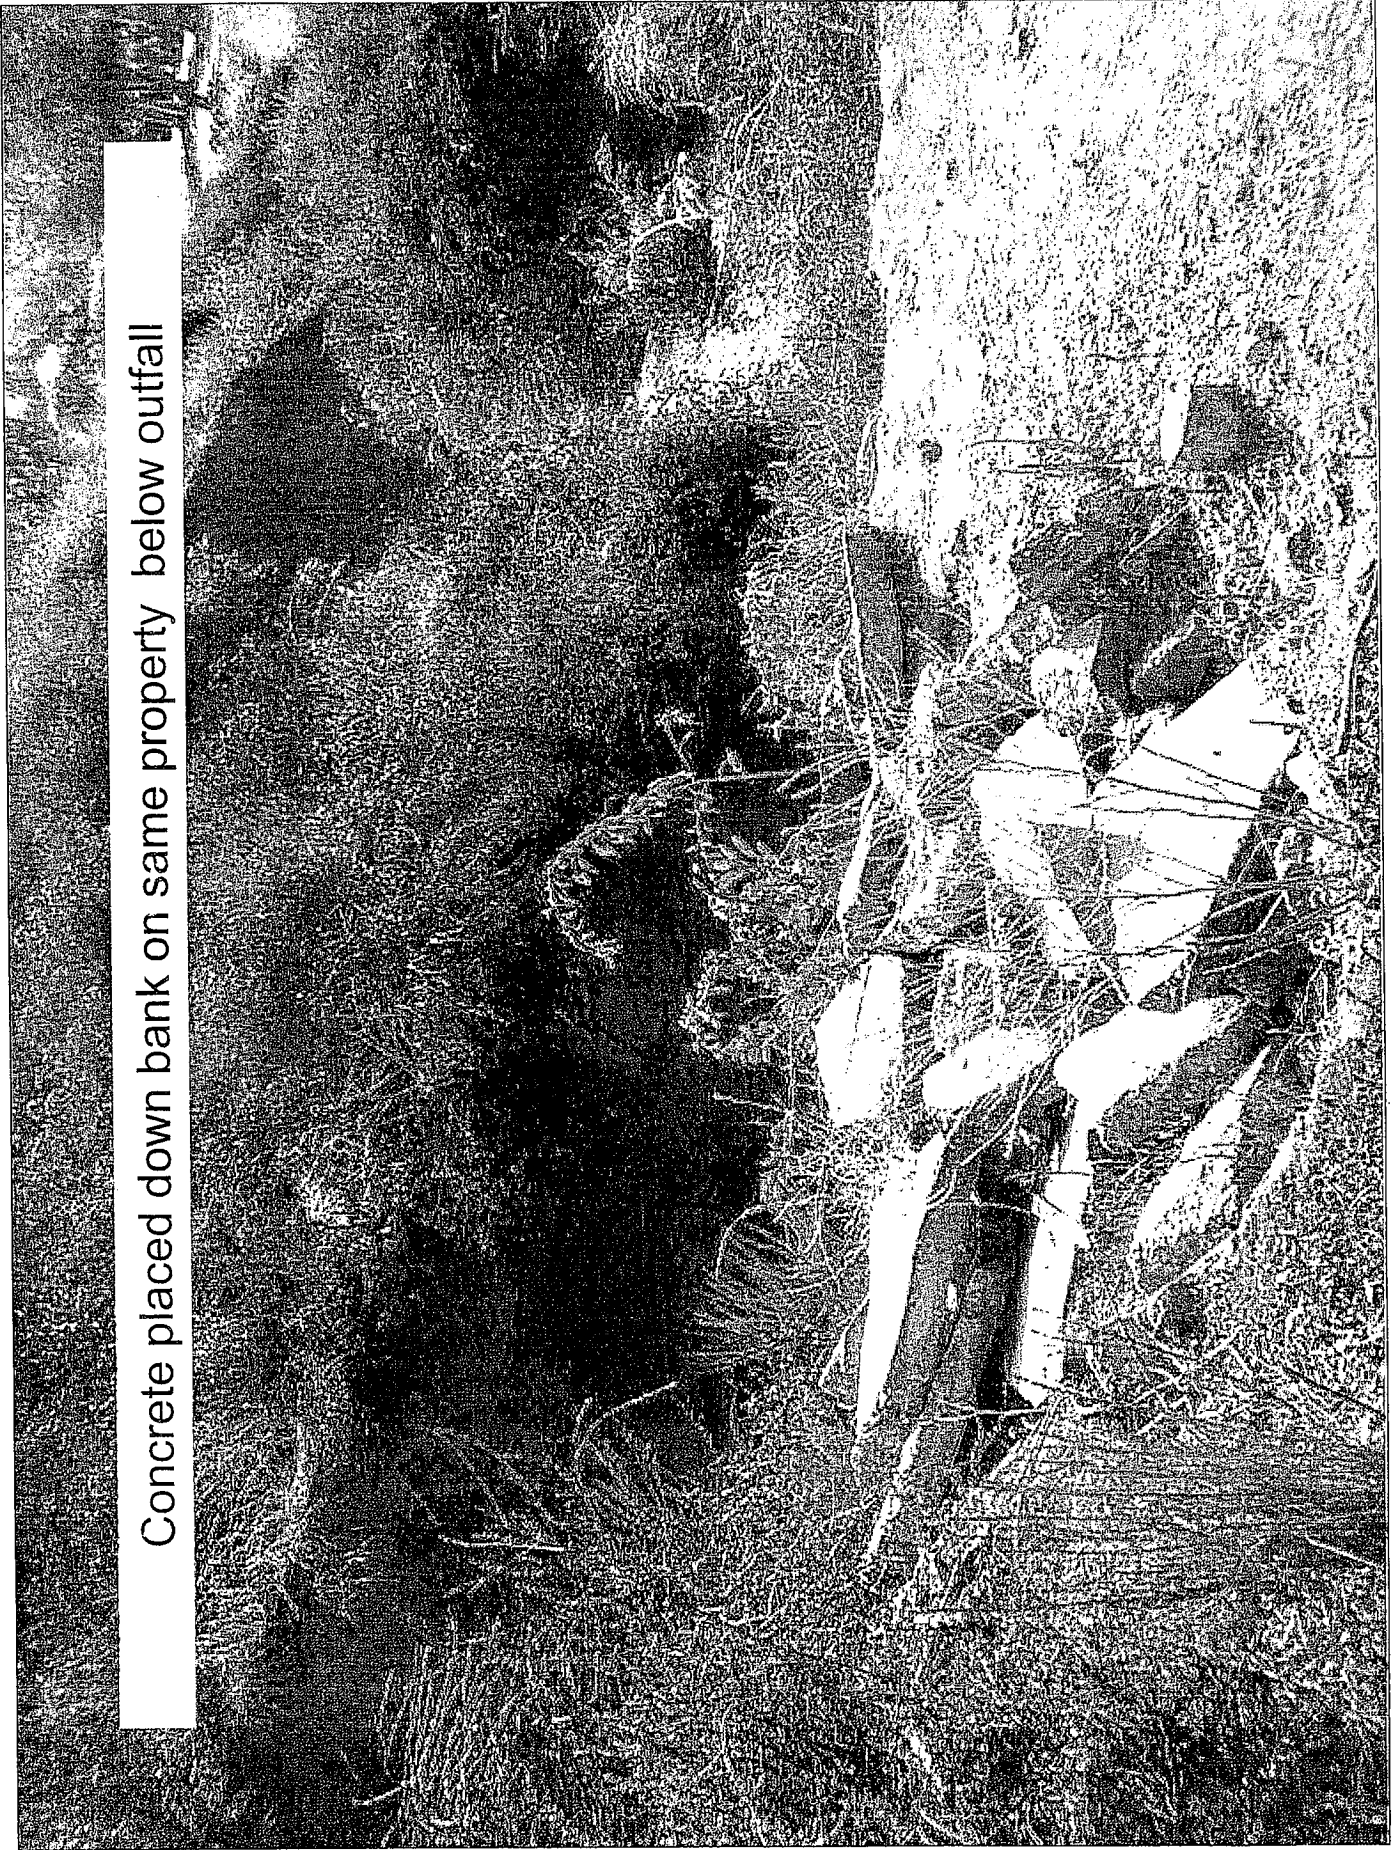
Concrete placed down bank on same property below outfall

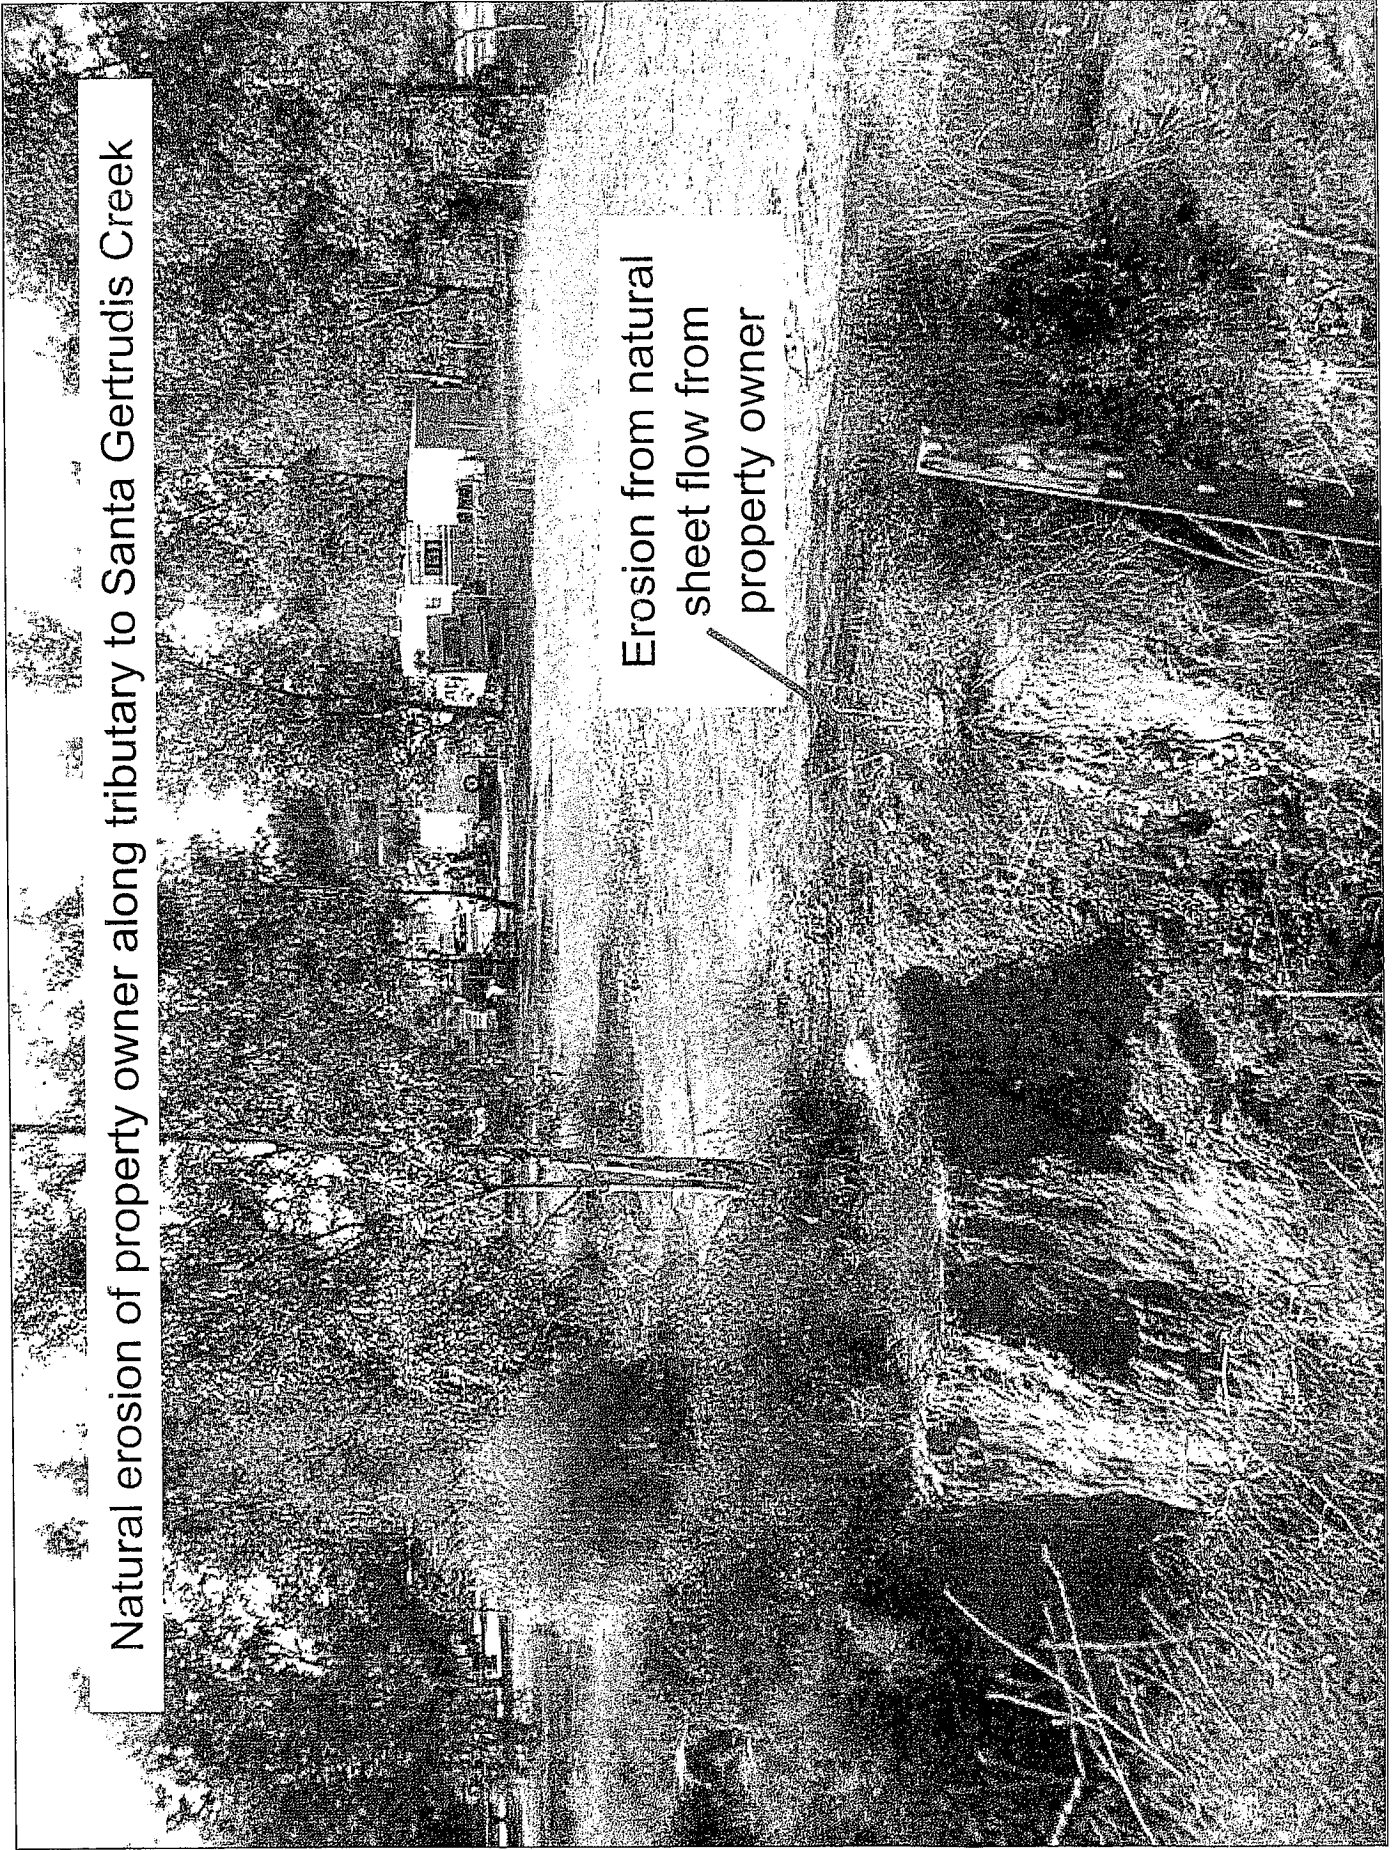
Natural erosion of property owner along tributary to Santa Gertrudis Creek

Erosion from natural
sheet flow from
property owner

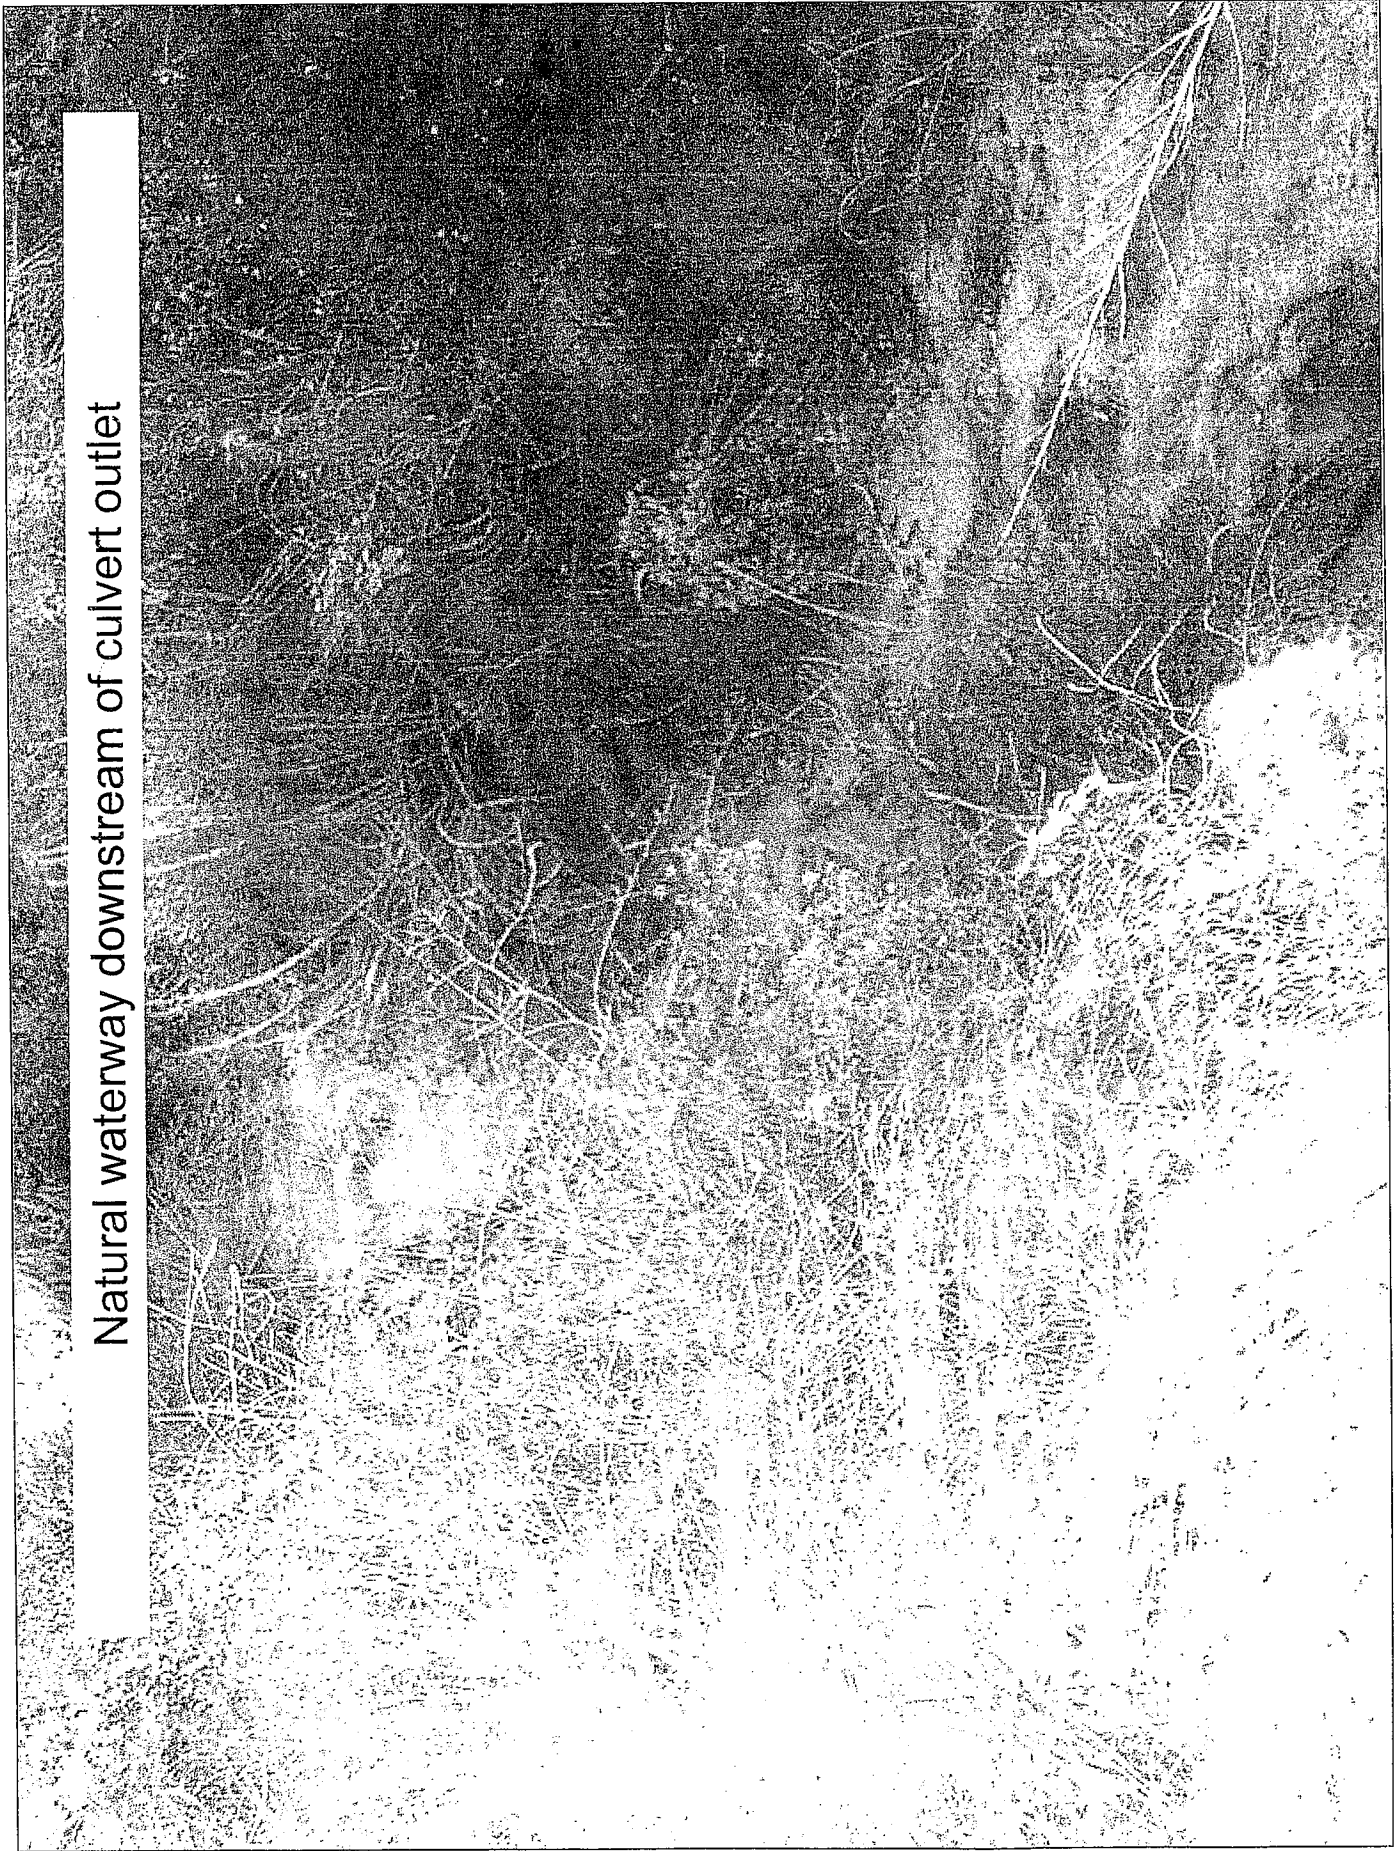
Natural waterway downstream of culvert outlet
