Appendix F

ASHBY USA, LLC

Ref: WPN: 10-3020657.02, 18-2001091.02:schwk
NOV No. R9-2006-0135

Subject: Required Technical Report

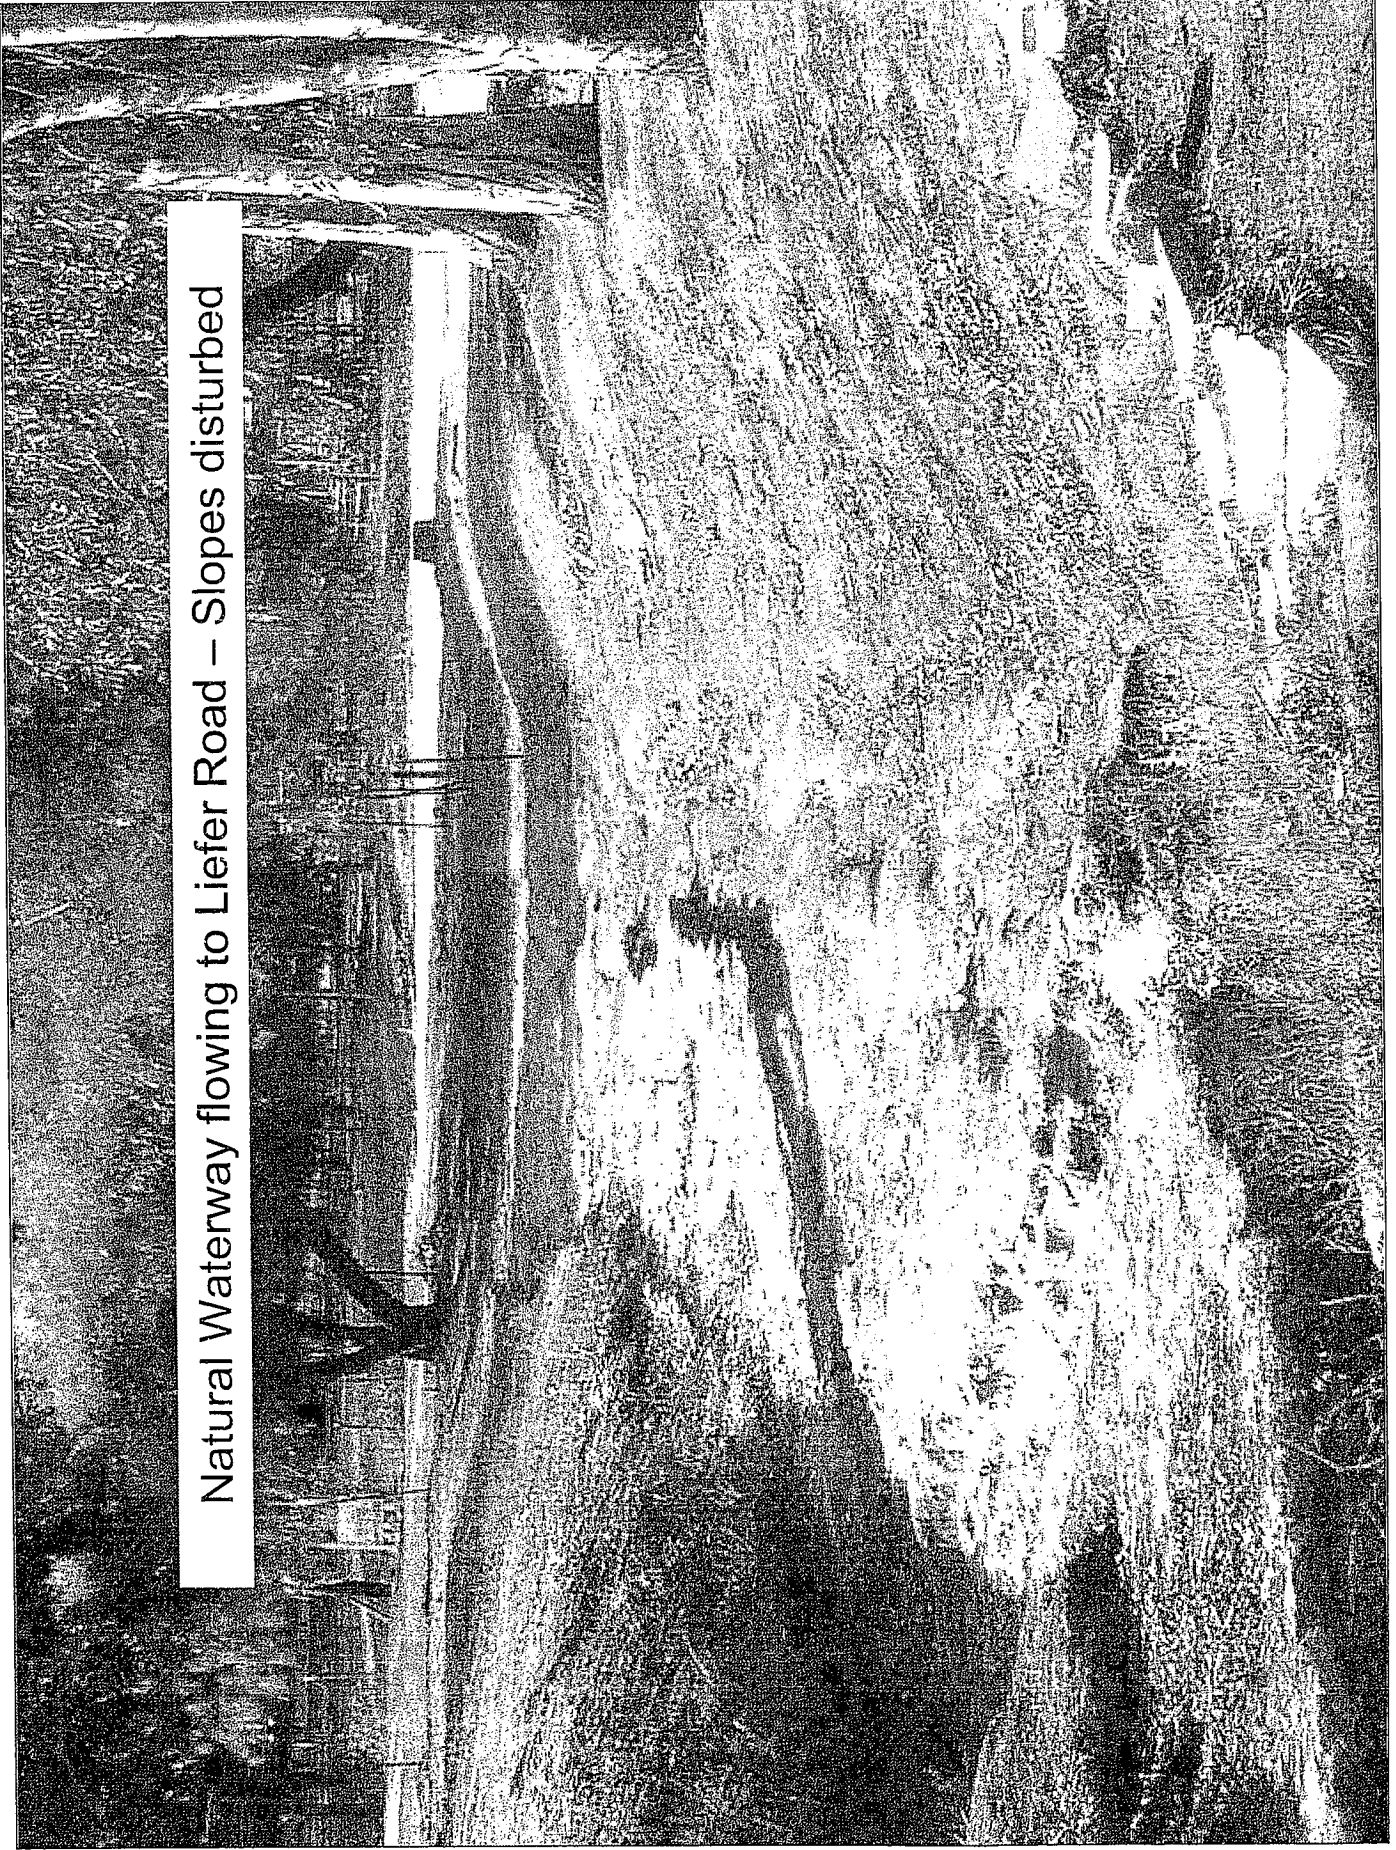
Natural Waterway flowing to Liefer Road – Slopes disturbed

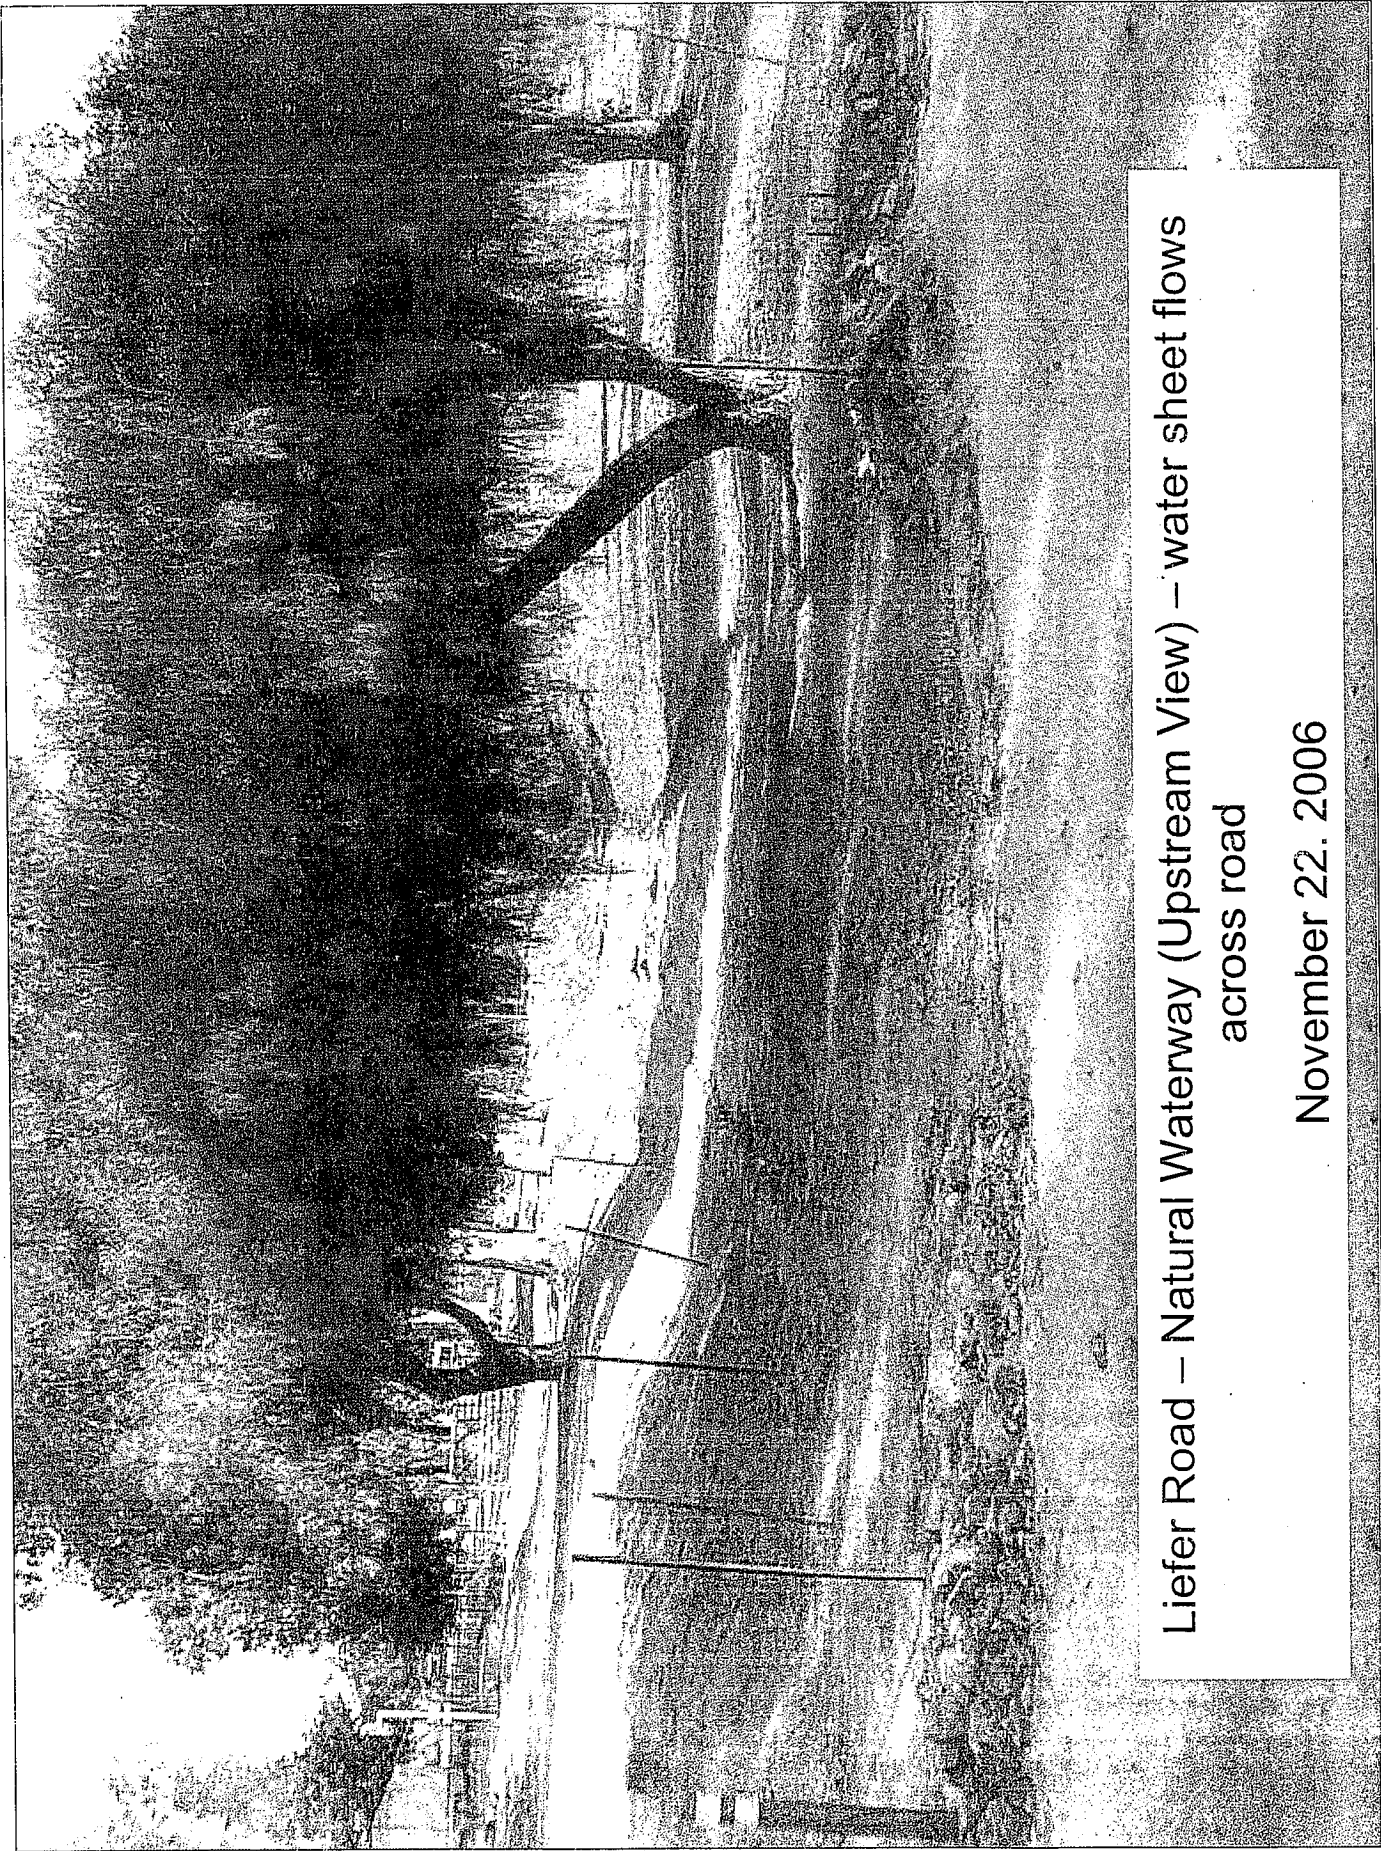
Liefer Road – Natural Waterway (Upstream View) – water sheet flows
across road
November 22. 2006

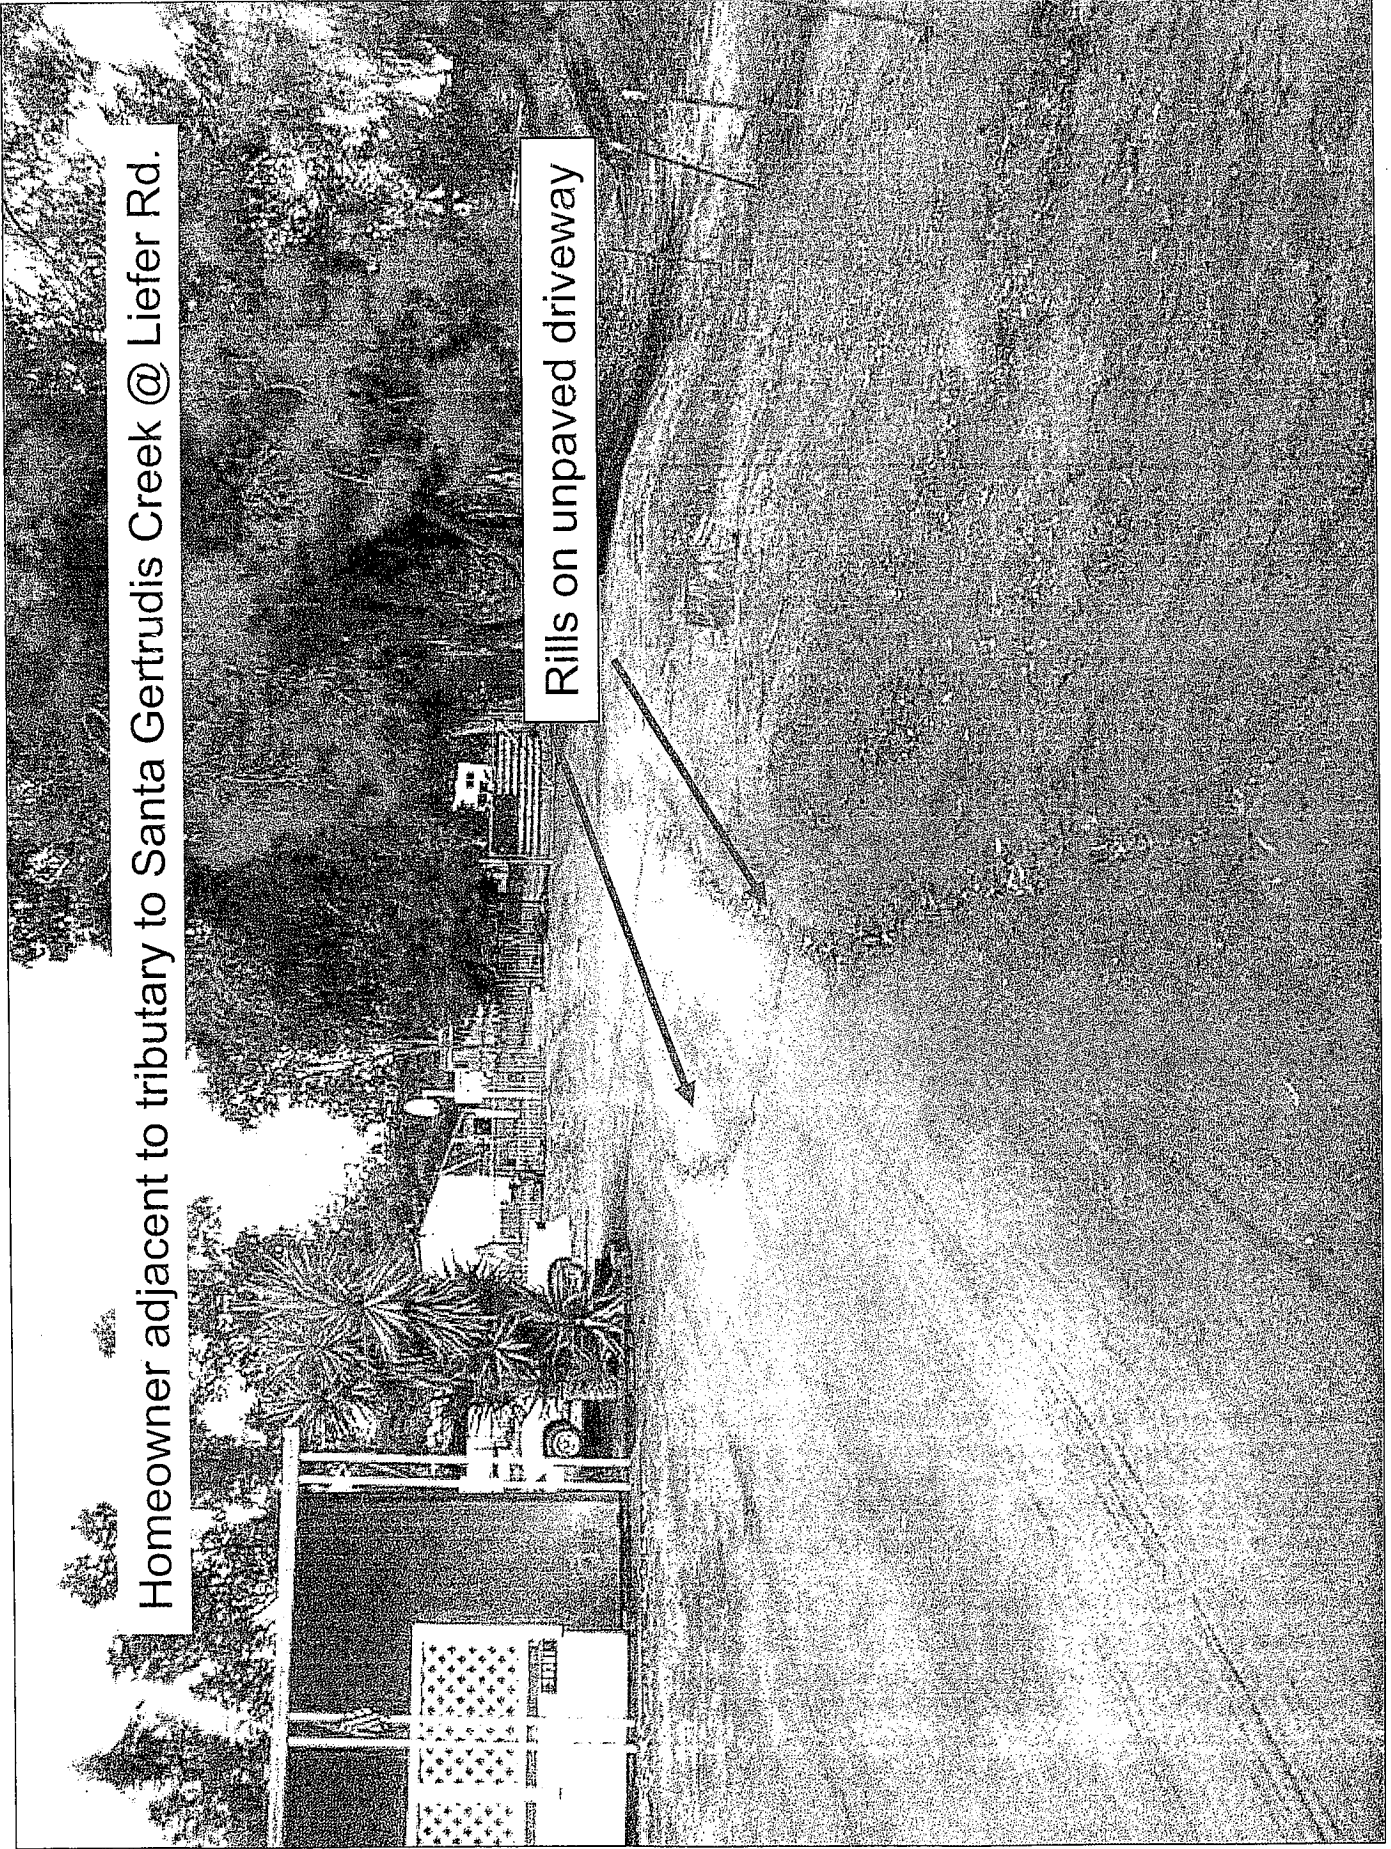
Homeowner adjacent to tributary to Santa Gertrudis Creek @ Liefer Rd.

Rills on unpaved driveway

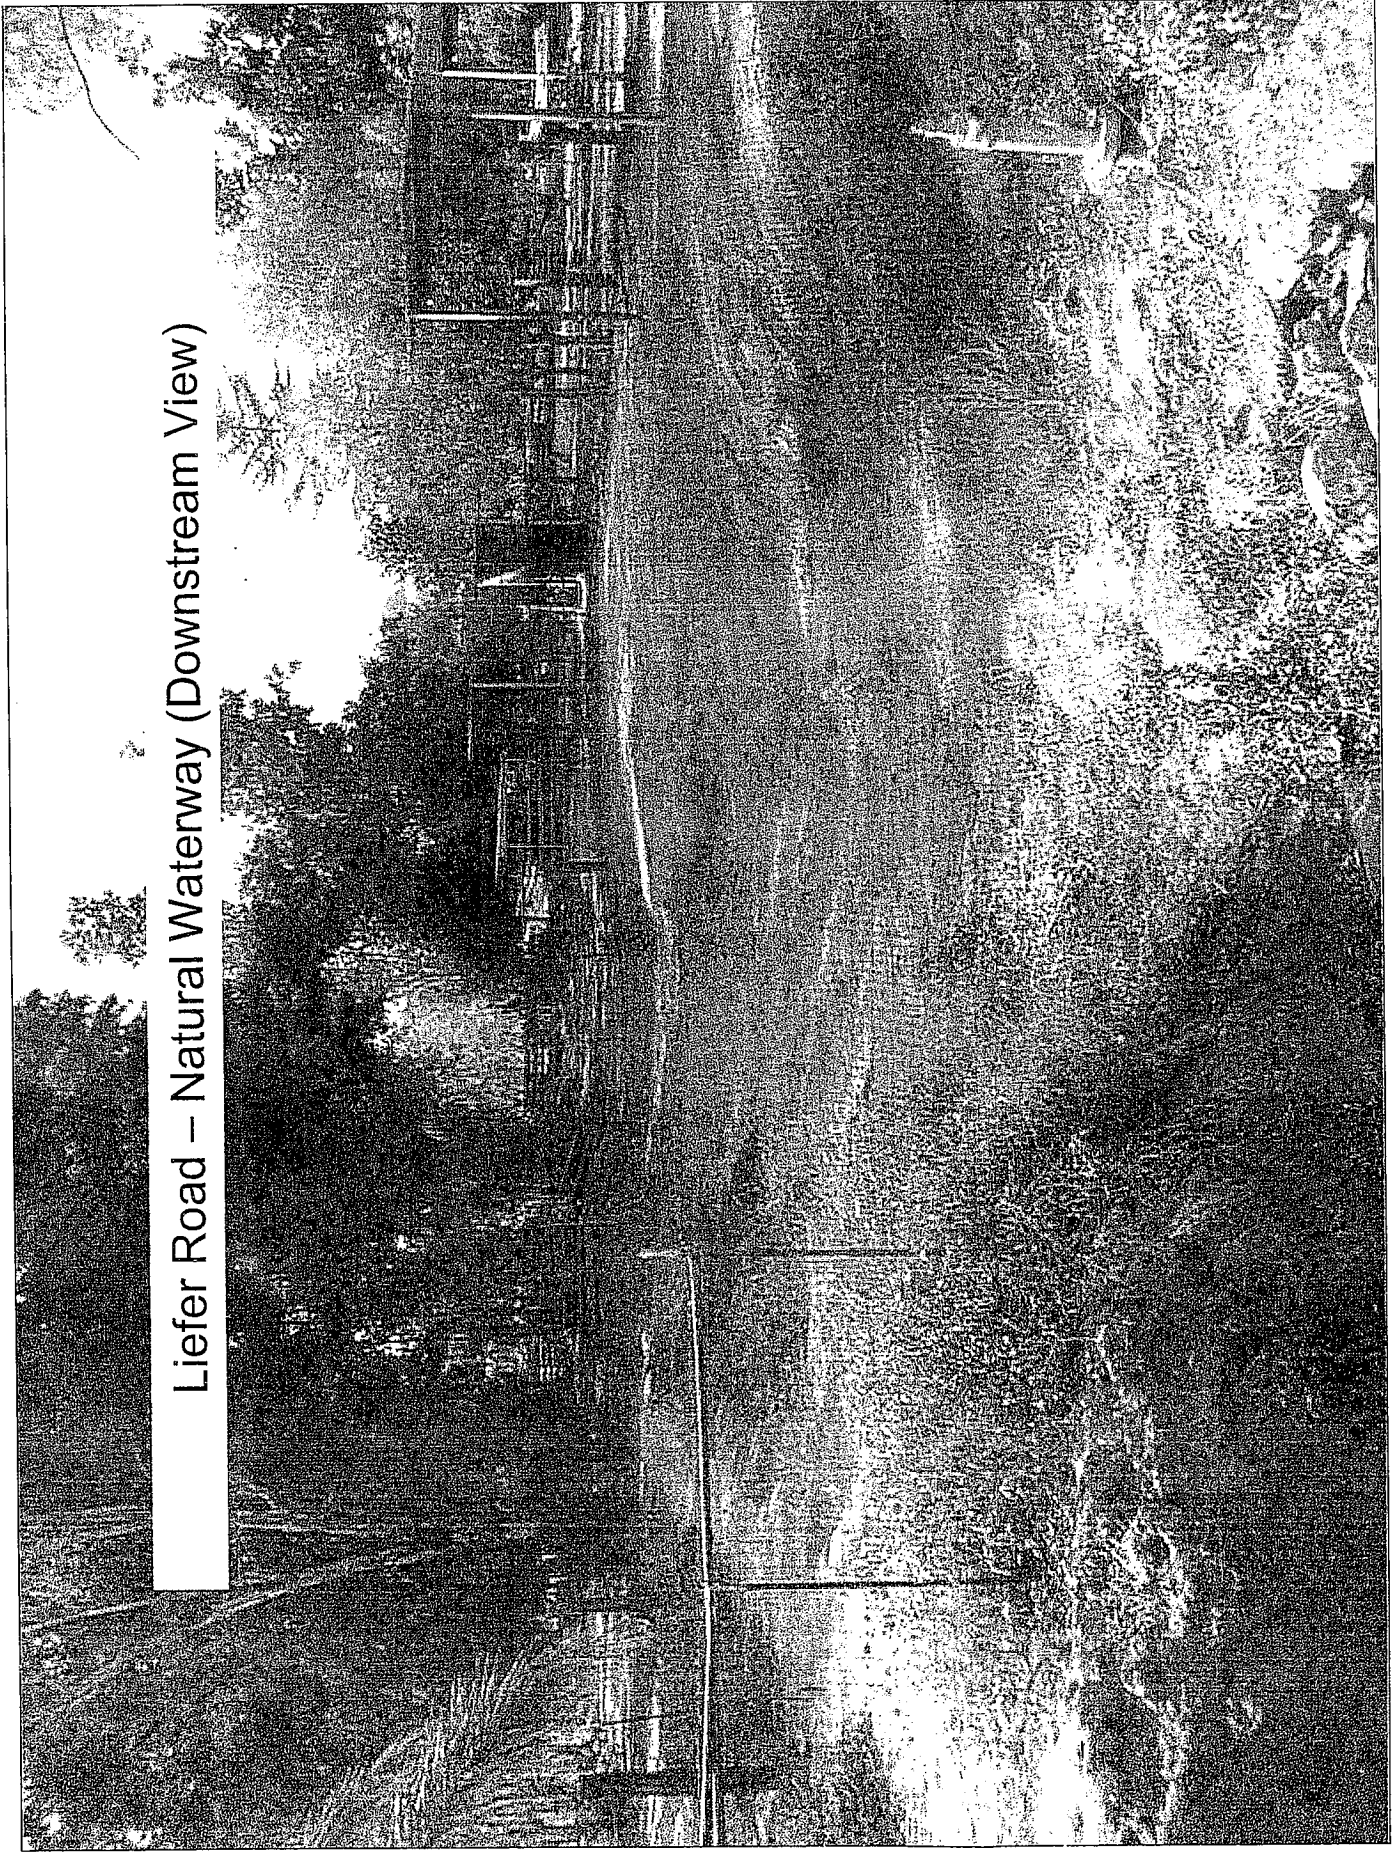
Liefer Road – Natural Waterway (Downstream View)

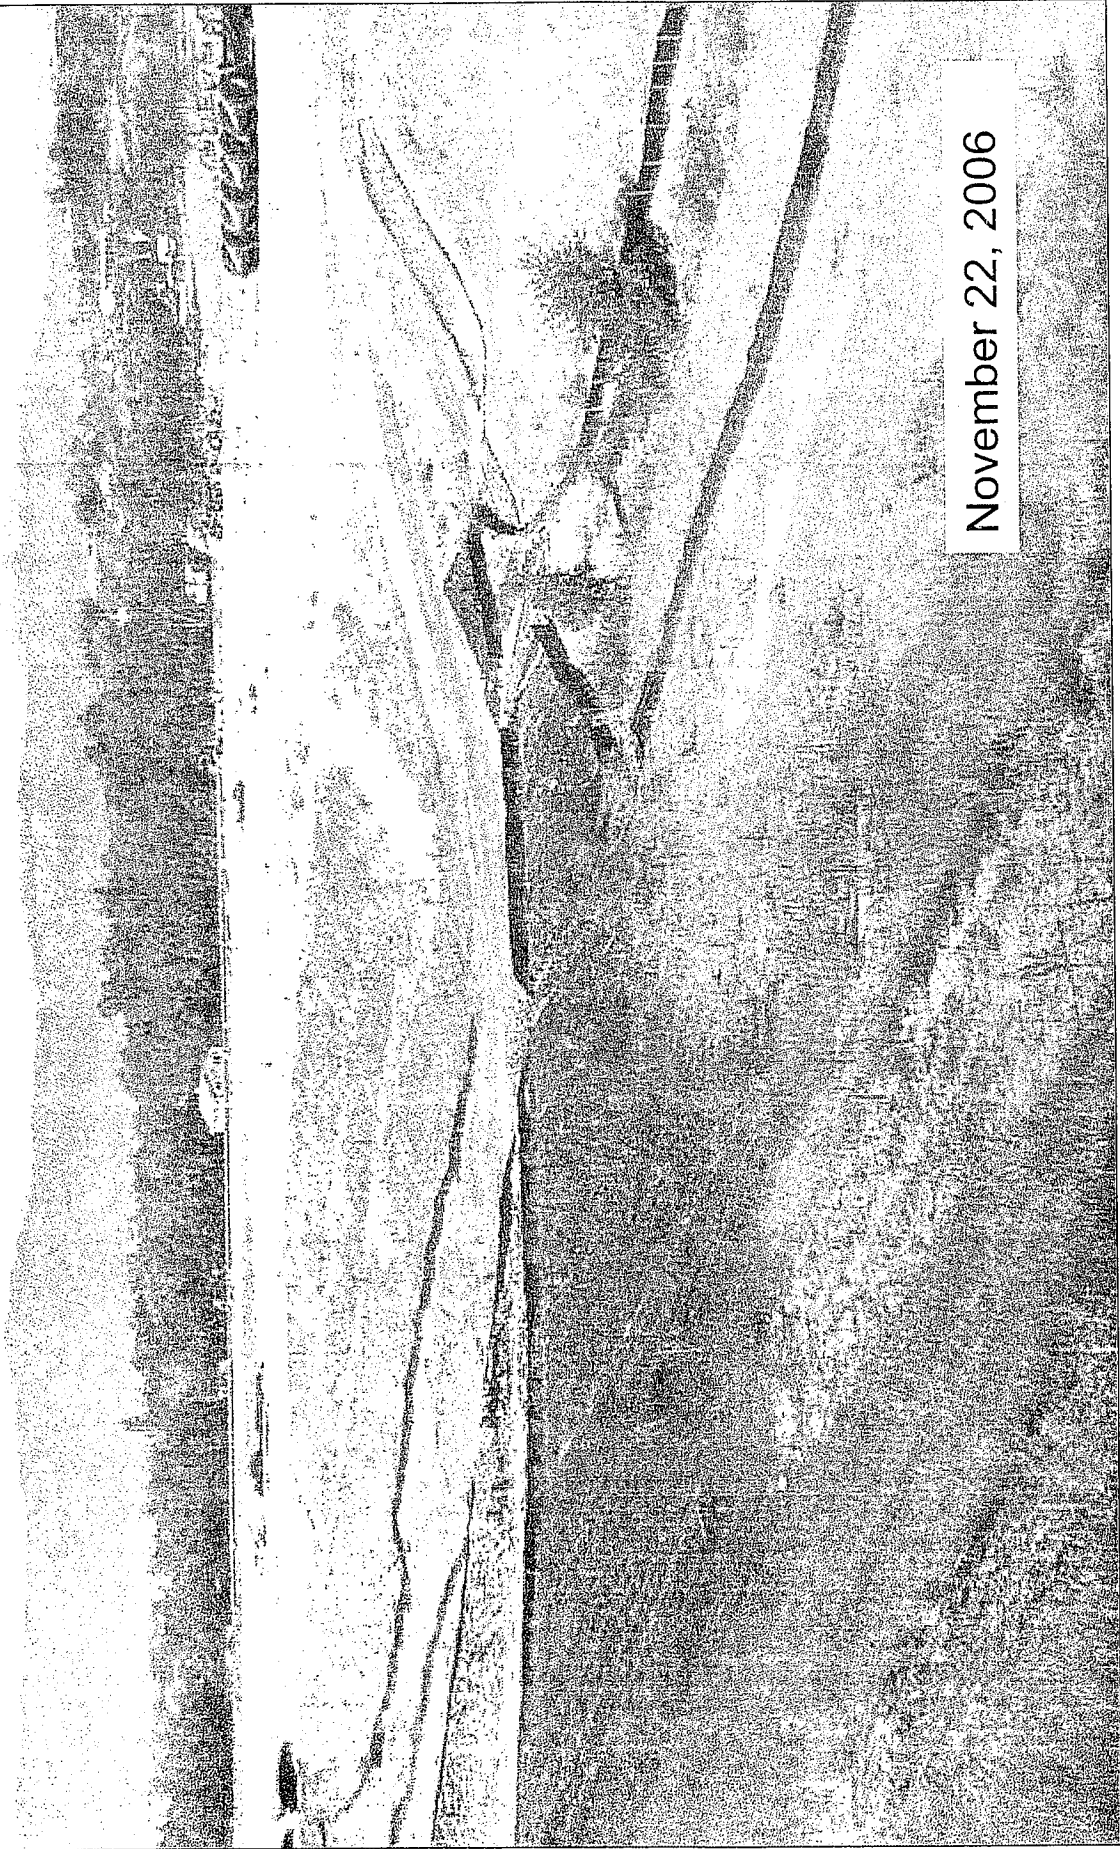
Long Valley Wash with Temporary Crossing prior to being removed

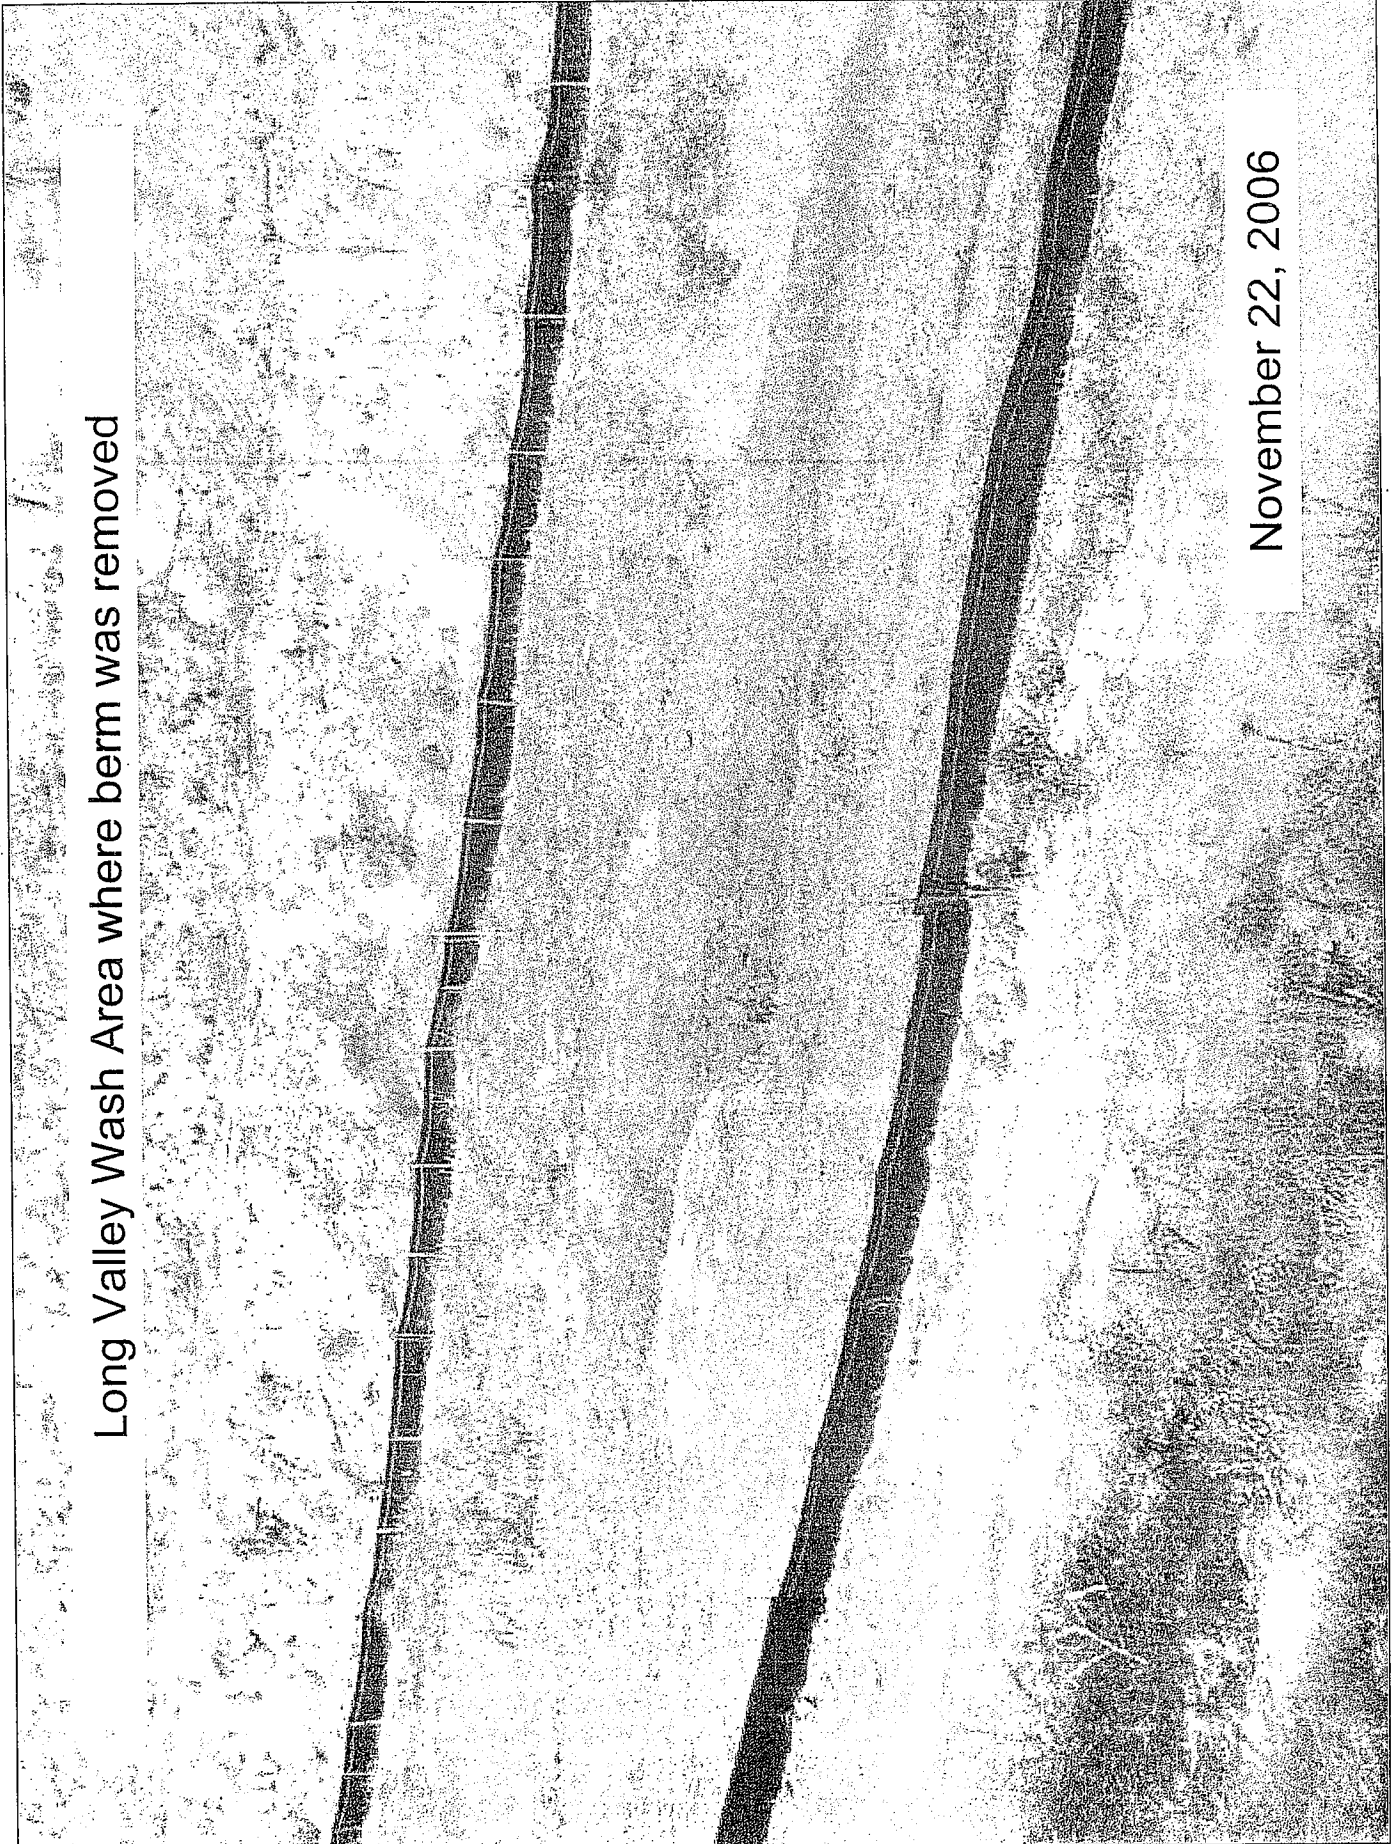
Long Valley Wash Area where berm was removed

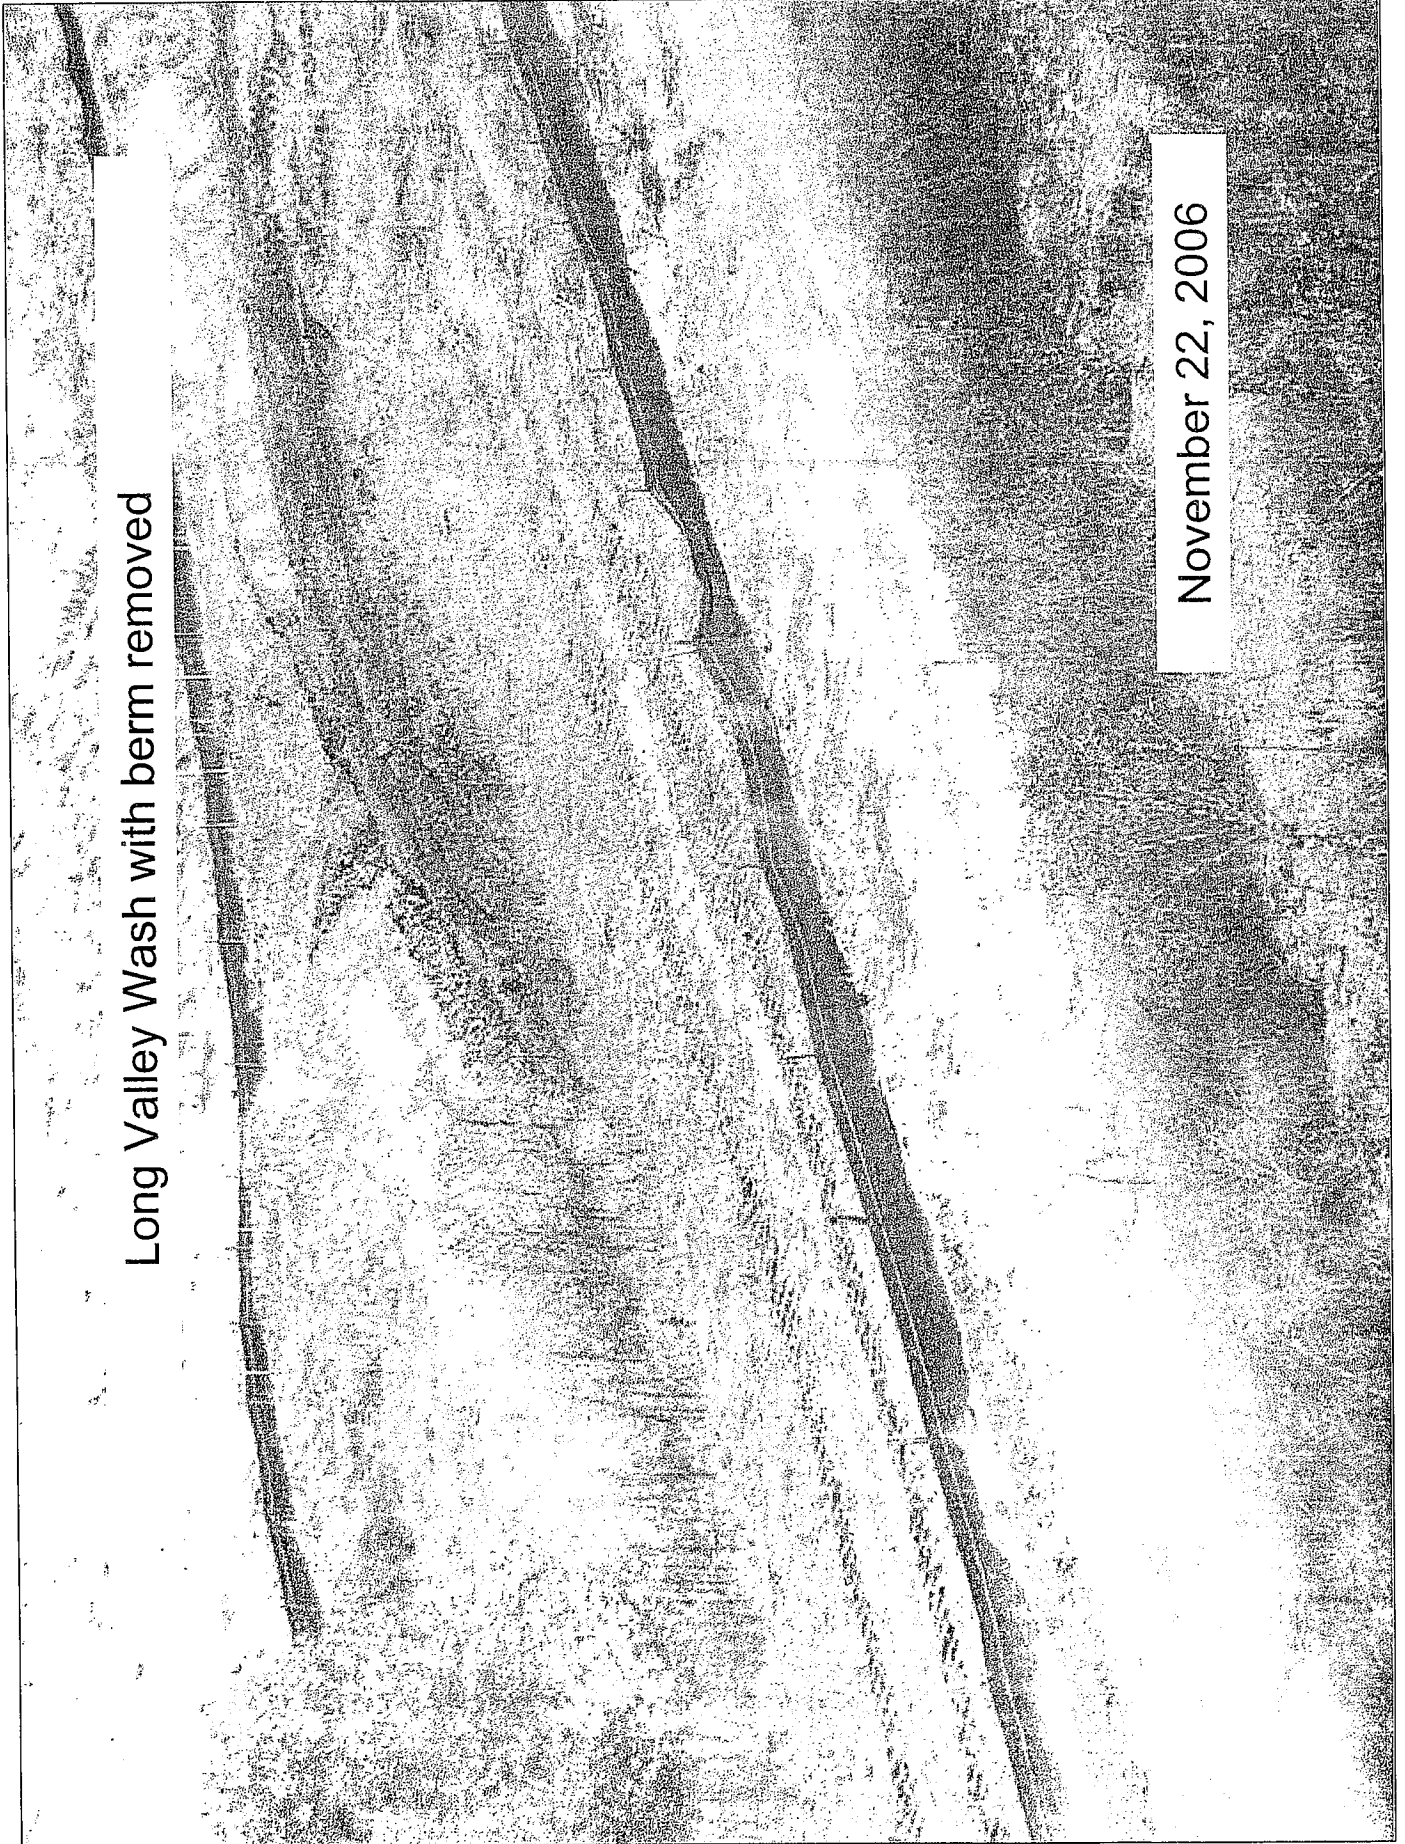
Long Valley Wash with berm removed

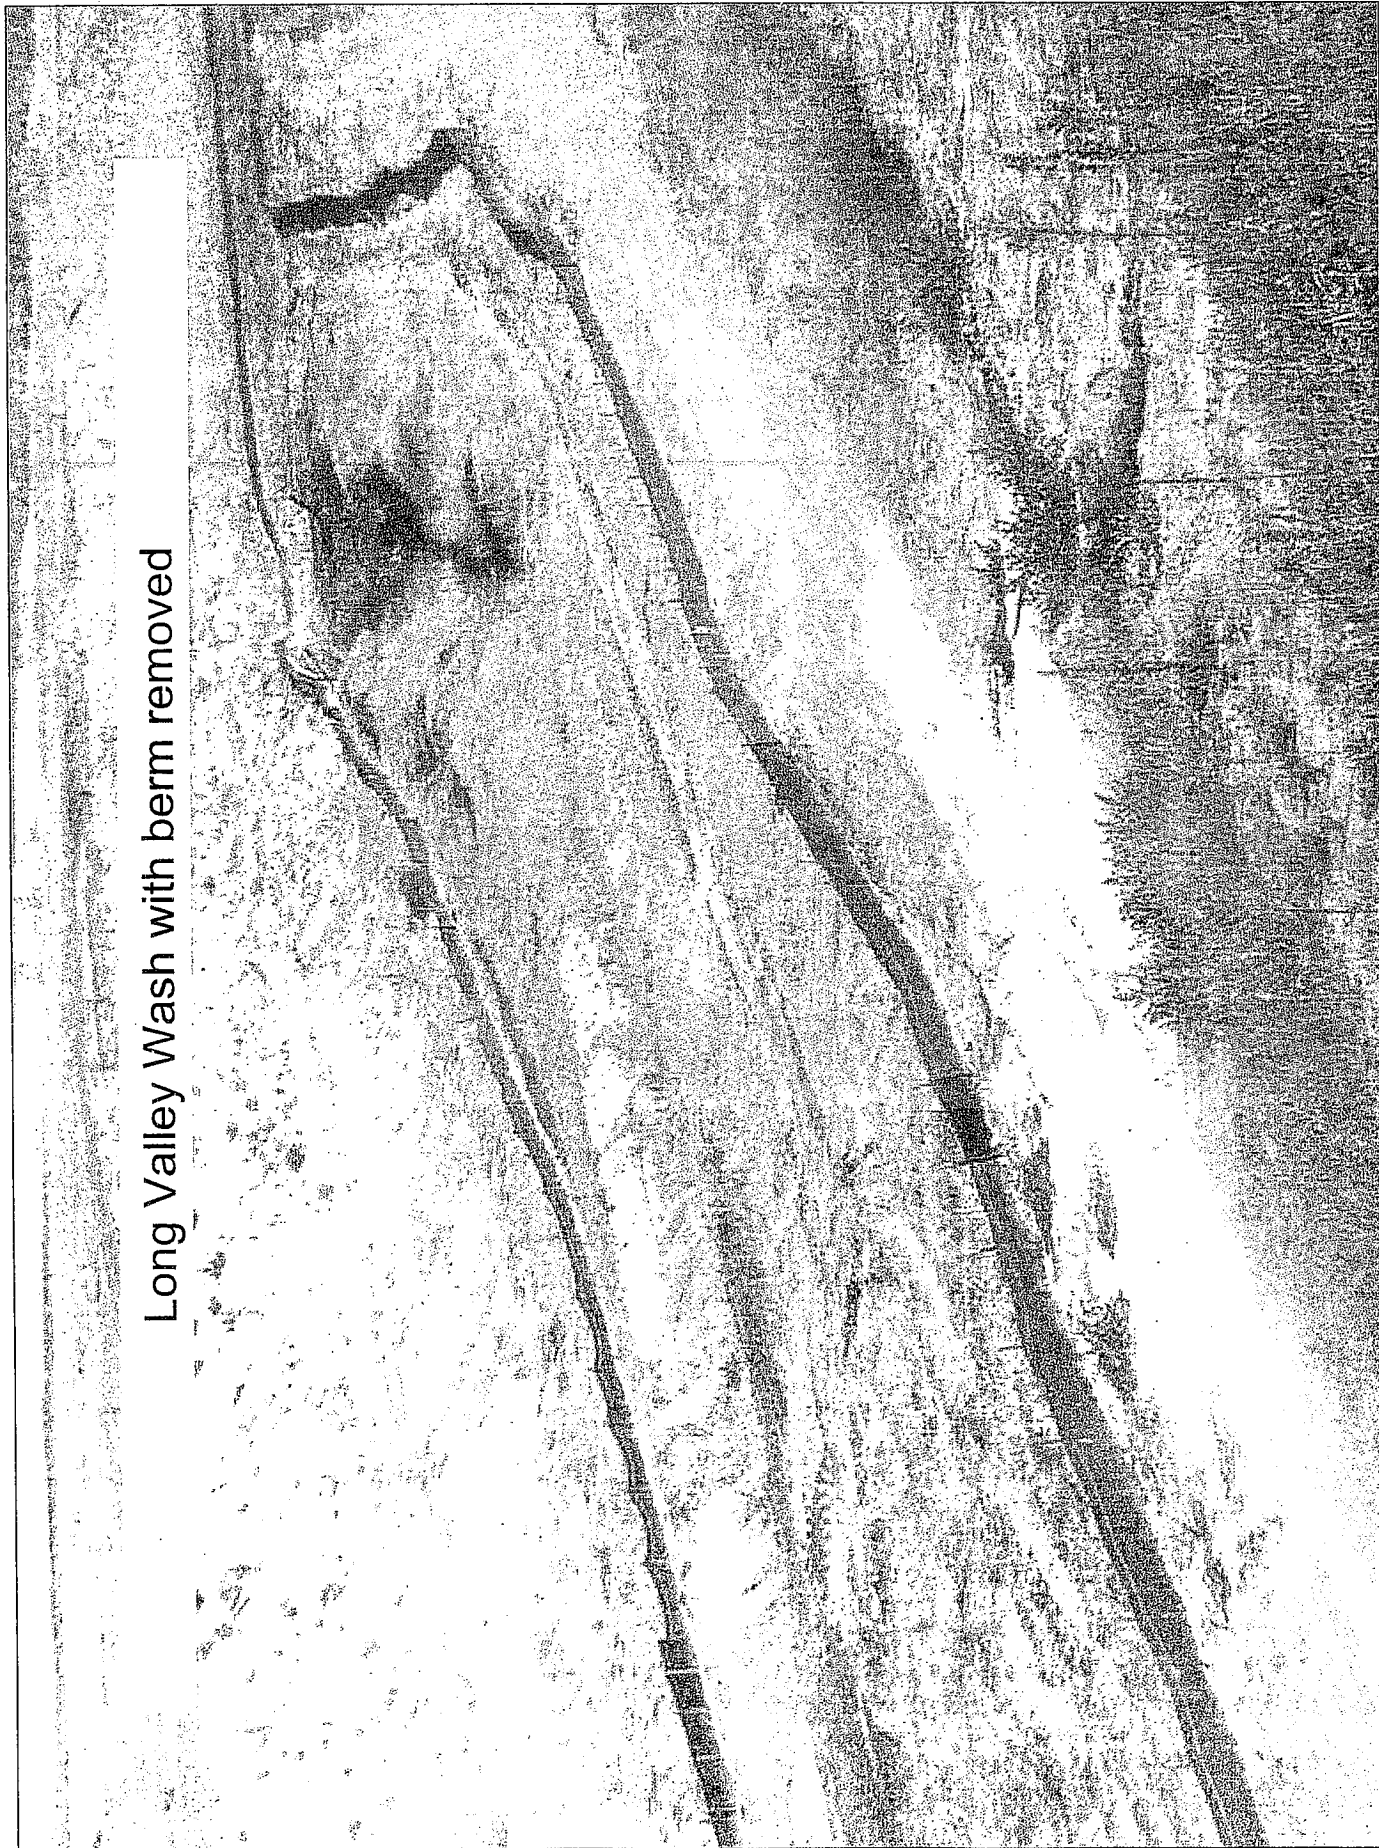
Long Valley Wash with berm removed

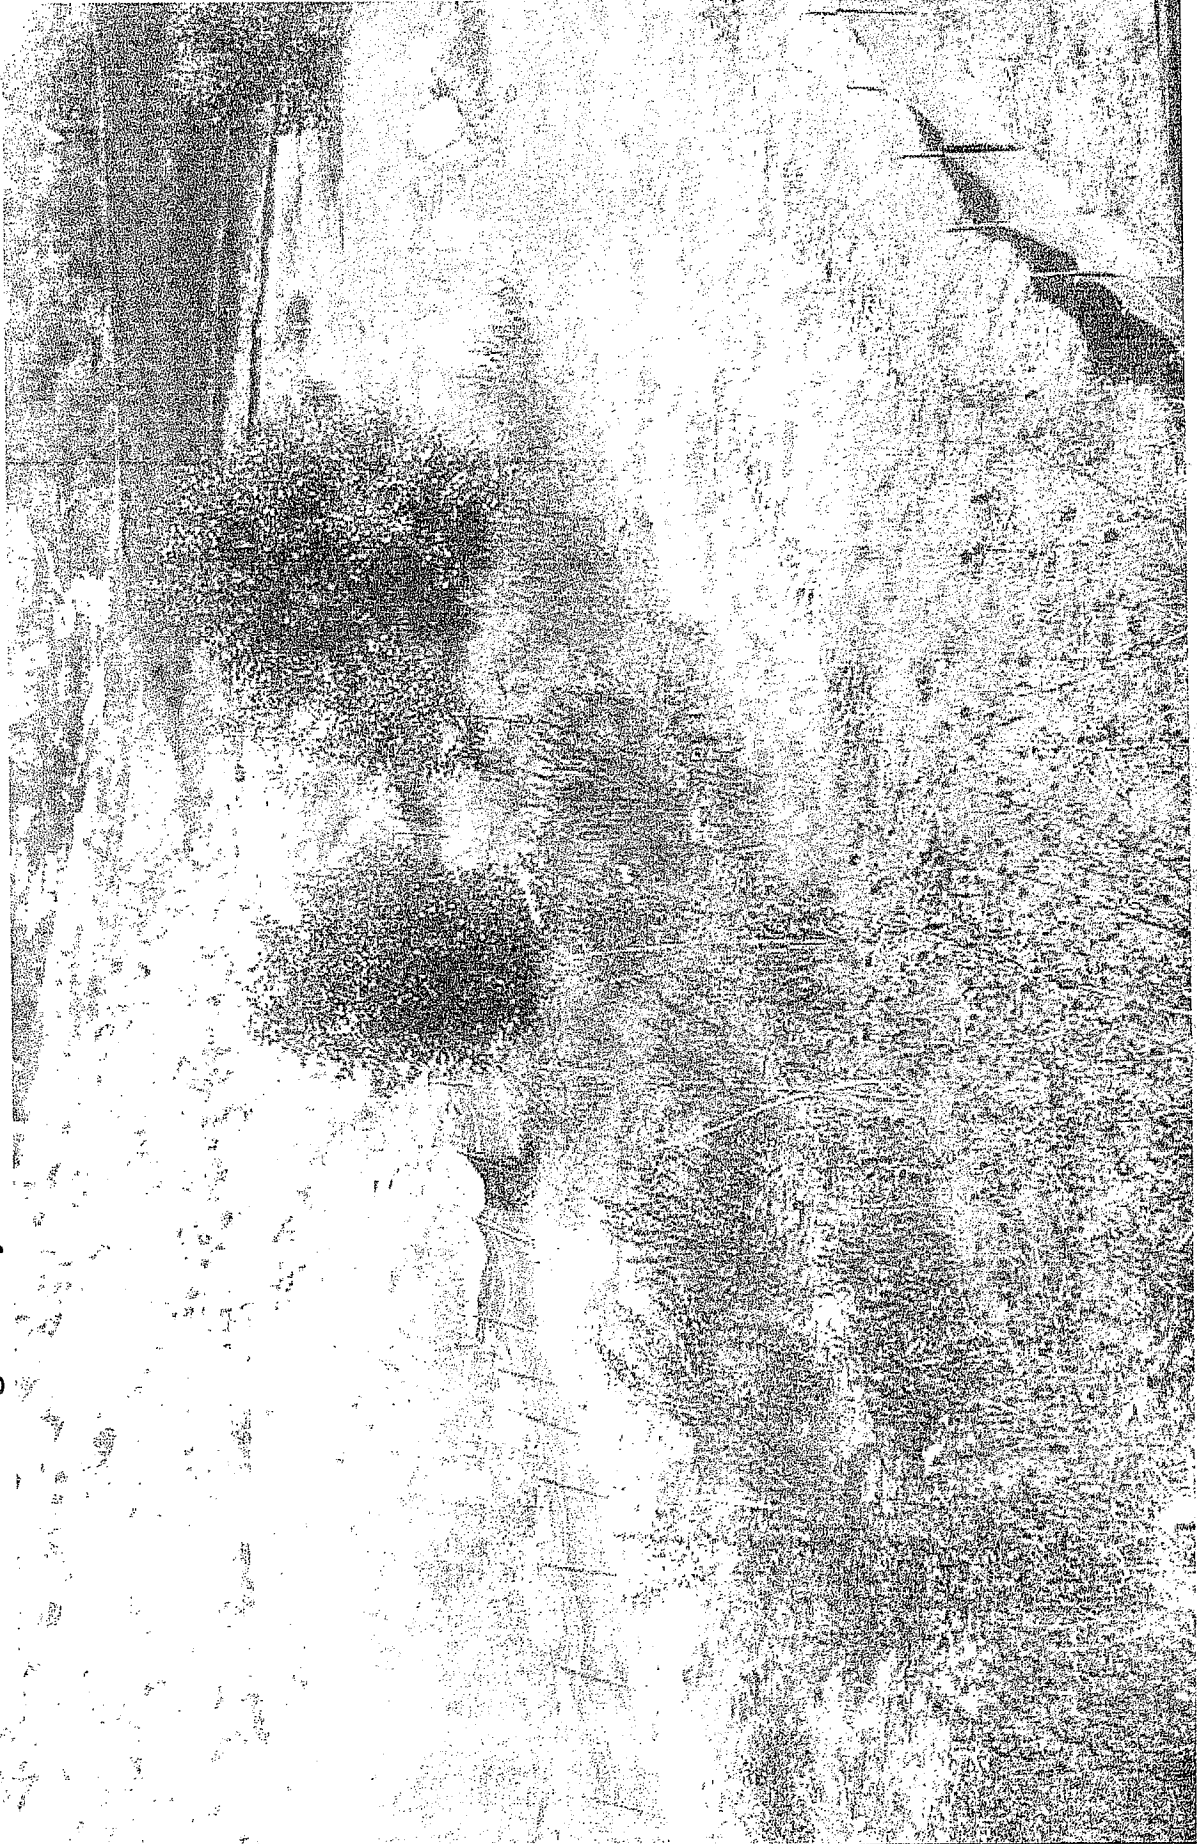
Long Valley Wash looking upstream with berm removed
