Appendix F

ASHBY USA, LLC

Ref: WPN: 10-3020657.02, 18-2001091.02:schwk
NOV No. R9-2006-0135

Subject: Required Technical Report

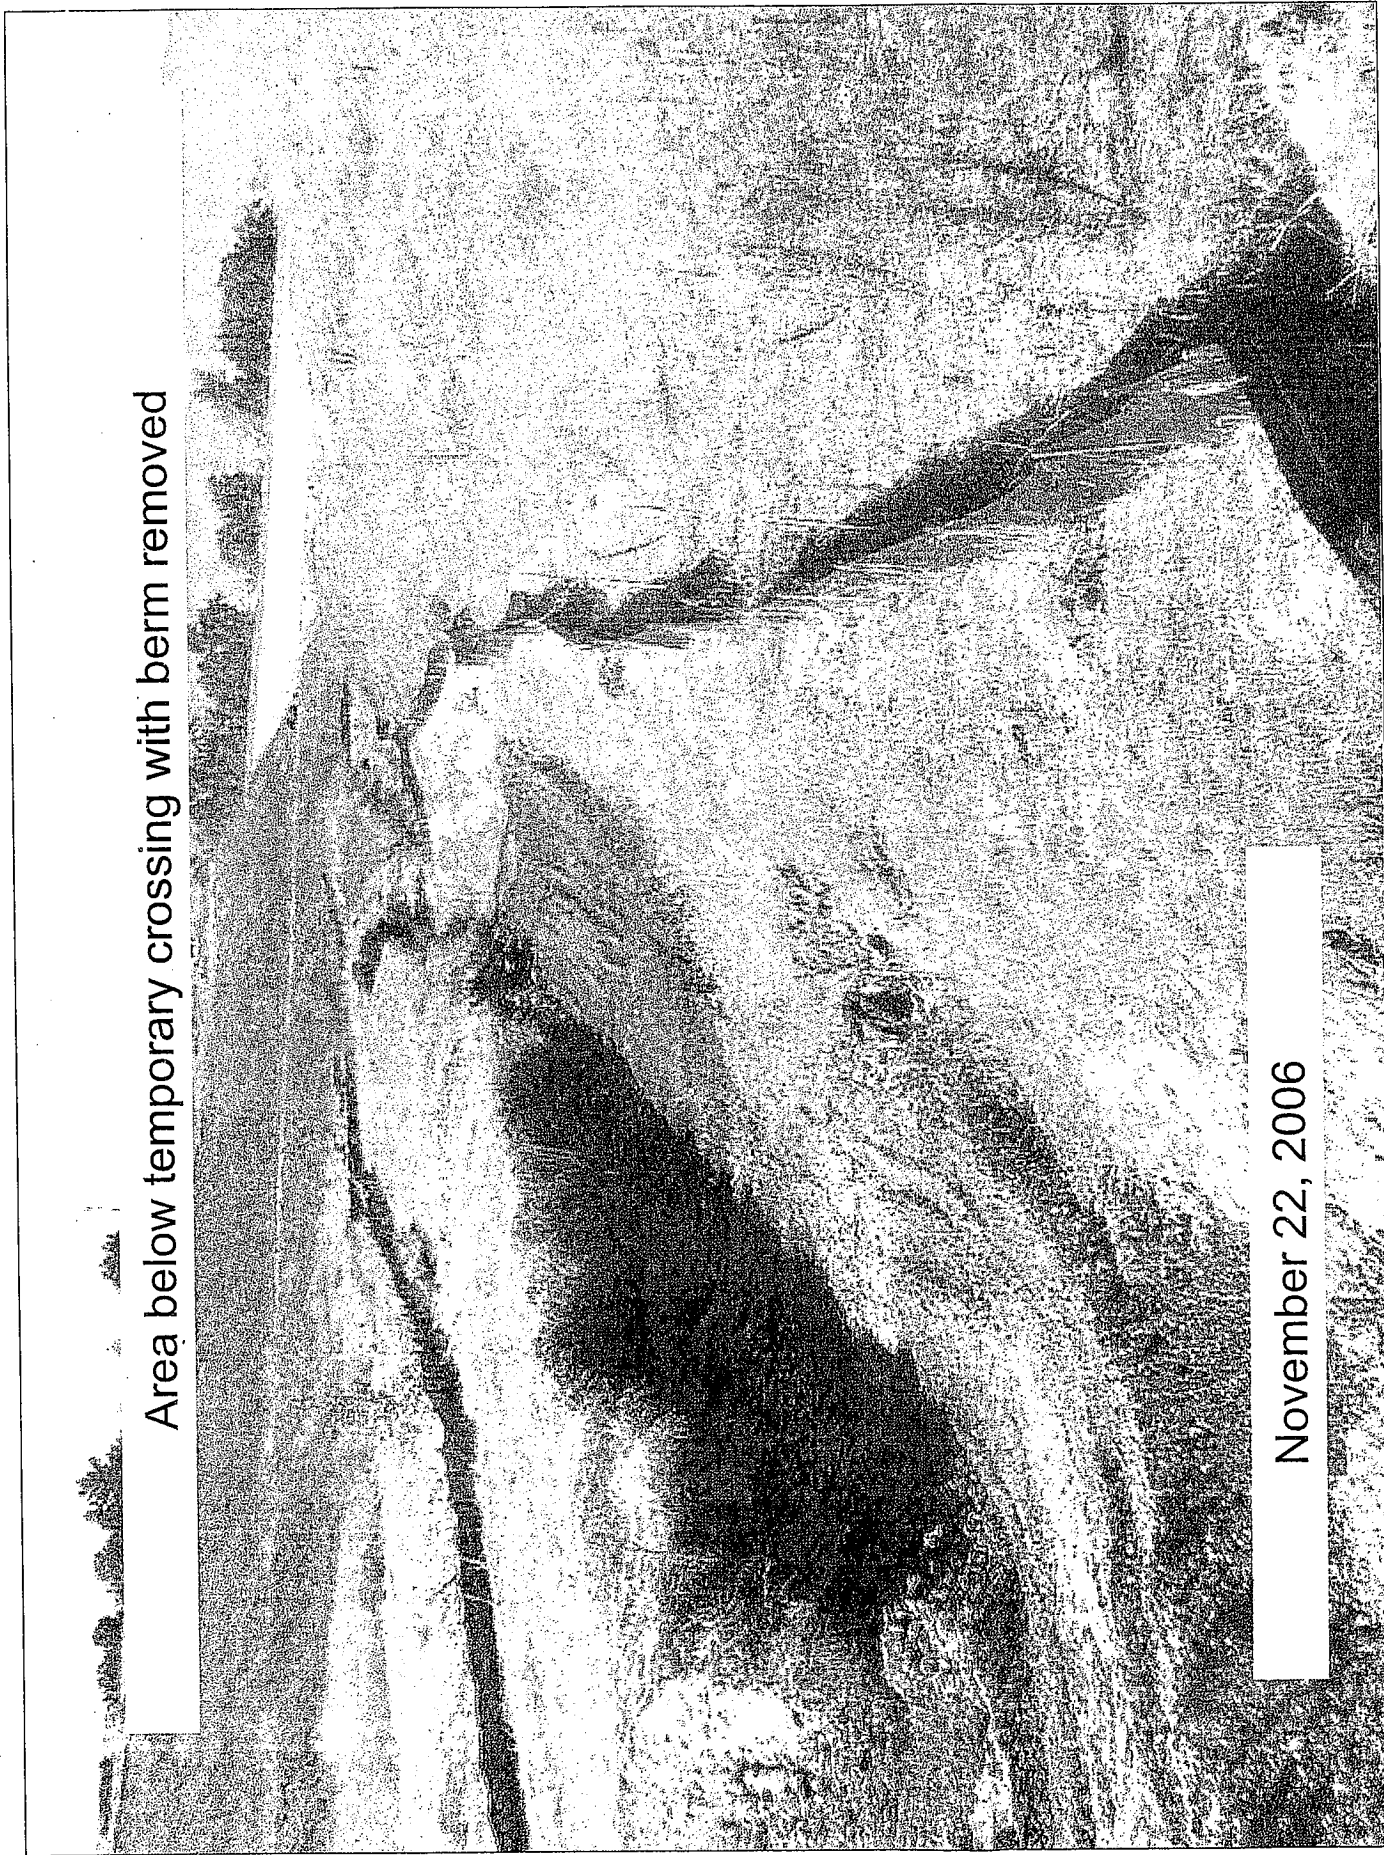
Area below temporary crossing with berm removed
