CALIFORNIA REGIONAL WATER QUALITY CONTROL BOARD - SAN DIEGO REGION

FACILITY INSPECTION DATA ENTRY FORM

INSPECTION DATE: August 29, 2006 TIME: 9:45 WQIDs: ORDER NOs. FILE NOs.
 9 00001C091 01C-091 18-2001091.02
 9 33C320657 99-08-DWQ 10-3020657.02
 9 0000512S1 R9-2004-001 10-7000.02

Roripaugh Ranch Tract 29353
 FACILITY OR DEVELOPER NAME (If different from owner)

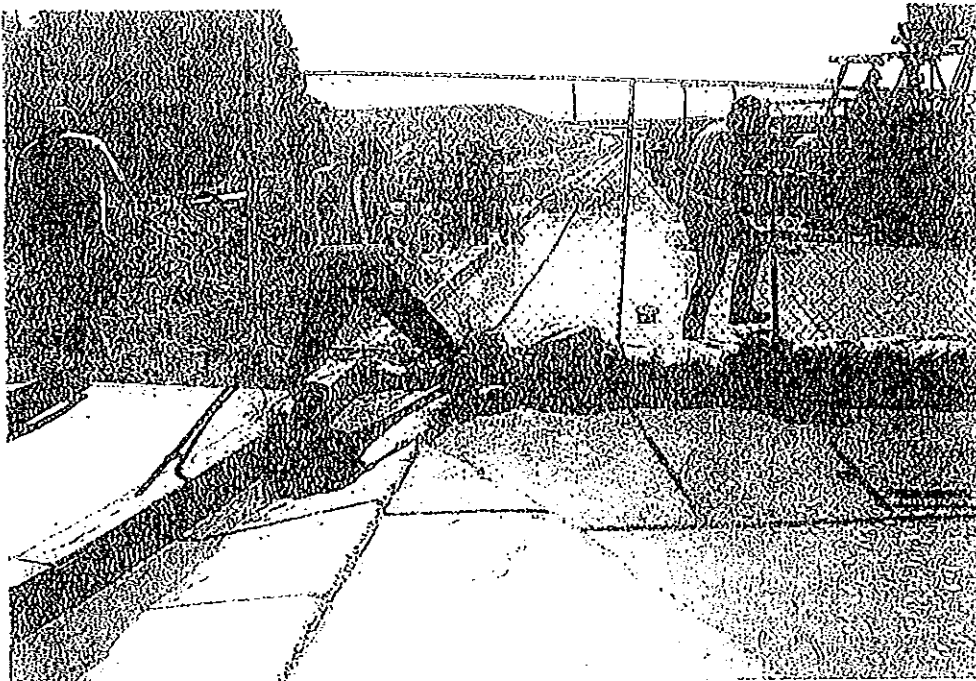
Our 10:00 a.m. arrival at the site was interrupted by a water line break, which occurred at the intersection of Murrieta Hot Springs Road and Pourroy Road (see vicinity map). Gravel bags, which were initially used to contain the pooling sediment-laden water, were being erroneously removed. This allowed the polluted water to flow freely down Murrieta Hot Springs Road (photos 1 and 2).

Photo 01: Ashby, USA workers attending to water line break. Initially, the workers were observed erroneously removing the gravel bags releasing the sediment-laden water along Murrieta Hot Springs Road.

We immediately alerted the Ashby USA workers that the release of sediment-laden water is strictly prohibited under state regulations and city ordinances. Upon recognizing that we were Regional Board employees, the Ashby workers immediately began replacing the gravel bags to contain the flowing water. By that time there was a significant volume of sediment-laden water discharging along Murrieta Hot Springs Road and entering the storm drain inlet at the intersection of Red Bridge Road (photo 2). The discharge along Murrieta Hot Spring Road occurred for about 30 minutes with approximately 10-20 gallons of sediment-laden water entering the storm drain inlet.

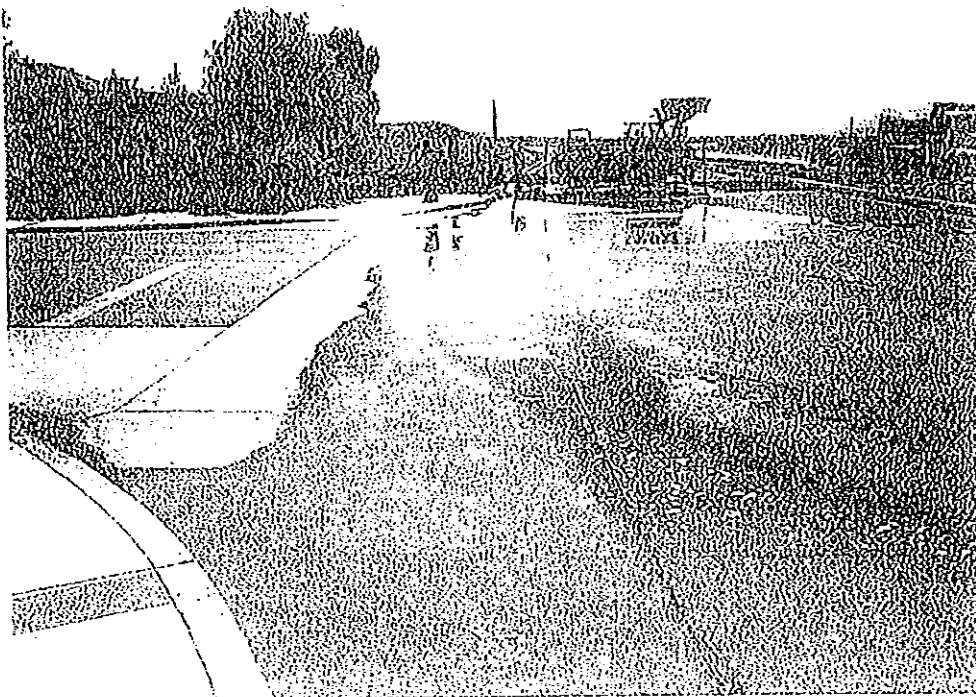
Photo 02: Our presence quickly alerted the Ashby works to maintain the BMPs as sediment-laden water entered the storm drain along Murrieta Hot Springs Road.

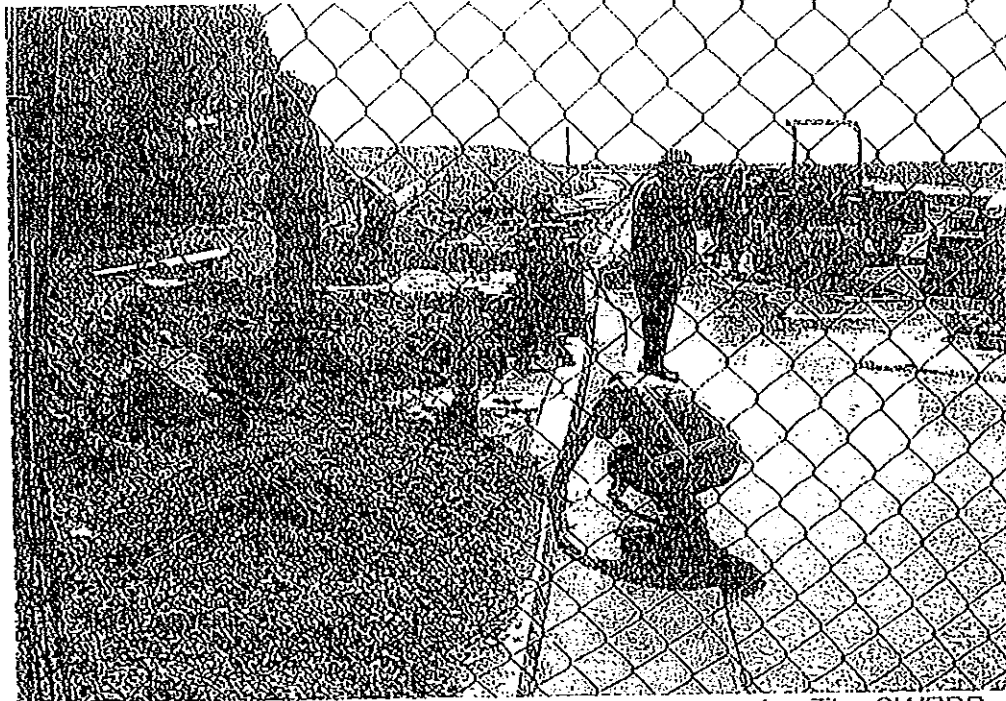
Photo 03: Workers attempting to shut off the water main. The SWPPP person, Mr. Henry Martinez, and his supervisor were present at the time of the incident.

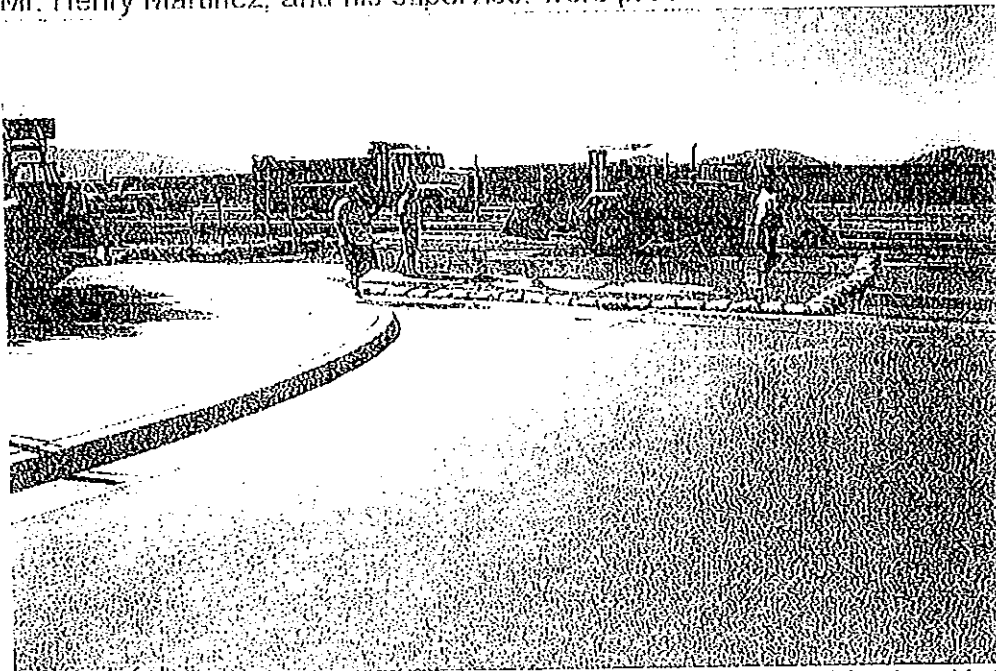
Photo 04: Sediment traps were immediately installed along Murrieta Hot Spring Road to contain and capture the sediment-laden water.

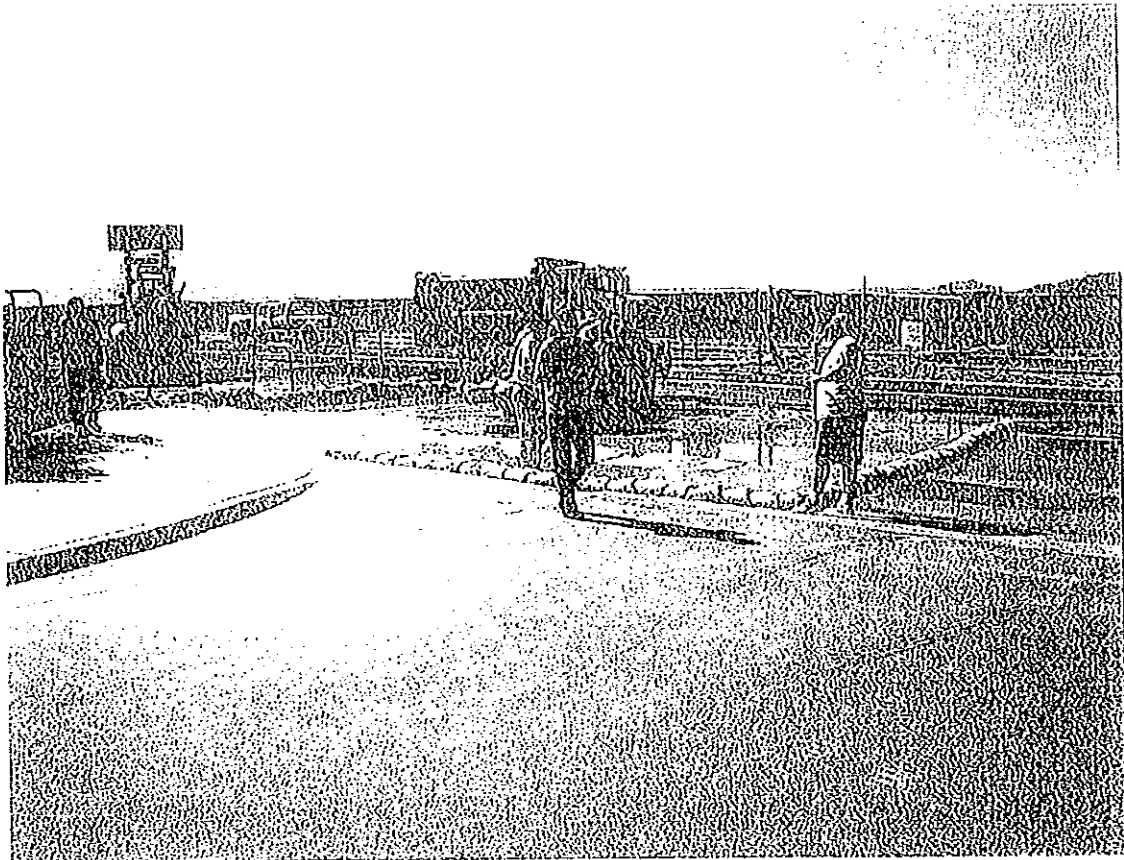
Photo 05: We notified Mr. Aldo Licitra of the City of Temecula of the incident. He proposed to conduct a follow up inspection of the incident to ensure proper clean up of the sediment that was deposited along Murrieta Hot Springs Road. The incident occurred the moment we approach the site entrance on Pourroy Road.

There was discharge into the City's storm drain located at the intersection of Murrieta Hot Springs Road and Red Bridge Road, which is in violation of the City of Temecula's Municipal Separate Storm Sewer Systems (MS4) permit.

About an hour later, the Ashby workers had laid out a series of sediment traps along Murrieta Hot Springs Road to contain the sediment discharge. The closest storm drain, located at the intersection on Red Bridge Road, was protected with gravel bags to contain the runoff.

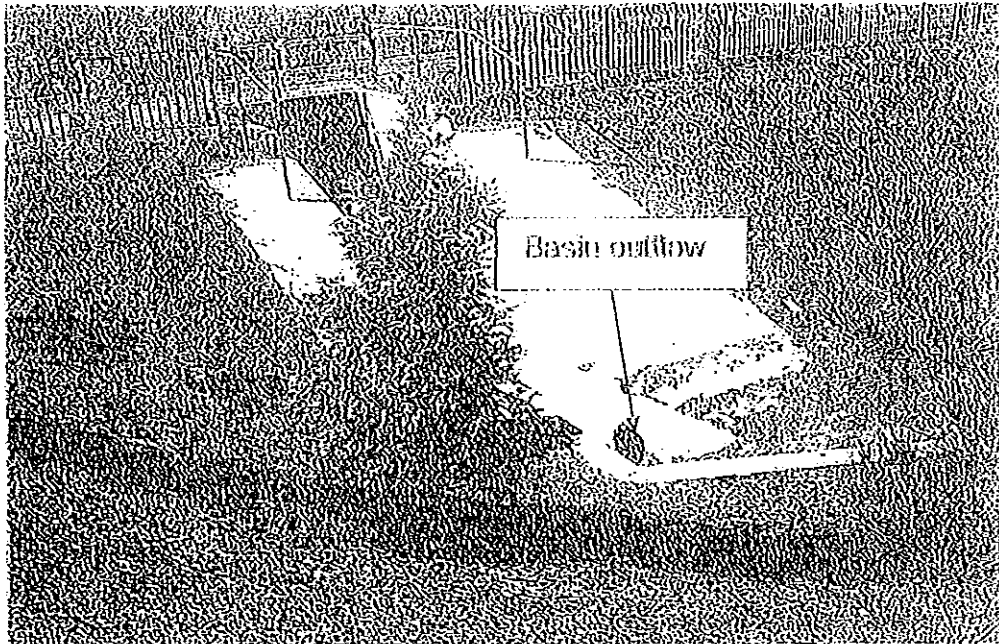
At 10:33 a.m., we entered Roripaugh Ranch to walk the site and to inspect the sediment basin. The basin is at the base of the panhandle of the site, directly behind the club house. The basin, 0.7 acre in size, is designed to capture the stormwater runoff from the "plateau" and the surrounding areas (photos 7 and 9). Close inspection of the basin shows the outlet is level with the base of the basin, making the basin a flow-through system (see photo 8). The basin lacks

The basin outlet design is causing erosion in the creek downstream from the outlet as shown in photos 8, 10, and 11. Ashby USA is in violation of Condition 16 of 401 Certification No. 01C-091 for failing to implement BMPs as described in the WQMP.

Photo 08: Placement of the basin outflow indicates the design is a flow-through system, eliminating settling time.

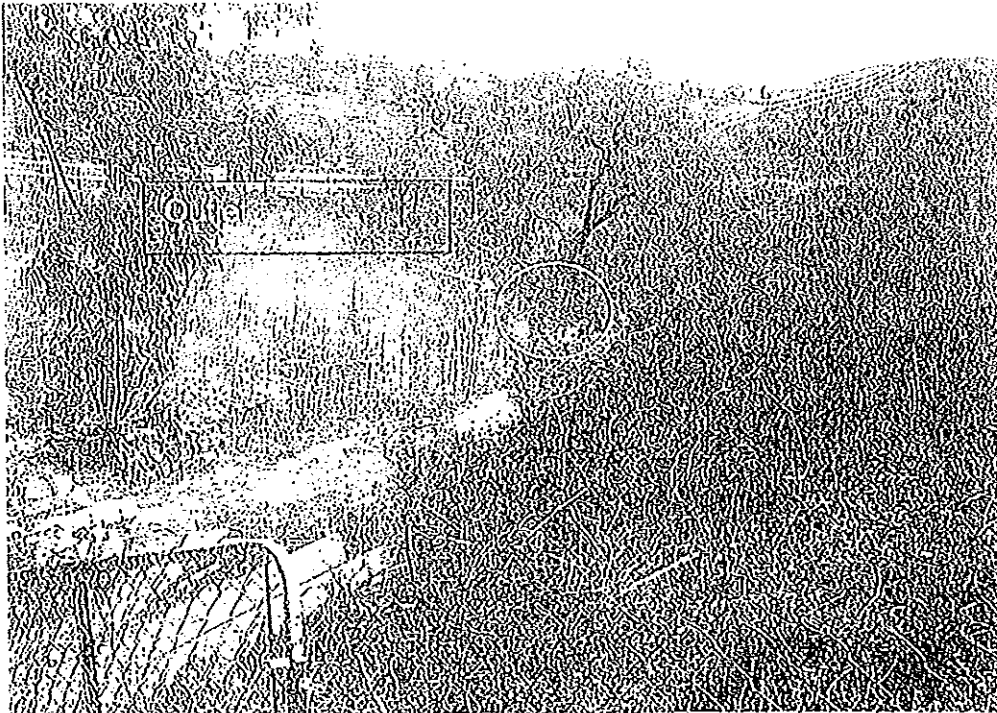
an anchored-riser that would facilitate sediment desilting time. The basin's 6-inch outlet pipe continues through an eighteen-inch pipe and daylight through the headwall located down gradient from the plateau (photo 10). Storm water runoff discharges through riprap, placed at the headwall, to diffuse the high velocity flows from the sediment basin (photo 10). We observed most of the riprap was covered with sediment and therefore, not expected to provide much velocity reduction. In response to the complaints, the City of Temecula had requested more riprap placed at the outlet to further reduce flow velocities from the sediment basin.

Photo 10: Inset shows outlet of sediment basin with velocity diffuser (barely visible because it is covered with sediment). Subsequent photos will trace the path of discharge from the sediment basin to the complainant's property.

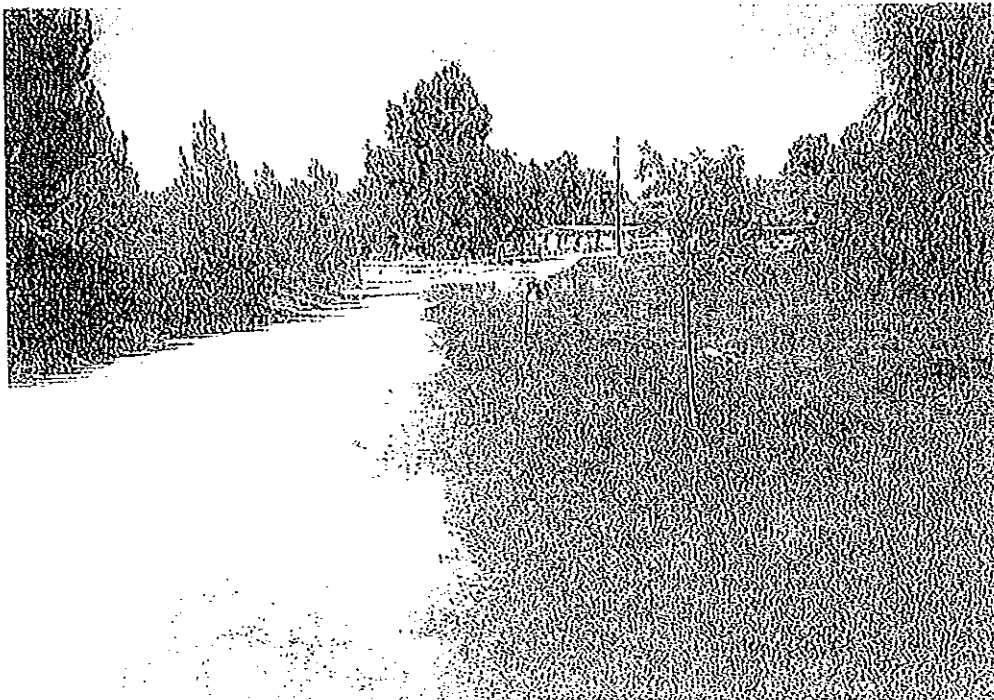
We traced the path of storm water discharge from the sediment basin's headwall through various private properties to the complainant's property. From the headwall the discharge continues through a grassy swale of a neighbor's backyard through a culvert pipe fitted with riprap at the inlet (photos 11 and 12). The complainant's property begins down gradient, at the intersection of the culvert pipe outlet and Kimberly Lane.

Photos 11, 12, 13, and 14 show illegal fills of waters of the US downstream of the detention basin. The complainant said that these fill areas were placed to address the erosion from the detention basin discharge.

Photo 11: Runoff from the sediment basin continues through this grassy swale exiting through the culvert pipe (seen in background)

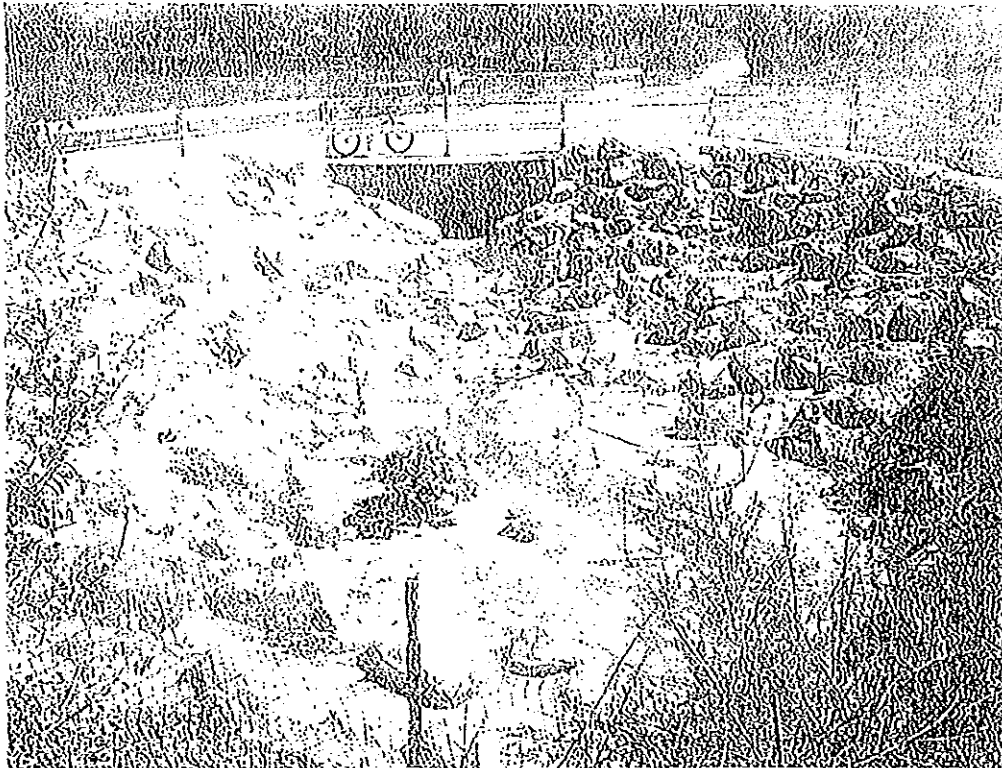
Photo 12: Culvert pipe-shows buildup of sediment deposit from discharges from sediment basin.

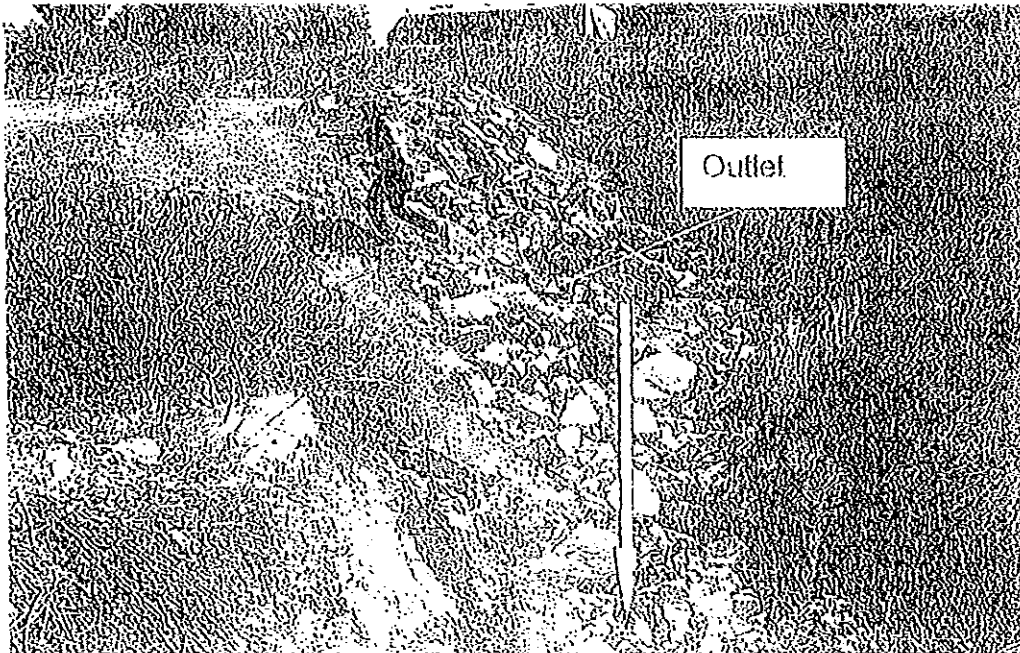
At the culvert pipe outlet, where storm water discharges enter the complainant's property, we observed severe erosion and sediment deposits within the natural waterway. The erosion effects and sediment deposits were more pronounced in areas along the complainant's property (photos 13 and 15). The natural waterway was scoured in some areas up to about 6 feet high (photo 15). The complainant recalled, "...as a child I could easily walk across the natural waterway." Getting across the tributary is now difficult or impossible because of the depth of erosion gullies that are formed from storm water discharges.

Photo 13: Insert shows culvert pipe's outlet. This natural waterway is a tributary to Santa Gertrudis Creek. Complainant states that the creek bed was at the level of the outlet pipe before the upstream Ragsdale basin was constructed.

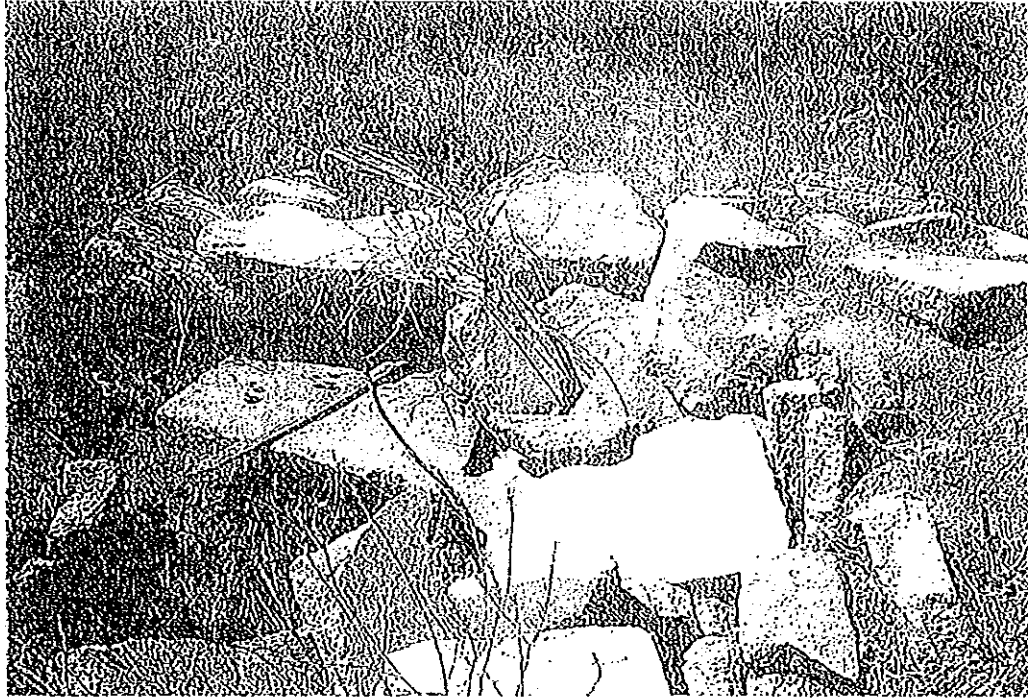
Photo 14: Complainant filled natural waterway with waste concrete blocks to serve as velocity diffuser. More of this can be seen in previous photo.

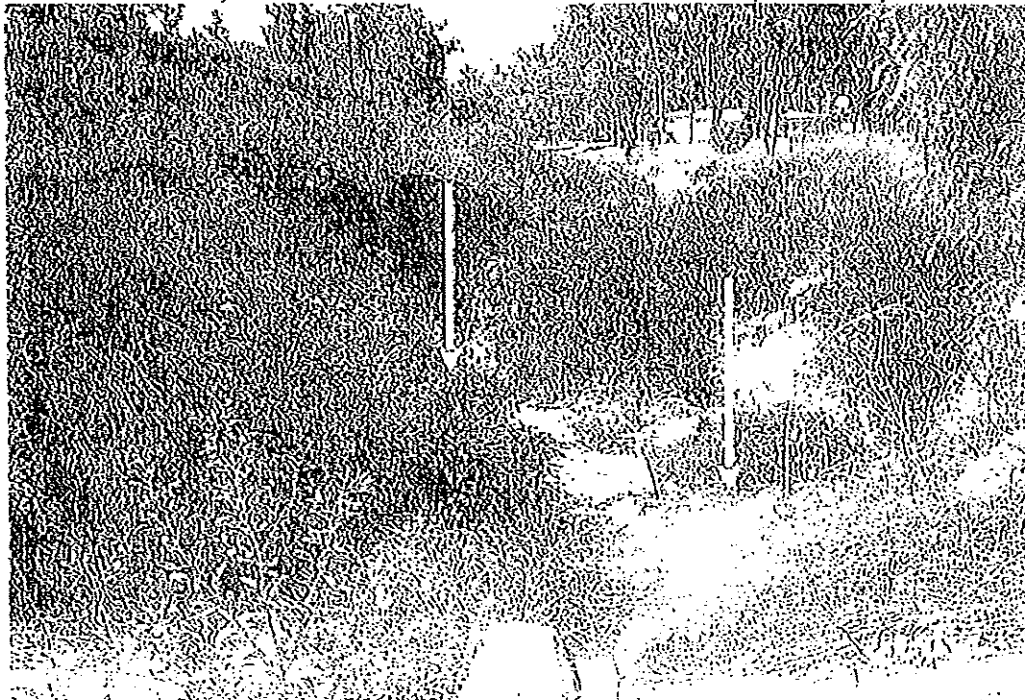
Photo 15: Complainant claims that high velocity and long duration discharges from the sediment basin has created deep gullies within the natural waterway. Note the depth of erosion from top of bank to bottom of creek bed shown with white arrows. Erosion was generally 3 to 4 feet, and up to 6 feet deep, in this area.

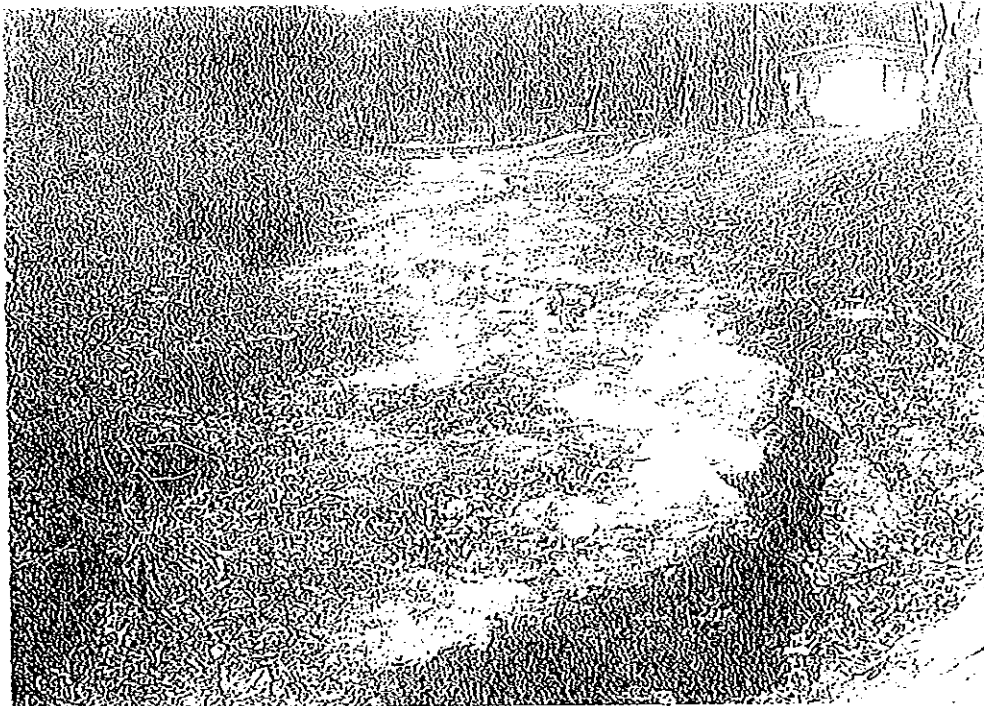
We observed significant amount of erosion, scouring of the embankment, and sediment buildup within the unnamed tributary that abuts the complainant's property and Liefer Road (see photos 16 and 17).

Photo 16: Complainant's property (5 acres) is to the left. Scouring of the embankment from erosion from low drainage flows. Per the complainant, during the wet season the erosion effects and sediment deposits are more pronounced in this area.

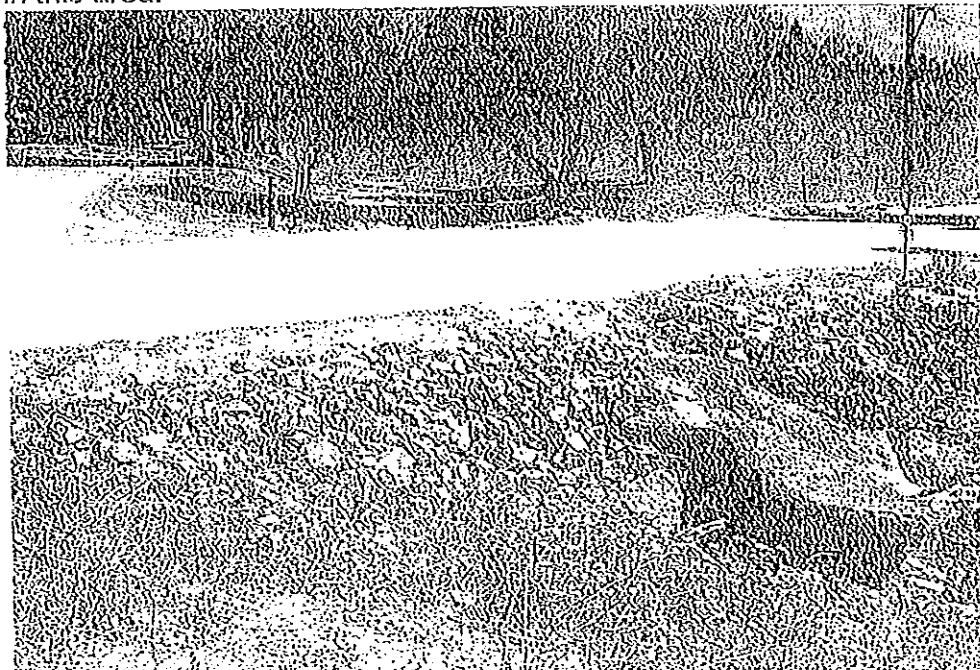
Photo 17: Facing upstream of natural waterway across Liefer Road. Storm water discharges continues through pipe underneath Liefer Road.
