**Biological Resources Damage Assessment
Within Murrieta Creek in Relation to the
Temecula Valley Regional Water Reclamation Facility
December 25, 2009 Sewage Spill**

City of Temecula, Riverside County, California
USGS – Murrieta and Temecula topographic quadrangles
Township 8 South, Range 3 West

Shay Lawrey
Ecologist / Regulatory Specialist
Prepared on January 05, 2010
Updated, revised and finalized on January 25, 2010

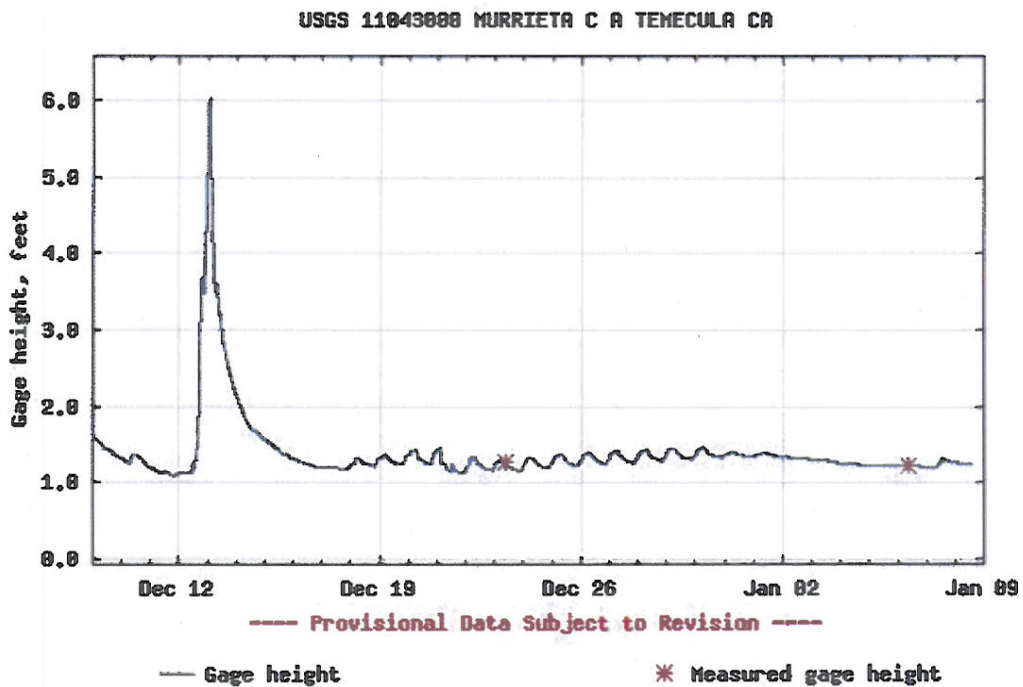
Figure 6. Flow Data of USGS Gaging Station 11043000 Between December 12, 2009 and January 09, 2010.

From the TVRWRF spill inlet into Murrieta Creek, the affected area spans 1.5 miles to Rancho California Road, where the spill was considered contained by the EMWD. The locations of the relevant USGS gaging stations near the study area, and gage flow data for a period before and after the spill for these stations is provided below (Figures 4-6). This data correlates with the assertion that the spill was contained and did not flow beyond Rancho California Road.

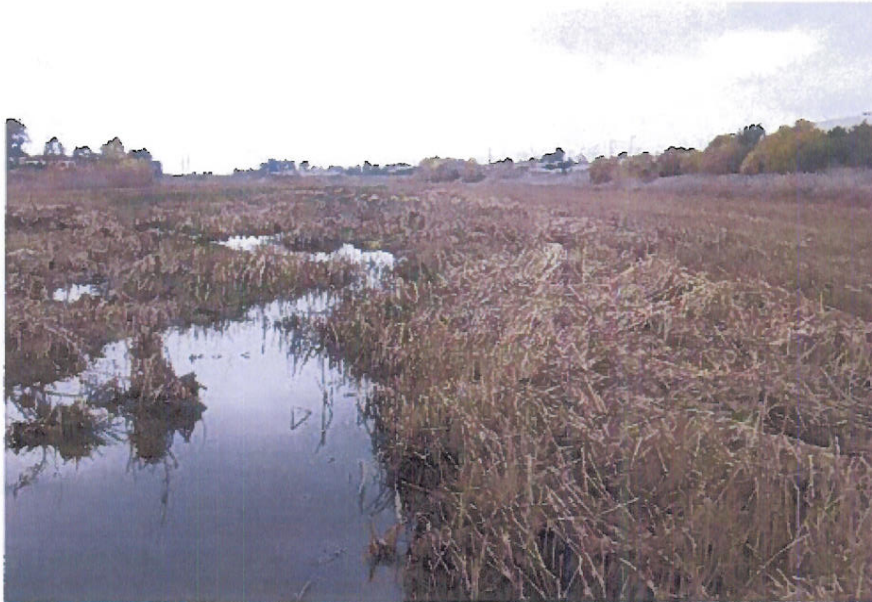
Photo 1. Standing 100 feet upstream of Via Montezuma looking upstream toward Winchester Road.

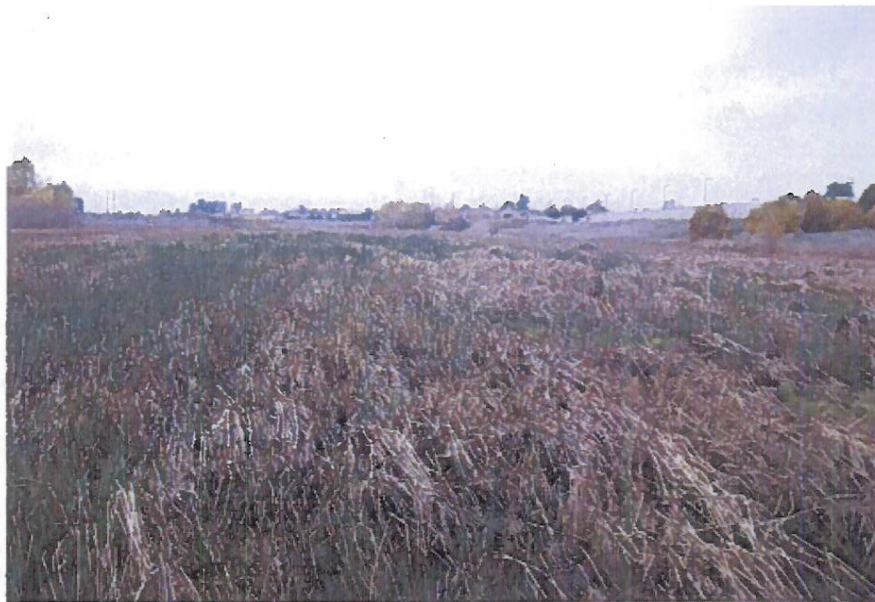
Photo 2. Standing in the mid-section of the survey area between of Via Montezuma and Winchester Road. Photo showing existing site conditions, habitat structure and disturbance from recent mowing for flood control.

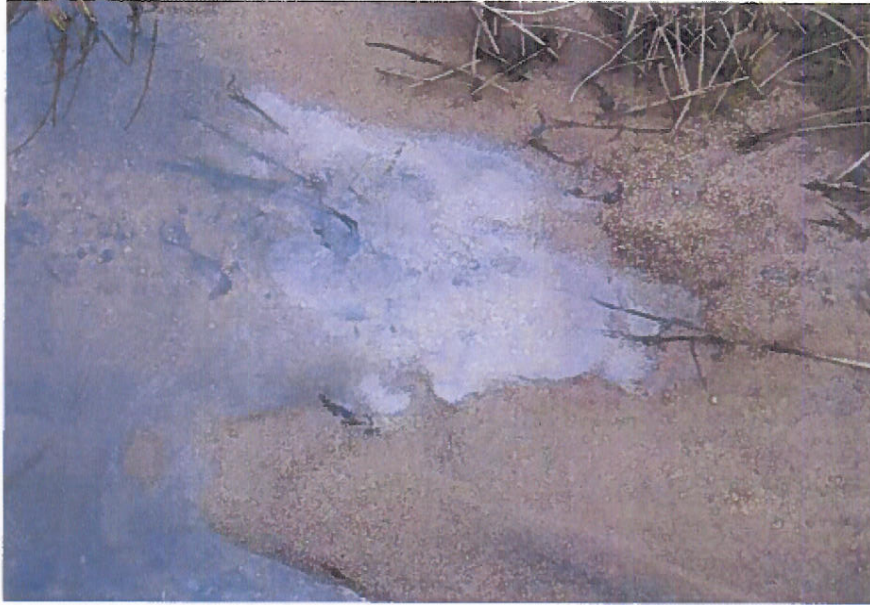
Murrieta Creek, visible signs of the spill were present in the form of an oily film slicking over the pooled areas and floating organic material. These visual signs were mostly concentrated in pooled areas along the west side of the channel. These signs are indicative of a backflow process during the spill event, however, another potential contributing factor to these signs may be the storm drain channel that inlets into the east side of Murrieta Creek (Figure 7). There was no visual indication of the spill downstream of Ranch California Road. The lack of visual signs of contamination in this area supports EMWD assumption that the spill was contained at the surface at Rancho California Road.

Photo 3. Photo showing the oily film observed in the study area which was primarily detected on the west side of Murrieta Creek, approximately 1,200 feet up and down stream of Via Montezuma.

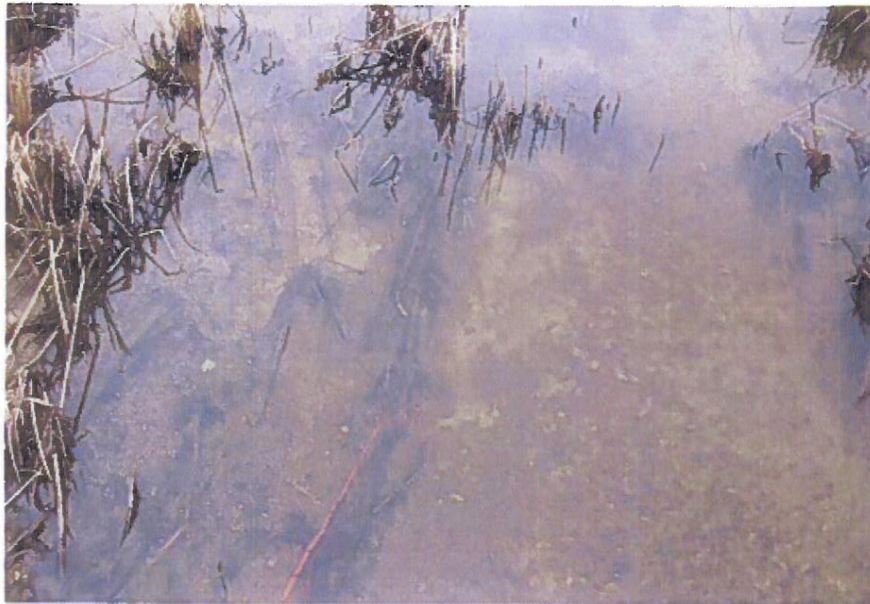
Photo 4. Photo showing clear aquatic conditions in the study area. Clear pooled water was mostly observed from Rancho California Road upstream to approximately 300 feet and from Winchester Road downstream to approximately 800 feet.

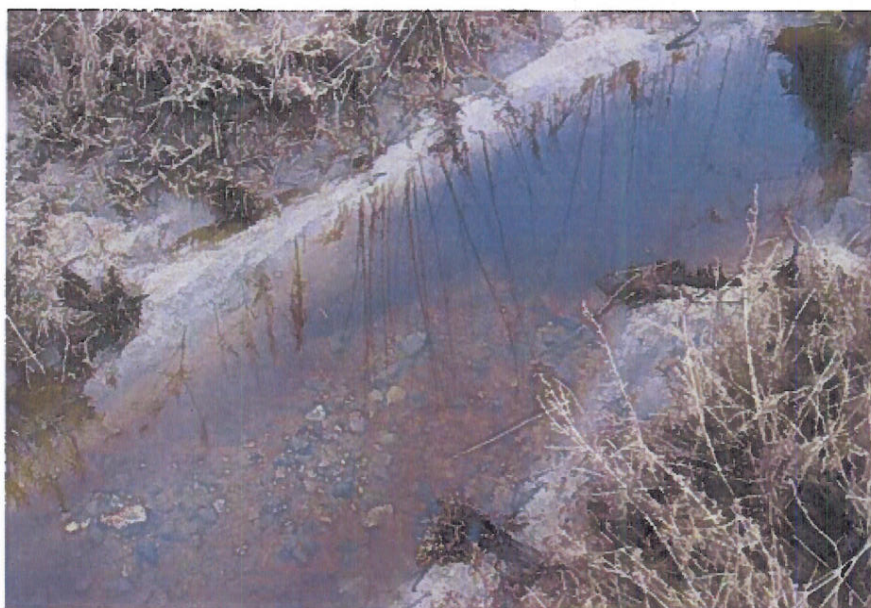
Photo 5. Standing 100 feet downstream of Via Montezuma Road showing conditions of pooled water on the west side of Murrieta Creek.

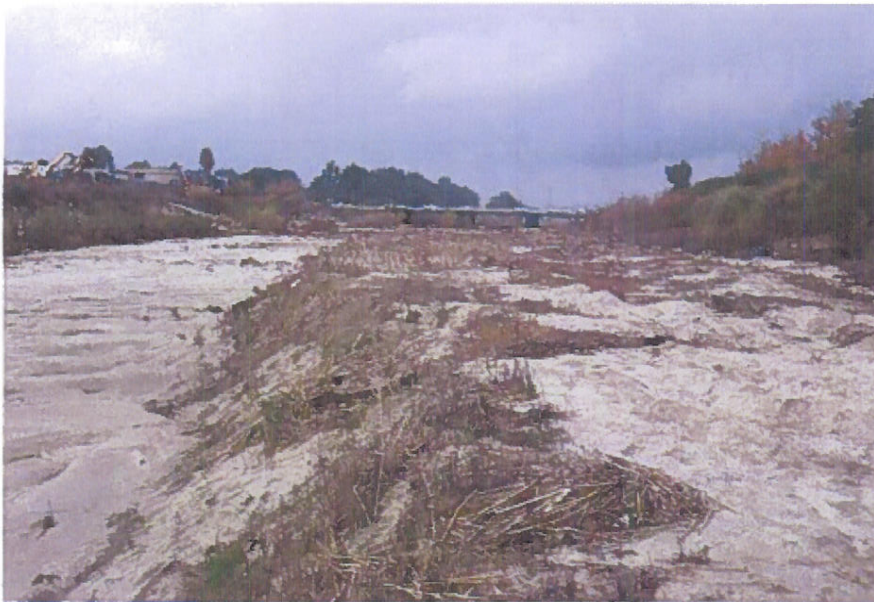
Photo 10. Photo showing dry creek conditions downstream of the Rancho California Road bridge crossing looking upstream towards the bridge.
