International Boundary and Water Commission  
United States and Mexico

Report of Transboundary Bypass Flows into the Tijuana  
River

Minute 320 Binational Technical Team

Final Report

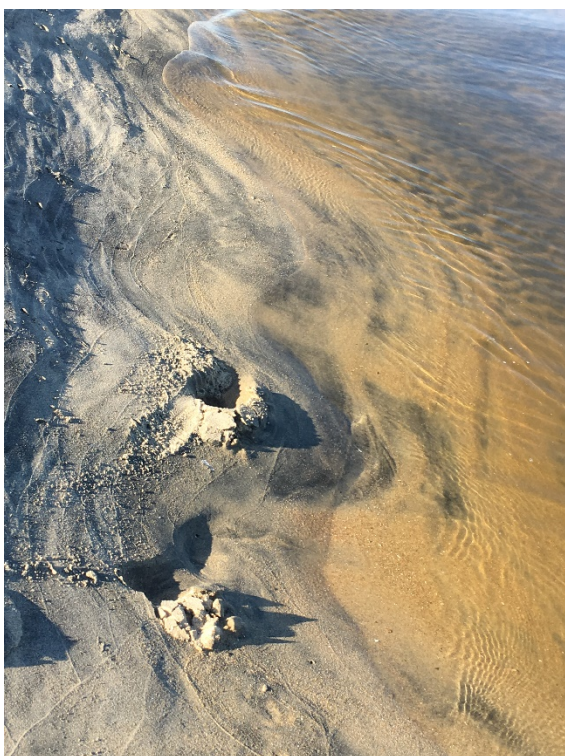
*Figure 3 Tijuana River at confluence with Pacific Ocean, dark material present -March 8, 2017*

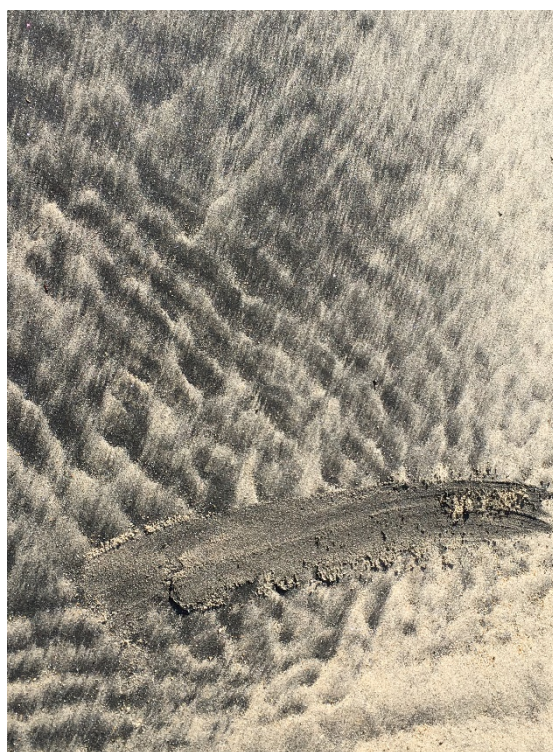
*Figure 4 Close up of sand material – March 8, 2017*

There was the presence of black organic material in the sands. USIBWC interviewed personnel at the Tijuana River National Estuarine Research Reserve and at Border Field State Park, located near the river's mouth. Those personnel noted that the odor of wastewater is consistent when there are flows in

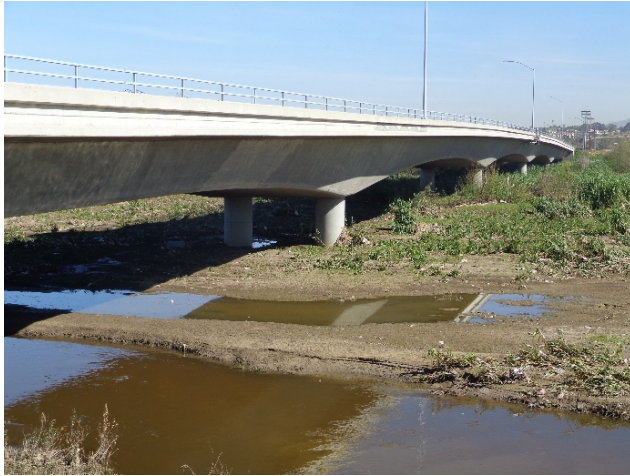
*Figure 5 Tijuana River at Dairy Mart Bridge*

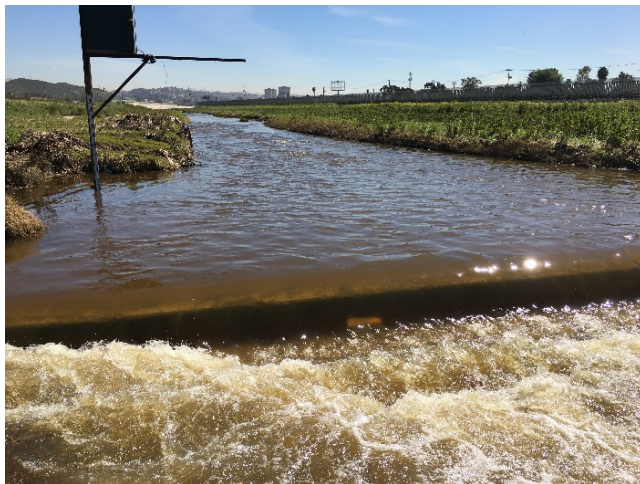
*Figure 6 Tijuana River at IBWC gaging station, March 8, 2017*

Further upstream at the USIBWC gaging station located in the pilot channel of the flood control project, immediately downstream of the international border, flow of the Tijuana River was fast moving and approximately two cubic meters per second (cms). The flood plain on either side of the pilot channel contained large amounts of trash and debris such as plastic bottles and tires. The water did not smell of wastewater but was slightly brown in color.

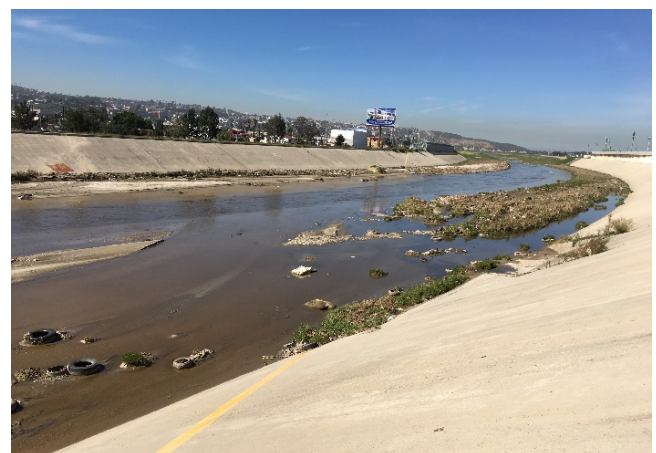
*Figure 7 Tijuana River at international boundary- March 8, 2017*

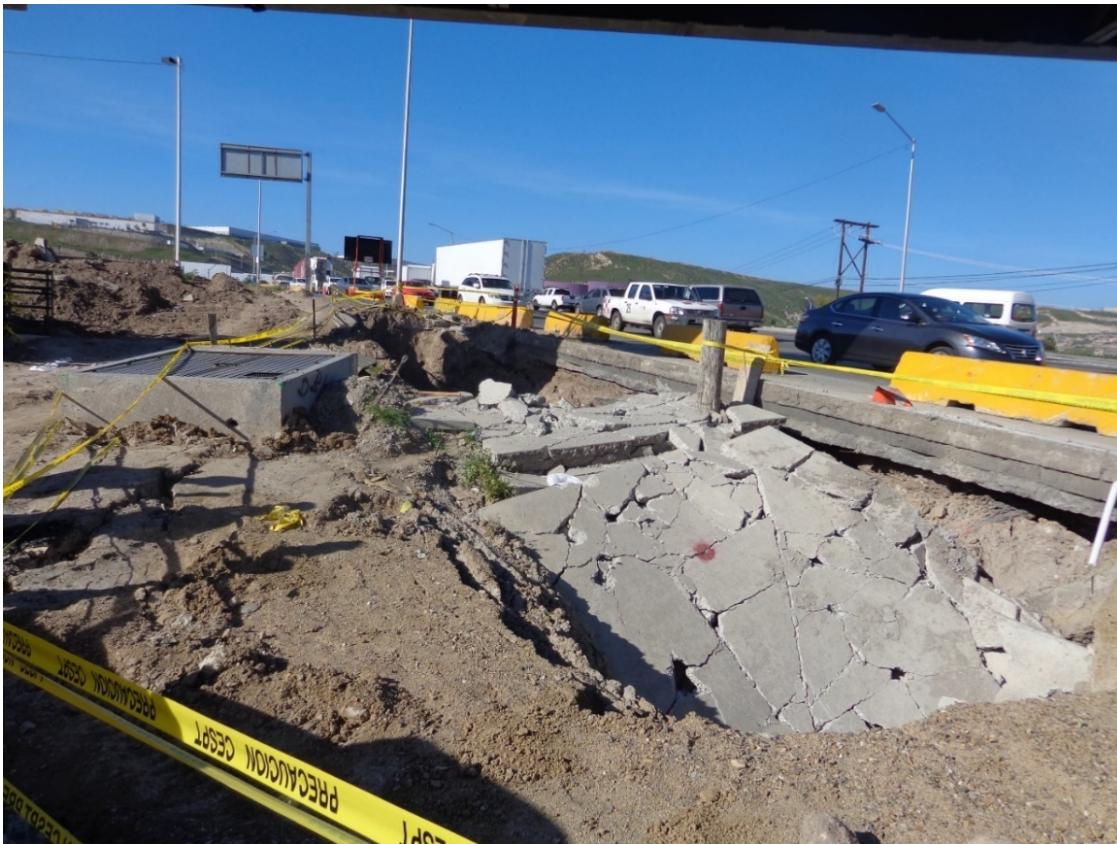
Many of the meeting participants went to the site of where the sinkhole had formed due to the collector break. The site was covered and the bus stop that had fallen in to the sinkhole had been replaced. CESPT showed everyone where the break had occurred and where the bypass had sent water to the *Poniente* collector which runs along the north side of the Rio Alamar. CESPT noted that at that location there is a 40-inch line and a 42-inch line connecting to the junction box that sends the combined flow down a 60-inch line. The area downstream of the junction box has also collapsed and this 60-inch line will need to be repaired in the upcoming dry season. Below is a photo of that area.

*Figure 10 Additional damage along roadway due to collector collapse downstream of junction box- Blvd Lazaro Cardenas, Colonia Los Pirules, Tijuana, B.C. - March 9, 2017*

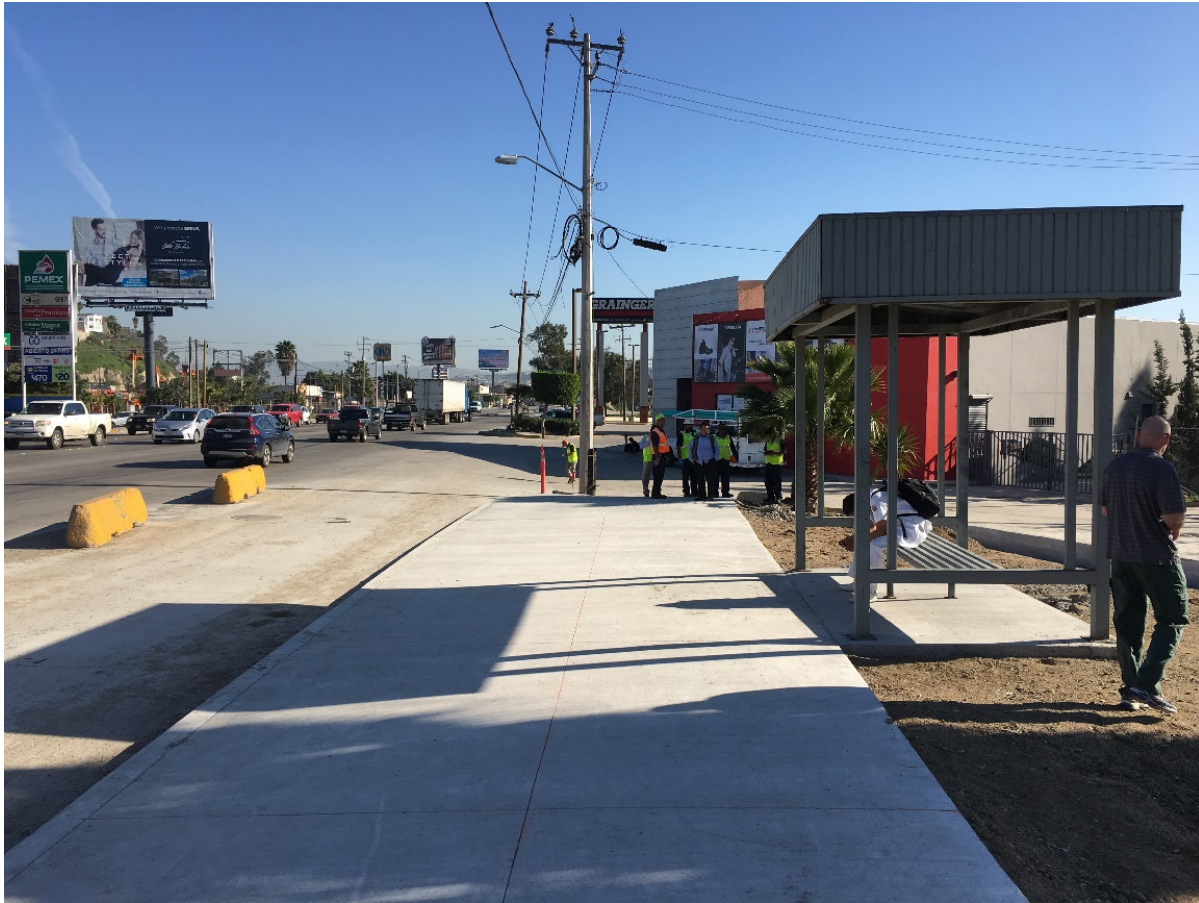
*Figure 11 Final repairs to road and bus stop and location of Insurgentes/Oriente collector repair- - Blvd Lazaro Cardenas, Colonia Los Pirules, Tijuana, B.C. - March 9, 2017*

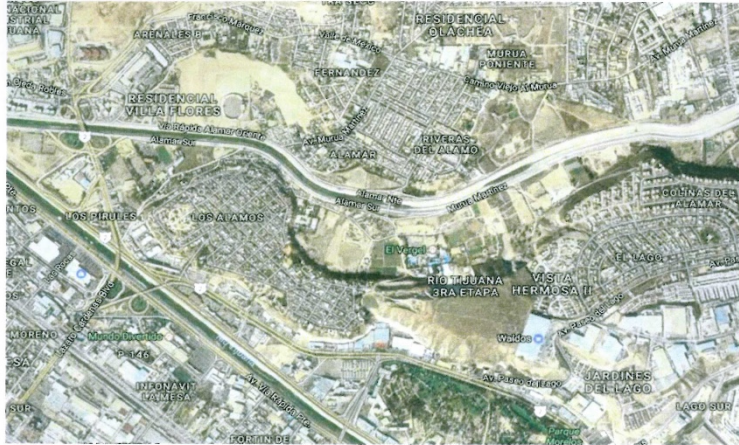
**Colector Insurgentes**

<p>EL 17 DE ENERO, COMO PARTE DE LOS TRABAJOS PRELIMINARES A LA REPOSICION DE LA TUBERIA COLAPSADA DEL COLECTOR INSURGENTES, SE INSTALO BY-PASS DE PCV DE 6" PARA ENCAUZAR EL FLUJO REMANENTE HACIA EL INTERCEPTOR ORIENTE</p>

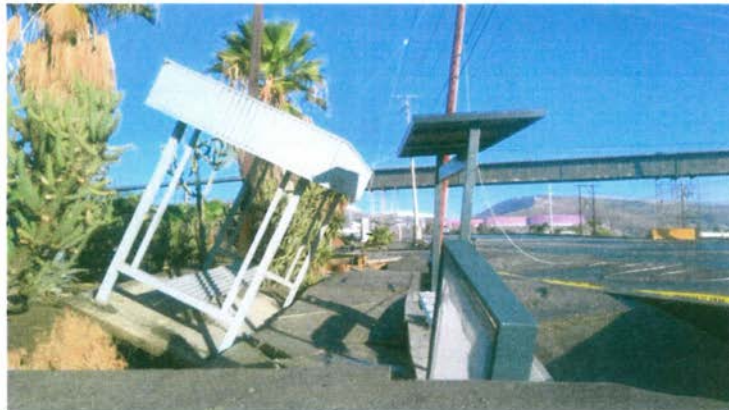
### ANTES DEL INICIO DE LA OBRA

Este fue un evento extraordinario, generado por la saturación del colector con agua de lluvia, debido principalmente a las tormentas atípicas en la zona, lo que provocó que la tubería de concreto (ya con vida útil avanzada) trabajara a presión, lo cual dañó en los costados. La tubería fallada tendió a compactarse, reduciendo su área hidráulica e iniciando el arrastre de sólidos del relleno.
