Subject: Notice of Violation, City of San Diego Construction Oversight Program, NPDES Order No. R9-2007-0001

NOTICE OF VIOLATION No. R9-2011-0027

FACILITY INSPECTION REPORT

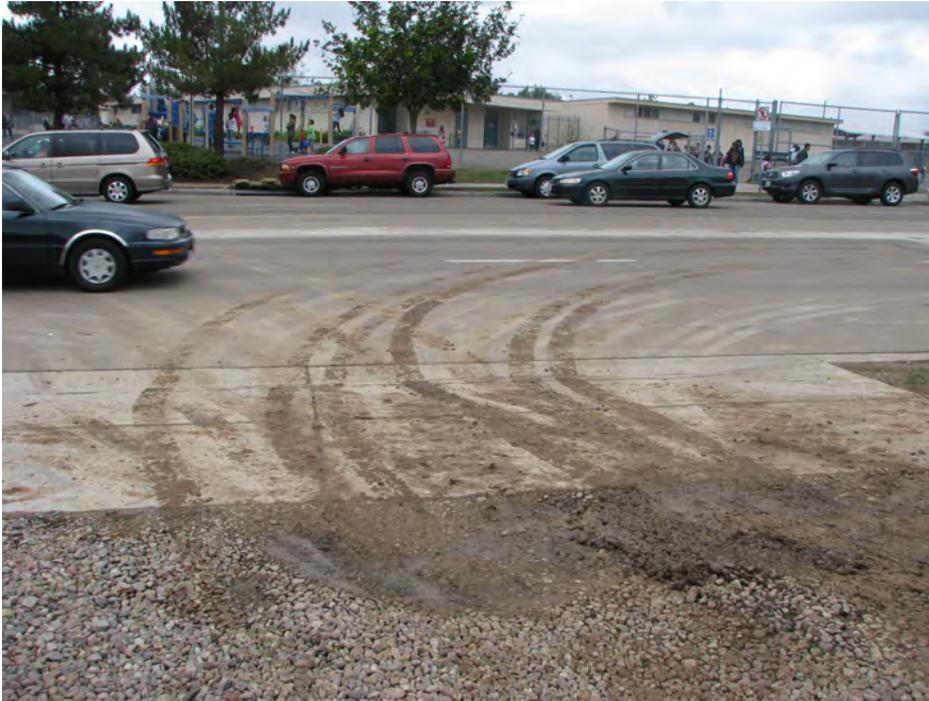
Figure 1. Construction site entrance

1. The entire site lacked adequate erosion control BMPs including several slopes susceptible to discharge (Figures 3, 4, 6).
2. Inadequate entrance/exit BMPs that have not been maintained (Figure 1).
3. A shopping cart was found in the middle of the desilting basin (Figure 2).
4. Lack of adequate sediment control BMPs have resulted in the discharge of sediment onto the side walk, street, and into storm drains (Figures 1, 5, 7).
5. Temporary stockpiles, disturbed sediment, and chemical dust were found uncovered and close to the sidewalk (Figures 4, 6).
6. Sediment-laden water was being pumped from the construction site and discharged illegally into a storm drain (Figures 8-12). During the inspection, Christina Arias notified Rod Fink of Garden Communities to immediately cease the discharge.

Note sediment on street. Gravel BMP in poor condition and in need of maintenance.

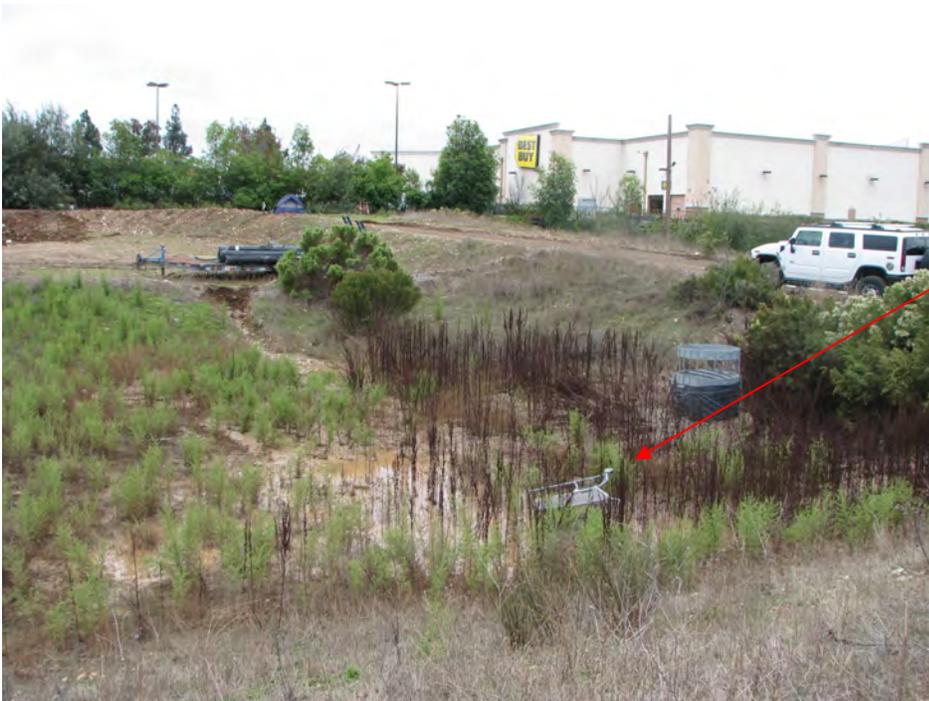
Figure 2. Desilting basin inside project boundaries

Shopping cart in desilting basin should be removed.

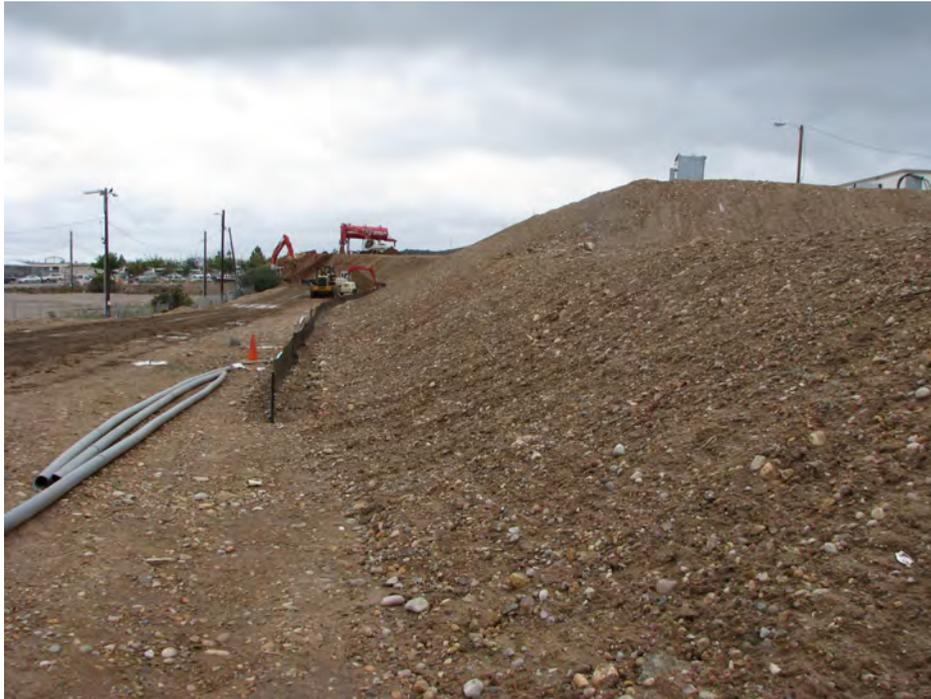
Figure 3. Uncovered slope (inside property)

Erosion control measures must be applied to slopes.

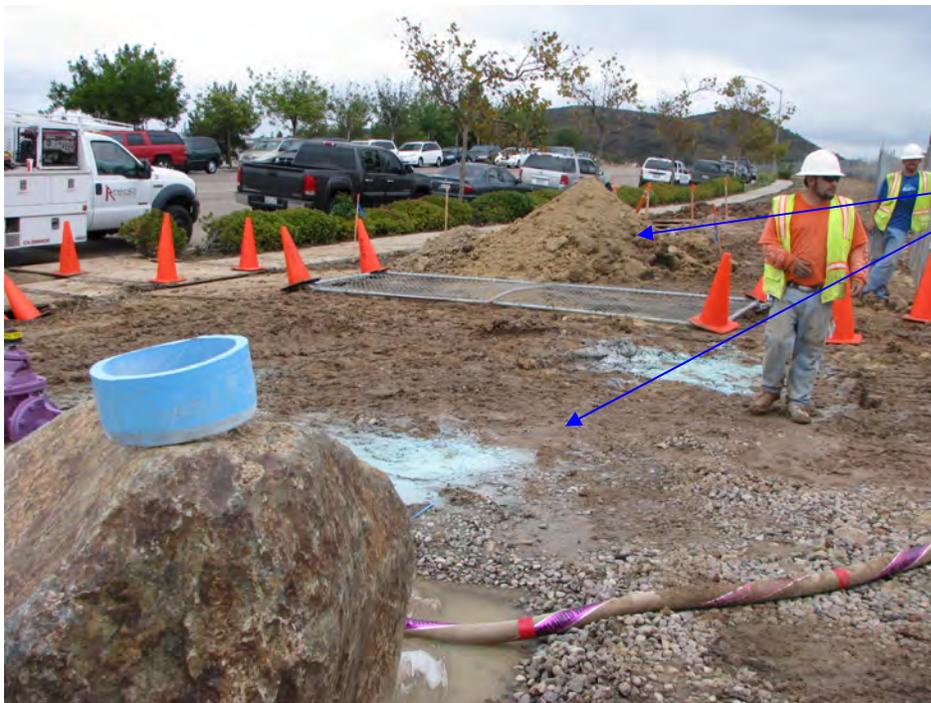
Figure 4. Project site at street level

Note uncovered stockpile and blue dust from pipe cutting

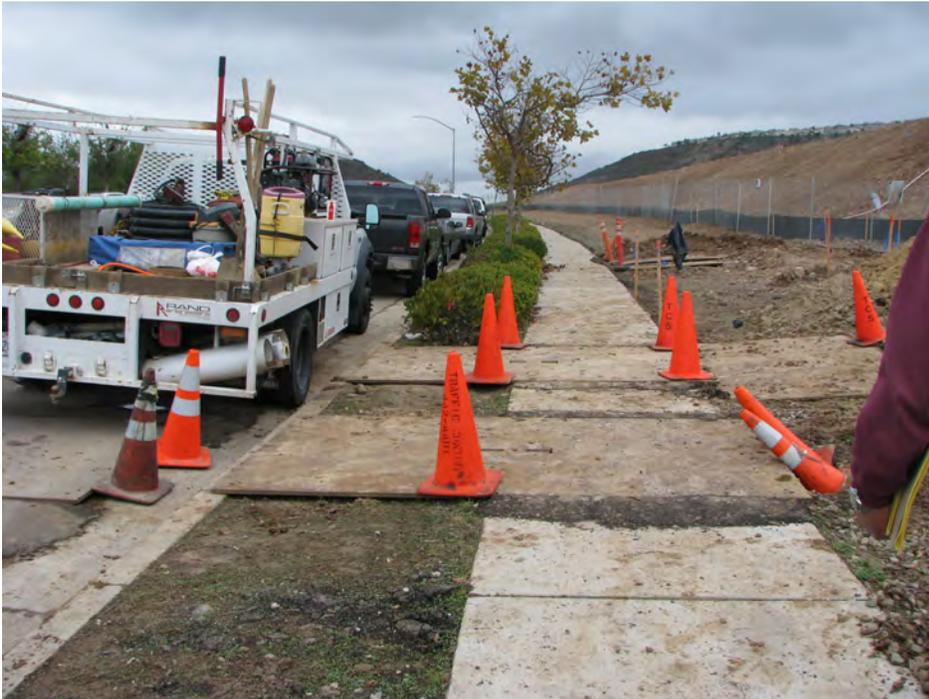
Figure 5. Sidewalk adjacent to project site

Project sediment is on sidewalk and street.

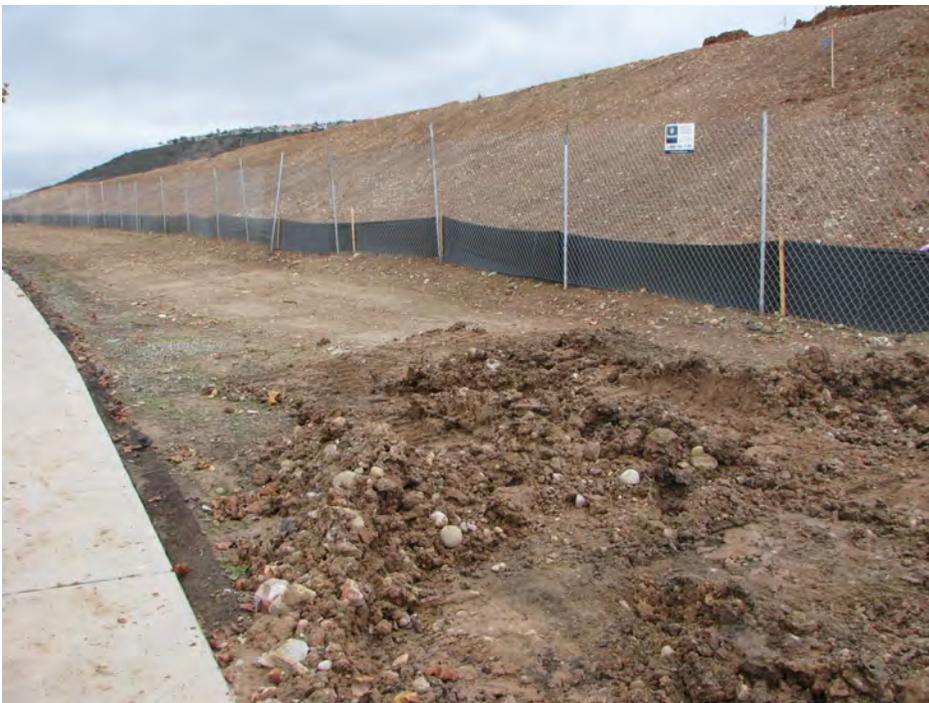
Figure 6. Slope and project material at perimeter

Slopes on West side (perimeter) of site have no erosion control BMPs. Also, disturbed sediment near sidewalk should be covered or removed.

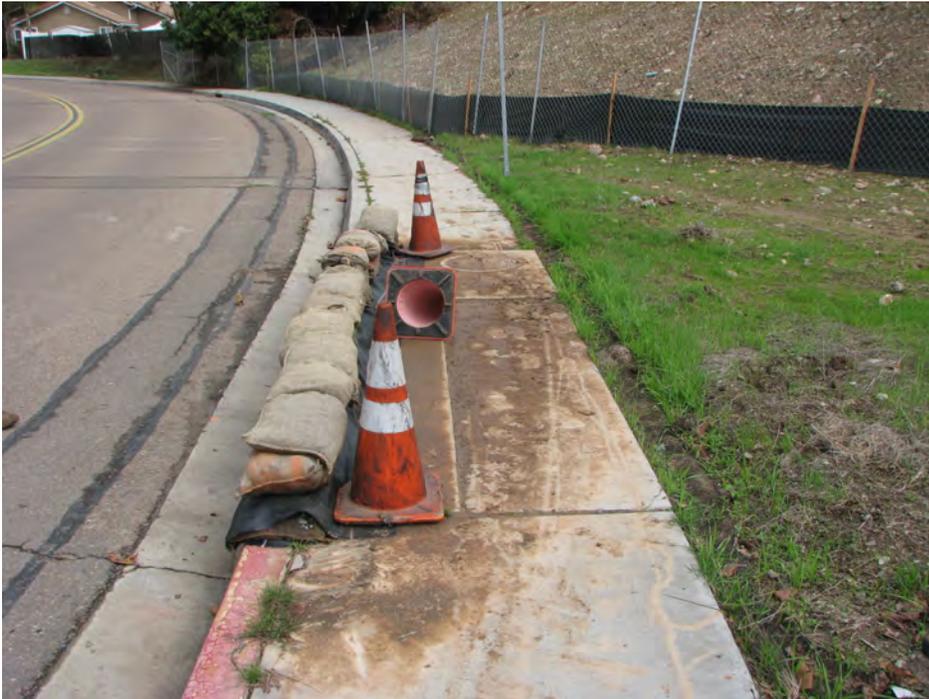
Figure 7. Storm drain inlet at North side of property

Area near storm drain inlet should be swept.

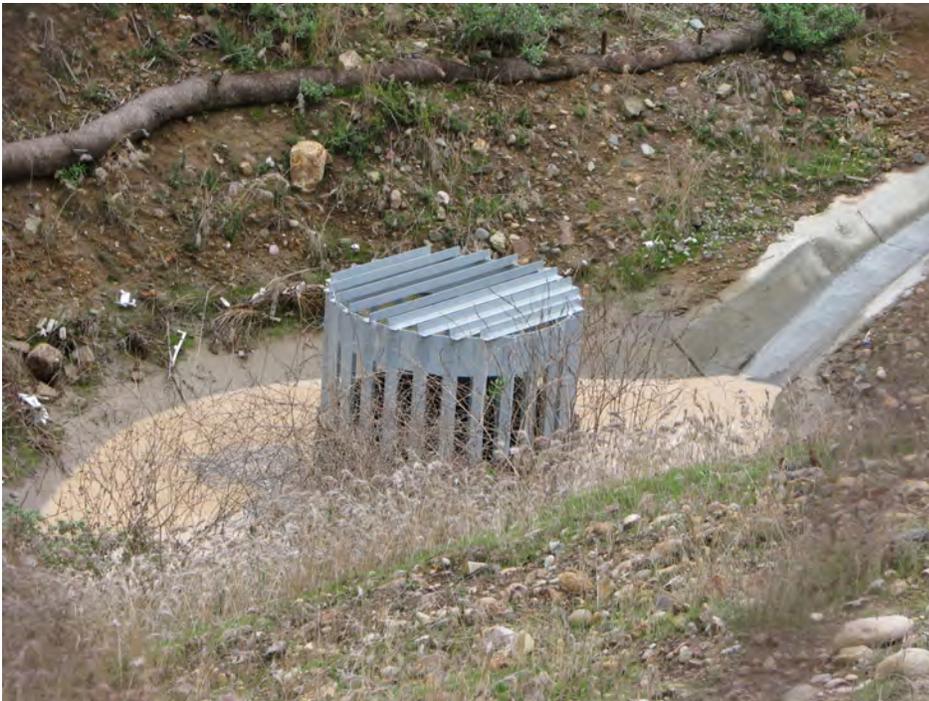
Figure 8. Storm drain on Caltrans right of way (East side project boundary)

Riser pipe is wrapped with filter fabric. Note turbid water surrounding pipe entering via concrete swale.

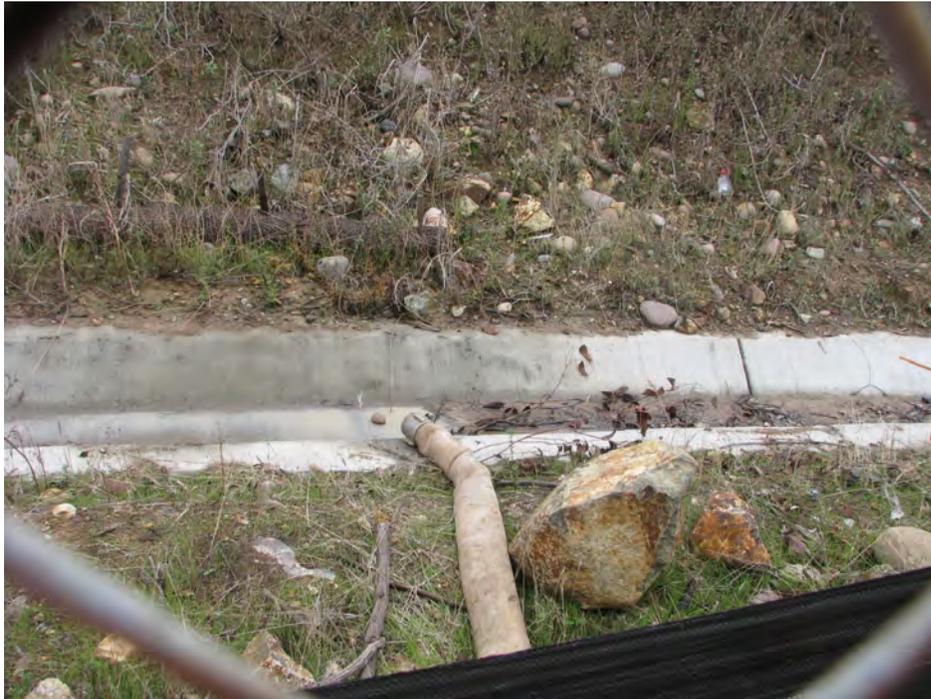
Figure 9. Outlet pipe of illegal discharge

Source of turbid water is illegal discharge from project site.

1. Prevent additional illegal pumping of sediment laden water into the storm drains. The illegal discharge observed during the inspection must be formally reported to the San Diego Water Board and Legally Responsible Person within 30 days (see SWPPP page 1-3).
2. Implement erosion control BMPs site-wide immediately.
3. Implement additional sediment control BMPs site-wide to prevent additional discharges of sediment. Site entrance/exit BMPs must be maintained.
4. Sediment from the construction site must be removed regularly from the public right-of-way and streets.
5. Temporary stockpiles should be covered during rain events.
6. Chemical residue should be removed and disposed of properly.

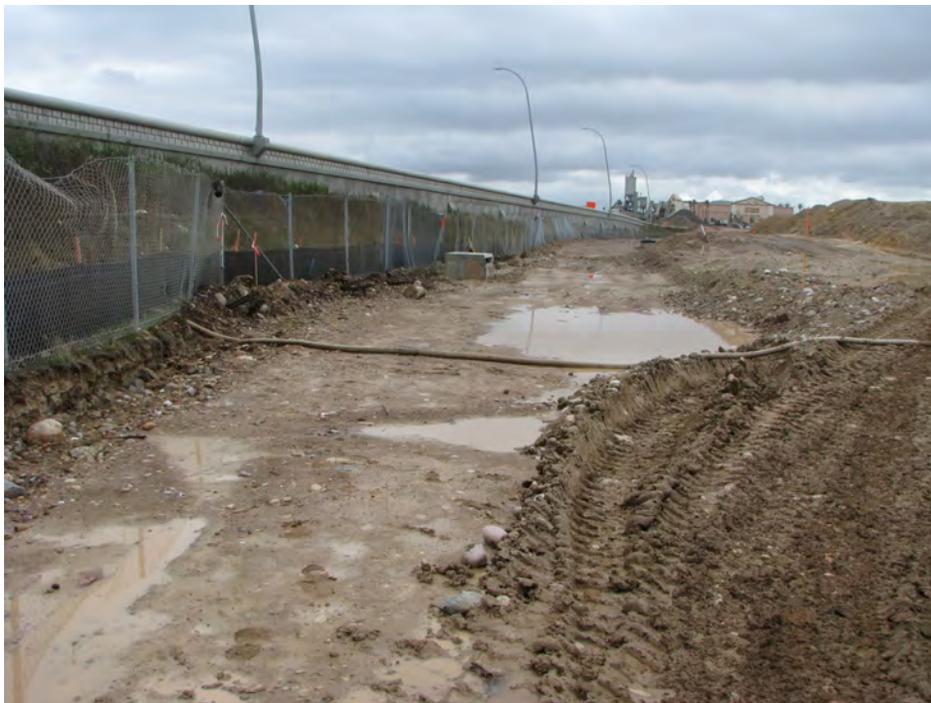
Figure 10. Pipe leading off property (from pump)

Pipe from project site was placed through chain link fence to concrete swale.

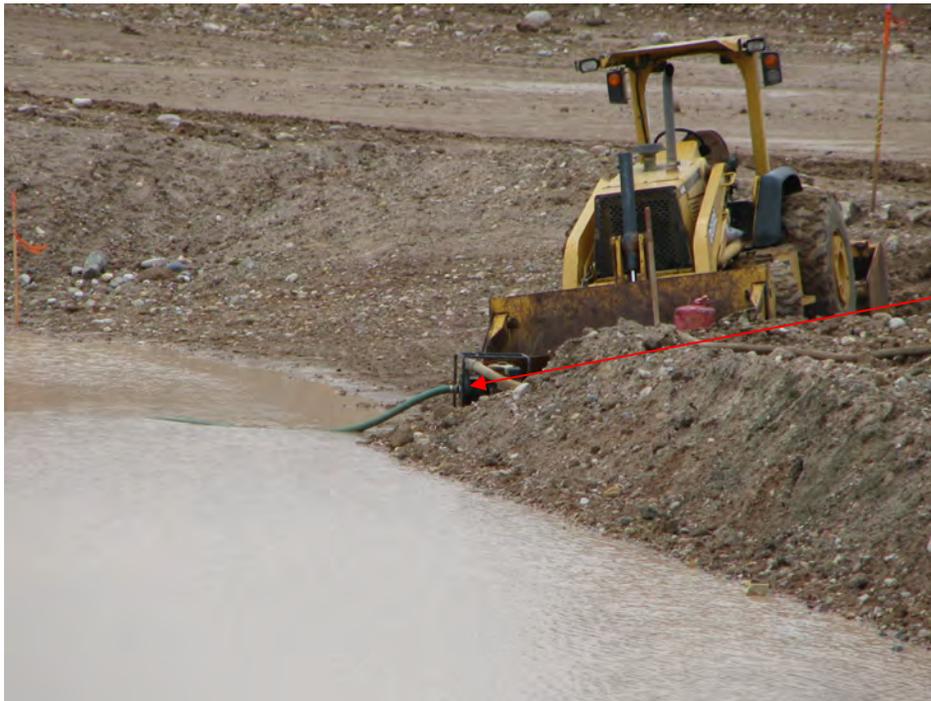
Figure 11. Pump intake

Pump intake line

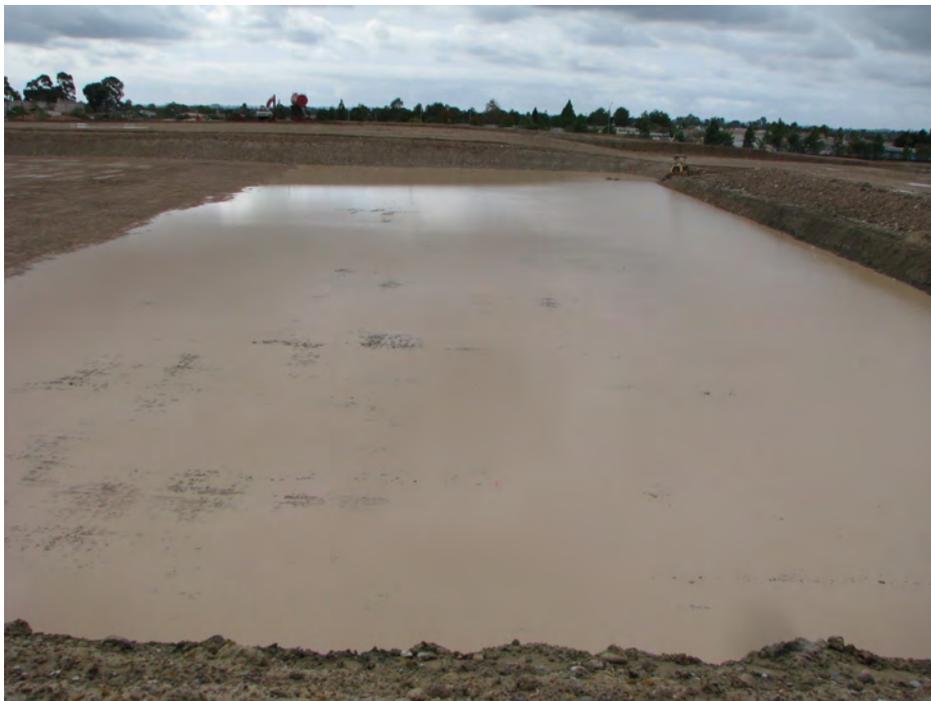
Figure 12. Dewatering area

Area of construction site being dewatered.

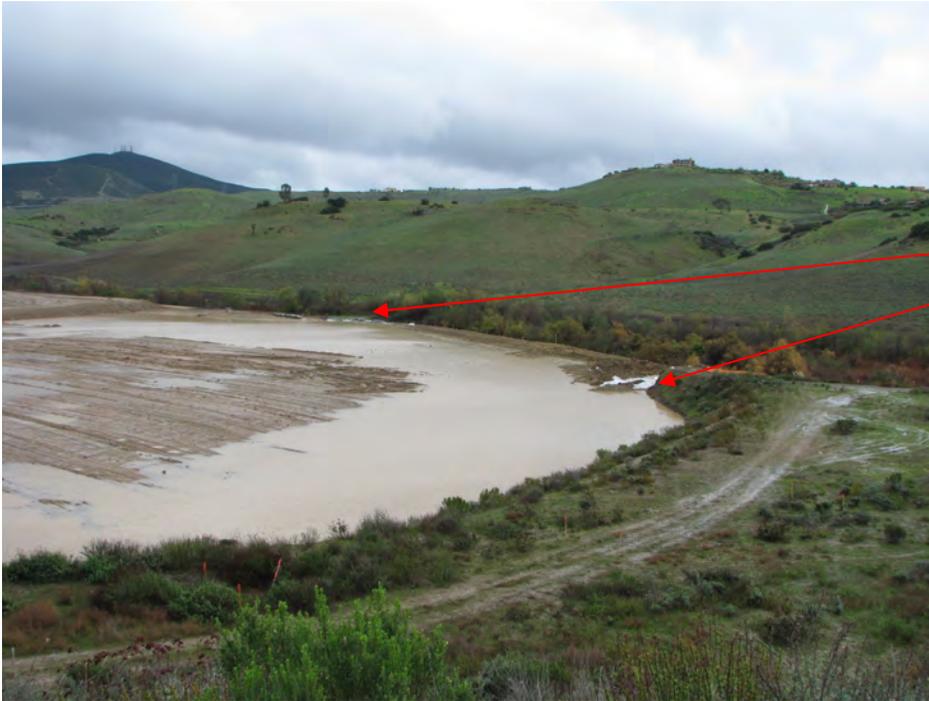
Figure 1. Construction site; looking south at Lusardi Creek

Sites of two recent breaches

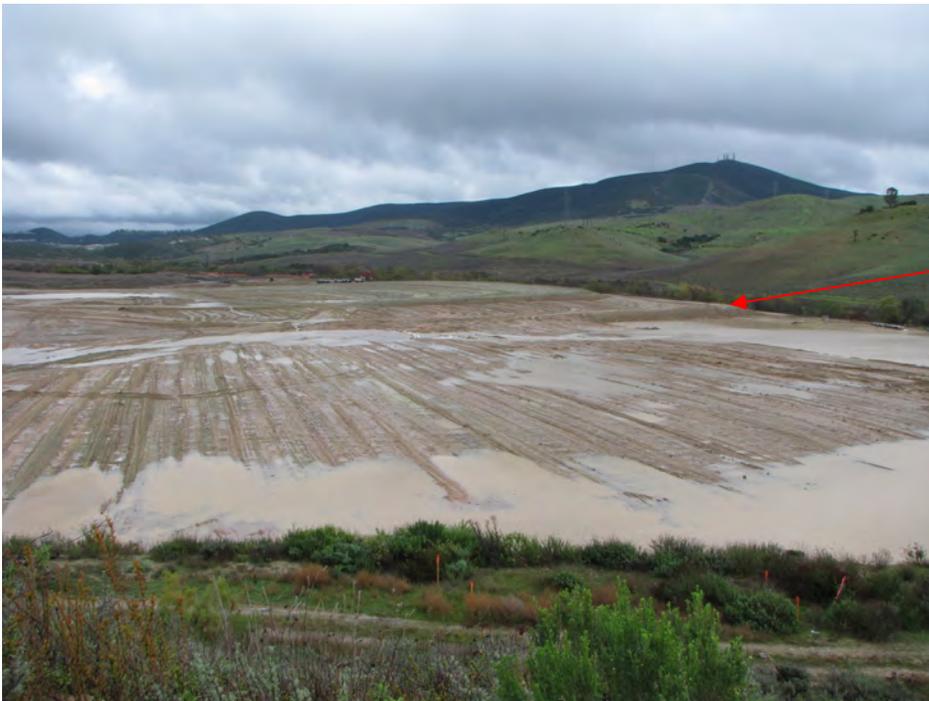
Figure 2. Construction site; looking east from Camino del Sur

Berm that will eventually be used as permanent storm water detention feature

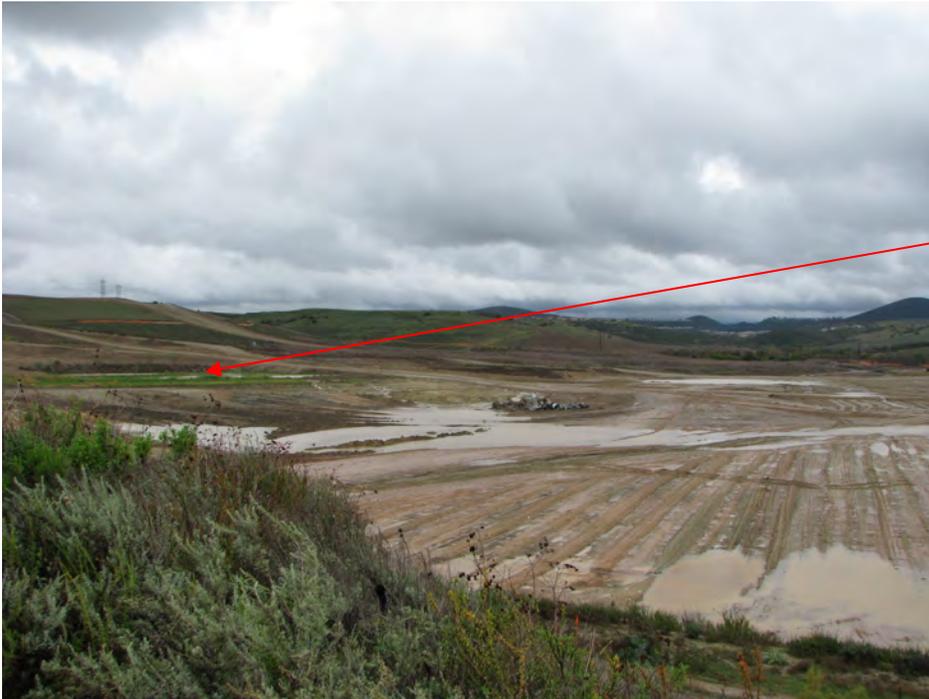
Figure 3. Construction site looking northeast

Storm water detention basin used to detain offsite run on from upstream development

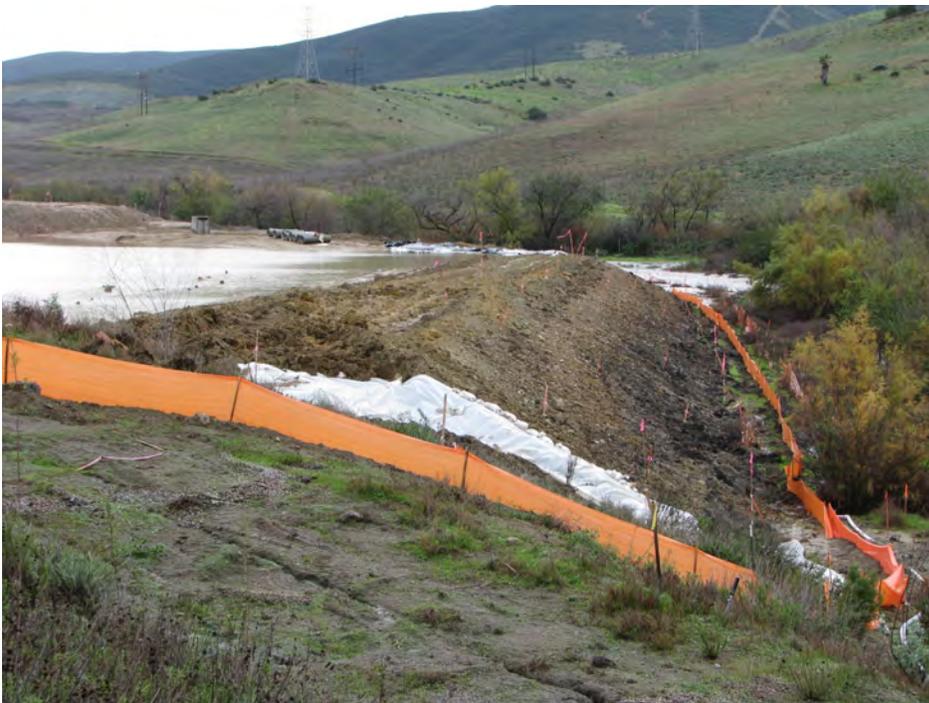
Figure 4. Berm used to detain storm water

4. The berm at the perimeter that was used to temporarily detain the storm water was overwhelmed by recent storms. Sediment-laden storm water breached the berm in at least two places and entered Lusardi Creek (Figures 4-9).

Note slopes have no erosion control

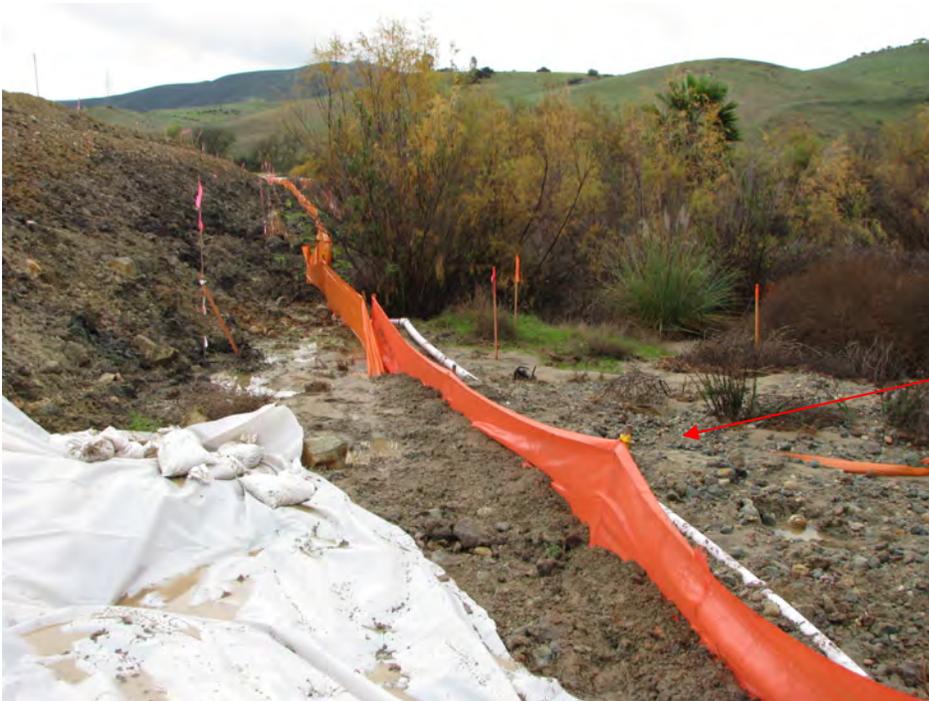
Figure 6. Foot of berm

Sediment from construction site has entered Lusardi Creek

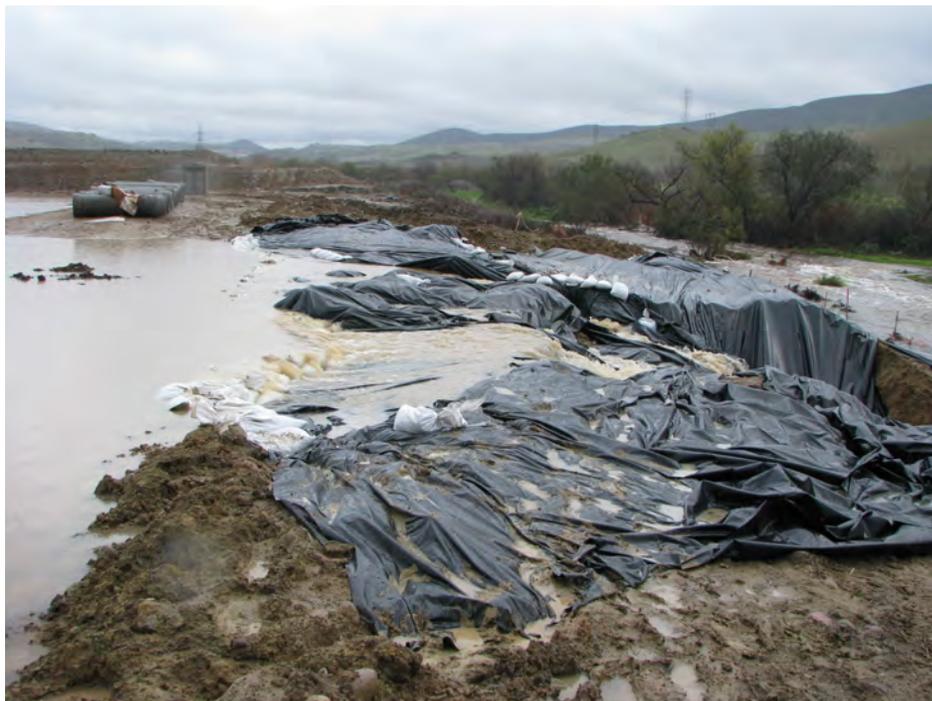
Figure 7. Location of second breach

5. The discharger placed visqueen at the locations of both breaches in order to prevent the berm from further eroding, but was ineffective.

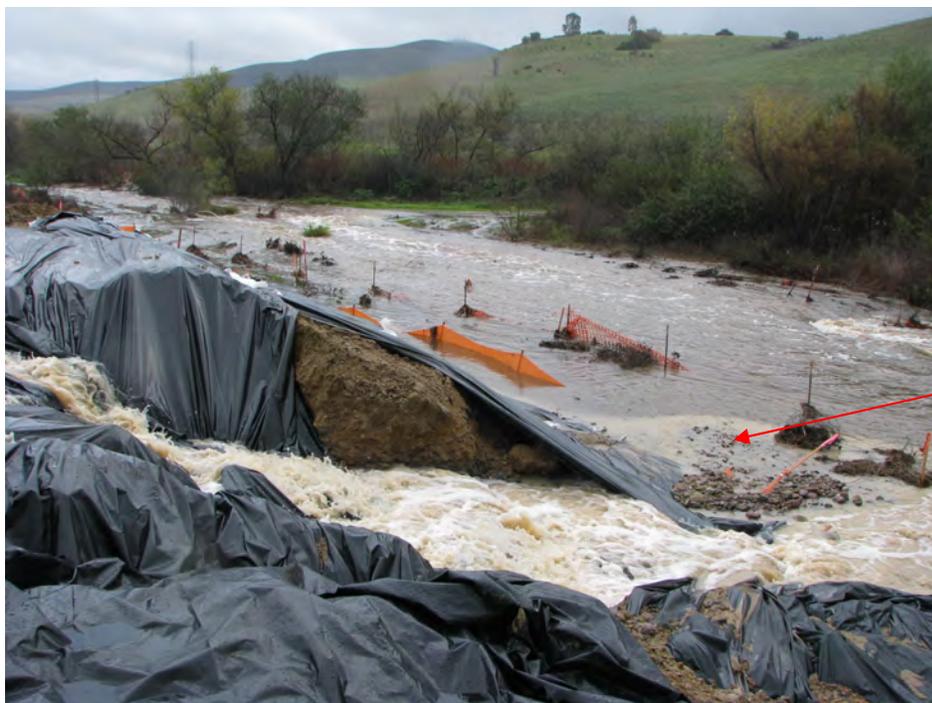
Figure 8. Construction site discharge entering Lusardi Creek

Note discoloration of storm water from site mixing with creek

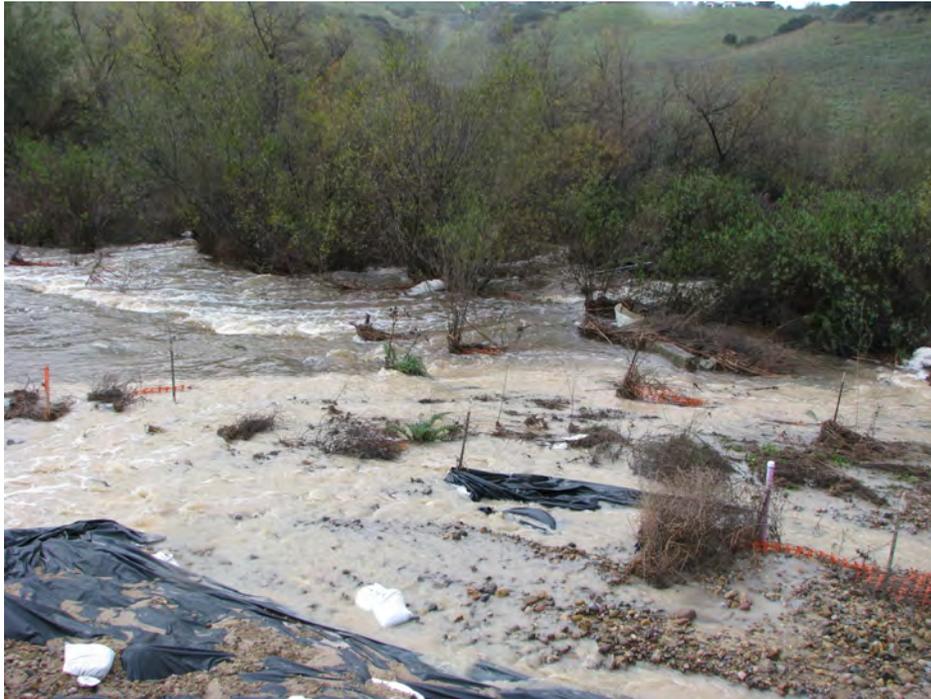
Figure 9. Construction site discharge entering Lusardi Creek

Note silt fences are underwater.
