CALIFORNIA REGIONAL WATER QUALITY CONTROL BOARD - SAN DIEGO REGION  
WATERSHED MANAGEMENT PROGRAM

FACILITY INSPECTION REPORT

INSPECTION DATE: November 27, 2007 TIME: 9 am WDID: 937C322900

Sprinter Rail Project  
FACILITY OR DEVELOPER NAME (if different from owner)

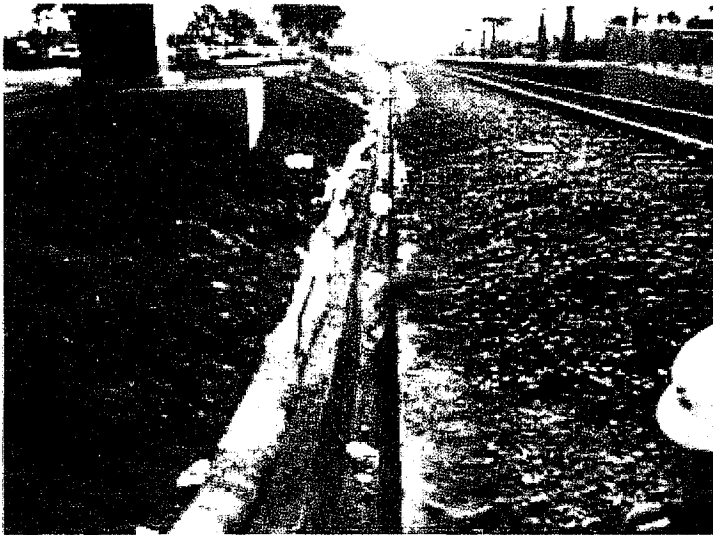
1. Drainage ditch with a significant amount of trash and sediment. No erosion controls on slope.

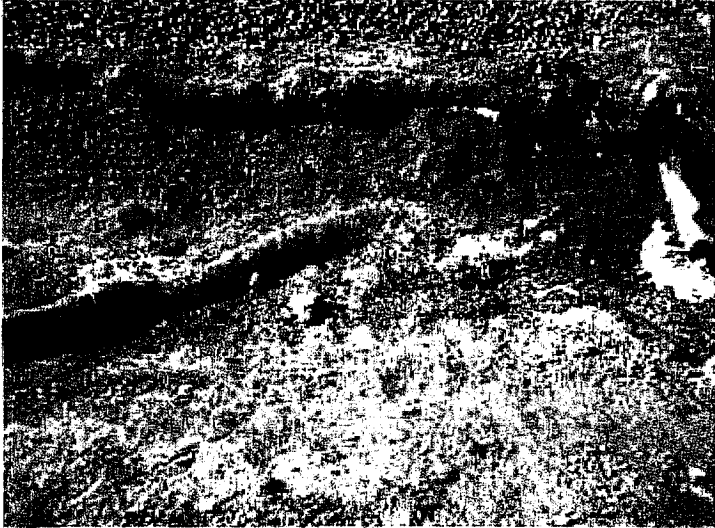
4. Fiber rolls on slopes out of place due to not being adequately staked in and trenched in.

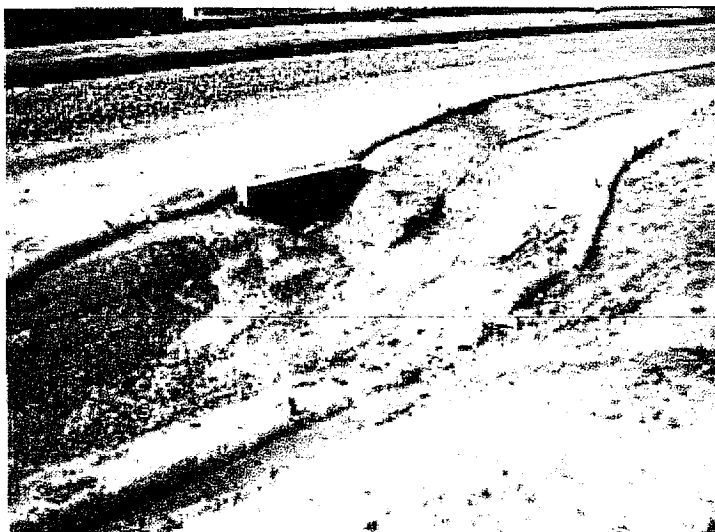
6. No erosion controls on slopes. Inadequate inlet protection. Fiber rolls not trenched in. Dirt channel needs protection.

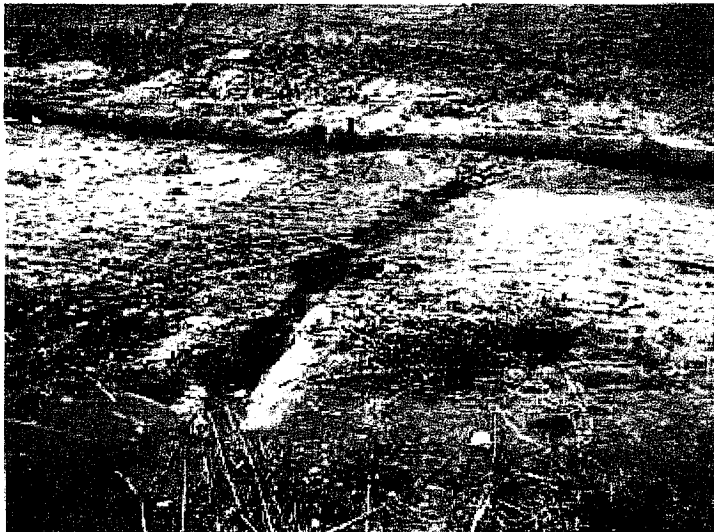
8. Gully formed below a storm water outfall – no erosion controls.

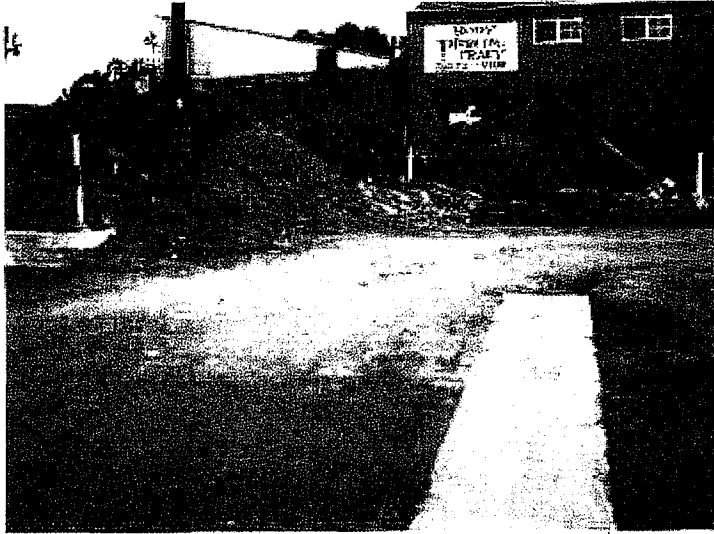
10. Sediment tracking on pavement and soil stockpile without erosion and sediment controls.

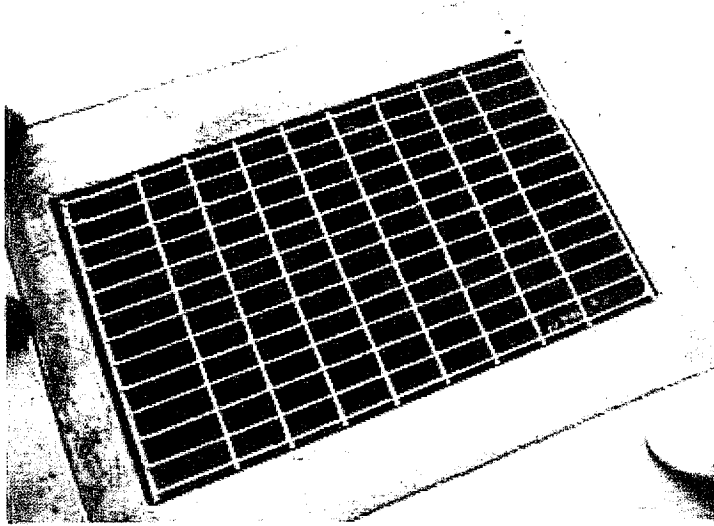
11. Storm drain inlet lacking inlet protection.

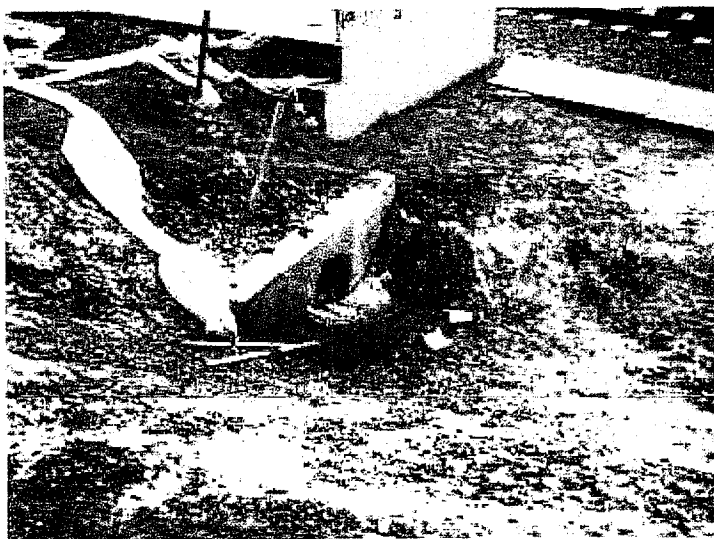
12. Inadequate inlet protection in an area with unstabilized slopes.

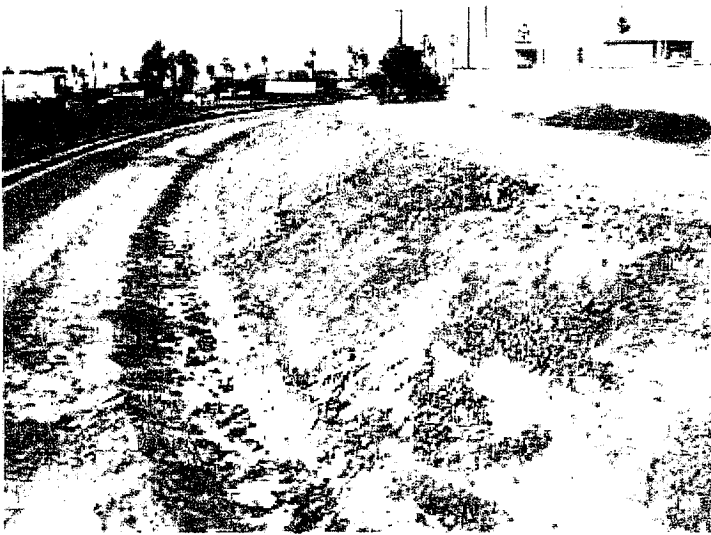
13. Exposed slopes with no erosion controls or sediment controls.

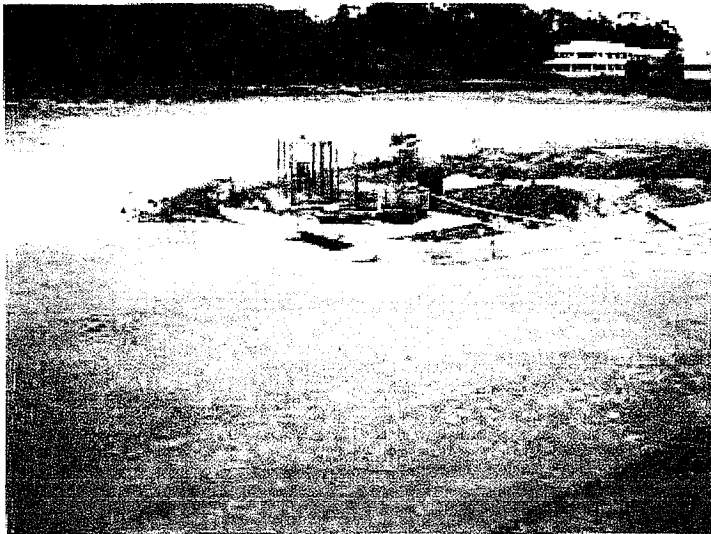
14. Lack of sediment controls at curbs and incomplete inlet protection.

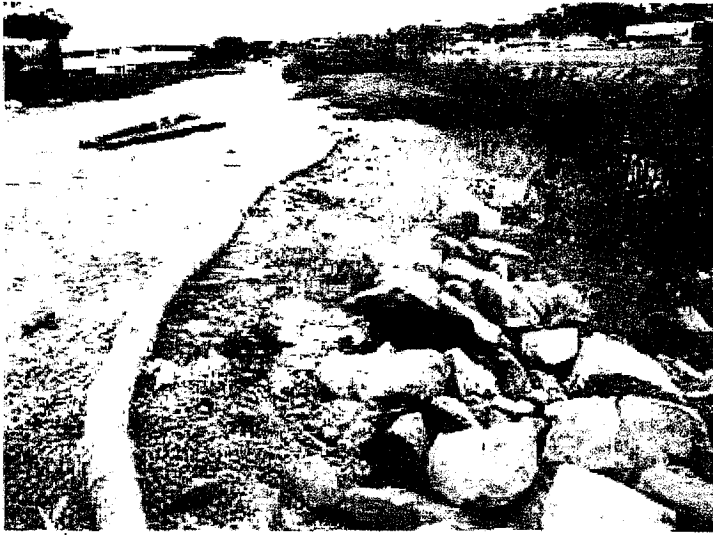
16. Fiber roll not properly  
trenched in.

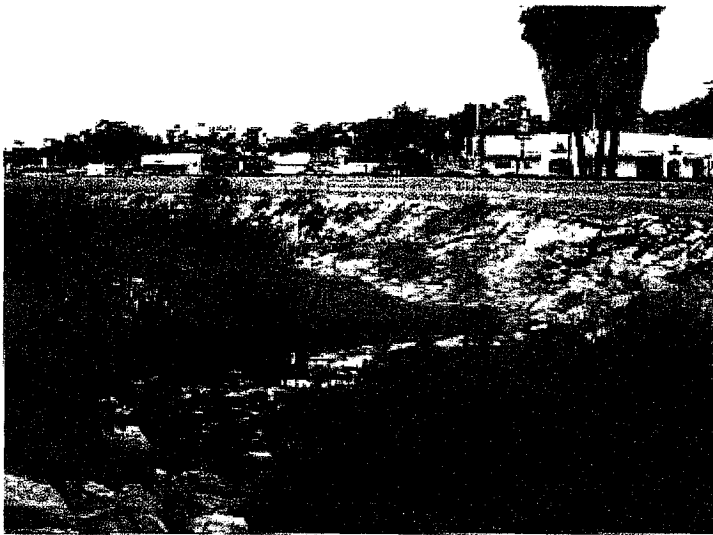
17. No erosion or sediment  
controls on slopes.

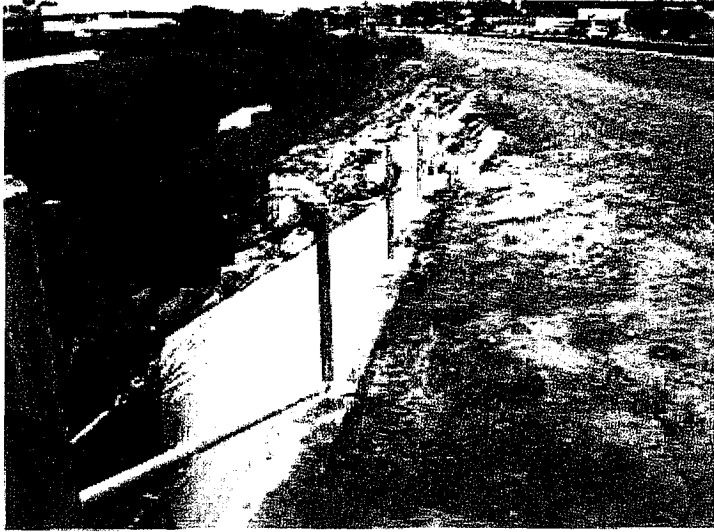
19. No erosion or sediment control along Loma Alta Creek.

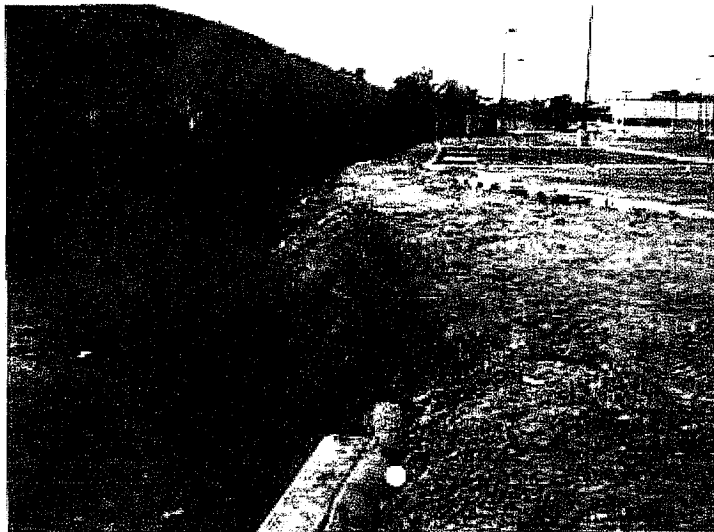
20. Lack of erosion and sediment controls for exposed soil.

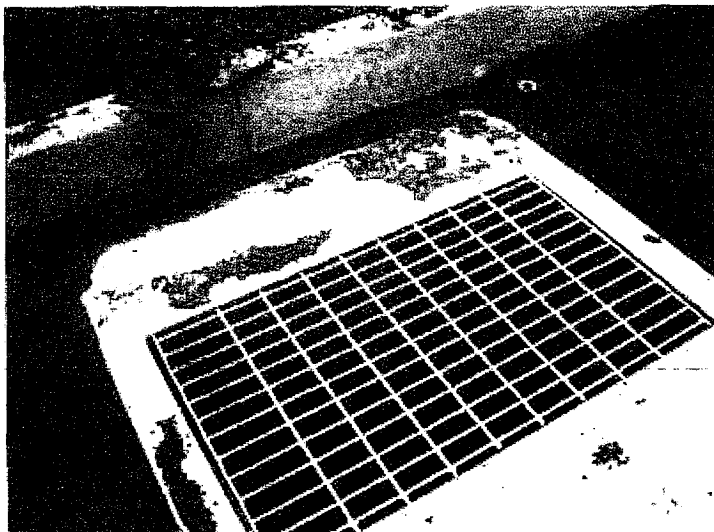
21. No inlet protection.

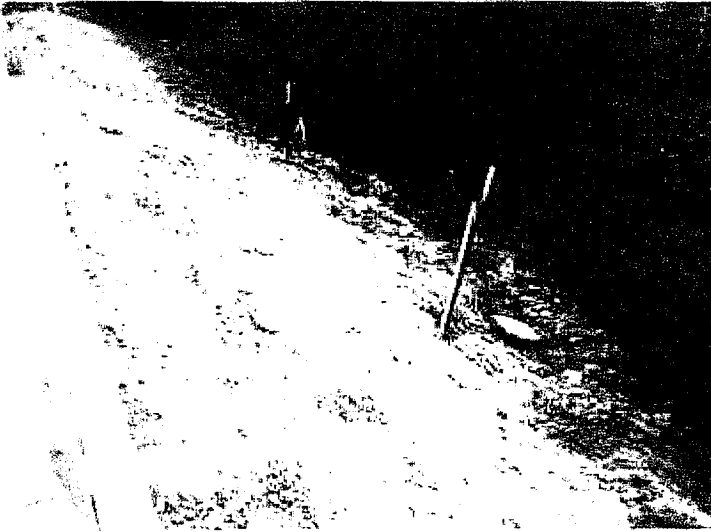
22. No erosion or sediment controls on steep slopes along Loma Alta Creek.

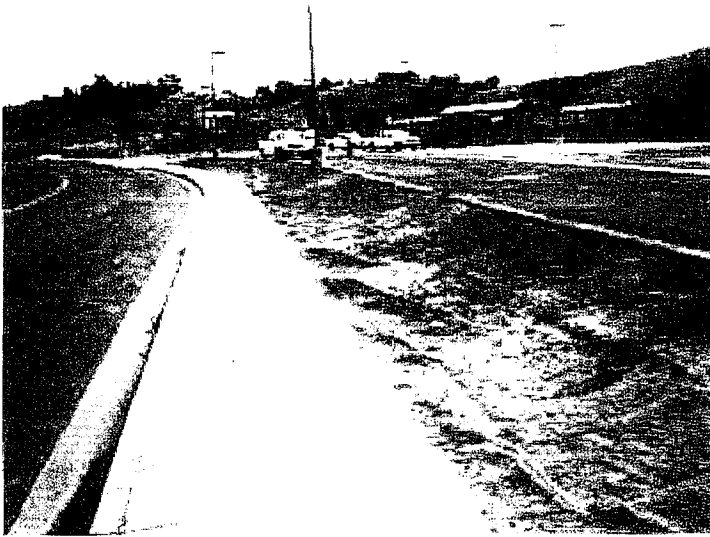
25. No erosion or sediment controls.

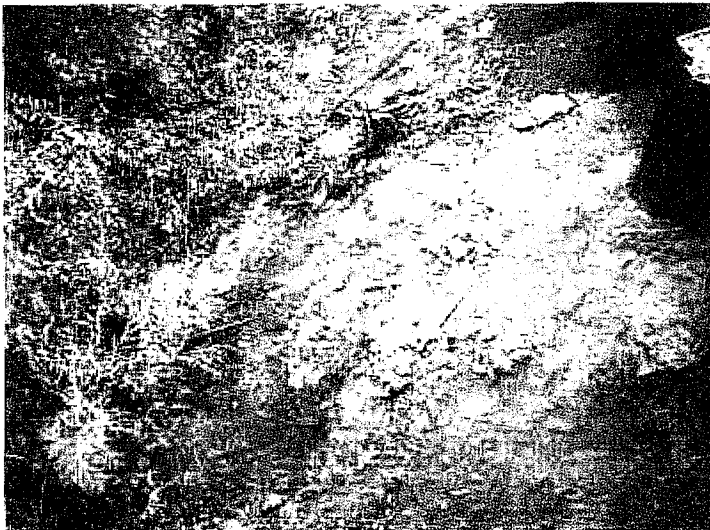
26. No erosion or sediment controls on north-facing slope next to station.

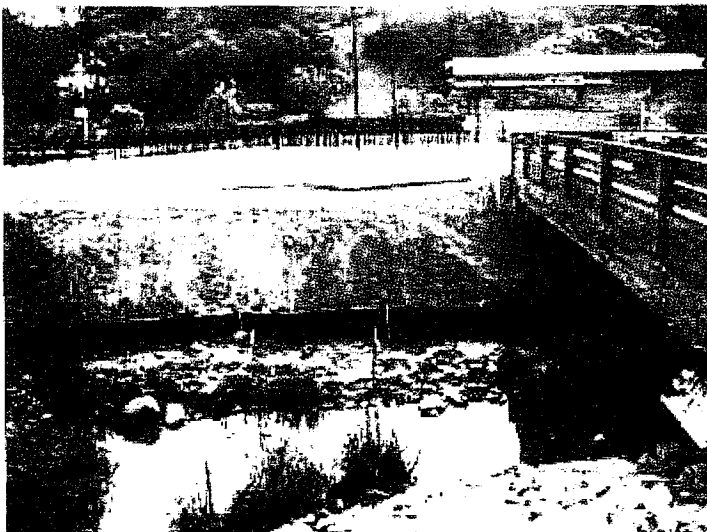
**5. Rancho Del Oro Station in Oceanside** - This station is bordered by Rancho del Oro Road to the east. Loma Alta Creek runs through the north side of the station. A pedestrian bridge is being built over the creek to access the station. A silt fence was installed in Loma Alta Creek where it will not prevent impacts to the creek (since it will only attenuate sediment that has already reached the bed of the creek) and the slopes above the creek were without erosion controls (Photo 27). Note that these violations were cited in the October 5, 2007 inspection report (and NOV No. R9-2007-0208) and still have not been corrected.

27. Silt fence improperly installed in Loma Alta Creek. No erosion controls on south-facing slope. Same violations noted in NOV No. R9-2007-0208.

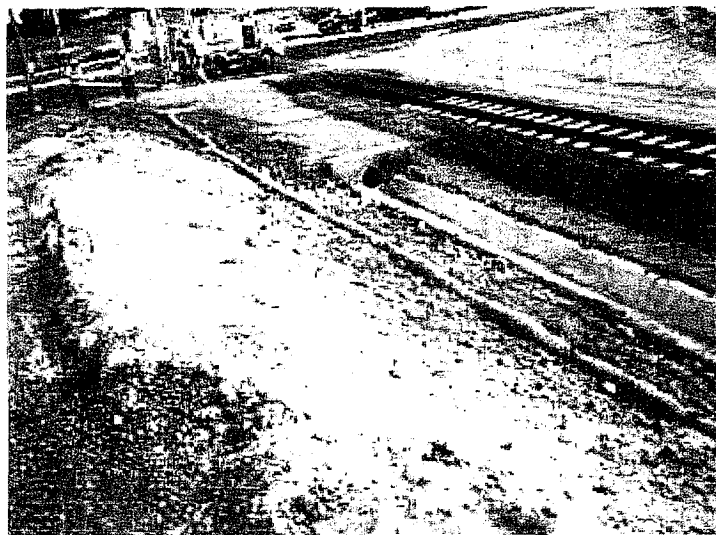
29. No erosion controls on north-facing slope.

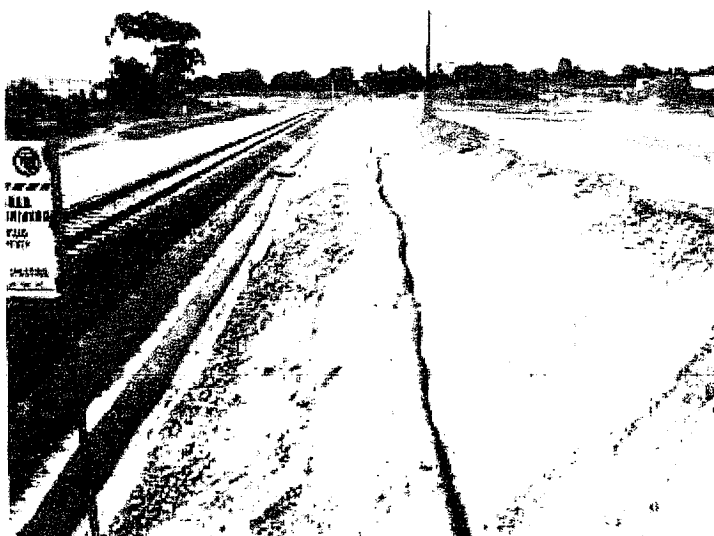
30. North-facing slope – looking to the east. Large area left without hydroseed.

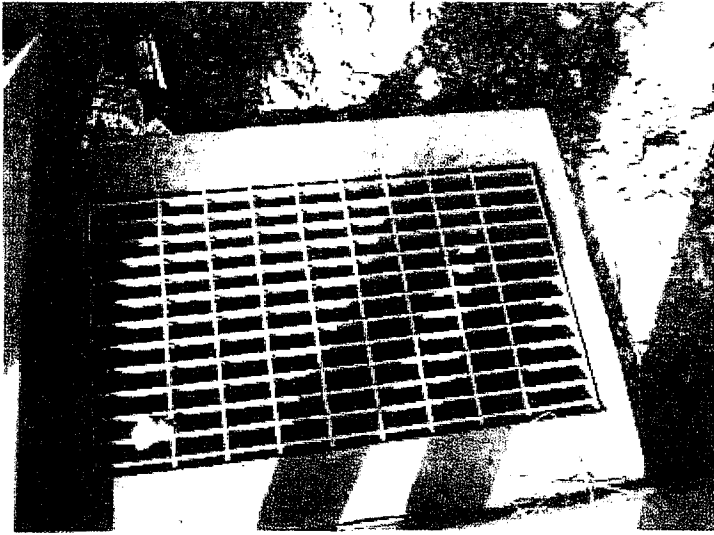
31. No inlet protection in area still under construction.

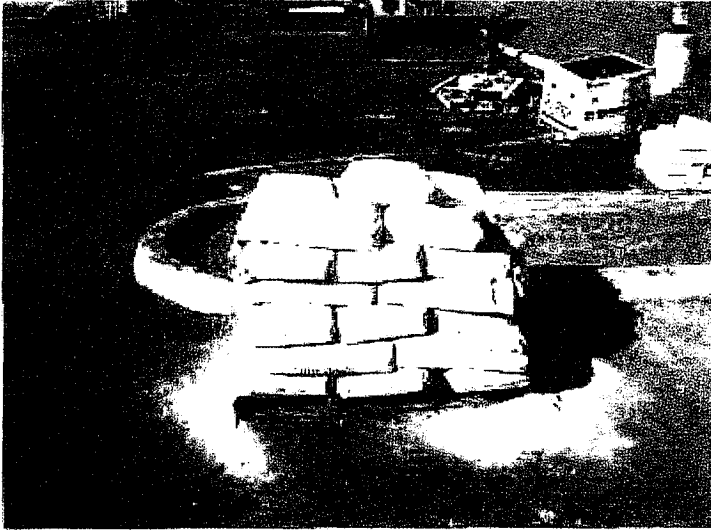
34. Cement mix spilled in parking area.

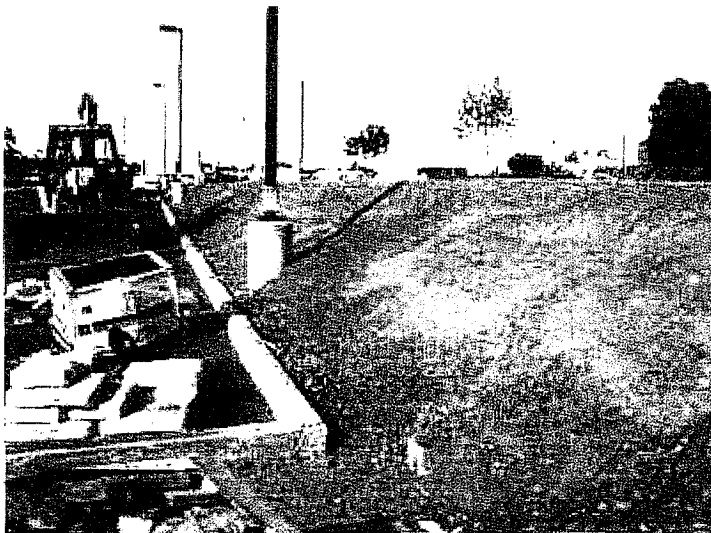
35. No sediment or erosion controls on slopes surrounding the parking lot.

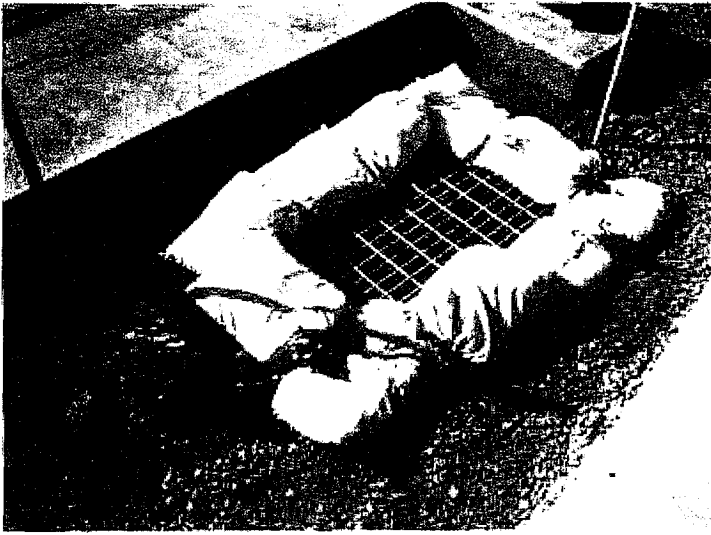
37. Properly installed gravel bags.

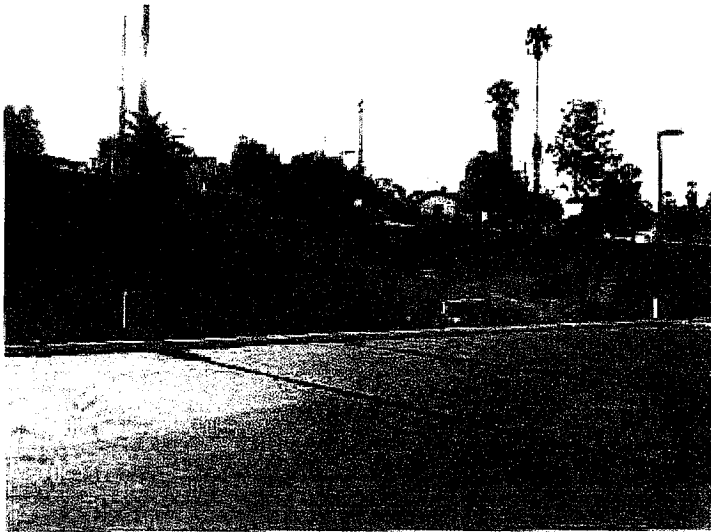
38. No erosion or sediment controls on slopes.

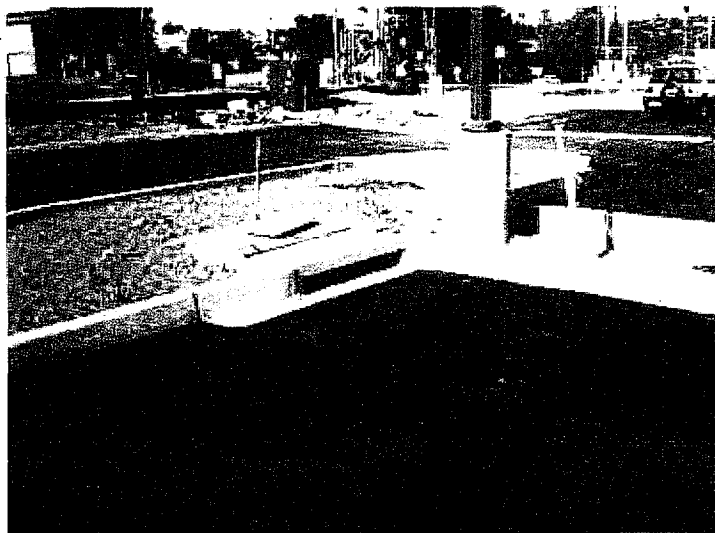
- 9. **Escondido Avenue Station in Vista.** This station is located at the intersection of Escondido Avenue and Phillips Street. Dirt slopes surrounding the parking lot had no erosion or sediment controls (Photo 38). Gravel bags outside a storm drain inlet were not stacked high enough to adequately protect the inlet (Photo 39). In addition, the channel leading to this inlet lacked any stabilization. An inlet in the parking lot was covered with filter fabric, but did not have sufficient sediment controls (e.g. gravel bags) to prevent clogging by sediment (Photo 40). Another storm drain inlet in the parking lot had no inlet protection whatsoever (Photo 41).

41. Storm drain lacks inlet protection. Parking lot still susceptible to sediment flows.

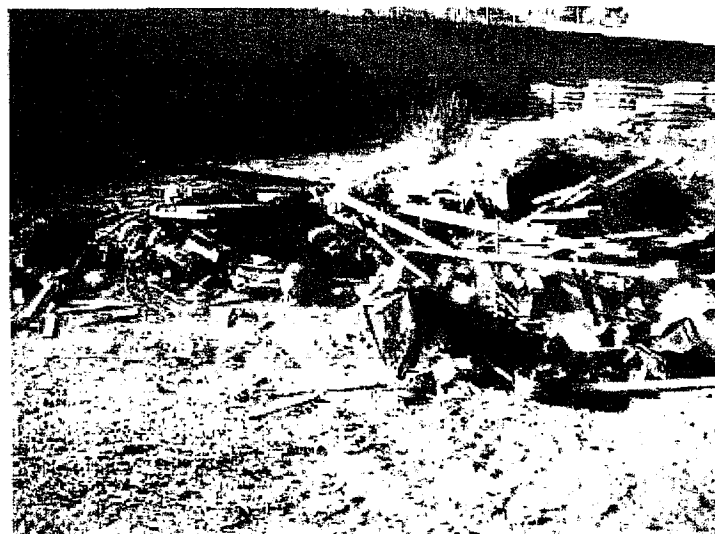
Photo 42 was taken at the Mar Vista storage yard.

- 10. **Mar Vista Drive storage yard in Vista** – This location has been cited in several prior NOV's. A persistent problem has been the lack of proper coverage and containment of construction debris that is stored at this site. Once again, a large amount of debris was laying exposed in the middle of the yard (Photo 42).

42. Construction debris not properly covered or contained. Same problem noted in February of 2007.

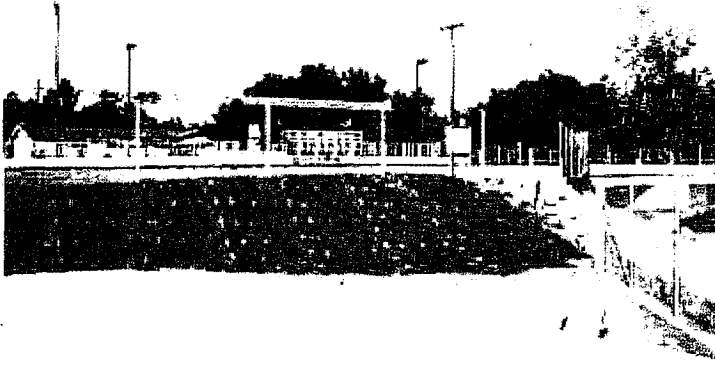
Photo 43 was taken at  
the Buena Creek Station.

- 11. **Buena Creek Station in San Diego County (Unincorporated).** This station is located at the intersection of Buena Creek Road and Santa Fe Avenue. Once again, station construction is near completion, but landscape installation has not yet begun. In this case, an effective erosion control (a coconut blanket) was being employed (Photo 43).

43. Coconut blanket provides  
effective slope stabilization.
