RE: NOTICE OF VIOLATION NO. R9-2008-0099

Subject Site:
Faraday Avenue Extension and Carlsbad Oaks
North Business Park

FACILITY INSPECTION REPORT

FACILITY: City of Carlsbad 401 Certification Compliance Review

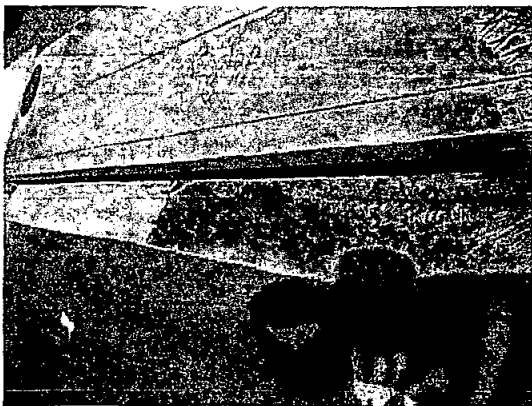
Status: Not all storm drain inlet structures were stamped and/or stenciled on 7/2/08.

Picture on left (IMG_0411.JPG): Drain inlet adjacent to "Welcome to Carlsbad" sign on the north side of Faraday Avenue.

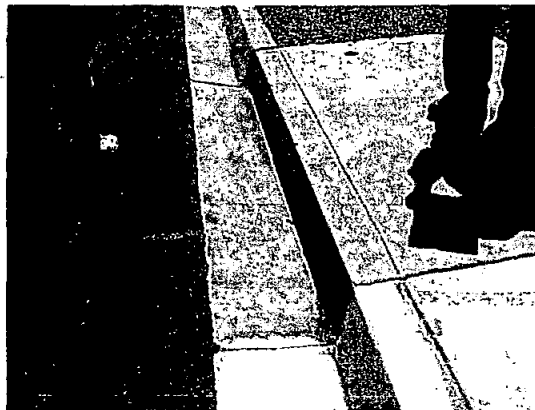
Picture on right (IMG_0481.JPG): Drain inlet west of the intersection with Brookhaven Pass, on the south side of Faraday Avenue, at the termination of the sidewalk.

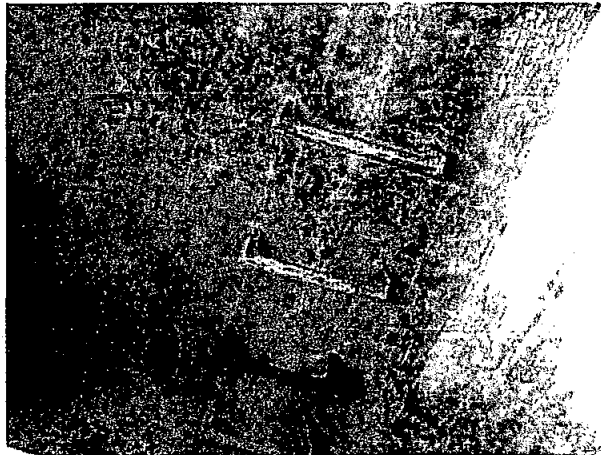
The number of storm drains proposed (7) in the Drainage Exhibit for El Fuerte Street was not the same number as actually constructed on the roadway (8). On the west side of the street there is 1 extra drain inlet. Of the 7 proposed inlets, 4 were required to have inlet filters (consisting of a basket and a boom). Only 2 baskets and 1 boom were observed along the roadway. The 2 drain inlets at the intersection with Faraday Avenue had baskets present, and only the inlet on the east side of the roadway had a boom. The 2 other drain inlets that were required to have inlet filters were missing baskets and booms. The rest of the drain inlets on El Fuerte Street, including the extra inlet did not contain a basket or a boom. No request for an amendment to the certification has been received by the Regional Board.

Picture on right (IMG_0453.JPG): Next drain inlet south on El Fuerte, on west side of the street, appears to be an additional inlet not on the Drainage Exhibit. No basket or boom present.

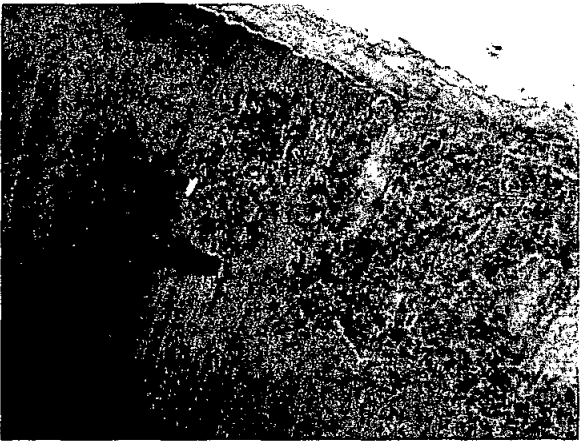
Picture on left (IMG_0459.JPG): Next drain south on the west side of the street, and last inside of the project area. This is the 2nd possible additional drain inlet, with no basket or boom.

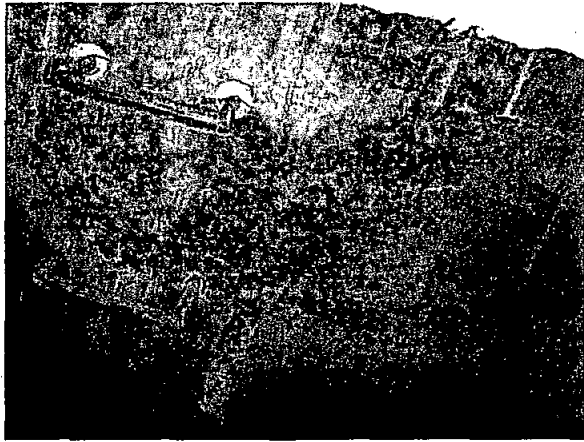
Picture on right (IMG_0461.JPG): Inside of the drain inlet at the southern end of the El Fuerte Street inside of the project area on the eastern side of the street. No basket or boom.

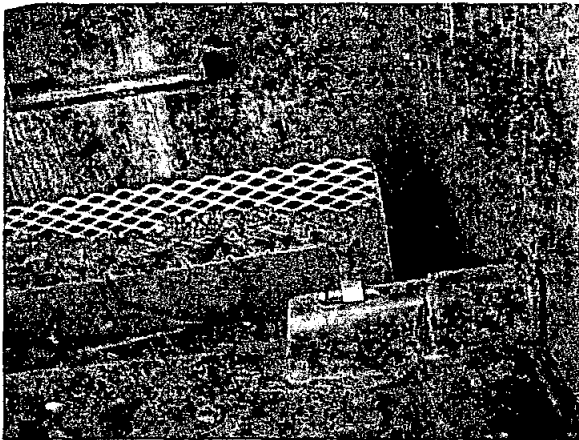
Picture on left (IMG_0469.JPG): On the eastern side of El Fuerte Street, at the intersection with Faraday Avenue. Both a basket and boom were observed in this inlet. Boom was covered by debris and sediment.

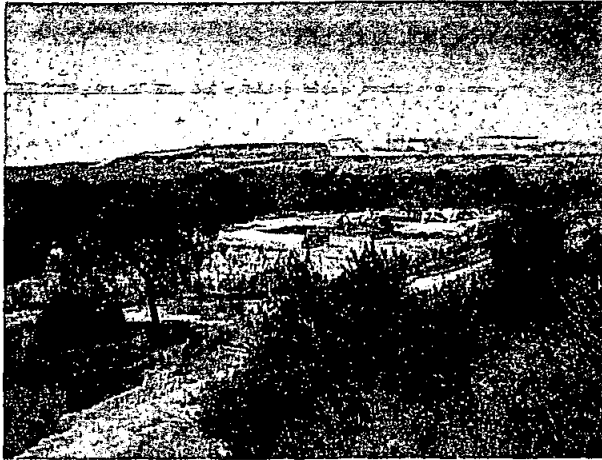
On 7/2/08 the Regional Board inspected the creation area of the mitigation site, located west of South Melrose Drive, south of Faraday Avenue extension. Visual observations indicate that the completed mitigation site, inside the orange fencing, is not the required 3.5 acres. This is further supported by the only the mitigation related report received, the *Mitigation Compliance Report for the Carlsbad Oaks North On-site Mitigation Area (No. 200200641-JMP)*, which states 3.06 acres of wetlands were created. Some work has been conducted, as plantings were observed in the southern portion of the site. Also, heavy machinery and work was observed being conducted in the mitigation area. Due to a lack of reporting, it is unknown if this work is related to the sewage spills in April 2007. Also as a result of the lack of reporting, it is unknown if the required enhancement component of mitigation has been completed. It appears that the required mitigation is not complete, and was not completed in the time required. (See the photographs on the next page.)

Picture on left (IMG_0485.JPG): Taken from the parking lot of the building at Apsen Way and S. Melrose Dr., overlooking mitigation area. Notice work being conducted in the mitigation area.

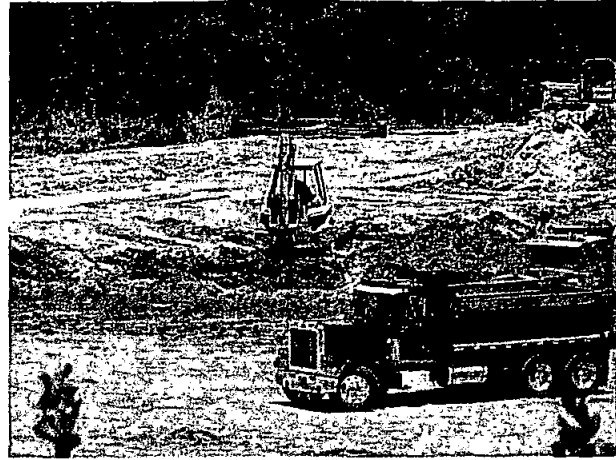
Picture on right (IMG_0486.JPG): Closer view of work being done in the mitigation area.

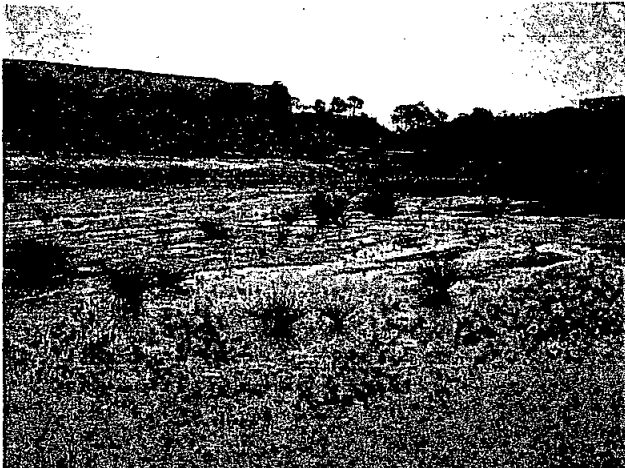
Picture on left (Photo 159, 4/3/07, Frank Durazo): Reference the lone tall tree in the background of this picture, is the same tree in the foreground of the above picture, and the picture to the right.²

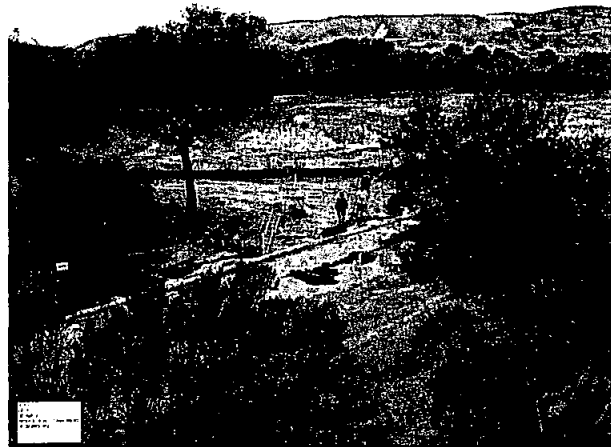
Picture on right (Photo 42, 04/07/2007 16:45, Cirilo Mariscal, Overview of the spilled sewage into the containment area): Taken from relatively the same vantage point as the above left picture.³

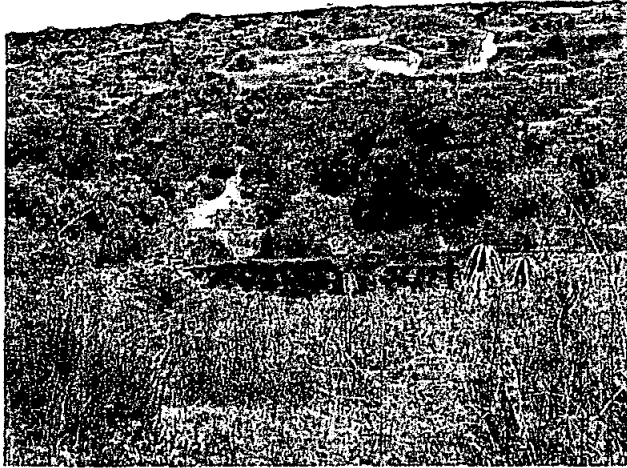
On 7/2/2008 the Regional Board inspected the proposed mitigation site at Lake Calavera. Visual observation indicated that no work has been conducted in the area as proposed in the *Draft 1 Compensatory Habitat Mitigation and Monitoring Plan*. These observations are supported by the lack of reporting as required by the 401 Certification.

Picture above (IMG_0487.JPG): Photograph of proposed enhancement area, on eastern side of northward extending finger, at Lake Calavera. Two Palm trees are visible.

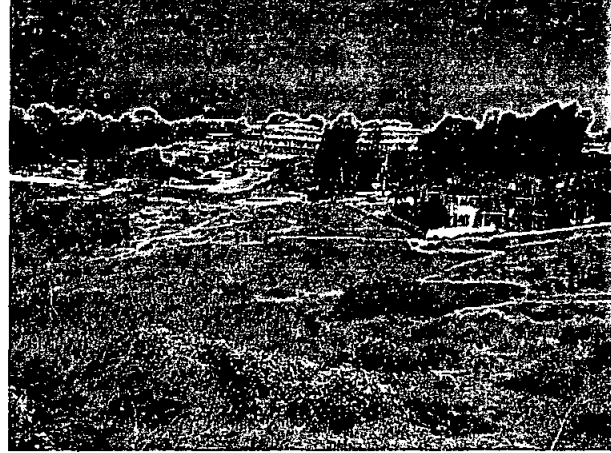
Picture on right (IMG_0508.JPG): End of Hoover Street, proposed new trail head, beginning of the new access road, and beginning of the shoreline protection wall.
