Subject: Notice of Violation No. R9-2013-0008 City of Encinitas, Hall Property Park, Order No. 2009-0009-DWR (NPDES No. CAS000002)

NOTICE OF VIOLATION No. R9-2013-0008

FACILITY INSPECTION REPORT

FACILITY: Hall Property Park, City of Encinitas Communit	y Park INSPECTION DATE/TIME: 12/17/2012; 1300
WDID/FILE NO.: 9 37C357837	
REPRESENTATIVE(S) PRESENT DURING INSPECTION	ı:
NAME: Laurie Walsh	AFFILIATION: San Diego Water Board
NAME: <u>Erik Steenblock, Storm Water Program Manager</u>	AFFILIATION: City of Encinitas
NAME: Mike Emerson, Env. Specialists	AFFILIATION: City of Encinitas
NAME: Ed Deane, Senior Civil Engineer	AFFILIATION: City of Encinitas
NAME: Larry Sobolsky, Site Forman	AFFILIATION: USS Cal Builders
NAME: David Chen, QSP	AFFILIATION: Scott Environmental Services
City of Encinitas NAME OF OWNER, AGENCY OR PARTY RESPONSIBLE FOR DISCHARGE	FACILITY OR DEVELOPER NAME (II different from owner)
505 South Vulcan, Encinitas, SD, CA 92024 OWNER MAILING ADDRESS	425 Santa Fe Drive
City of Encinitas OWNER CONTACT NAME AND PHONE #	City of Encinitas FACILITY OR DEVELOPER CONTACT NAME AND PHONE #
□ CONSTRUCTION GENERAL PERMIT □ GENERAL OR IN	NDIVIDUAL WASTE DISCHARGE REQUIREMENTS OR NPD

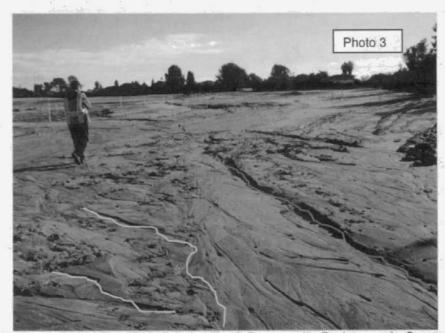
Finding 2: Erosion controls and sediment controls not in place at the site.

Photo 3: Looking uphill, over largest area of *Community Park* towards Caretta Way. Erosion and sediment controls not present on site. There are no check dams, erosion control blankets, or soil binders in place within the concentrated flow paths as specified in the SWPPP. Erosion evident by rills (a few shown in yellow) and channel incisions (a few shown in red) seen in soil on site.

- Adequate erosion control BMPs shall be implemented at the site on all slopes and other areas necessary to prevent the discharge of sediment.

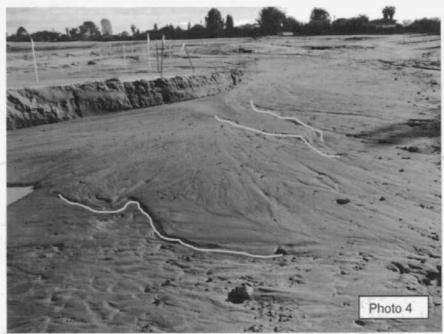
Photo 4: Erosion (rills shown by yellow lines) occurred due to lack of erosion and sediment control BMPs on site prior to the rainy season. There are no check dams, erosion control blankets, or soil binders in place within the concentrated flow paths as specified in the SWPPP.

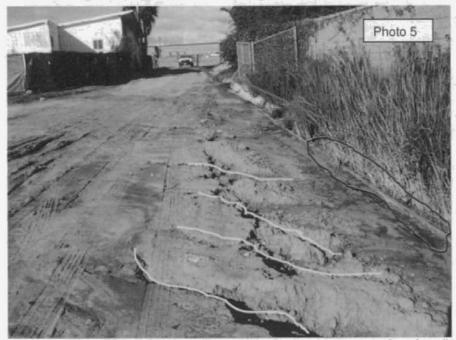
Drainage path leading to Rossini Creek (red arrow). Sediment discharge to drainage ditch evident by large erosion rills (yellow lines) and sediment within vegetation (blue outline).

Photo 5: Significant erosion occurred due to lack of erosion control and sediment control BMPs on site prior to the rain. There are no check dams, erosion control blankets, or soil binders in place within the concentrated flow paths as specified in the SWPPP. Sediment discharged from the site to the concrete ditch (at the right of the photo) that discharges to Rossini Creek.

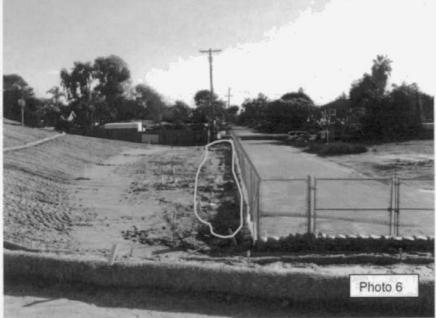
Finding 3: Erosion control BMPs (runoff control and soil stabilization) were not present on site. Sediment-laden storm water was discharged from the construction to Rossini Creek.

Photo 6: Soil binders were reportedly used in conjunction with "track-up/track-down" BMPs on the slope. These BMPs failed to secure soil and prevent erosion. This photo shows sedimentation at the base of the slope (outlined in yellow) along the fence line (shown in red).

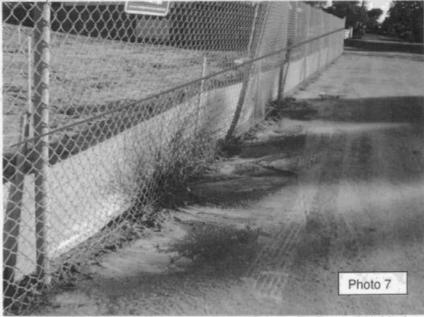
Photo 7: This is the same fence line (in red) shown in Photo 6. Soil binders and track-up/track-down BMPs failed to secure soil and prevent erosion. This photo shows sediment left the site and was discharged to Starlight Drive. This sediment still had not been cleaned up at the time of inspection. This silt fence looked new because of how clean it is. It is unknown if a silt fence was there prior to the rain event.

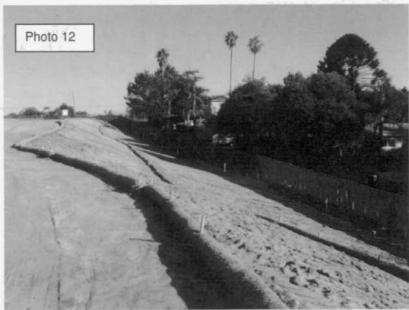
Finding 4: Sediment Control on slopes along Caretta Way.

Photo 12: Soil binder plus "track-up/track down" was reportedly used as a sediment control BMP on the slope shown in Photo 12. The fiber rolls in Photo 12 and the gravel bags at the fence line were placed after the rain event and before the inspection because they were free of any sediment and very clean.

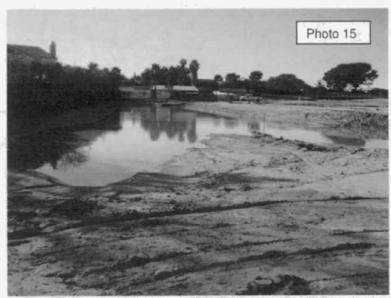
Finding 5: Storm water detention basins to control sediment were not present on site.

Photo 15 shows reported location where a sediment basin will be constructed.

- Sediment control basins can be used provided they are designed with adequate capacity to capture and treat sediment-laden storm water generated from the site. Implementation of adequate erosion control BMPs, sediment control BMPs, and sediment basins are required to prior to the rainy season (October 1), as described in the SWPPP.
