**Subject: Notice of Violation No. R9-2014-0018, Casa Mira View,  
NPDES Order No. 2009-0009-DWQ, Statewide Construction General Storm Water  
Permit**

**NOTICE OF VIOLATION  
No. R9-2014-0018**

Casa Mira View

Facility: Casa Mira View, WDID 9 37C353628  
Inspection Date: 01/09/2014

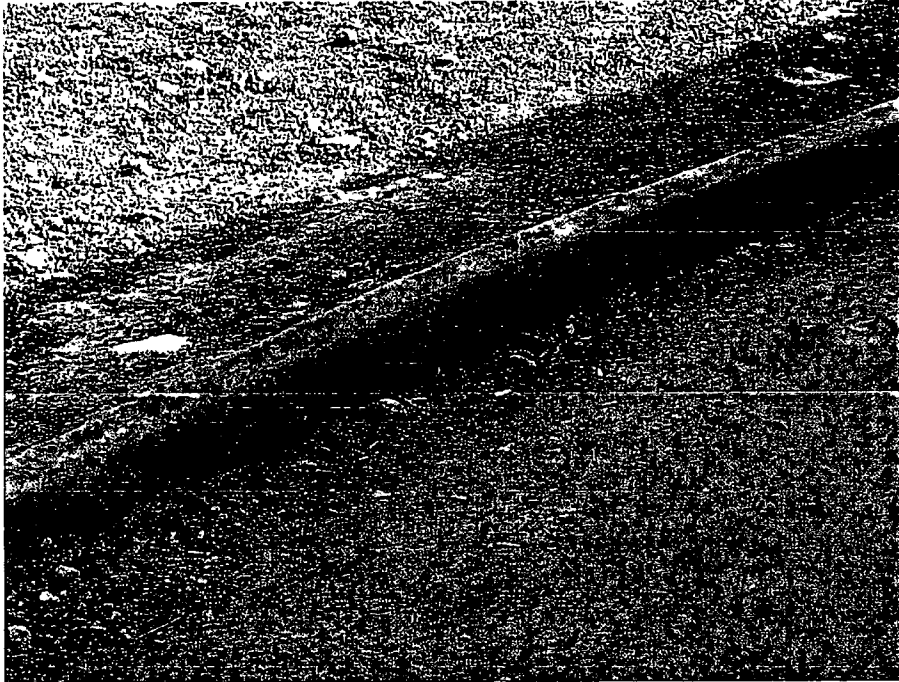
1. The site was littered with cigarette butts, trash, debris, and other construction-related waste throughout. (See Figures 1-4, 14-25).
2. None of the finished curbs within the site had sediment control BMPs (such as silt fence) installed. As a result, the streets were covered in sediment (Figures 1, 3, 16-22).
3. There were no sediment control BMPs at one construction site exit/entrance located on Mira Lee Way, and sediment had been tracked into the street (Figure 5).
4. There was an uncovered stockpile, although it appeared to be active (Figure 6).
5. Two concrete wash-out bins were leaking, and waste material discharged to the surrounding the soil (Figures 7-8).

Figure 1. Near trailer; cigarette butts

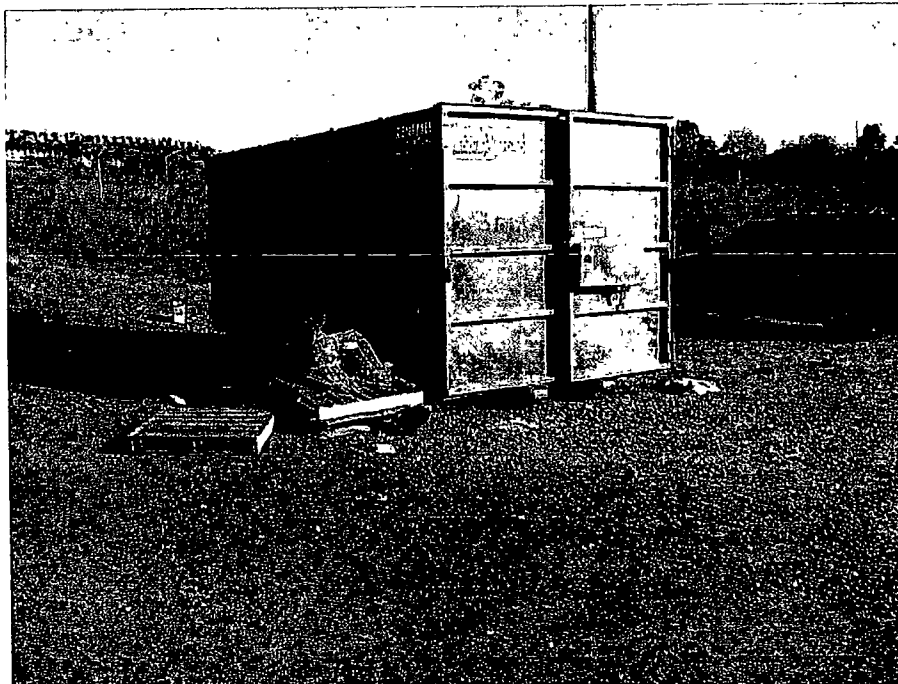
Figure 4. Site interior; construction debris

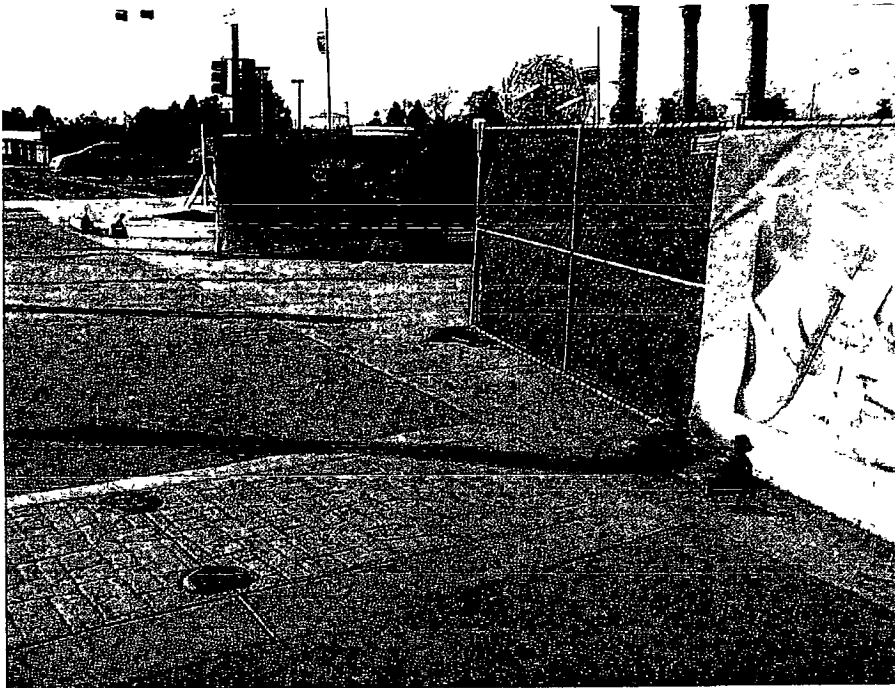
Figure 5. South-facing construction entrance; no BMPs; sediment tracking onto street

5. The concrete washout BMPs must be fixed or replaced to prevent leaks. Concrete waste must not be allowed to come into contact with bare ground.
6. Site entrance/exit BMPs are required.

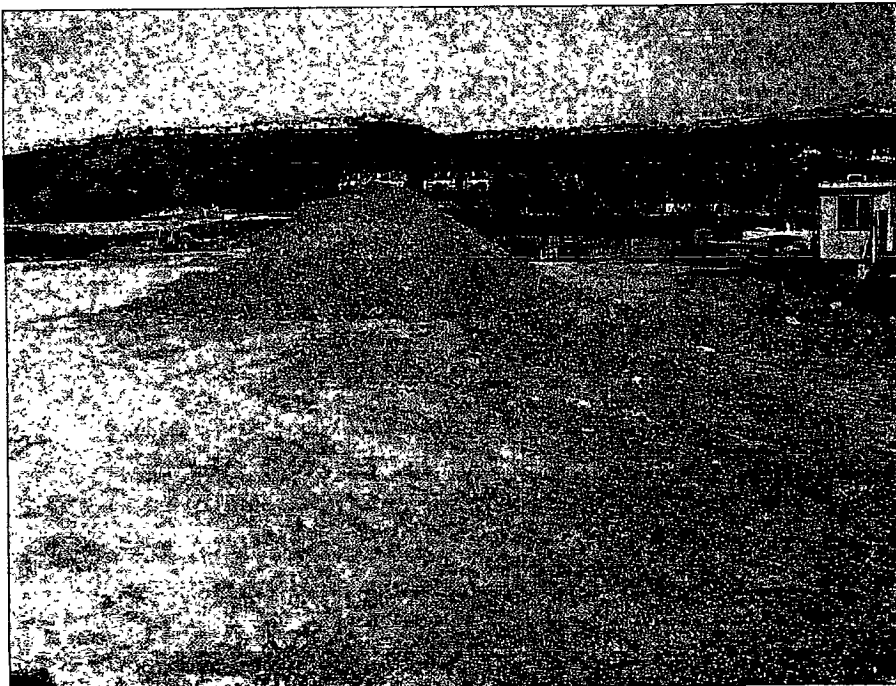
Figure 6. Sediment stockpile

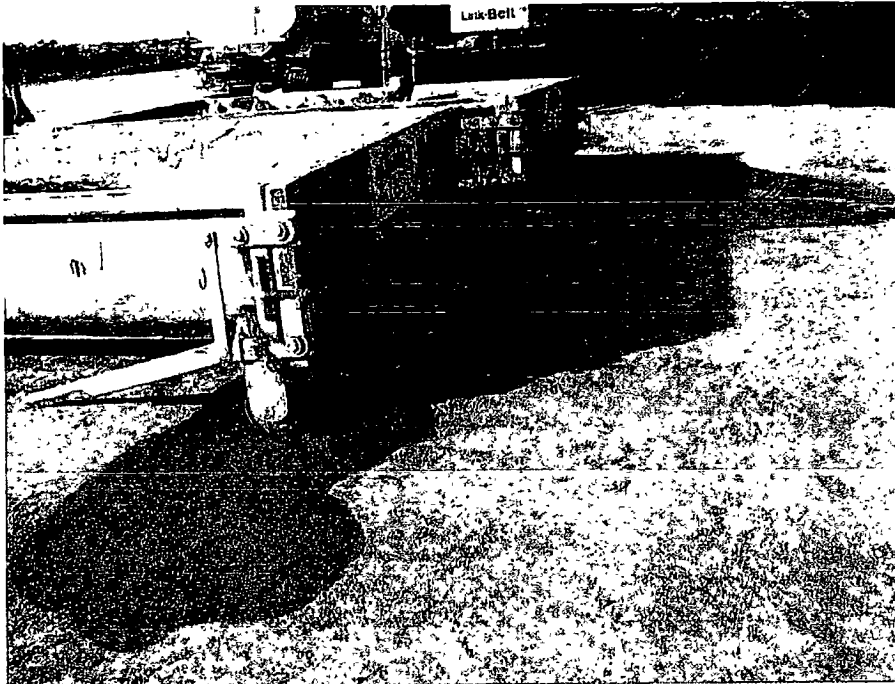
Figure 7. Leaking concrete washouts

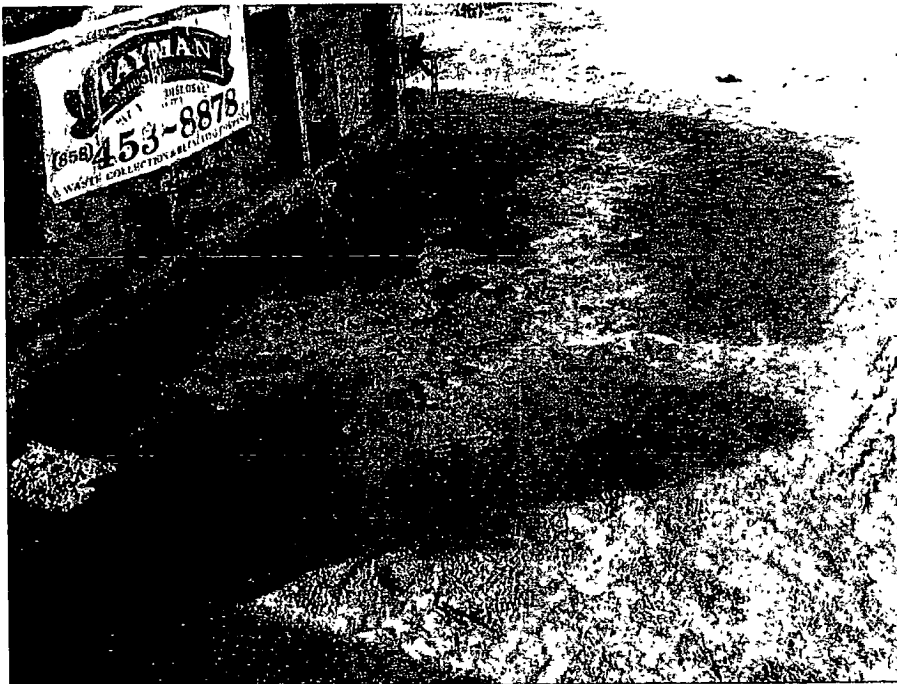
Figure 8. Concrete staining on soil from leaking washouts

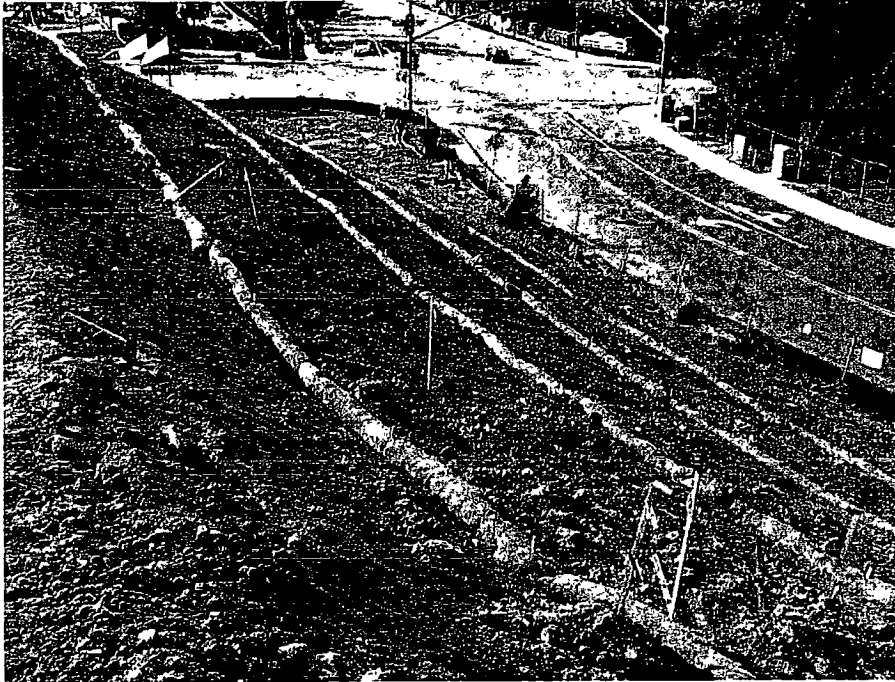
Figure 9. Slope on north side with no erosion control

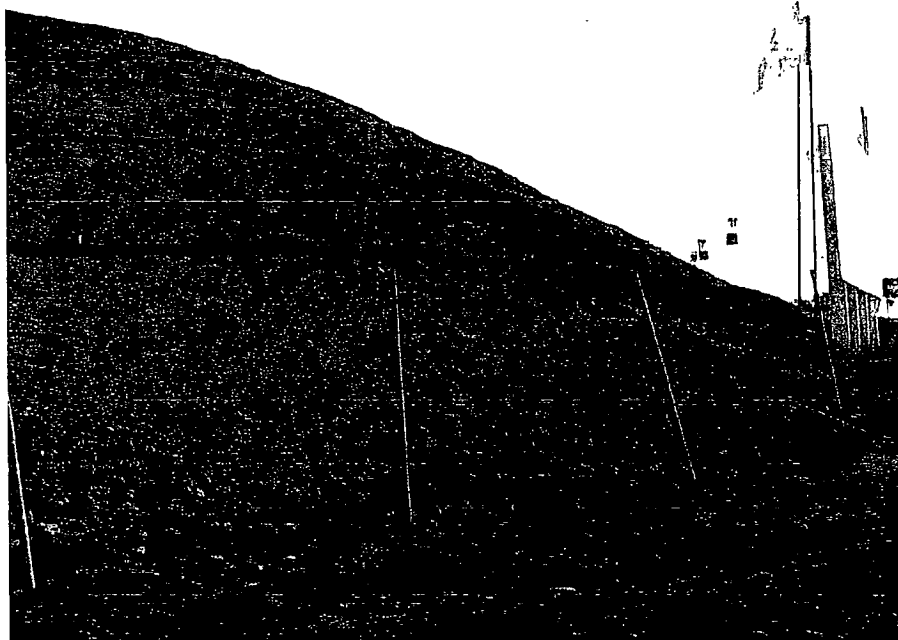
Figure 10. Slope is 2:1 Horizontal: Vertical according to SWPPP

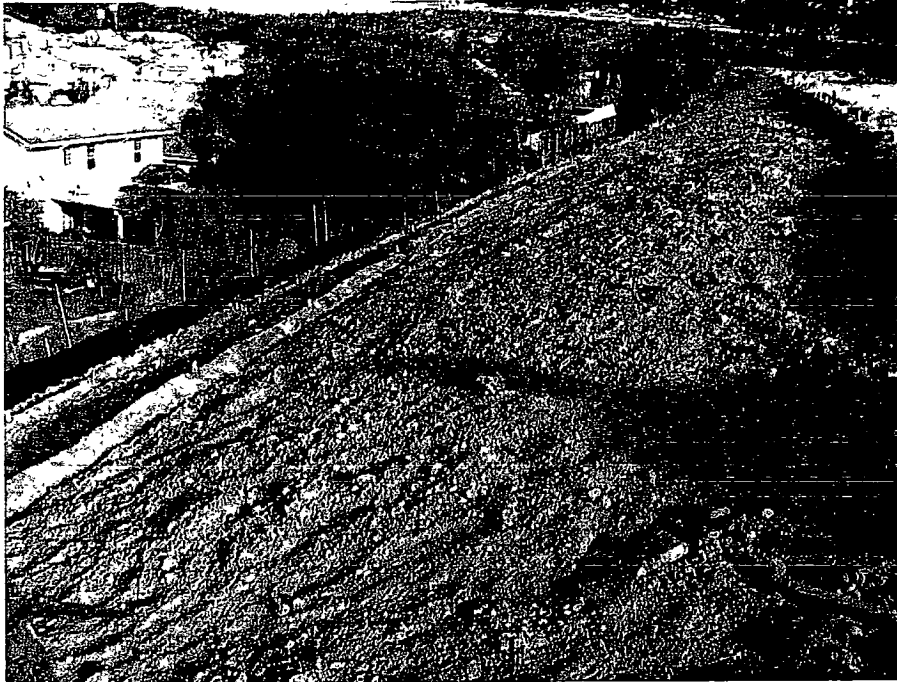
Figure 11. North slope looking easterly

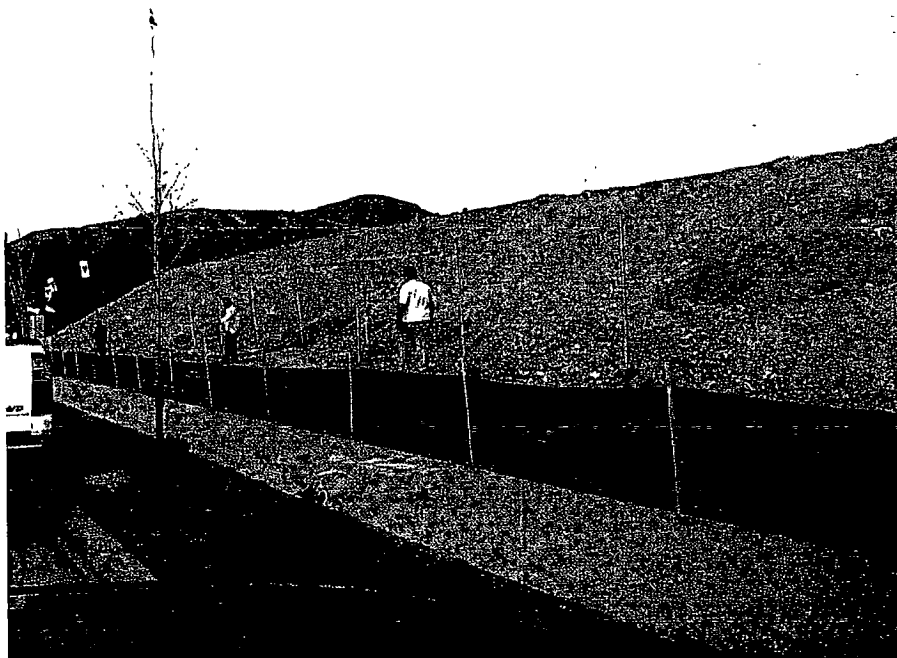
Figure 12. Slope on west side of property

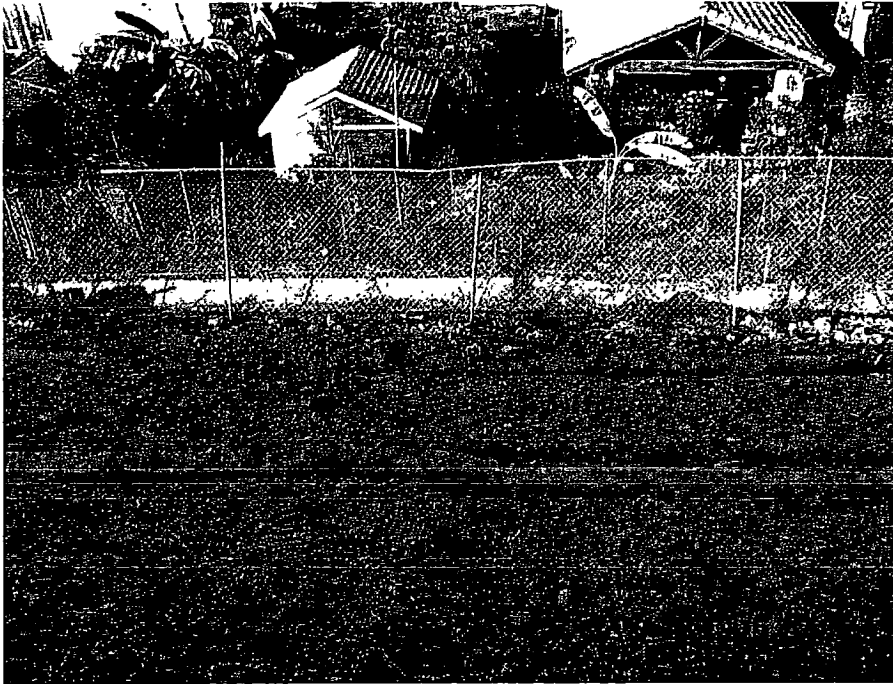
7. The silt fence along the north side of the property had fallen and was in need of repair (Figure 13).
8. Sediment control BMPs throughout the site need replacement or had not been maintained. Examples include broken gravel bags (Figure 22).

Figure 13. Damaged silt fence

3. All sediment control BMPs must be adequately maintained. The silt fence on the north side of the property requires replacement.
4. Sediment control BMPs such as silt fence should be installed at finished curbs to prevent sediment from reaching the streets.

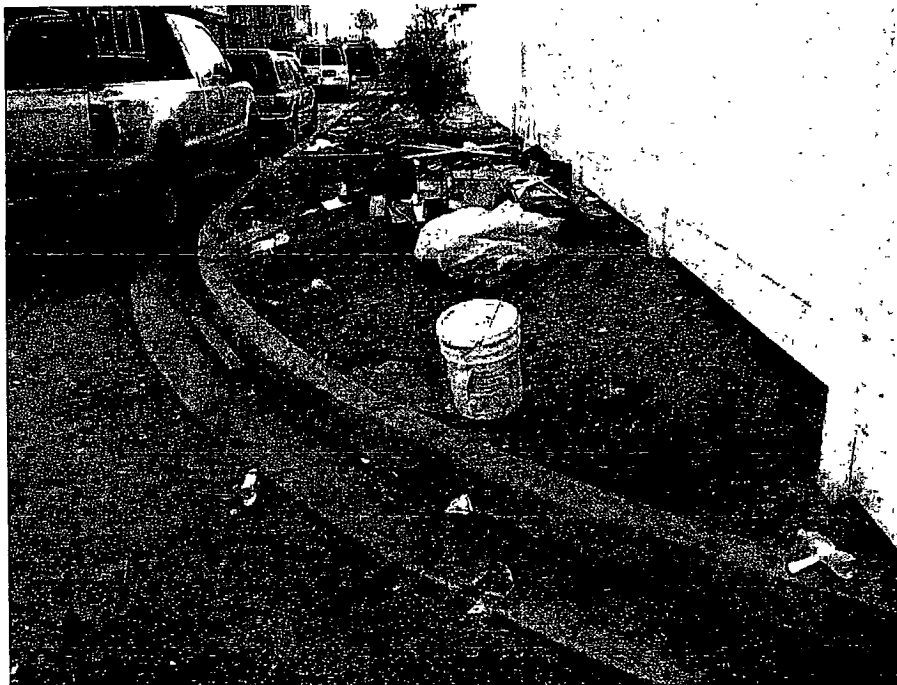
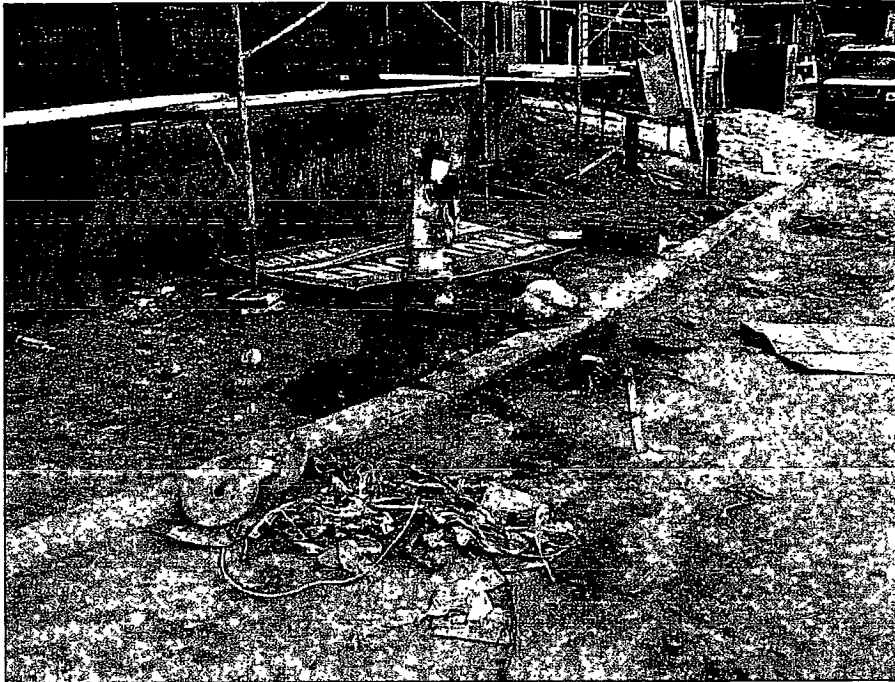
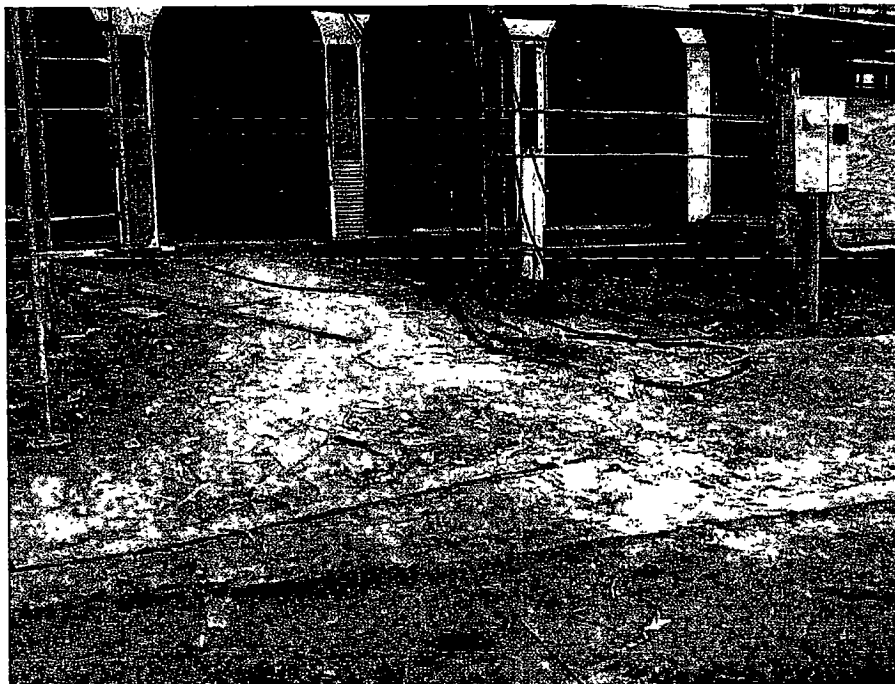
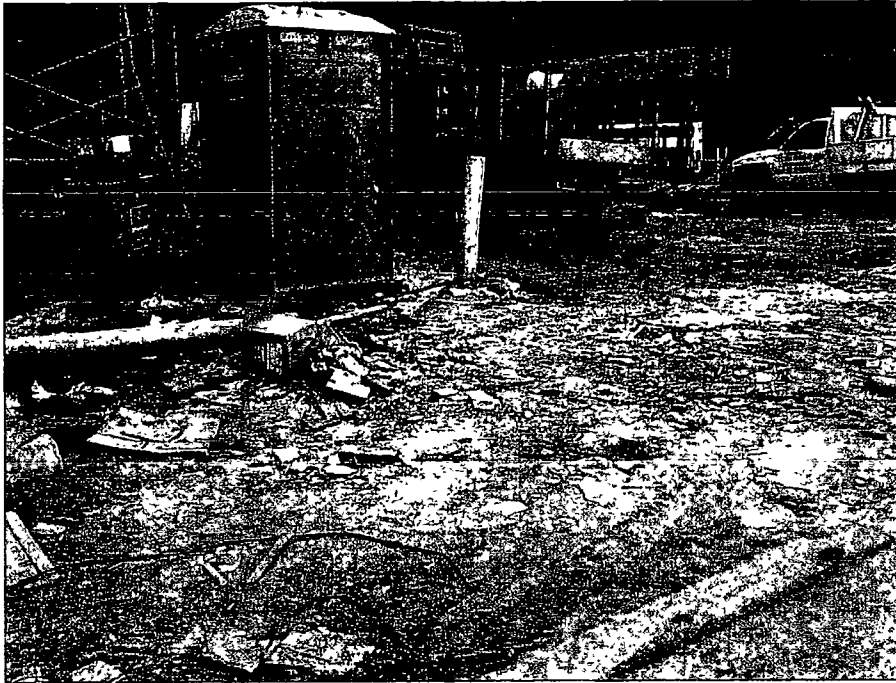
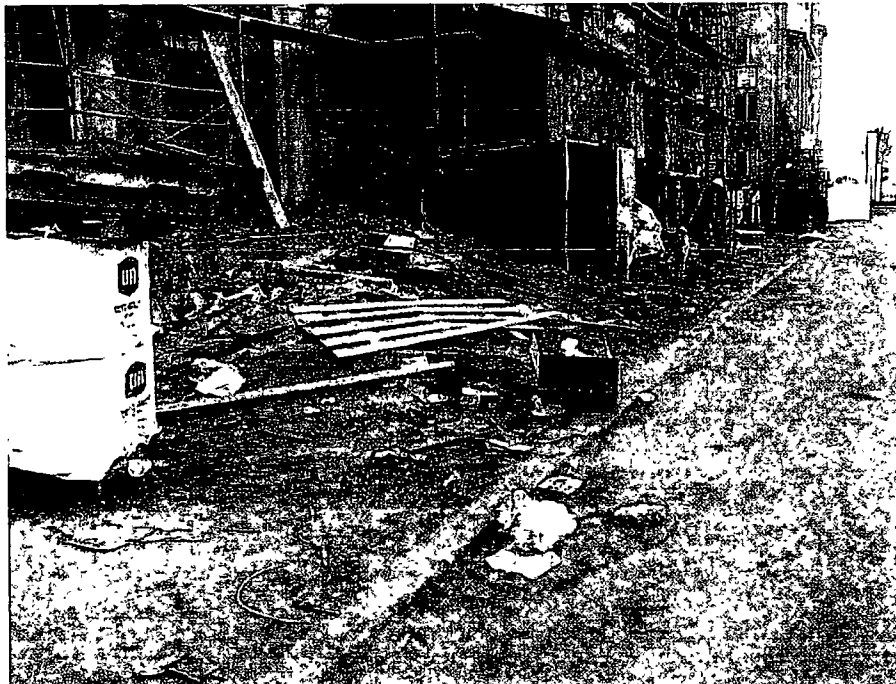
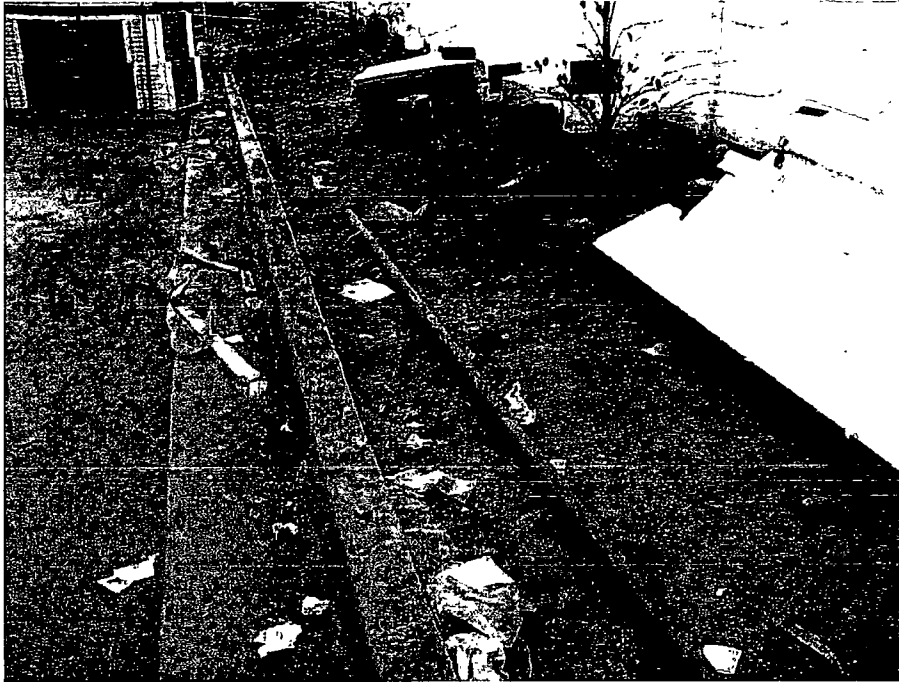
Figure 14. Construction debris

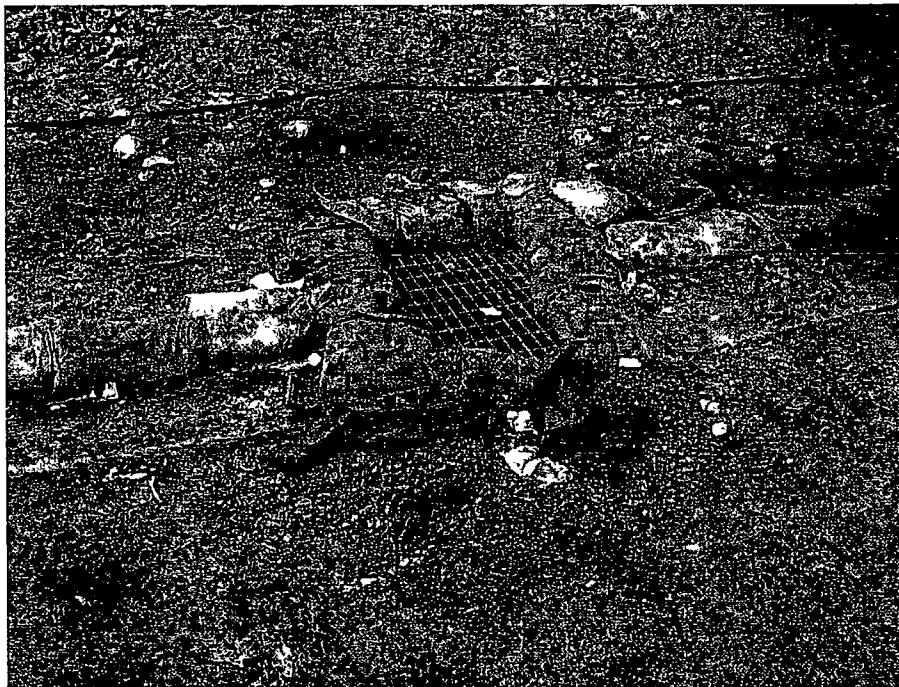
Figure 22. Broken gravel bags

7. Storm drain inlets within the construction site require protection to prevent sediment, trash, and construction debris from entering.
8. Gravel bags that have been broken need replacing.

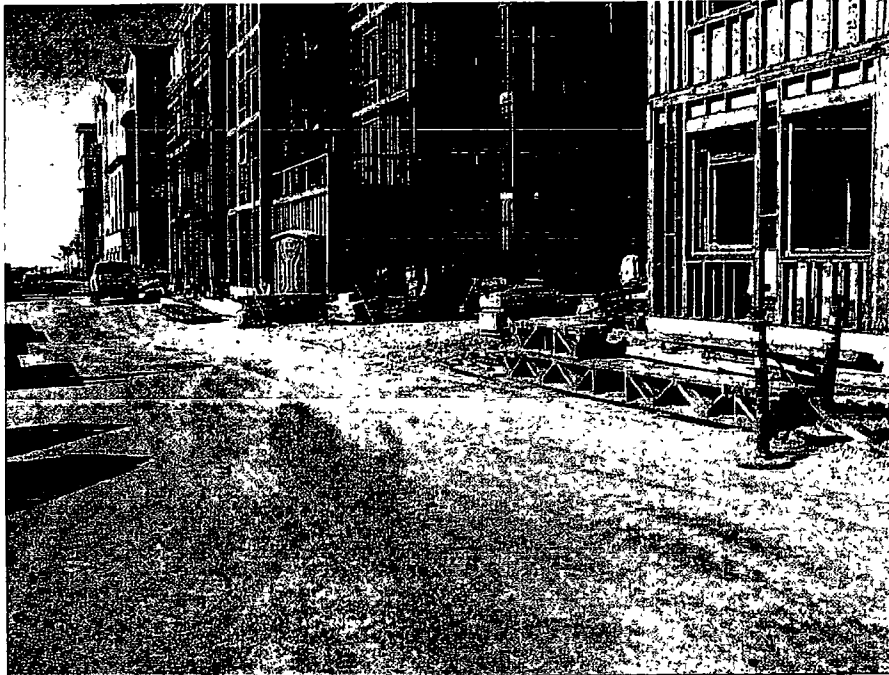
1. The finished roads within the site have been swept and are much cleaner than the previous site visit (Figures 1-2, 4).
2. One storm drain on the east side requires improved protection (Figure 3).
3. Sandbags had been replaced; however, additional BMPs are needed to prevent sediment from reaching the street (Figure 5).
4. A trash bin was overflowing (Figure 7).
5. Cigarettes in front of the trailers had been swept (Figure 8).
6. The leaking concrete wash-out bins were replaced or fixed (Figure 9).
7. The exterior slopes had adequate erosion control BMPs (Figures 10-11).

Figure 1. South side of active construction site

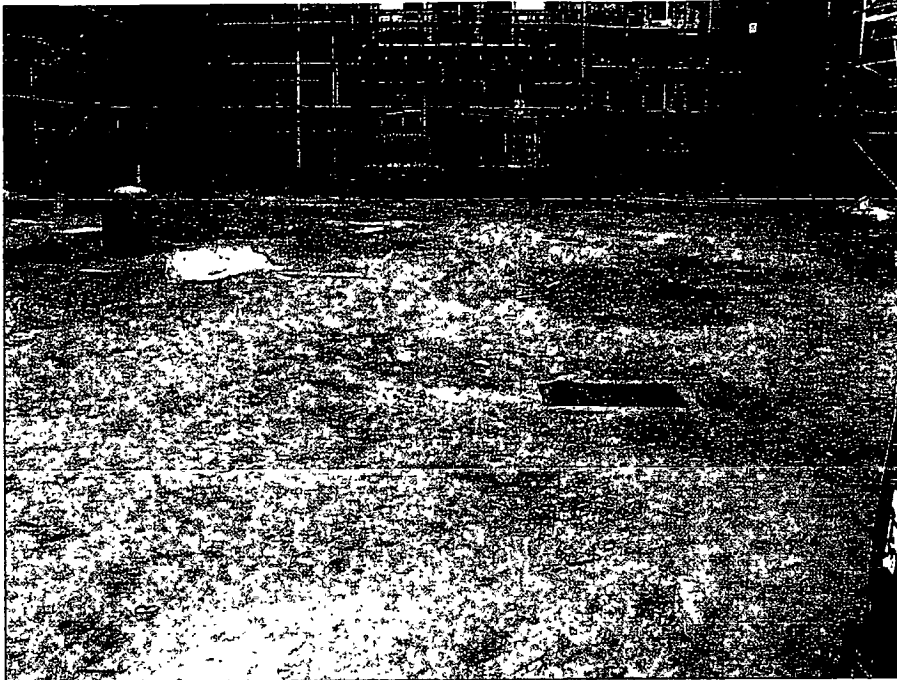
Figure 3. Site interior; inlet requires better protection

5. Storm drain inlets within the construction site require protection to prevent sediment, trash, and construction debris from entering.
6. Additional site entrance/exit BMPs should be implemented since tracking in the street was still observed.

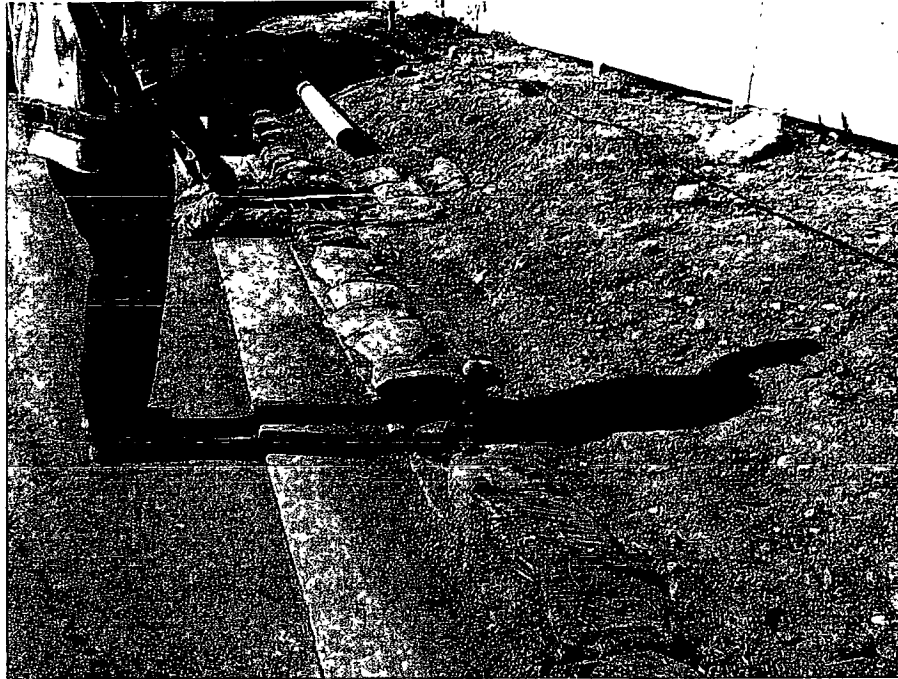
Figure 5. Site interior; linear sediment control BMPs not effective

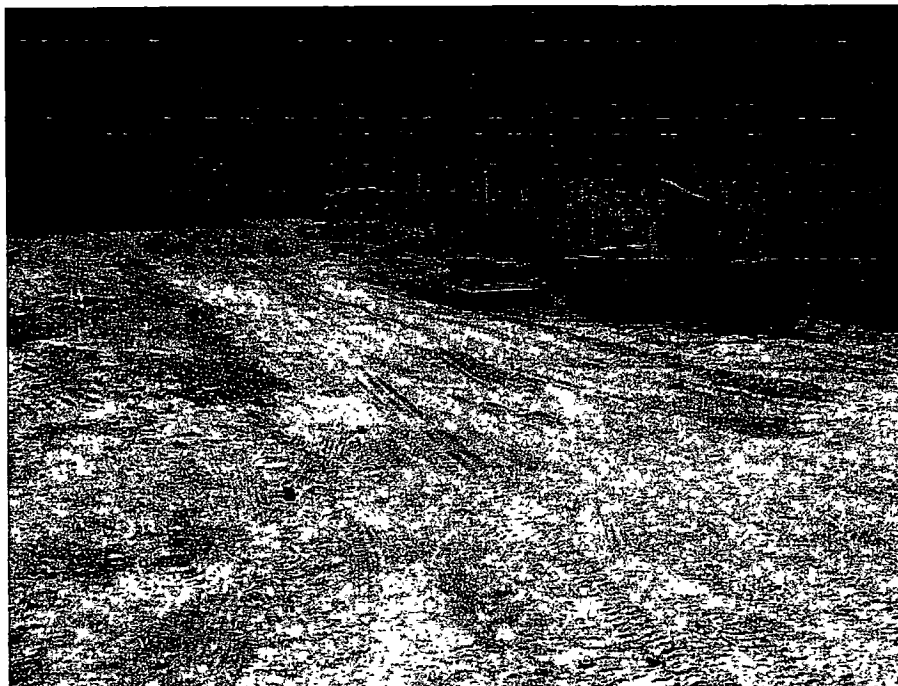
Figure 6. Site interior; trash and debris has been removed

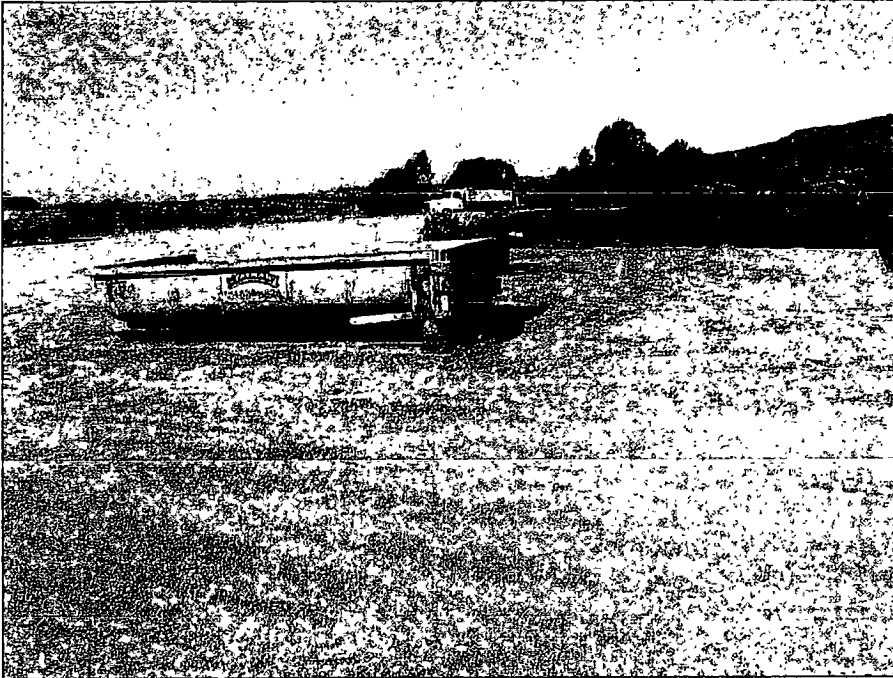
Figure 9. Leaking concrete waste bin has been replaced

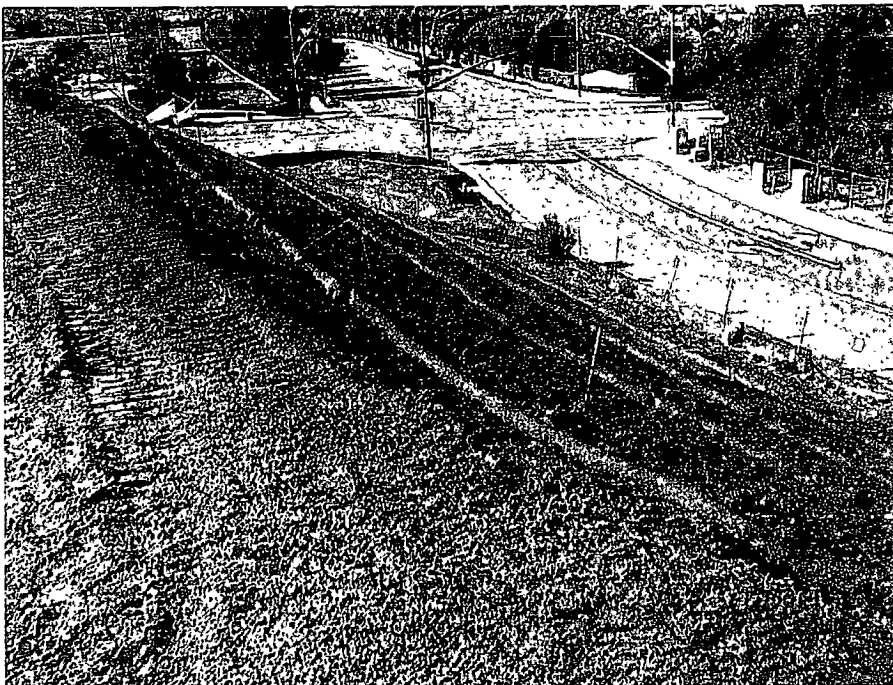
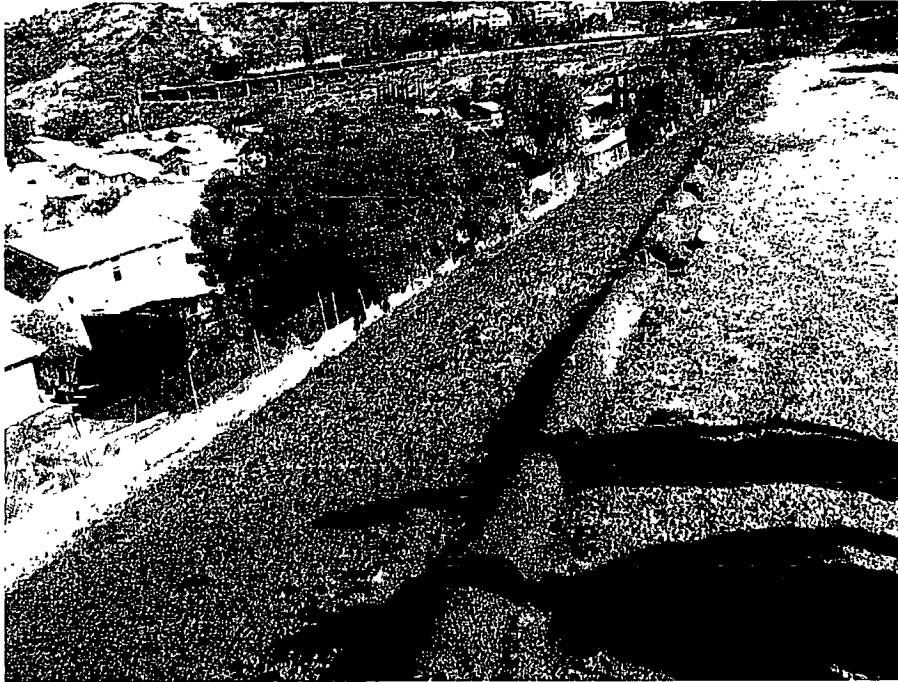
Figure 10. North slope has erosion control BMPs

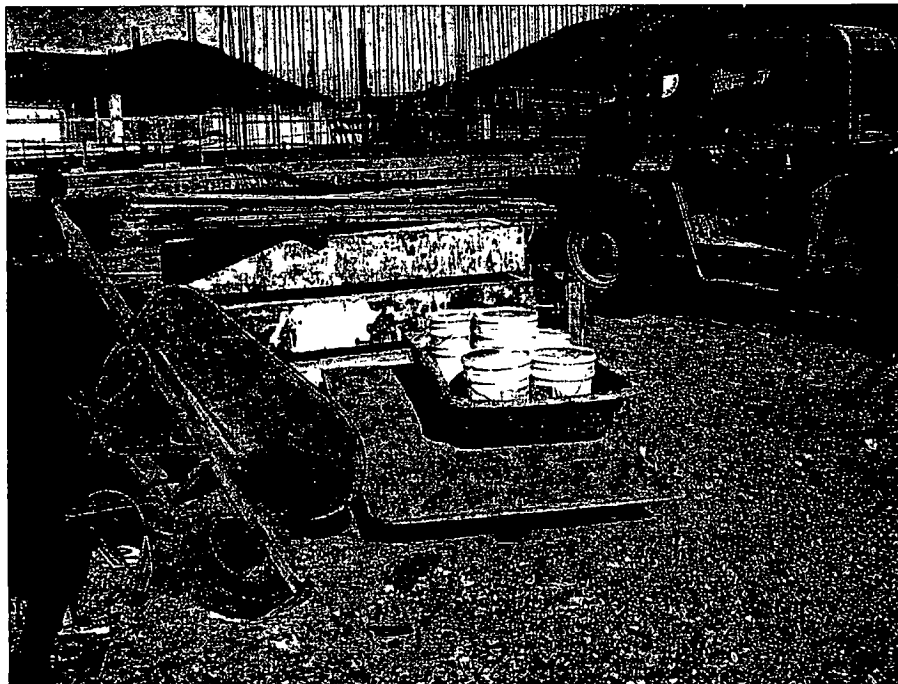
8. Chemical containers had secondary containment and the site was much tidier than the previous inspection (Figure 12).
9. There were no sediment control BMPs at one construction site exit/entrance located on Mira Lee Way, and sediment had been tracked into the street (Figures 13-14). Site operators indicated that this area is swept; however, a structural BMP such as gravel or shaker plates should be considered since street sweeping does not occur daily.
10. We found some fiber rolls that could be used in the event of rain; however, overall the site contains inadequate stockpiled BMPs. Mr. Melbourn asked that the site operators produce a list of stockpiled BMPs within two weeks.

Figure 12. Chemicals with secondary containment

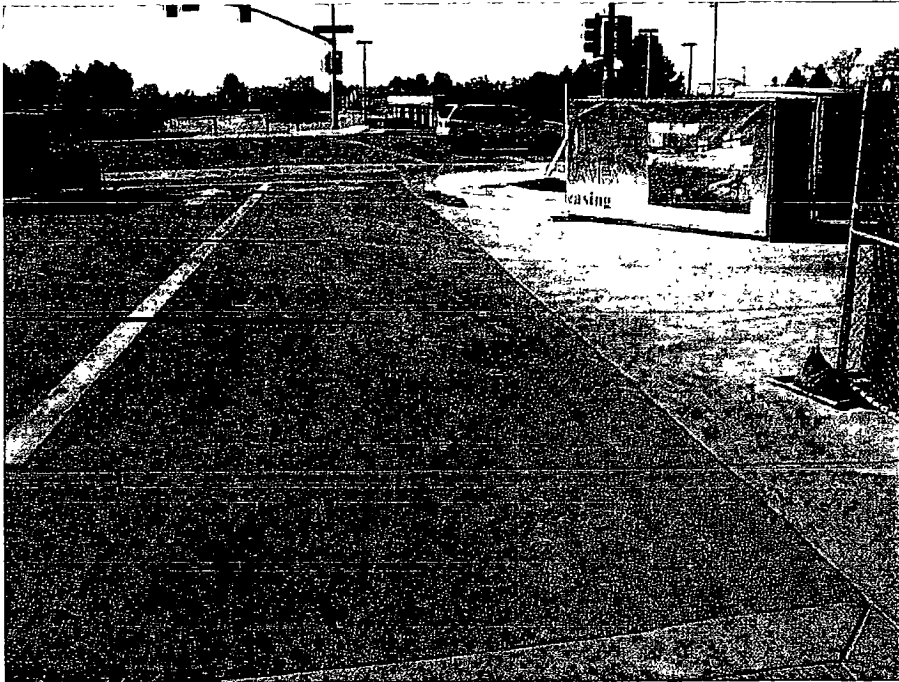
Figure 13. Construction entrance shows tracking
