**Subject: Notice of Violation No. R9-2014-0062, Jonas Salk Elementary School,
Order No. 2009-0009-DWQ, NPDES Permit No. CAS000002**

NOTICE OF VIOLATION
No. R9-2014-0062

FACILITY INSPECTION REPORT

FACILITY: Jonas Salk Elementary School **INSPECTION DATE/TIME:** 4/2/2014; 9:00 am

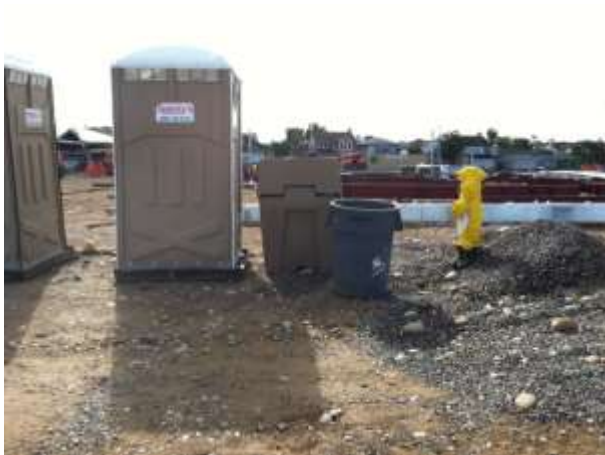
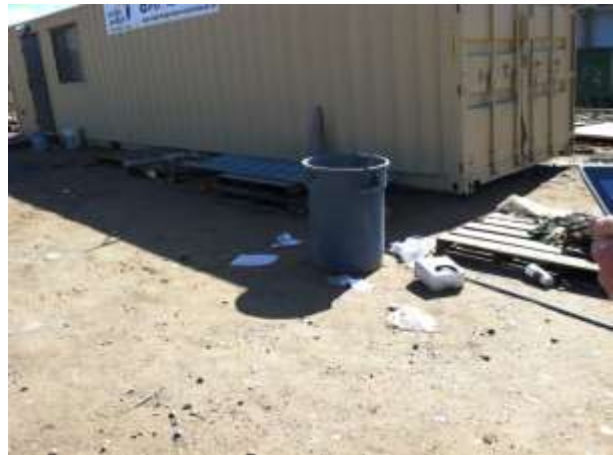
- b. Observation:** During the April 2, 2014 inspection, the San Diego Water Board inspector observed several waste containers that lacked covers, and no evidence that there were covers available for the containers. See attached April 2, 2014 Facility Inspection Report Photos 1 and 2.

2. Several waste disposal containers observed to be inadequately covered, and there was no evidence that there was a cover available for the container (See Photos 1 and 2). All Risk Level 2 construction sites are required to cover waste disposal containers at the end of every business day and during a rain event (Section B.2.d of Attachment D to CGP).

Photos 1-2 show waste disposal containers that were inadequately covered, and no evidence that there are covers available for the containers. Photo 2 also shows trash that was not properly disposed.

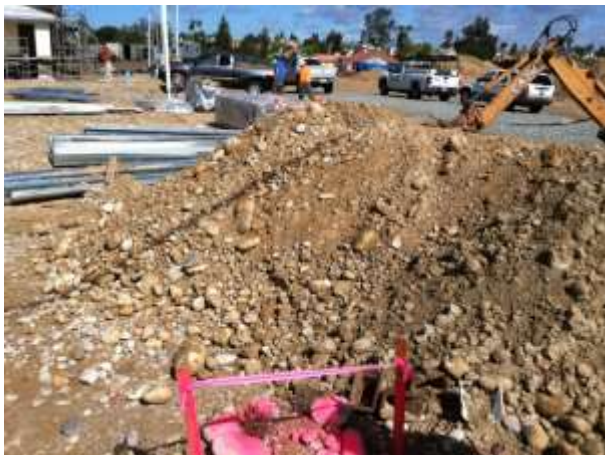
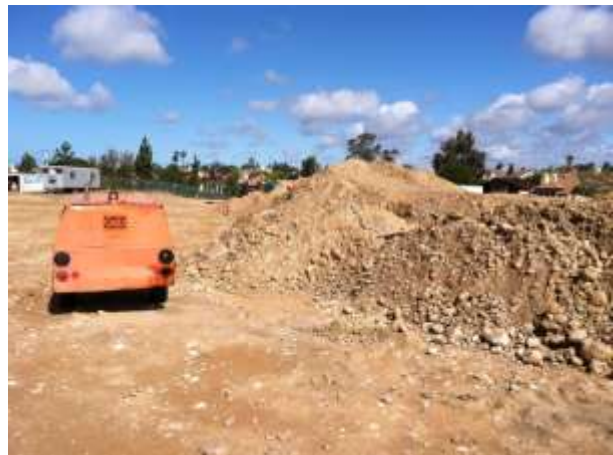
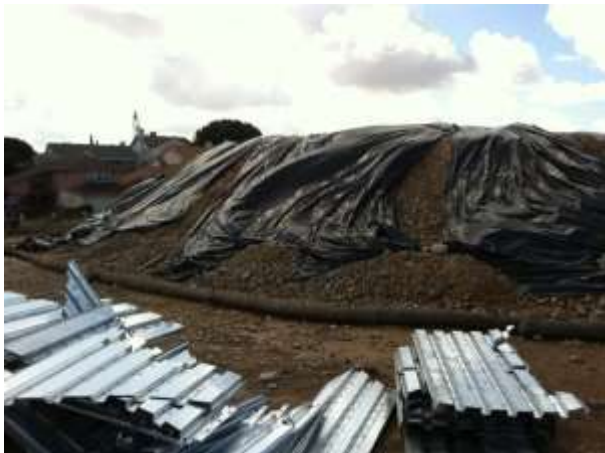
scheduled to be inactive without adequate cover or berm. See attached April 2, 2014 Facility Inspection Report Photos 3 through 5.

3. Soil stockpiles observed without adequate cover or containment (See Photos 3 to 5). Soil stockpiles appeared to be waste material, but will likely be re-used on site as construction material. All Risk Level 2 construction sites are required to contain and securely protect stockpiled waste material from wind and rain at all times unless actively being used (Section B.2.f of Attachment D to CGP). All Risk Level 2 construction sites are required to cover and berm loose stockpiled construction materials that are not actively being used (i.e. soil, spoils, aggregate, fly-ash, stucco, hydrated lime, etc.) (Section B.1.b of Attachment D to CGP).

Photos 3-5 show soil stockpiles without adequate cover or containment to protect materials from wind and rain.

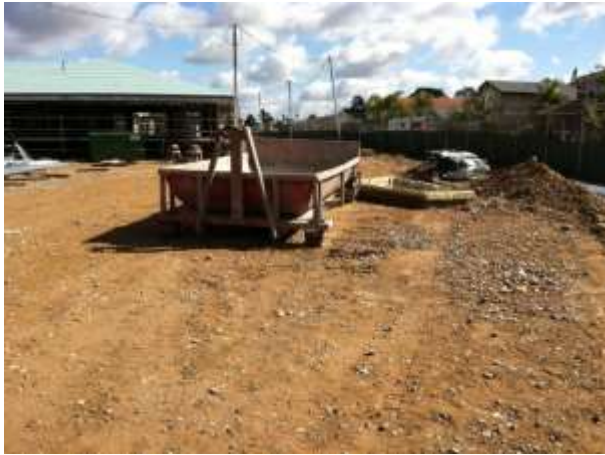
- d. Observation:** During the April 2, 2014 inspection, the San Diego Water Board inspector observed a concrete washout area without measures to contain and prevent discharges into underlying soil and onto surrounding areas. See attached April 2, 2014 Facility Inspection Report Photo 6.

4. Inadequate containment of concrete washout area observed during the inspection (See Photo 6). All Risk Level 2 construction sites are required to ensure containment of concrete washout areas so there is no discharge into the underlying soil and onto surrounding areas (Section B.2.i of Attachment D to CGP).

Photo 6 shows concrete washout without any secondary containment to prevent discharges to underlying soil and surrounding areas.

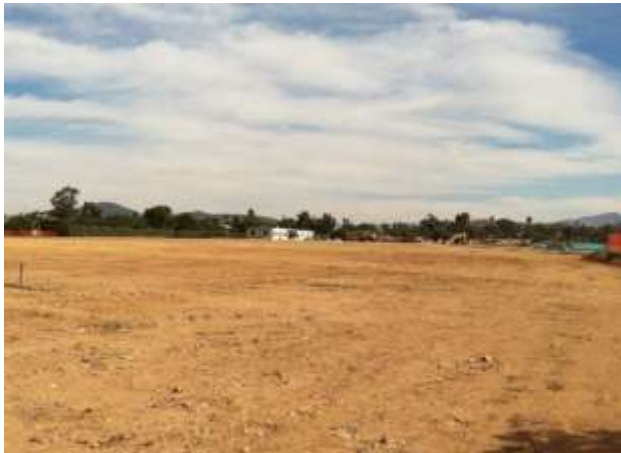
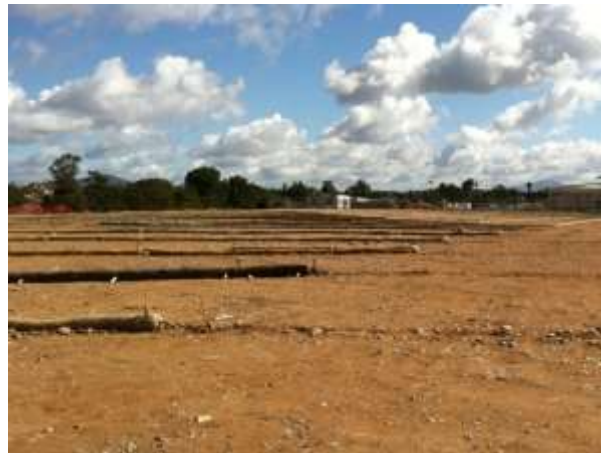
5. Several areas were observed to be inactive, or could be scheduled to be inactive, without effective soil cover to control potential erosion. At least one area, referred to as the joint use field, was inactive since the October 7, 2013 inspection and did not have adequate erosion controls implemented as of the April 2, 2014 inspection (See Photos 7, 8, 15, and 16). All Risk Level 2

Photos 7-8 show the joint use field that was considered inactive during the October 7, 2013 inspection. Photo 7 was taken on October 7, 2013 and shows lack of sediment control and internal runoff control BMPs, and lack of erosion control BMPs (i.e. effective soil cover). Photo 8 was taken on April 2, 2014 and shows the addition of sediment control and internal runoff control BMPs, but continued lack of erosion control BMPs.

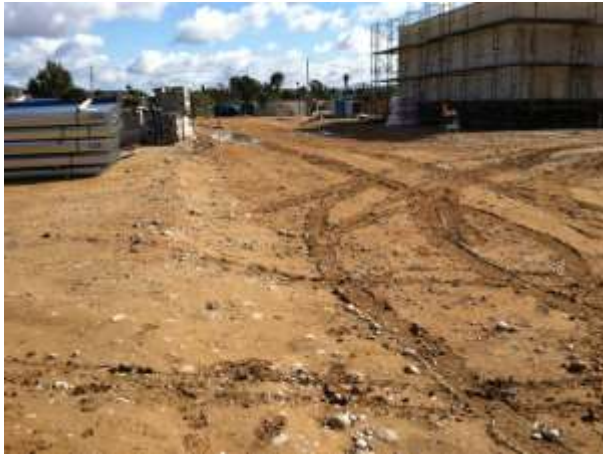
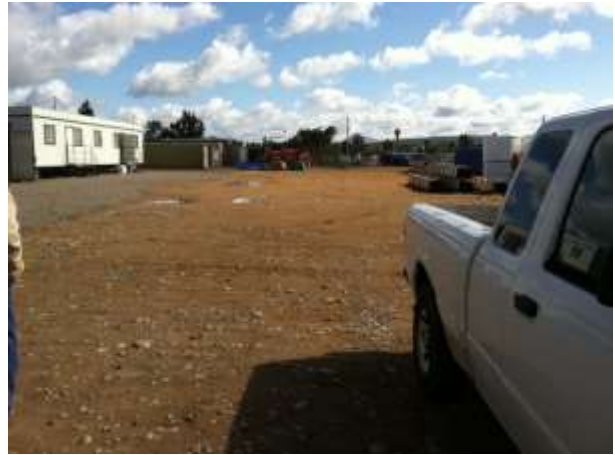
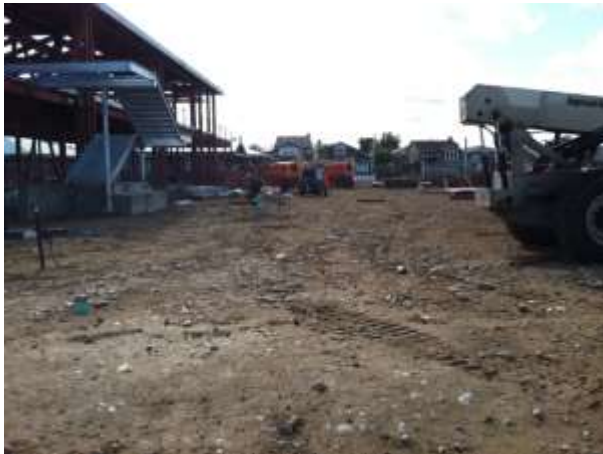
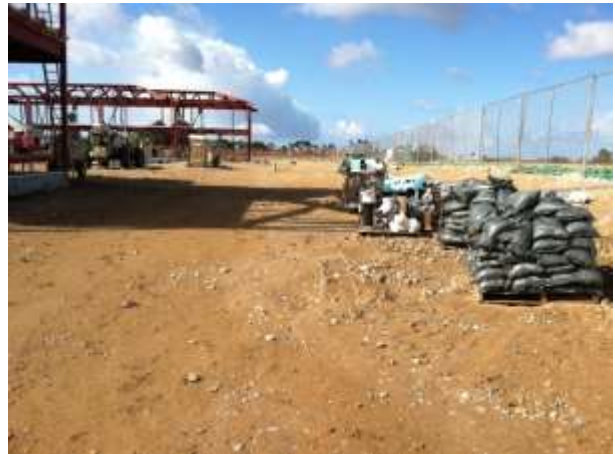
- a. Pursuant to Provision X and Section E.3 of Attachment D of State Water Board Order No. 2009-0009-DWQ:** Risk Level 2 dischargers shall implement appropriate erosion control BMPs (runoff control and soil stabilization) in conjunction with sediment control BMPs for areas under active construction.
- b. Observation:** During the April 2, 2014 inspection, the San Diego Water Board inspector observed several areas of the site under active construction without appropriate BMPs to prevent erosion in conjunction with sediment control BMPs. See attached April 2, 2014 Facility Inspection Report Photos 9 through 12.

6. Several areas under active construction were observed to lack erosion controls, and the QSP could not describe the erosion controls that were being implemented, in conjunction with sediment controls (See Photos 9 through 12). All Risk Level 2 construction sites are required to implement appropriate erosion controls (runoff control and soil stabilization) in conjunction with sediment controls for areas under active (i.e. areas undergoing land surface disturbance) construction (Section E.3 of Attachment D to CGP).

Photos 9-12 show areas considered to be active areas lacking erosion controls (runoff control and soil stabilization) in conjunction with sediment controls, as required for Risk Level 2 sites.

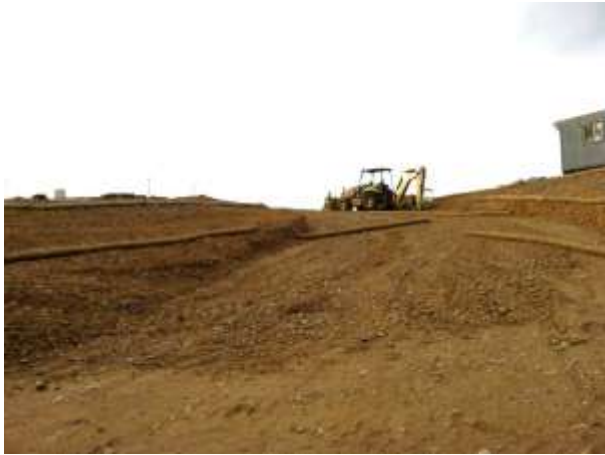
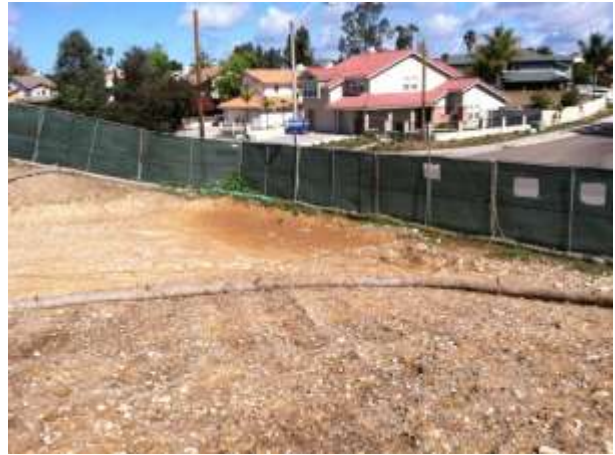
- a. Pursuant to Provision X and Section E.4 of Attachment D of State Water Board Order No. 2009-0009-DWQ:** Risk Level 2 dischargers shall apply linear sediment controls along the toe of the slope, face of the slope, and at the grade breaks of exposed slopes to comply with sheet flow lengths.
- b. Observation:** During the April 2, 2014 inspection, the San Diego Water Board inspector observed several exposed slopes lacking linear sediment controls along the toe of the slopes. At least one exposed slope had been identified as and observed to be lacking linear sediment control along the toe of the slope on October 24, 2013, and was observed to lack linear sediment controls along the toe of the slope during the April 2, 2014 inspection. See attached April 2, 2014 Facility Inspection Report Photos 13 through 16.

7. Several slopes observed without linear sediment controls along the toe of exposed slopes (See Photos 13 through 16). Several slopes observed during the April 2, 2014 inspection have not had adequate linear sediment controls since at least the October 24, 2013 inspection. All Risk Level 2 construction sites are required to apply linear sediment controls along the toe of the slope, face of the slope, and at the grade breaks of exposed slopes to comply with sheet flow lengths (Section E.4 of Attachment D to CGP).

Photos 13-14 show a slope that does not have adequate linear sediment control along the toe of exposed slope, as required for Risk Level 2 sites. Photo 13 was taken on October 24, 2013, looking south and up the slope, and shows lack of linear sediment controls at the toe of the slope. Photo 14 was taken on April 2, 2014, looking northwest and down the slope, and shows continued lack of linear sediment controls at the toe of the slope.

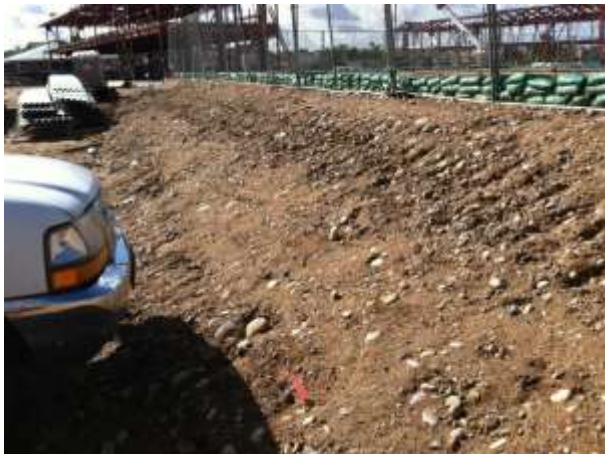
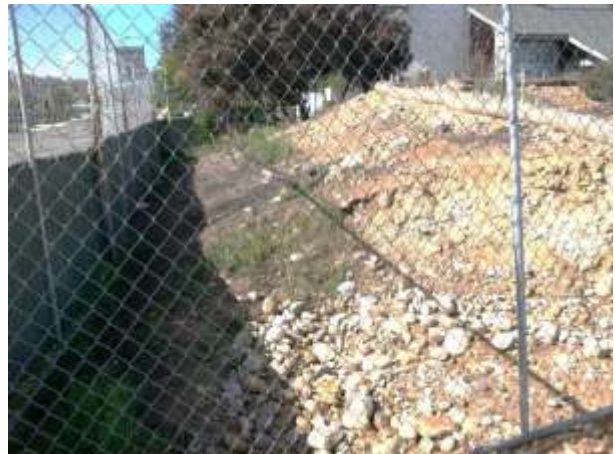
Photos 15-16 show inactive slopes that lack erosion control BMPs, as required for Risk Level 1 and Risk Level 2 sites, as well as lack of linear sediment control BMPs at toe of slopes, as required for Risk Level 2 sites.

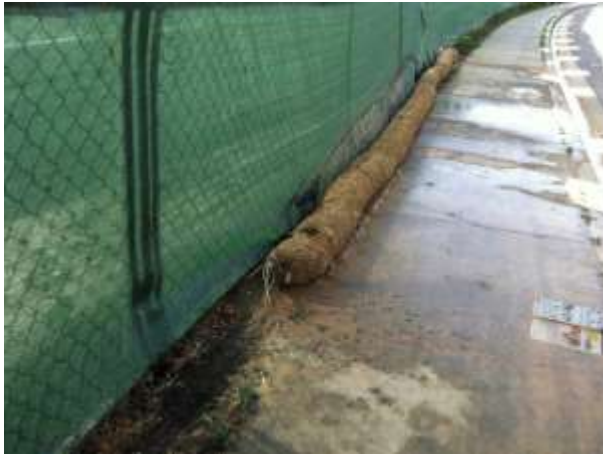
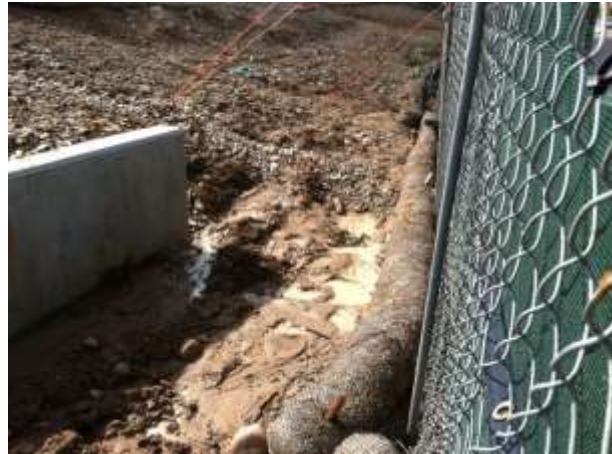
- b. Observation:** The San Diego Water Board conducted a drive-by inspection of the Jonas Salk Elementary School construction site (WDID 937C365865) on March 3, 2014, and a follow-up inspection on April 2, 2014. The San Diego San Diego Unified School District (SDUSD) is the Legally Responsible Person (LRP) enrolled under the Construction General Permit (CGP) for the site. On March 3, 2014, the San Diego Water Board inspector observed evidence of sediment and sediment-laden water discharging from the site due to inadequate and ineffective implementation of best management practices (BMPs), constituting an unauthorized storm water discharge from the site. The discharge was the result of inadequate implementation of erosion controls observed during the April 2, 2014 inspection. See attached April 2, 2014 Facility Inspection Report Photos 17 through 20 and Attachment 1.

Photos 17-18 taken on March 3, 2014 after February 26 - March 2 storm event show discharge from the site due to ineffective erosion control and perimeter sediment control BMPs. Photo 17 shows discharge of sediment and sediment-laden water from the site, and additional fiber roll placed outside the fence. Photo 18 shows the inside of the fence where the discharge originated, where a significant buildup of sediment behind the fiber roll can be observed and exposed soil on the slope that was the source of the sediment.

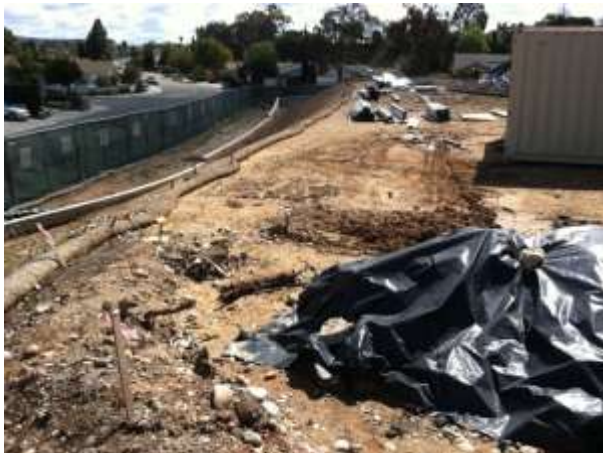
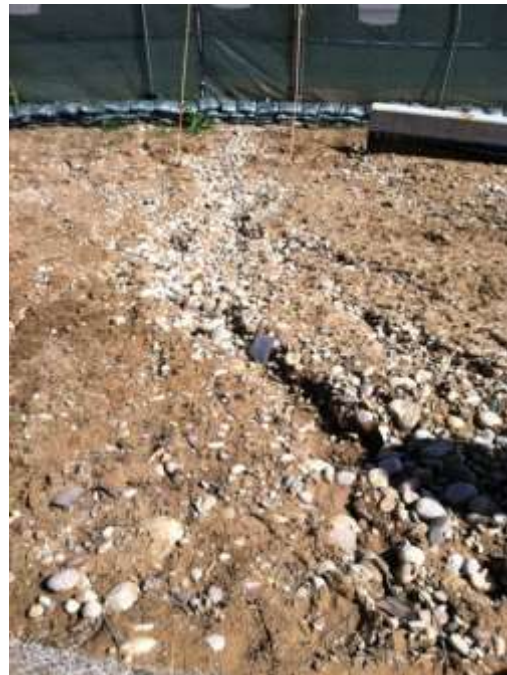
- c. Observation:** During the April 2, 2014 inspection, the San Diego Water Board inspector observed the lack of effective erosion controls required by the CGP, which directly lead to erosion and sedimentation that ultimately resulted in the discharge of sediment and sediment-laden water from the site observed on March 3, 2014. The discharge was a result of the implementation of controls, structures, and BMPs that do not achieve BCT. See attached April 2, 2014 Facility Inspection Report Photos 19 and 20.

- a. Pursuant to Provision X and Section G.3 of Attachment D of State Water Board Order No. 2009-0009-DWQ:** Upon identifying failures or other shortcomings, as directed by the QSP, Risk Level 2 discharges shall begin implementing repairs or design changes to BMPs within 72 hours of identification and complete the changes as soon as possible.
- b. Observation:** During the April 2, 2014 inspection, the San Diego Water Board inspector observed erosion control BMPs on a slope that failed and required repairs. The failure occurred during a storm event that occurred on February 26 through March 2, 2014, which resulted in a discharge of sediment and sediment-laden water from the site observed on March 3, 2014. No repairs or changes to BMPs to address and prevent a subsequent failure was observed. See attached April 2, 2014 Facility Inspection Report Photo 20.

8. Evidence of erosion on a slope covered with bonded fiber matrix, in combination with inadequate erosion controls for an inactive area observed, resulting in the discharges of sediment and sediment-laden water from the site observed during the March 3, 2014 inspection. Additional sediment control BMPs were implemented for perimeter protection, but no evidence that bonded fiber matrix was re-applied to repair erosion control BMPs on eroded slope or erosion controls added to prevent erosion from unprotected areas (See Photos 17 through 20). No documentation provided that noted failure of erosion controls, and no evidence of amendments to the SWPPP to change sediment or erosion controls.

Photos 19-20 taken on April 2, 2014, show lack of effective erosion control BMPs which resulted in discharges observed on March 3, 2014. Photo 19 shows an area at the top of the slope that could have been scheduled to be inactive and stabilized with effective soil cover where the discharge originated. Photo 20 shows the slope where the bonded fiber matrix had been washed away and evidence of erosion can be observed. Additional gravel bags placed at perimeter, but bonded fiber matrix slope cover not repaired, and additional erosion controls not observed to be implemented on the slope or at the top of the slope.

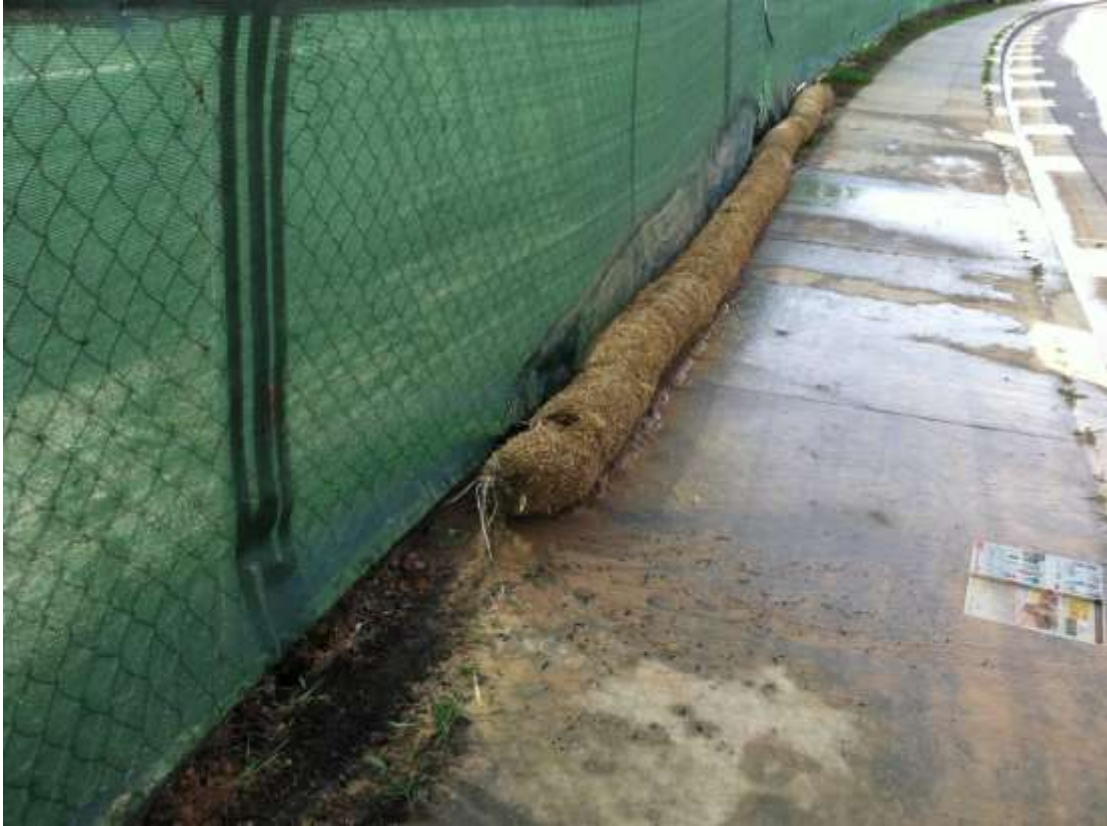
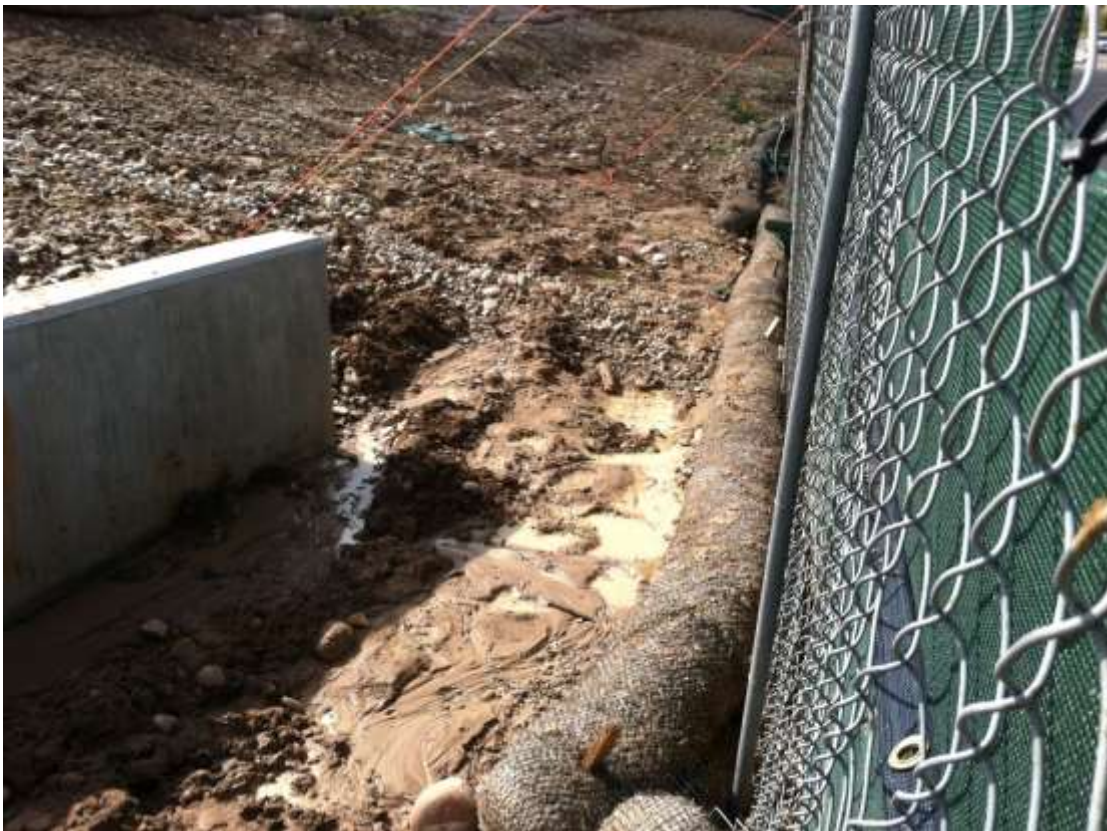
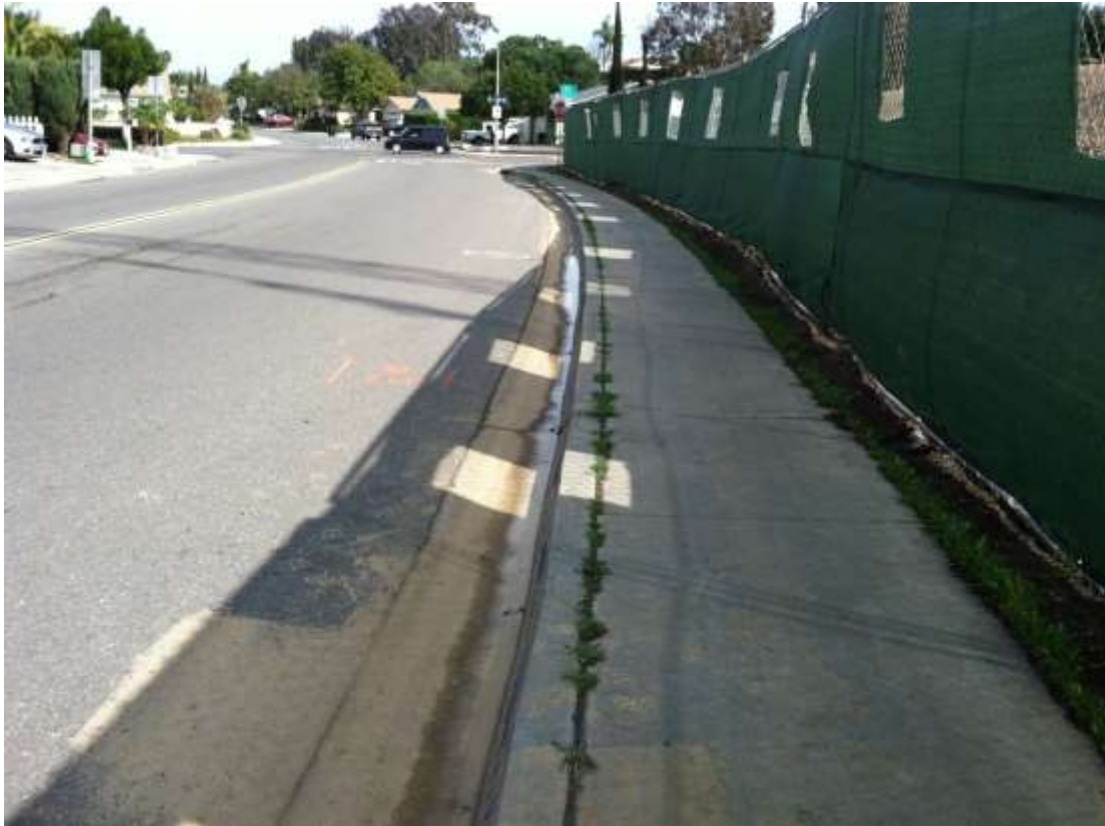
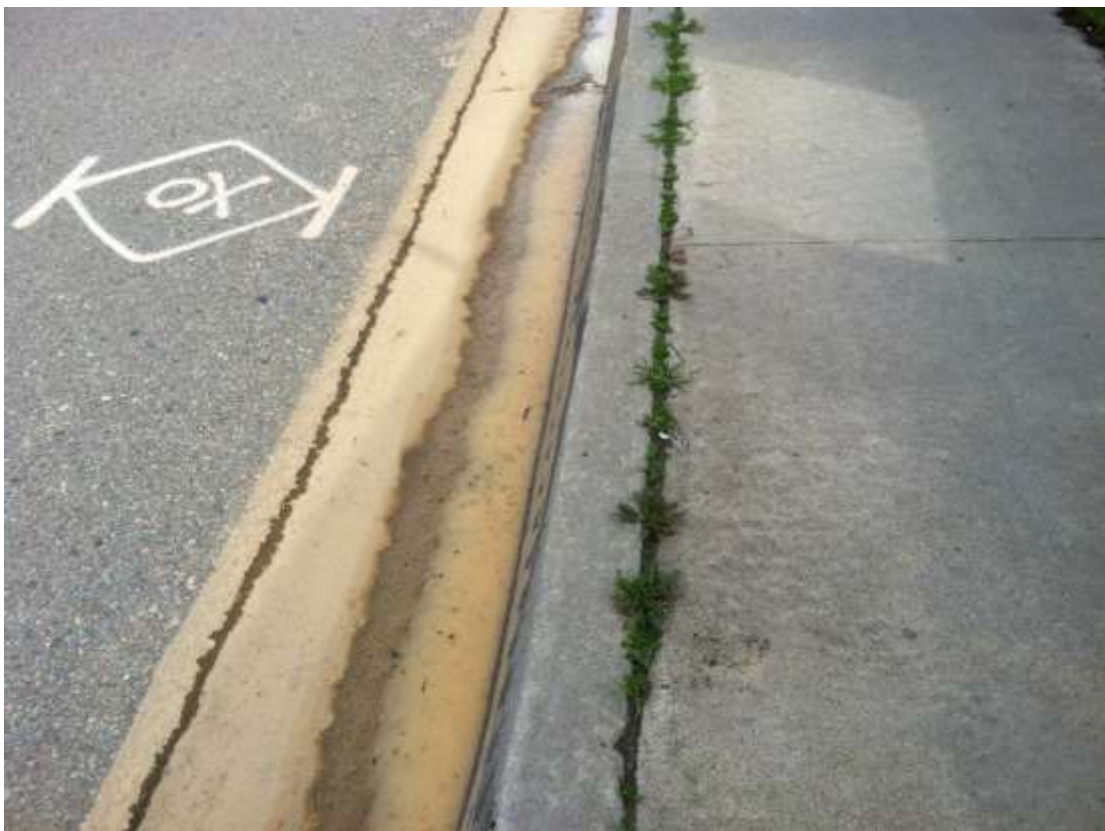
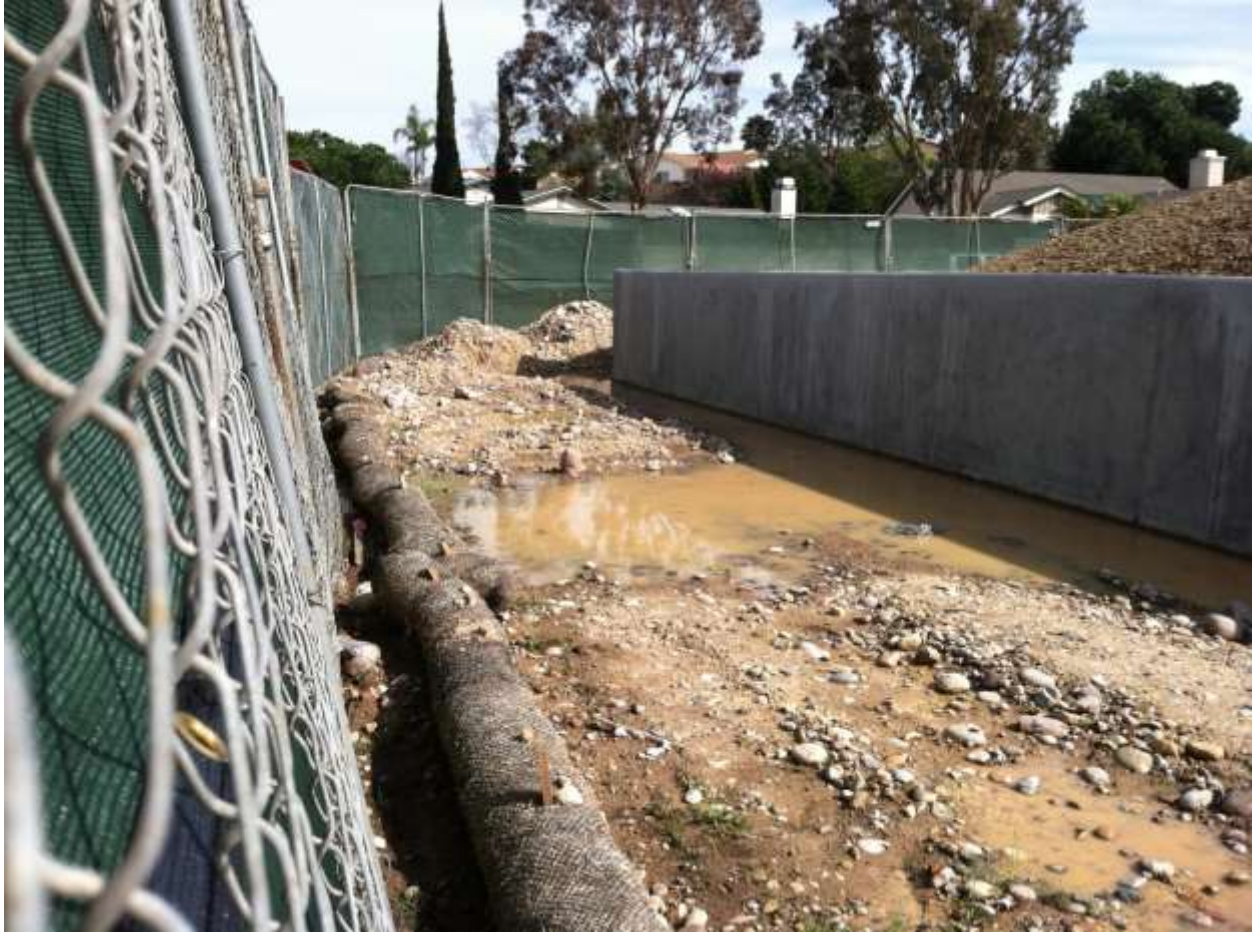
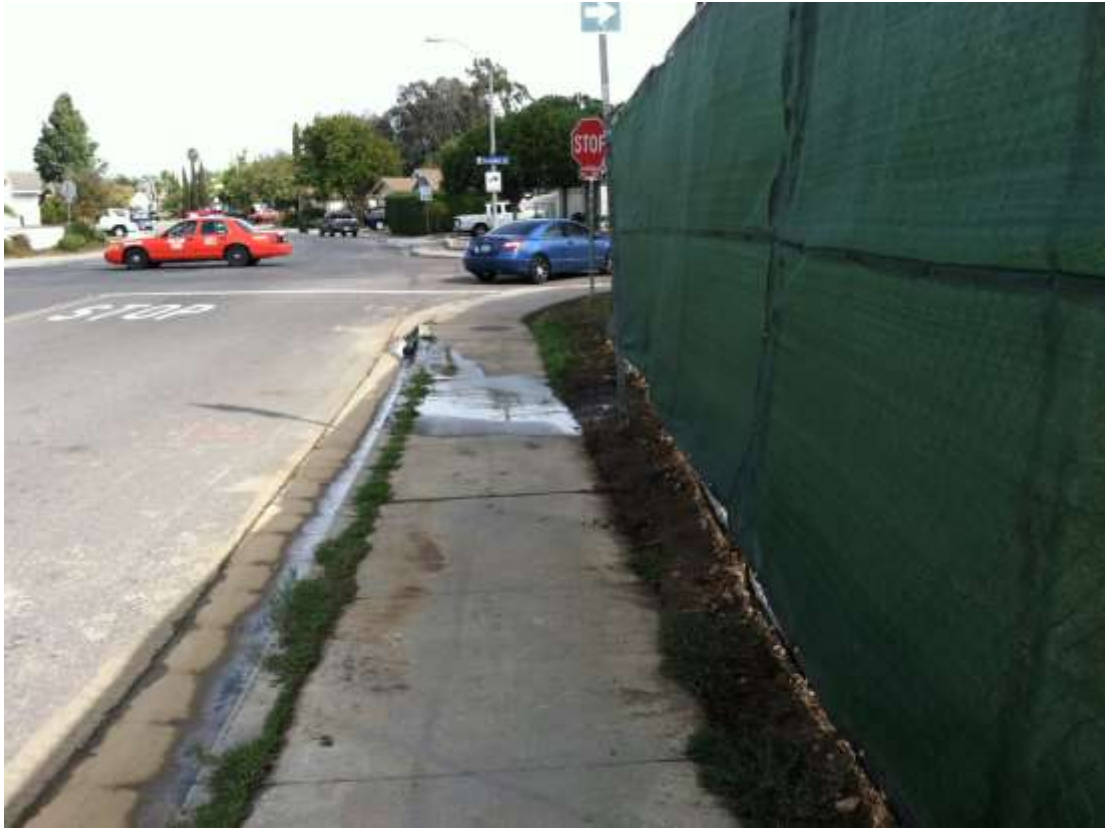
Photos from
March 3, 2014 Inspection

On March 3, 2014, following a storm event that took place between February 26 to March 2, 2014, the San Diego Water Board inspector conducted a drive by inspection of the site and observed evidence of sediment and sediment-laden water discharged from the site (see Attachment 1). The discharges appeared to be due to the lack of erosion control BMPs for several inactive areas.
