California Regional Water Quality Control Board, San Diego Region

Subject: Notice of Violation No. R9-2014-0024, City of San Diego Construction Management Program, NPDES Order Nos. R9-2013-0001 and R9-2007-0001, Municipal Storm Water Permits

**NOTICE OF VIOLATION
No. R9-2014-0024**

Facility: Torrey Hills Unit 19
Inspection Date: 09/20/2013

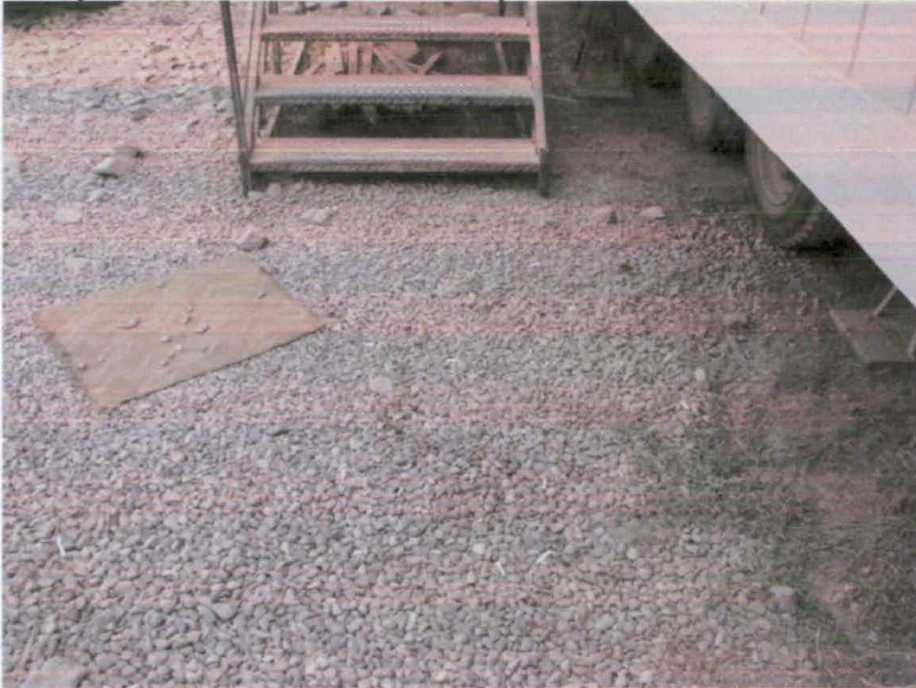
Figure 1. Trailer entrance; cigarette butts

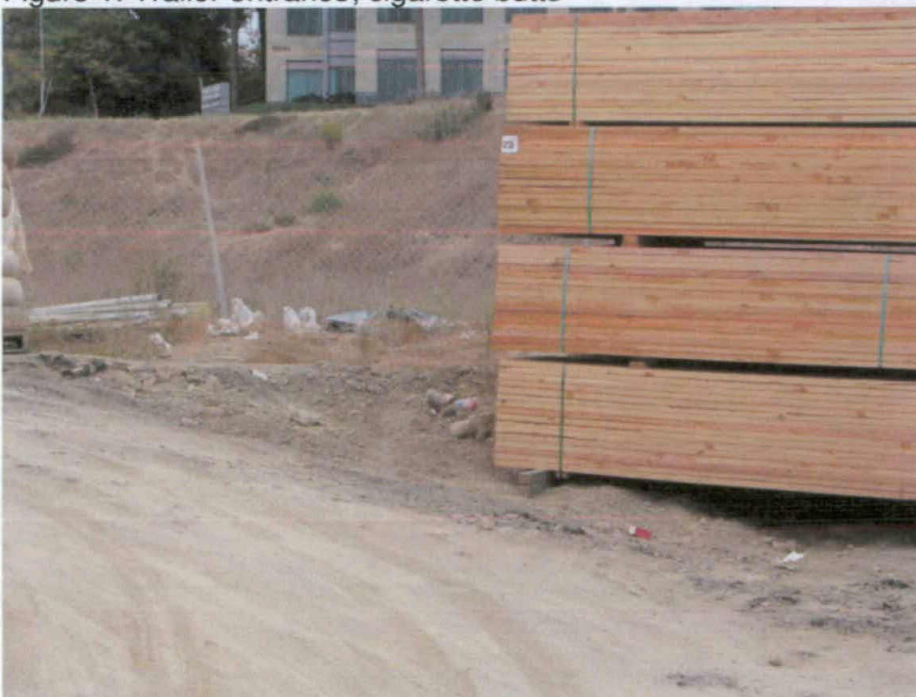
Figure 2. Near south entrance; trash area

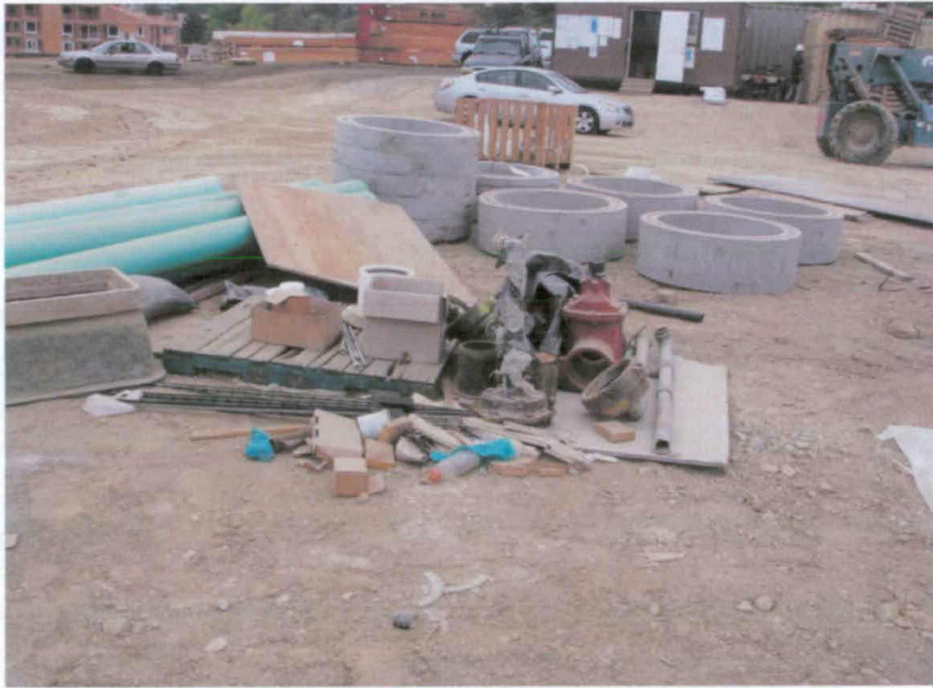
Figure 3. Site interior; construction debris

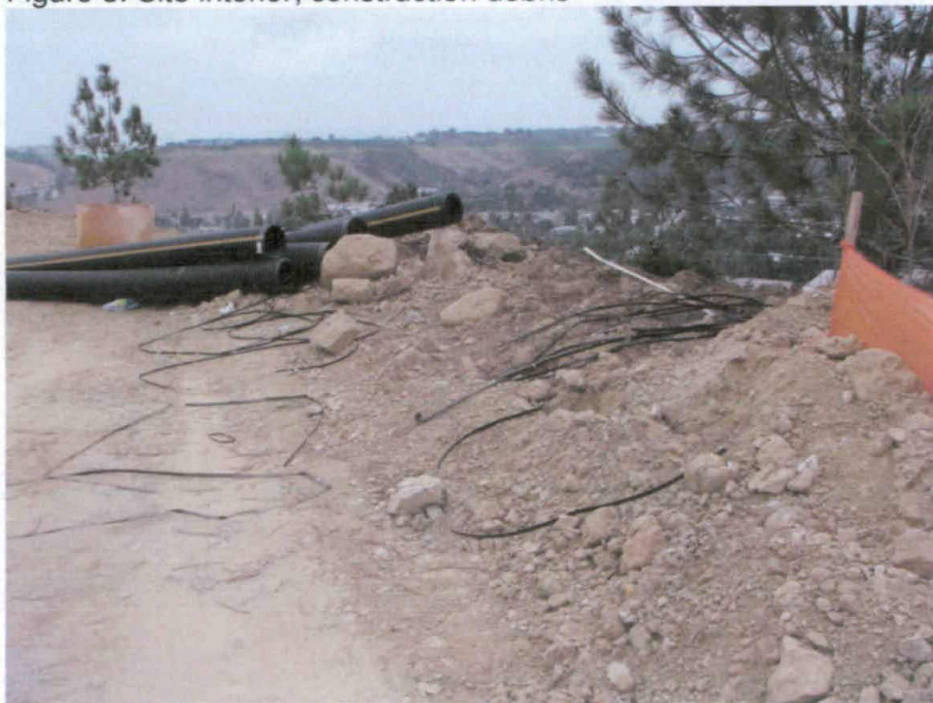
Figure 4. South west side; construction debris

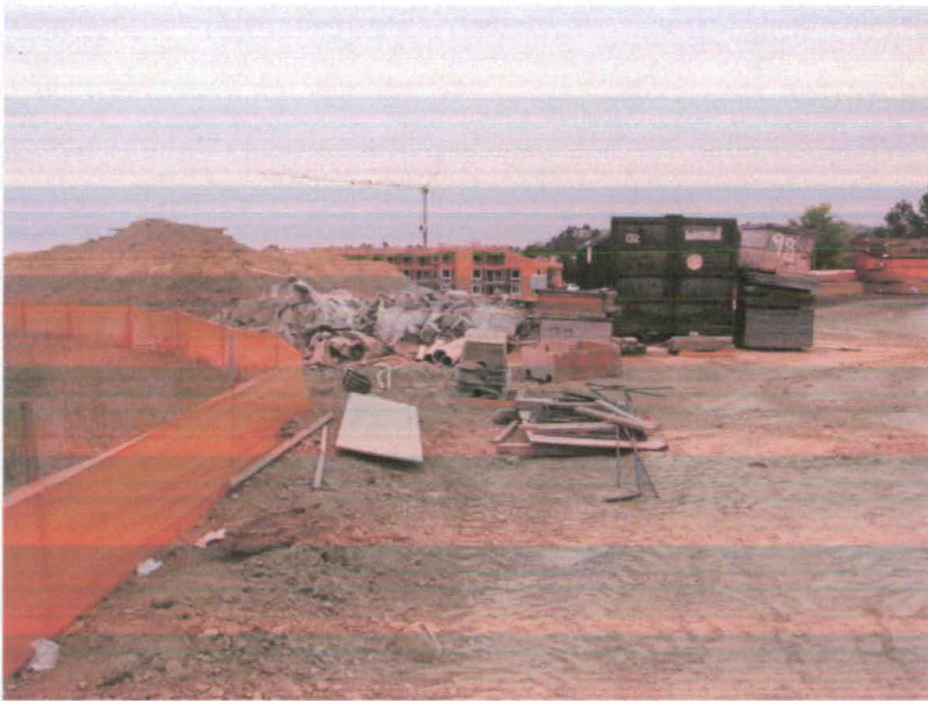
Figure 5. Site interior; construction debris

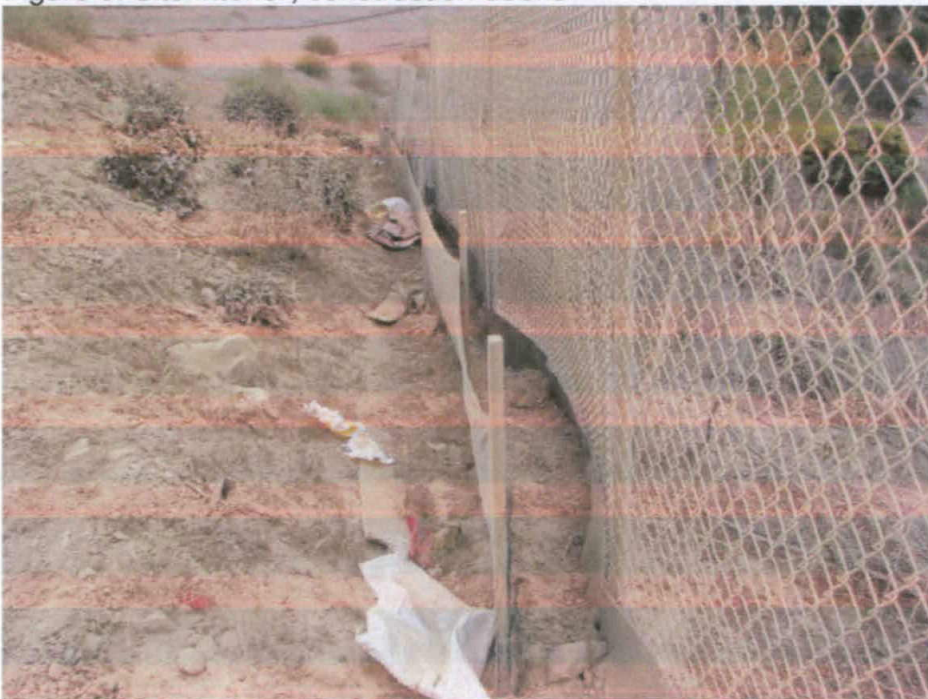
Figure 6. West perimeter; trash

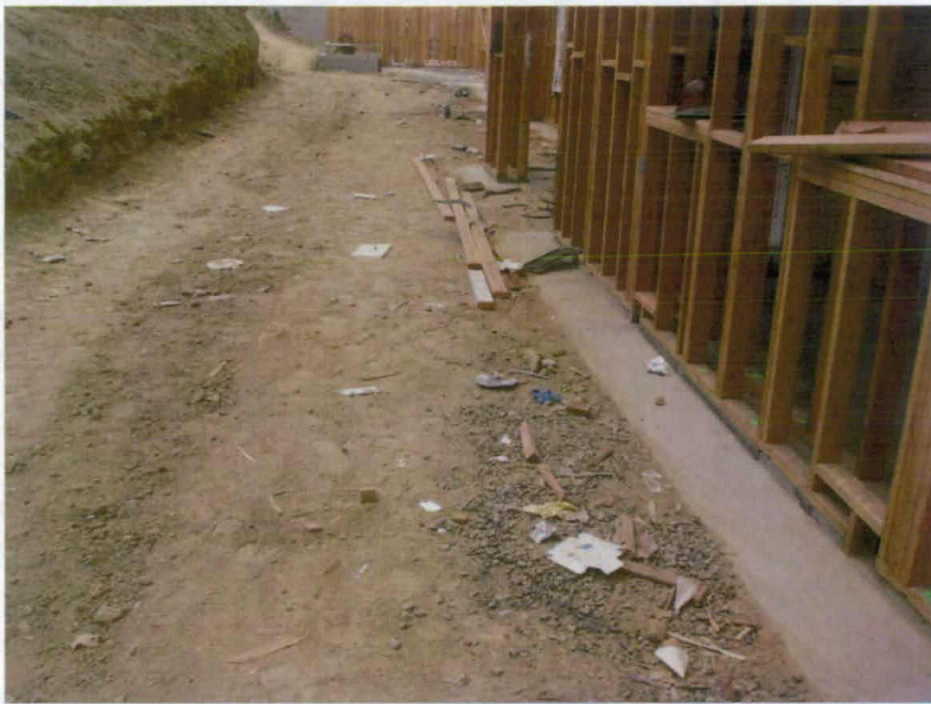
Figure 7. Site interior; trash

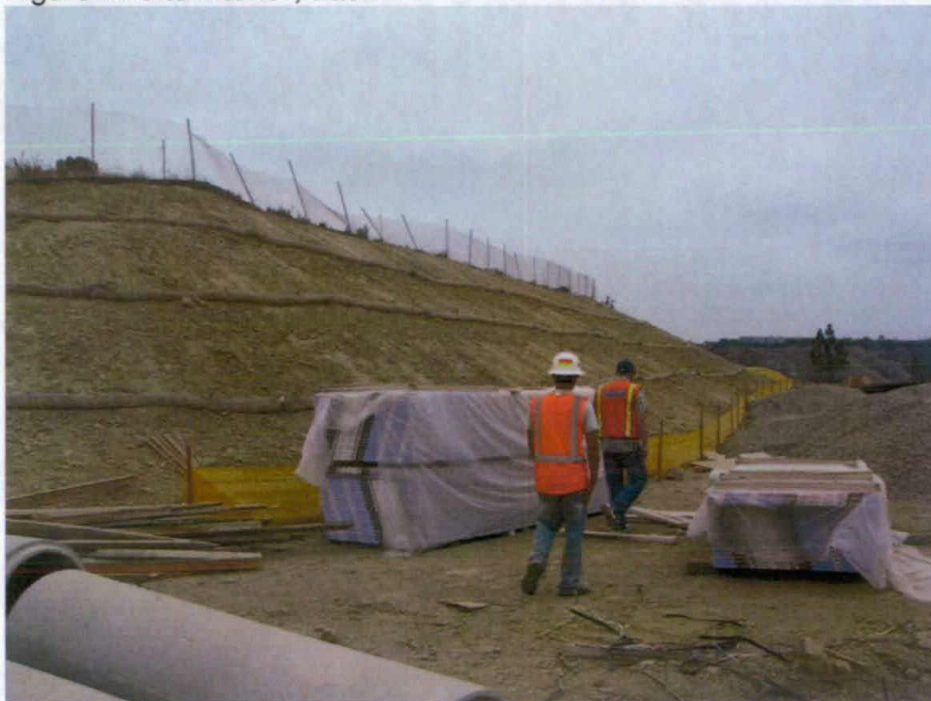
2. The site had inadequate erosion control and sediment control BMPs throughout the site.
3. The steep slopes on the east side of the site had fiber rolls and a silt fence at the toe of the slope. However, there was no erosion control. The slopes were bare and require erosion control BMPs because they are at risk for mobilization during a heavy rain (Figure 8).

Figure 8. Slope east side; bare soil

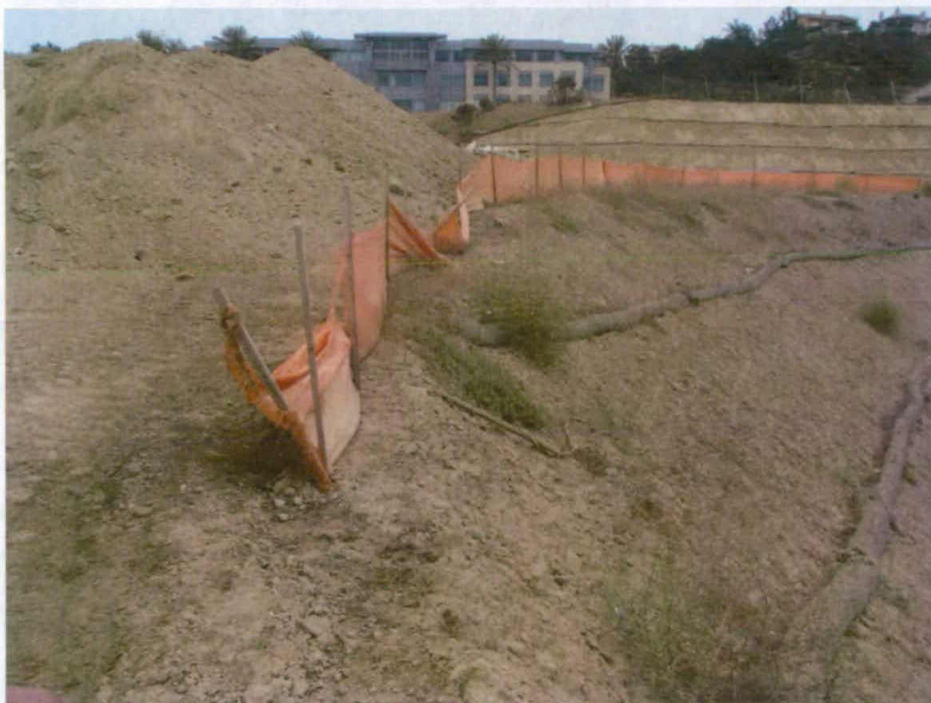
4. There is a stockpile located next to a steep slope. The silt fence between the stockpile and slope is in need of repair (Figures 9). Mr. Do was unaware of when the adjacent/downstream slope had been last sprayed with hydroseed.

Figure 9. Sediment stockpile with broken silt fence

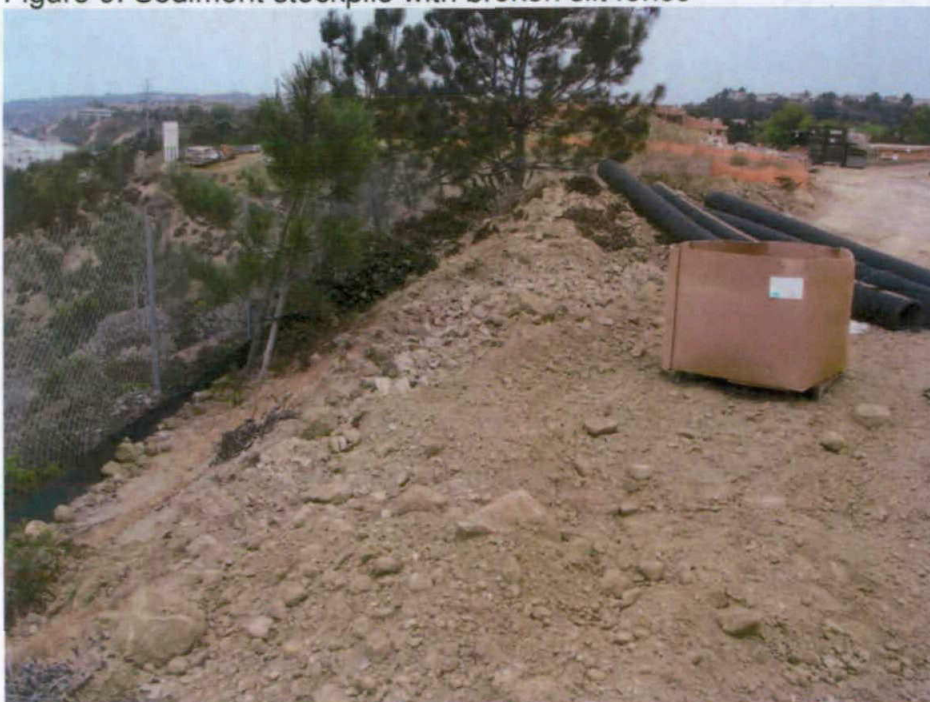
5. The site generally slopes towards the westerly direction. The perimeter controls along the west side were inadequate for containing the sediment within the construction site (Figures 10-12). There was evidence of a sediment discharge from the site and onto the adjacent downstream property (Figure 12).

Figure 10. Perimeter south west side

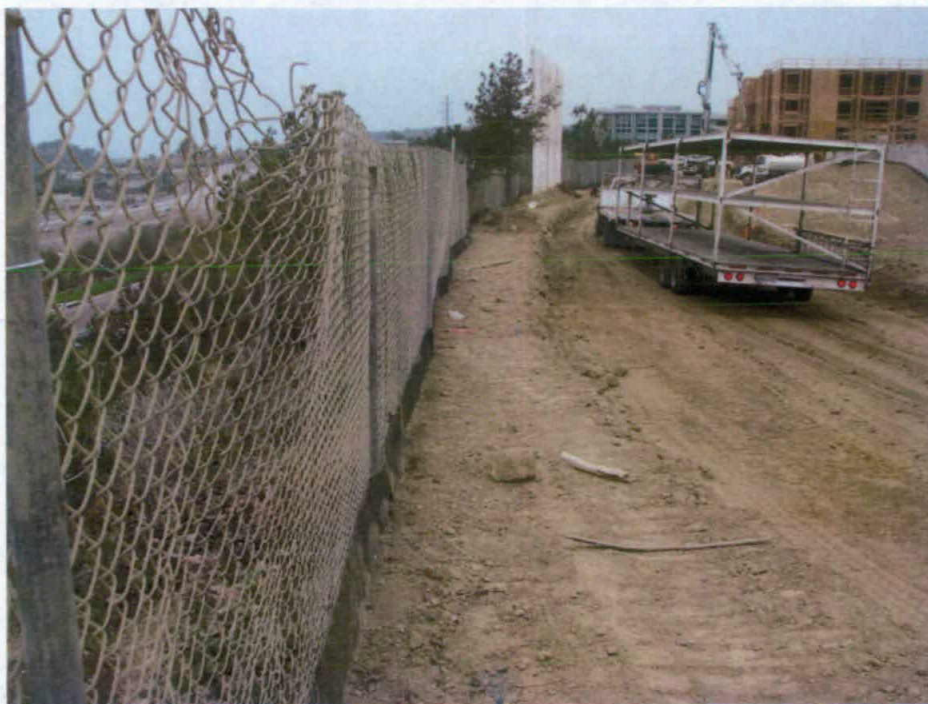
Figure 11. Perimeter west side

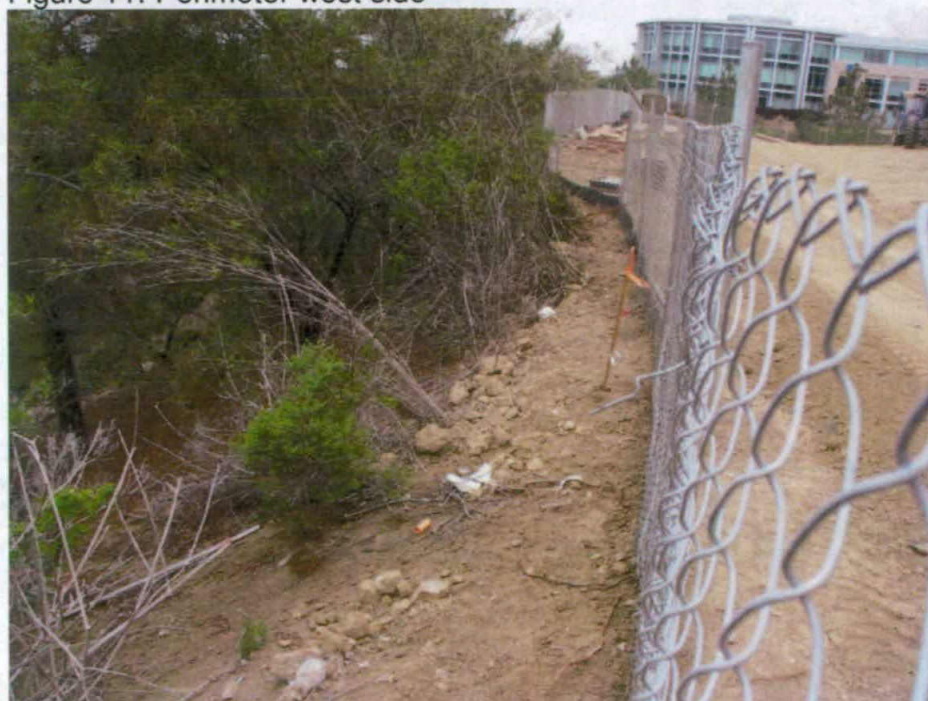
Figure 12. Sediment discharge outside site boundary

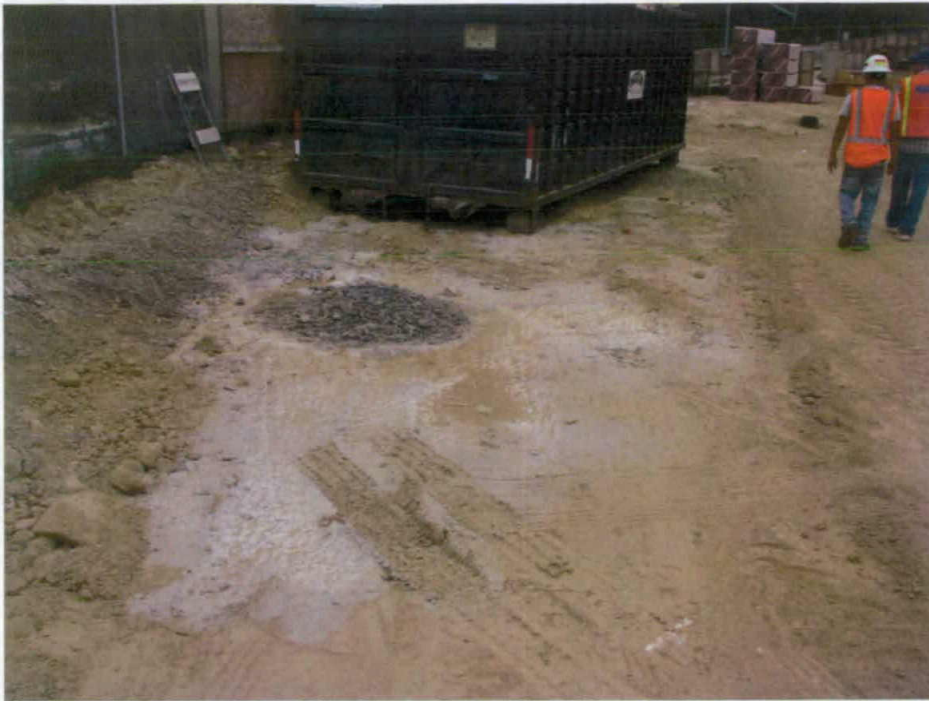
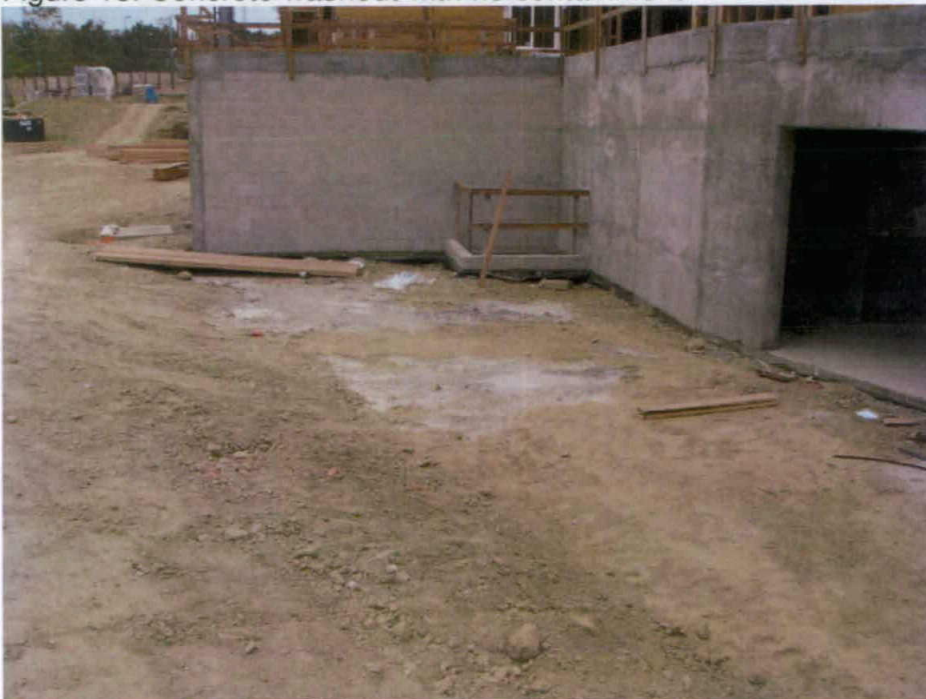
Figure 13. Concrete washout with no containment

Figure 14. Concrete washout with no containment

5. A designated concrete washout area for the site must be established and used. Concrete must not be allowed to come into contact with bare ground.
6. Site entrance/exit BMPs are inadequate and require maintenance.

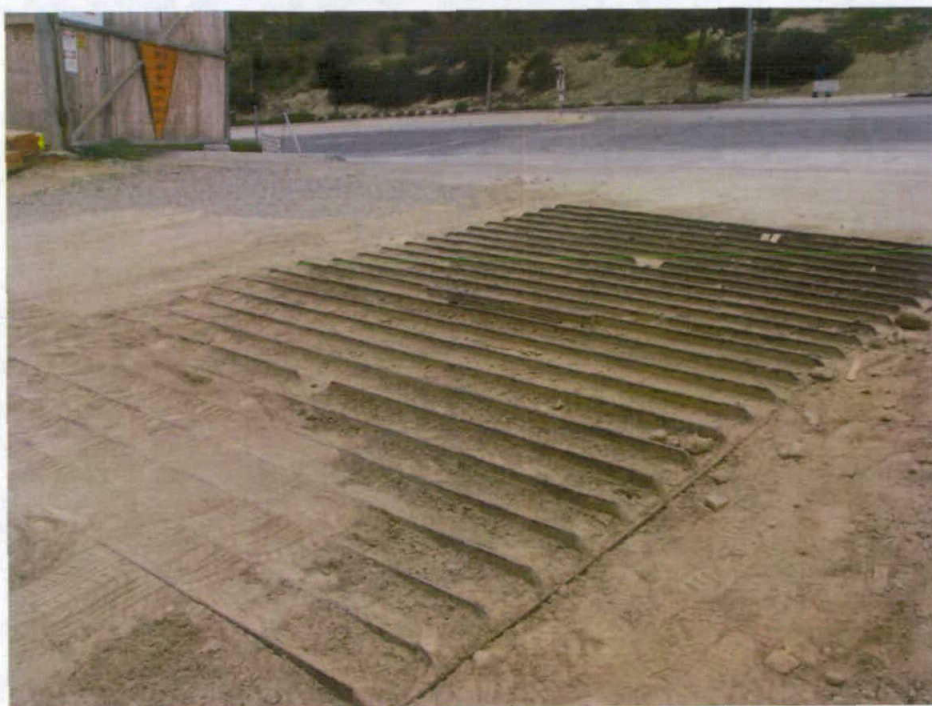
Figure 15. Shaker plates north entrance

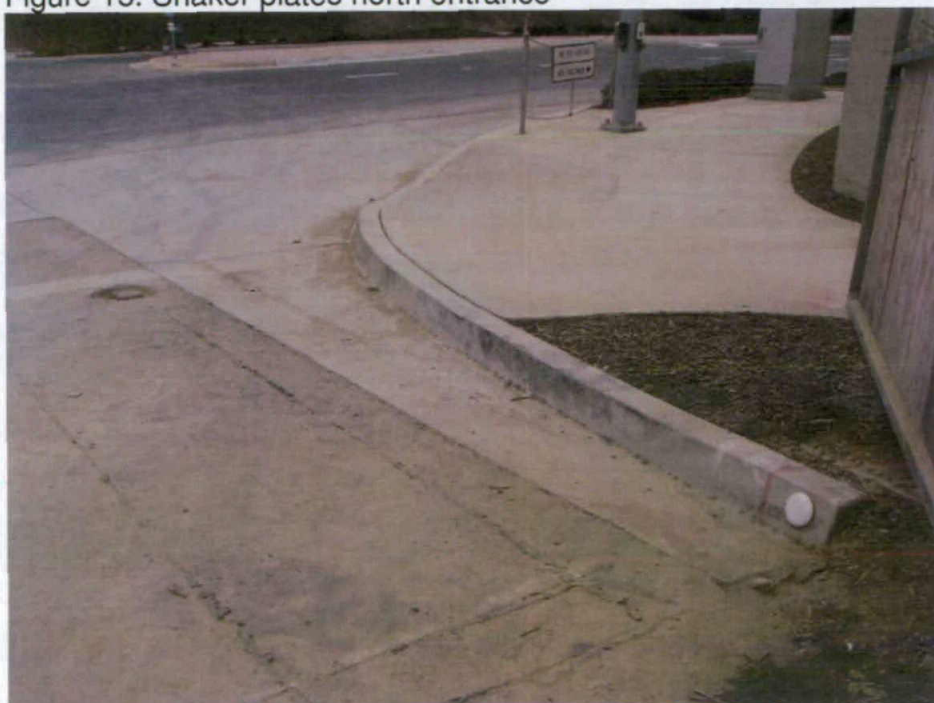
Figure 16. Public street outside construction site

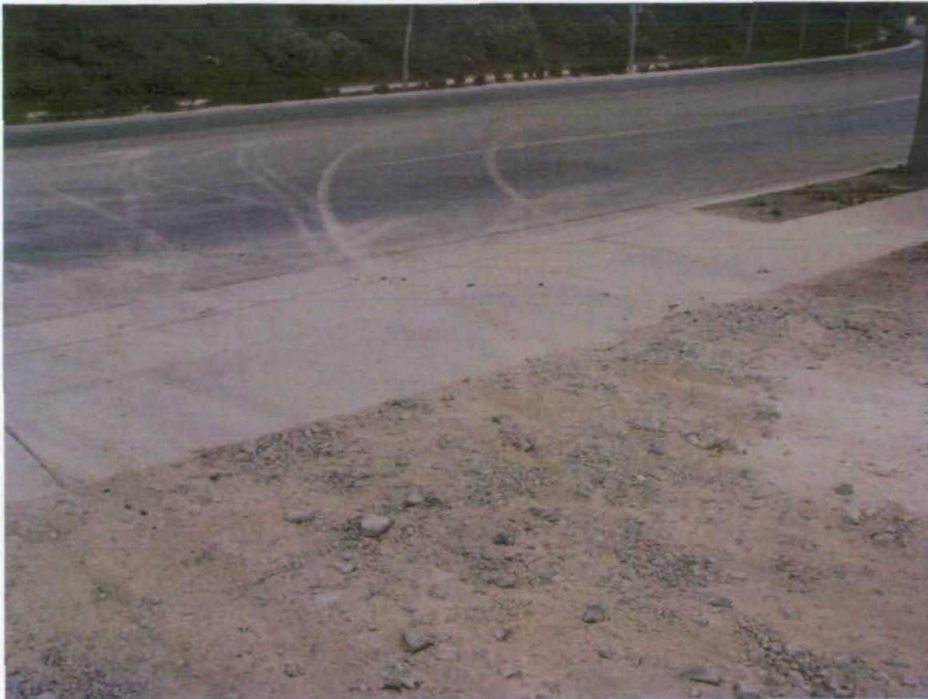
Figure 17. Gravel at south entrance

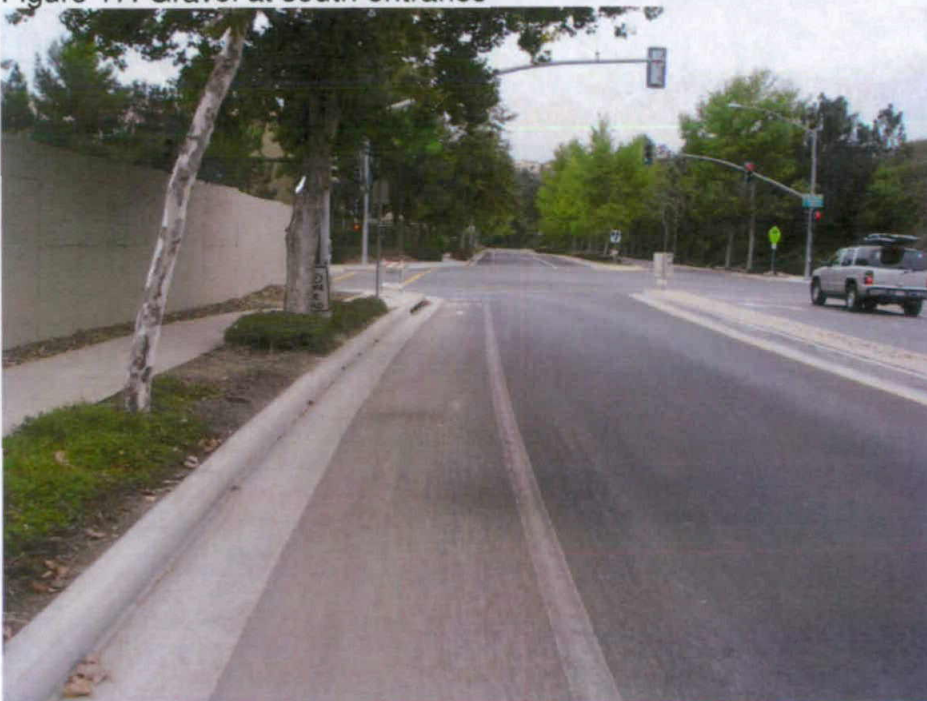
Figure 18. Nearest storm drain downstream; no inlet protection

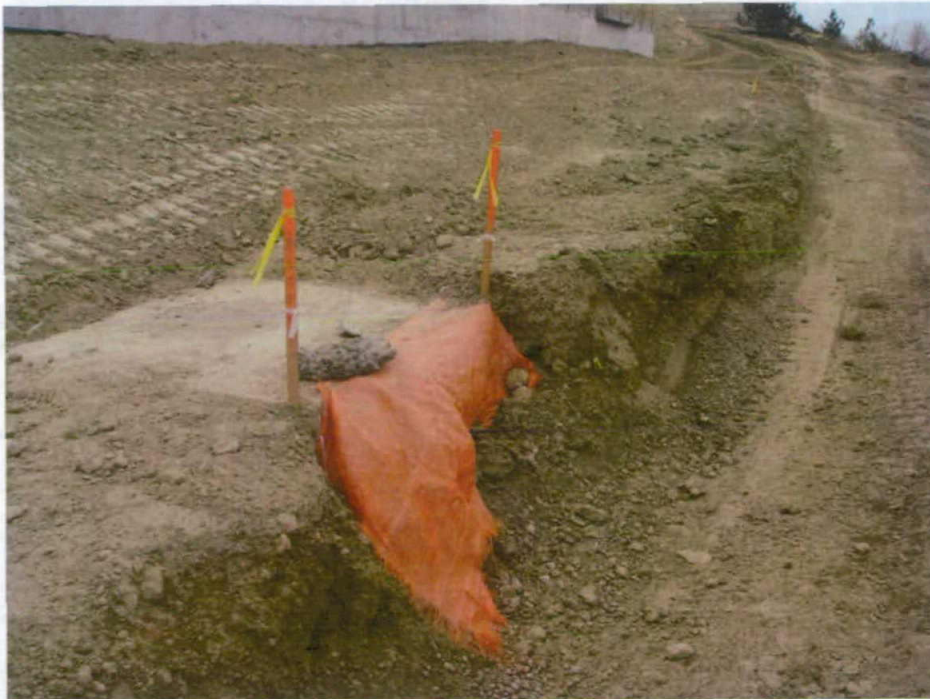
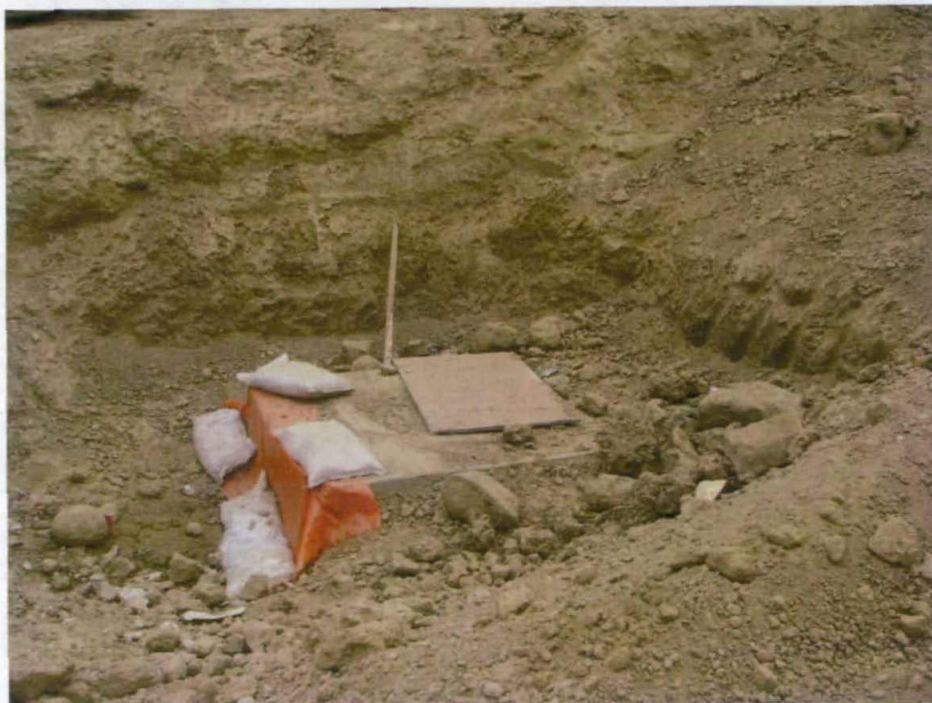
Figure 19. Live storm drain covered with permeable fabric

Figure 20. Live storm drain covered with permeable fabric

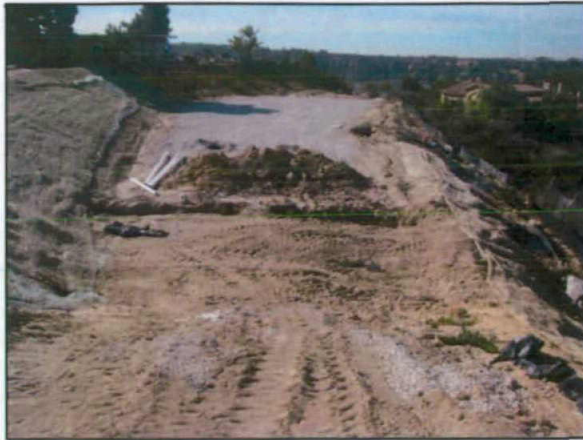
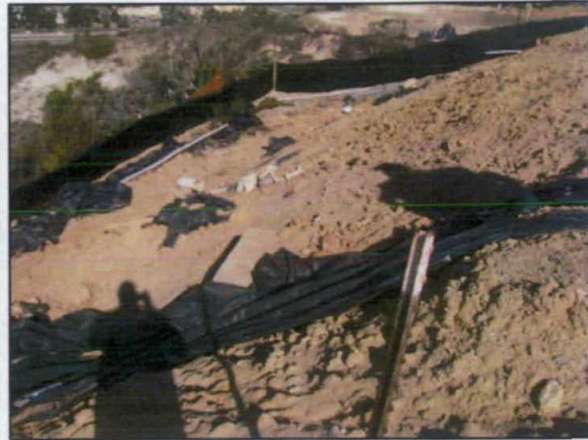
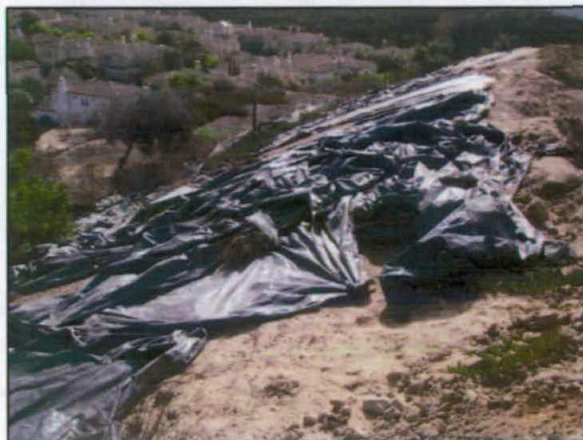
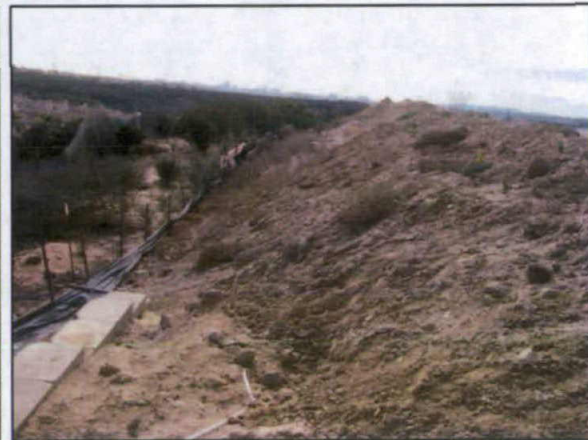
- a. Several slopes located in the interior and exterior of the site appeared to be inactive and had inadequately implemented, inadequately maintained, or did not have erosion control BMPs to provide effective soil cover and stabilization (see Photos 1-4);

- d. Linear sediment controls were not observed along the toe of slopes and grade breaks of exposed slopes, as required for Risk Level 2 sites (see Photos 1-4)

Photos 1-4 show lack of erosion and sediment control BMPs required to be implemented by Risk Level 2 dischargers for slopes throughout the site.

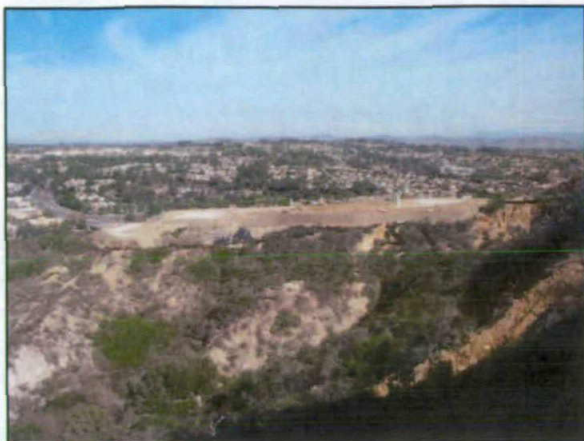
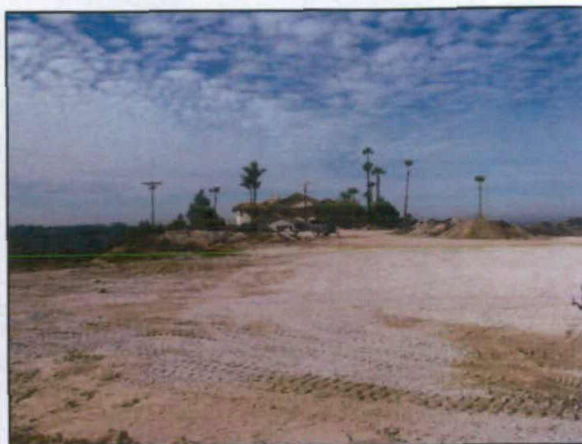
- b. Most of the building pads appeared to be inactive and had a layer of gravel, but no erosion control BMPs (e.g. soil binder, bonded fiber mulch) providing effective soil cover were observed (see Photos 1, 5 and 6);

Photos 5-6 show lack of erosion control BMPs implemented to provide effective soil cover for building pads that appears to be inactive at the site (also see Photo 1).

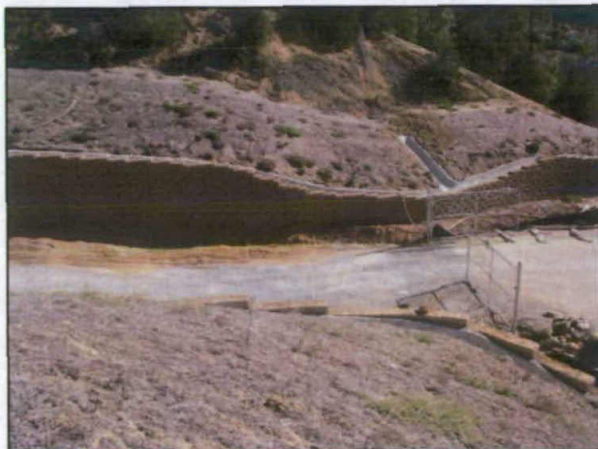
- e. Silt fence was observed around the perimeter of the site, but did not appear to be adequately maintained to sufficiently control erosion and sediment discharges from the site (see Photos 4 and 7); and

Photo 7 shows the entrance/exit to site lacking adequate stabilization to control erosion and sediment discharges from the site, and lack of BMPs to prevent tracking of sediment from the site.

5. Refresh or replace rock and/or place additional BMPs (e.g., shaker plate or rumble strip, stone pads, concrete or steel wash racks) at entrance/exit to site to prevent offsite vehicle tracking of sediment;

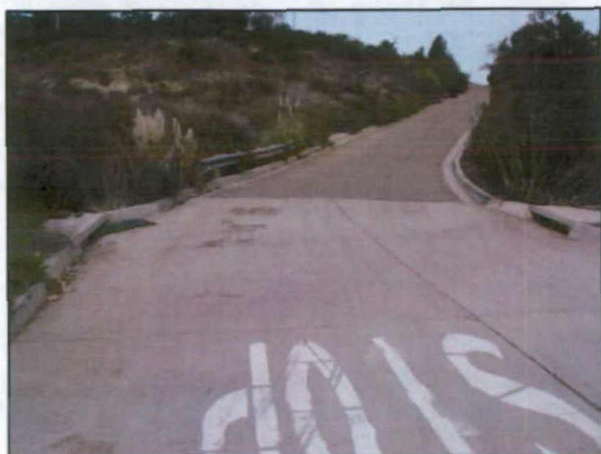
9. Storm drain inlets were inadequately protected, and evidence of sediment in surface runoff discharged from the site leading to the inlets was observed (see Photos 8).

Photo 8 shows lack of BMPs to protect storm drain inlets, with evidence of sediment in surface runoff discharged from the site leading to the inlets.

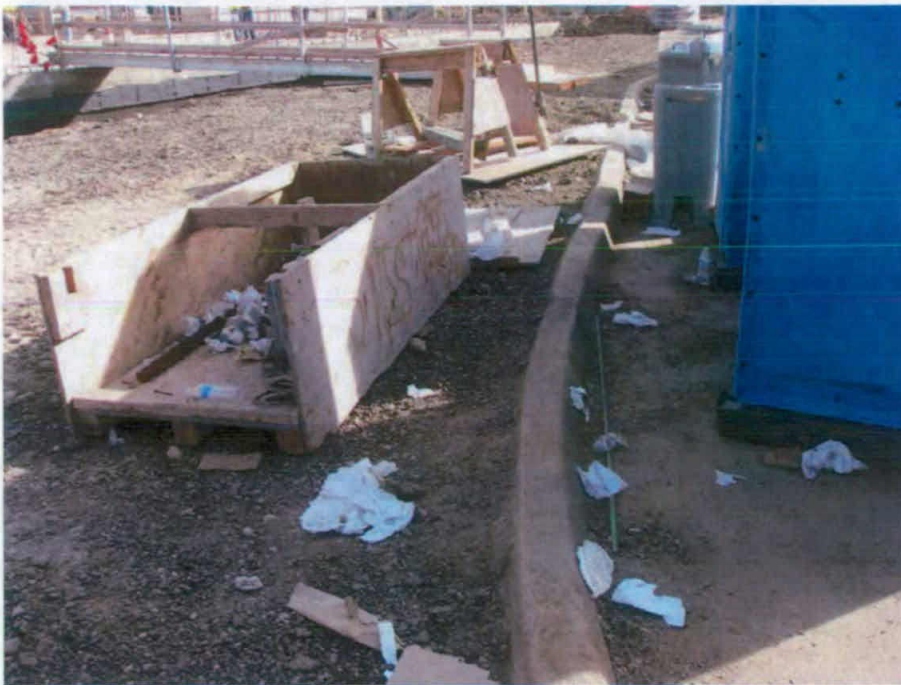
1. The site was littered with cigarette butts, trash, debris, and other construction-related waste throughout. (See Figures 1-4, 14-25).
2. None of the finished curbs within the site had sediment control BMPs (such as silt fence) installed. As a result, the streets were covered in sediment (Figures 1, 3, 16-22).
3. There were no sediment control BMPs at one construction site exit/entrance located on Mira Lee Way, and sediment had been tracked into the street (Figure 5).
4. There was an uncovered stockpile, although it appeared to be active (Figure 6).
5. Two concrete wash-out bins were leaking, and waste material discharged to the surrounding the soil (Figures 7-8).

Figure 3. Site interior; trash

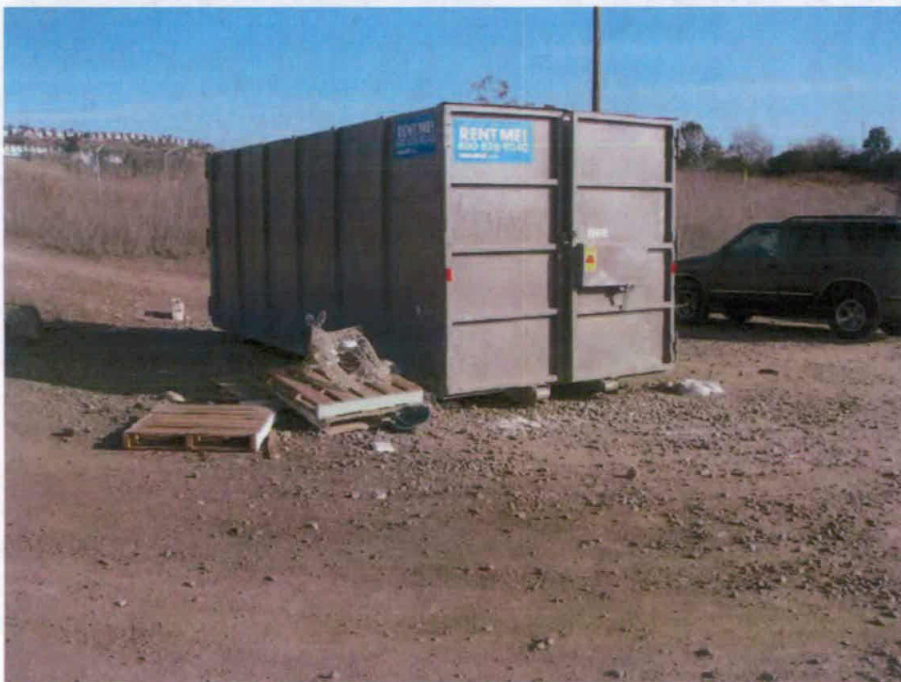
Figure 4. Site interior; construction debris

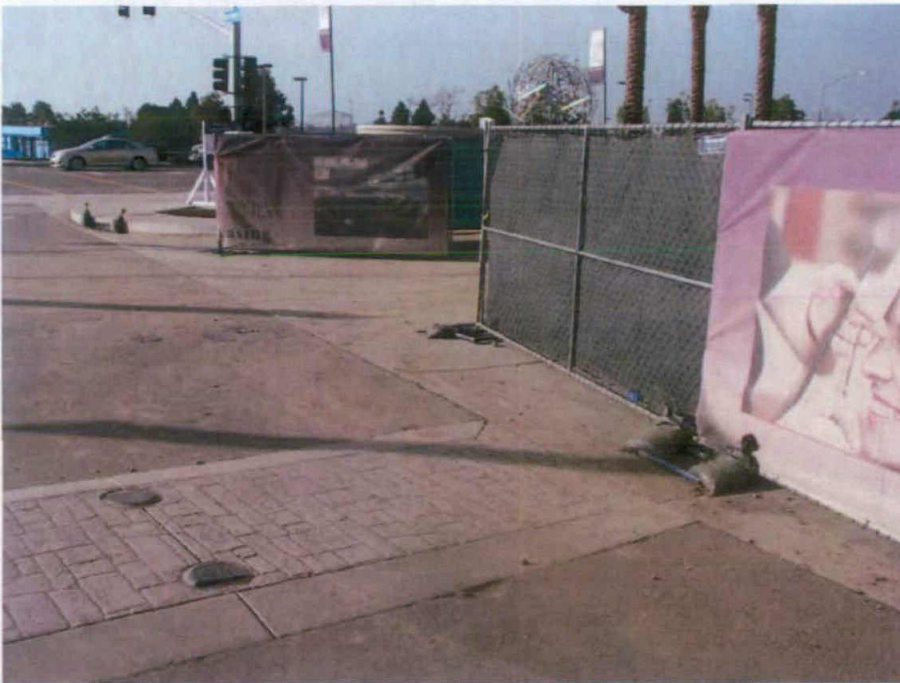
Figure 5. South-facing construction entrance; no BMPs; sediment tracking onto street

5. The concrete washout BMPs must be fixed or replaced to prevent leaks. Concrete waste must not be allowed to come into contact with bare ground.
6. Site entrance/exit BMPs are required.

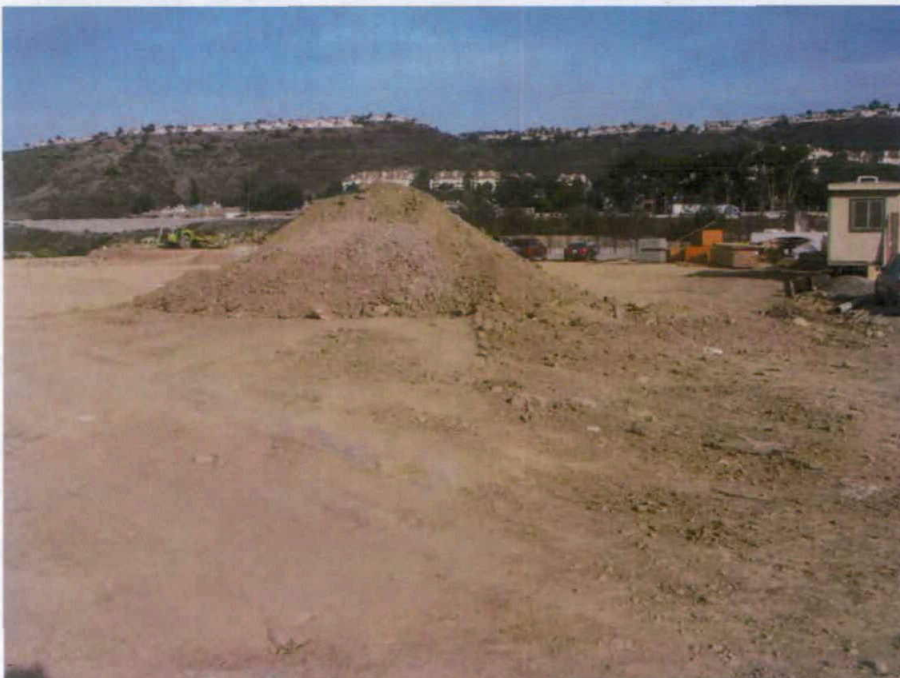
Figure 6. Sediment stockpile

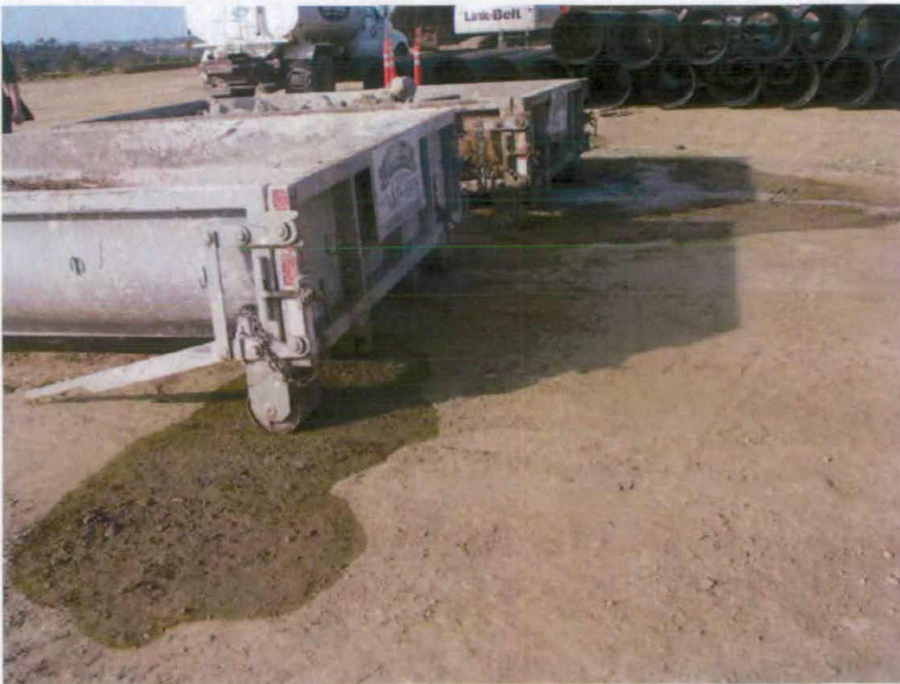
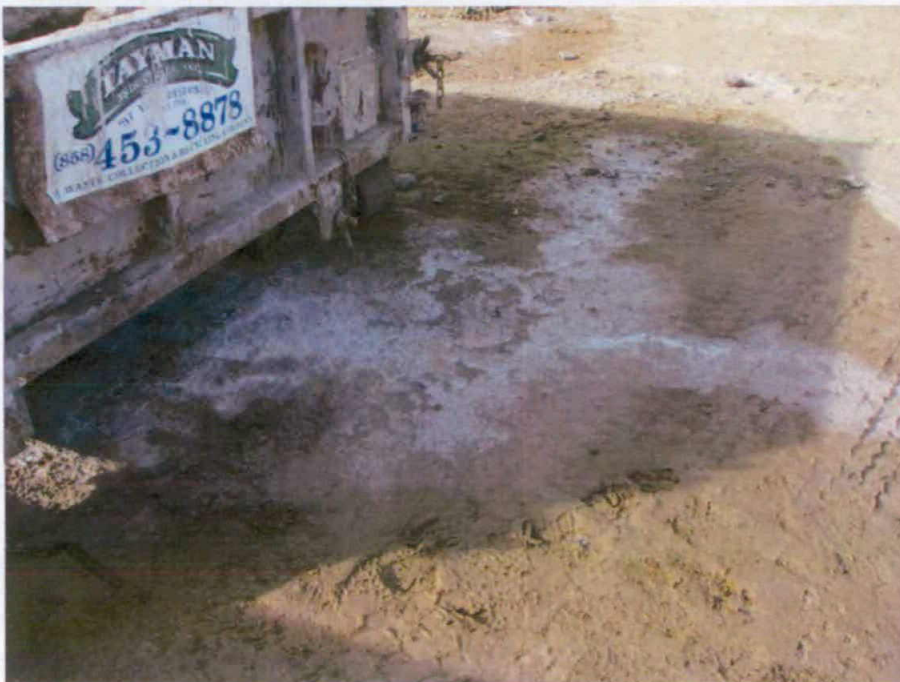
Figure 7. Leaking concrete washouts

Figure 8. Concrete staining on soil from leaking washouts

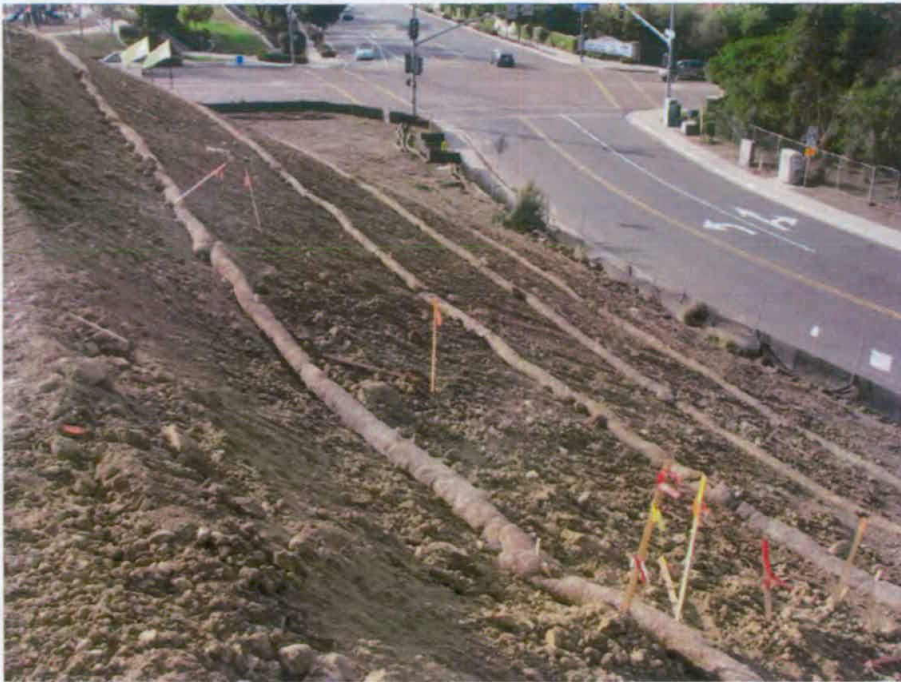
Figure 9. Slope on north side with no erosion control

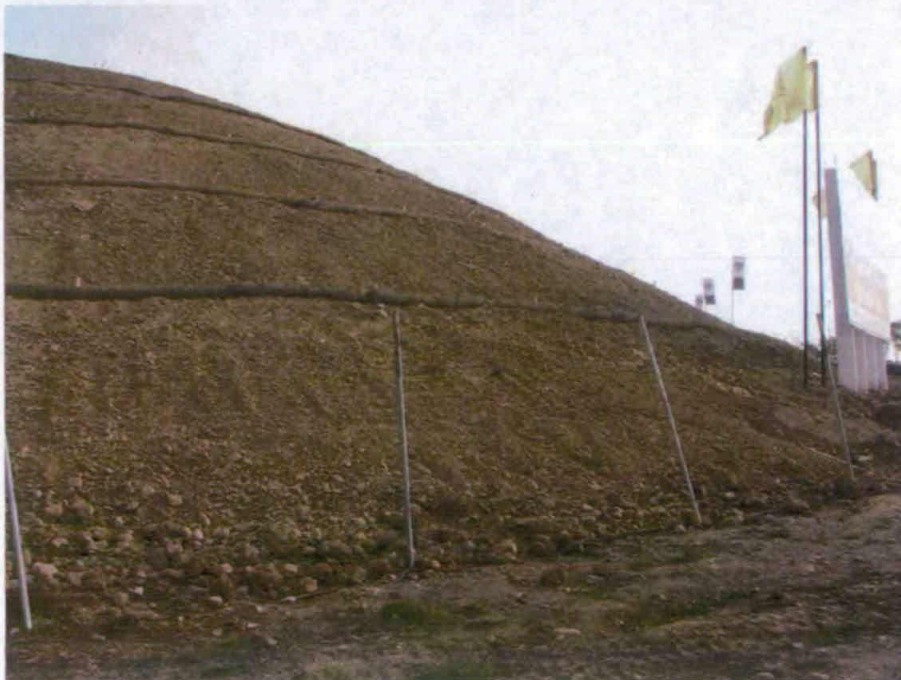
Figure 10. Slope is 2:1 Horizontal: Vertical according to SWPPP

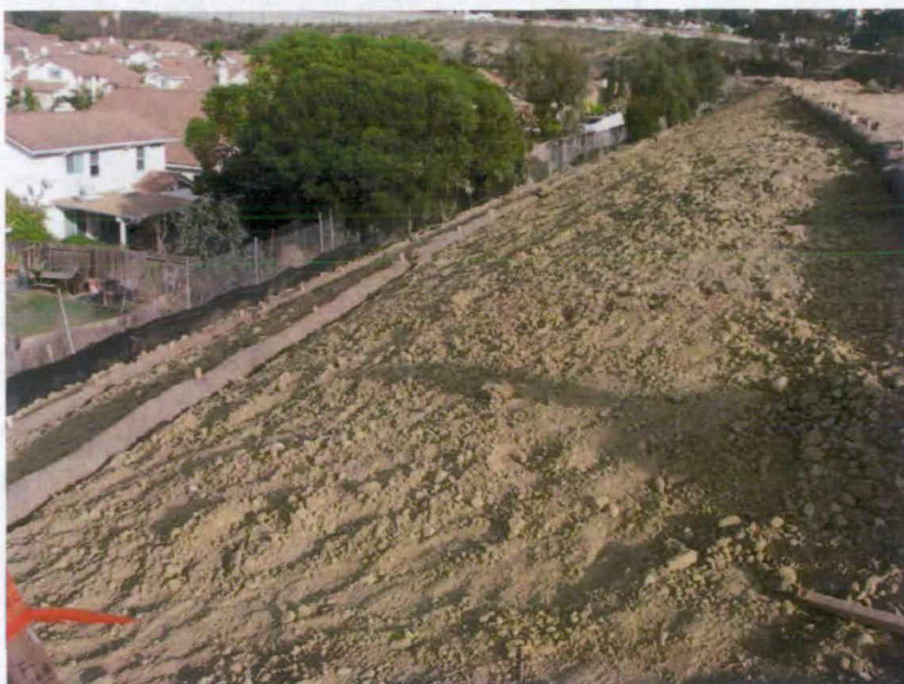
Figure 11. North slope looking easterly

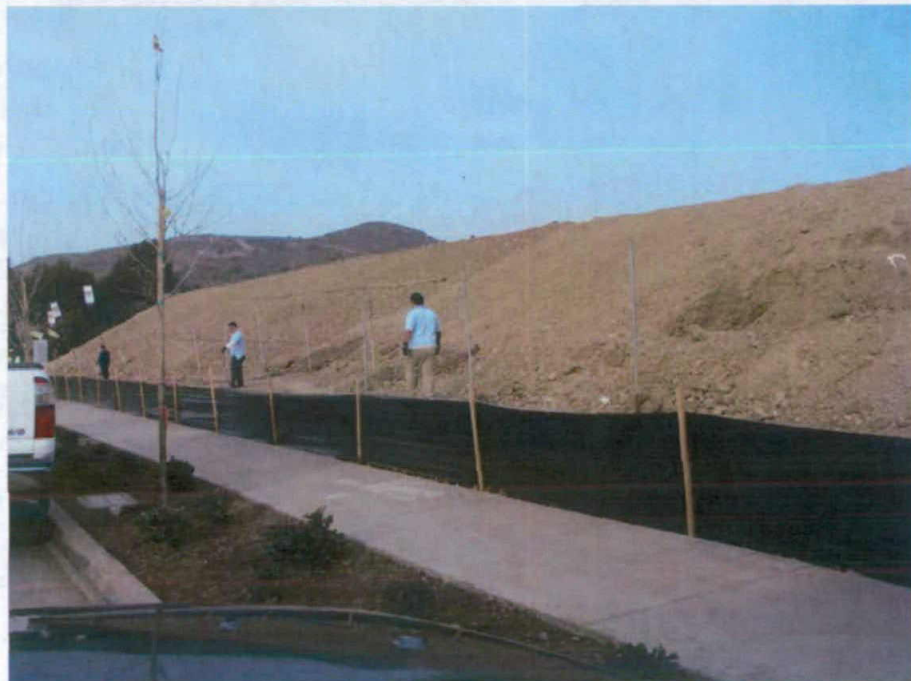
Figure 12. Slope on west side of property
