California Regional Water Quality Control Board, San Diego Region

Subject: Notice of Violation No. R9-2014-0024, City of San Diego Construction Management Program, NPDES Order Nos. R9-2013-0001 and R9-2007-0001, Municipal Storm Water Permits

**NOTICE OF VIOLATION
No. R9-2014-0024**

Facility: Torrey Hills Unit 19
Inspection Date: 09/20/2013

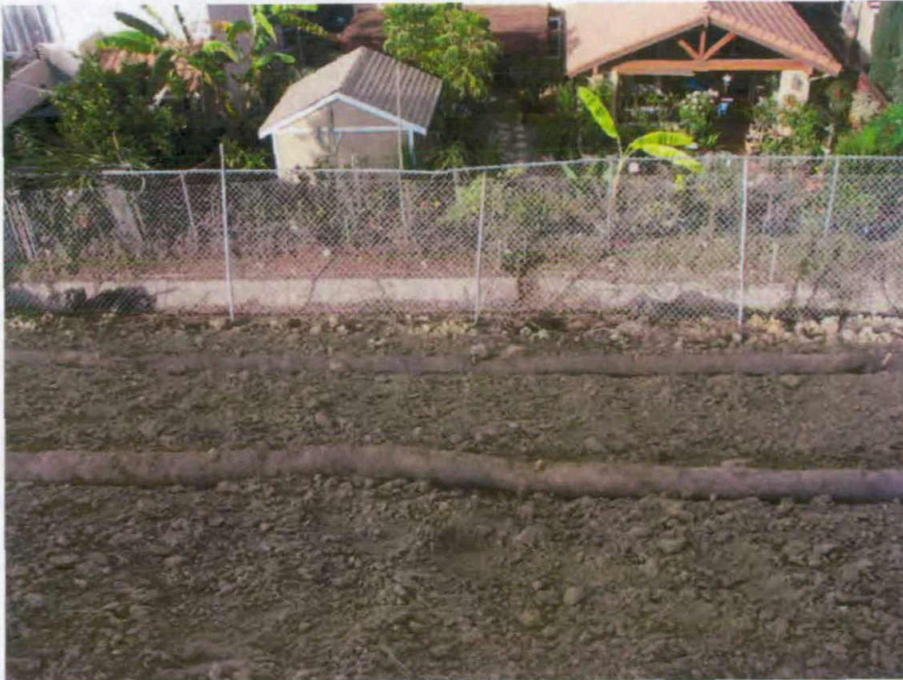
7. The silt fence along the north side of the property had fallen and was in need of repair (Figure 13).
8. Sediment control BMPs throughout the site need replacement or had not been maintained. Examples include broken gravel bags (Figure 22).

Figure 13. Damaged silt fence

3. All sediment control BMPs must be adequately maintained. The silt fence on the north side of the property requires replacement.
4. Sediment control BMPs such as silt fence should be installed at finished curbs to prevent sediment from reaching the streets.

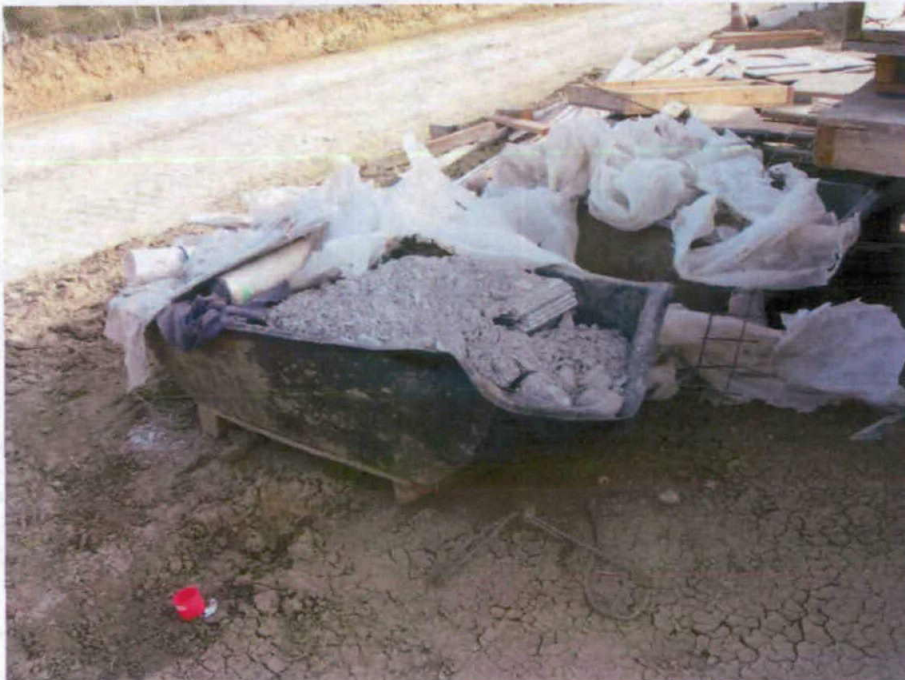
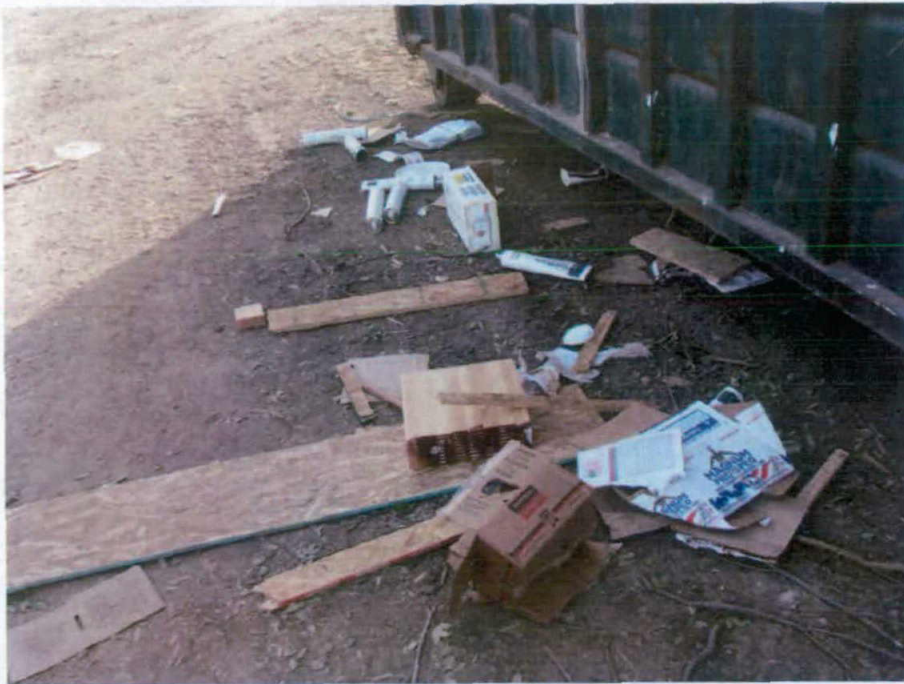
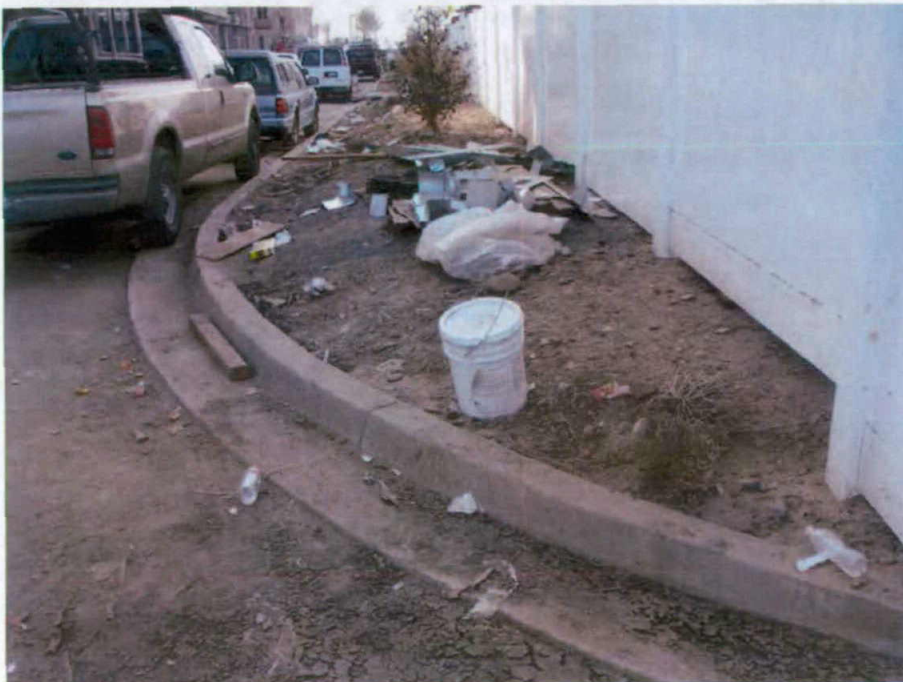
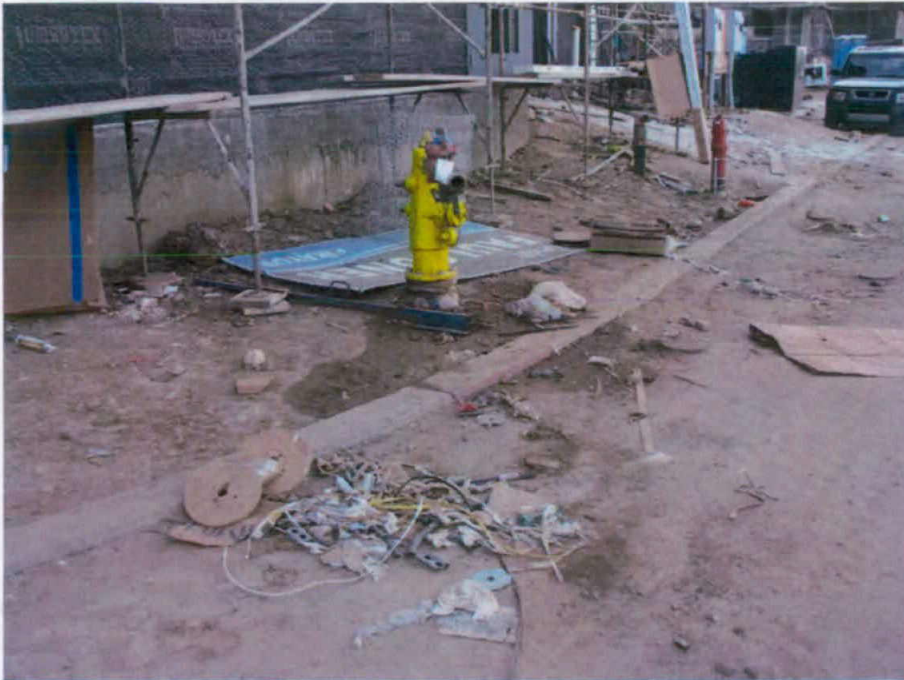
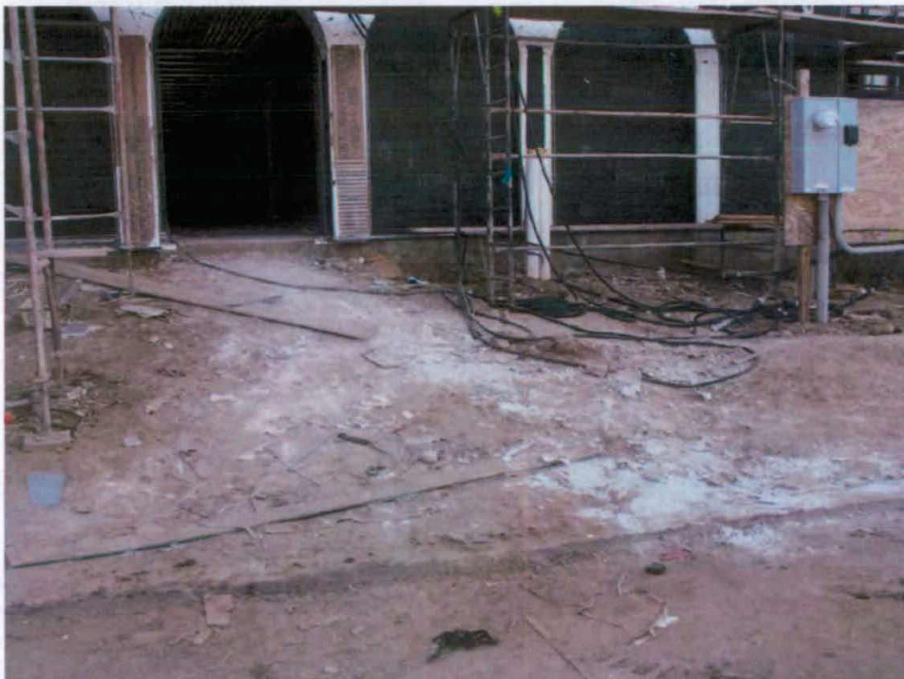
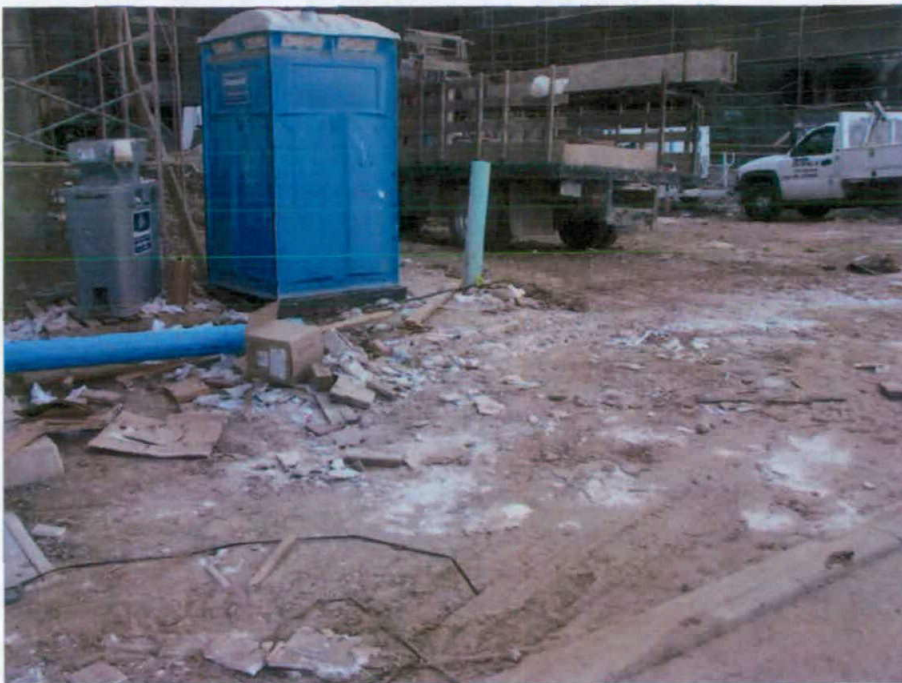
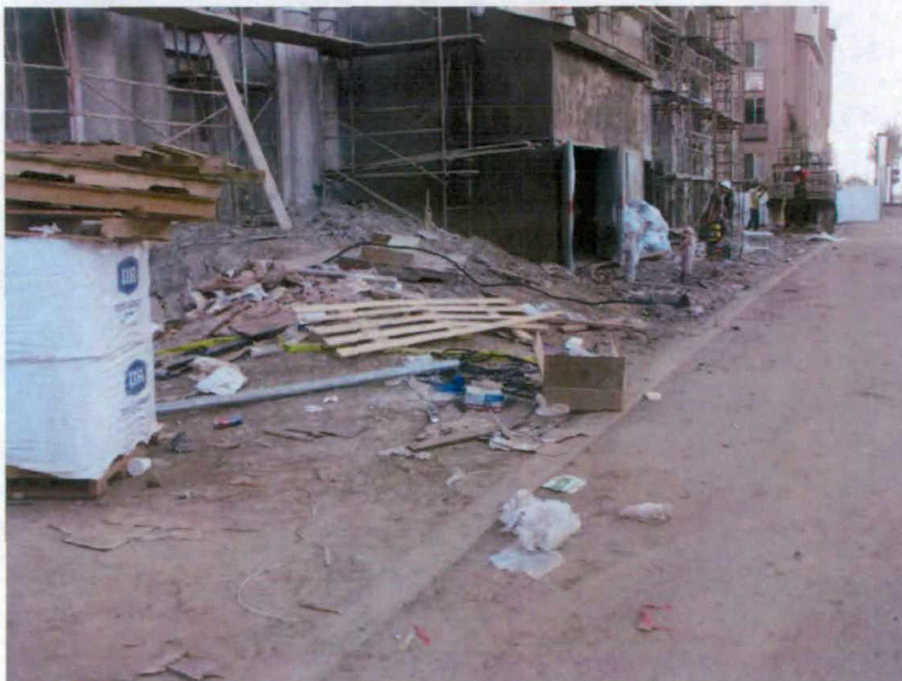
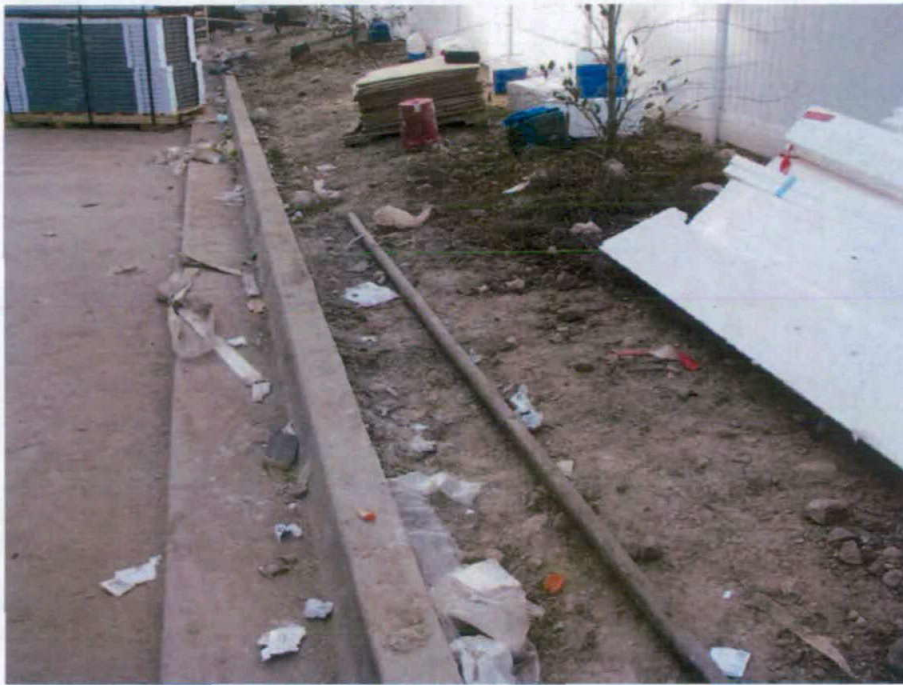
1. The site was littered with cigarette butts, trash, debris, and other construction-related waste throughout. (See Figures 1-4, 14-25).
2. None of the finished curbs within the site had sediment control BMPs (such as silt fence) installed. As a result, the streets were covered in sediment (Figures 1, 3, 16-22).
3. There were no sediment control BMPs at one construction site exit/entrance located on Mira Lee Way, and sediment had been tracked into the street (Figure 5).
4. There was an uncovered stockpile, although it appeared to be active (Figure 6).
5. Two concrete wash-out bins were leaking, and waste material discharged to the surrounding the soil (Figures 7-8).

Figure 14. Construction debris

Figure 15. Construction debris

Figure 16. Construction debris

Figure 17. Construction debris

Figure 18. Construction debris

Figure 19. Construction debris

Figure 20. Construction debris

Figure 21. Construction debris

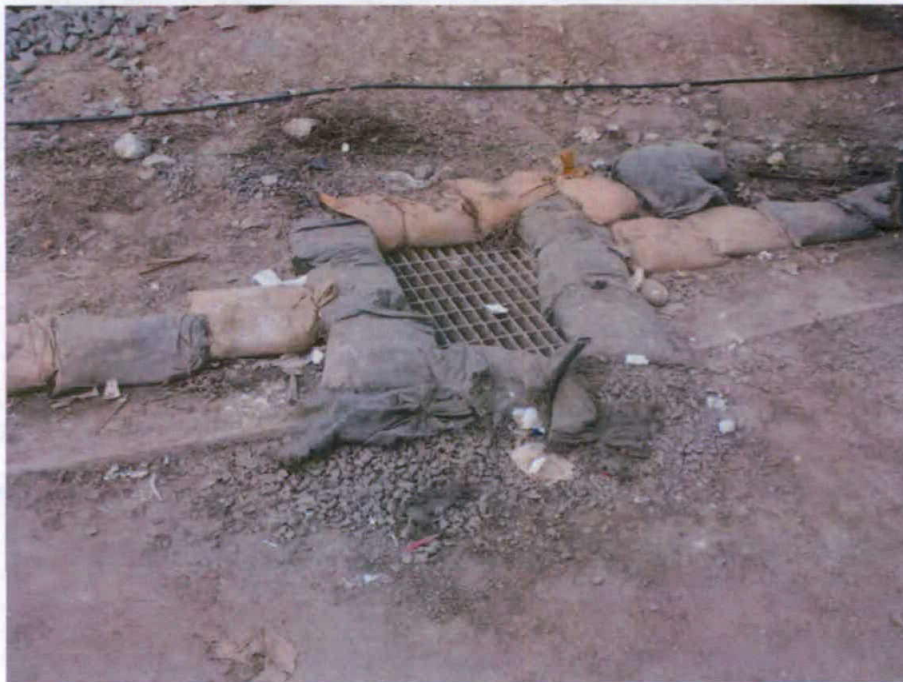
Figure 22. Broken gravel bags

7. Storm drain inlets within the construction site require protection to prevent sediment, trash, and construction debris from entering.
8. Gravel bags that have been broken need replacing.

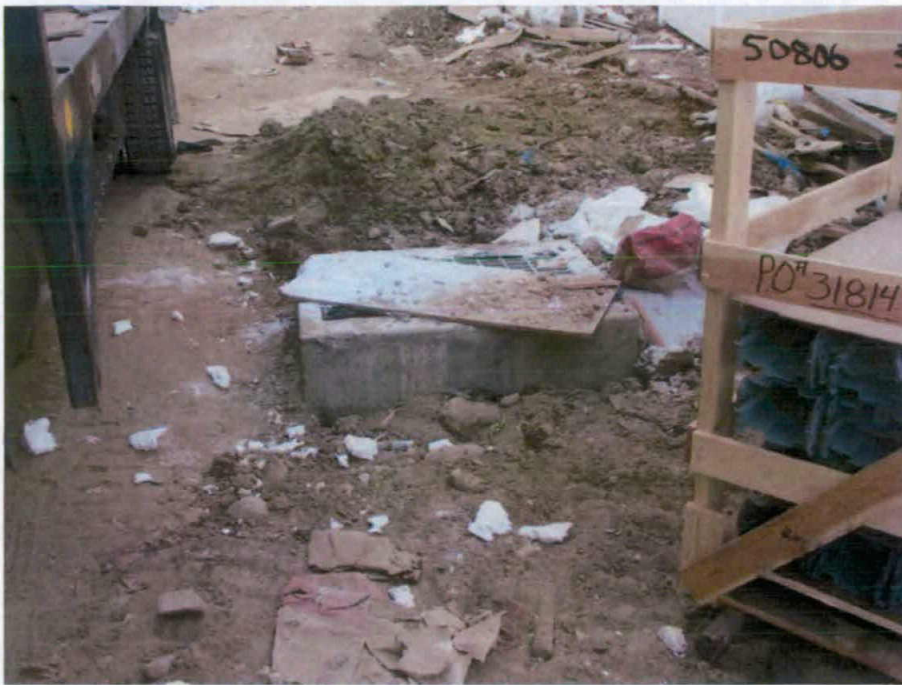
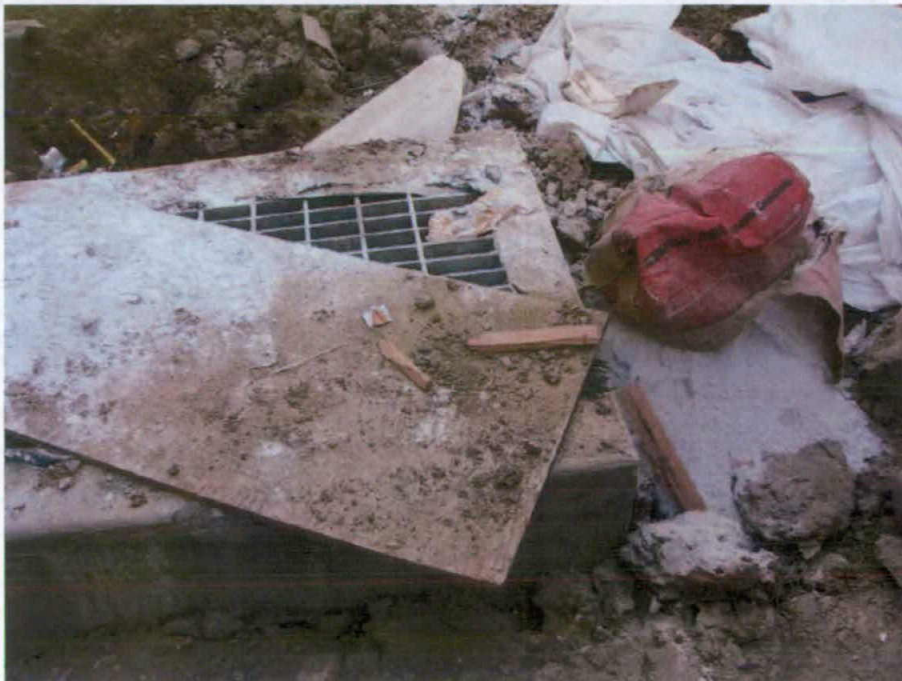
9. Mortar mix and other construction wastes had entered an unprotected inlet (Figures 23-24).
10. Several chemical containers were found throughout the site without secondary containment or other proper storage practices (Figure 25).

Figure 23. Storm drain littered with construction debris

Figure 24. Storm drain littered with construction debris

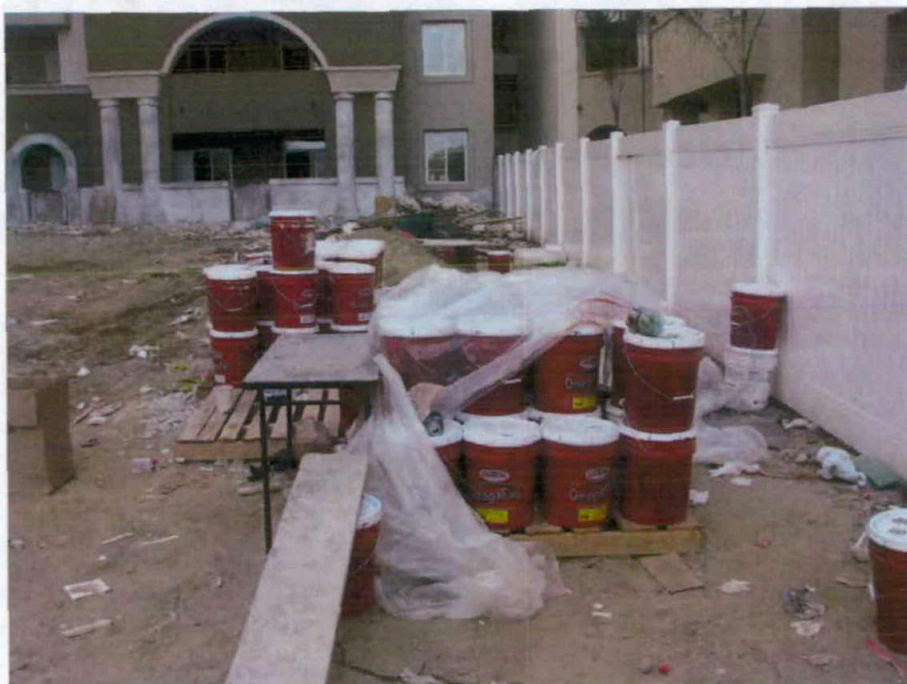
Figure 25. Improperly stored chemicals
