From: [Ghoram, Whitney@Waterboards](mailto:Ghoram.Whitney@Waterboards)
To: corycasey@gmail.com
Cc: [Walsh, Laurie@Waterboards](mailto:Walsh.Laurie@Waterboards); slindsey@sandiego.gov; [Ghoram, Whitney@Waterboards](mailto:Ghoram.Whitney@Waterboards)
Subject: Casey Development - Parkview Estates Construction: Post Inspection Required Corrective Actions
Date: Wednesday, February 10, 2016 5:05:23 PM
Attachments: [InspectionPics-CaseyDevelopment-ParkviewConstruction.pdf](#)
Importance: High

Mr. Casey, (RE: WDID 9 37C371859)

Casey Development-Parkview Estates Construction
1229 Saturn Blvd., San Diego 92154
WDID: 9 37C371859

Inspection Date: February 9, 2016
Inspector: Whitney Ghoram
San Diego Water Board

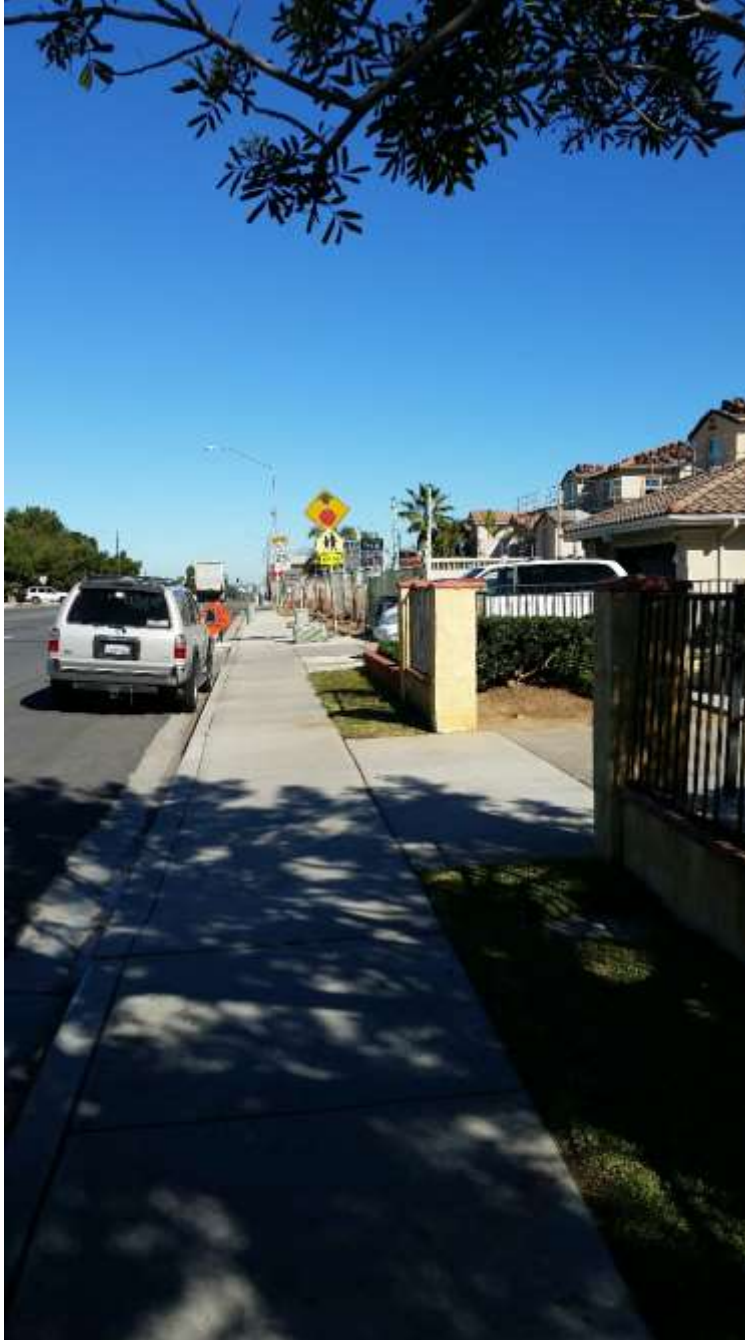
Looking north toward site boundary along Saturn Blvd.

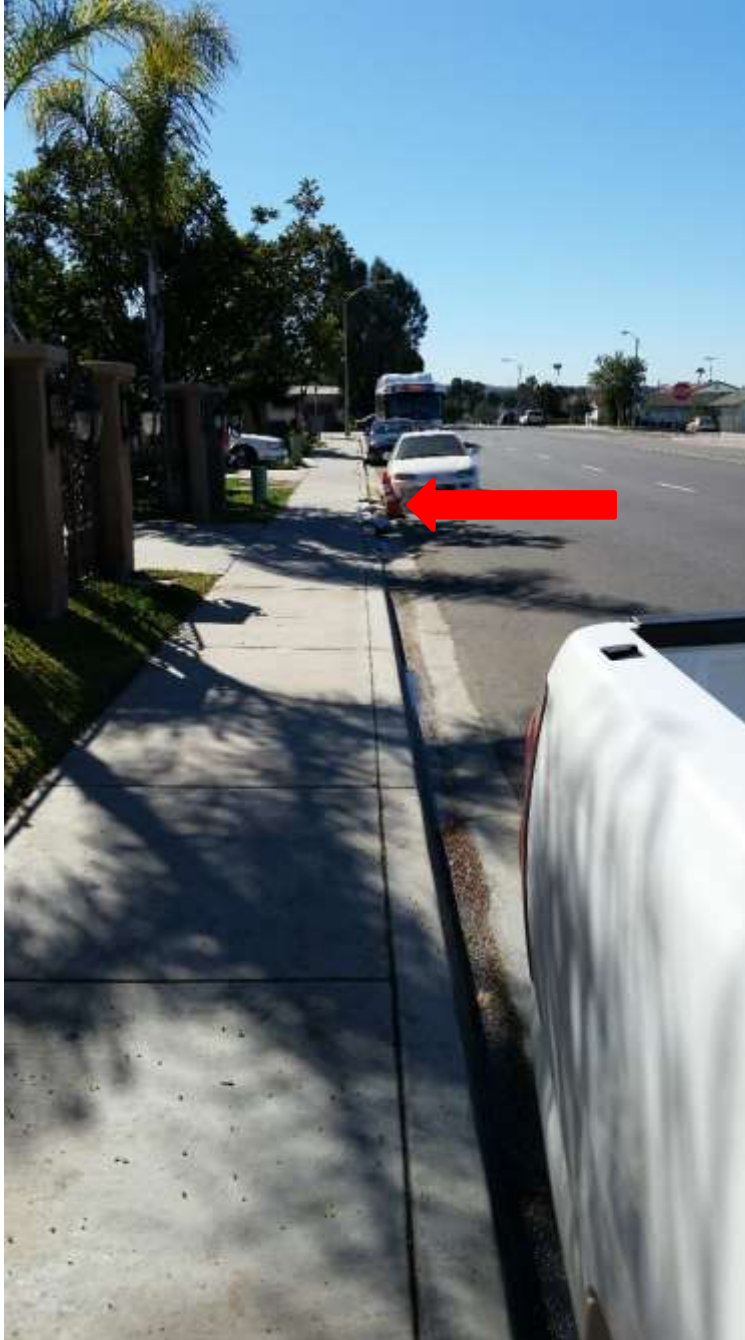
Location of a fiber roll along Saturn Blvd. Purpose unknown.

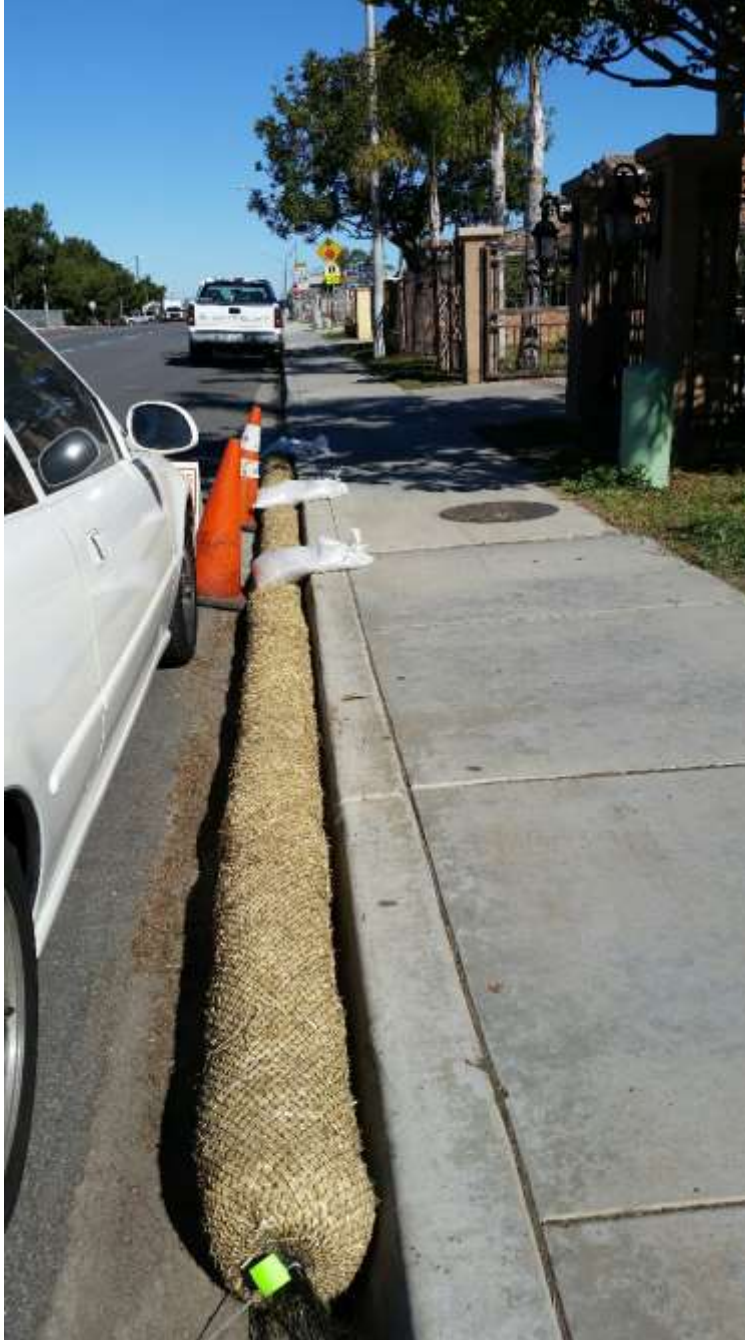
This new fiber roll is placed against the curb approximately 100 feet away from the site, to the south on Saturn Blvd. Please explain the purpose.

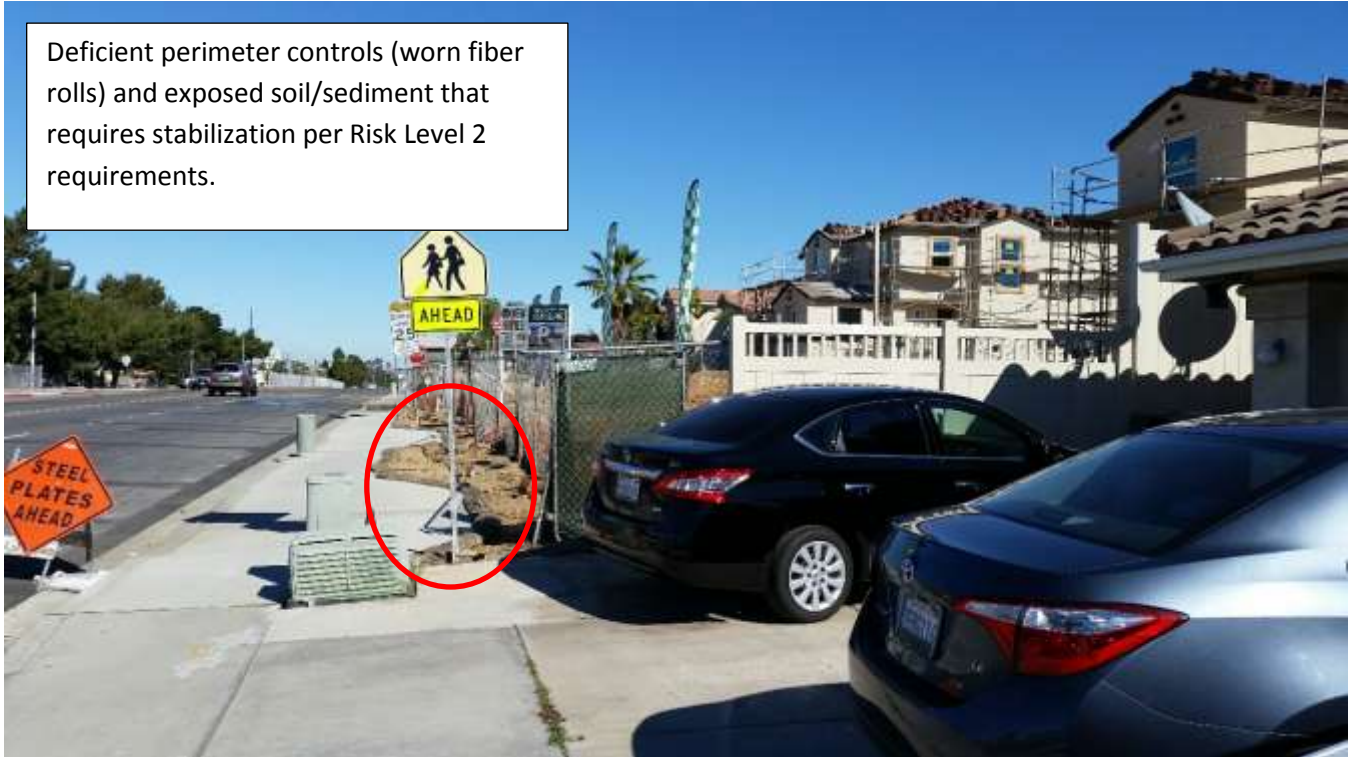
Deficient perimeter controls (worn fiber rolls) and exposed soil/sediment that requires stabilization per Risk Level 2 requirements.

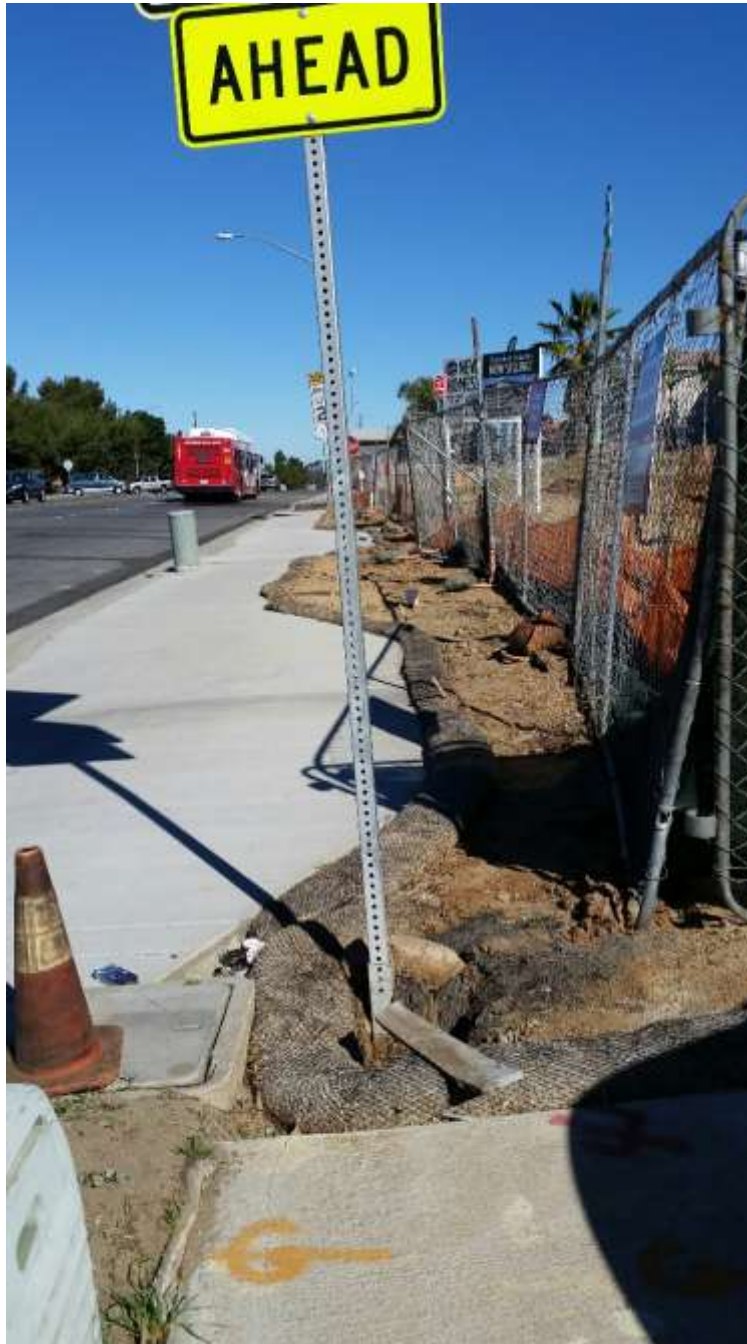
Deficient perimeter control BMPs. Fiber rolls require replacement and proper staking at 4 foot intervals. Also, exposed soil/sediment requires stabilization.

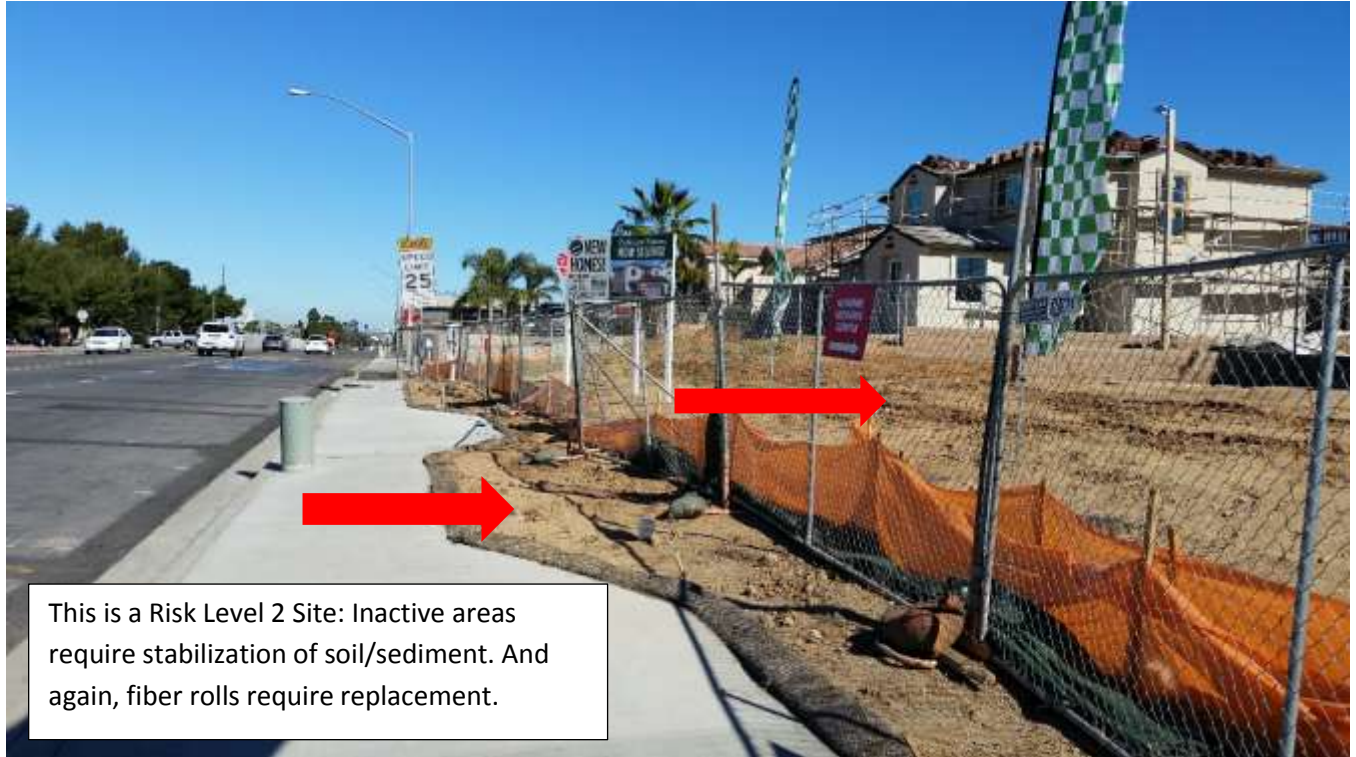
This is a Risk Level 2 Site: Inactive areas require stabilization of soil/sediment. And again, fiber rolls require replacement.

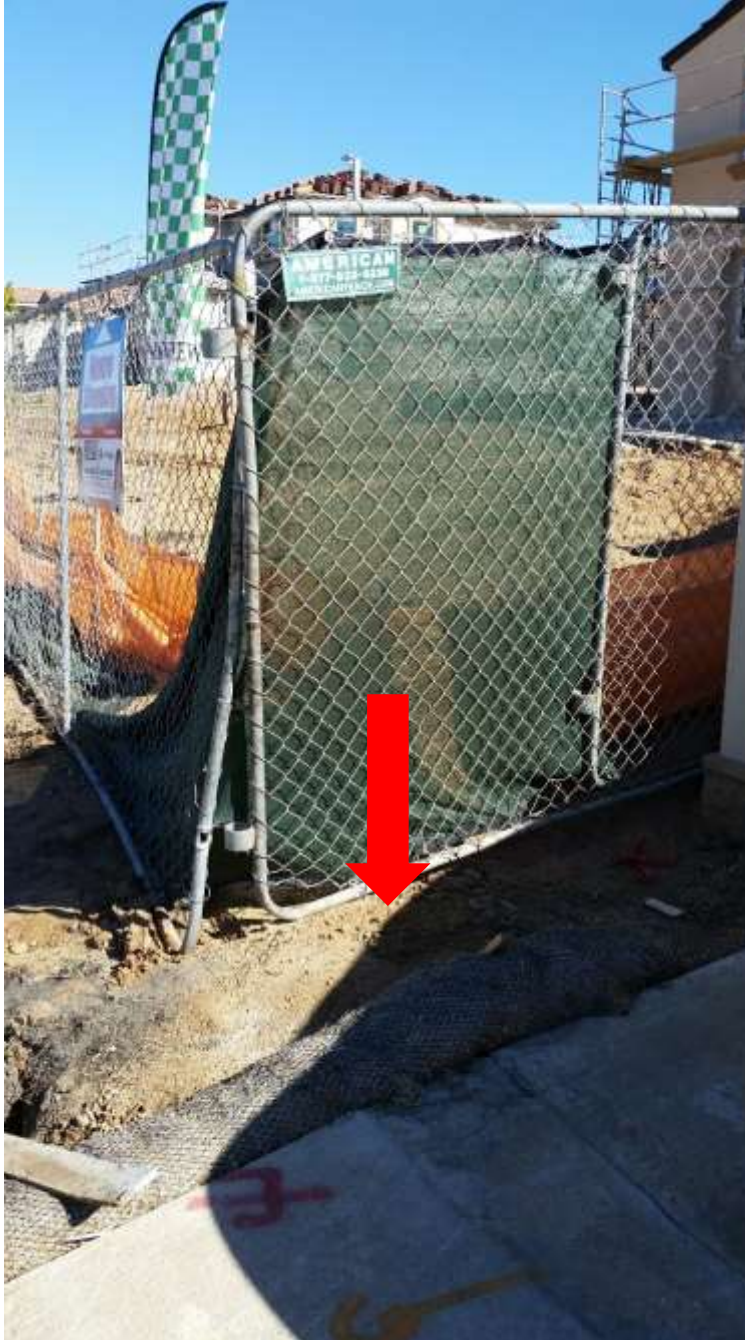
Exposed soil/sediment requires stabilization. Fiber rolls require replacement.

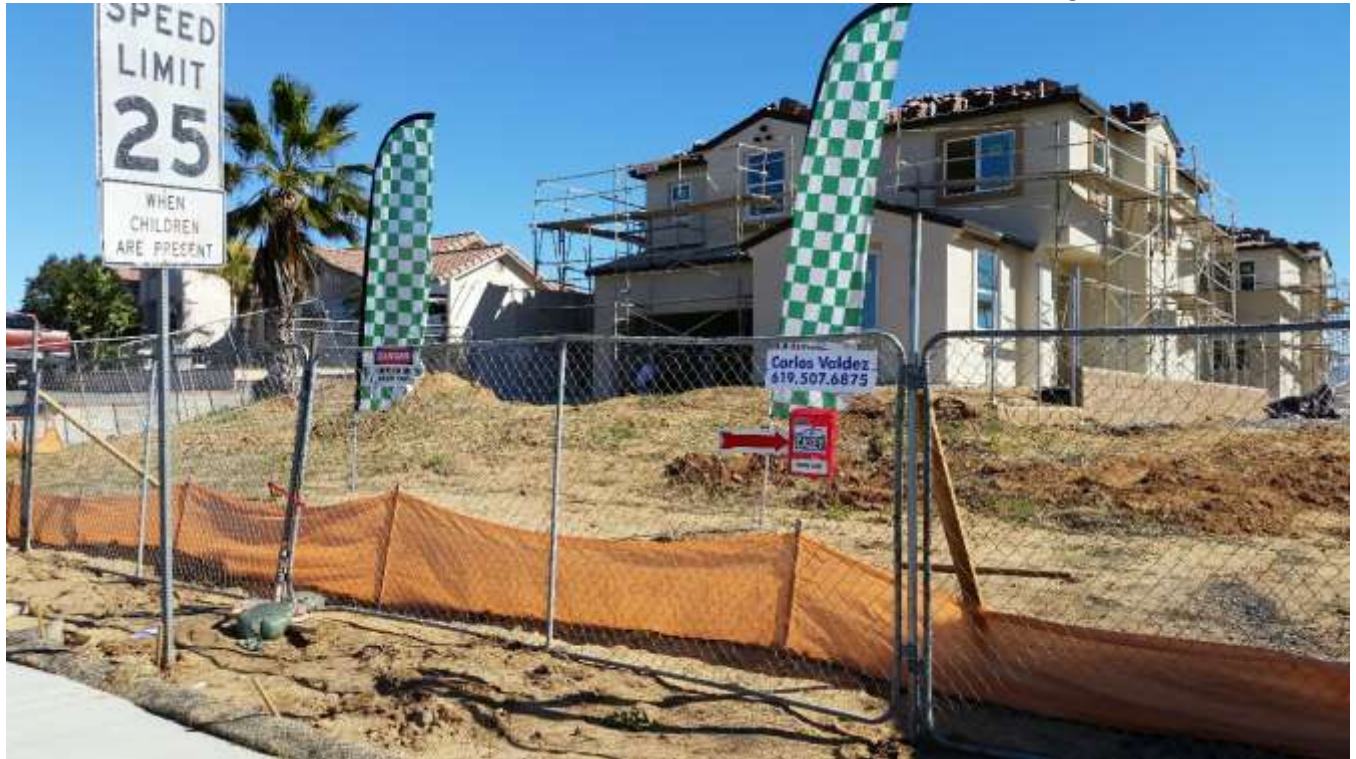
Exposed soil/sediment requires stabilization. Improperly installed silt fence.

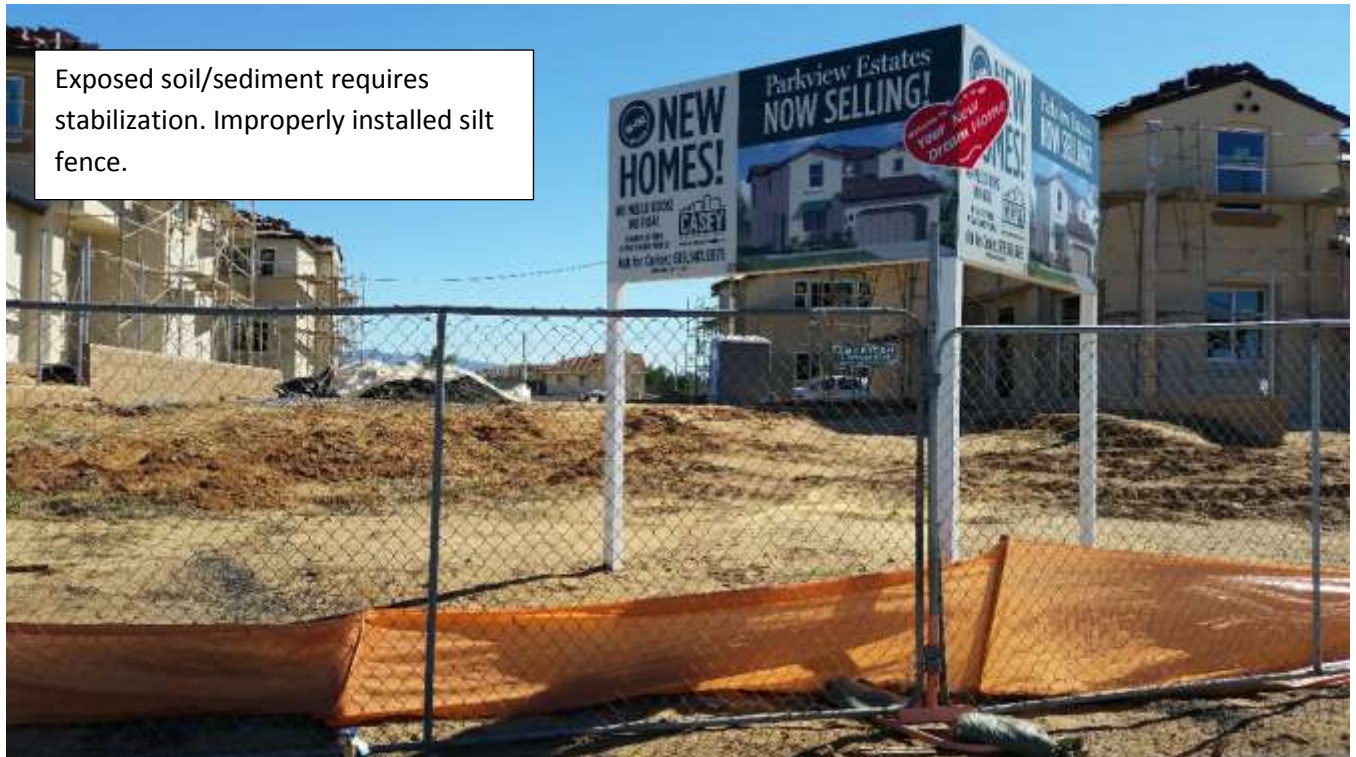
Deficient perimeter controls. Fiber rolls require replacement and proper staking. Exposed soil/sediment on site requires stabilization.

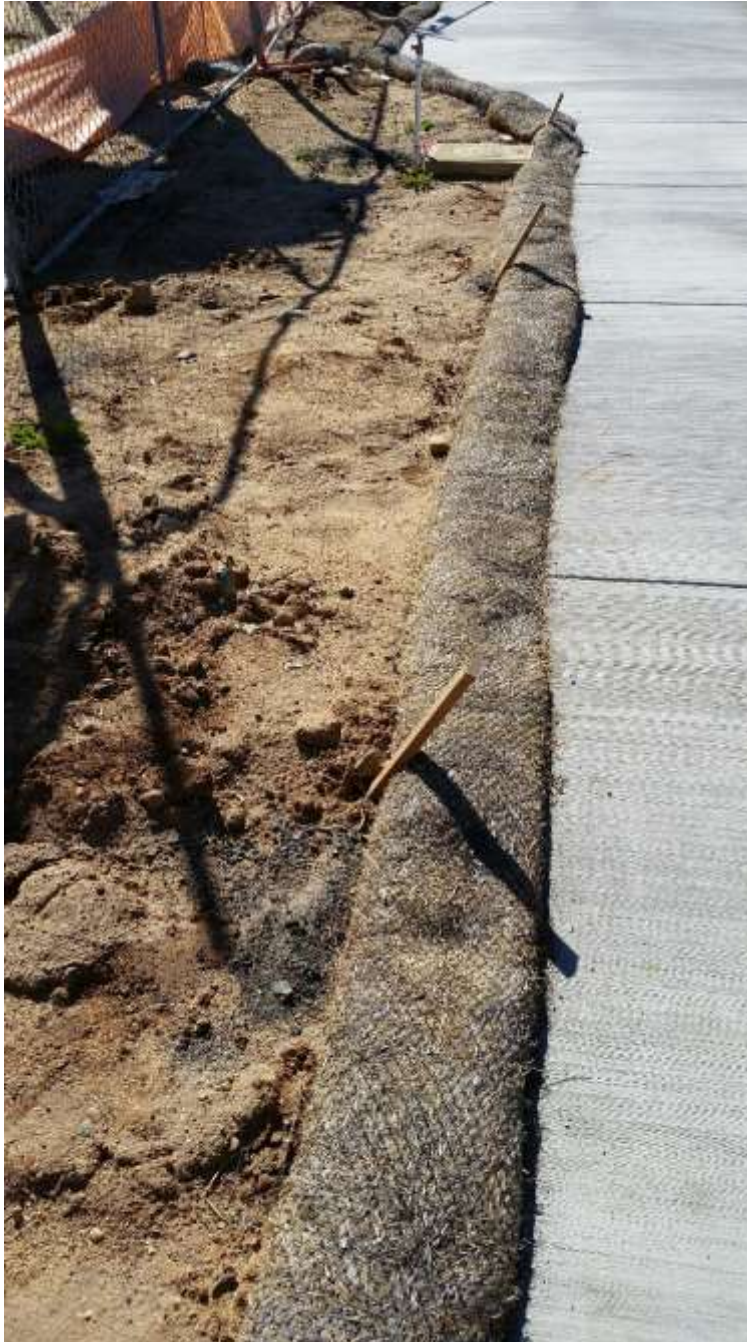
Worn fiber rolls require replacement. Incorrect staking of fiber rolls. Exposed soil/sediment.

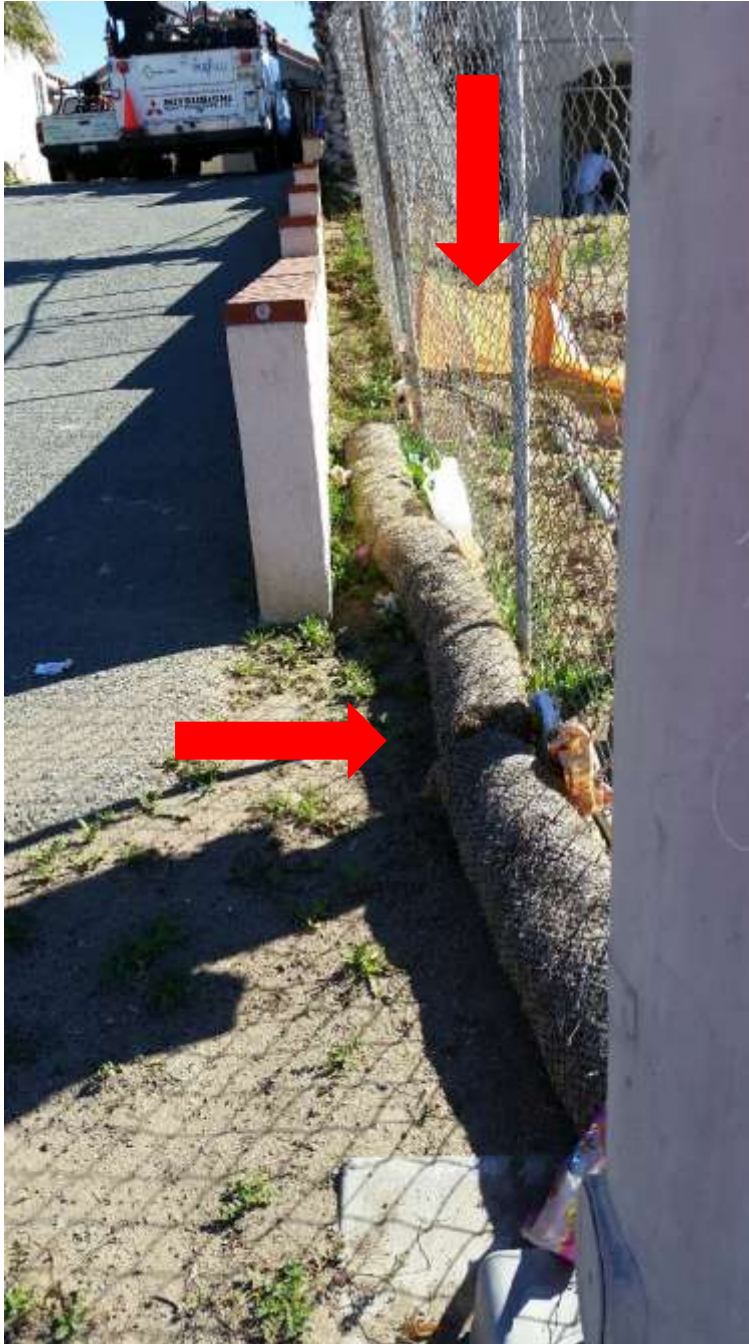
Unstaked, unsecured fiber roll.
Improperly installed and failing
silt fence. Trash on the ground.

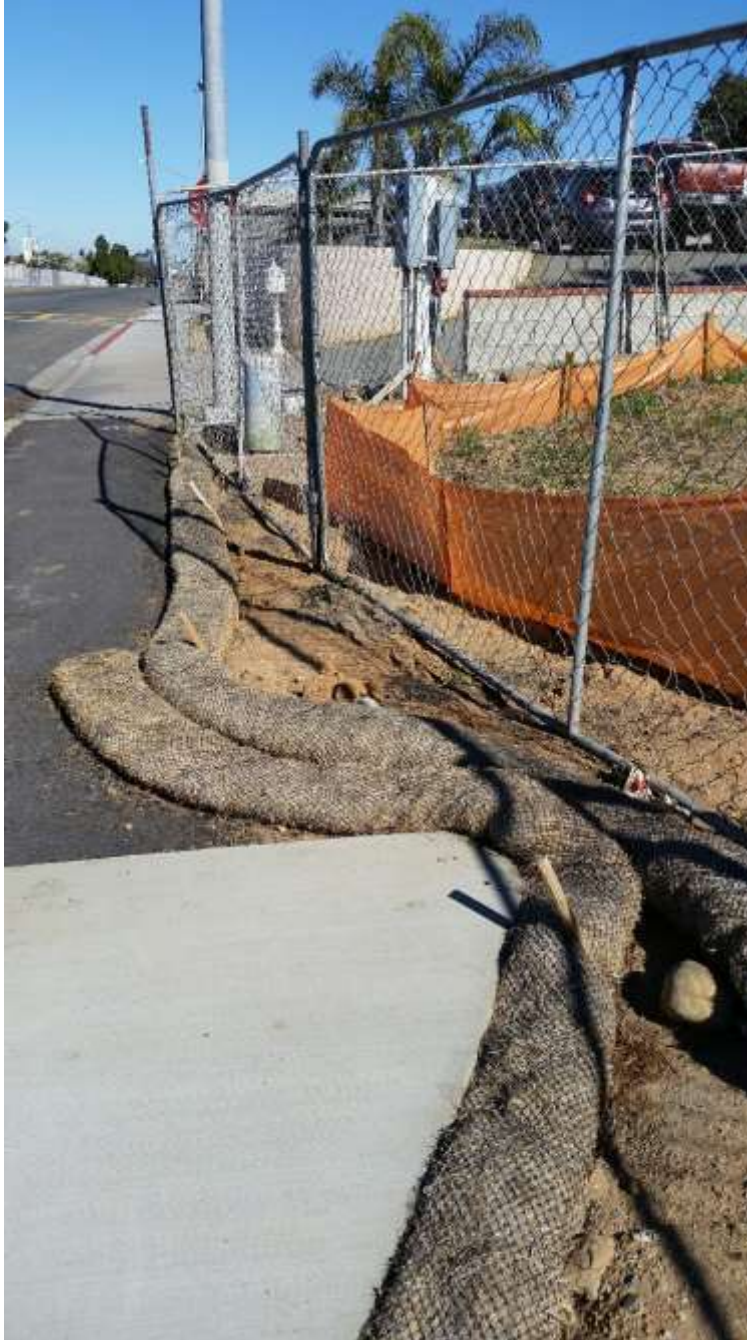
Worn and improperly installed fiber rolls. Exposed soil/sediment that should be stabilized per Risk Level 2 requirements.

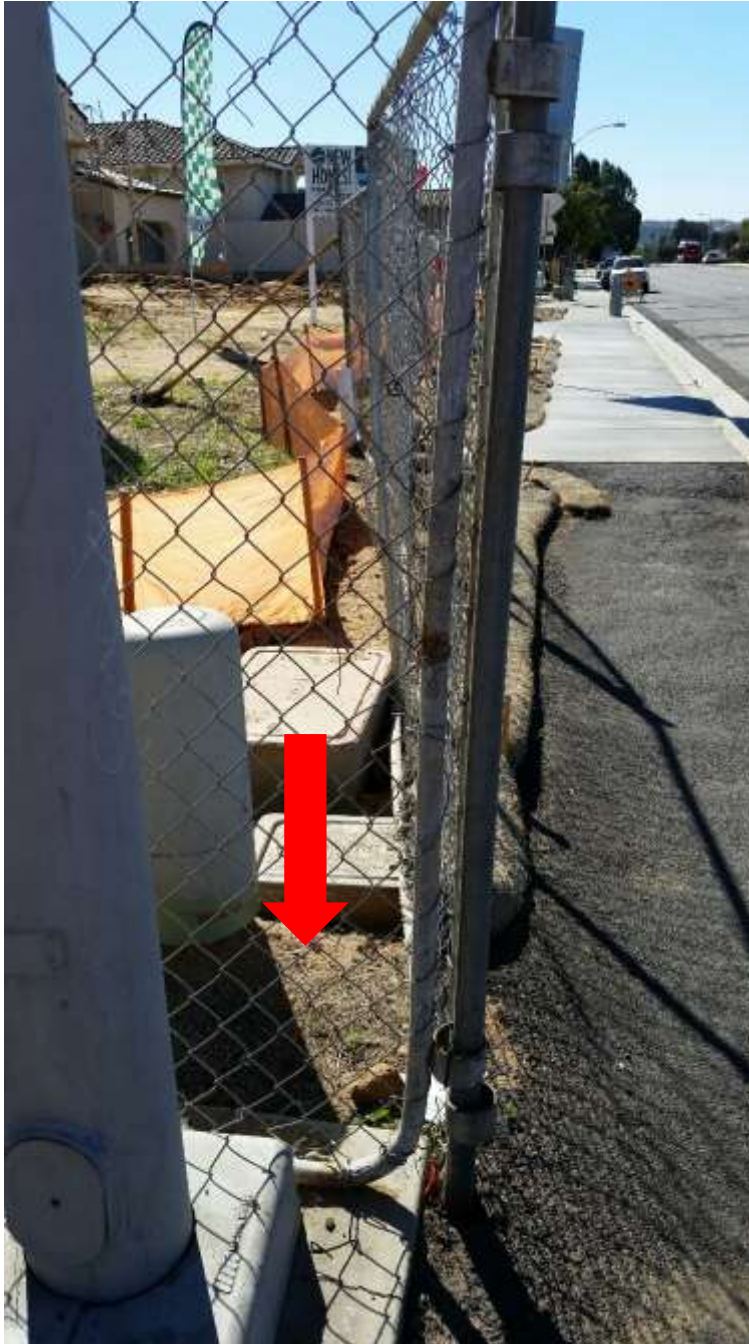
Exposed soil/sediment.

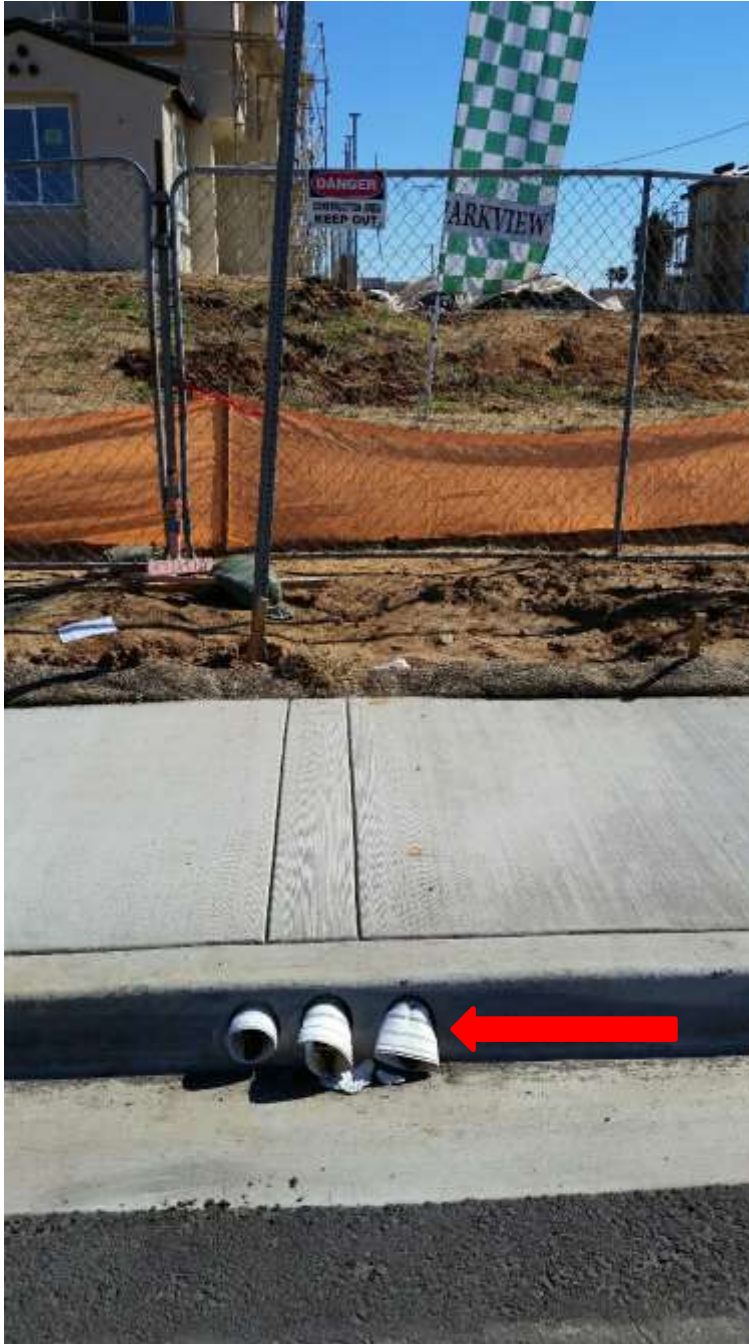
Curb core drains containing sediment.

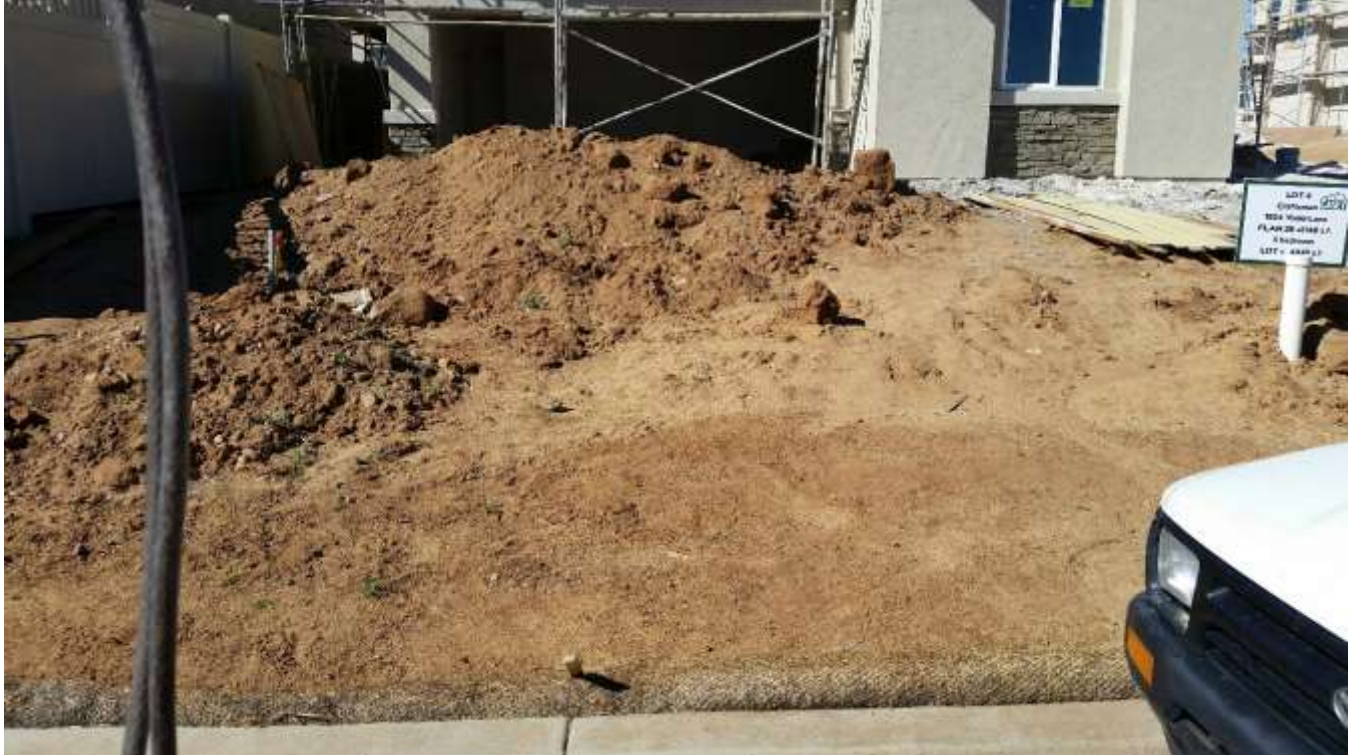
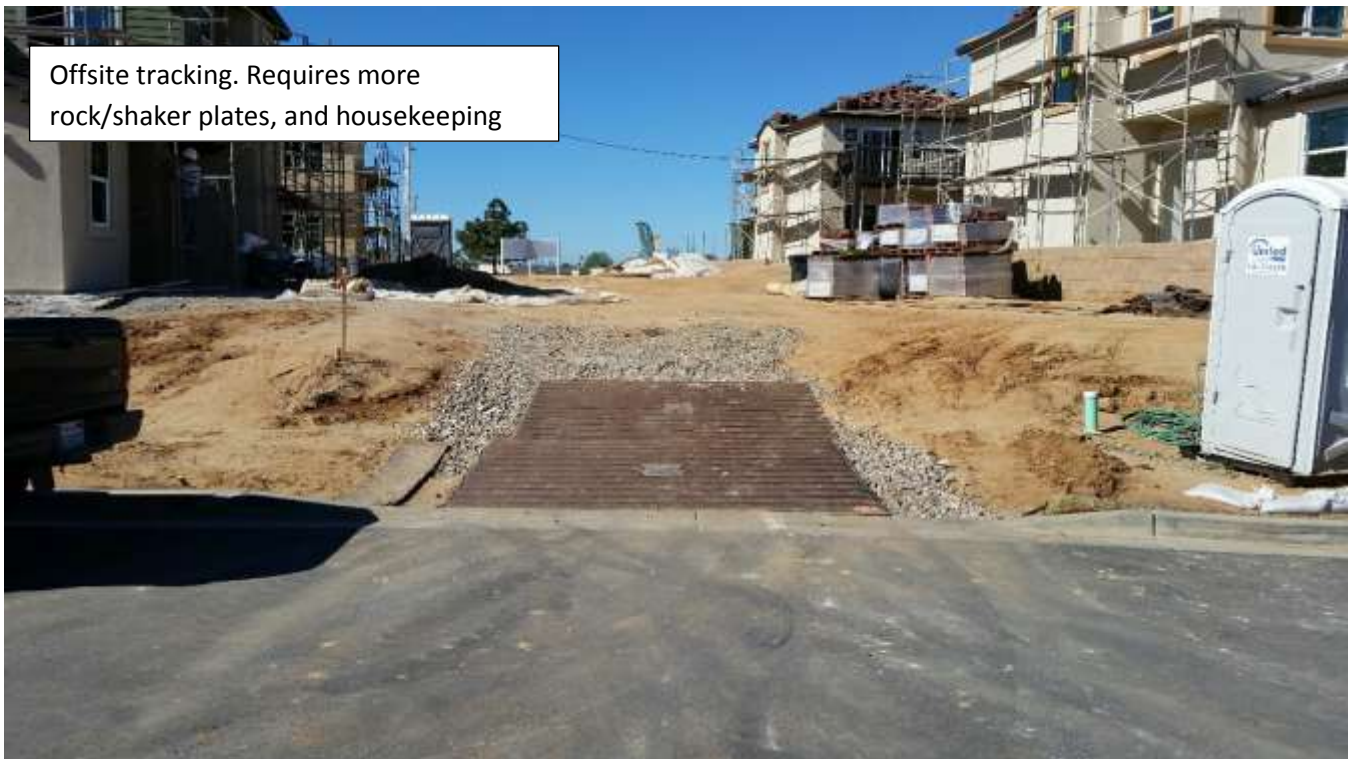
Offsite tracking. Requires more rock/shaker plates, and housekeeping

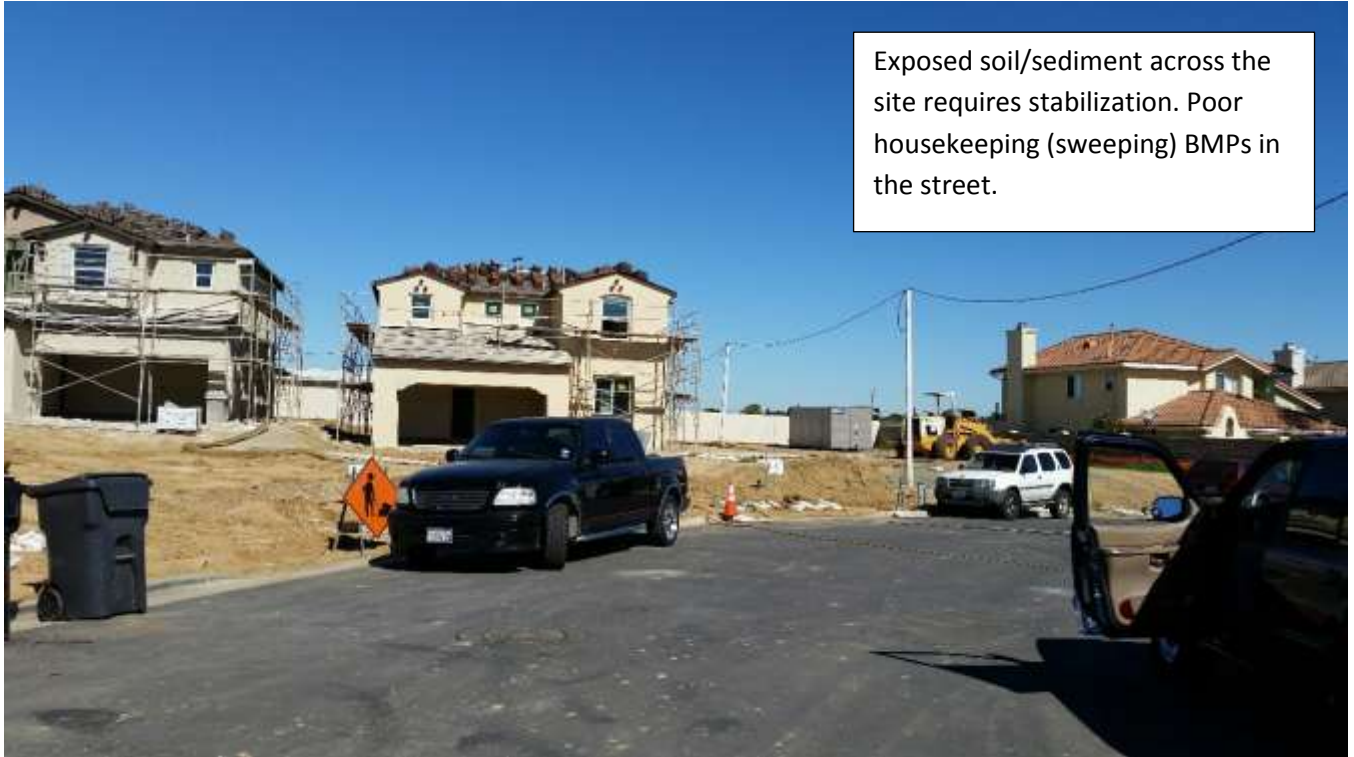
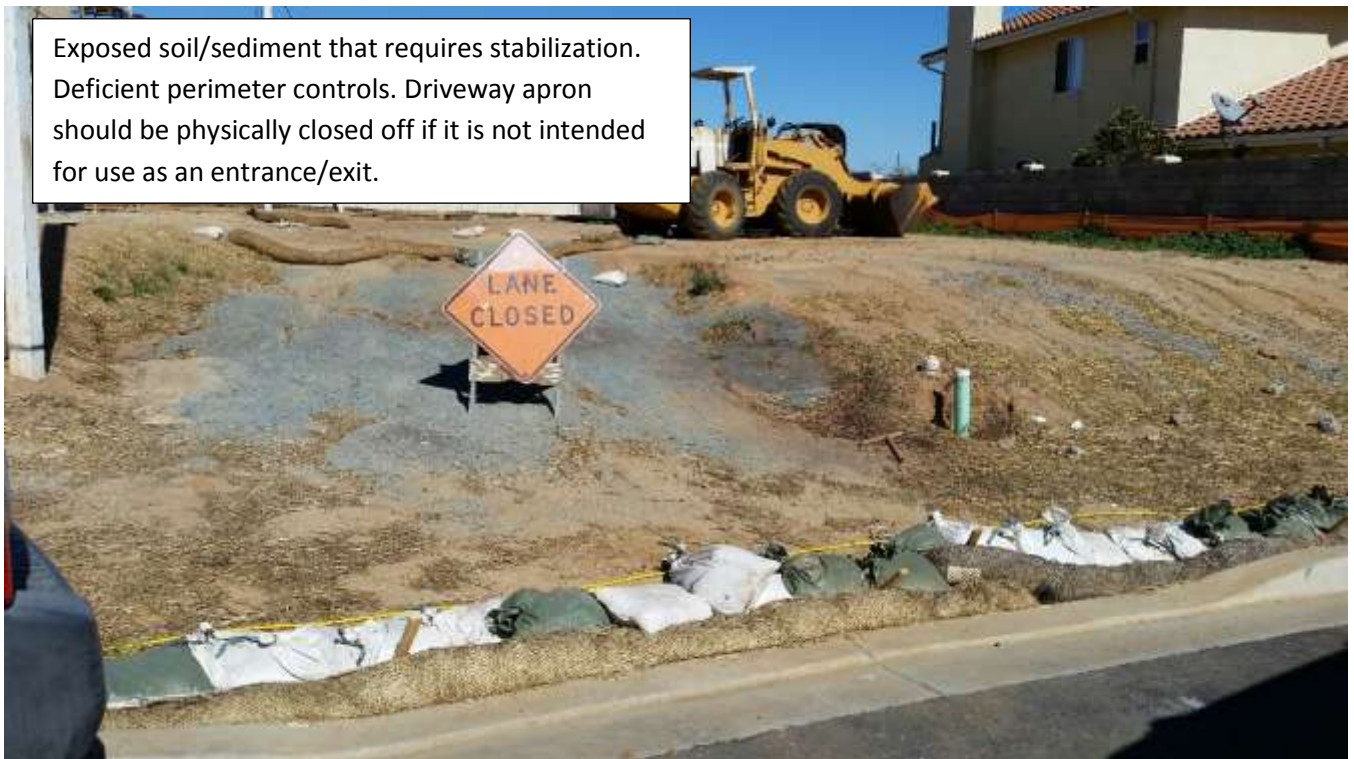
Exposed soil/sediment that requires stabilization.

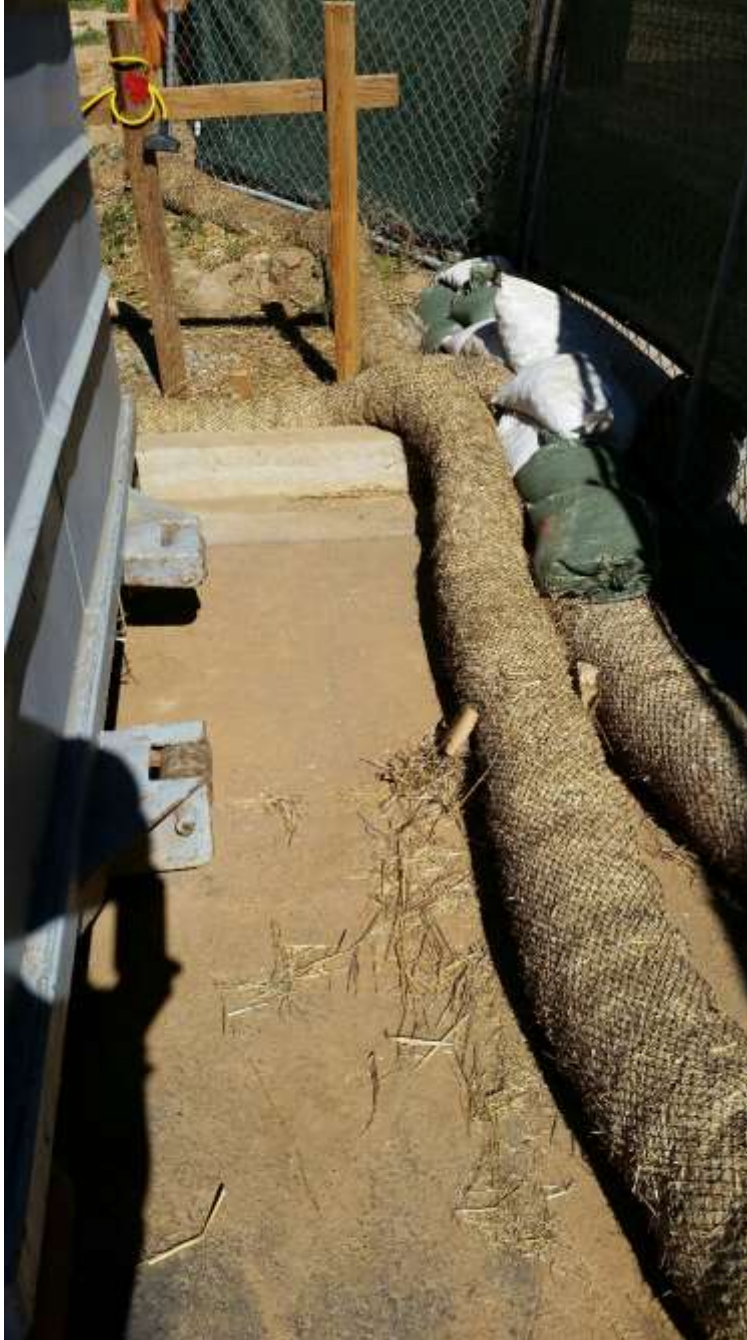
Sediment discharges onto asphalt. Poor housekeeping. Improperly installed perimeter controls.

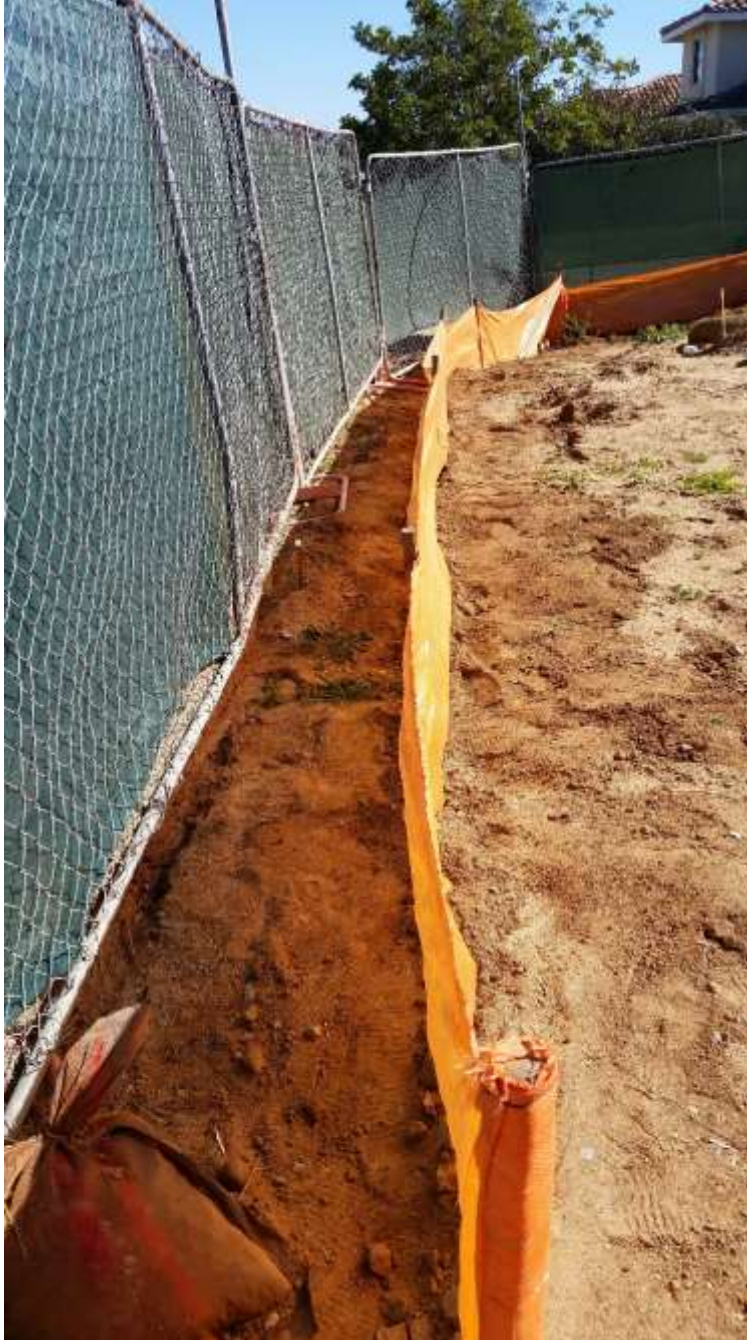
Improperly installed silt fence
perimeter control.

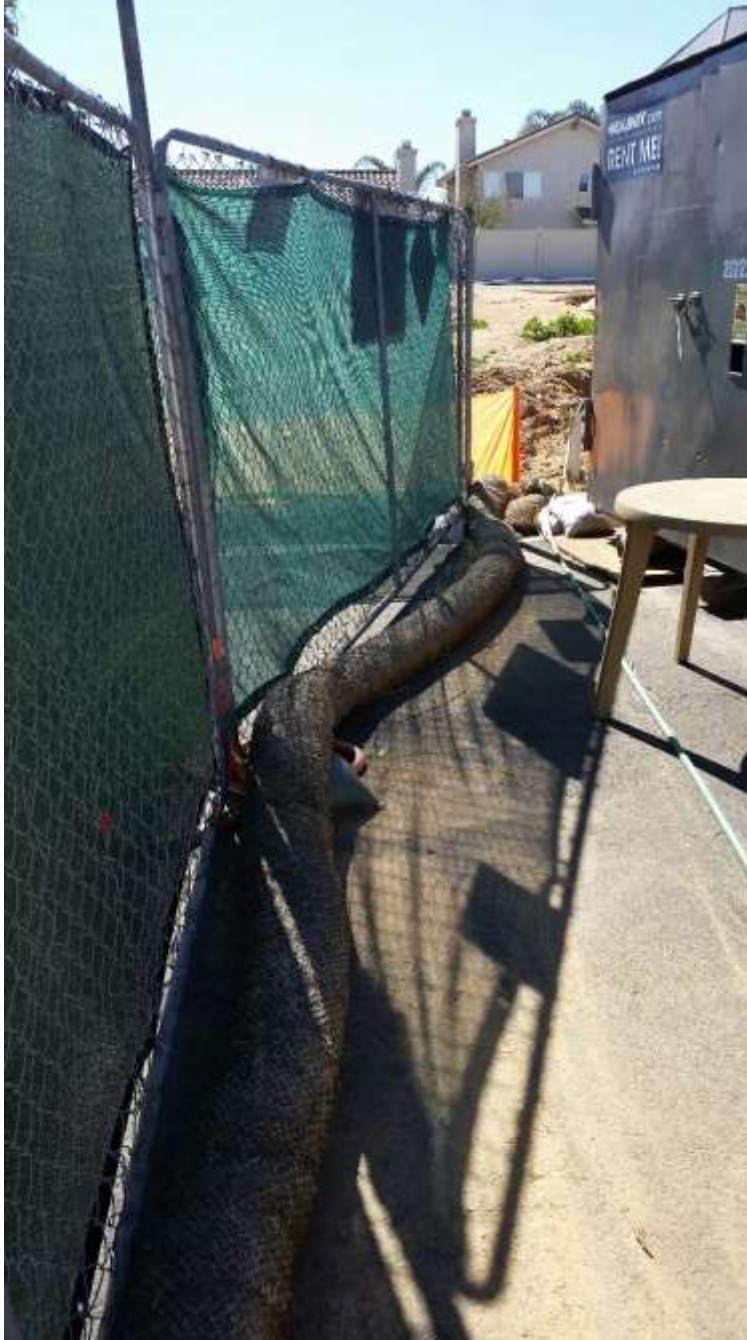
Improperly installed perimeter controls.

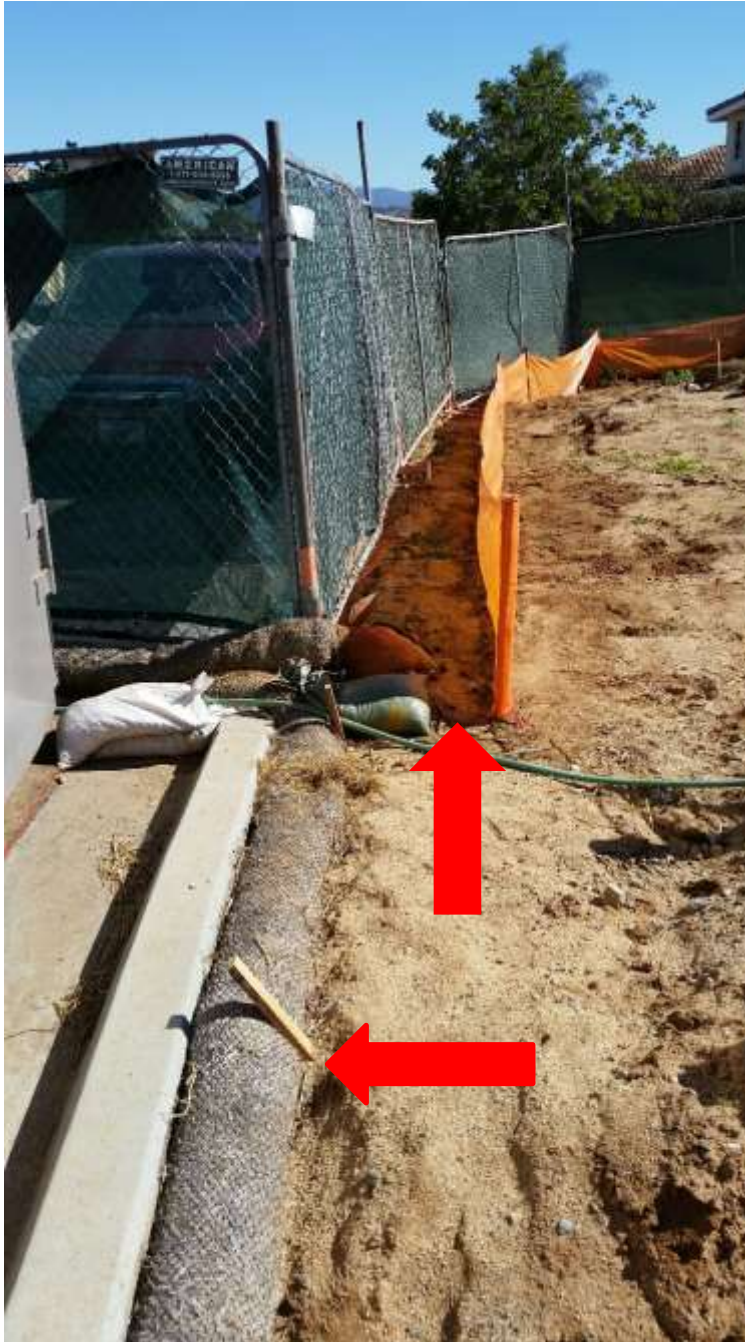
Improperly installed silt fence
and fiber rolls.
