From: [Ghoram, Whitney@Waterboards](mailto:Ghoram.Whitney@Waterboards)
To: corycasey@gmail.com
Cc: [Walsh, Laurie@Waterboards](mailto:Walsh.Laurie@Waterboards); slindsey@sandiego.gov; [Ghoram, Whitney@Waterboards](mailto:Ghoram.Whitney@Waterboards)
Subject: Casey Development - Parkview Estates Construction: Post Inspection Required Corrective Actions
Date: Wednesday, February 10, 2016 5:05:23 PM
Attachments: [InspectionPics-CaseyDevelopment-ParkviewConstruction.pdf](#)
Importance: High

Mr. Casey, (RE: WDID 9 37C371859)

Casey Development-Parkview Estates Construction
1229 Saturn Blvd., San Diego 92154
WDID: 9 37C371859

Inspection Date: February 9, 2016
Inspector: Whitney Ghoram
San Diego Water Board

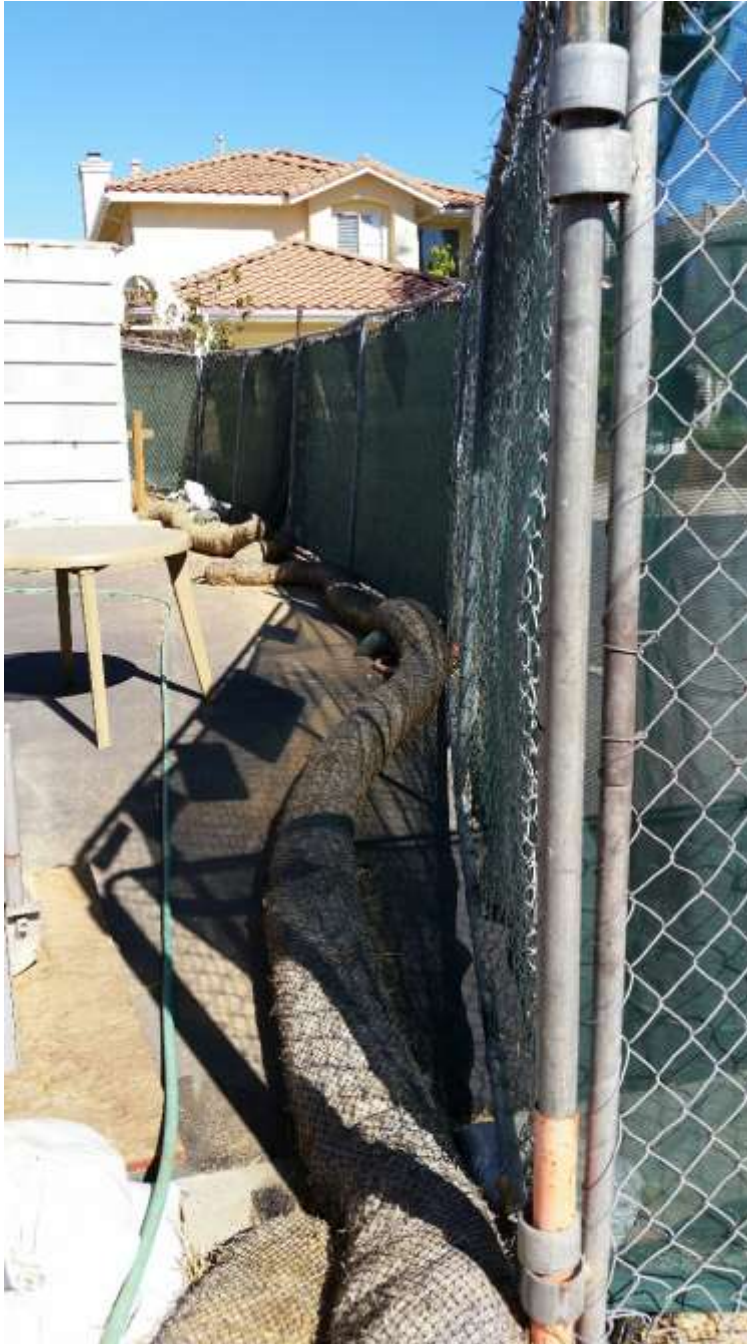
Sediment discharge onto asphalt and improperly installed perimeter control (fiber rolls).

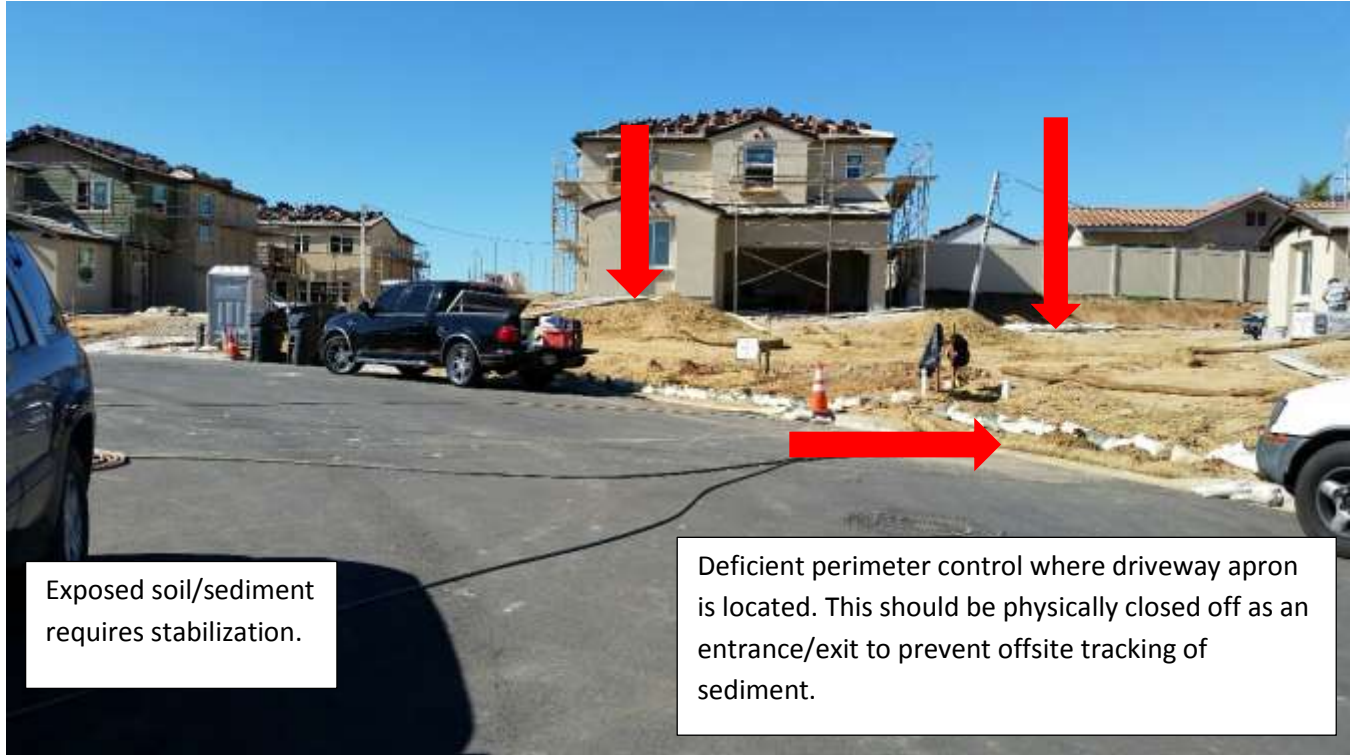
Exposed soil/sediment requires stabilization.

Deficient perimeter control where driveway apron is located. This should be physically closed off as an entrance/exit to prevent offsite tracking of sediment.

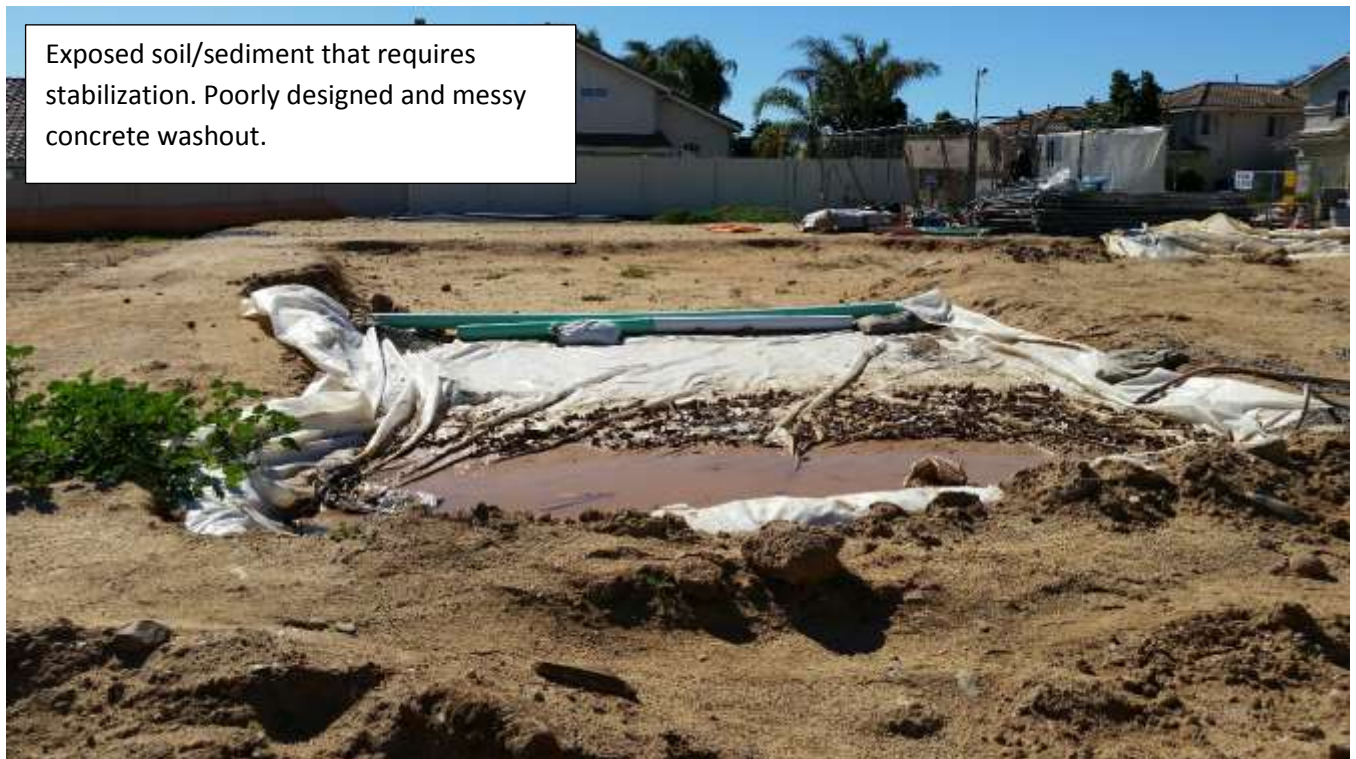
Exposed soil/sediment that requires stabilization. Poorly designed and messy concrete washout.

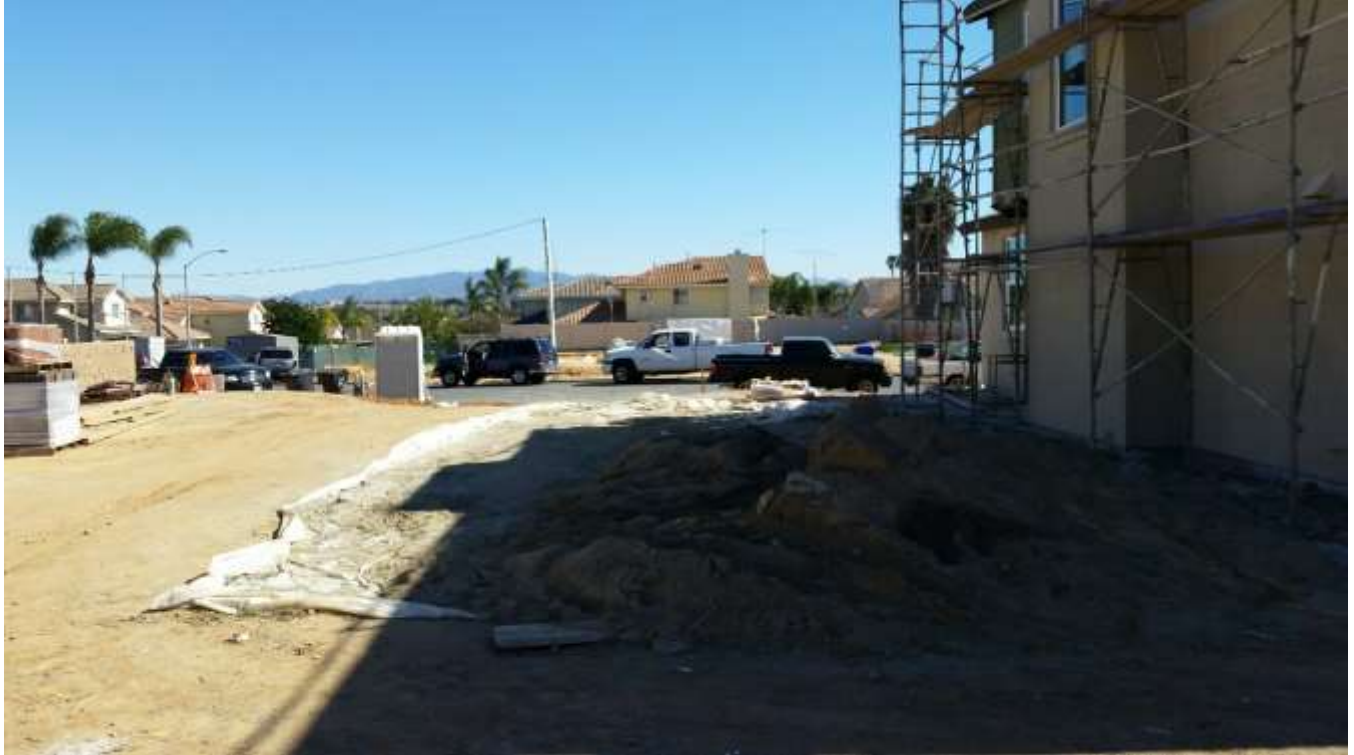
Inadequate plastic cover on inactive piles. Exposed soil/sediment requires stabilization.
