**San Diego Regional Water Quality Control Board**

**Subject: Notice of Violation No. R9-2016-0030, Riverside County Waste Management Department, Anza Sanitary Landfill, Riverside County**

# NOTICE OF VIOLATION

## No. R9-2016-0030

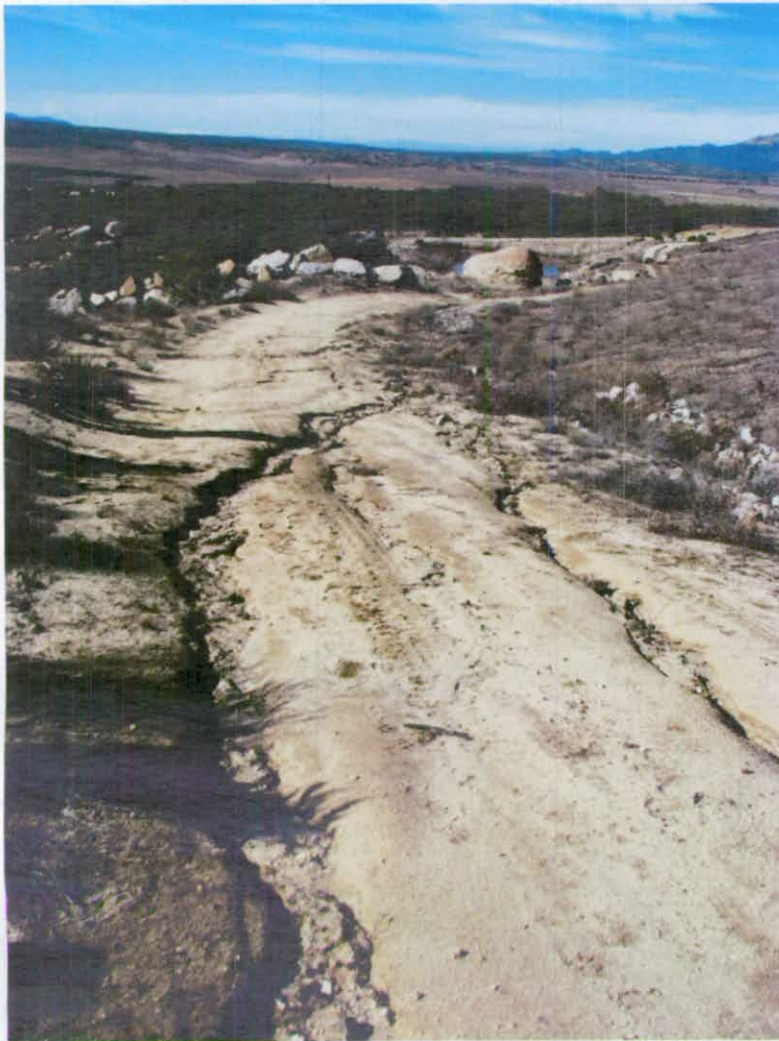
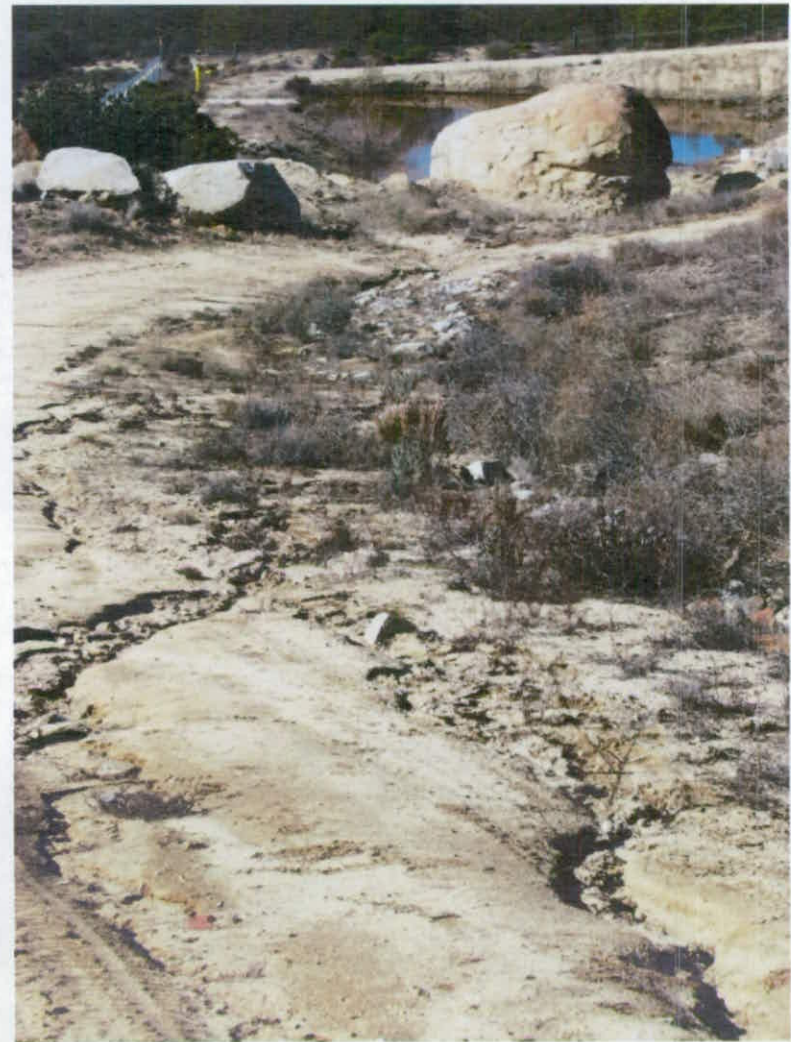
Erosion along lower bench caused by unmanaged storm water flows. Photo taken January 14, 2016 during a site inspection.

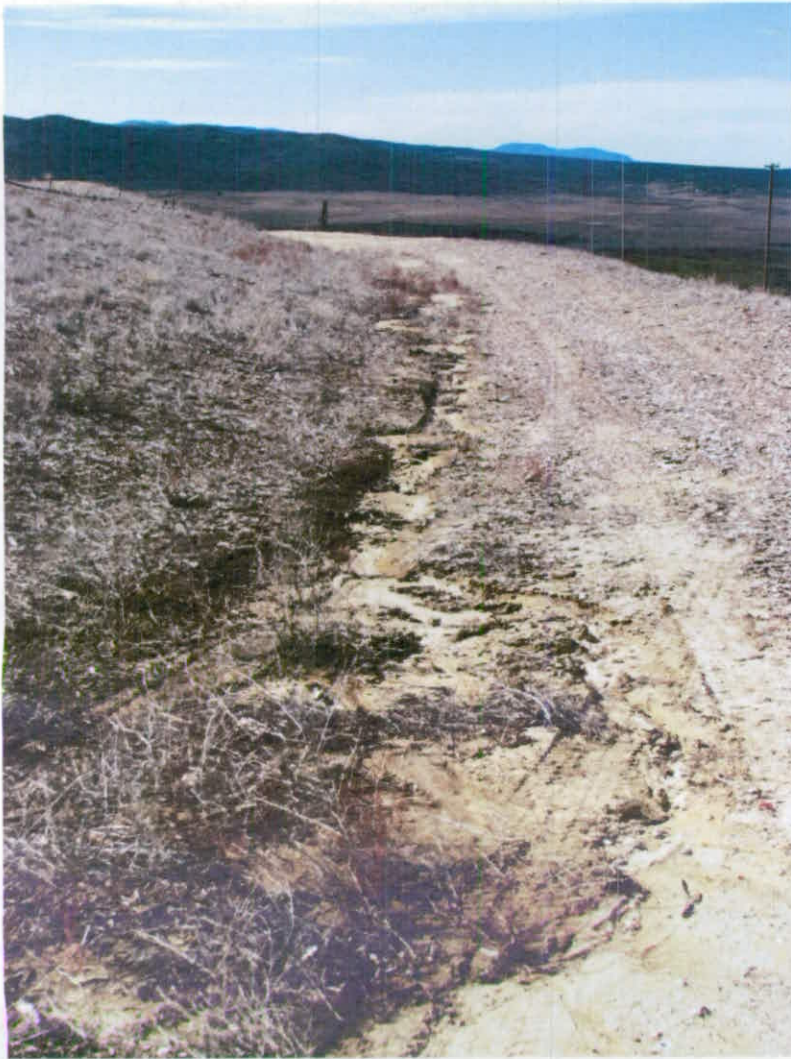
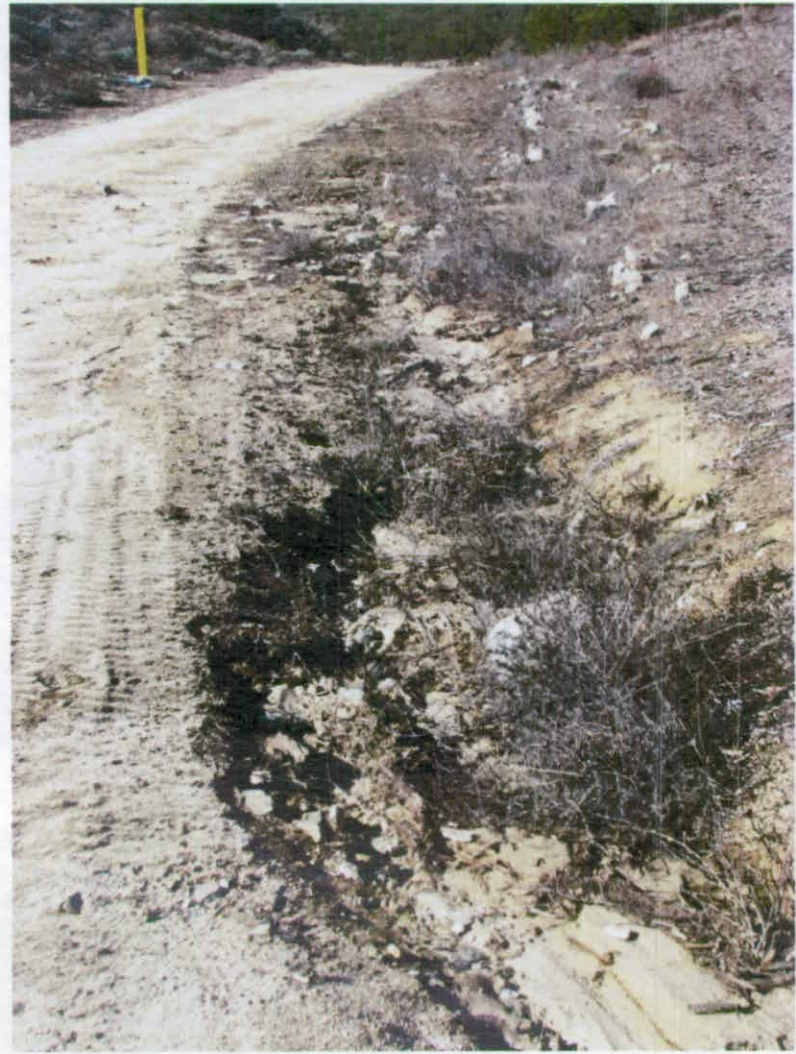
Erosion along the middle bench (left photo) and lower bench (right photo) caused by unmanaged storm water flows. Photo taken January 14, 2016 during a site inspection.

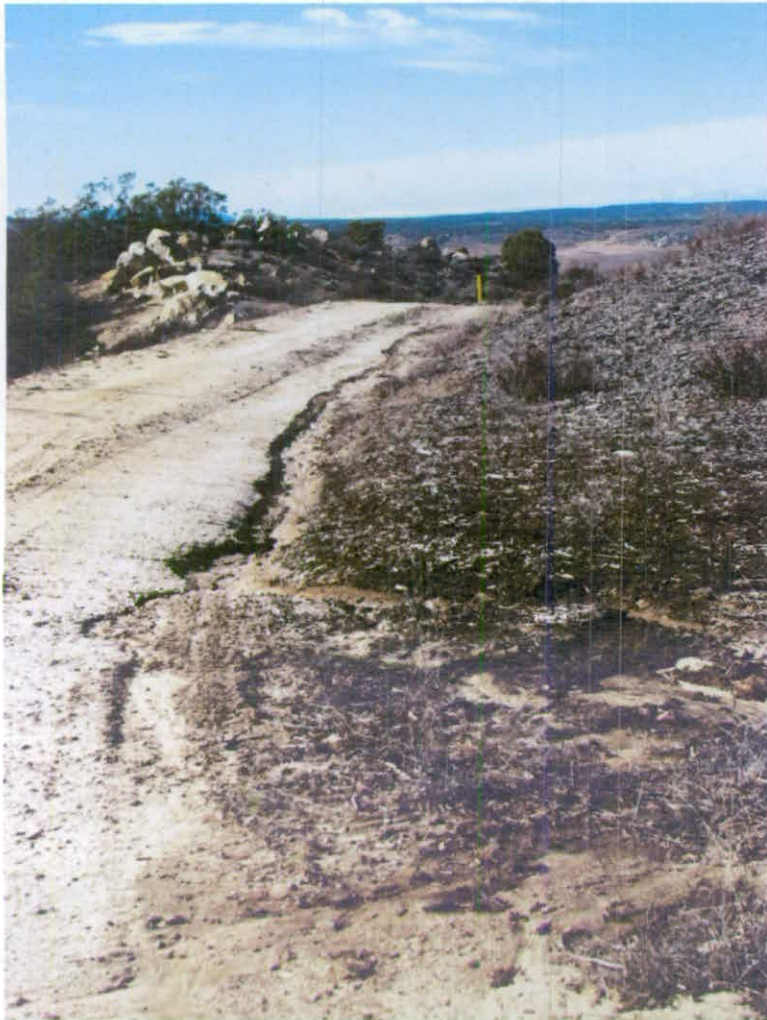
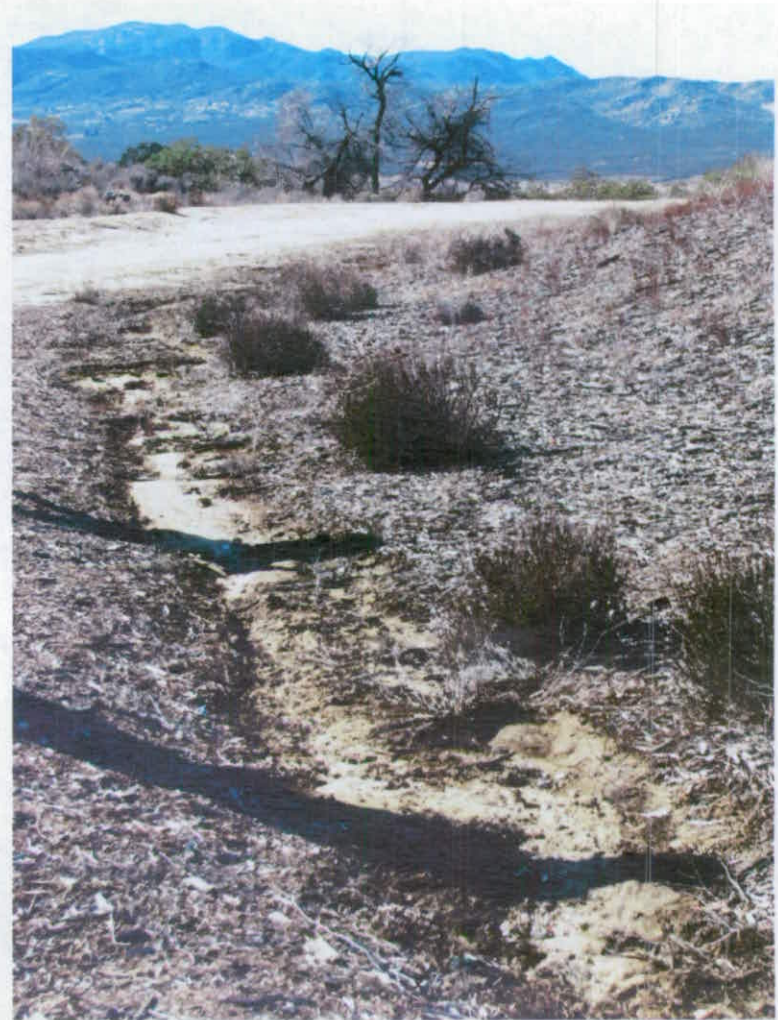
Erosion along the bench/service road caused by unmanaged storm water flows. Photo taken on January 14, 2016 during a site inspection.

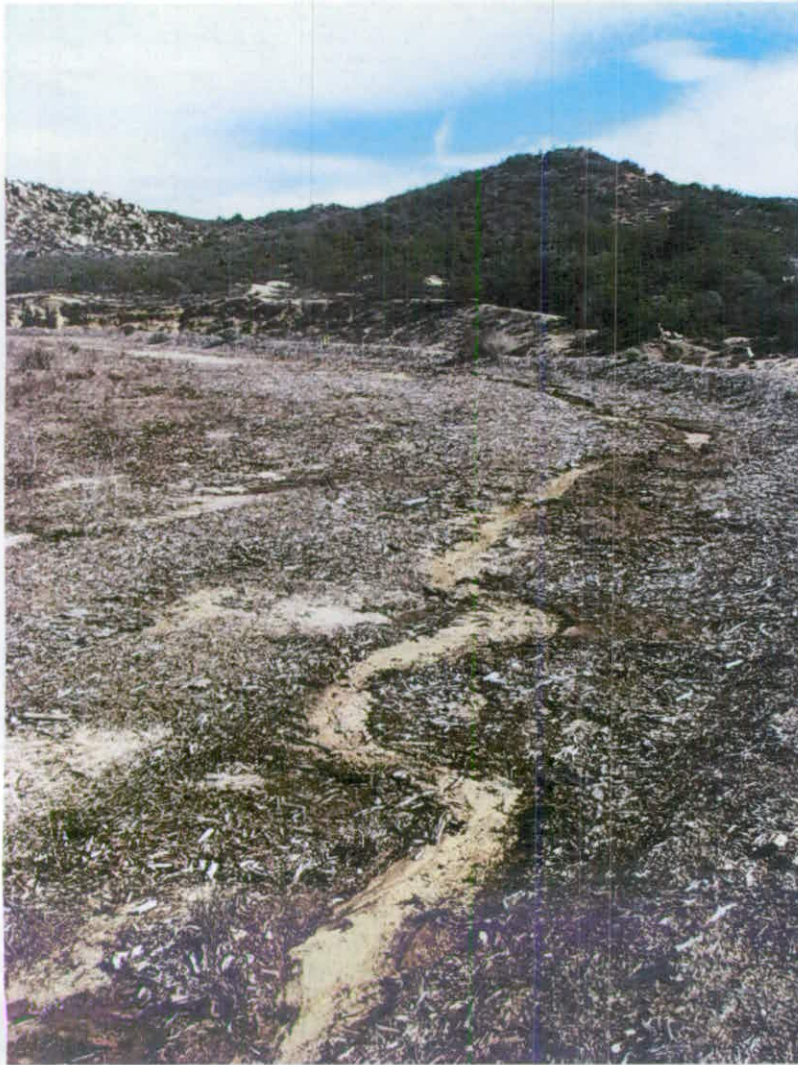
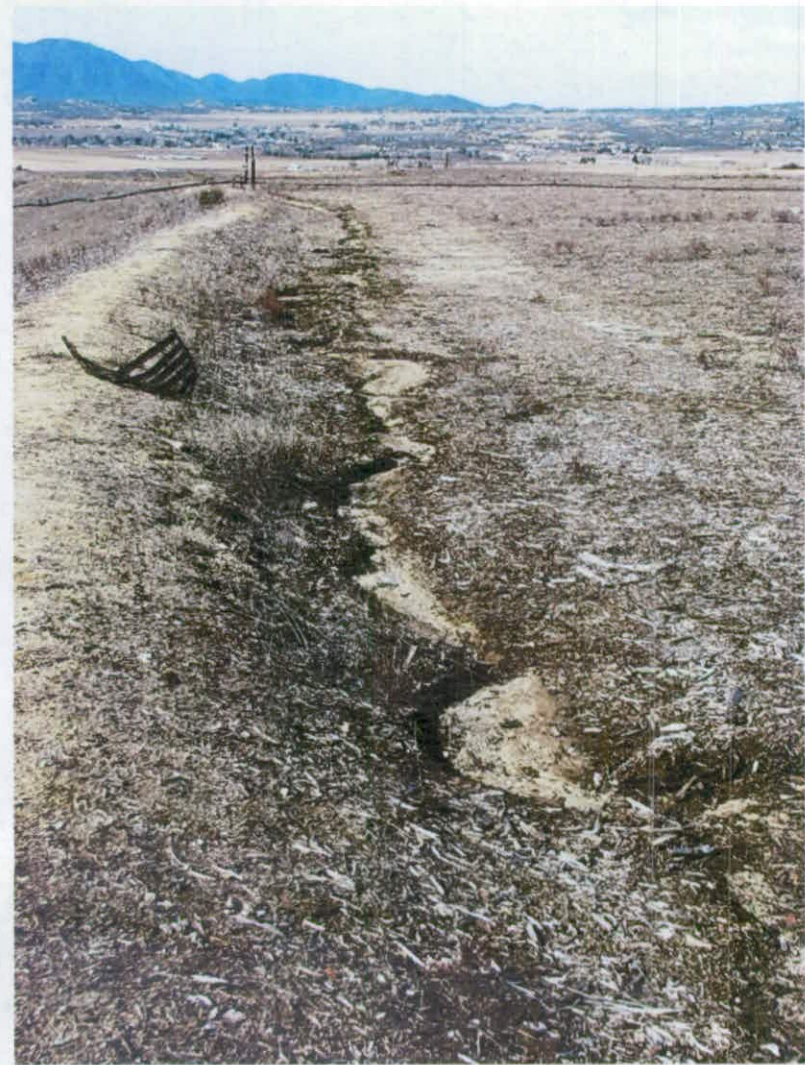
Erosion along the top deck of the landfill. A lack of BMPs and storm water management has caused erosion along the perimeter of the top deck. Photo taken January 14, 2016 during a site inspection.

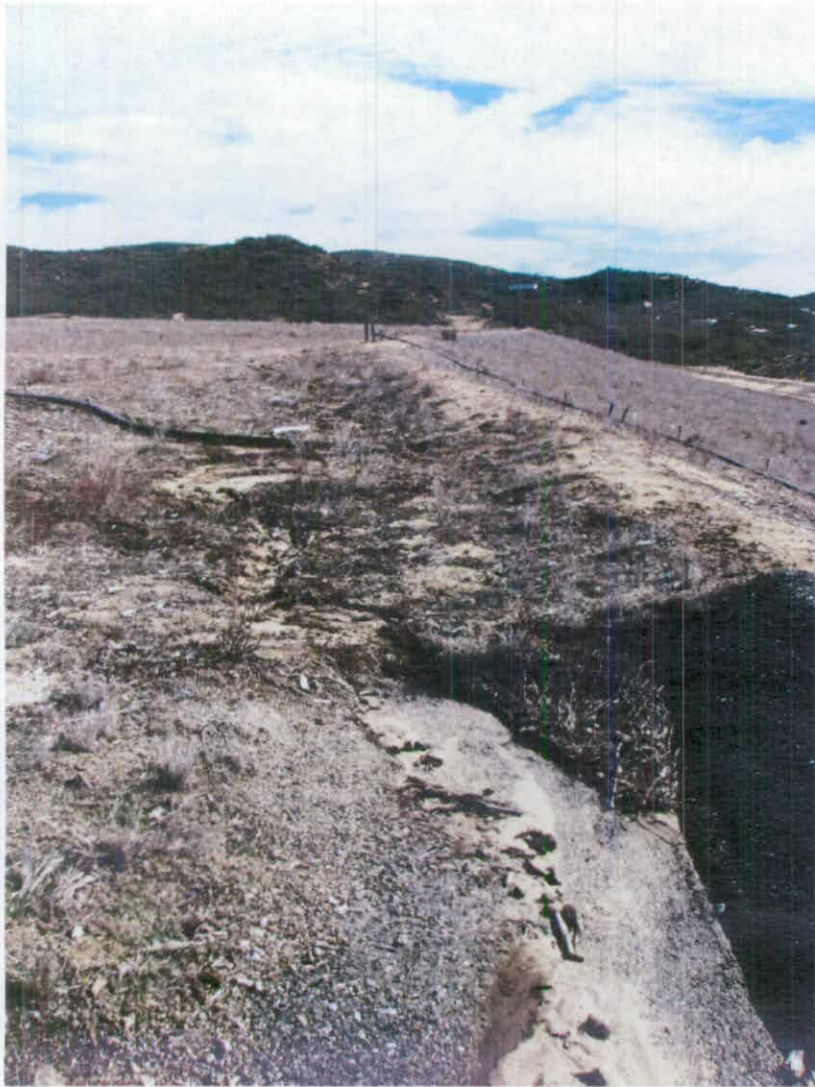
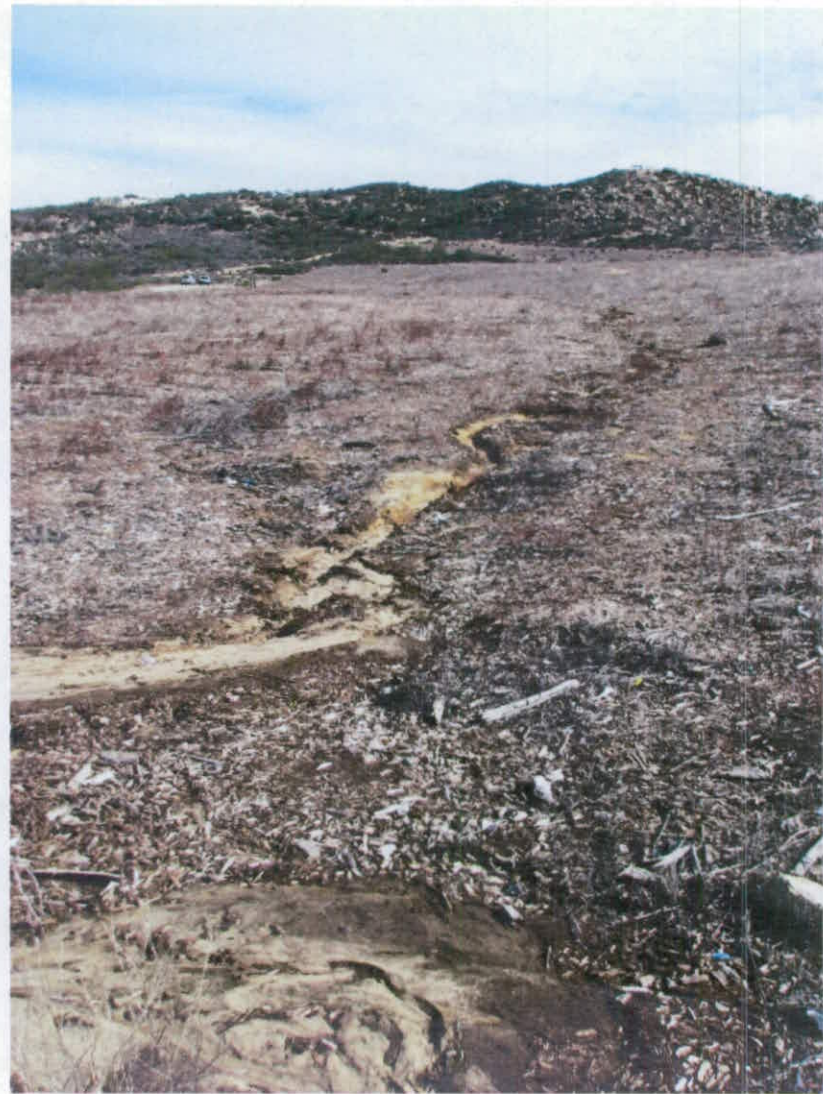
Erosion along the upper deck leading to a drainage swale designed to carry storm water runoff to the desiltation basin at the toe of the landfill. Photo taken January 14, 2016 during a site inspection.

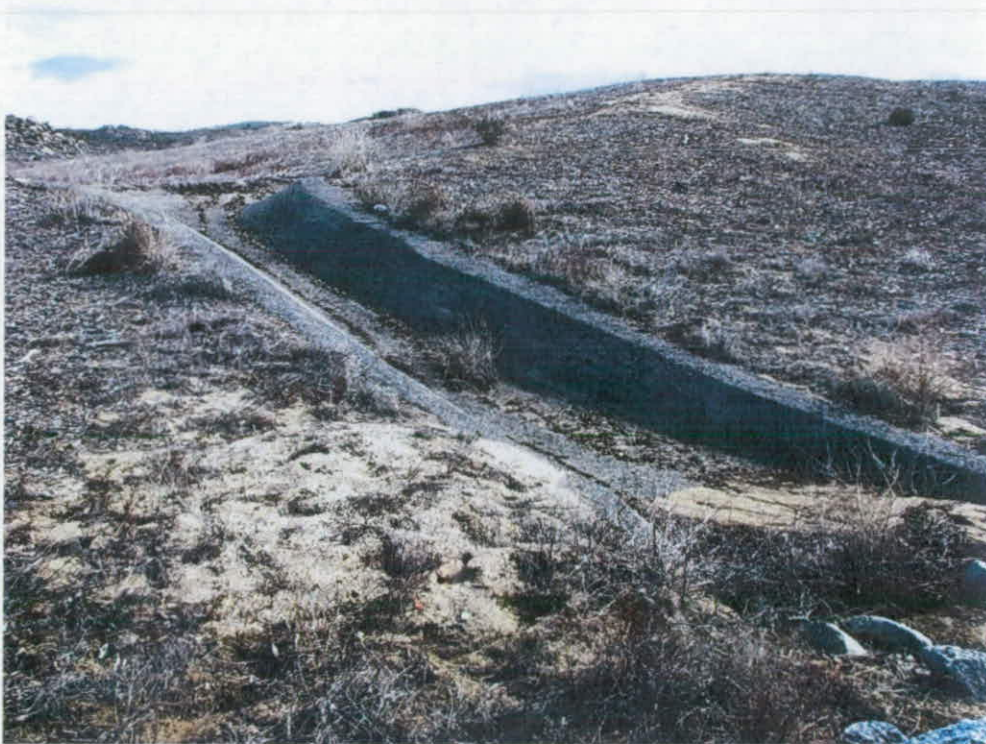
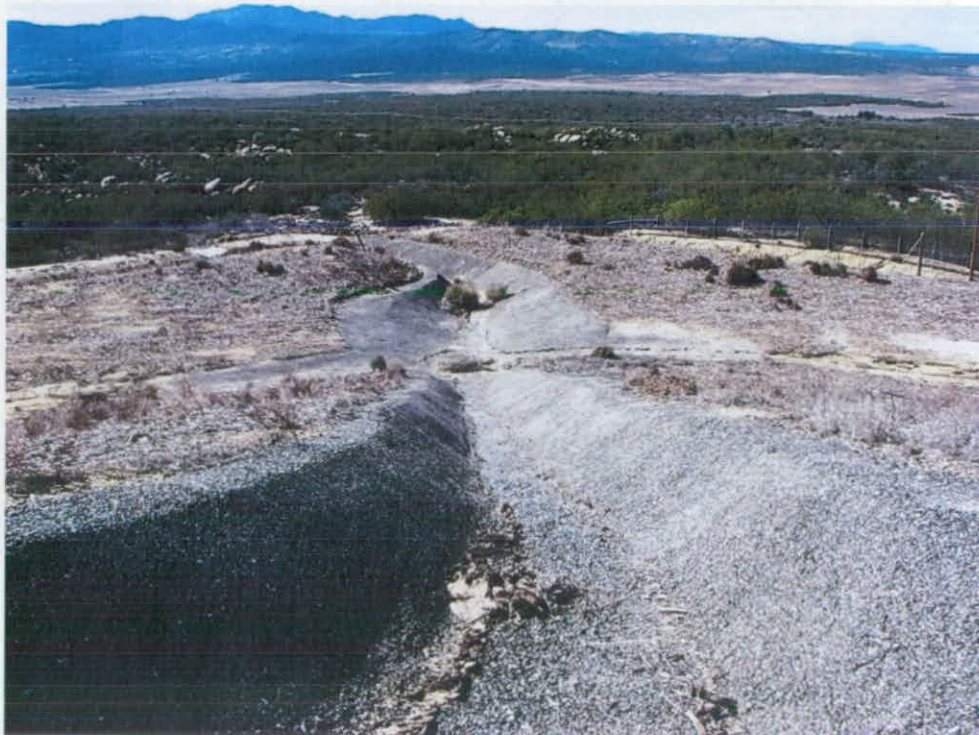
Drainage Swale from the upper deck to the middle bench (top photo) and from the upper deck looking down the entire side slope (lower photo). Drainage swale is full of debris which should be removed prior to the next storm event to promote positive flow and drainage to the desiltation basin. Photo taken January 14, 2016 during a site inspection.

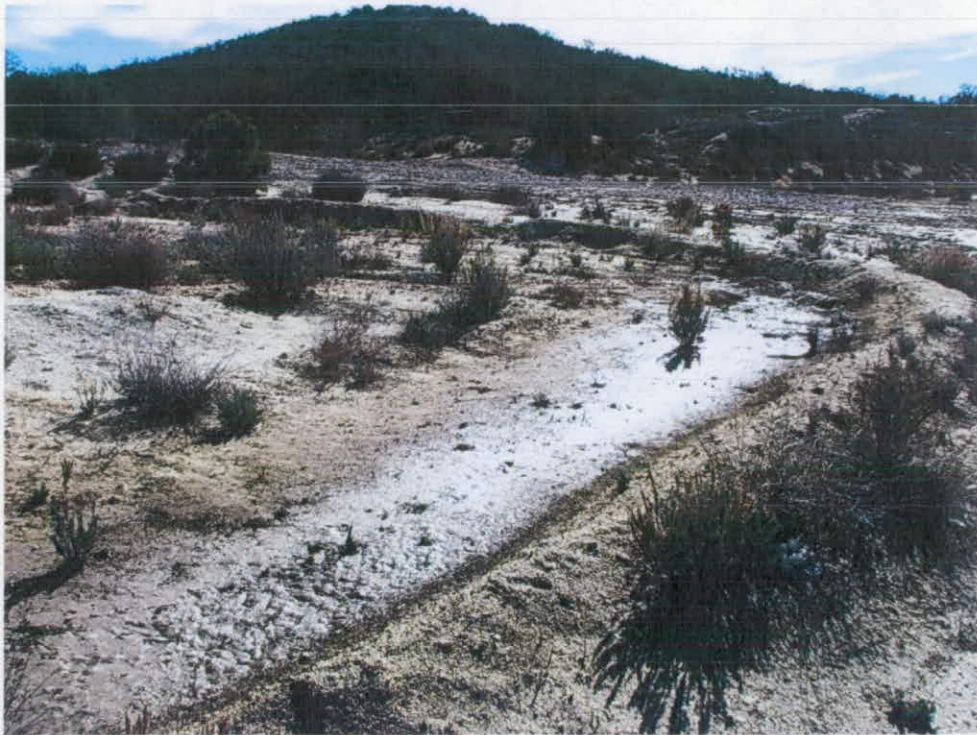
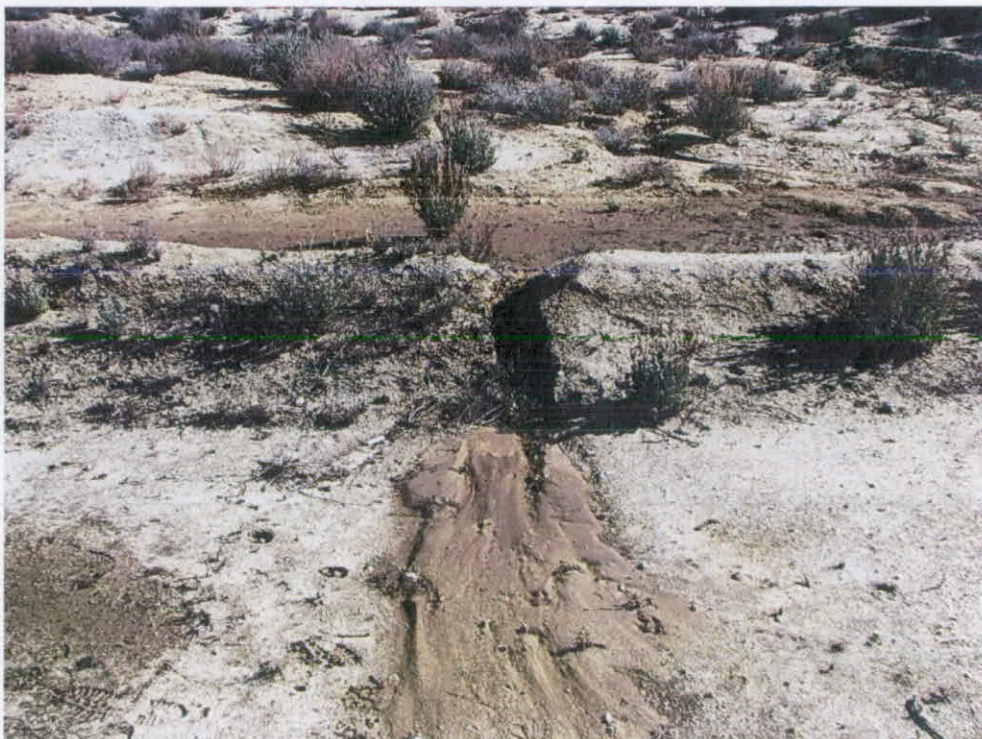
Earthen berm constructed along the eastern (up-gradient) boundary of the site. Based on its location and orientation, it is believed this structure was built to divert storm water flows away from the landfill. As seen in the photo below, the earthen berm alone cannot manage the storm water flows associated with a major storm event. Photo taken January 14, 2016 during a site inspection.

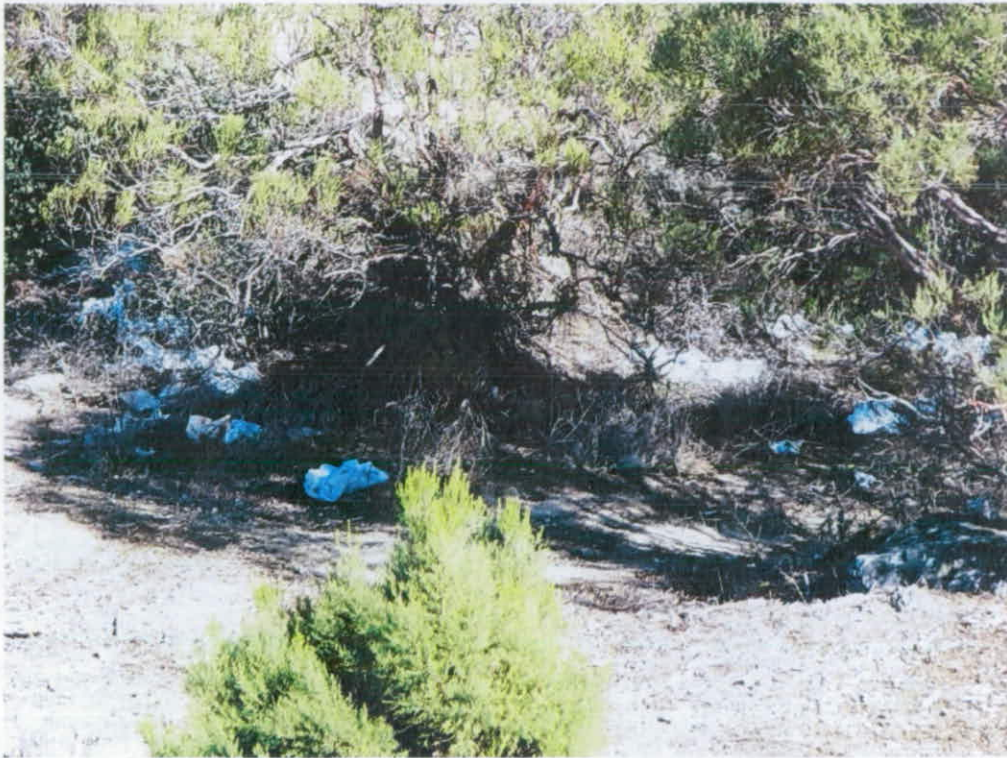
The Anza transfer station is located adjacent to the Anza Sanitary Landfill and within the landfill property boundary. A considerable amount of trash was observed during the inspection indicating that either wastes are being removed from the transfer station by animals or humans, or that trash is blowing away from the transfer station and creating a condition of nuisance in the open space adjacent to the Landfill and within the landfill property. The Discharger should install measures to prevent the migration of waste into areas not designated for waste disposal.

Littler observed in the open space adjacent to the landfill and up-gradient and adjacent to the transfer station. Photo taken January 14, 2016 during a site inspection.
