WDID 937C368067 (Corner at Twin Oaks Revegetation Project): 7 January 2016 Inspection

I conducted an inspection of the site on January 7, 2016 following multiple storm events, and before another predicted storm event. As there was no one on the site, I inspected the site from outside the perimeter and publicly accessible locations. Based on my observations, several requirements for a Risk Level 2 construction site were not implemented or inadequately implemented in compliance with the CGP. Following the inspection, I met with Mike Absell at another site who informed me that he is the contractor responsible for implementing the storm water BMPs at this site. I informed Mr. Absell of the deficiencies I observed at this construction site. He assured me that the site would be brought into compliance with the requirements of the CGP as soon as possible.

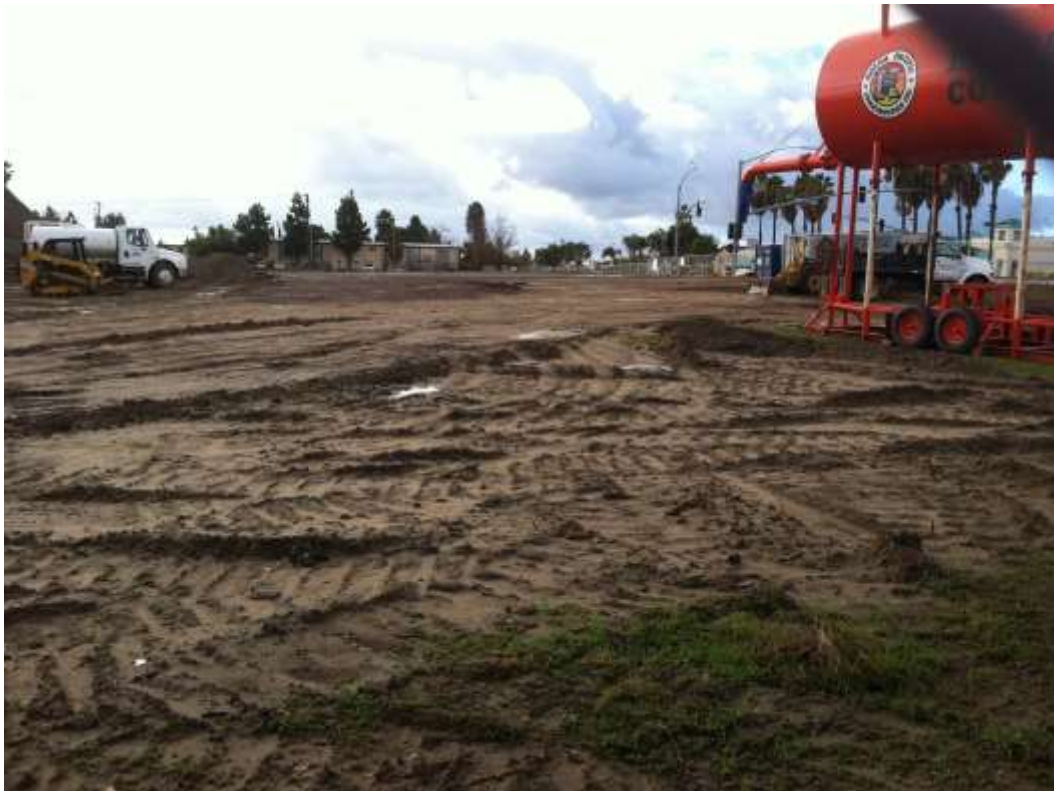
Photo 1

1. All Risk Level 2 sites are required to implement effective soil cover for inactive areas. All Risk Level 2 sites are required to implement appropriate erosion control BMPs (runoff control and soil stabilization) in conjunction with sediment control BMPs for active areas. Areas that were inactive should have had already had effective soil cover or soil stabilization implemented before the storm event. Runoff controls and soil stabilization are expected to be implemented prior to a predicted rain event for all active areas. Photos 1 through 8 show several areas of the site lacking evidence of effective soil cover or soil stabilization measures implemented to prevent erosion in preparation of the storm events that occurred or for the storm events predicted to occur. Photo 2 shows evidence of significant sediment transport, which is a clear indication that the site lacked appropriate erosion control BMPs to prevent erosion for inactive or active areas.

3. All Risk Level 2 sites are required to effectively manage all run-on, all runoff within the site and all runoff that discharges from the site. Photos 1 through 8 and show a lack of controls to manage run-on (Photo 8) and all runoff within the site (Photos 1 through 7).

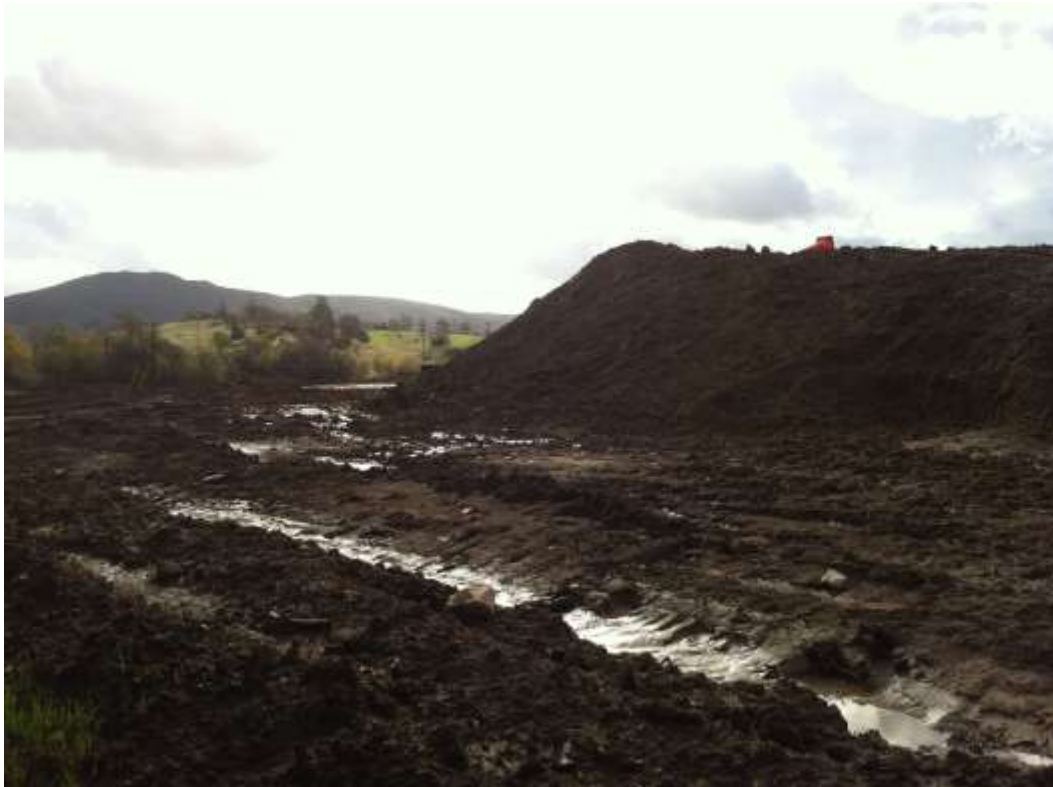
Photo 3

2. All Risk Level 2 sites are required to contain and securely protect stockpiles of waste and construction material from wind and rain at all times unless actively being used. Photos 3 through 7 show what appears to be a very large soil stockpile that evidently is not being used as there is no activity on the site, and does not have protection from rain or containment. Photo 5 shows evidence of rilling on the stockpile, indicating the stockpile has been exposed to storm water runoff that has caused significant erosion. Photo 8 also shows a waste stockpile without containment or protection.

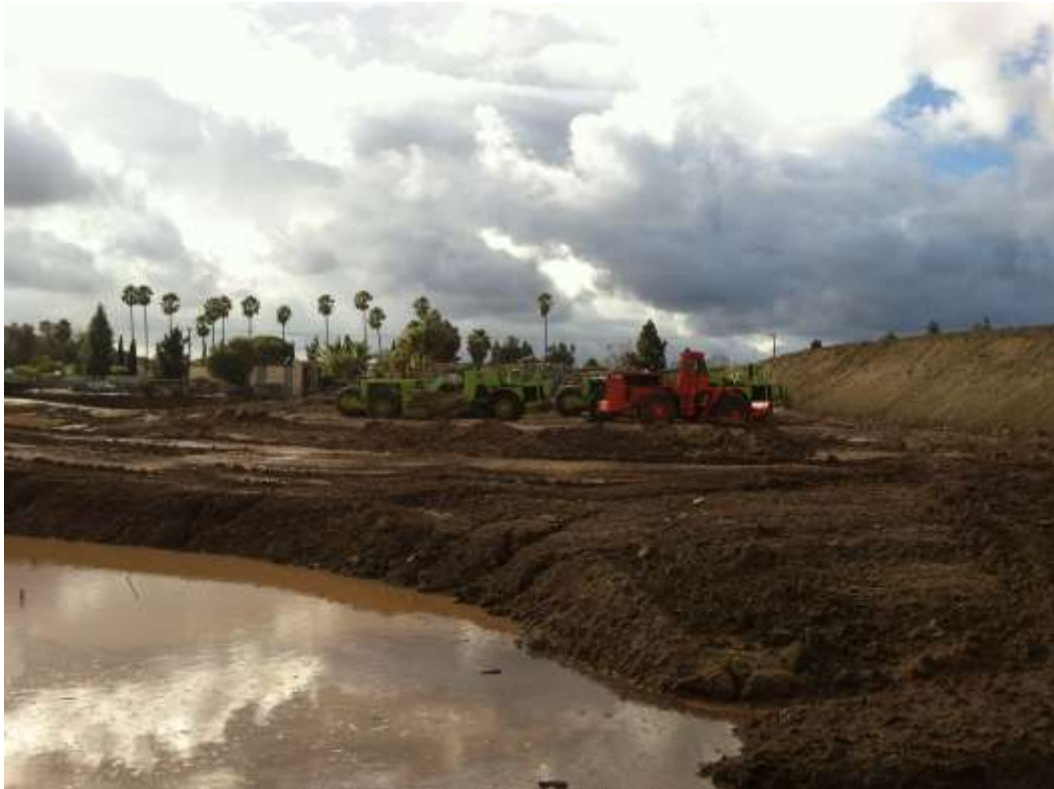
5. All Risk Level 2 sites are required to implement good housekeeping for vehicle storage to prevent oil, grease, or fuel to leak into the ground, storm drains, or surface waters. Photo 7 shows several vehicles lacking drip pans or other BMPs to prevent oil, grease, or fuel to leak into the ground.

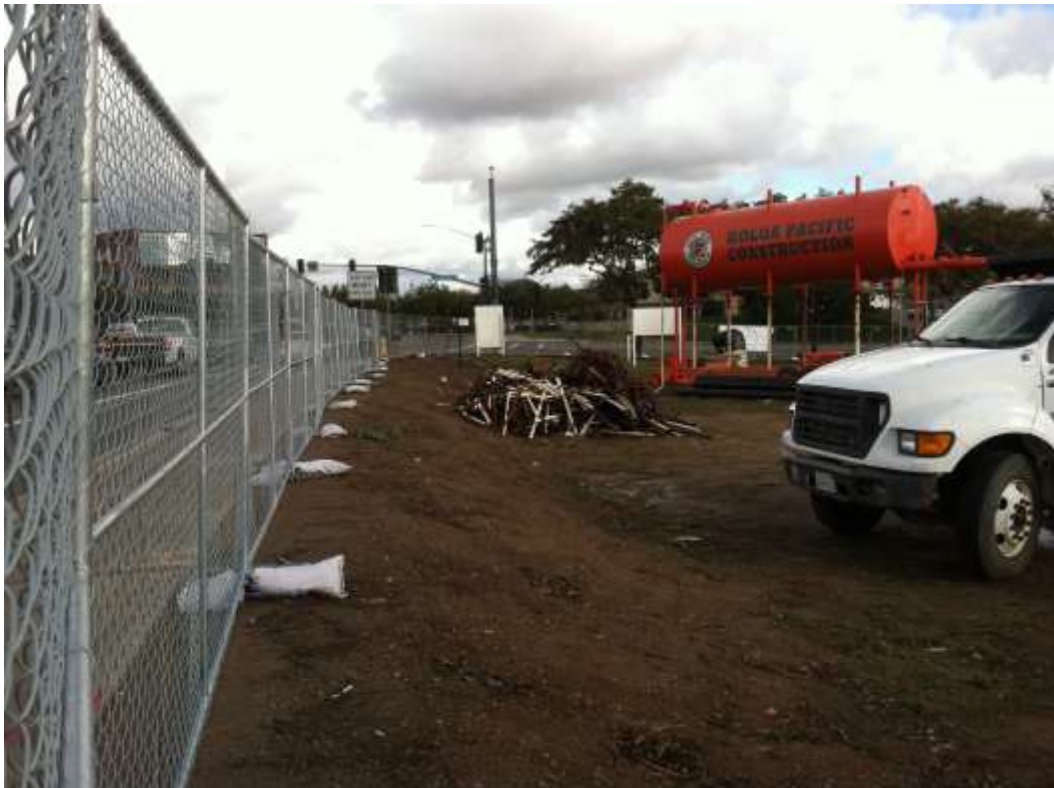
Photo 8

control erosion and sediment discharges from the site. Photos 8 shows a lack of perimeter controls to prevent runoff that can cause erosion on the site and result in discharges of sediment from the site.
