From: Chiu, Wayne@Waterboards
Sent: Friday, January 08, 2016 4:59 PM
To: 'Amy Garzot'
Cc: Michael DeHart; Walsh, Laurie@Waterboards; Clemente, Chiara@Waterboards; Joe Kuhn (jkuhn@ci.la-mesa.ca.us)
Subject: WDID 937C369357 (Fairfield Luxury Apartments): 6 January 2016 Inspection
Attachments: 2016-0106 Inspection Photos (Fairfield).pdf

This email is to document my observations, as well as provide you an opportunity to provide additional information. During the inspection, I observed several requirements for a Risk Level 1 construction site that were not implemented or inadequately implemented in compliance with Order No. 2009-0009-DWQ, the Statewide Construction General Storm Water Permit (CGP).

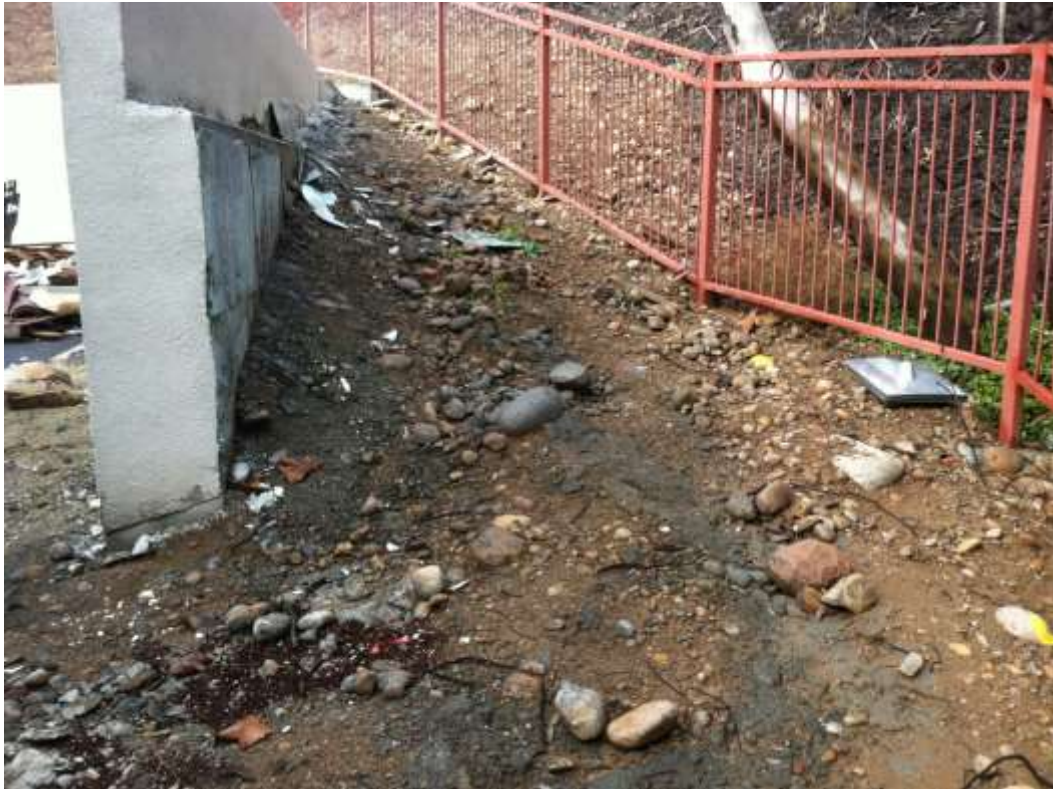
Photo 1

1. All Risk Level 1 site are required to implement effective soil cover for inactive areas. Areas that were inactive should have already had effective soil cover or soil stabilization implemented before the storm event. Photos 1 through show several areas that appeared to be inactive, or should have been scheduled to be inactive and provided effective soil cover, especially in anticipation of the predicted storm events.

3. All Risk Level 1 sites are required to ensure containment of concrete washout areas and other washout areas so there is no discharge to underlying soil and onto surrounding areas. Photos 1 and 7 show concrete and other cementaceous material improperly disposed to disturbed soil areas.

4. All Risk Level 1 sites are required to effectively manage all run-on, all runoff within the site and all runoff that discharges from the site. Photos 1 through 6 and 8 through 10 show a lack of controls to manage runoff within the site (Photos 1 and 6) and runoff that is discharging from the site (Photos 2, 4, and 8 through 10).

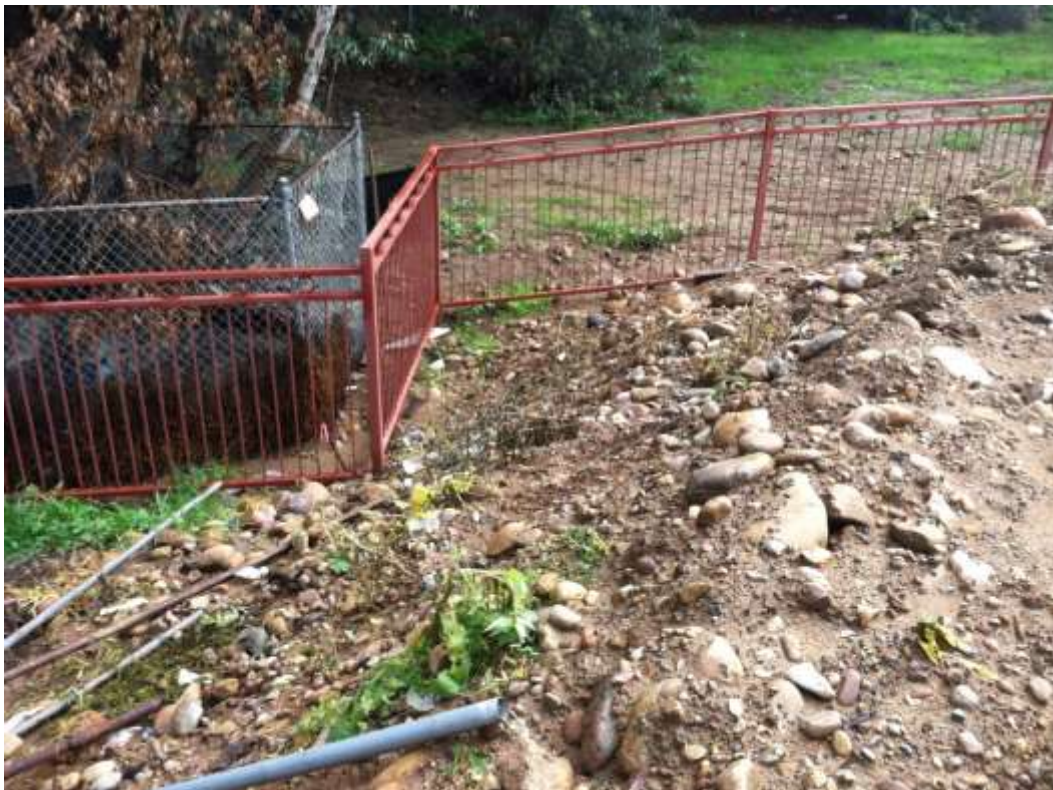
Photo 2

5. All Risk Level 1 sites are required to establish and maintain effective perimeter controls to sufficiently control erosion and sediment discharges from the site. Photos 2 and 4 shows a lack of perimeter controls to sufficiently control discharges of sediment from the site.

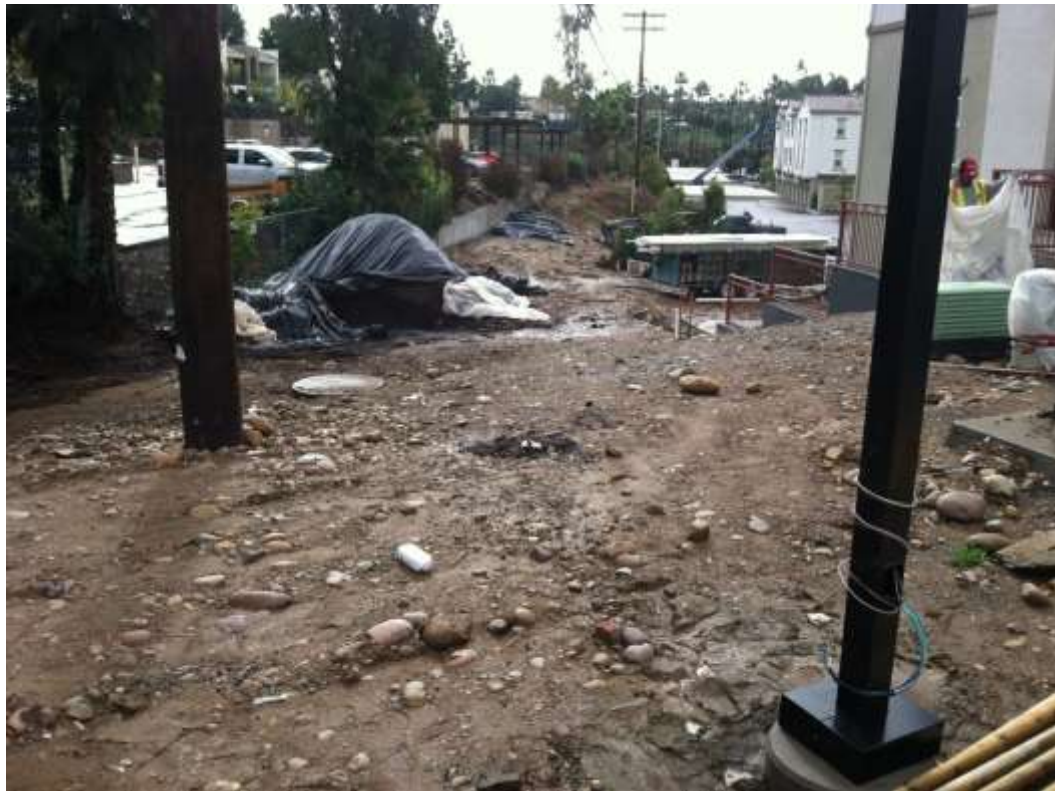
Photo 5

2. All Risk Level 1 sites are required to contain and securely protect stockpiles construction and waste material from wind and rain at all times unless actively being used. Photos 5 and 6 show stockpiles that did not have adequate protection from rain or containment to prevent flow from the areas shown in Photos 1 through 4 through the stockpiles.

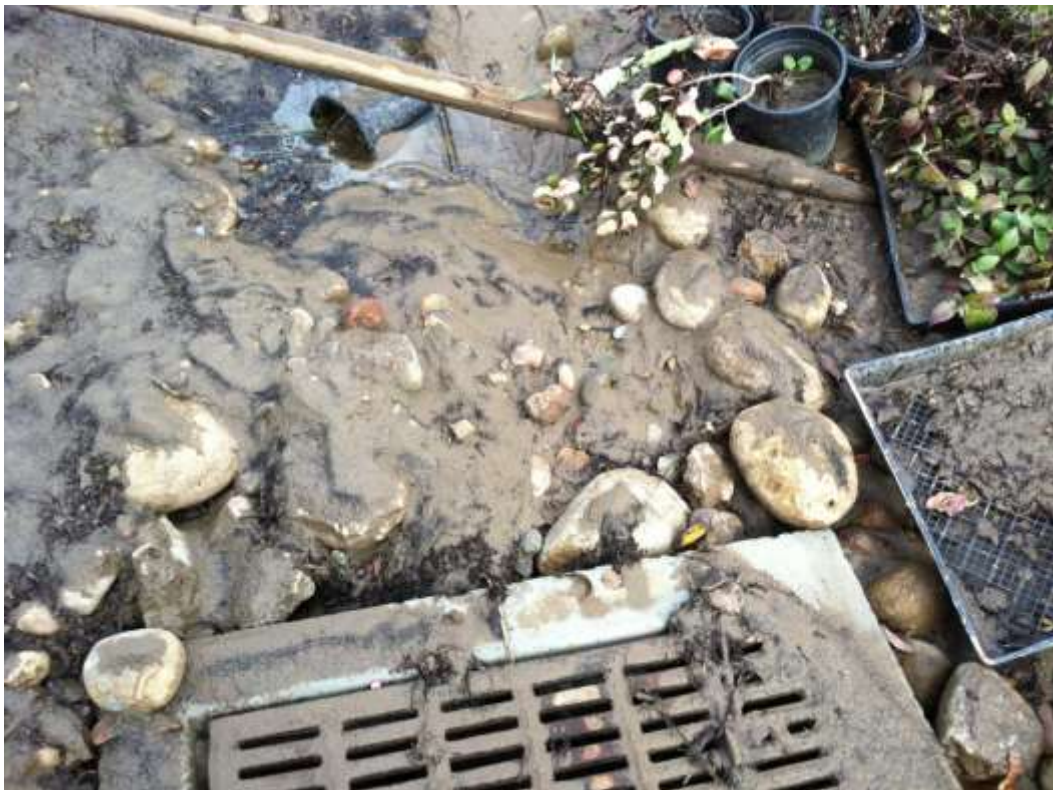
6. All Risk Level 1 sites are required to minimize or prevent pollutants in storm water discharges through the use of controls, structures, management practices that achieve BCT for conventional pollutants. Photo 8 through 10 shows evidence of sediment conveyed in storm water runoff discharged to several storm drain inlets. The sediment in the discharge was observed to originate from runoff that flowed through the unprotected areas in Photos 1 through 4, the unprotected stockpiles in Photos 5 and 6, and other unprotected exposed soil areas adjacent to the storm drain inlets shown in Photos 8 and 9.
