WDID 937C371940 (Mohawk and Keeney St Grading Plan): 6 January 2016 Inspection

Thanking you for taking the time to discuss your with me on Wednesday, January 6. This email is to document my observations, as well as provide you an opportunity to provide information that will demonstrate the site has been brought into compliance with the requirements of Order No. 2009-0009-DWQ, the Statewide Construction General Storm Water Permit (CGP). According to the Storm Water Multiple Application and Report Tracking System (SMARTS) you are the Legally Responsible Person (LRP) listed for the site, and the site was determined to be a Risk Level 2 construction site, subject to the requirements in Attachment D to the CGP.

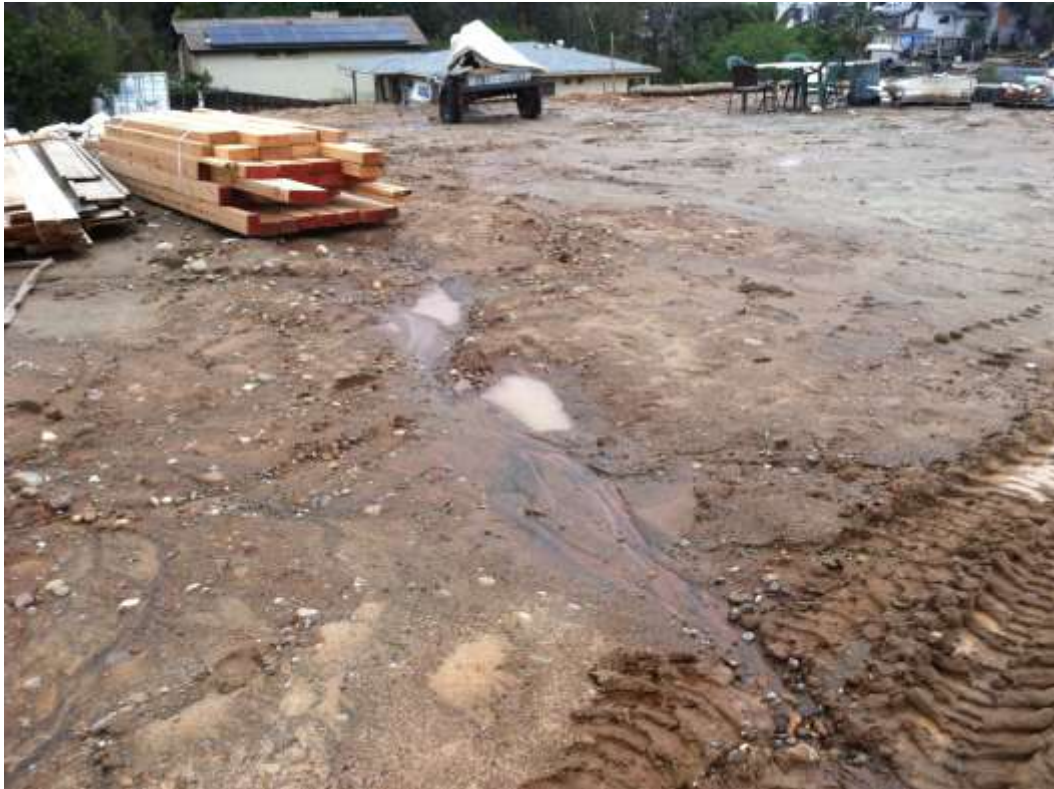
Photo 1

5. All Risk Level 2 sites are required to effectively manage all run-on, all runoff within the site and all runoff that discharges from the site. Photos 1 through 4, 7 and 8 show a inadequate controls to manage runoff within the site (Photos 1 and 4) and runoff that is discharging from the site (Photos 7 and 8).

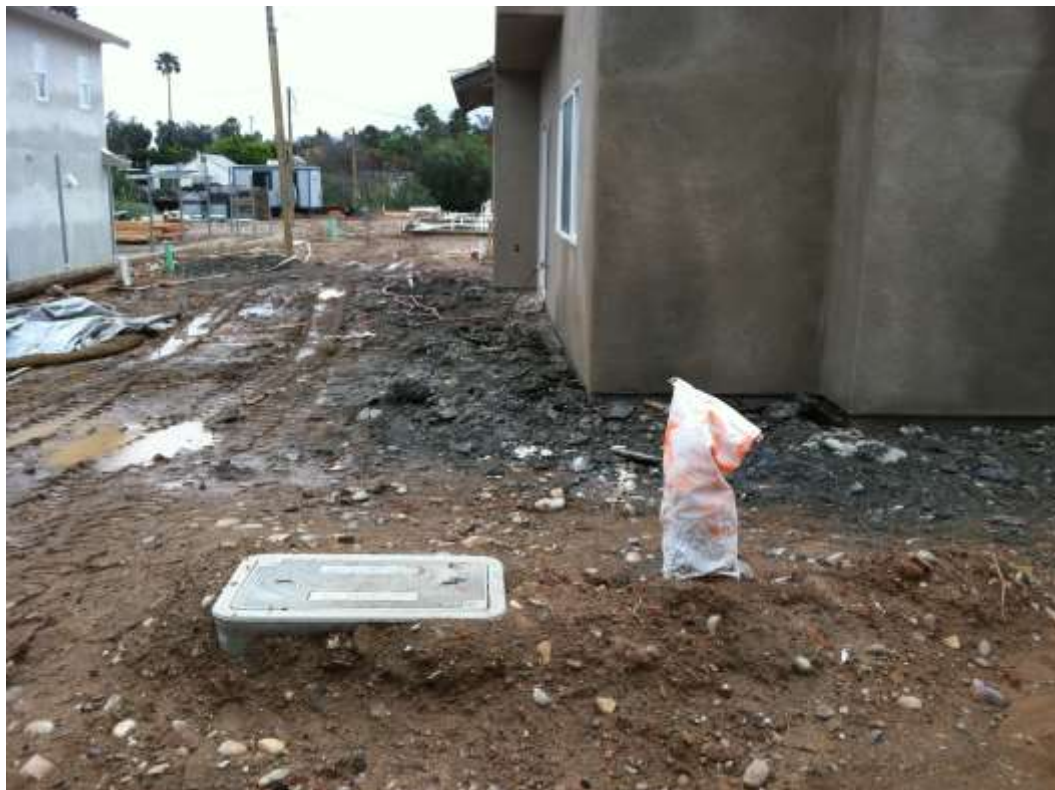
3. All Risk Level 2 sites are required to ensure containment of concrete washout areas and other washout areas so there is no discharge to underlying soil and onto surrounding areas. Photo 4 shows concrete or other cementaceous material improperly disposed to disturbed soil areas.

inlet. The sediment in the discharge was observed to originate from runoff that flowed through the unprotected areas in Photos 4 and 7.

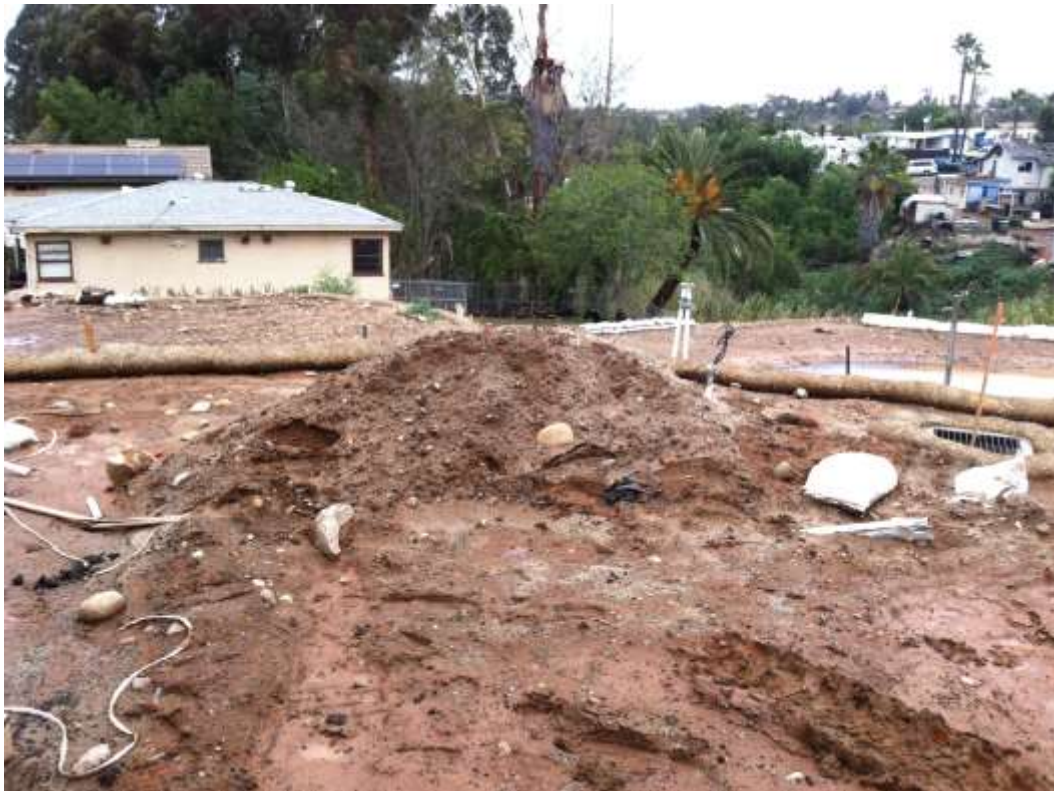
2. All Risk Level 2 sites are required to contain and securely protect stockpiles construction and waste material from wind and rain at all times unless actively being used. Photo 5 shows a stockpile that did not have protection or containment prior to or during the storm event.

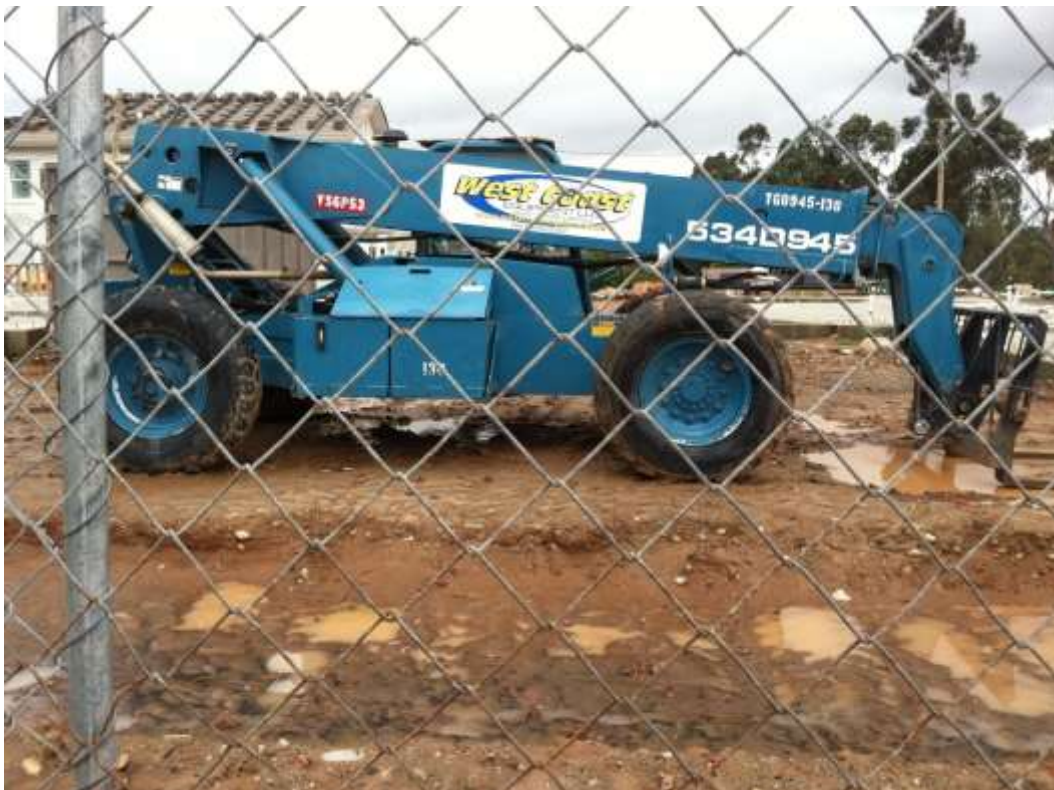
4. All Risk Level 2 sites are required to implement good housekeeping for vehicle storage to prevent oil, grease, or fuel to leak into the ground, storm drains, or surface waters. Photo 6 shows a vehicle lacking a drip pan or other BMPs to prevent oil, grease, or fuel to leak into the ground during a storm event.

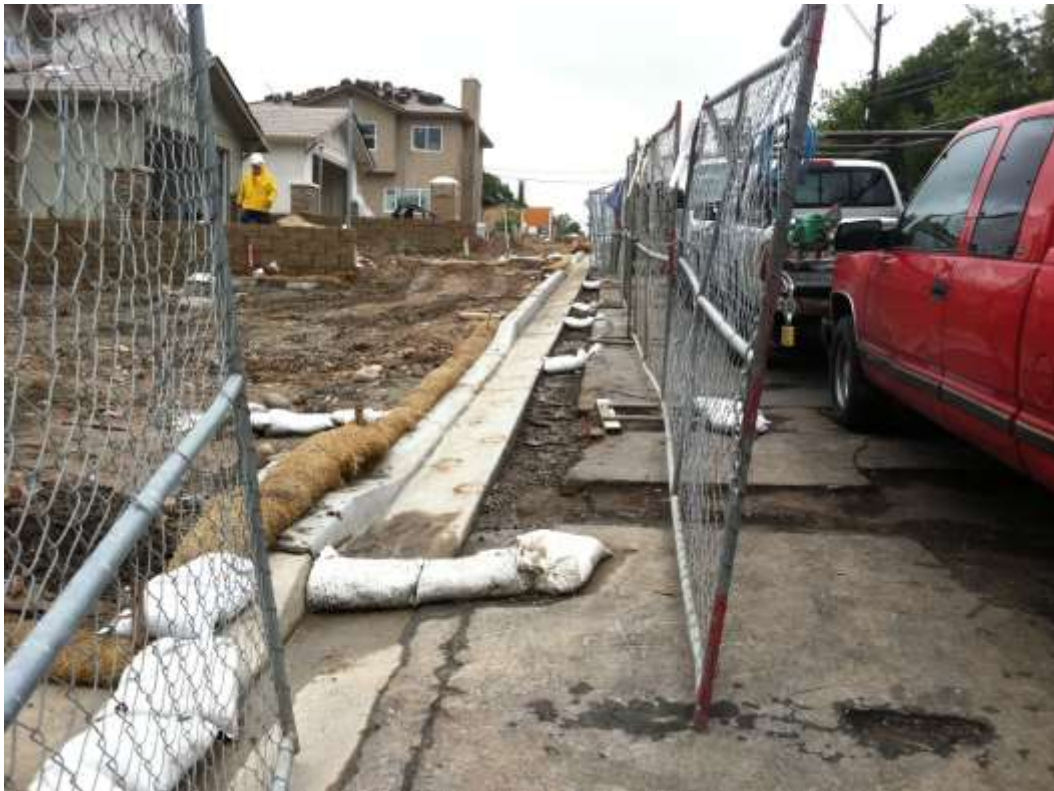
6. All Risk Level 2 sites are required to establish and maintain effective perimeter controls to sufficiently control erosion and sediment discharges from the site. Photo 7 shows a lack of perimeter controls to sufficiently control discharges of sediment from the site.

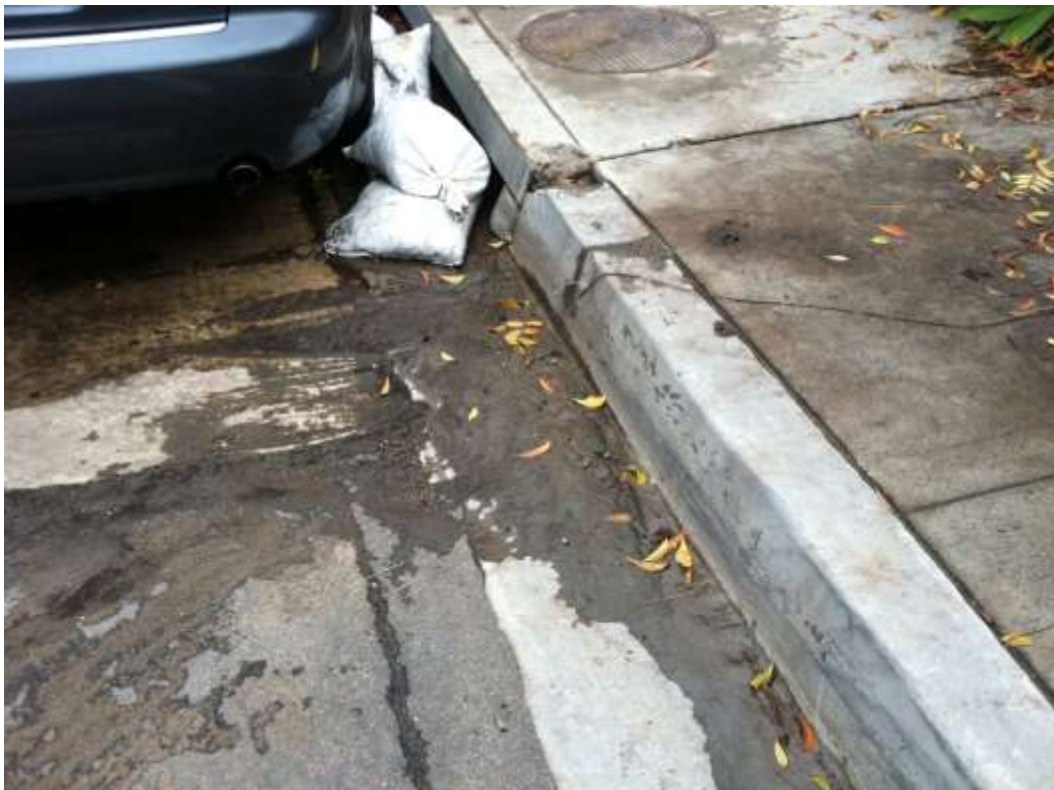
7. All Risk Level 2 sites are required to minimize or prevent pollutants in storm water discharges through the use of controls, structures, management practices that achieve BCT for conventional pollutants. Photo 8 shows evidence of sediment conveyed in storm water runoff discharged to an offsite storm drain
