NOTICE OF VIOLATION
No. R9-2016-0032

Facility: Murrieta Creek
Inspection Date: 1/7/2016

Attachment 2
to
January 7, 2016
Facility Inspection Report
for
Murrieta Creek Construction Site

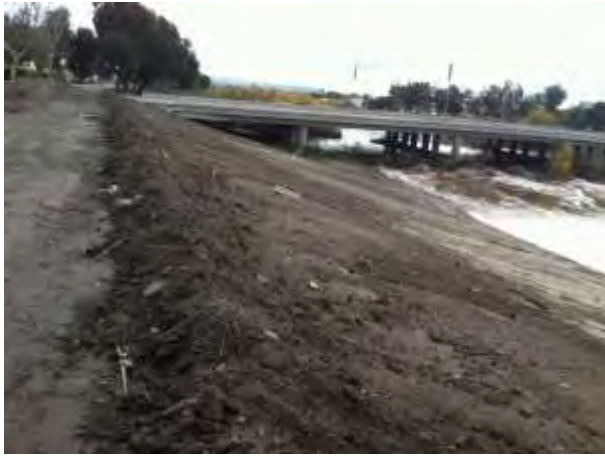
Photo 1

1. Risk Level 2 construction sites are required to provide effective soil cover for inactive areas (areas of construction activity that have not been disturbed and are not scheduled to be re-disturbed for at least 14 days) and all finished slopes, open space, utility backfill, and completed lots. San Diego Water Board inspectors observed several slopes that appeared to be inactive or could be scheduled to be inactive per the EC-1 Scheduling erosion control BMP included in the SWPPP (see Attachment 4). San Diego Water Board inspectors did not observe any evidence of erosion controls that provided effective soil cover on any slopes within the project boundaries. Evidence of significant rilling and sediment transport on several slopes that appeared to be inactive, or could be scheduled to be inactive, was observed, which was a clear indication that no erosion control BMPs had been implemented (see Photos 1 through 6). Mr. Kelly confirmed that most of the slopes along the project had not been worked on since before the holidays (i.e. December 25, 2015). Mr. Dickeson confirmed that no erosion control BMPs or effective soil cover could be observed on any of the slopes.

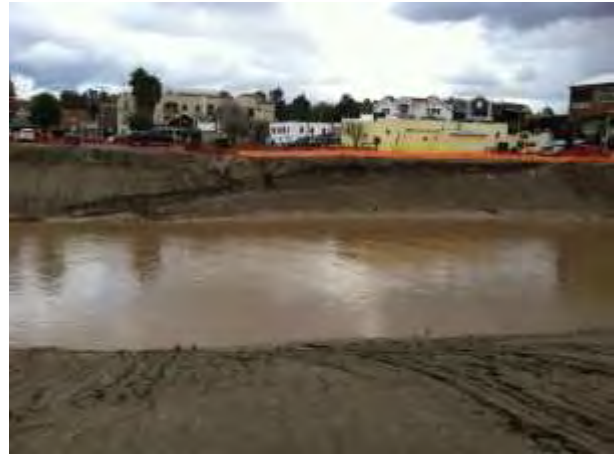
Photos 7 through 10 show examples of areas where there was inadequate implementation of controls to manage run-on to the site and runoff within the site. Photo 7 shows the upstream boundary of the site where Murrieta Creek flows run-on to the site and there is no obvious evidence controls have been implemented to manage the run-on to the site. Photo 8 shows the opposite bank where gullies have formed as a result of run-on to the site and lack of controls to manage runoff within the site. Photo 9 shows a location where a tributary is flowing under a silt fence installed for perimeter control with no evidence of controls to manage the run-on and runoff through the site. Photo 10 is downstream of Photo 9 and shows the gully erosion that has been caused as a result of the lack of run-on controls and runoff controls within the site.

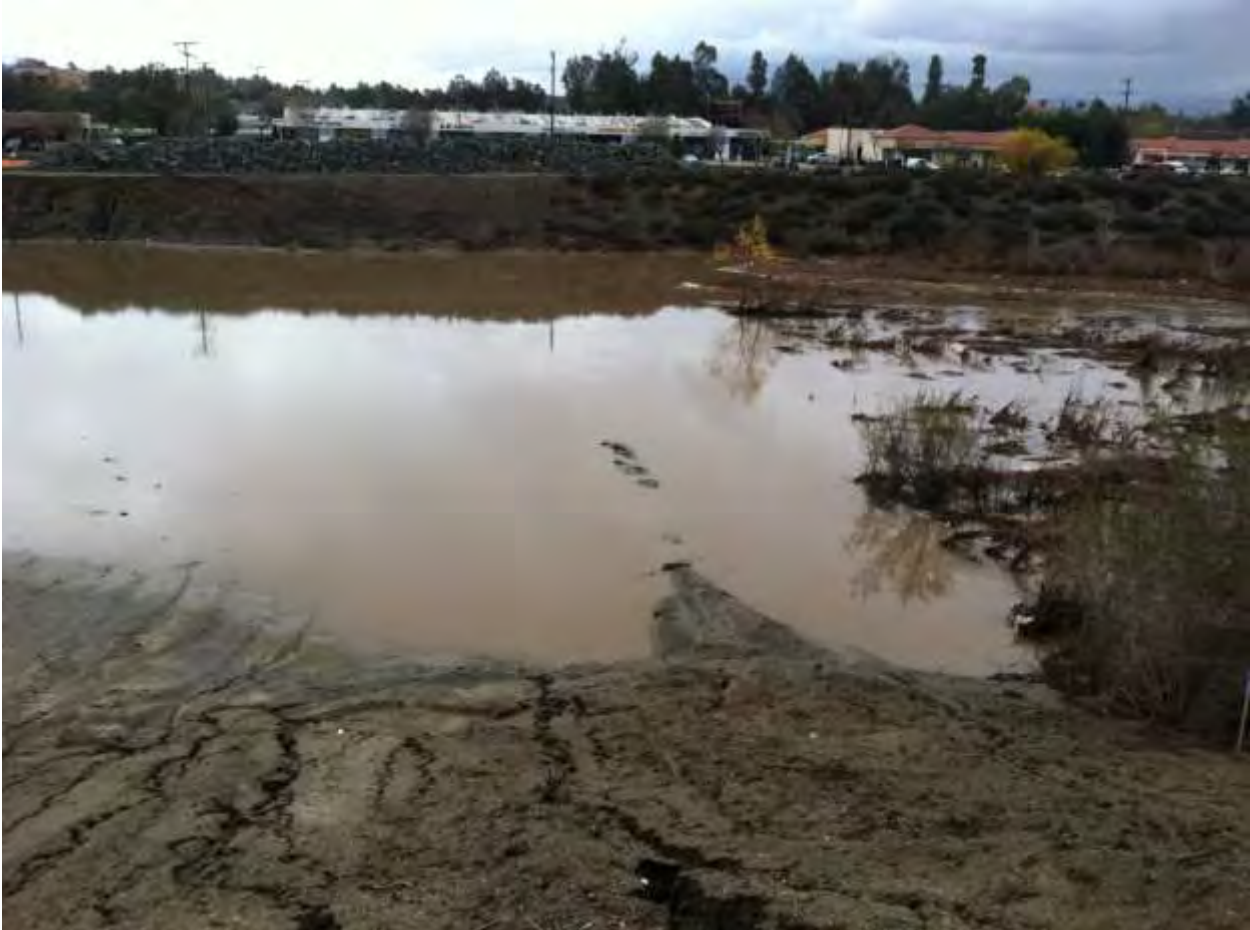
- b. Observation:** On January 7, 2016, the San Diego Water Board inspected the Murrieta Creek construction site (WDID 933C374007). OHL USA, Inc. is the Legally Responsible Person (LRP) enrolled under the Permit for the site. The San Diego Water Board inspectors observed sediment-laden storm water discharged from the site without implementation of adequate best management practices (BMPs). See attached January 7, 2016 Facility Inspection Report Photo 11.

4. Risk Level 2 construction sites are required to effectively manage all run-on, all runoff within the site and all runoff that discharges from the site. Risk Level 2 construction sites must direct run-on from off site away from all disturbed areas or the run-on that is discharged from the site must collectively be in compliance with the effluent limitations of the CGP (see Finding 8). San Diego Water Board inspectors observed inadequate implementation of controls to effectively manage all run-on to the site (Photos 7 through 9), all runoff within the site (Photos 1 through 11), and all runoff that discharges from the site (Photo 11). San Diego Water Board inspectors observed run-on from off site that was not directed away from disturbed areas (Photos 7 through 10), and contributed to discharges from the site that were not in compliance with the effluent limitations of the CGP (Photo 11).

Photo 11 shows the downstream end of the site where this is evidence that there was an earthen berm that had been in place to manage runoff from the site. There is no evidence of any other runoff controls to manage storm water runoff discharges within the channel of the site, and from the site. Run-on to the site (as shown in Photos 7 through 11) was not directed away from disturbed areas, and contributed to discharges of sediment and sediment laden storm water runoff from the site that was not collectively in compliance with the effluent limitations of the CGP. Photo 11 also shows evidence of significant rilling and sediment transport to the receiving water, which is a clear indication that the site did not implement adequate erosion controls, run-on and runoff controls and sediment controls to prevent discharges of sediment and sediment-laden storm water runoff to the downstream receiving water. Photo 11 also shows that there have been significant impacts to the downstream vegetation and habitat as a result of inadequately managed run-on to the site and runoff from the site.

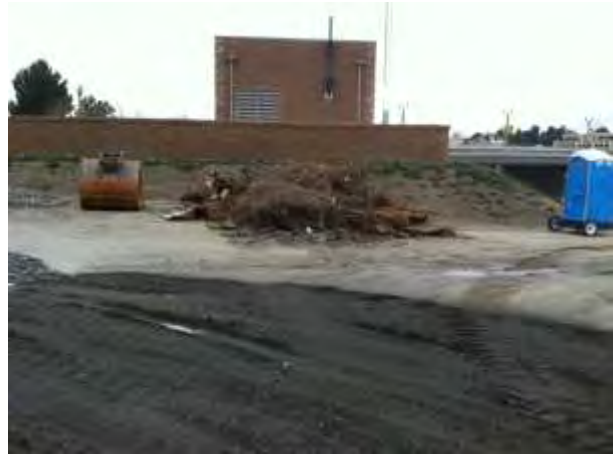
- c. **Observation:** During the January 7, 2016 inspection, the San Diego Water Board inspectors observed stockpiles without adequate berm or containment. See attached January 7, 2016 Facility Inspection Report Photos 12 and 13.

5. Risk Level 2 construction sites are required to cover and berm loose stockpiled construction materials and contain and securely protect stockpiled waste material from wind and rain at all times unless actively being used. San Diego Water Board inspectors observed at least one stockpile of loose construction material with an inadequate berm (see Photo 12), and at least one stockpile of waste material without adequate containment (Photo 13).

Photos 12 and 13 show stockpiles observed without adequate implementation of good housekeeping measures required for Risk Level 2 construction sites. Photo 12 shows loose stockpiled construction materials that are not actively being used without a berm that completely surrounds the stockpile. Photo 13 shows a waste material stockpile lacking measures to contain and securely protect the waste material (i.e. scrap metal) from wind and rain at all times.
