Subject: Notice of Violation Order No. R9-2018-0118, Las Pulgas Landfill, Marine Corps Base Camp Pendleton, San Diego County

NOTICE OF VIOLATION

No. R9-2018-0118

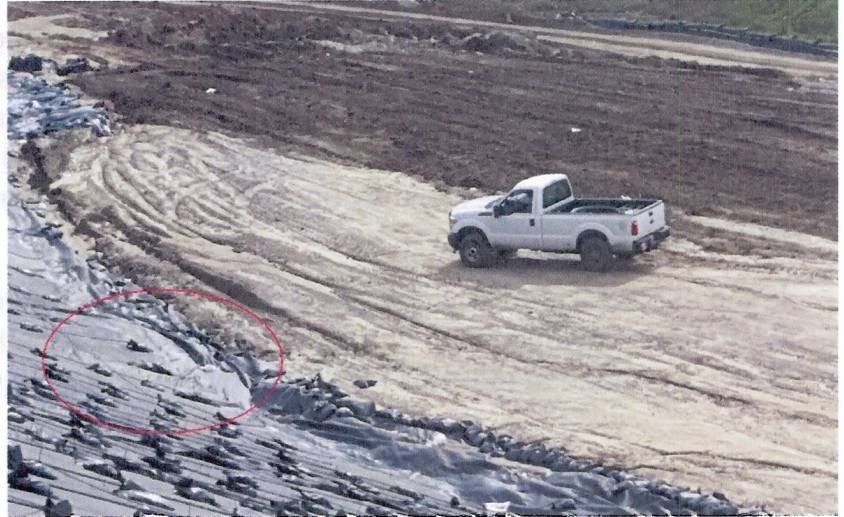
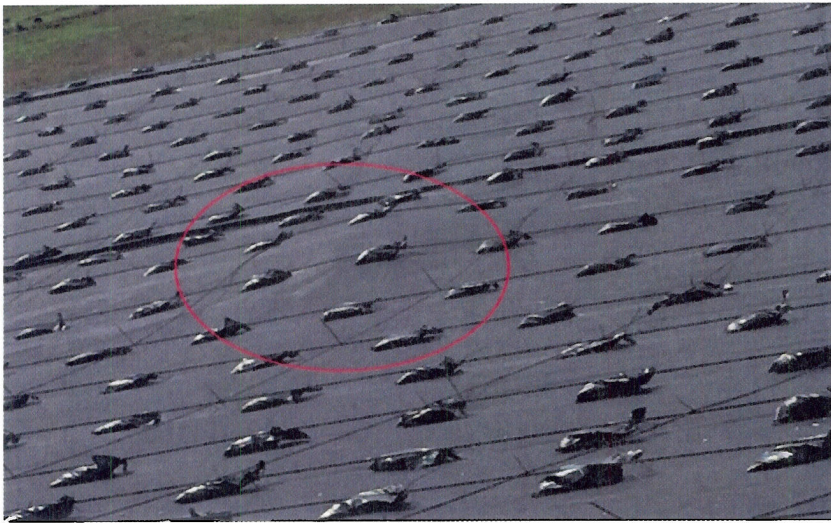
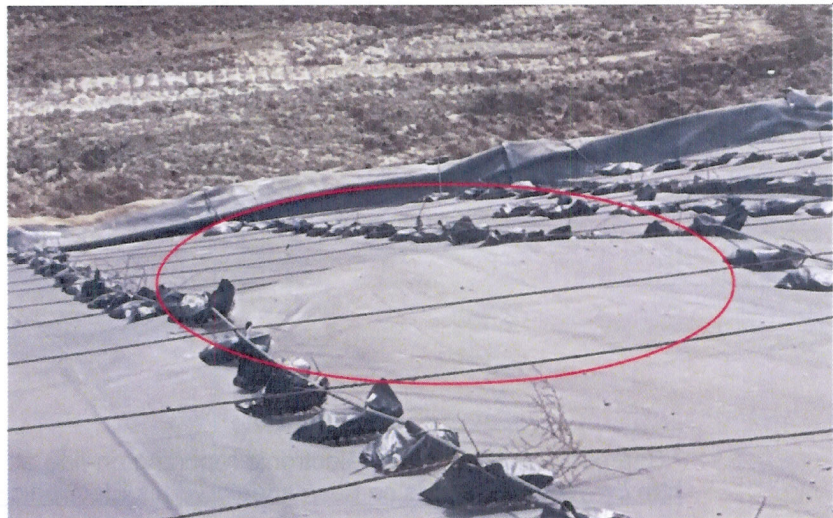
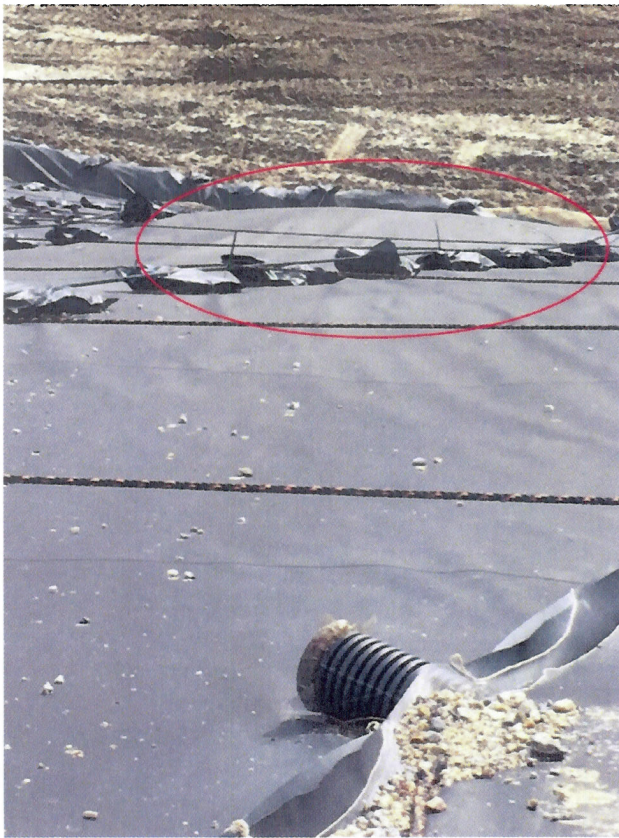
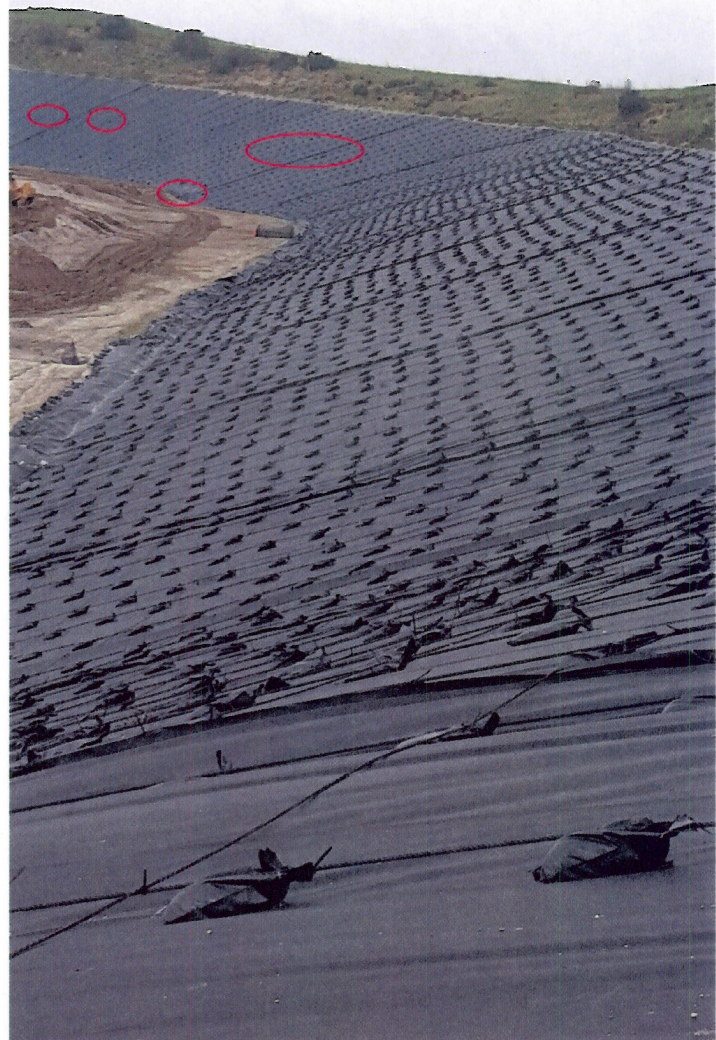
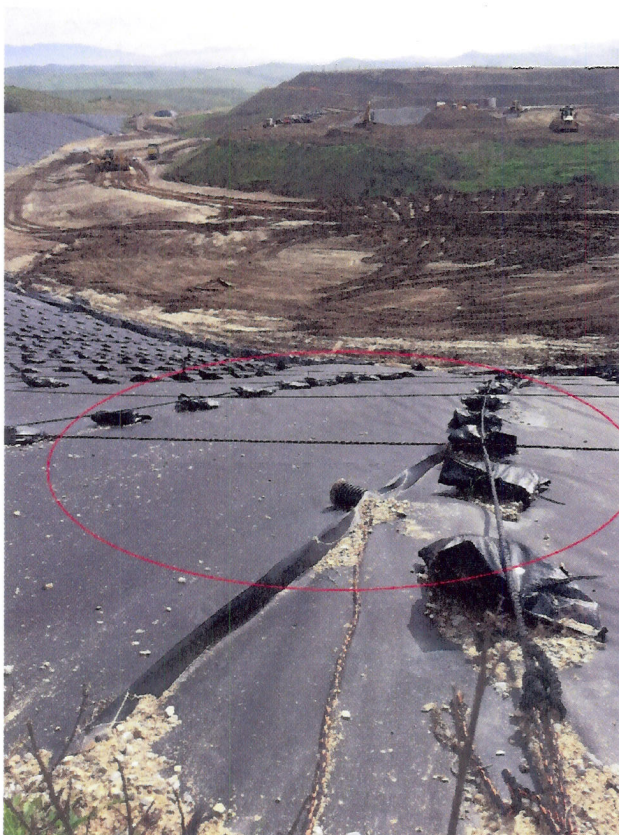
In January 2017, the Discharger notified the San Diego Water Board that the side slope liner system failed in the Phase I unit at the Las Pulgas Landfill (Landfill). During a site visit in February 2017, San Diego Water Board staff (Ms. Amy Grove and Mr. John Odermatt) confirmed that the side slope liner system was compromised in the Phase I Unit at the Landfill. The extent of the liner system damage could not be determined at that point in time. During the site visit, San Diego Water Board staff verbally advised the Discharger that an investigation is necessary to determine the extent and cause of the damage to the liner system and assess the work that would be necessary to repair the Phase I liner system as soon as possible.

- a. CFR title 40, part 258.40 (Design Criteria) requires that liner systems, comprised of flexible membrane liners (geomembranes) and clay layer components, must be constructed so that these liner components are in direct and uniform contact at all times. The failure of the clay layer within the side slope liner system created a condition where the liner components are no longer in uniform contact, creating an ongoing violation of this regulatory requirement.

- d. Order Section E.6.a (Landfill Construction Specifications) requires the Discharger to construct a 24-inch low permeability layer installed to ensure complete long-term coverage of the underlying subgrade materials. The slumping of the liner system's low-permeability clay layer creates a condition that violates this specification.

The following represent the photographic documentation taken by San Diego Water Board staff during the February 10, 2017 site visit to confirm the side slope conditions in the Phase I lined expansion area of the Las Pulgas Landfill. Areas of bulging or apparent clay layer failure are circled in red.
