REGIONAL WATER QUALITY CONTROL BOARD  
SAN FRANCISCO BAY REGION

## STAFF REPORT

**SUBJECT:** Tesoro Petroleum Coke Storage and Handling Facility  
Pittsburg, Contra Costa County  
File No. 2119.1048 (RAD)

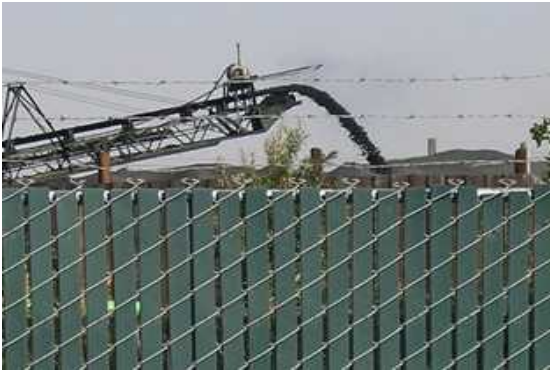
A local citizen took photos of the facility and the surrounding area on October 27, 2004. The photos show coke was piled higher than the surrounding 14' fence, which rendered the fence ineffective in keeping the coke dust on site.

Level of coke pile is visible above the fence line

I recommend that Board staff issue Tesoro a letter requiring it to propose corrective actions with time schedules to prevent further discharges of coke to the area around its facility.

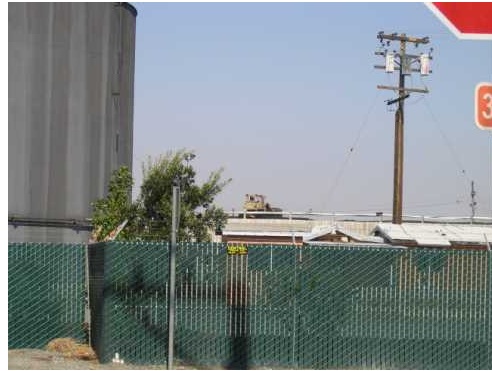
Tractor used to sort coke is visible above the fence line

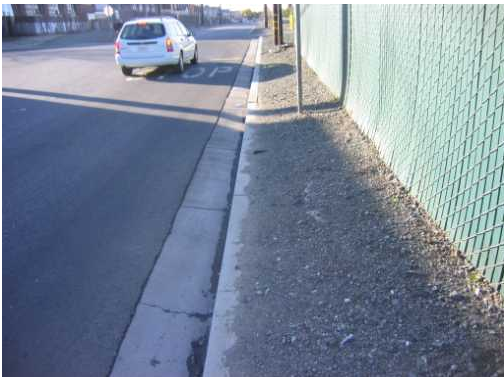
Photos taken on February 5, 2005, show coke dust that has been deposited onto the curb outside the facility. If uncollected, coke deposited in the streets or curbs will eventually be discharged to the slough via stormwater.

Sediment in curb just outside the facility fence

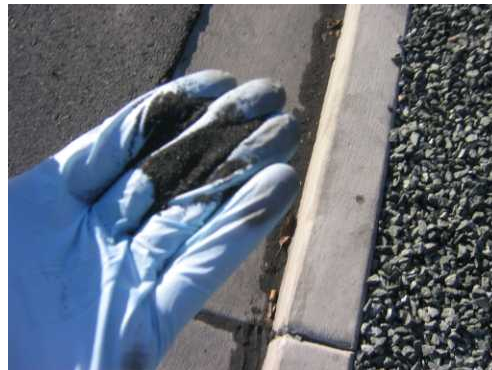
Close-up of coke found in curb

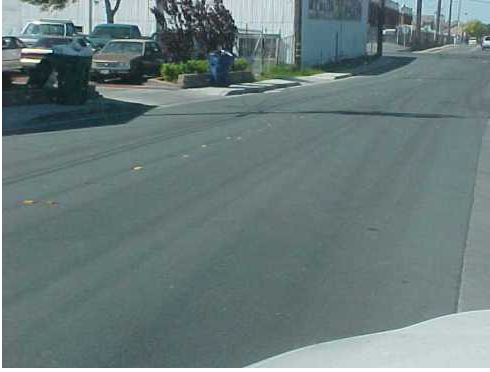
Staff from the Bay Area Air Quality Management District (BAAQMD) responded to a complaint on March 14, 2005. The complainant stated that coke would always blow into his boatyard during a strong northerly wind. The inspector noted that, “large amounts of coke dust were seen leaving the site from an open stockpiled area” and that, “perimeter mounted sprinklers were on but seemed to have no dust control effect.” The inspector noted coke dust leaving the facility and blowing into the nearby boatyard.

Coke dust swirling in street

The BAAQMD inspector noted that the “real time wind data readout showed winds gusting into the high 30’s (MPH).” Data from the nearby NOAA Port Chicago wind station recorded wind gusts above 30 MPH on March 14, 2005. Wind data also showed similar wind gusts occurring between April and November 2005 suggesting that the March 14 event is not uncommon.

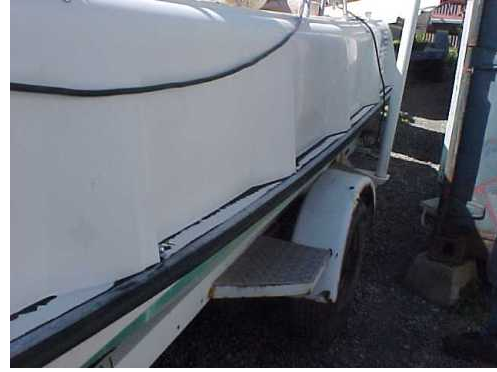
Coke dust accumulation on boat

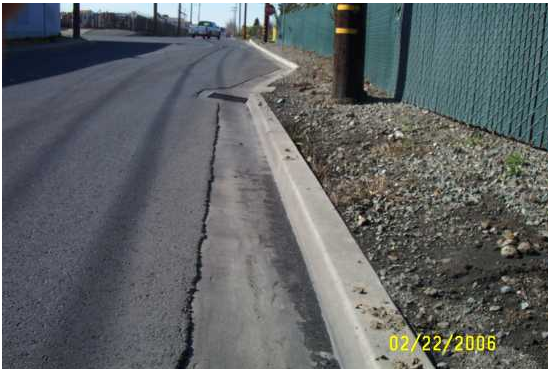
Board staff visited the facility's surroundings on February 22, 2006. A local citizen met with Board staff to point out areas where coke dust outside the facility may have collected. Board staff observed black sediment in the curb adjacent to the facility that may have contained coke dust. The citizen stated that coke is still being discharged during loading operations but was not able to provide photo documentation because loadings have recently been done during nights and on weekends.

Sediment in curb just outside the facility fence

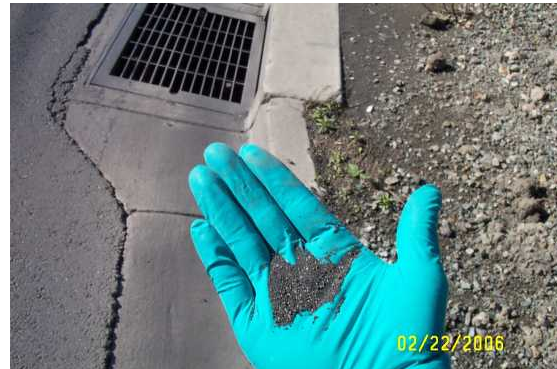
Close-up of sediment found in curb
