FACILITY INSPECTION REPORT

FACILITY: Plano Lift Station SMWD

INSPECTION DATE/Time: 03/25/10 10:30 am to 12:30

FACILITY: **Plano Lift Station sewage spill, Tijeras Creek@Antonio Parkway, Rancho Santa Margarita CA**

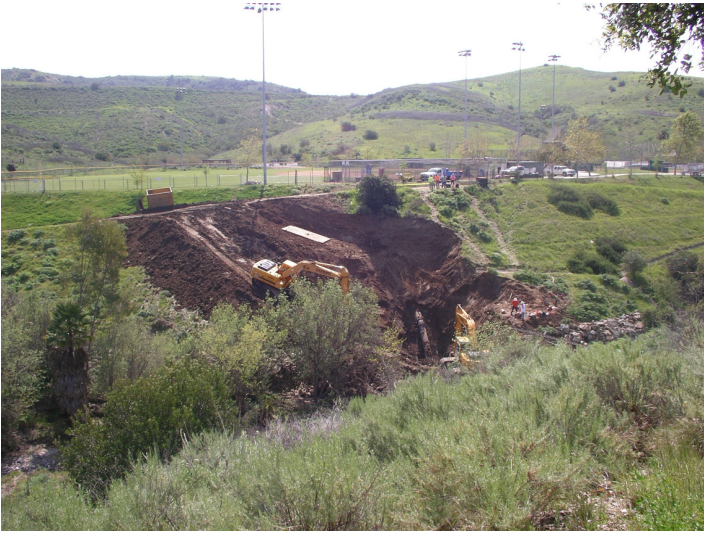
Crews and machinery excavating the slope of Tijeras Creek to locate the pipe break. The pipe is a 24-inch iron forcemain. The leak is thought to be under the creek bed.

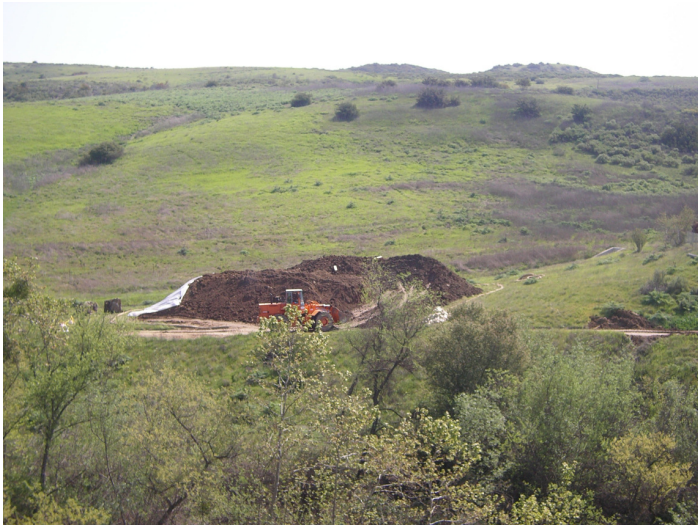
Soil from creek excavation is being stored north of the excavation site.

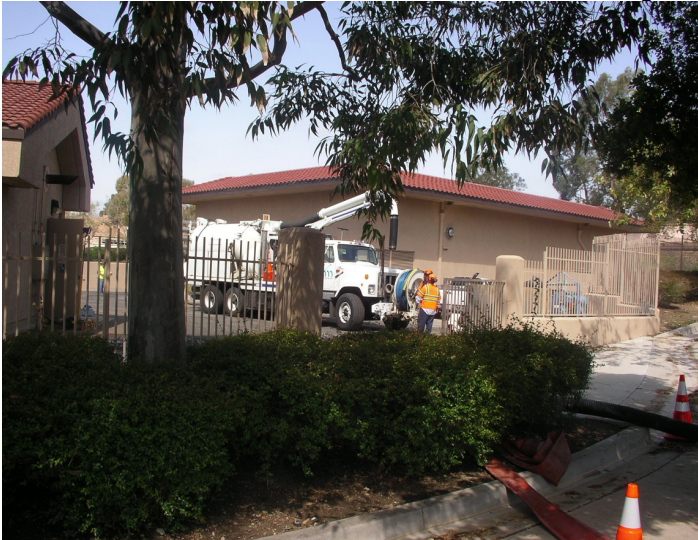
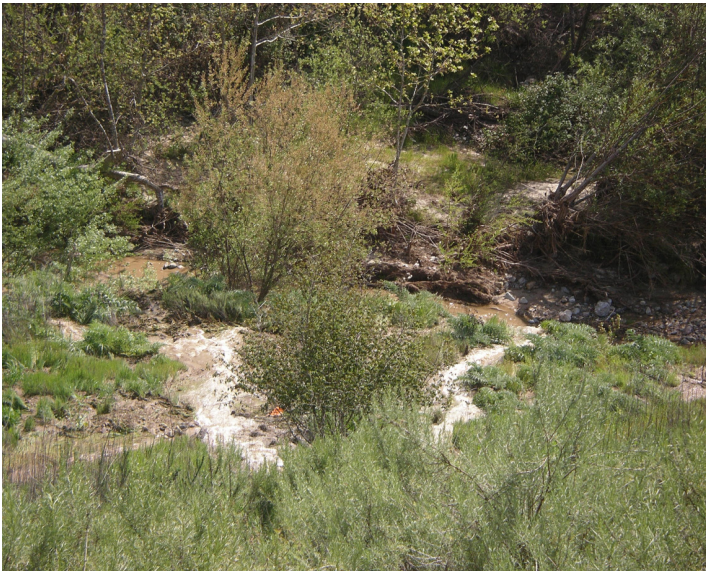
- To prevent the discharge of sewage from the lift station onto Antonio Parkway SMWD is utilizing a fleet of tanker and vacor trucks to remove sewage from the lift station
