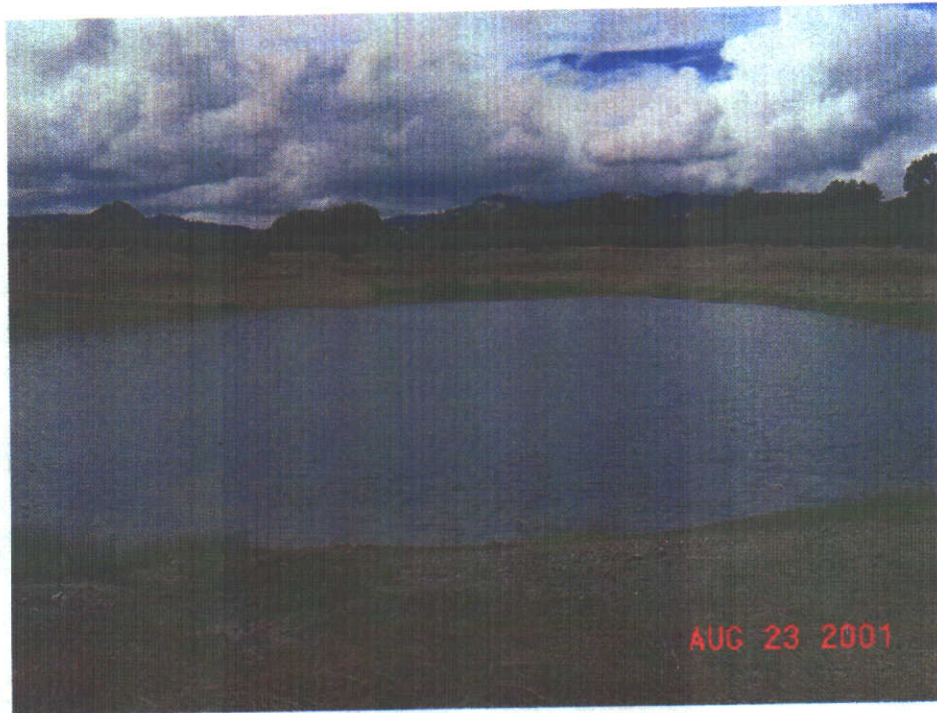
This photograph of the Upper Reservoir is the view looking north from the dam. The vineyard around the north side of the reservoir was not included in the licensed place of use.

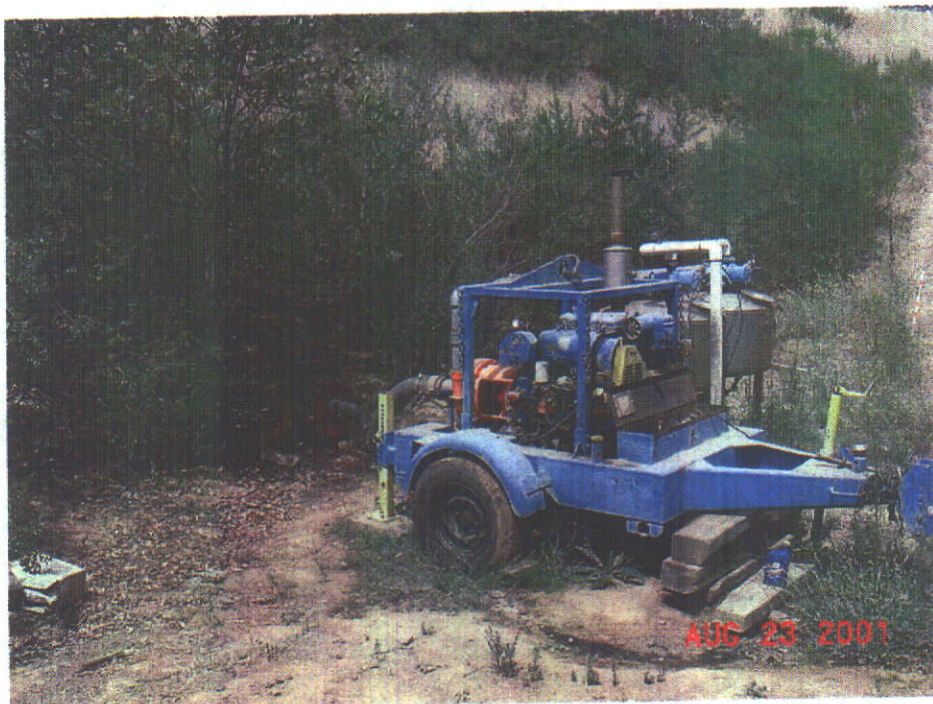
Pump at the toe of the Upper Reservoir dam.

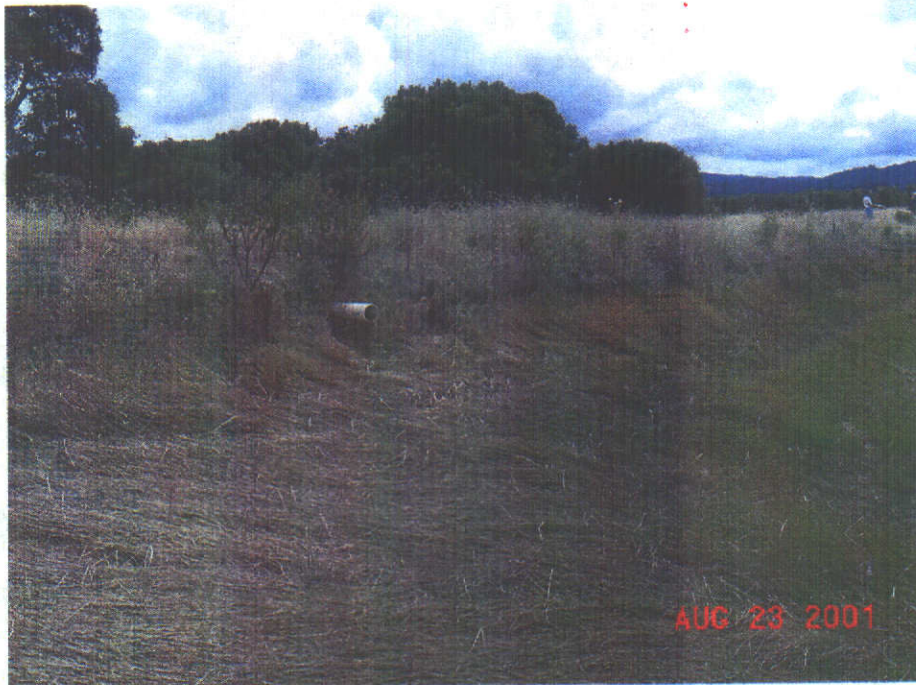
This photograph shows the spill pipe in the Upper Reservoir's dam on the day of the inspection.

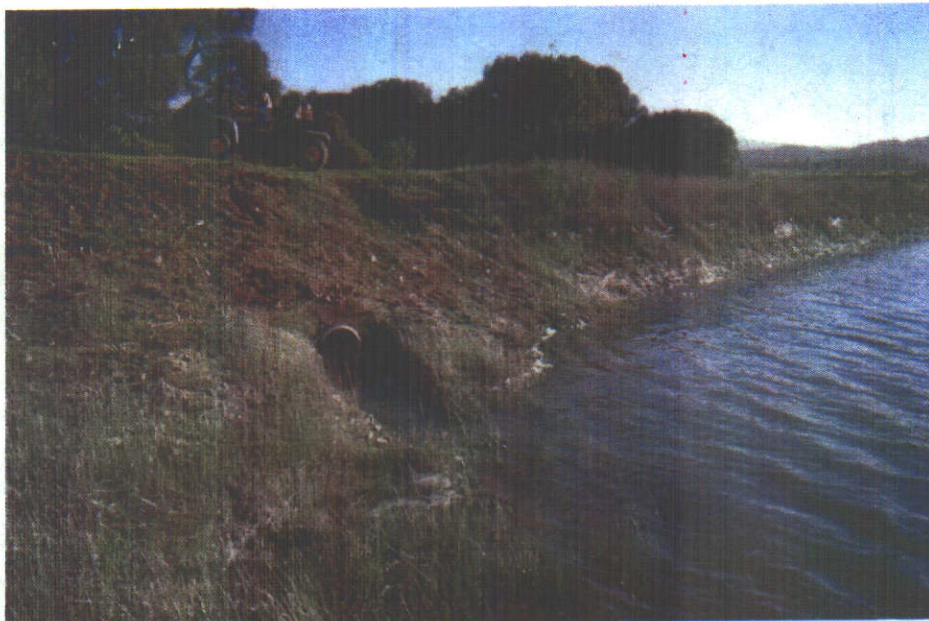
This photograph, taken after the inspection (about April 2002), was provided by the licensee and shows the spill pipe after it was lowered. The new elevation is not certain. Lowering it 4.5 feet from the inspected level would bring the capacity within compliance with the license. Lowering it 2.5 feet may only put the dam outside the jurisdiction of the Division of Safety of Dams.

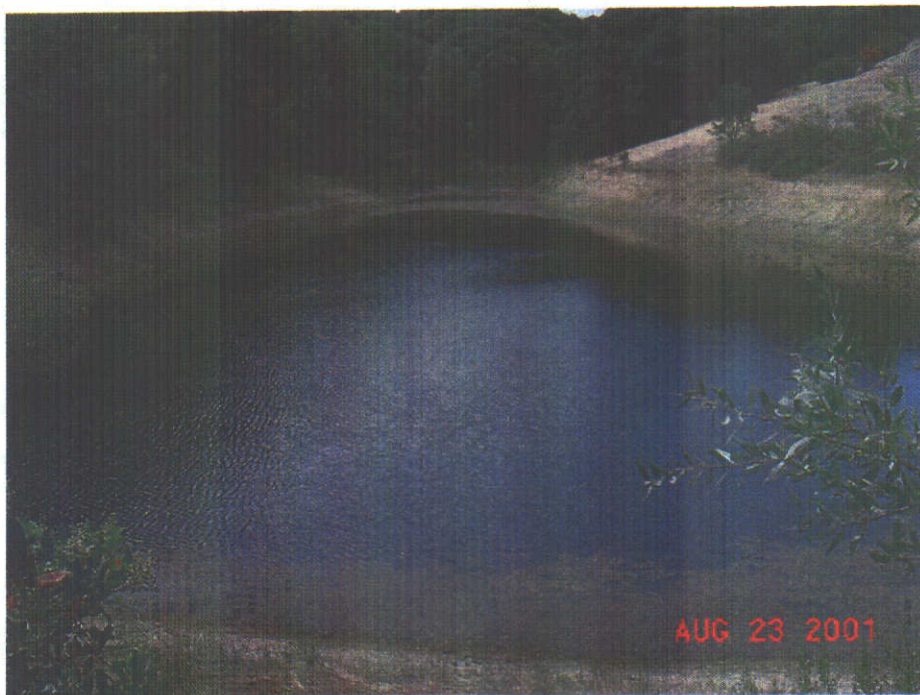
The Middle Reservoir looking north from the dam.

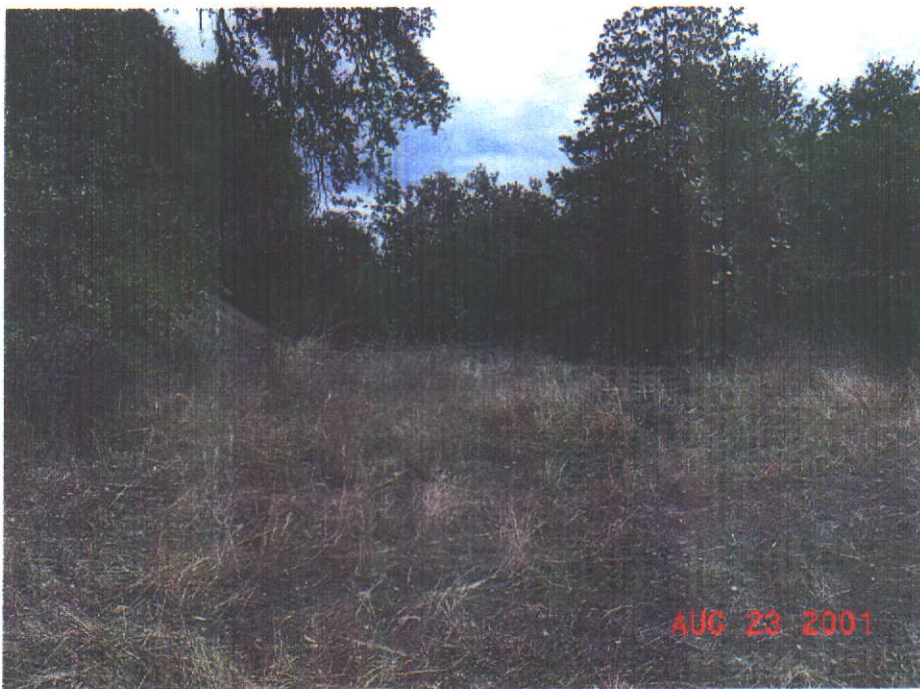
The spillway at the Middle Reservoir looking south.

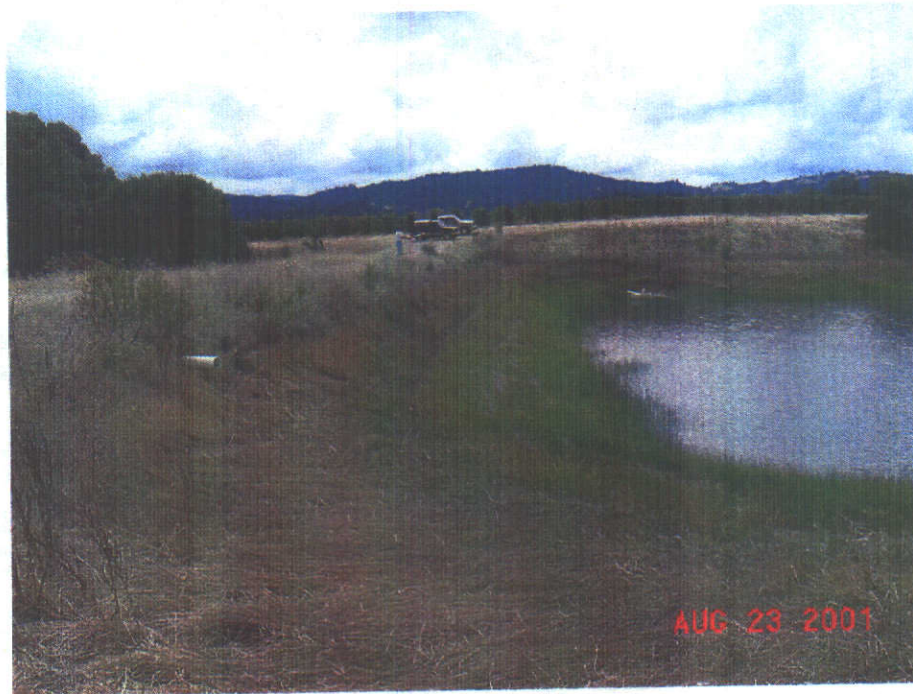
The Upper Reservoir looking west across the dam. Note the spill pipe in the left side of the photograph. The former spillway observed at licensing has been filled.

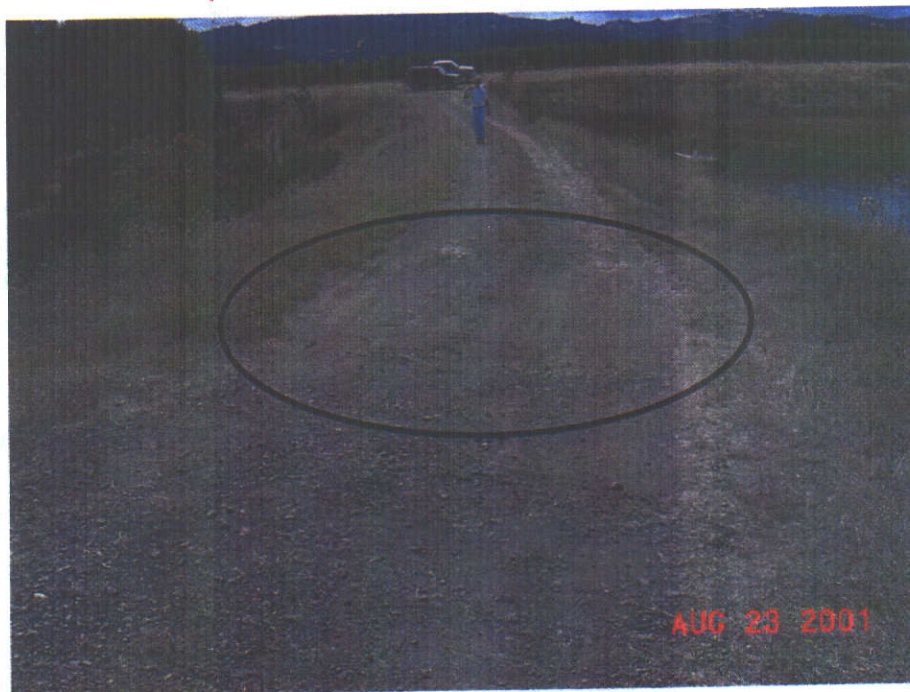
The circle drawn on this photograph of the Upper Reservoir dam shows the location of the old spillway.

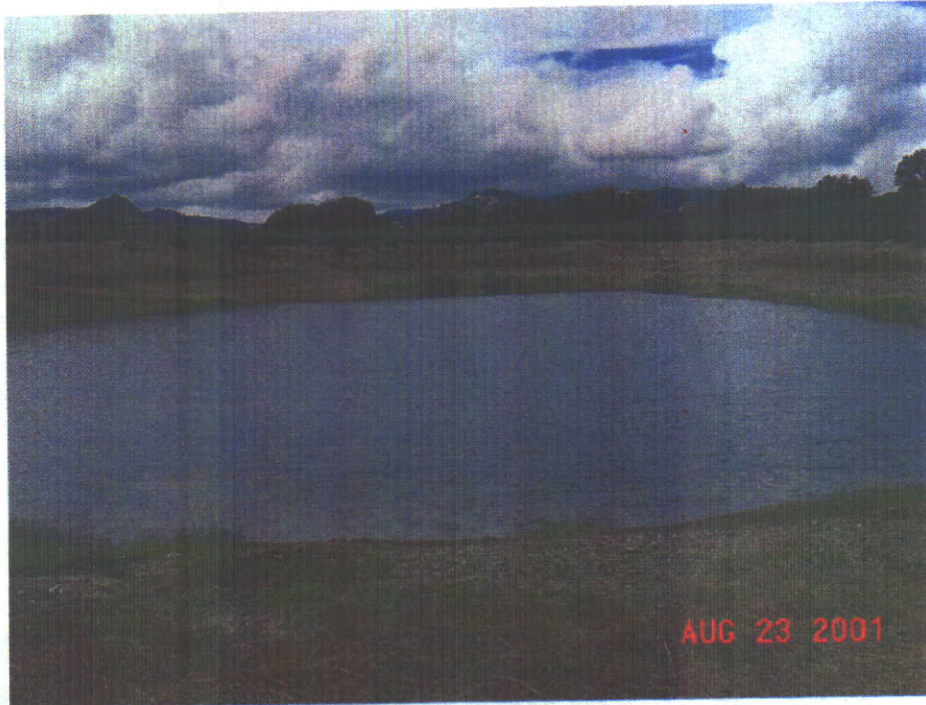
This photograph of the Upper Reservoir is the view looking north from the dam. The vineyard around the north side of the reservoir was not included in the licensed place of use.
