WaterFix Construction Impacts—Yolo County Traffic, Road Safety, and Pavement Deterioration

Prepared by the County of Yolo for presentation to the State Water Resources Control Board

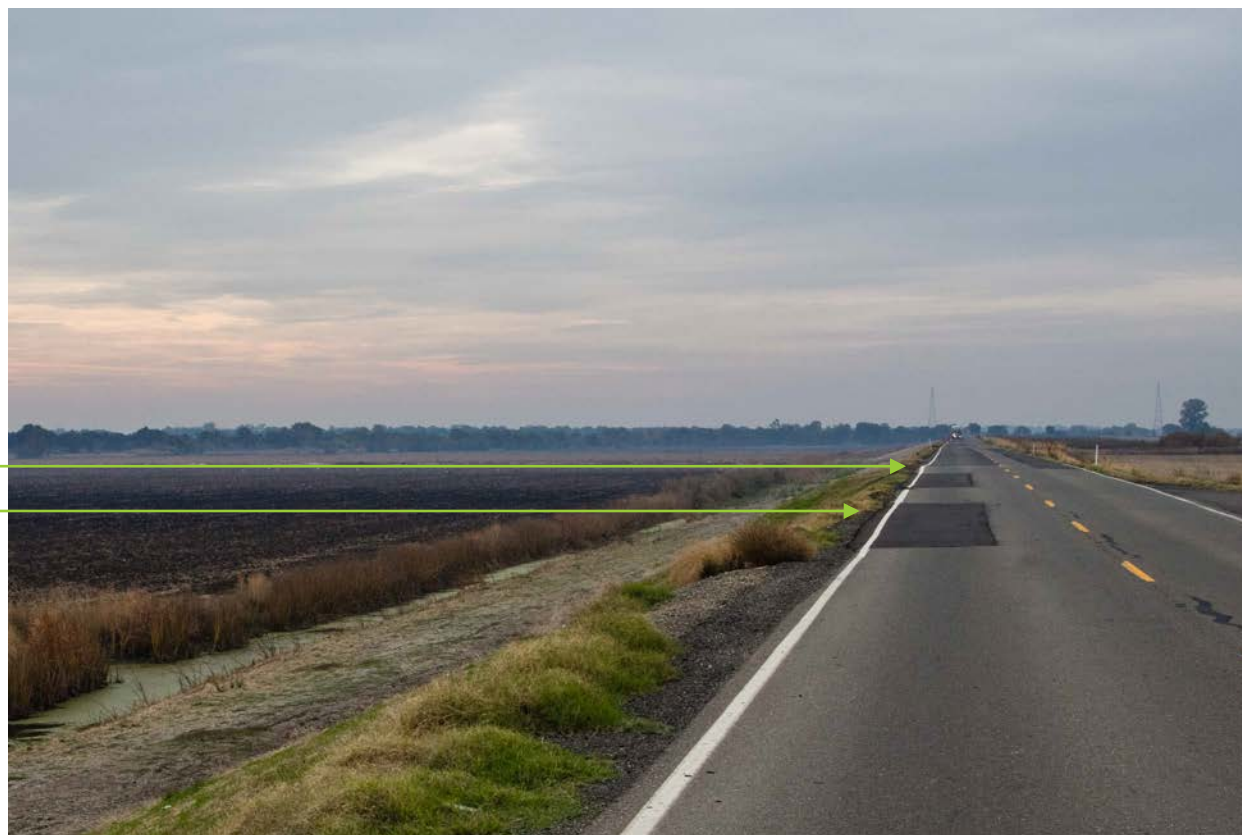
State Route 84

Typical east lane (levee
slope side) pavement
failures along the Deep
Water Ship Channel Levee

Note drop-off (at left),
narrow lanes and shoulders

(Photo taken 11/2017)

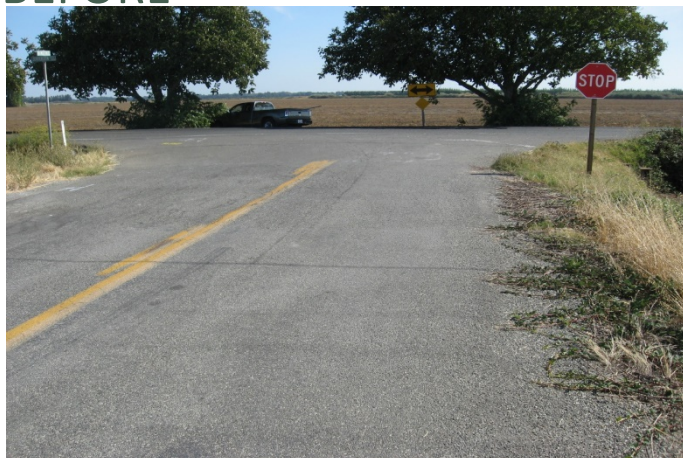
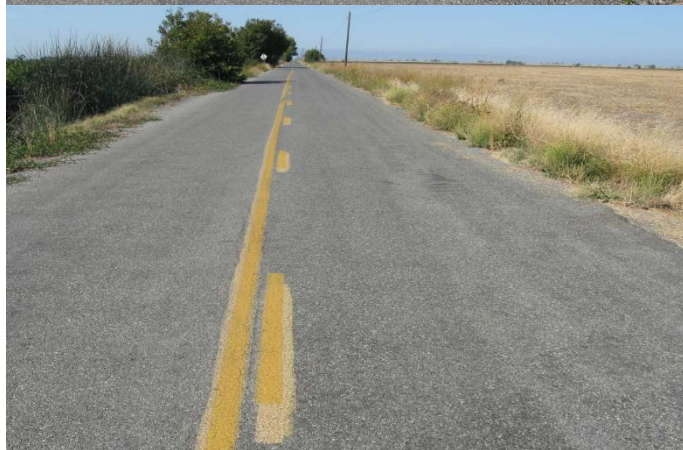
BEFORE

Hamilton Road Before/After Bogle Production Facility Construction

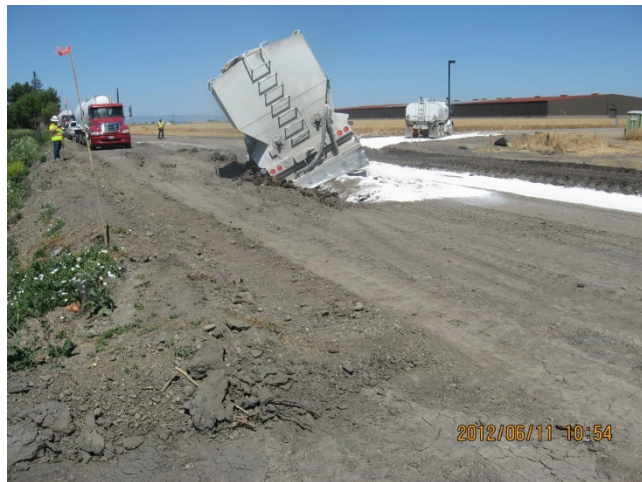
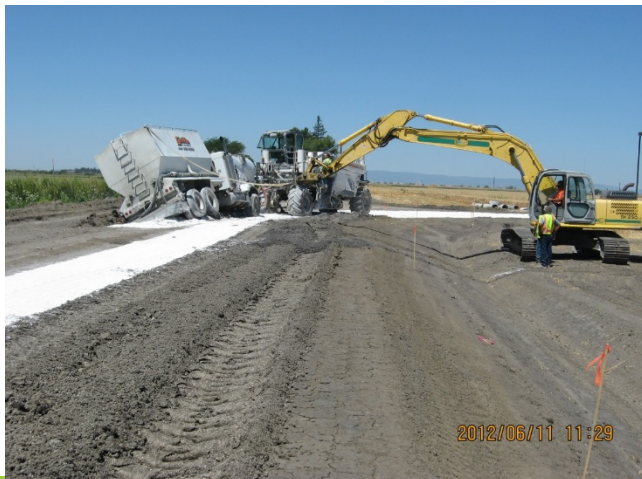
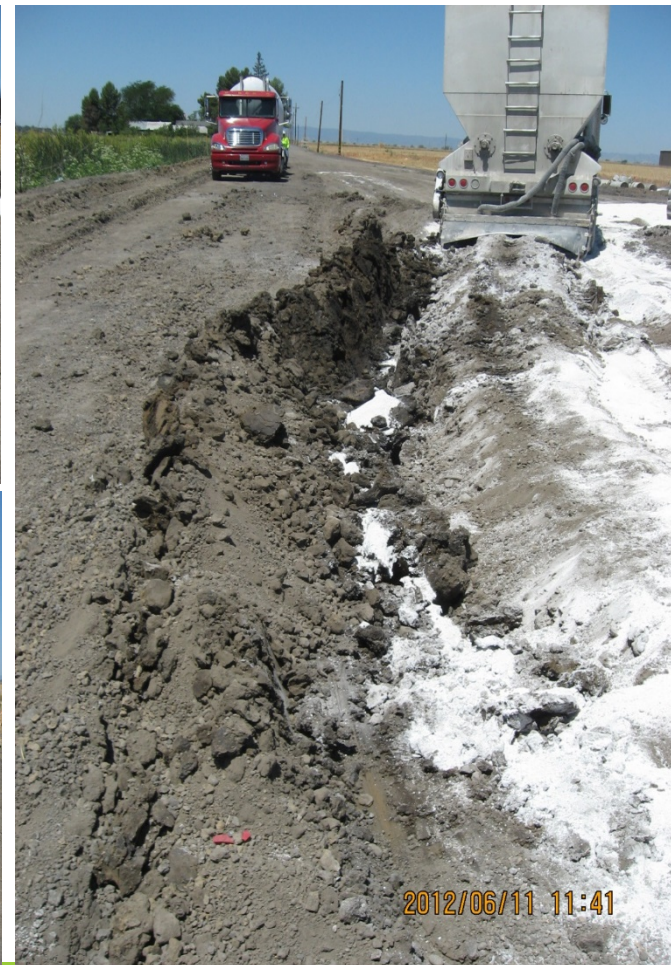
Hamilton Road west
of State Route 84
(2012 Photos)

Subgrade insufficient
to support legally
loaded lime
transport truck

Note dewatered
roadside ditches and
extent of subgrade
damage

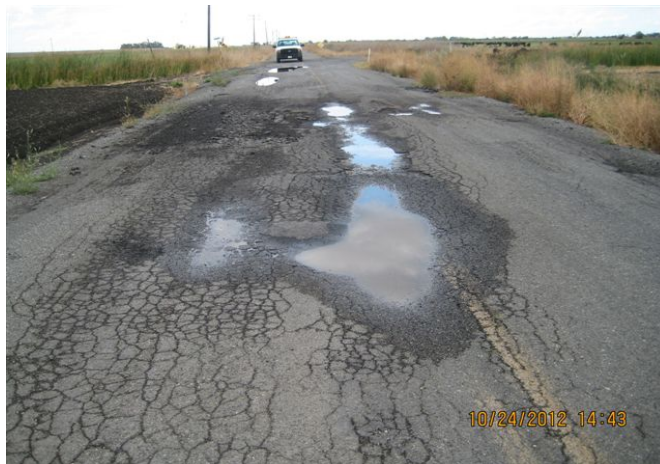
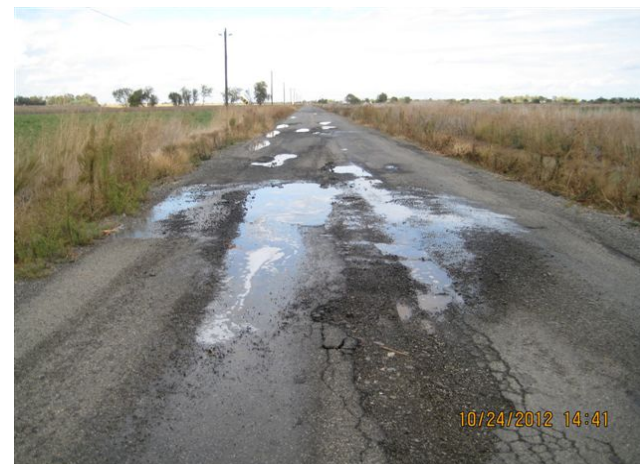
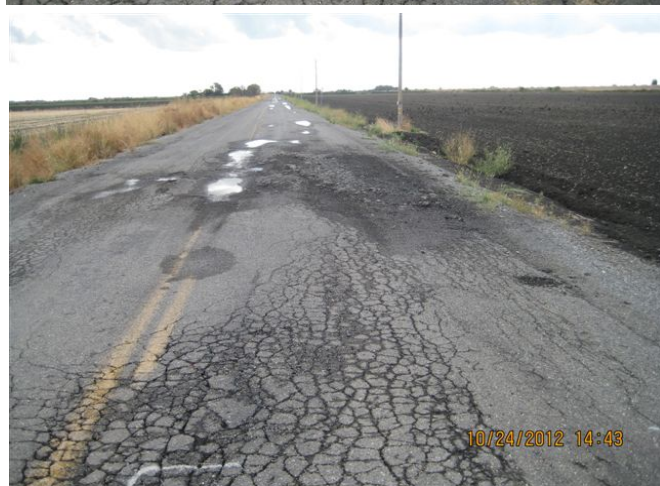
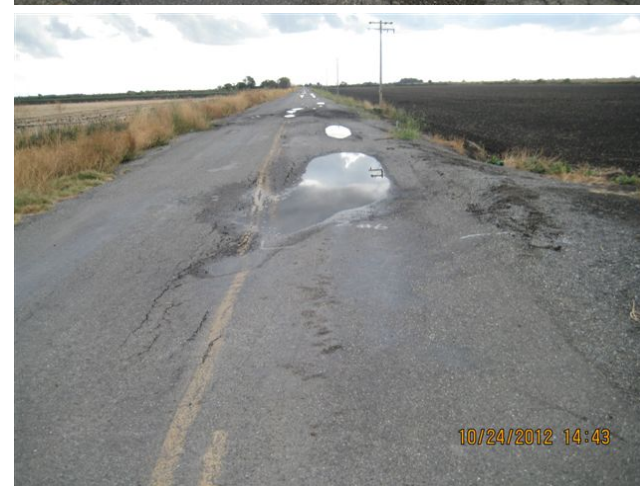
Z Line Road, west of
and parallel to SR 84
(2012 Photos)

Z Line Road: Damage from brief service as detour route

Top photos look north

Bottom photos look
south

Note damage in
particular to
southbound lane in
photos (left lane at
top, right lane at
bottom) —the lane
that received the
most traffic from
loaded trucks during
the detour period

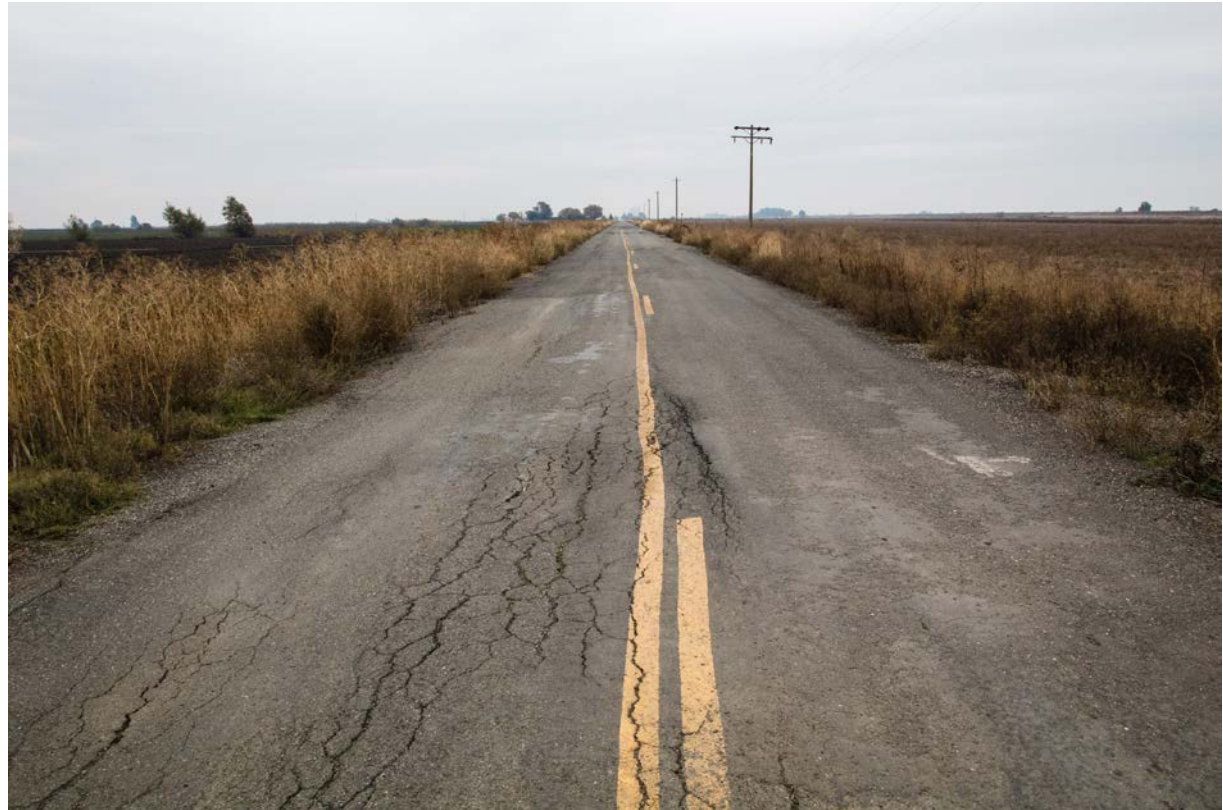
Z Line Road Today, following reconstruction

Note that just a few years after reconstruction, Z Line Road is already showing significant deterioration simply from local traffic (including heavy trucks)

(Photo taken 11/2017)

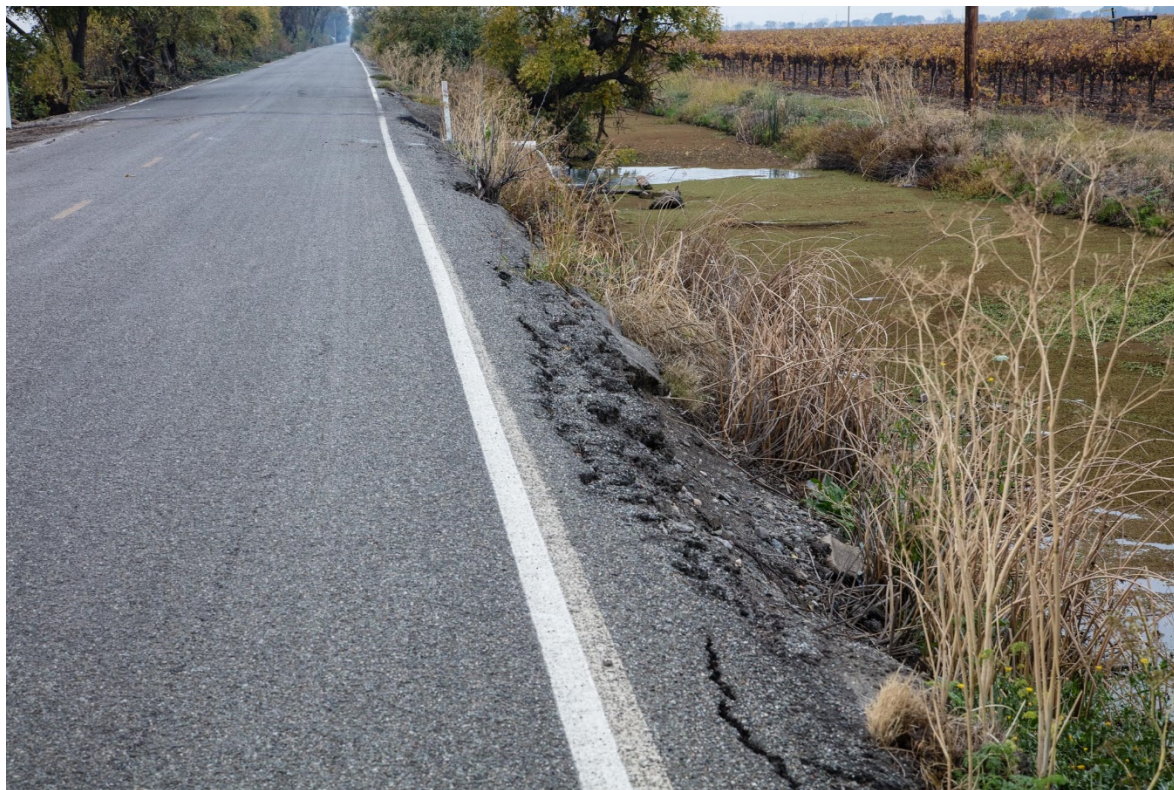
Willow Point Road: Typical pavement edge deterioration

Saturated soils due to nearby drainage ditch and saturated soils cause erosion and pavement failure

(Photo taken 11/2017)
