DIVISION OF WATER RIGHTS REPORT OF INSPECTION

DATE AND TIME: August 9, 2016 at 10:00 AM

LOCATION: On property of Nancy K Donovan and Stephen J Peters located at 21451 Highway 128, Yorkville CA, 95494-9207

PURPOSE: The purpose of this inspection was to become familiar with the site and determine whether the physical features of the property and operation of the reservoirs have changed since the Division's September 15, 2010 site inspection.

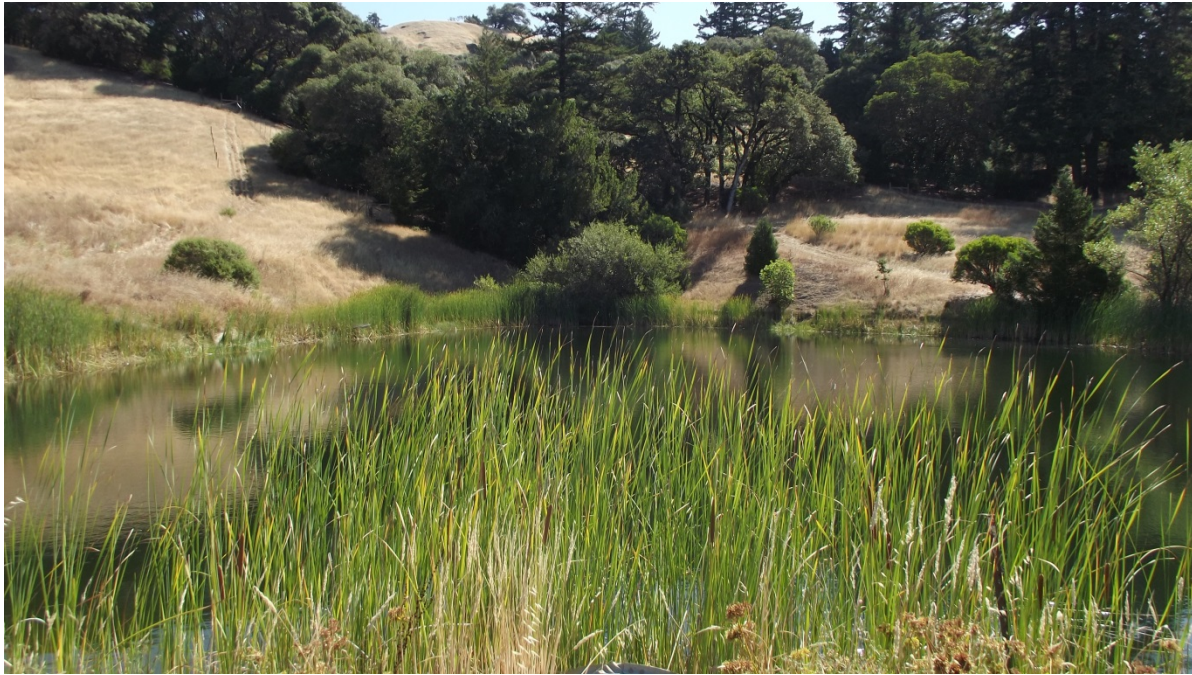
Figure 2: Reservoir 1 facing east from the dam. The drainage area can be seen in the background.

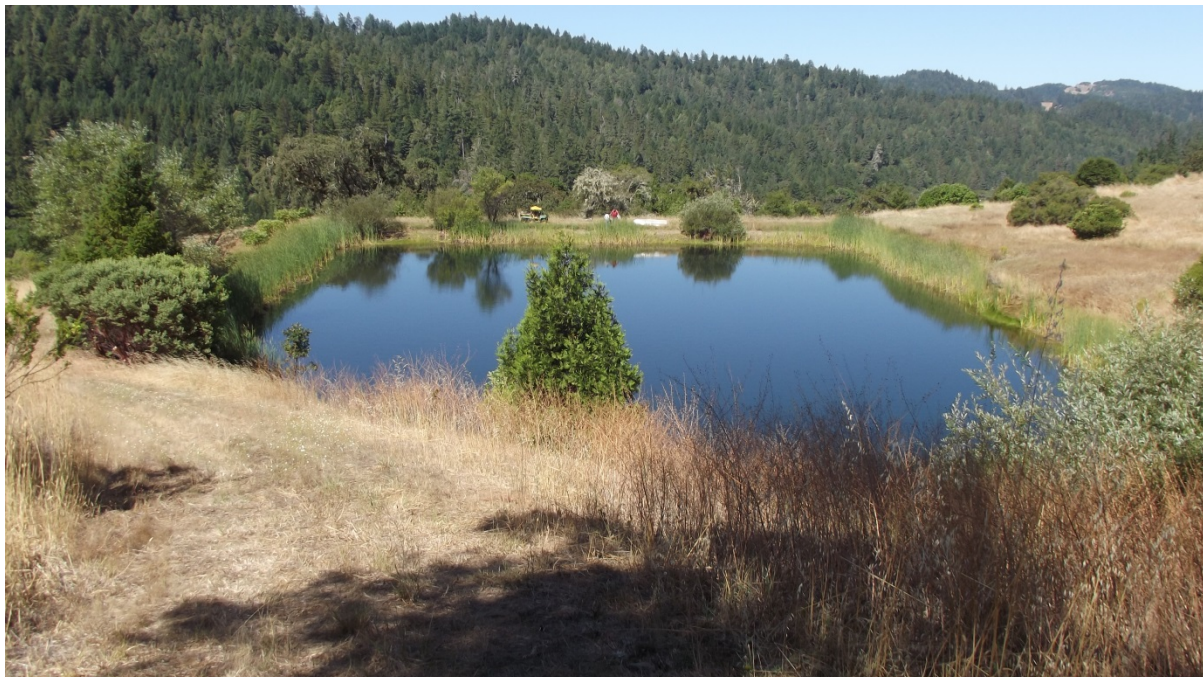
Figure 3: Reservoir 1 facing downstream to the west. The dam can be seen on the far side of the reservoir.

Reservoir 1 is bounded by an approximately 24 feet high earthen dam on the west side. The maximum surface area of the reservoir is approximately 0.75 acres based on measurements of aerial photographs. Mr. Peters told Division staff the maximum depth of the reservoir was approximately 25 feet when it was built in the early 1990's. Based on the surface area and depth estimates, and a correction factor of 0.7, the maximum capacity of the reservoir is approximately 13 acre-feet.

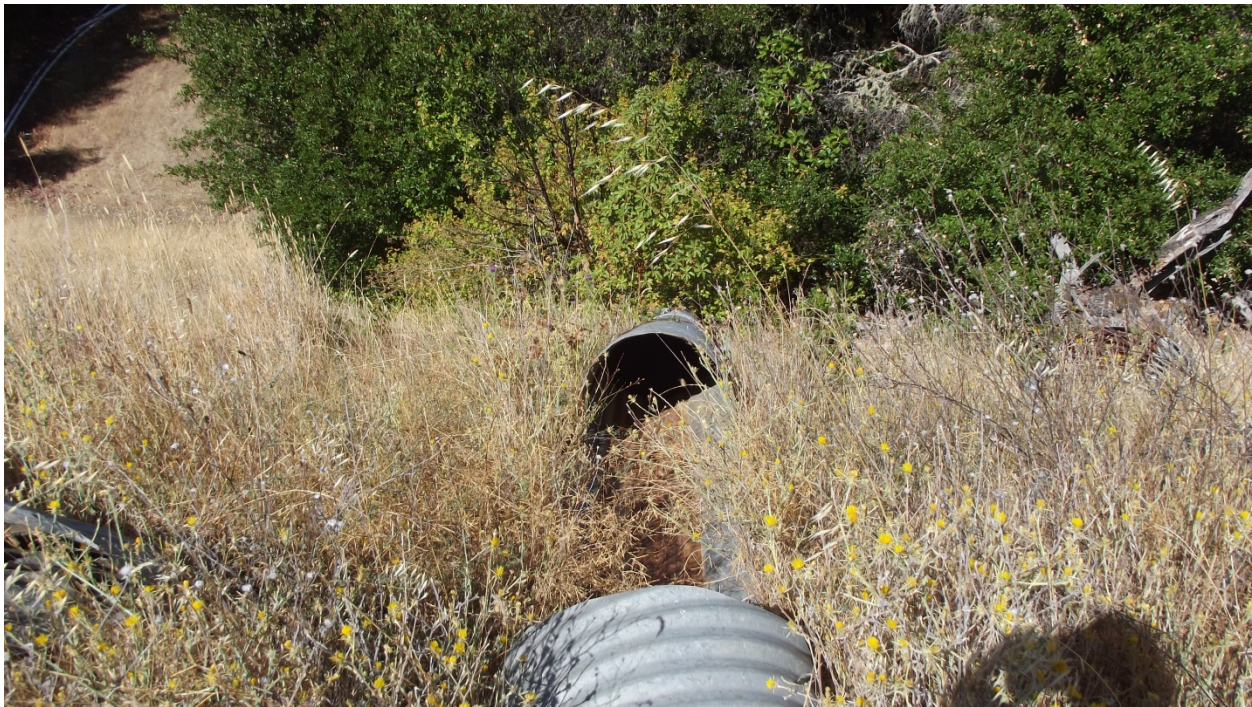
A spillway pipe runs through the dam just below the top surface. The intake of the pipe is turned up at a 45 degree angle so that the level where water will begin to enter the spillway is slightly higher than the bottom of the spillway pipe. The spillway pipe runs through the dam and down a steep grade to the stream connecting the two reservoirs. During the inspection, the surface water level of the reservoir was approximately 3 feet below the spillway intake.

Figure 4: Spillway pipe leading down the face of the dam to the stream connecting the reservoirs.

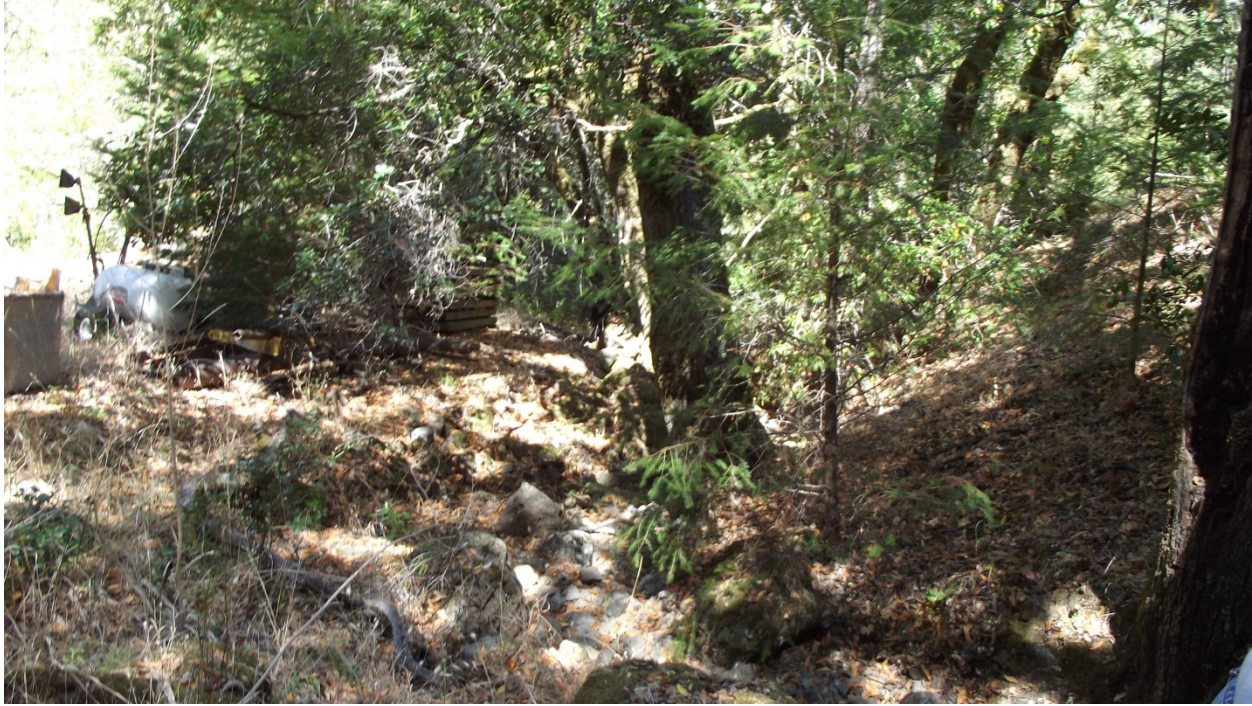
The upper portion of the stream connecting the reservoirs is steep and heavily vegetated. Division staff was able to access the stream approximately 100 yards downstream from Reservoir 1 and observed that the stream had well defined bed and banks although no water was flowing at that location.

Figure 5: Streambed between the reservoirs located 100 yards downstream of the outlet of the spillway pipe of Reservoir 1.

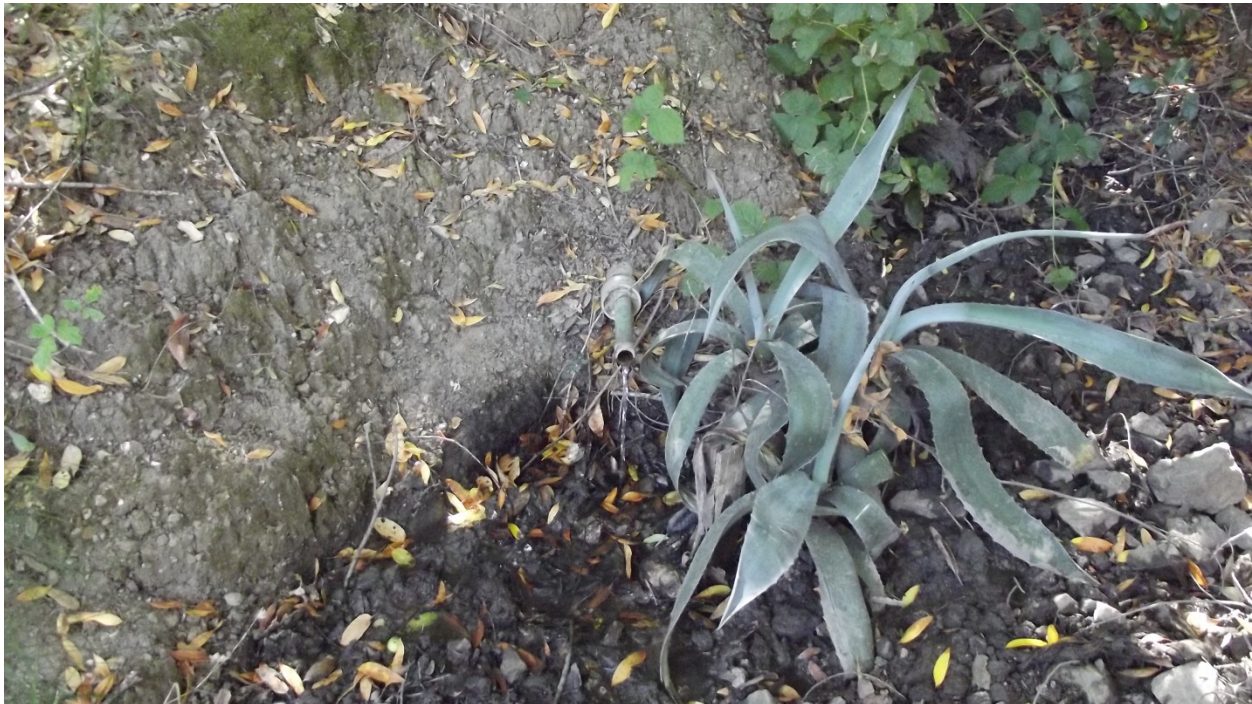
Approximately 25 yards upstream of Reservoir 2, a one inch metal pipe discharging a small flow of water surfaced out of the bank of the stream. The flowing water created a small pool below the pipe that submerged a few yards downstream. Mr. Peters explained that this horizontal well existed when he obtained the property, and that he improved the yield by drilling it deeper into the hillside.

Figure 6: Horizontal pipe emerging from the bank of the stream connecting the reservoirs

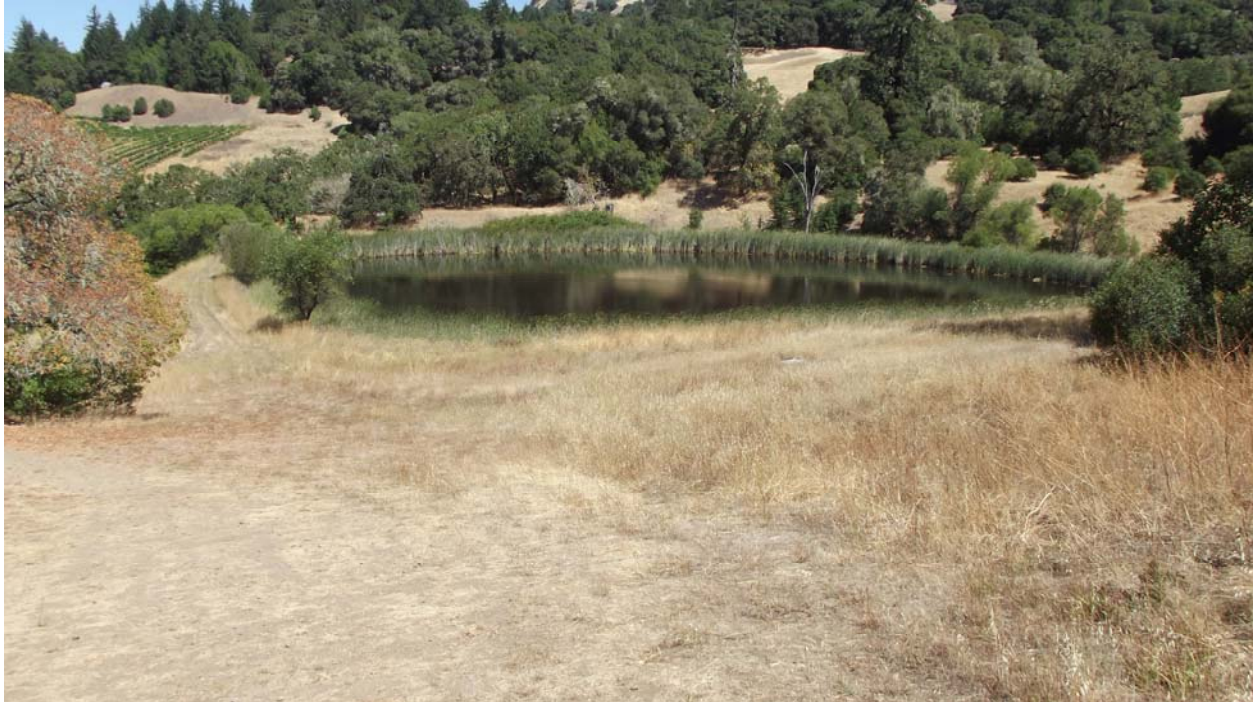
Reservoir 2 is bounded by an earth fill dam on the west and northwest sides. The maximum surface area of the reservoir is approximately 1.25 acres based on measurements of aerial photographs. Mr. Peters estimated the maximum depth to be approximately 20 feet. Based on the surface area and depth estimates, and a correction factor of 0.7, the maximum capacity of the reservoir is approximately 17 acre-feet.

Figure 7: Reservoir 2 facing north-west. The dam can be seen on the left and far sides of the reservoir.
