Exhibit MMR-02

Photographs of Point of Diversion at Stanshaw Creek and the Diversion

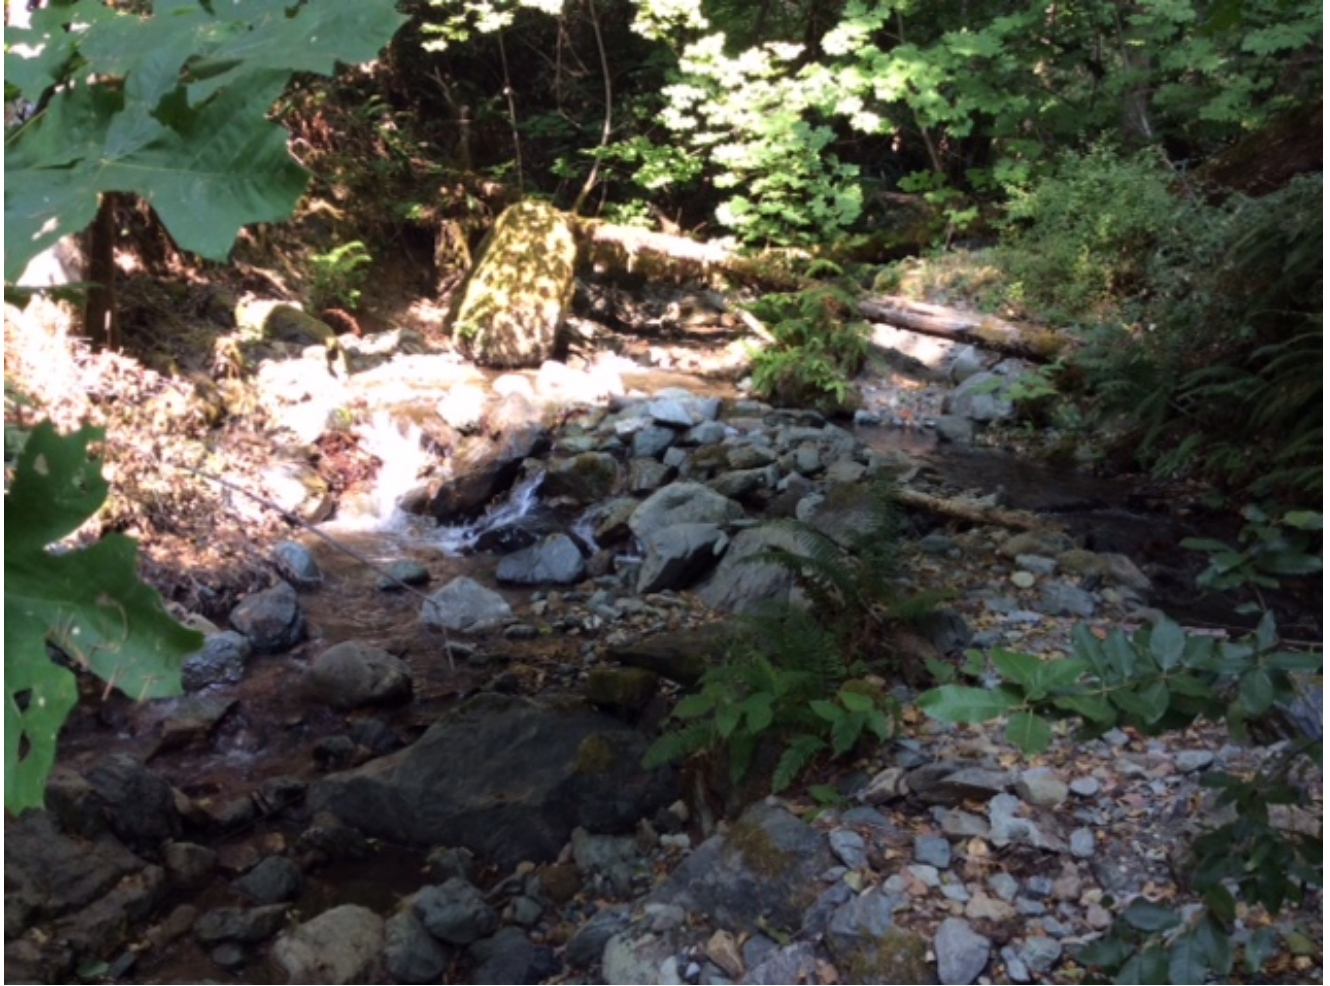
Exhibit MMR-02 Photograph #1 – The point of diversion at Stanshaw Creek with rock dam during a period of lower flows in late summer 2016

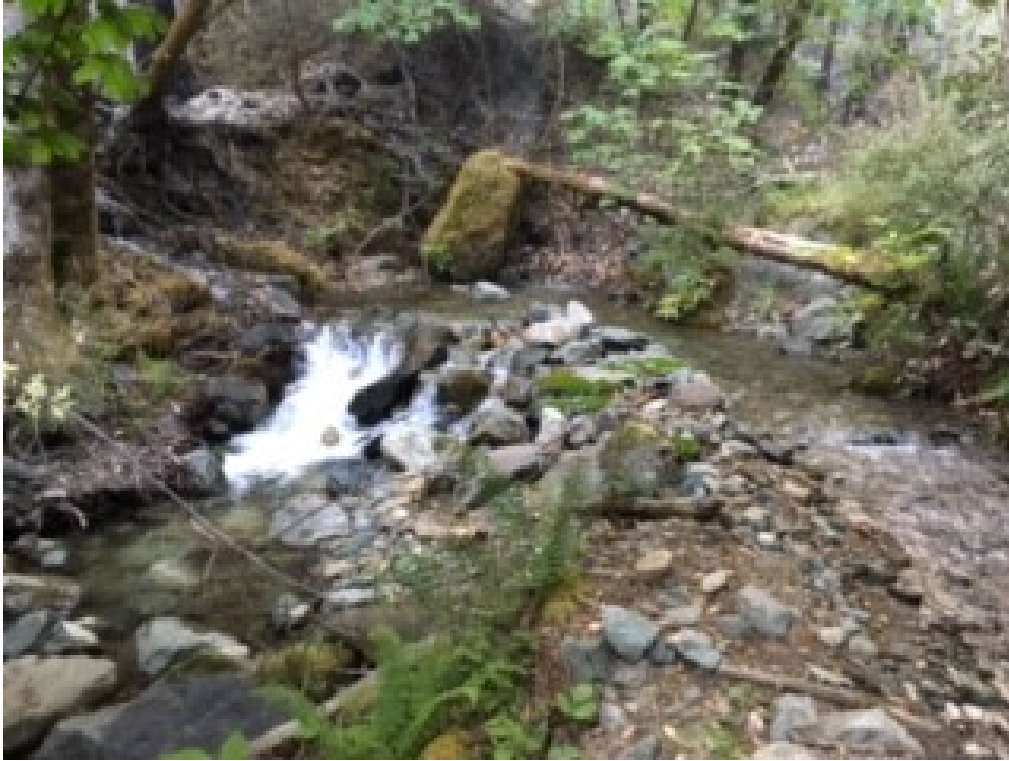
Exhibit MMR-02 Photograph #2 – The point of diversion at Stanshaw Creek with rock dam during a July 2017 fire event

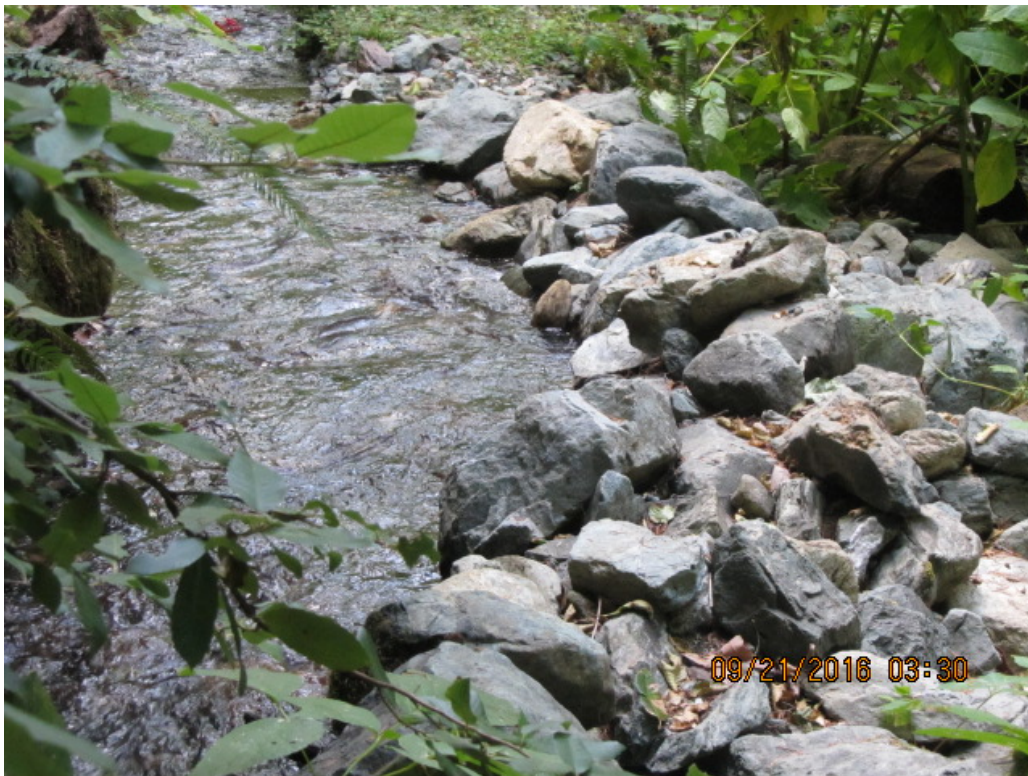
Exhibit MMR-02, Photograph #3 showing a portion of the diversion on September 21, 2016

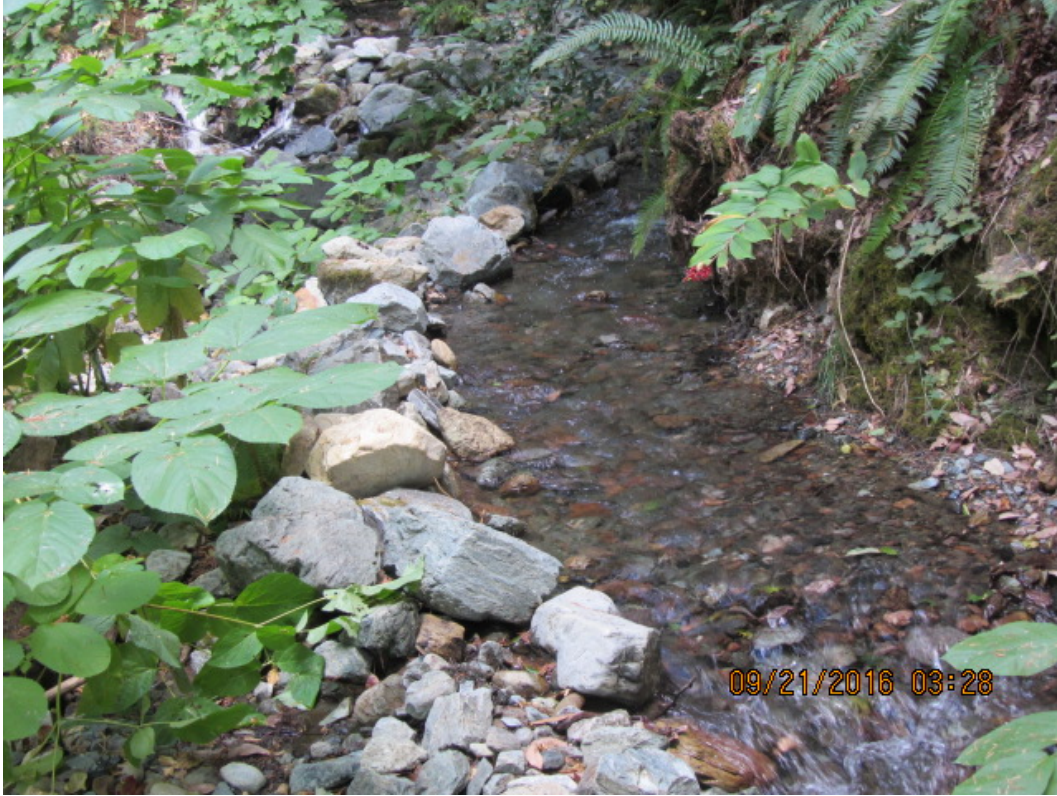
Exhibit MMR-02, Photograph #4 showing a portion of the diversion on September 21, 2016

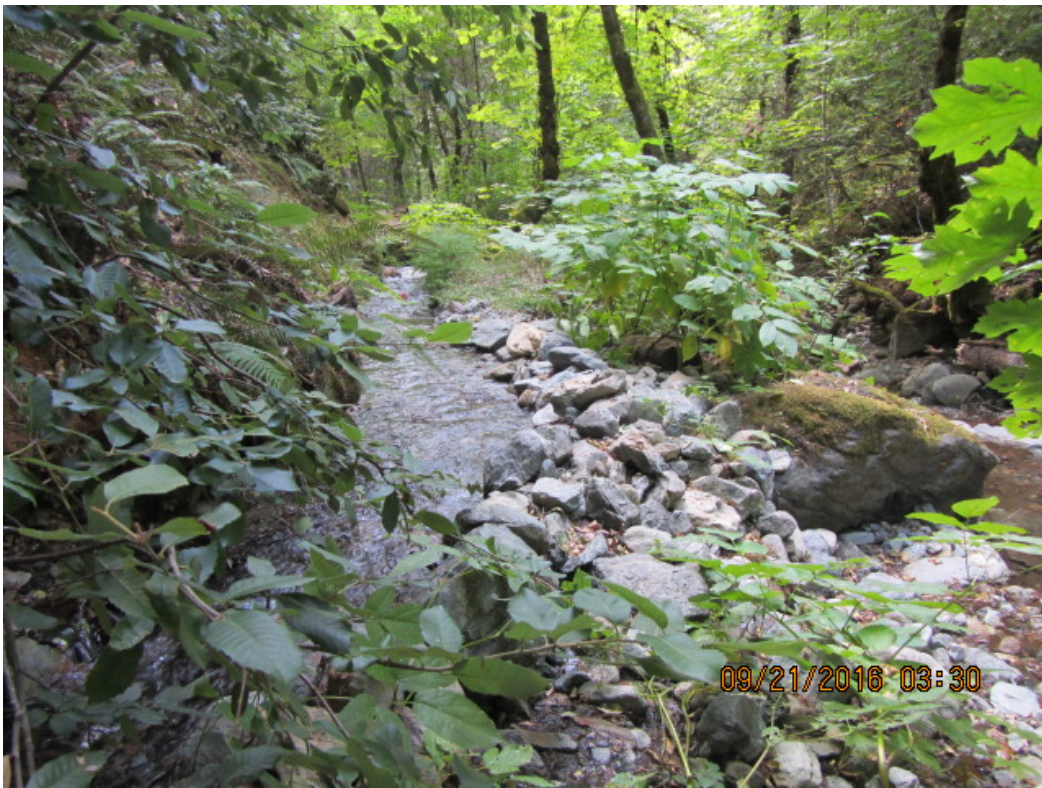
Exhibit MMR-02, Photograph #5 showing a portion of the diversion on September 21, 2016

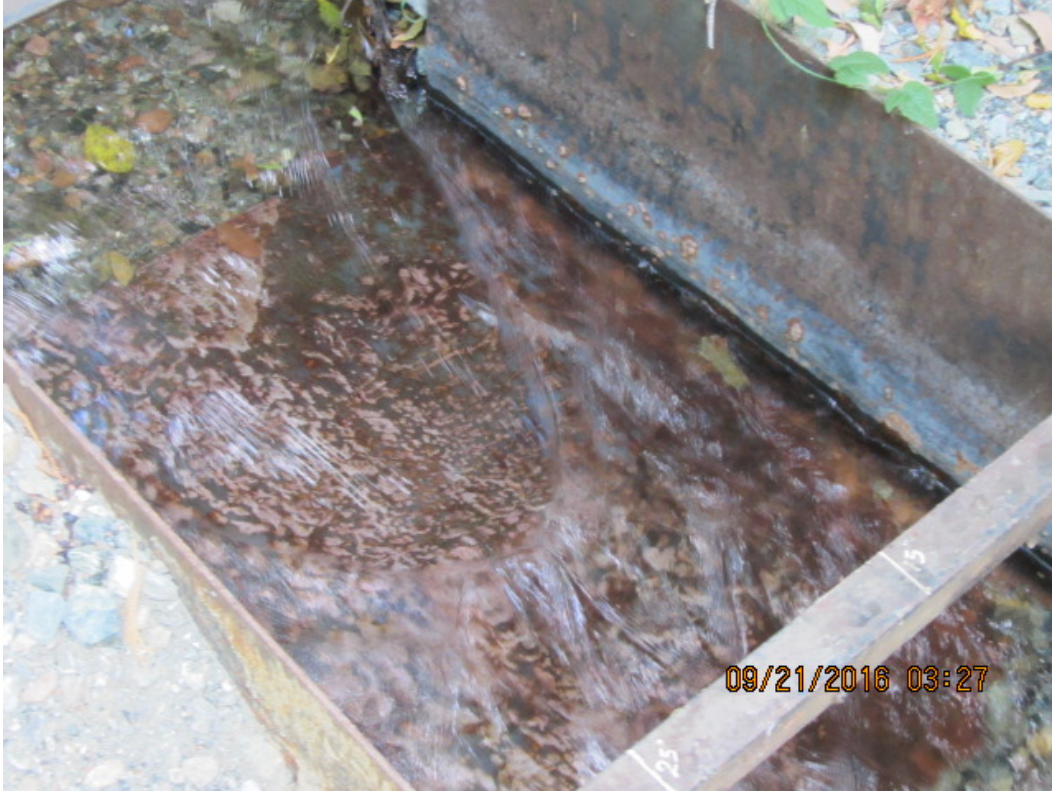
Exhibit MMR-02, Photograph #6 showing a culverted portion of the diversion on September 21, 2016

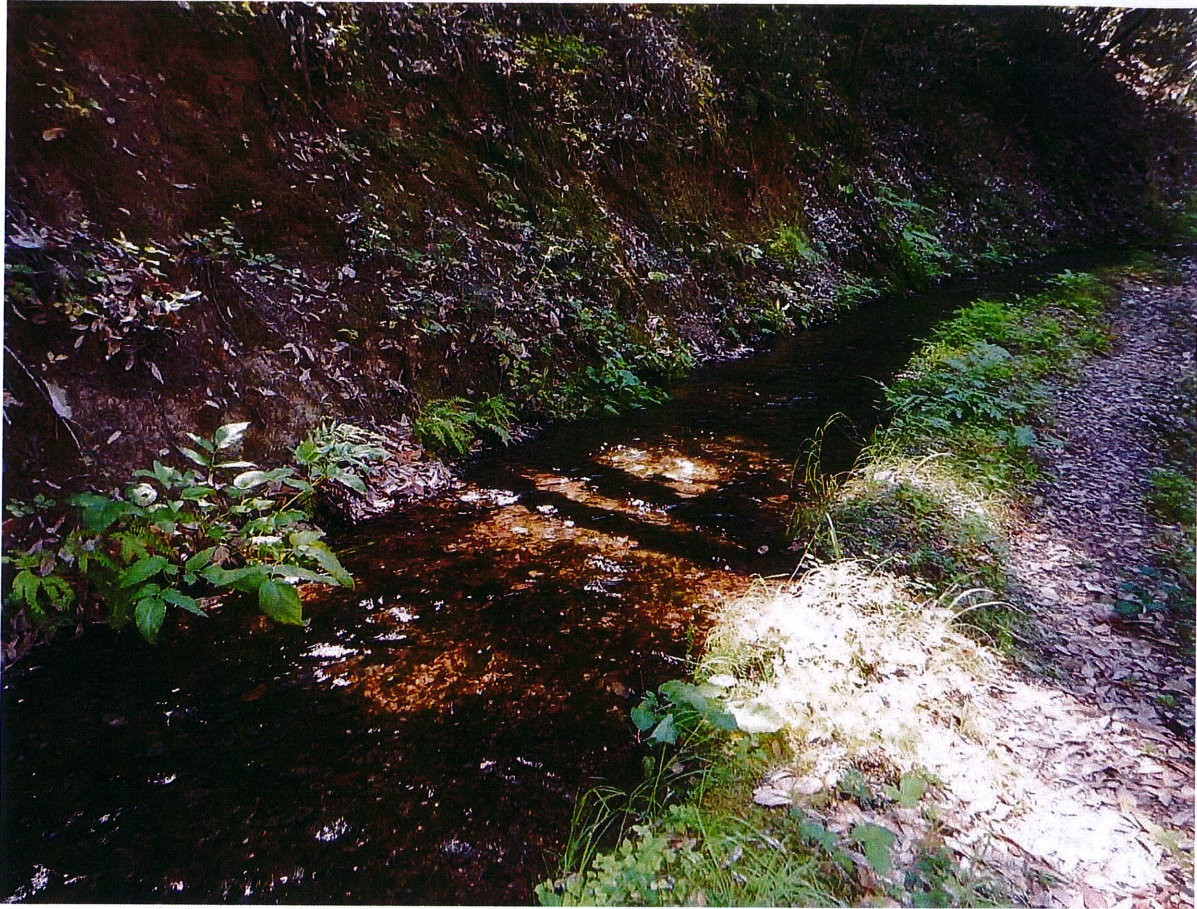
Photograph 10. Unlined ditch.

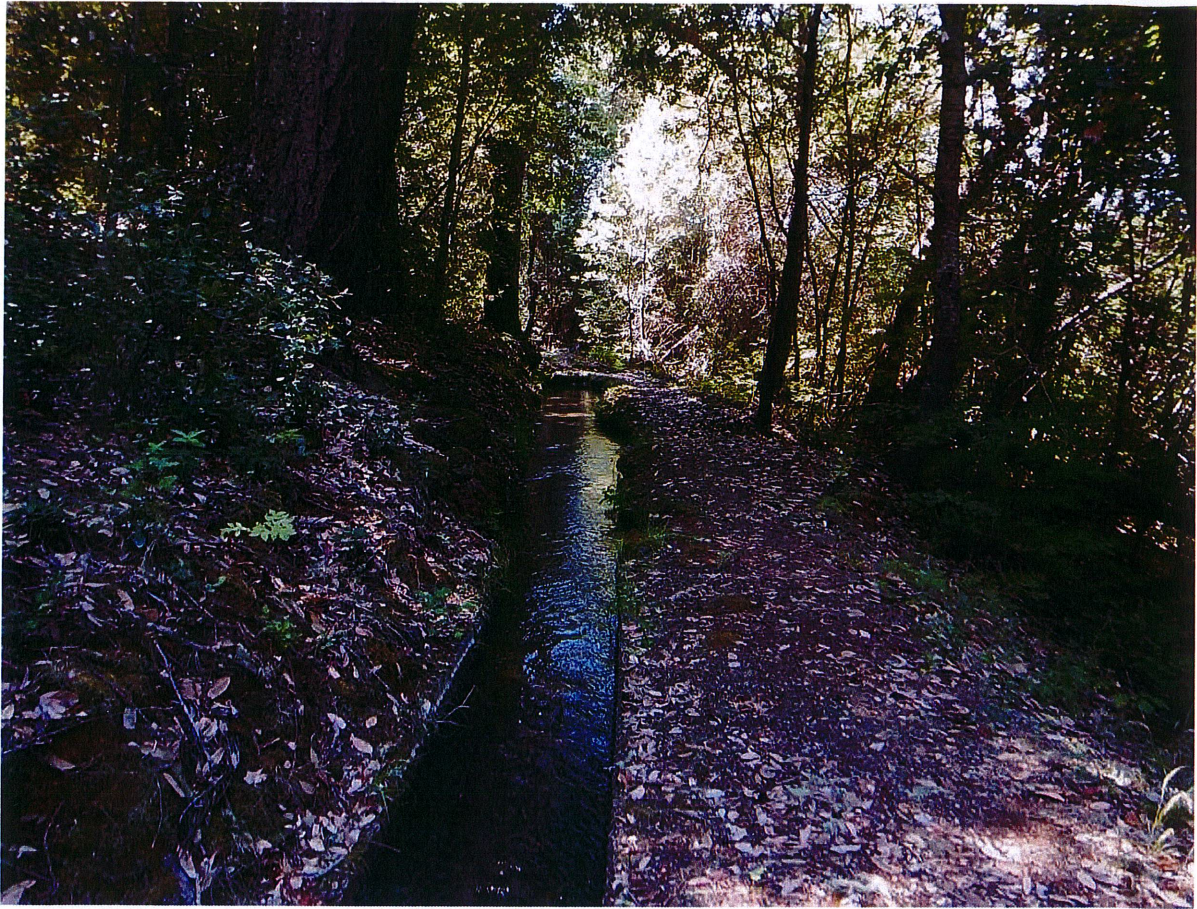
Photograph 9. HDPE pipe lining ditch.
