Exhibit MMR-06

Photographs of the Outfall to the Irving Creek Tributary and Confluence of Outfall with Irving Creek from Spring 2017

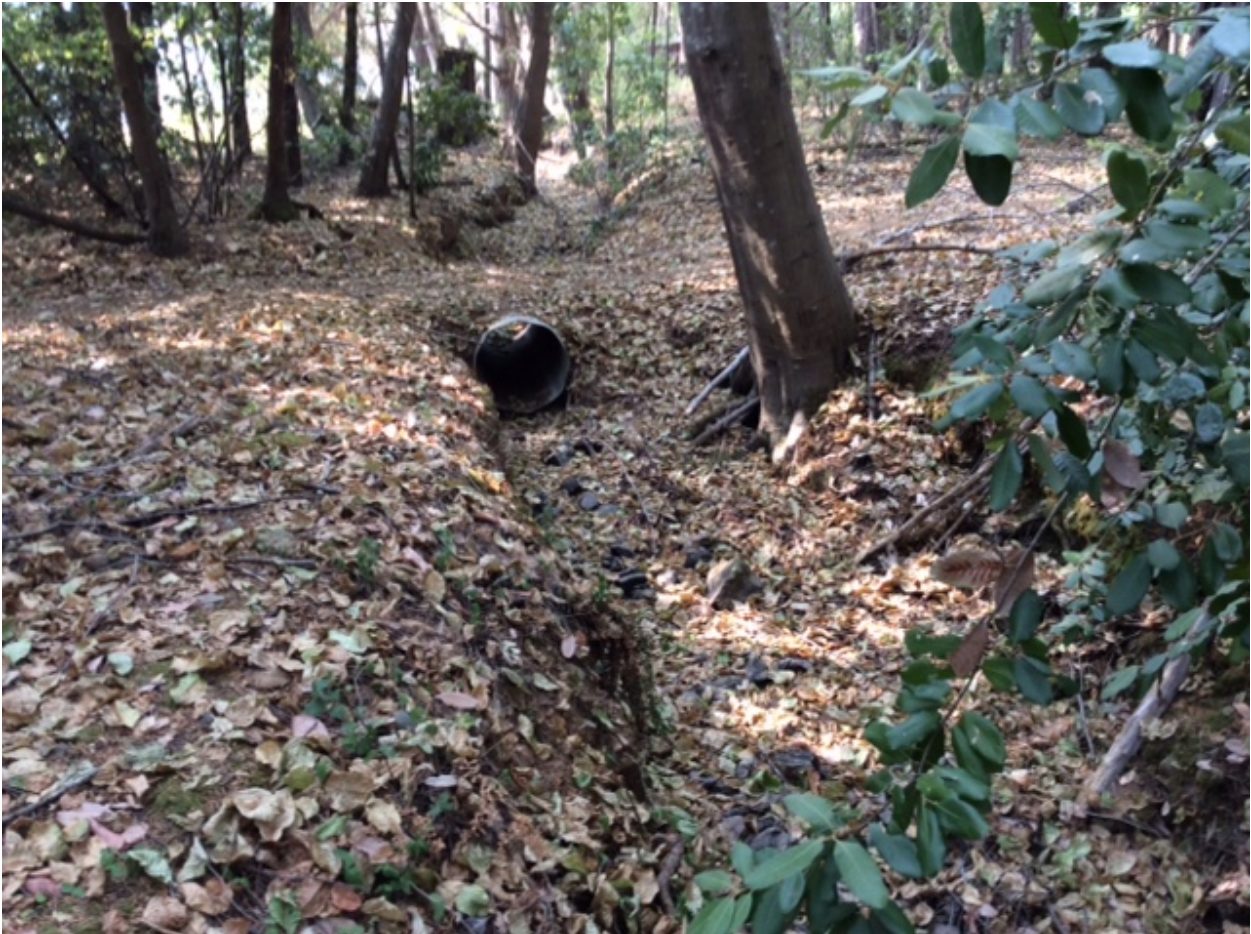
Exhibit MMR-06 Photograph #1 – End of Marble Mountain Ranch return flow channel to Irving Creek outfall showing no flow present in spring 2017

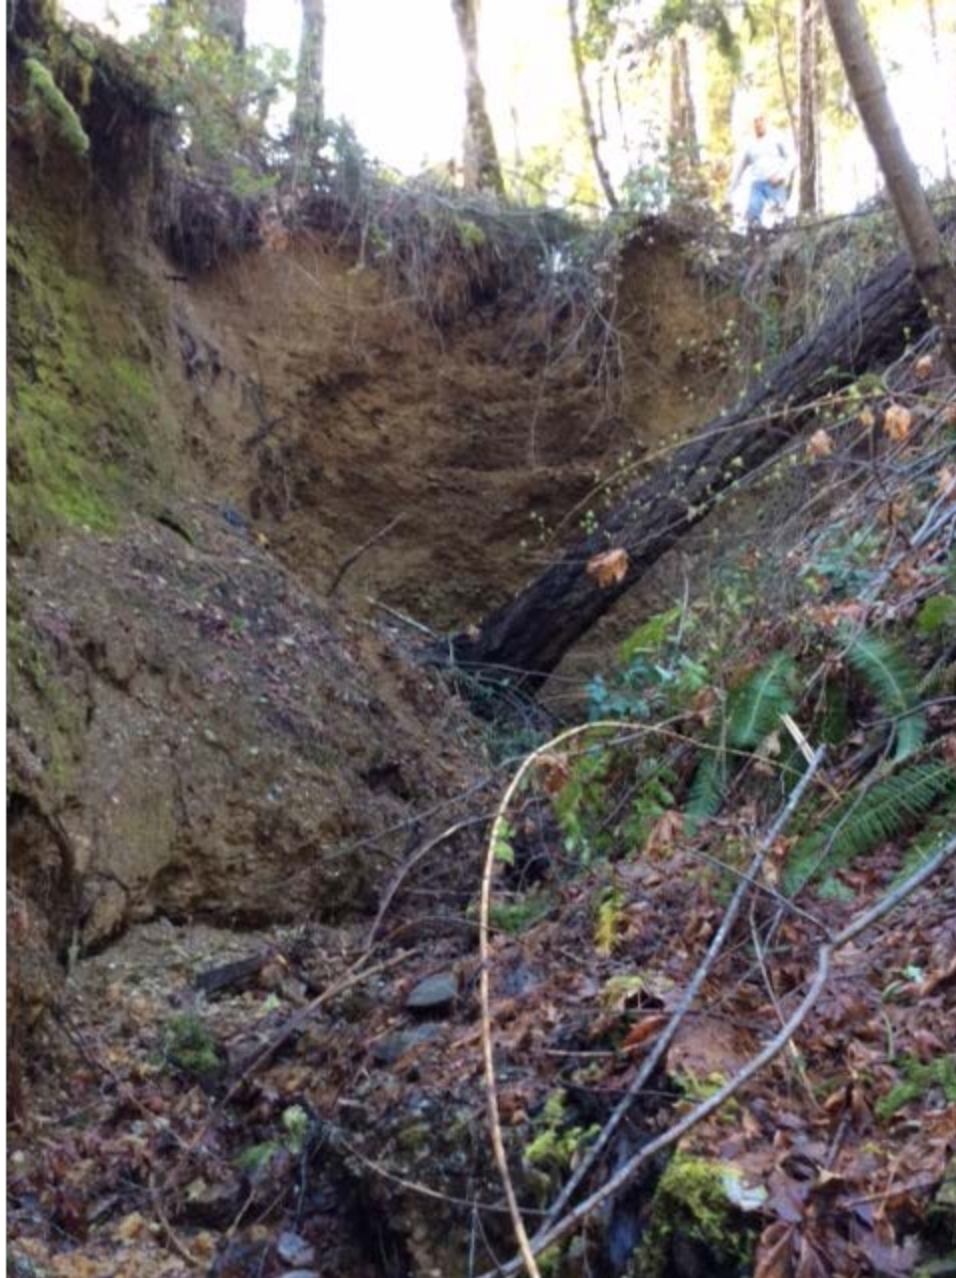
Exhibit MMR-06 Photograph #2 – Headcut of Irving Creek outfall showing no flow present in spring 2017

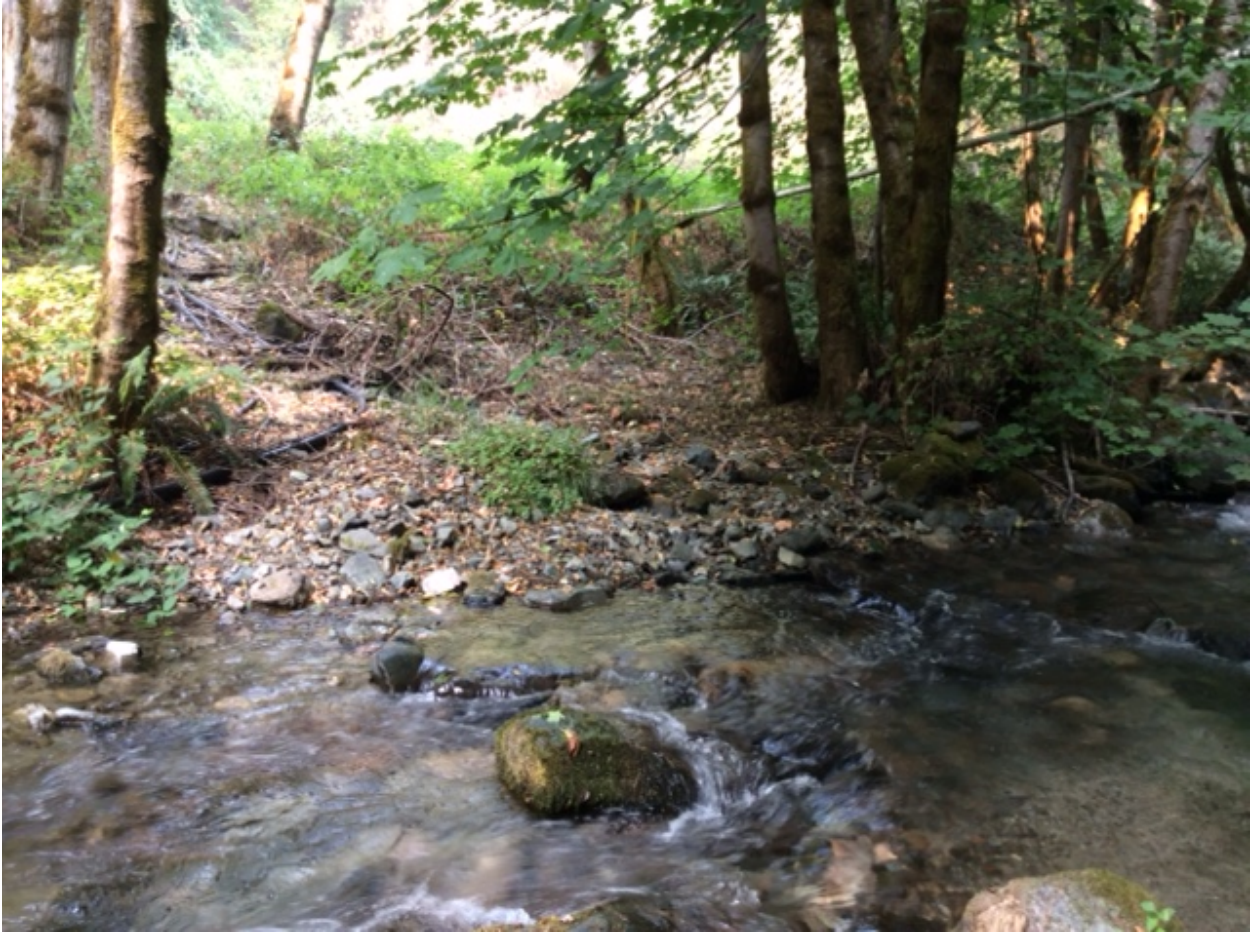
Exhibit MMR-06 Photograph #3 – Confluence of outfall water and Irving Creek showing no flow into Irving Creek from Marble Mountain Ranch in spring 2017
