Exhibit MMR-08

Photographs of Screen and Box Culvert in Diversion before entering Treatment and Hydroelectric System

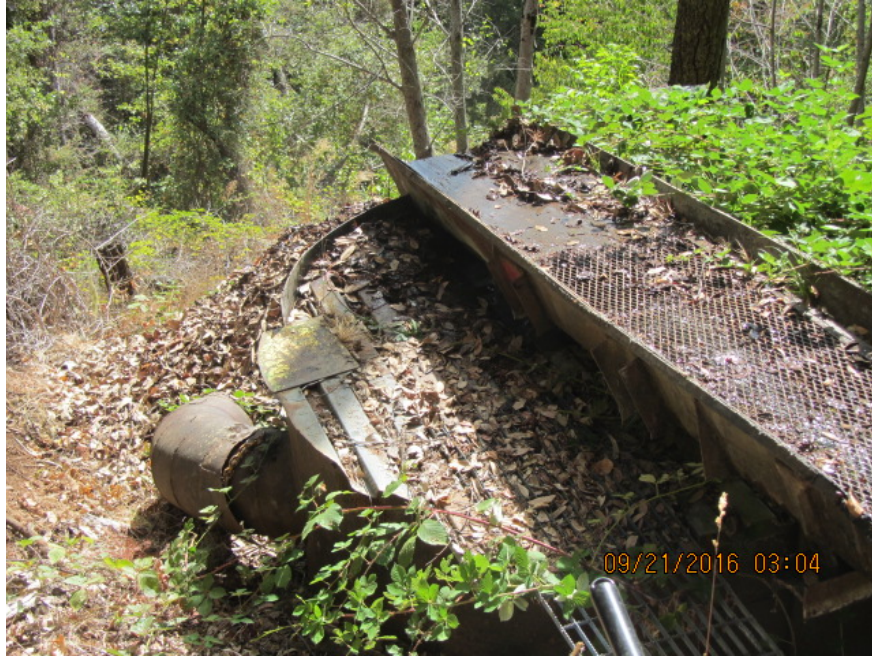
Exhibit MMR-08 Photograph #1 – screened portion of diversion and culvert before water in the diversion moves to treatment and hydroelectric systems

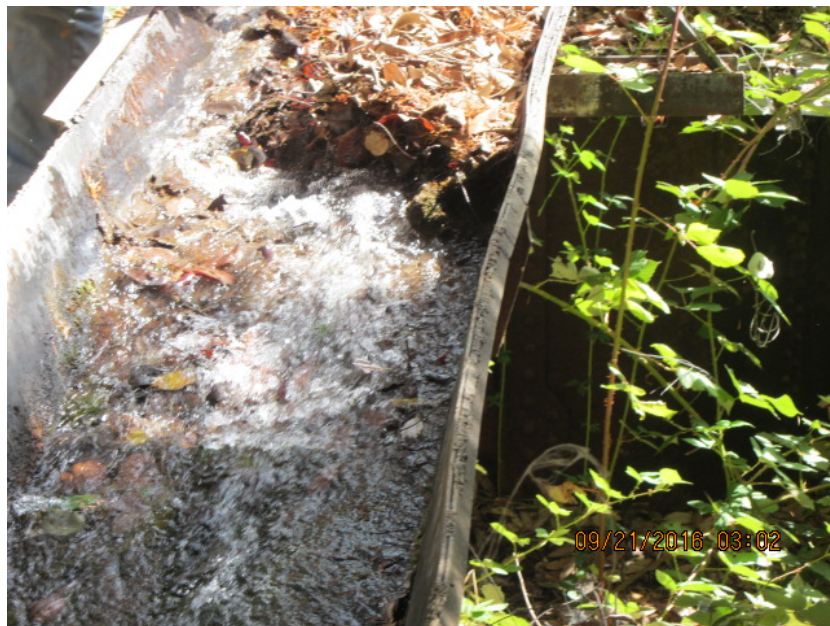
Exhibit MMR-08 Photograph #2 – a culverted portion of the diversion just before the water meets the screened portion of the diversion

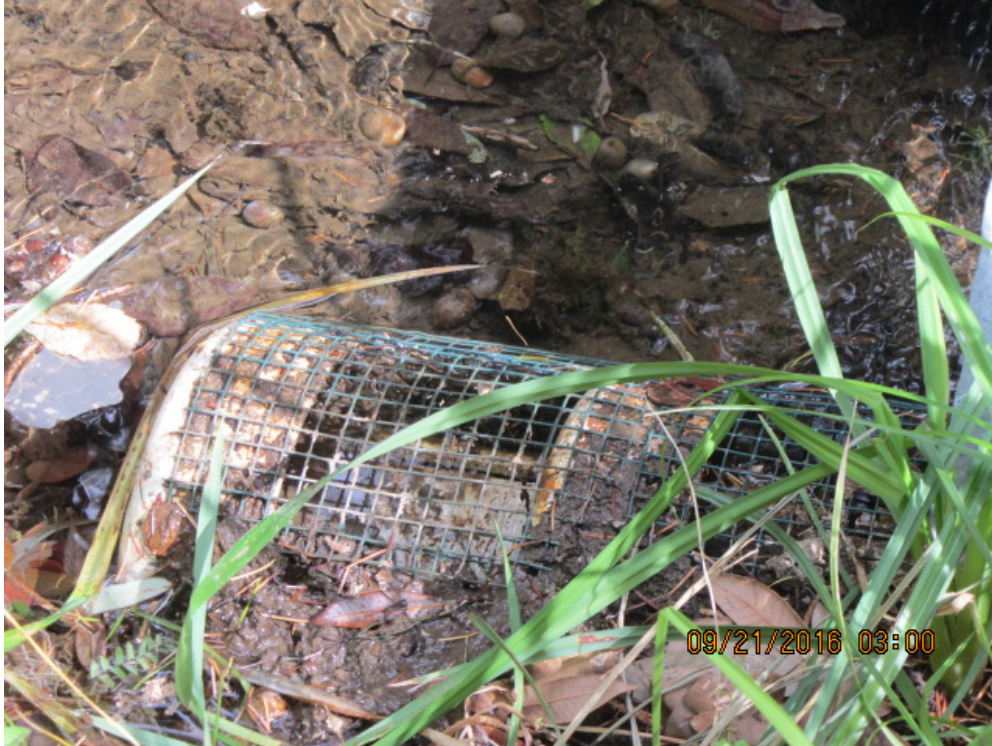
Exhibit MMR-08 Photograph #3 – A screen within the diversion hat is regularly cleaned and cleared of debris

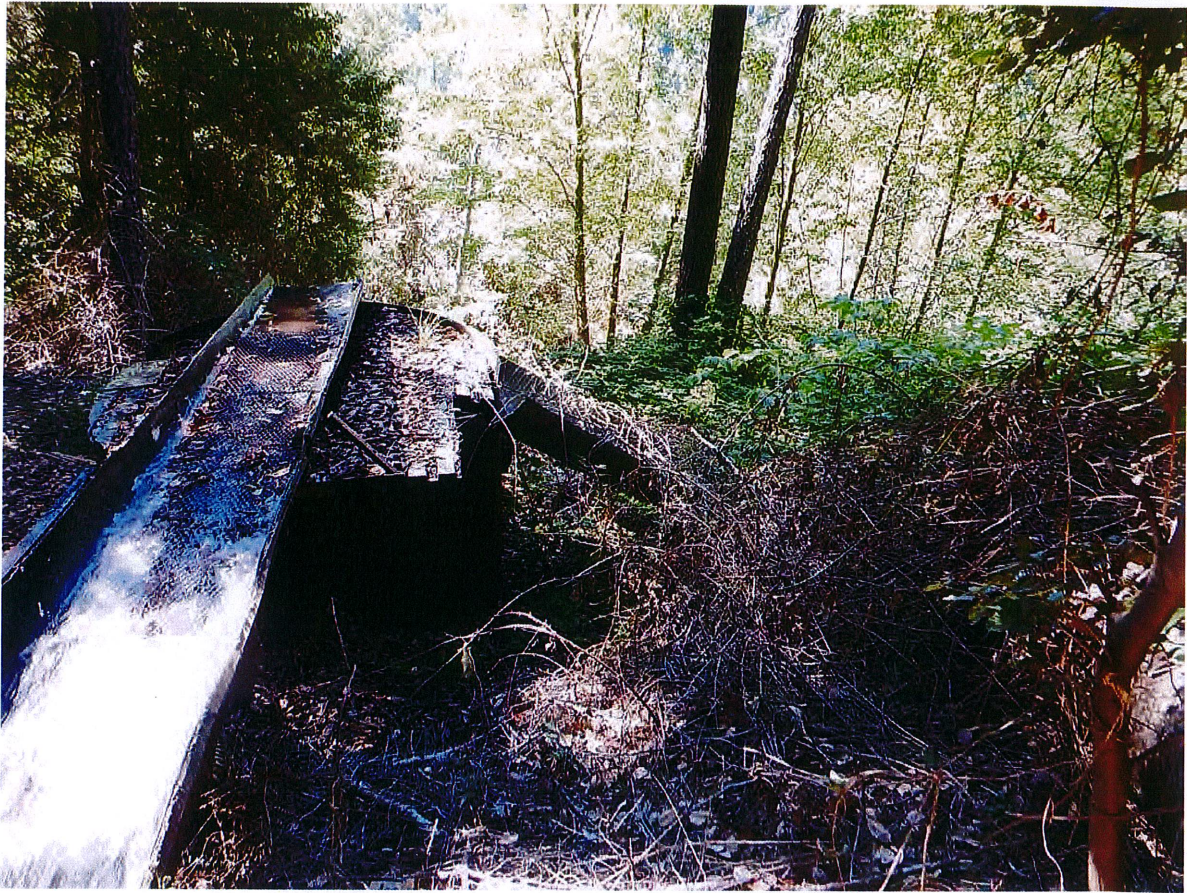
Photograph 7. Forebay to pressurized system. Flows enter system through the screen in the half pipe section.
