RE: Marble Mountain Ranch/ Stanshaw Creek Water Right Division and North Coast Regional Water Board Inspection Reports and Notice of Violation

REGISTRATION: D030945

DIVISION OF WATER RIGHTS
REPORT OF INSPECTION

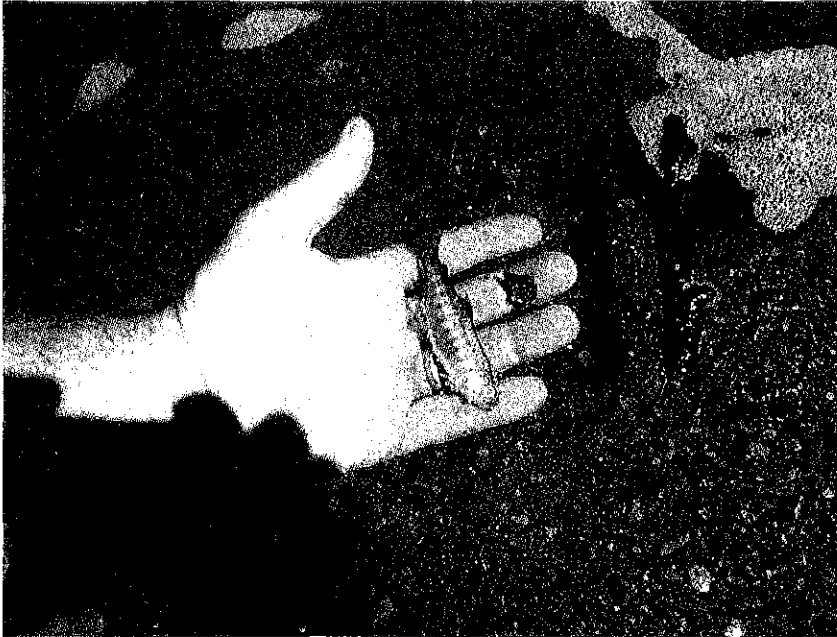
On February 13, 2015 Division staff received photographic evidence from Toz Soto, Fisheries Program Coordinator for the Karuk Tribe Department of Natural Resources of a Coho salmon and five juvenile steelhead fish kill found in a Coho rearing pond located off channel near the confluence of Stanshaw Creek and the Klamath River in late July 2009 (Photo 1 & 2). Mr. Soto believes that the fish mortality was due to a lack of flow entering the pond that led to a water temperature increase when Stanshaw Creek flows were reduced by MMR's diversion. The Karuk tribe was monitoring temperature in the Stanshaw Creek off channel pond in the summer of 2009, however; the water data logger was buried by sediment in the fall and lost. The basis for Mr. Soto's temperature findings are based on another data logger deployed a half mile upstream along the Klamath River in off channel ponds at Sandy Bar Creek that recorded 22.9 Celsius and 19.2 Celsius on July 30, 2009.

Photo 1 - Dead Coho salmon found in near confluence of Stanshaw Creek and Klamath river in the off channel pond that is supplied water from Stanshaw Creek.

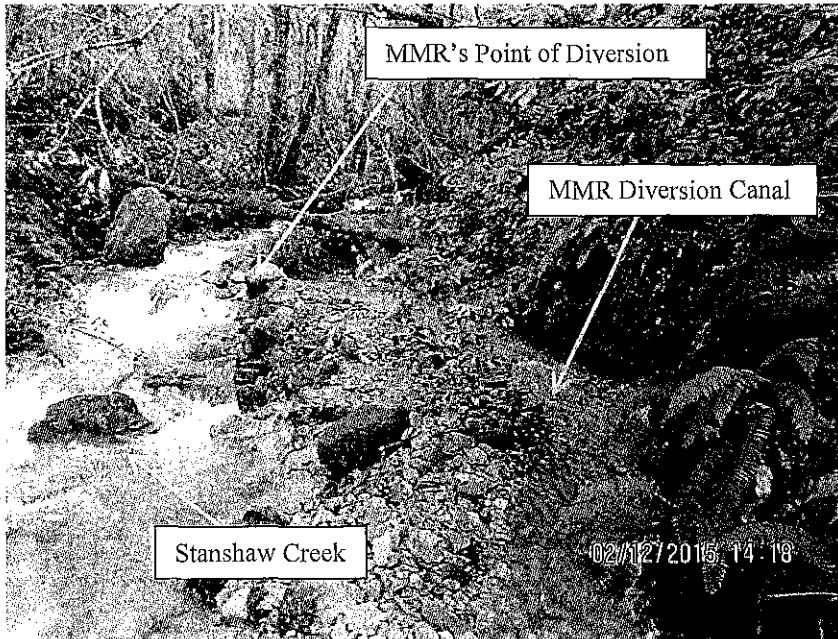
During the Division's facility inspections on December 17, 2014 and on February 12, 2015, Division staff observed that the facility's POD intake did not have a control mechanism to manage flow through the open ditch system. Without a control mechanism, such as a diversion gate that has the ability to restrict flow through the POD, water may be diverted in excess of the diversion ditch capacity and in excess of what is reasonably required for beneficial use.

Photo 3 – MMR POD on Stanshaw Creek

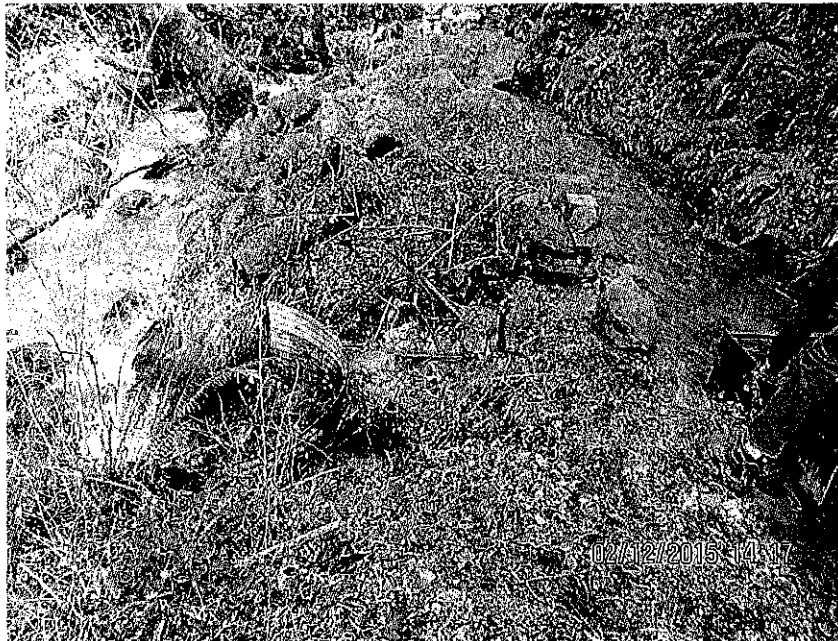
Photo 4 – Outfall structure located 50-feet downstream of POD.

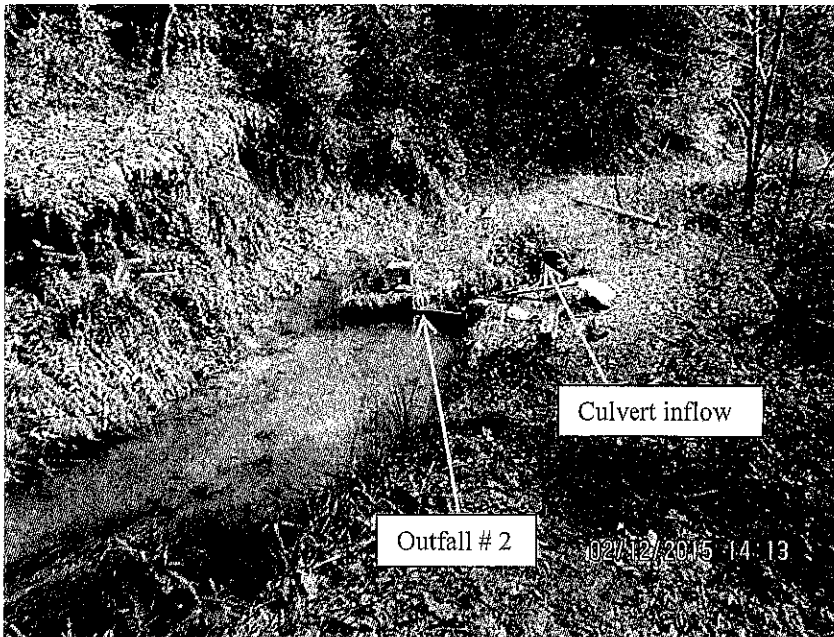
Photo 5 – Second outfall structure in diversion ditch.

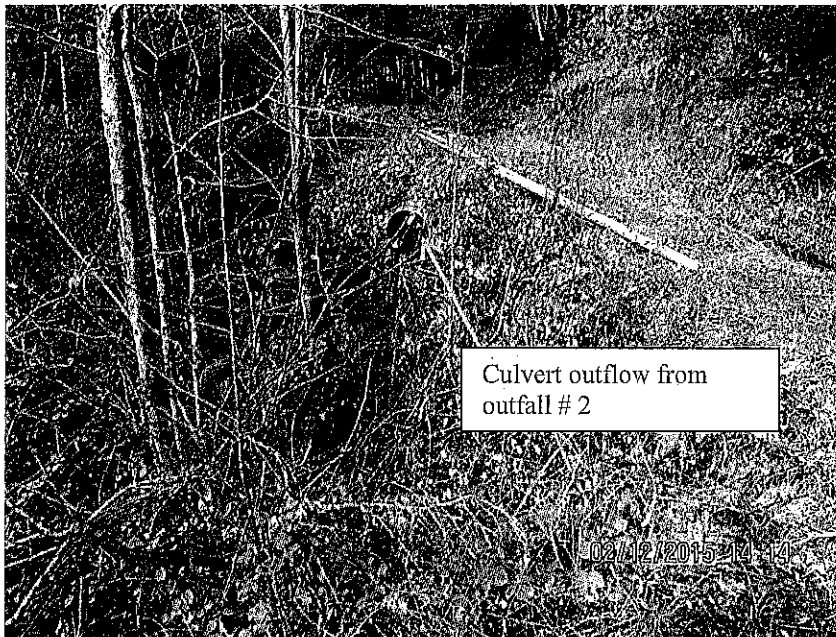
Photo 6 – This photo shows the outflow from Outfall # 2 on the diversion ditch.

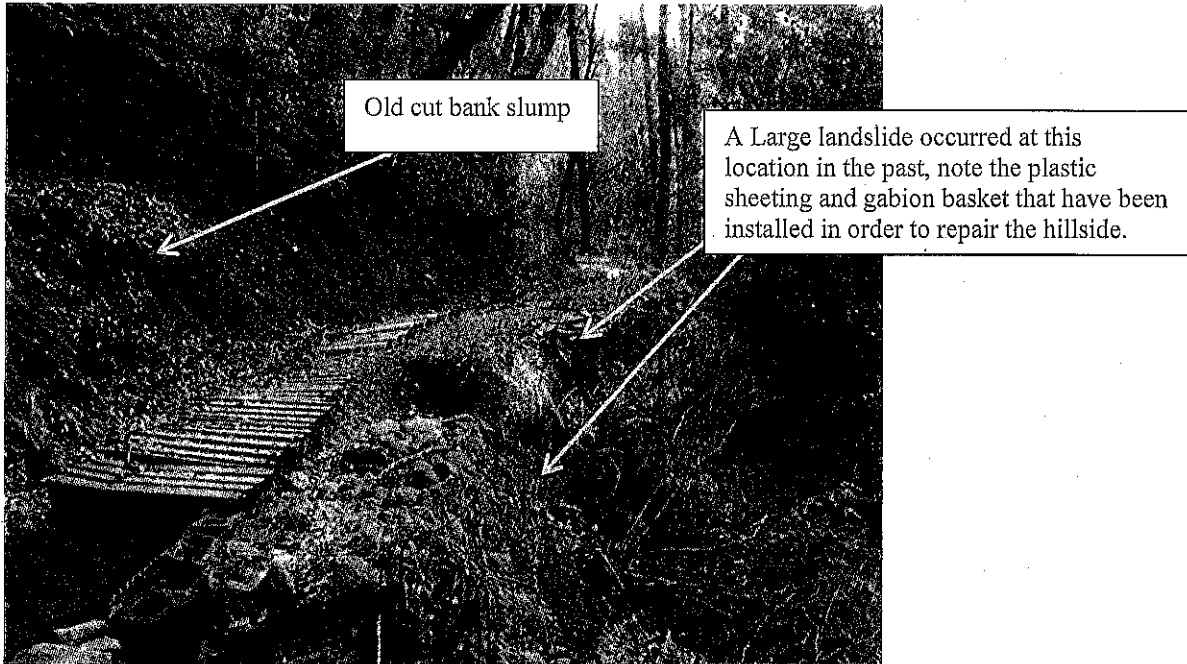
materials up-slope, resulting in slumps into the ditch (Photo 9). Division staff Skyler Anderson noted limited free board space along the majority of the diversion ditch (Photo 10). The elevation of the outer berm crest of the diversion ditch varies greatly. These variations can be attributed to flows in the diversion ditch historically overtopping the low berm crest areas, resulting in hill slope sloughing and landslides (Photo 11).

Photo 11 – Large landslide caused by cut bank slump damming ditch and redirecting diverted flow downhill..

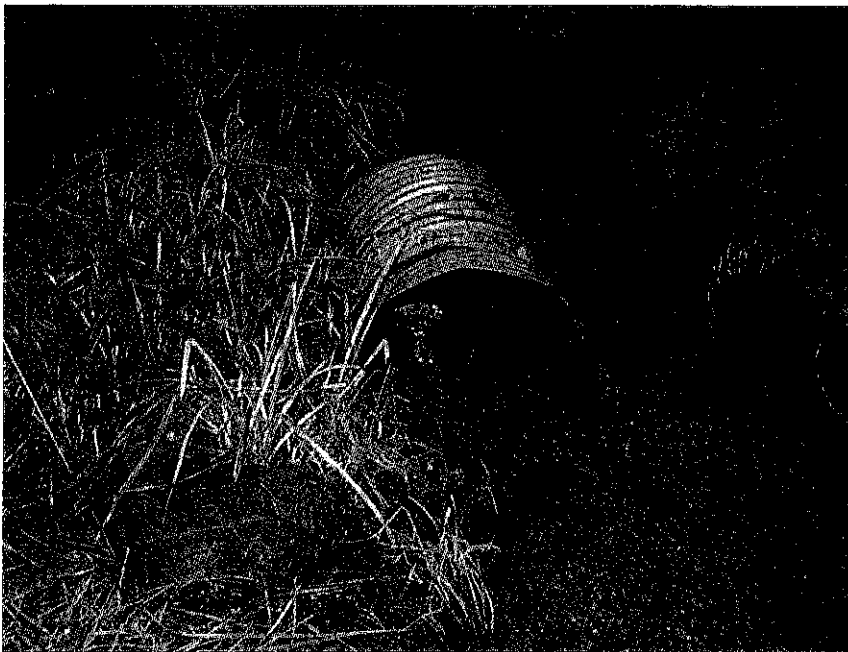
The Division finds that MMR's diversion may constitute a waste of water resources. Division staff observed a number of leaks in MMR's drinking water tanks (Photo 12 & 13). Division staff was not able to quantify the amount of water leaking from two of the three tanks used in the sand filtration process, although the leaks appear to be substantial. Quantities of water lost to leaks in the domestic water treatment plant system and not put to beneficial use constitute a waste.

Photo 12 – Intake for water treatment facility.

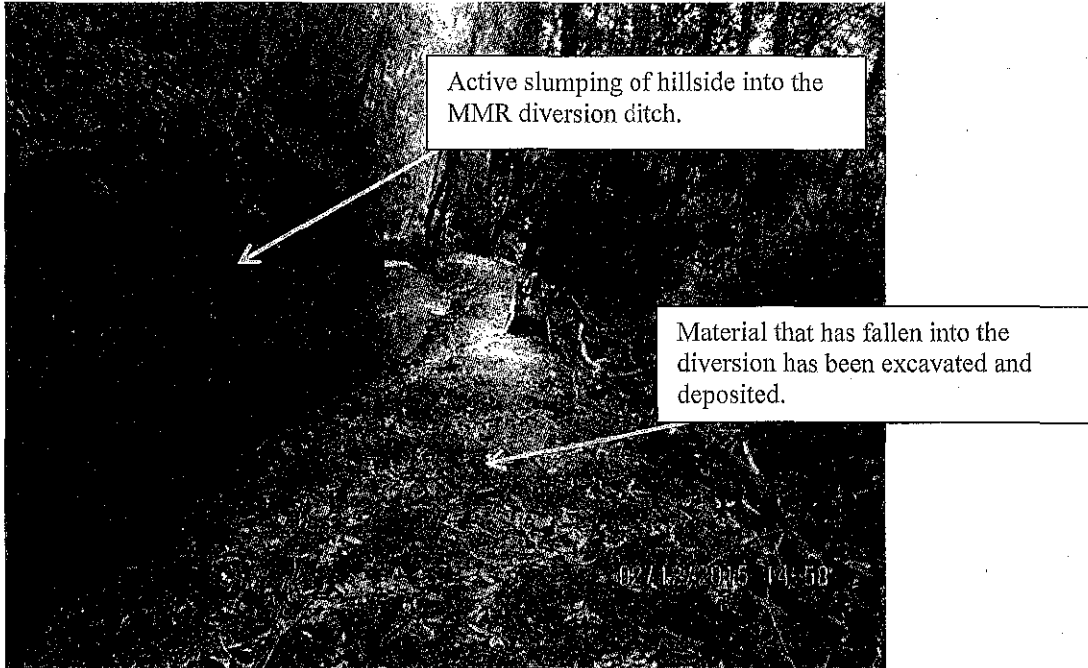
Photo 9 – Area of active slumping into MMR Diversion ditch.

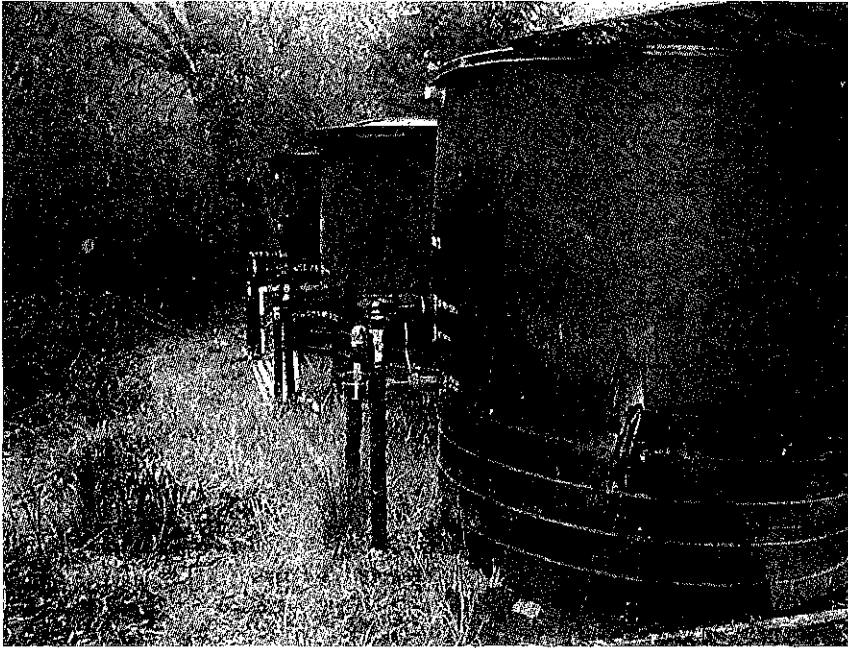
Photo 13 – (3) 3,000 gallon storage tanks.

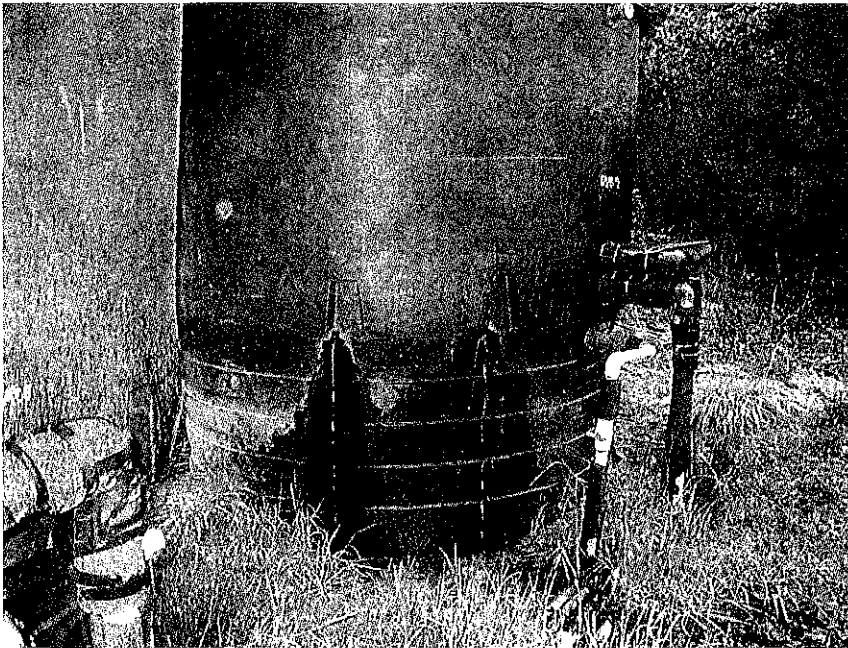
Photo 14 – leaks coming from one of the 3,000 gallon water tanks used for filtration.

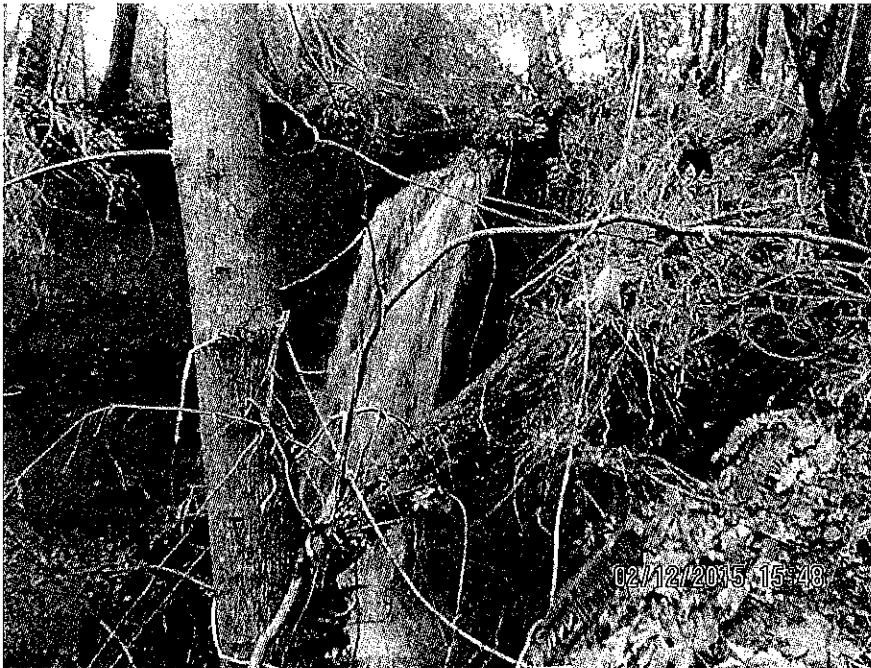
Photo 20- Discharge to Irving Creek.

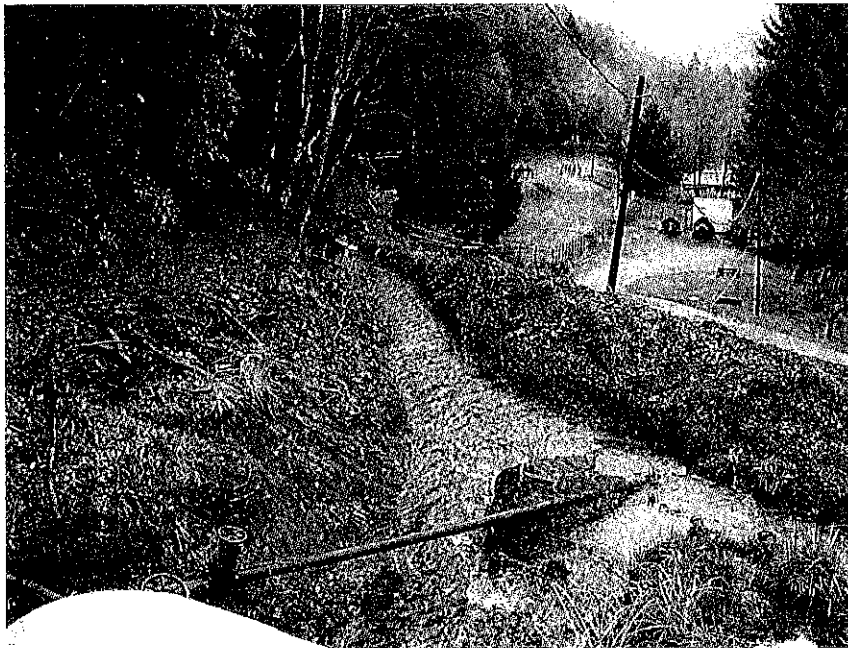
Photo 18 – None consumptive water used for hydroelectric power flowing towards the Coles' pond.

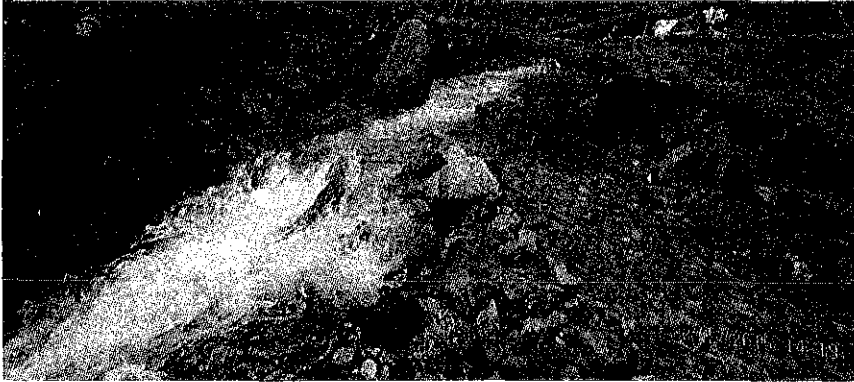
Image 3- shows Point 1, the Point of Diversion. The Stanshaw Diversion flows toward the lower right corner of this image. It appears the rock and cobble diversion structure fails episodically and likely requires periodic modification as Stanshaw Creek's flows change, in order to maintain a diverted flow. (Photos 8459, 8460 and 8461 stitched)

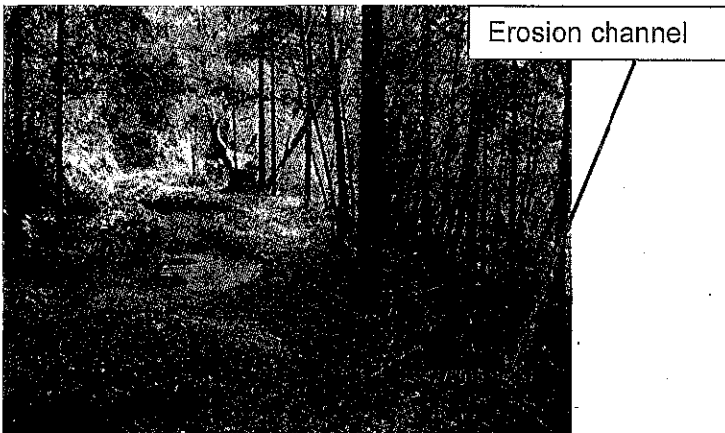
Image 5- shows Point 3, a tank or railroad tank car buried in the ditch channel, likely intended to trap sediment. The tank car is full of sediment. Water flowing in the ditch appears to have overtopped the outboard berm at this location and caused some erosion on the slopes below. (Photo 8467)

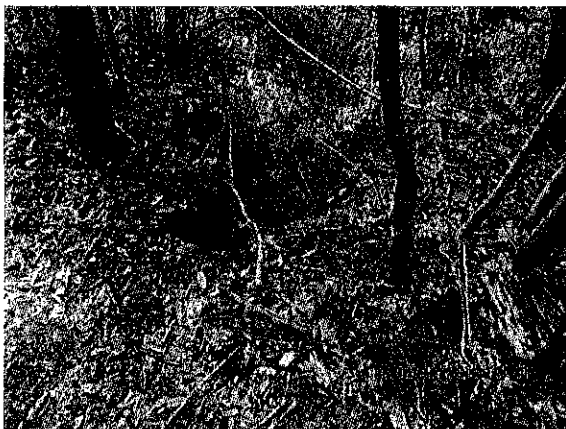
Image 7- shows the erosion channel downslope of Point 3. The void is visible here in the foreground; the erosion extends downslope an unknown distance.

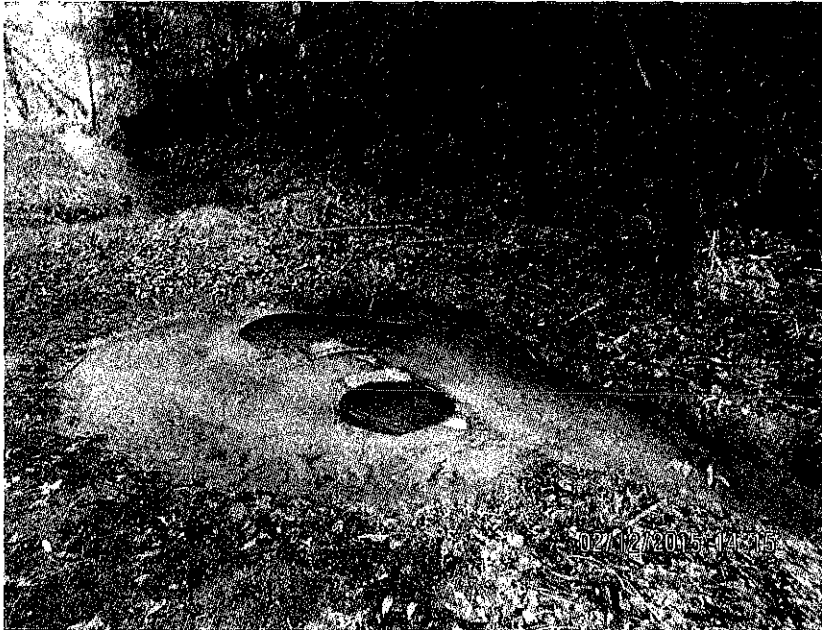
Image 8- at Point 3, shows a closer view of the buried tank car with stored sediments visible. (Photo 8450)

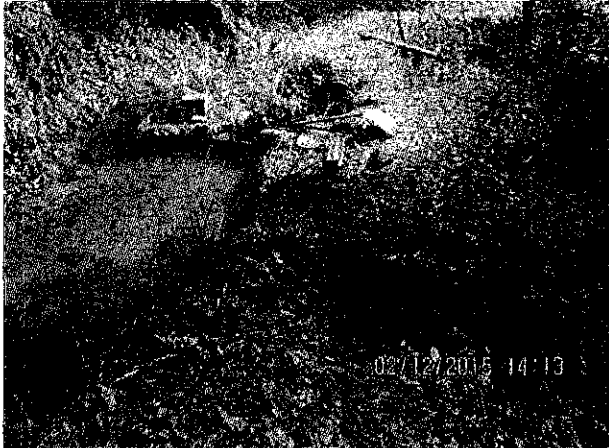
Image 10- at Point 4, shows a closer look at the seepage in the berm; note the muddy soils in the foreground. (Photo 8441 cropped)

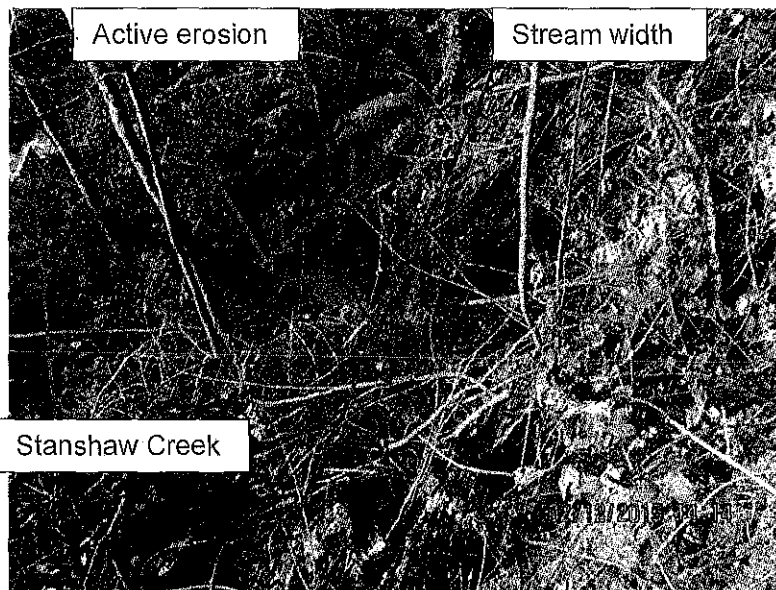
Image 11- shows the unnamed stream channel downstream of Point 5, and the erosion caused by water draining from the shotgunned culvert. Stanshaw Creek can be seen a short distance downslope. I conservatively estimate that this site has delivered 150-300yds³ of sediment and debris to Stanshaw Creek over the life of the Diversion. (Photo 8478)

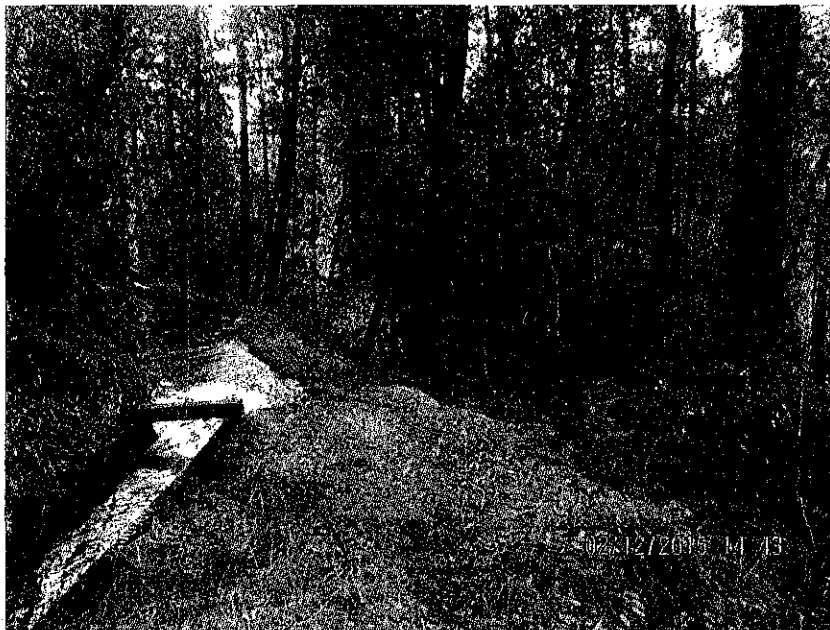
Image 13- point 7, shows the end of the flume in the previous photo; note the black plastic sheeting on the outboard slope face, and the low outboard berm as the diversion ditch exits the flume. The lack of freeboard creates a high potential for overtopping and erosion. The presence of the pipe section and plastic sheeting in the area suggests that the berm or underlying slope in this area has likely failed in the past. (Photo 8483)

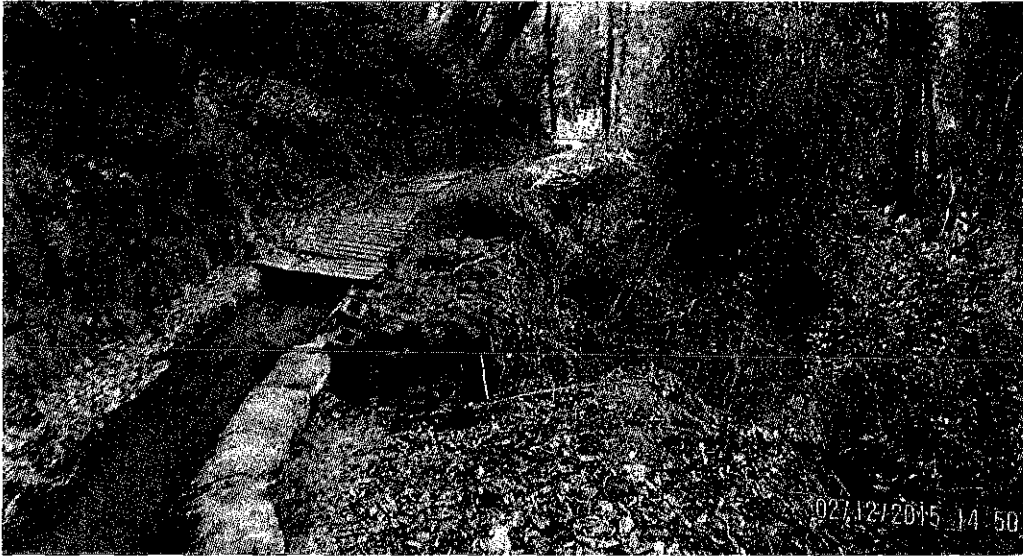
Image 15- shows Point 9, a significant failure point, likely caused by a cut bank slump filling the diversion channel and diverting the stream flow. Note the cut bank slump above and the erosion void downslope. This failure likely accelerated erosion on lower slopes and into the nearby streams. (Photo 8490 and 8491 composite)

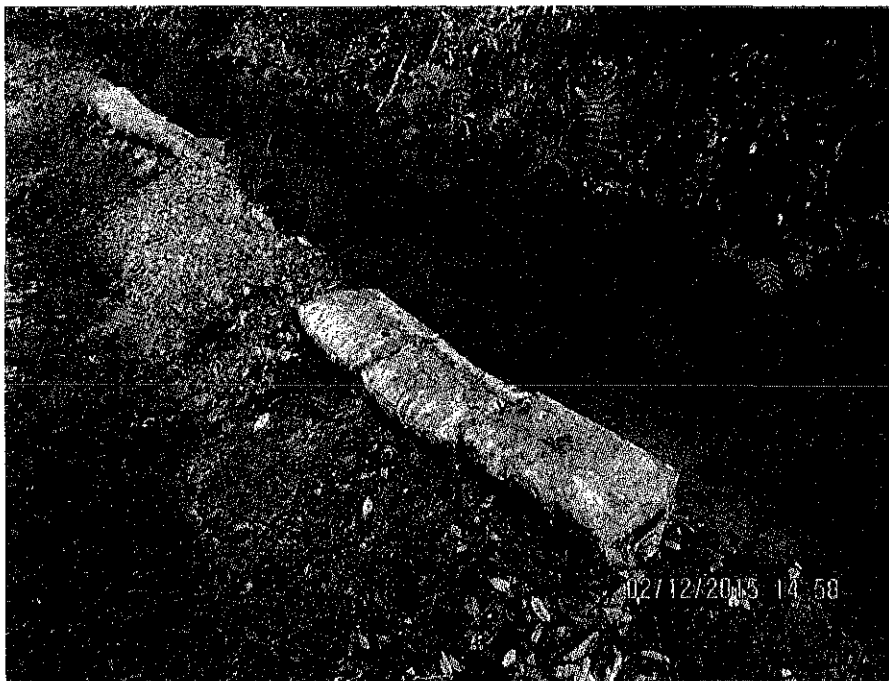
Image 19- Point 12, closer view of berm repair made with ready crete concrete sacks and soils. Note the saturated soils along the outboard berm where water is seeping. (Photo 8510)

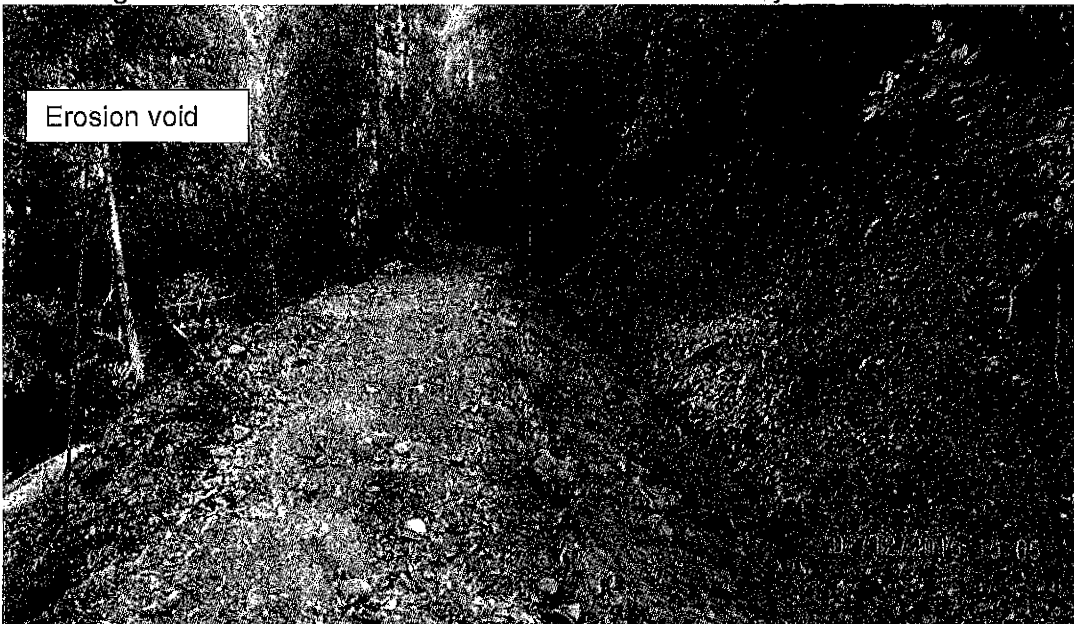
Image 21- Point 14, a cut bank that appears to have slumped in the recent past, causing water to overtop the berm and erode the berm and lower slopes. (Photo 8520 and 8521 composite)

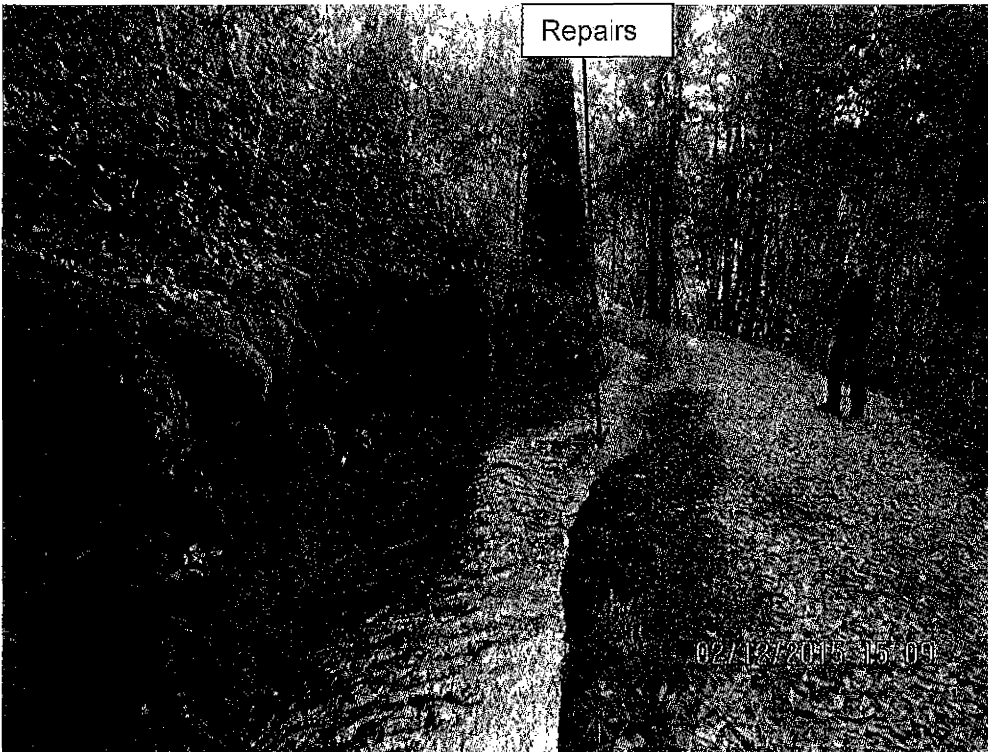
Image 22- Point 15 shows an active cut bank slump, and evidence of recent repairs to the ditch and berm. (Photo 8523)

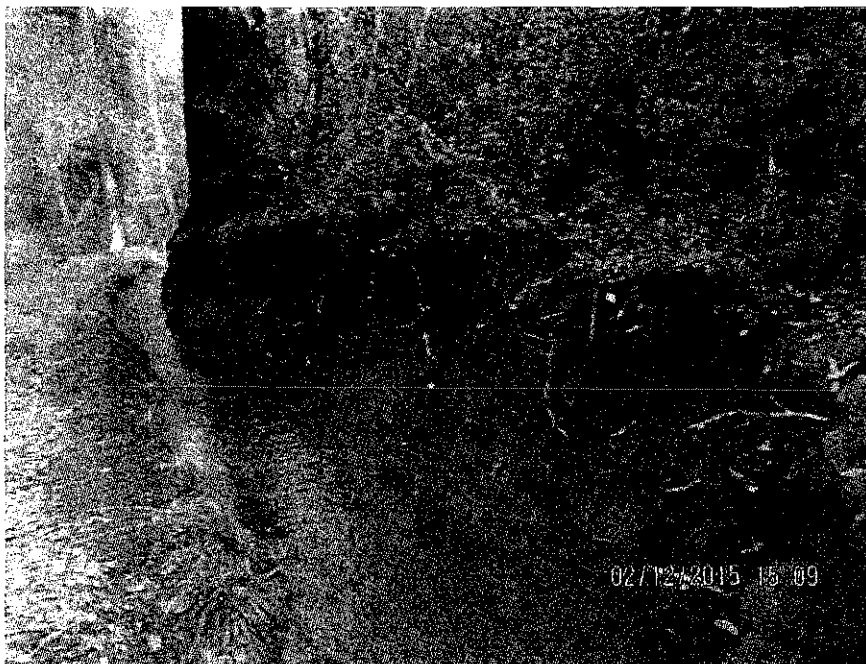
Image 23- Point 16, another cut bank that has a high risk of failure. Note the steep, near vertical slope of this cut bank, which indicates that the bank is still likely to erode. The roots hanging out of the cut bank are indicators of the erosion that has occurred. Most cut banks are originally constructed in a planar form with no visible roots protruding. Over time the cut bank erodes, exposing the roots, and leaving an indicator as to the amount of soil that has eroded or slumped. (Photo 8525)

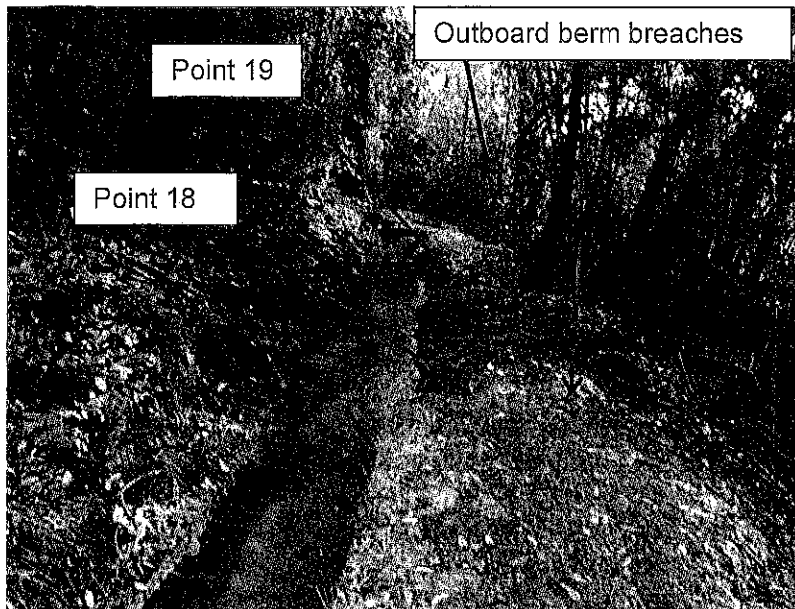
Image 25- shows two locations, points 18 and 19, where the outboard berm has apparently breached in the past, resulting in gully erosion on lower slopes. The failure at Point 19 resulted in the formation of a gully channel for a long distance down the slope, and may have contributed a significant sediment load to the Klamath River and possibly Stanshaw Creek. I did not follow the gully all the way down the slope, but did see an erosion channel from the lower road.

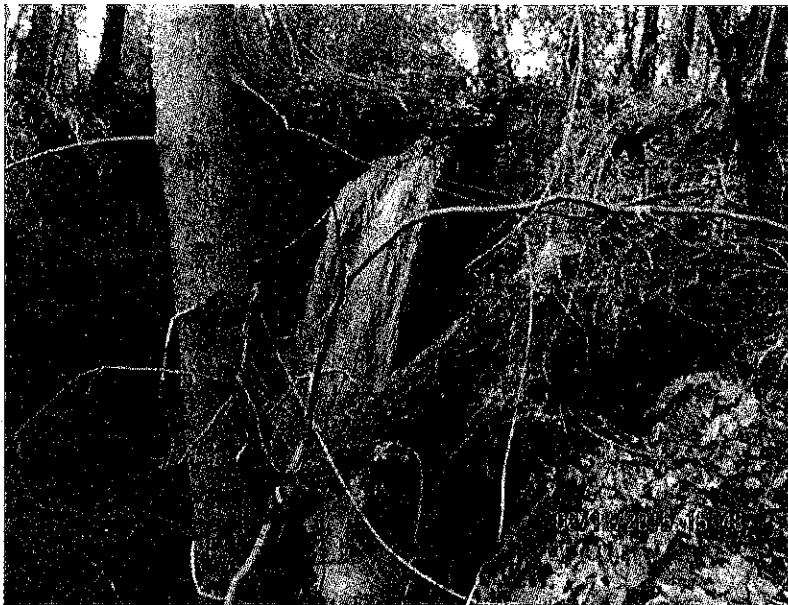
Image 26- Point 20 is the headcut upslope from Irving Creek. This is where tailwater from the Stanshaw Diversion is discharged to an unnamed stream, tributary to Irving Creek. This area is actively eroding. Several trees appear to have fallen recently through erosion of their root masses. I estimate that the headcut erosion has delivered between 1500-2200 yds³ of sediment to the Irving Creek watershed. (Photo 8529)
