North Coast Regional Water Quality Control Board

Inspection Report
Stanshaw Creek Diversion
Marble Mountain Ranch
Douglas and Heidi Cole, Landowners
92520 Hwy 96, Somes Bar
Siskiyou County
WDID No. 1A15024NSI

Date: March 9, 2015

Inspection Date: February 12, 2015

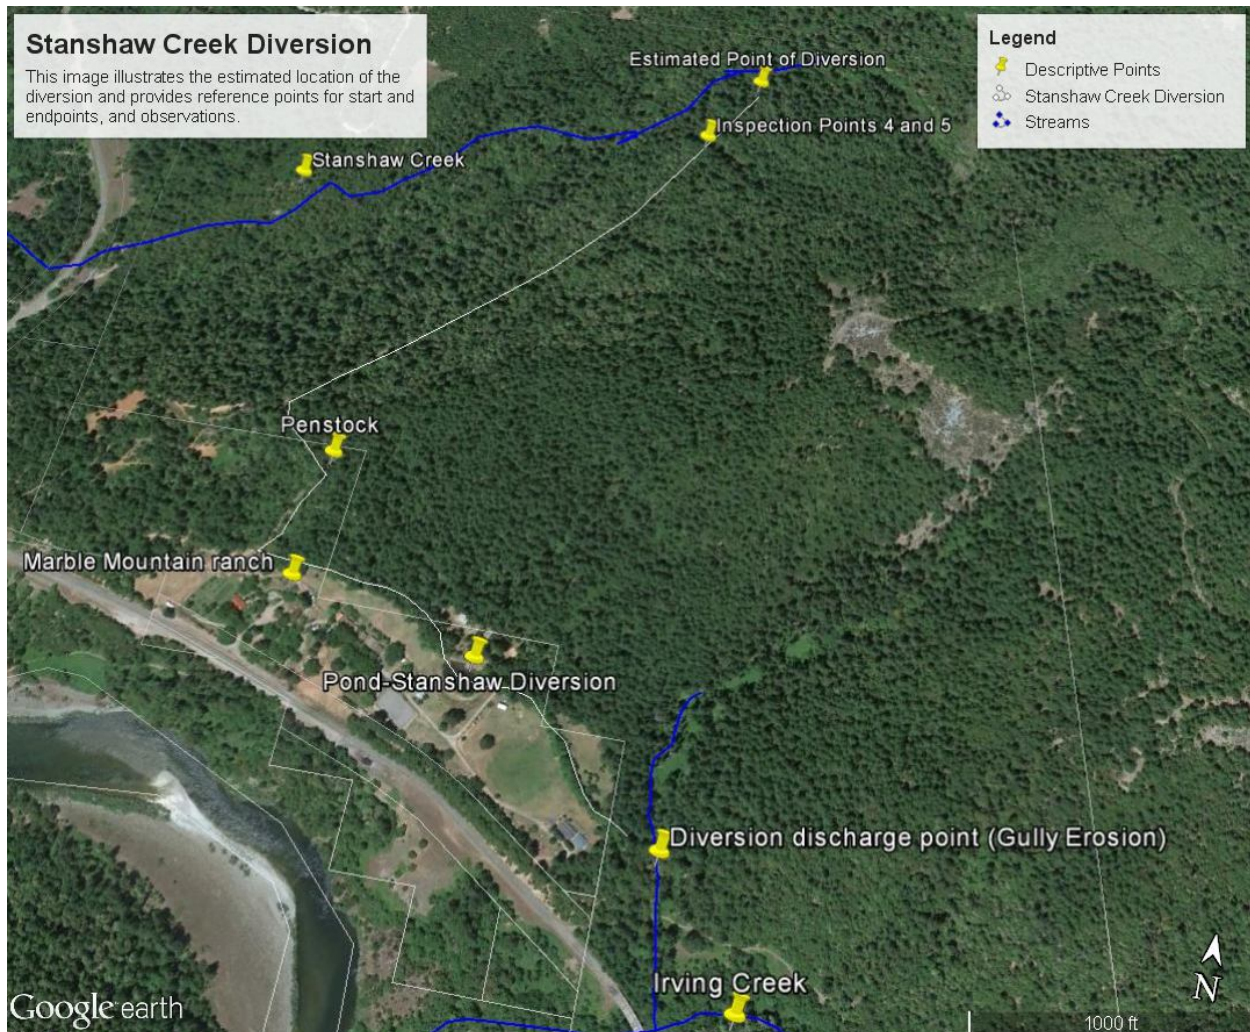
Image 1 provides general locations for the Point of Diversion at Stanshaw Creek (Point 1), and the discharge point above Irving Creek (Point 20), which are the start and end points of inspection observations as ordered below.

Image 1- shows an overview of the Stanshaw Diversion route and Marble Mountain Ranch. The locations identified are estimated based upon visual observation of the area during the inspection and through subsequent comparison with existing 6/6/2013 Google Earth Pro imagery, Arcview GIS topographic maps, and historic maps of the diversion.

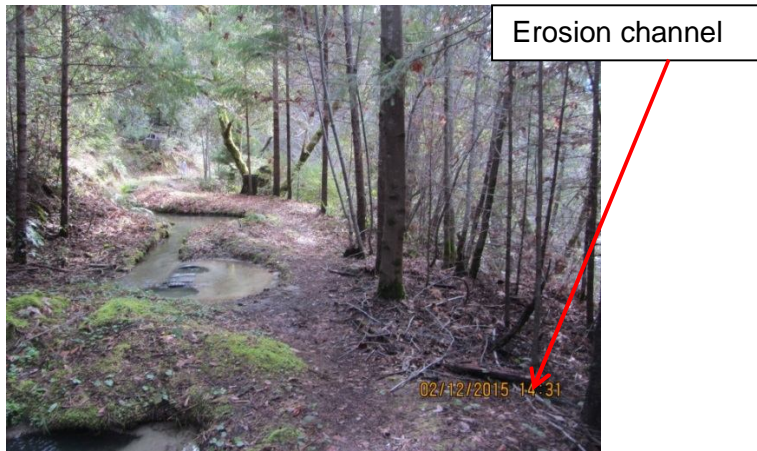
Image 5- shows Point 3, a tank or railroad tank car buried in the ditch channel, likely intended to trap sediment. The tank car is full of sediment. Water flowing in the ditch appears to have overtopped the outboard berm at this location and caused some erosion on the slopes below. (Photo 8467)

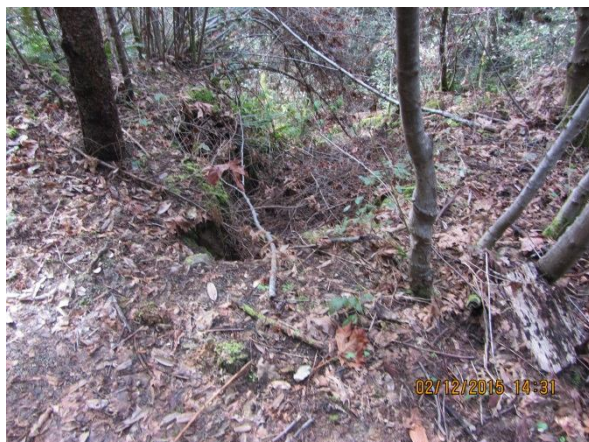
Image 7- shows the erosion channel downslope of Point 3. The void is visible here in the foreground; the erosion extends downslope an unknown distance.

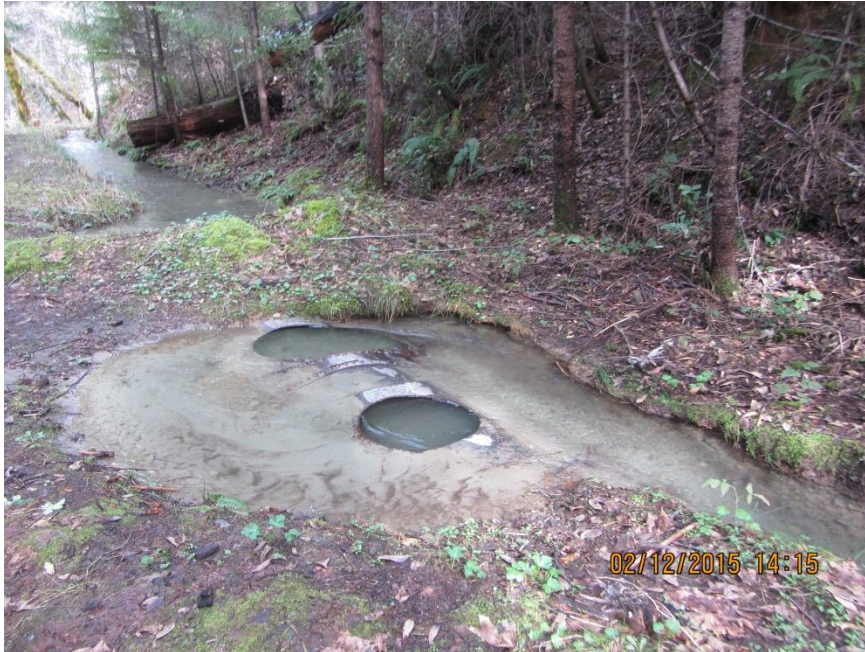
Image 8- at Point 3, shows a closer view of the buried tank car with stored sediments visible. (Photo 8450)

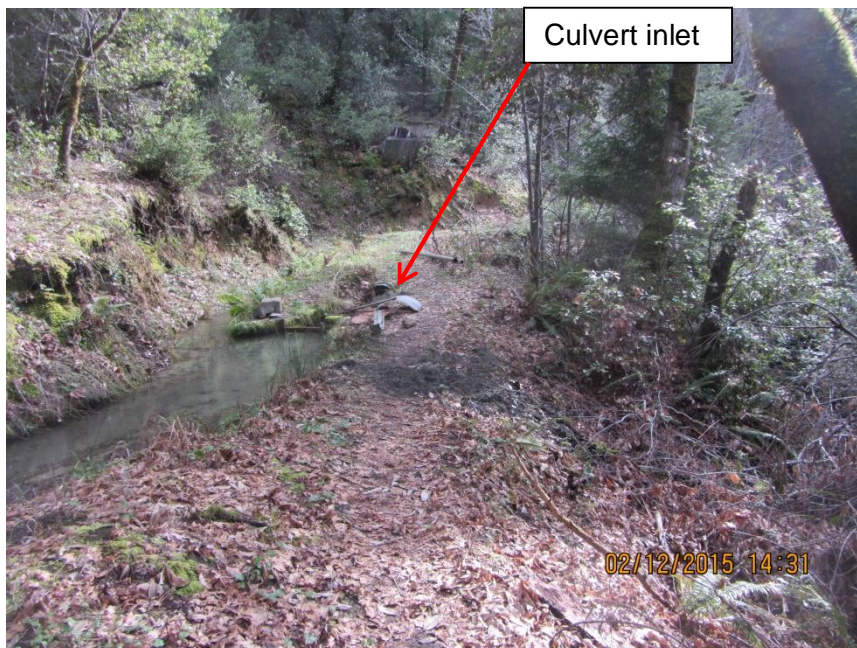
As discussed below, at inspection Points 4 and 5, and visible in image 1, the upper ditch crosses over an unnamed tributary to Stanshaw Creek. The tributary is conveyed under the ditch via culvert. At this location, there is also a culvert that drains a portion of the water in the ditch and discharges it through a shotgunned outlet onto the slope a short distance below the outfall for the stream crossing culvert. The combination of uncontrolled discharges and additional flows into the unnamed tributary has caused significant streambank erosion and channel widening in the tributary downstream of the culvert. The ditch may have historically failed at this location, which has likely also contributed to stream channel enlargement.

Image 9- at Point 4, shows the partial diversion of the ditch into an unnamed tributary to Stanshaw Creek through the inlet of a 12-inch culvert, before the diversion ditch is routed across the stream in a lined ditch. The culvert is shotgunned, which appears to have caused significant instream erosion in the downslope channel. The stream above the crossing is 3-4 feet wide at bankfull width; the eroded stream channel below the diversion crossing is 12-14 feet wide, and does not appear stable. At this location, I also observed muddy soils in the berm adjacent to the ditch, indicating that seepage from the ditch is saturating surrounding soils, which may lead to catastrophic failure of the ditch. (Photo 8441)

For either alternative, the ditch repair or decommissioning plan shall include specifications to restore the affected stream/unnamed tributary that crosses at inspection points 4/5, replant with native vegetation, and to protect streams from any further impacts or discharges associated with the ditch.

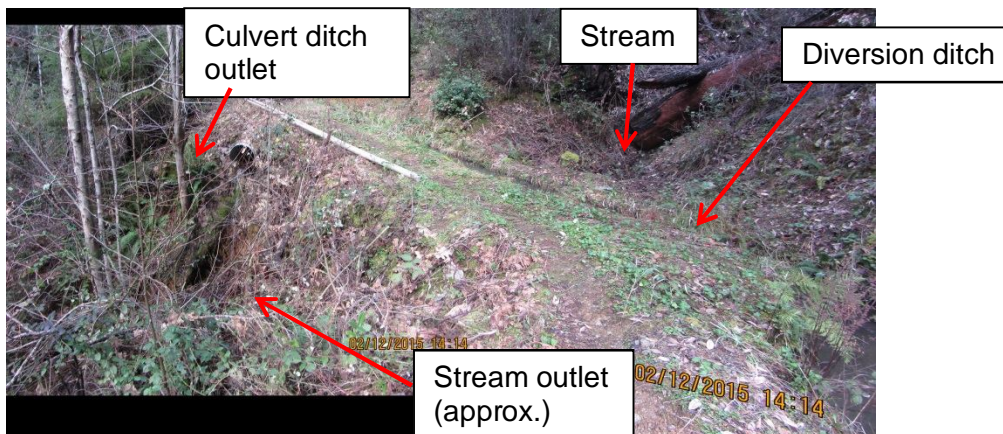
Image 9- at Point 5, shows the shotgunned 12-inch ditch culvert outlet, diversion ditch and native stream channel flowing under the diversion ditch. (Photos 8442, 8443, 8444, 8445 composite)

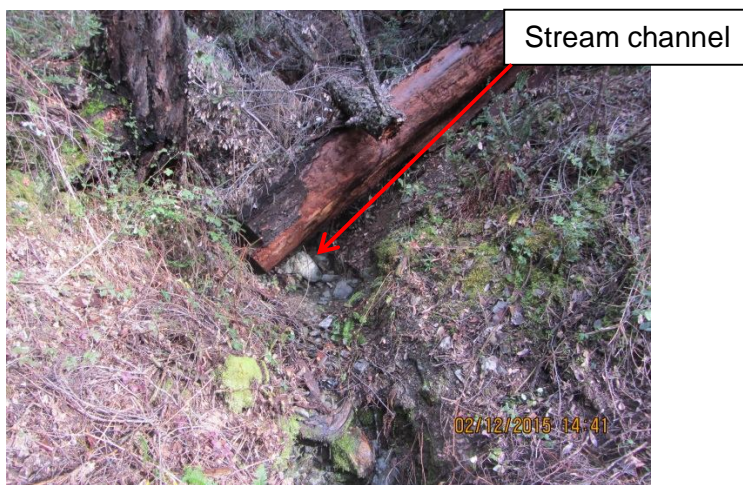
Image 10- shows the unnamed stream channel above Points 4 and 5; the upslope active bankfull stream channel width is approximately 3-4 feet.

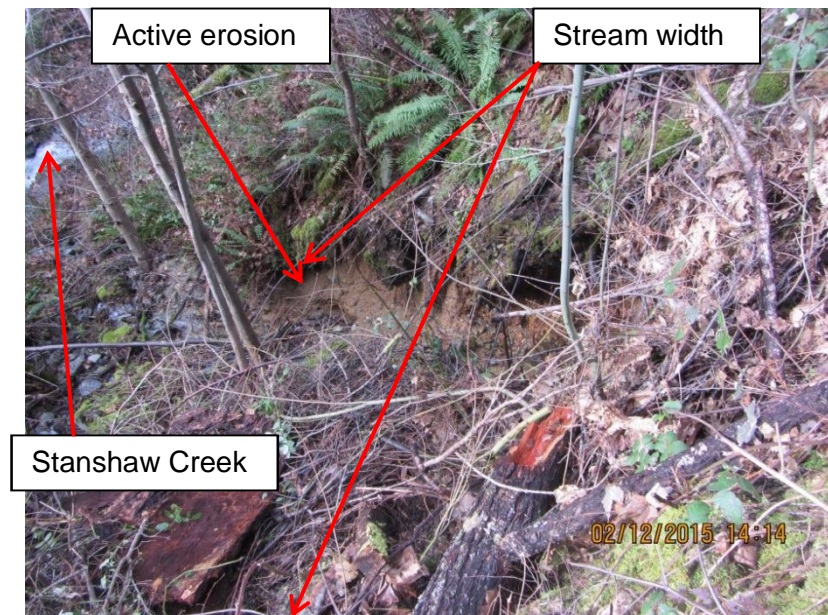
Image 11- shows the unnamed stream channel downstream of Point 5, and the erosion caused by water draining from the shotgunned culvert. Stanshaw Creek can be seen a short distance downslope. I conservatively estimate that this site has delivered 150-300yds³ of sediment and debris to Stanshaw Creek over the life of the Diversion. (Photo 8478)

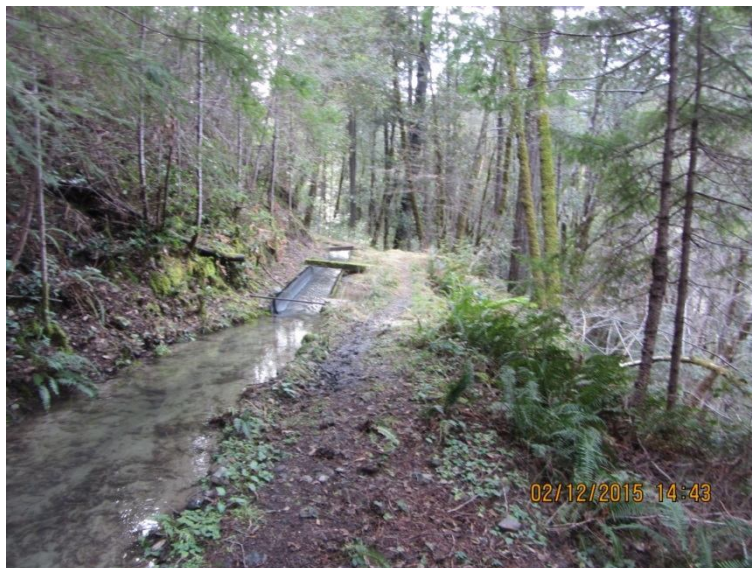
Image 12- shows Point 6, where the diversion channel is full, leaving no freeboard should it rain or the ditch receive a bank slump upstream. It appears the outboard berm may have failed in this area in the past, and at present is seeping, indicating that a portion of the berm may be saturated. Stanshaw Creek is within 200 feet; any failure here likely results in direct delivery of sediment and erosional debris. The flume section visible in the photo appears to have been installed to remedy previous ditch failures and/or to prevent future failures.

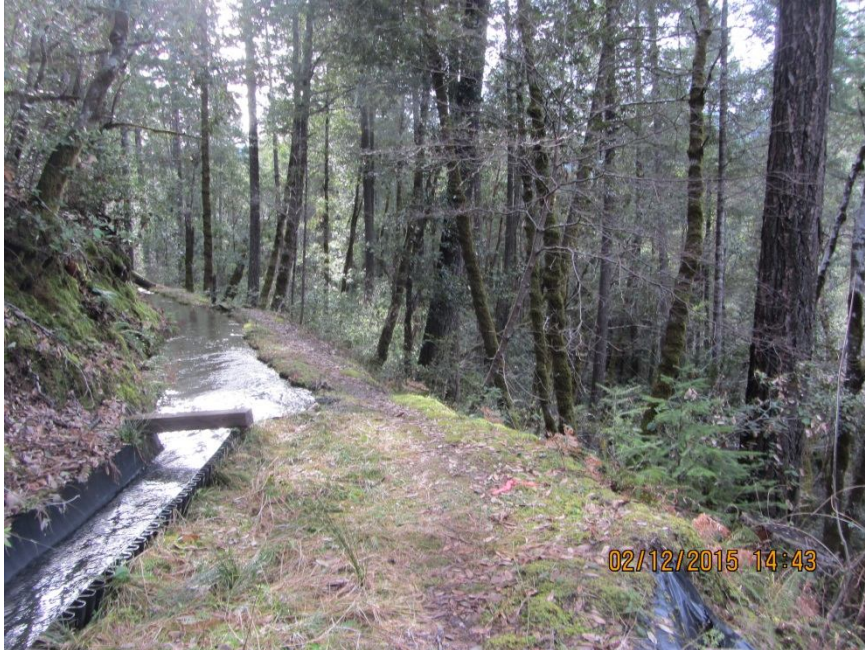
Image 13- point 7, shows the end of the flume in the previous photo; note the black plastic sheeting on the outboard slope face, and the low outboard berm as the diversion ditch exits the flume. The lack of freeboard creates a high potential for overtopping and erosion. The presence of the pipe section and plastic sheeting in the area suggests that the berm or underlying slope in this area has likely failed in the past. (Photo 8483)

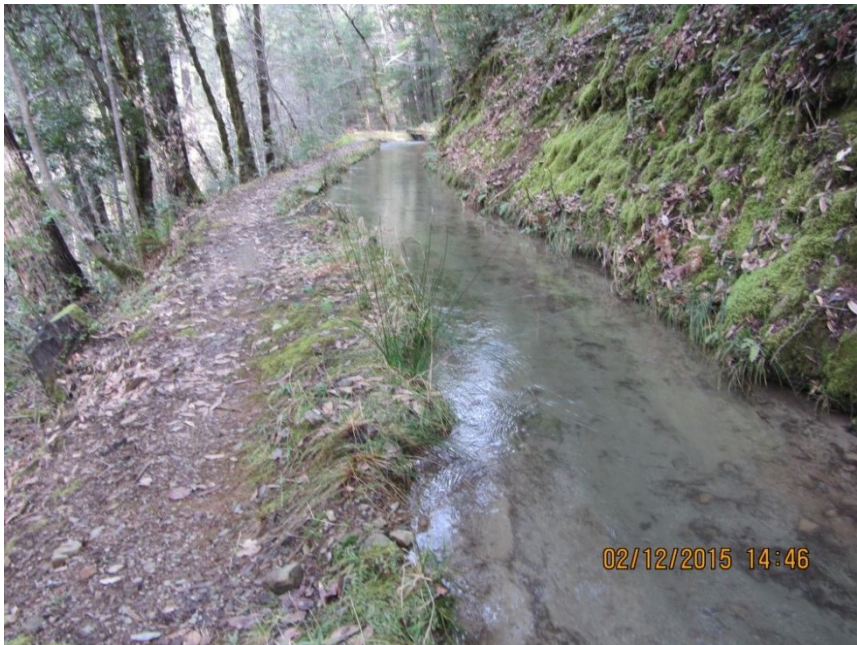
Image 14- shows point 8, an approximately 150-foot section of the channel downstream of Point 7, where the low berm and full ditch likely creates a high potential for berm or slope failure, erosion, and sediment transport downslope. I observed concrete blocks at various locations along the outboard edge of the berm throughout this segment, likely to rebuild or reinforce berm sections. (Photo 8486)

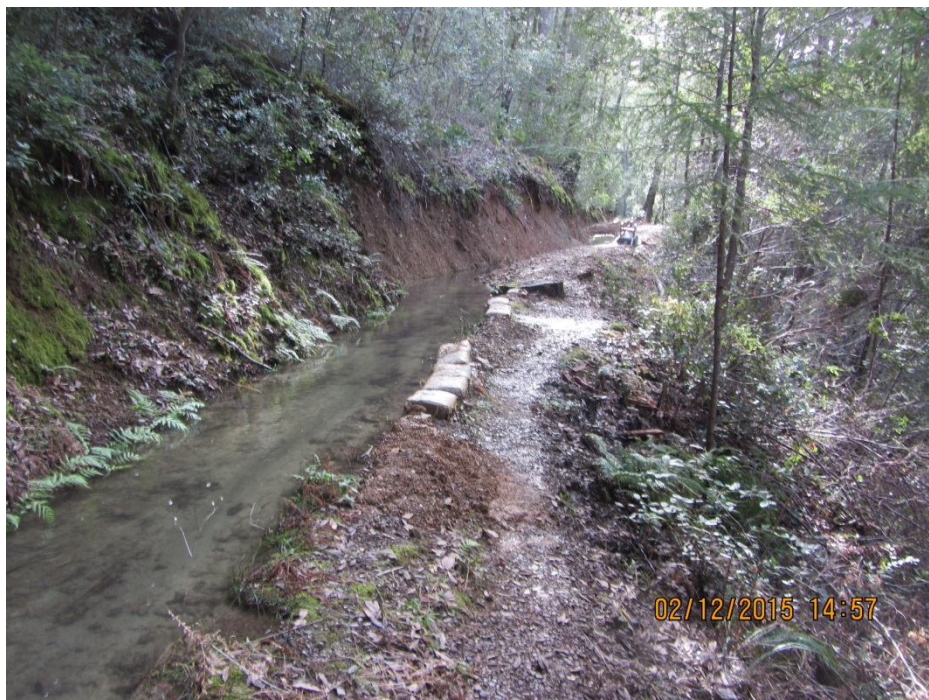
Image 18- Point 12 shows evidence of a recent bank failure that caused water to overtop the outboard berm and erode slopes below the ditch. The outboard ditch shows signs of seepage throughout this length. Note the sand bags and fresh soils along the outboard berm, indicating recent repairs. Also, note the 50-75 foot section of the cut bank with exposed soils. (Photo 8503)

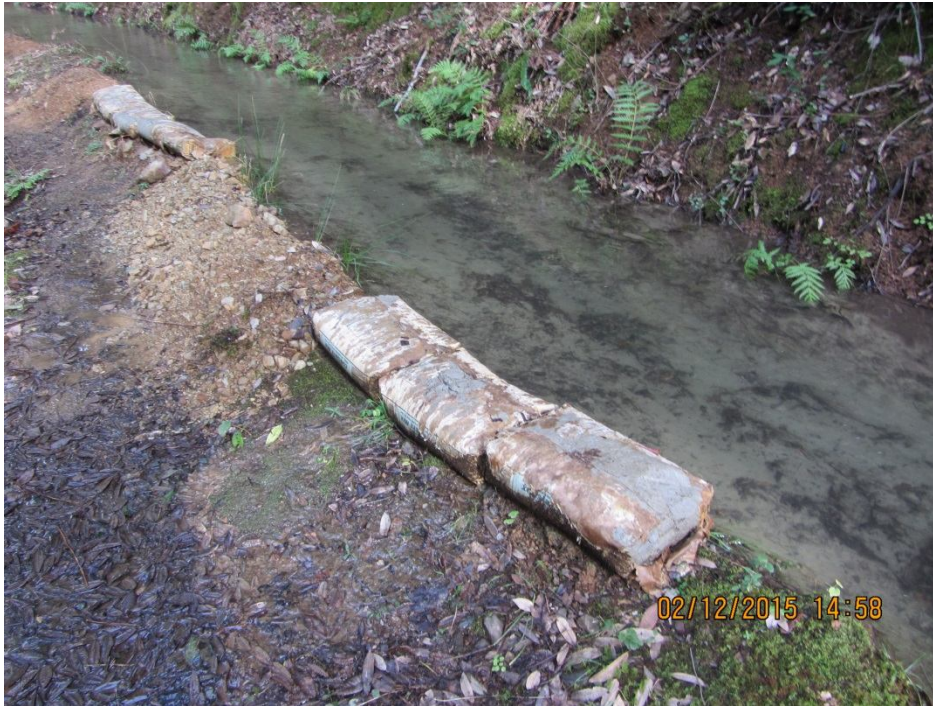
Image 19- Point 12, closer view of berm repair made with ready crete concrete sacks and soils. Note the saturated soils along the outboard berm where water is seeping. (Photo 8510)

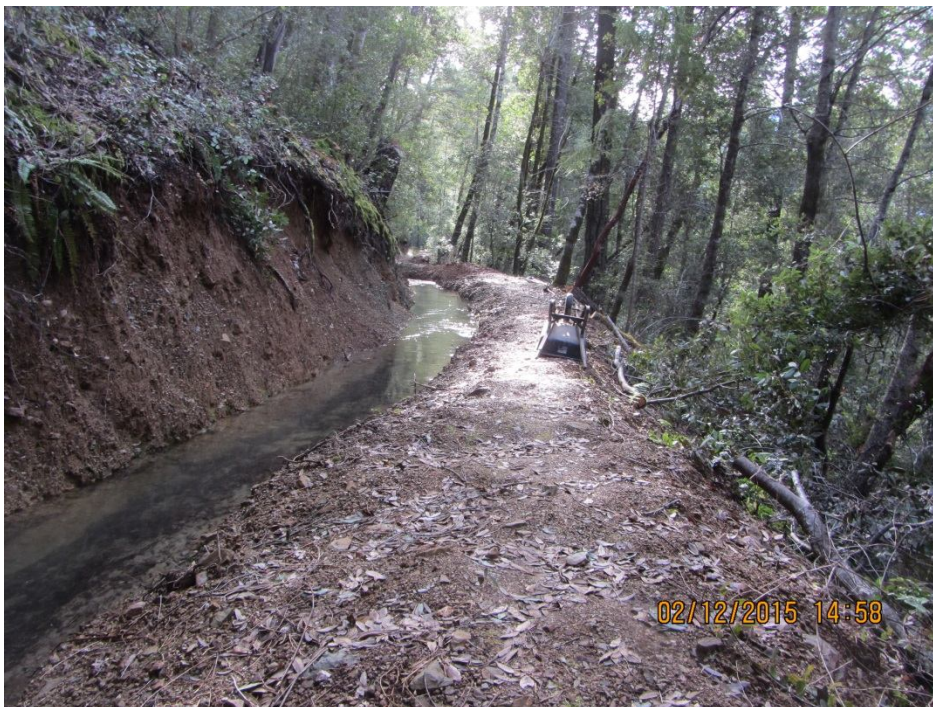
Image 20- Point 13 shows a large continuous cut bank slump that extends for approximately 220 feet. Based on my observations, it appears the cut bank slumped along this stretch over this past winter, delivering approximately 10 yds³ of sediment into the ditch, blocking the channel, and causing water to overtop the berm

and erode the lower slopes. Cut banks are often chronic sources of erosion, delivering additional sediment to streams and ditches each year.

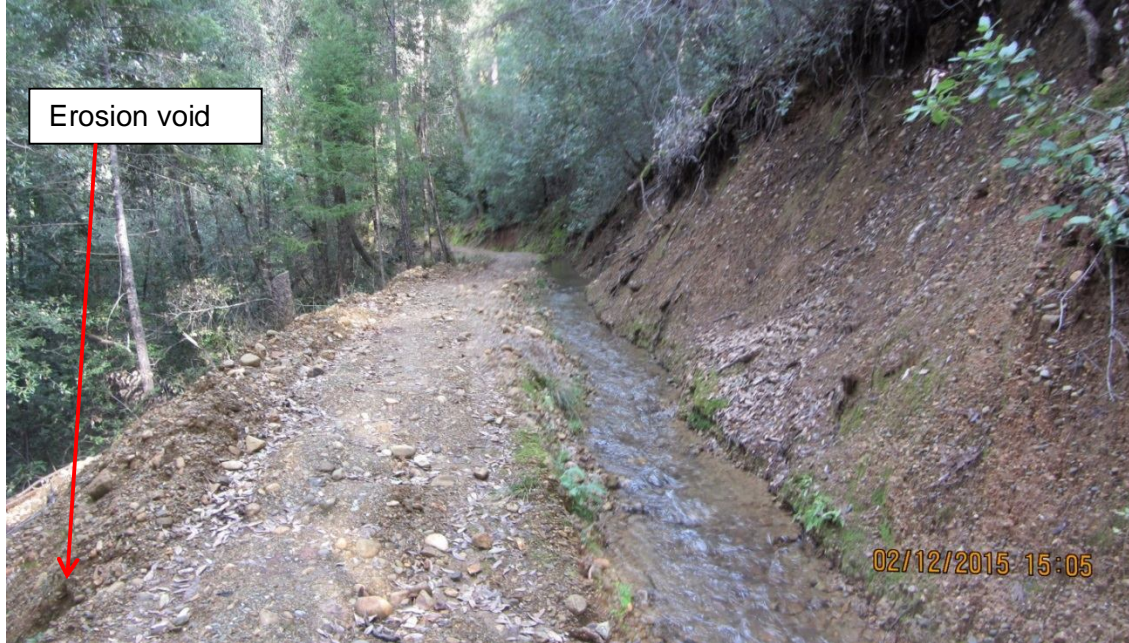
Image 21- Point 14, a cut bank that appears to have slumped in the recent past, causing water to overtop the berm and erode the berm and lower slopes. (Photo 8520 and 8521 composite)

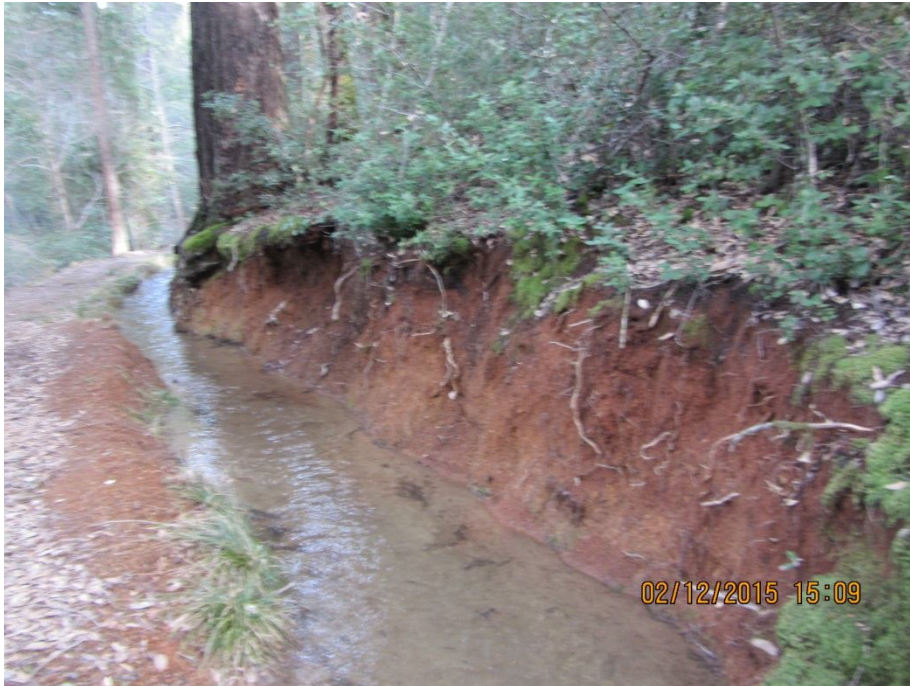
Image 23- Point 16, another cut bank that has a high risk of failure. Note the steep, near vertical slope of this cut bank, which indicates that the bank is still likely to erode. The roots hanging out of the cut bank are indicators of the erosion that has occurred. Most cut banks are originally constructed in a planar form with no visible roots protruding. Over time the cut bank erodes, exposing the roots, and leaving an indicator as to the amount of soil that has eroded or slumped. (Photo 8525)

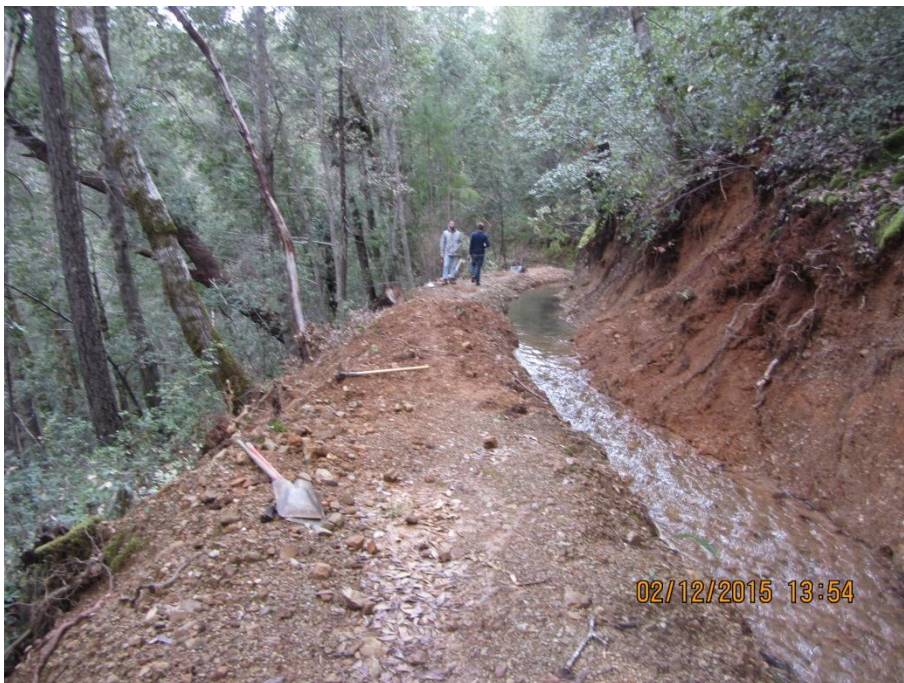
Image 24- Point 17 shows a segment of channel with an active cut bank slump and evidence of recent repairs to the outboard berm.

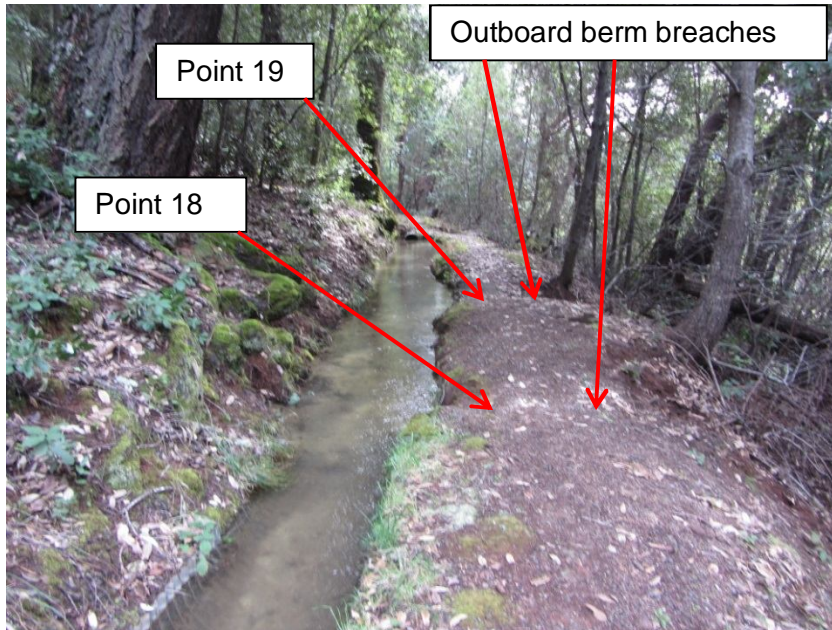
Image 25- shows two locations, points 18 and 19, where the outboard berm has apparently breached in the past, resulting in gully erosion on lower slopes. The failure at Point 19 resulted in the formation of a gully channel for a long distance down the slope, and may have contributed a significant sediment load to the Klamath River and possibly Stanshaw Creek. I did not follow the gully all the way down the slope, but did see an erosion channel from the lower road.

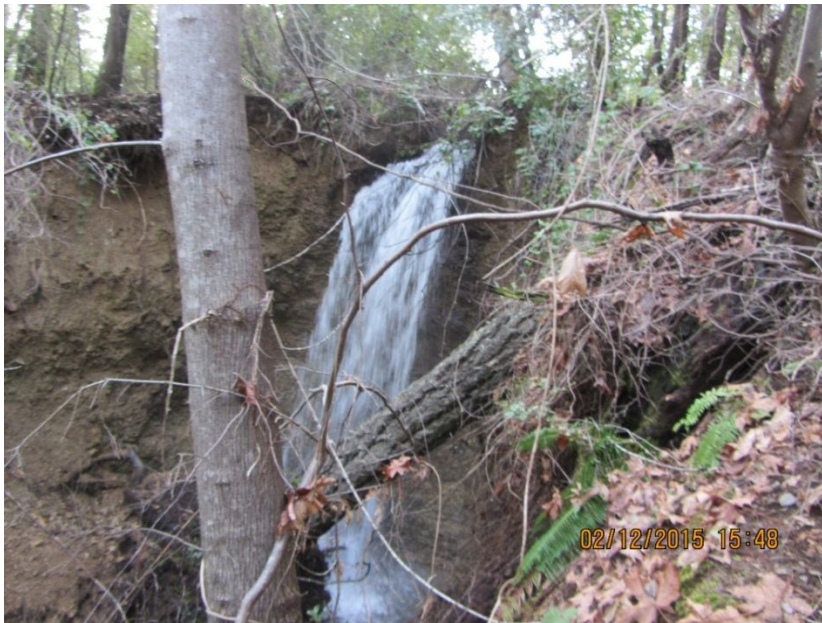
Image 26- Point 20 is the headcut upslope from Irving Creek. This is where tailwater from the Stanshaw Diversion is discharged to an unnamed stream, tributary to Irving Creek. This area is actively eroding. Several trees appear to have fallen recently through erosion of their root masses. I estimate that the headcut erosion has delivered between 1500-2200 yds³ of sediment to the Irving Creek watershed. (Photo 8529)

On the lower ditch, I observed evidence of significant active erosion occurring at the downstream discharge point to Irving Creek, representing a chronic source of sediment delivery into Irving Creek and, thence, to the Klamath River.

Regional Water Board staff recommend that an appropriately qualified California licensed professional experienced in Geology and stream restoration evaluate the diversion outfall tributary to Irving Creek and develop a stream restoration plan to restore stream side vegetative and hydrological functions of the tributary, if applicable, and to ensure the long term recovery of the affected streams; and 2) replant slopes and streamside areas with native vegetation to prevent erosion and sediment delivery. The plan shall include provisions to ensure that continued use of this tributary, either for diversion outfall flow or for transport of seasonal flows through the ranch property, does not create new or exacerbate existing erosion.
