## TATE WATER RIGHTS BOARD

## REPORT OF INSPECTION

Application 553 Owner Southern Pacific Company  
Permit \_\_\_\_\_ Address 65 Market Street  
License 659 San Francisco, California 94105

Date of Inspection April 16, 1968 Inspected by D. J. Leve *A. J. Leve*  
Accompanied by Thomas C. Bridges, Water Supervisor (S.P. Co.), A. L. Severtson  
Persons interviewed (Mr. Bridges Ass't), Bob Bailiff (lessee of SP land), and Mr  
~~Reason for Inspection~~ Patrick Rogers, General Manager of the Cabazon County Water District  
Reason for inspection: No report of licensee

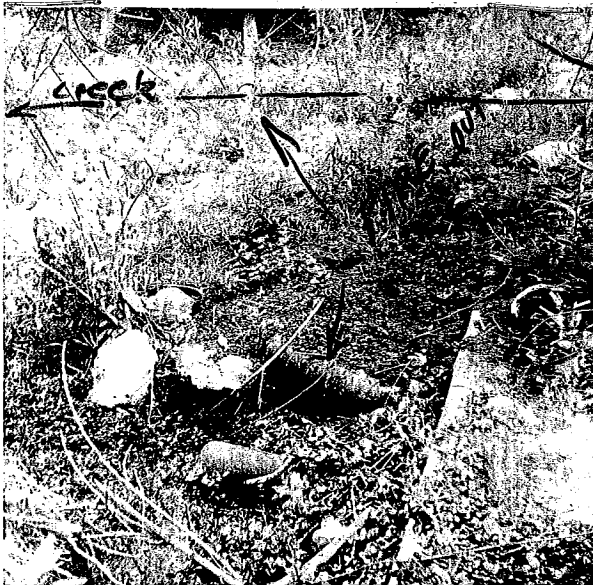
RJX. Photo 1

OLD EAST POINT (POD) ABD

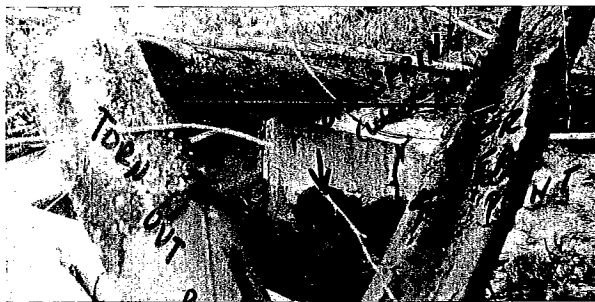
Photo 2

POD 4/16/68

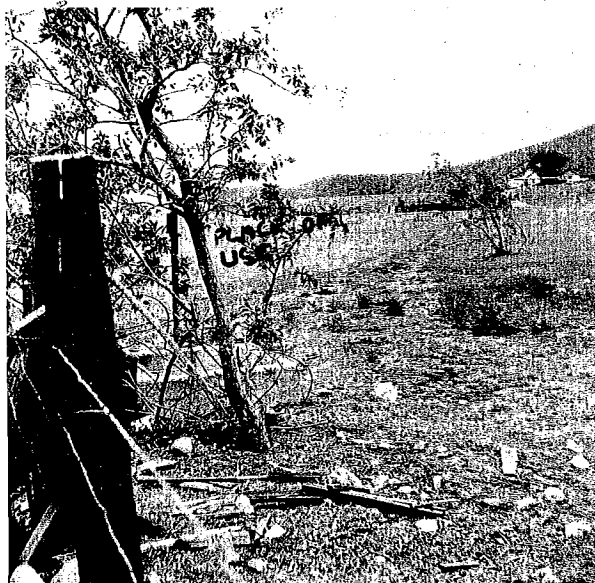
DIVERTING BOX (ABD) PLACE OF USE Photo 7

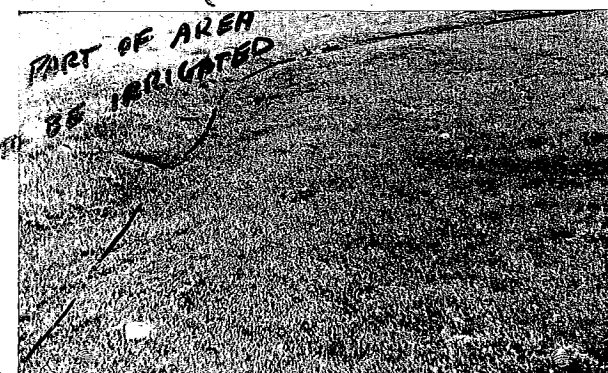
Irrig. ditch 5/6 Diverting Box. Photo 6

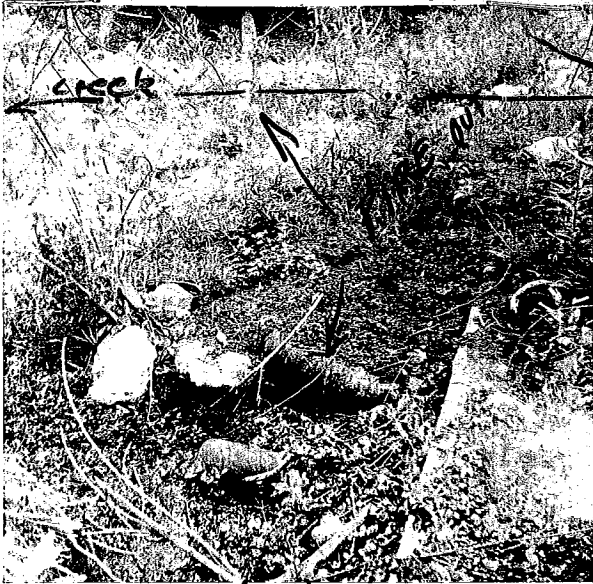
DLX. Photo 1

OLD EAST POINT (POD) ABD

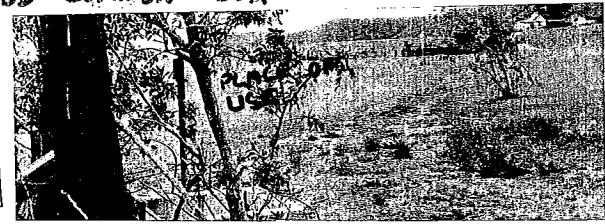
Domestic use (not licensed)

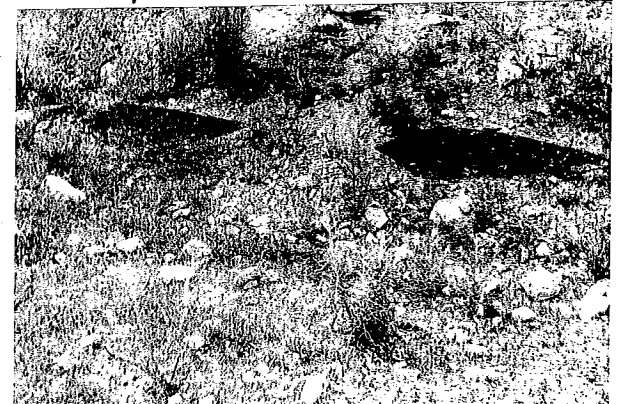
Photo 3

PORTION OF OLD LINE TORN OUT

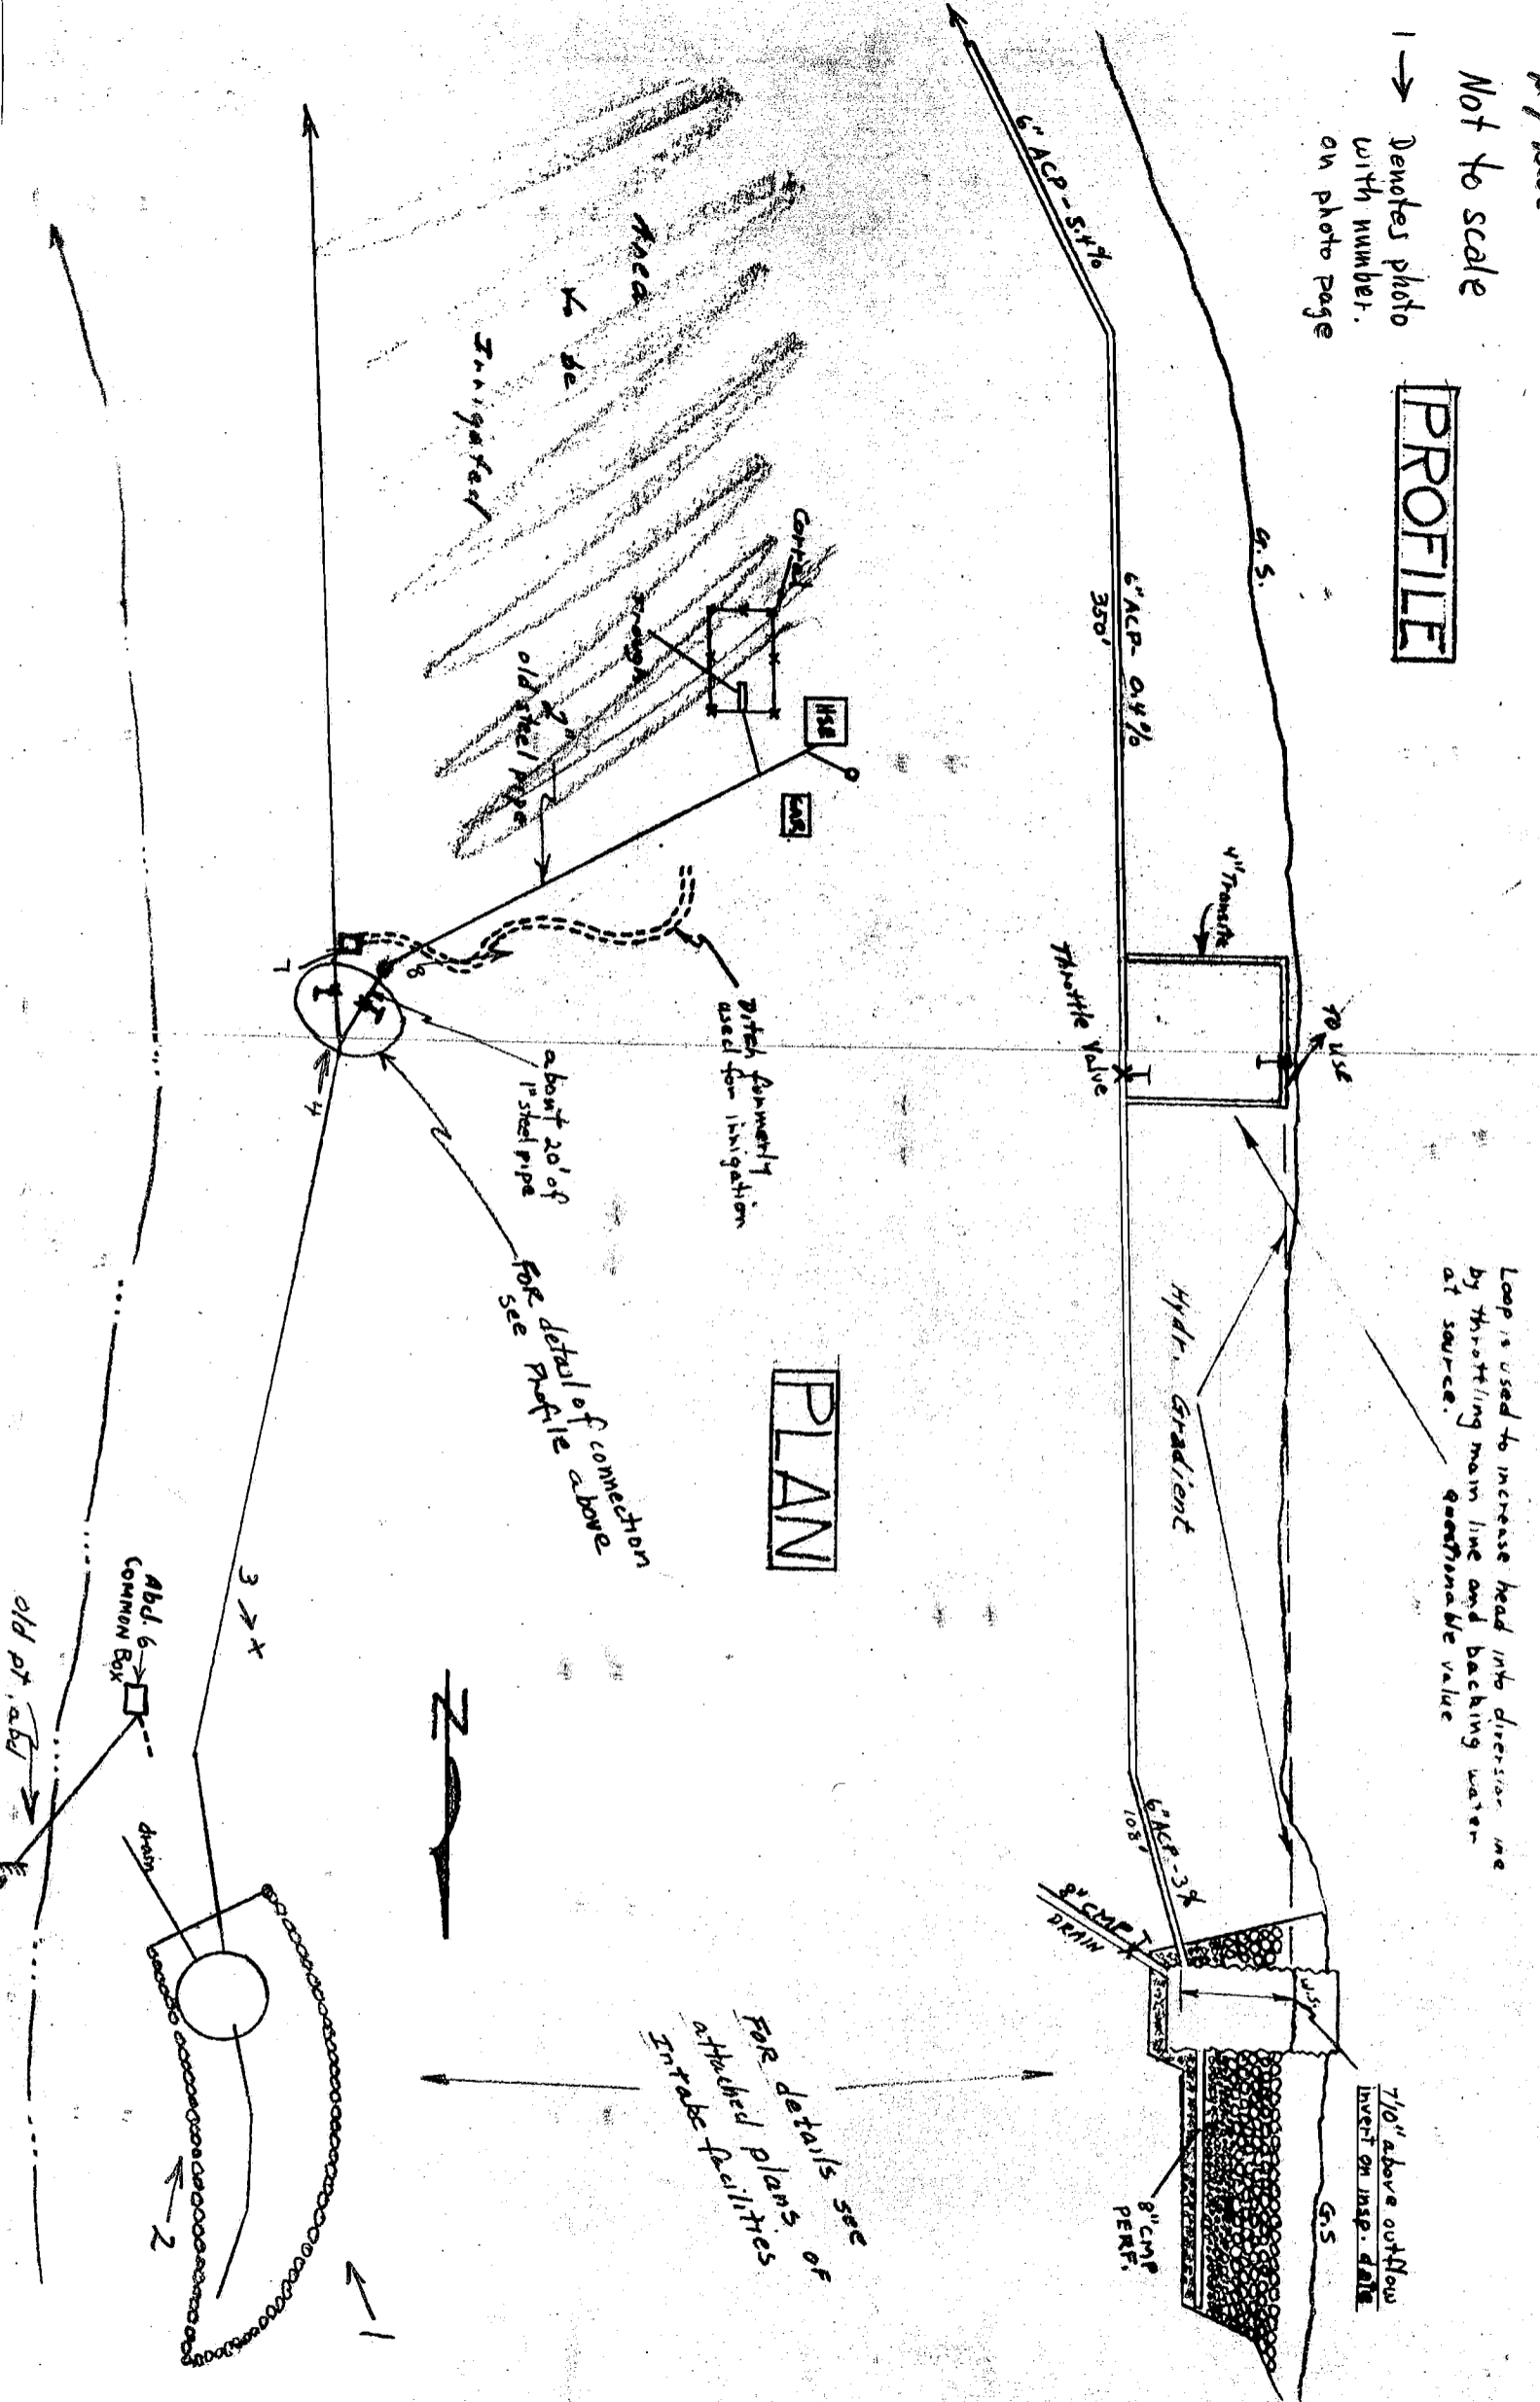
# PROFILE

Loop is used to increase head into direction in by throttling main line and backing water at source. *questionable value*

7/10" above outflow level on insp. data

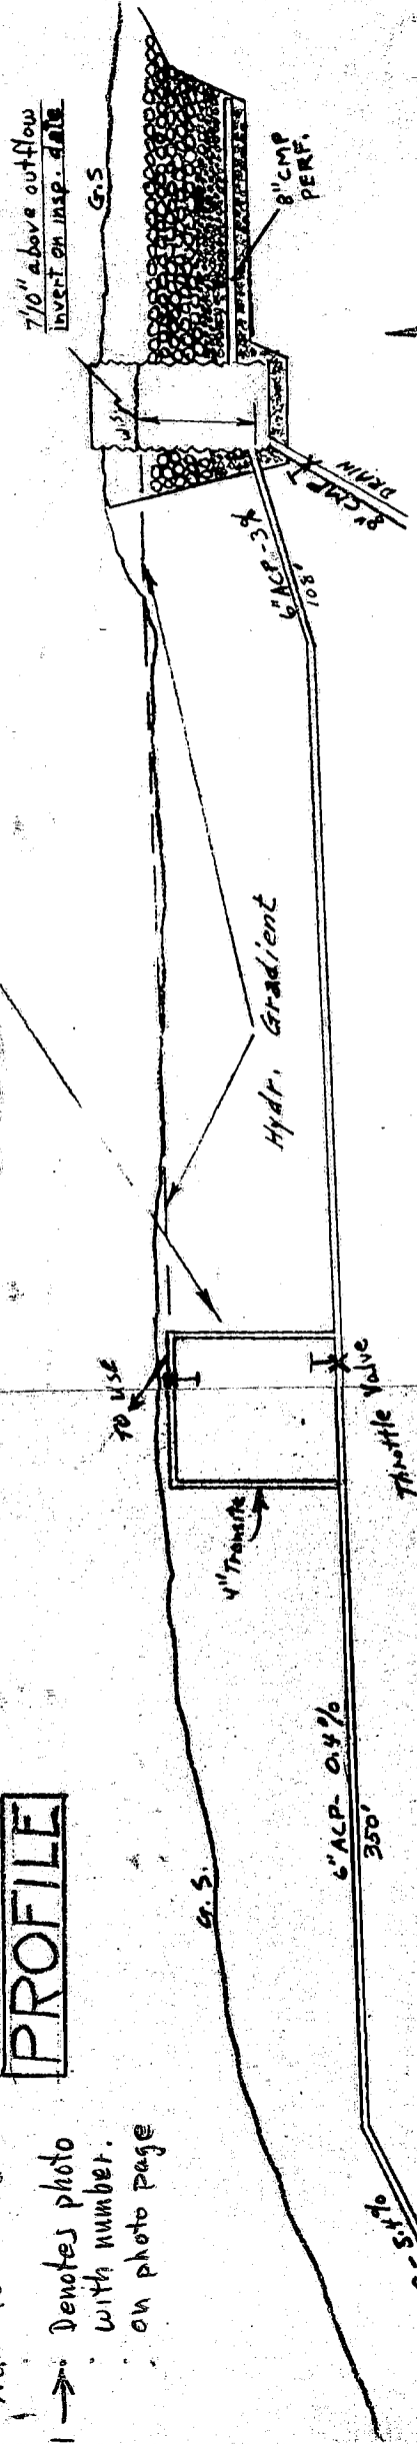
# PROFILE

Loop is used to increase head into diversion line by throttling main line and backing water at source.
