**DIVISION OF WATER RIGHTS
REPORT OF COMPLIANCE INSPECTION**

APPLICATION: 26224

PERMIT: 20035

LICENSE: 12831

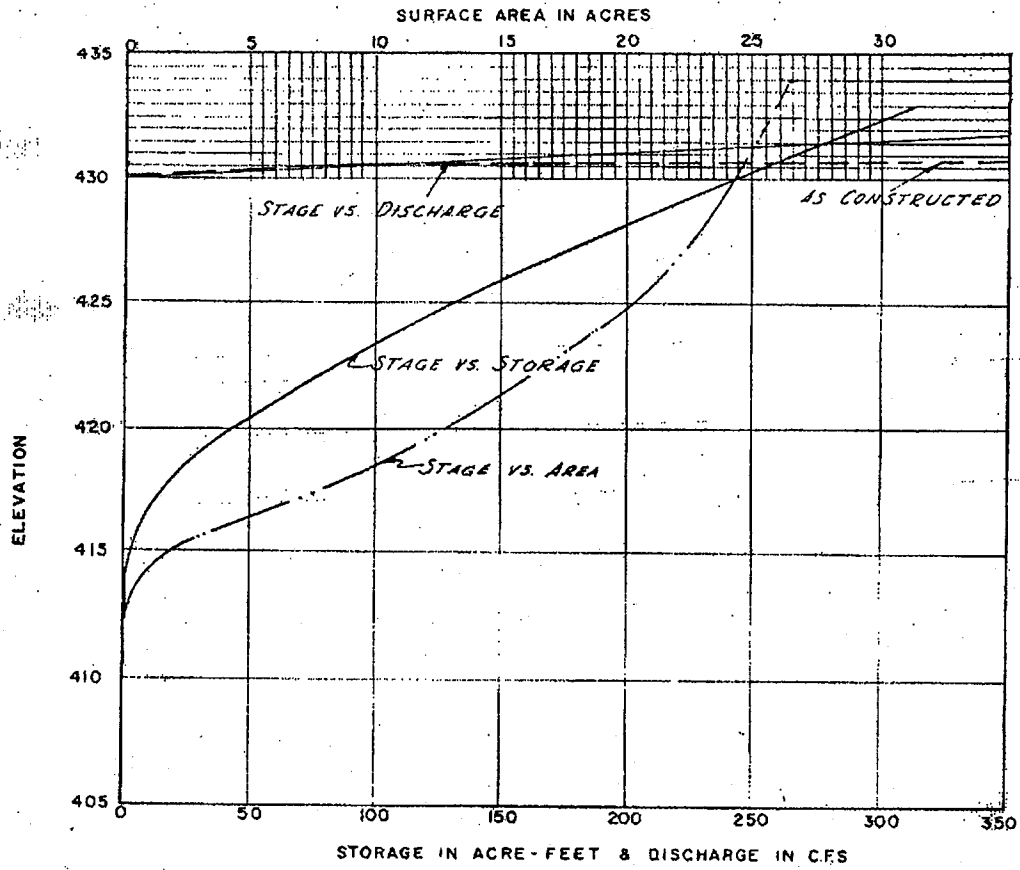
Capacity curve from "as-built" plan on file at the Division of Safety of Dams.

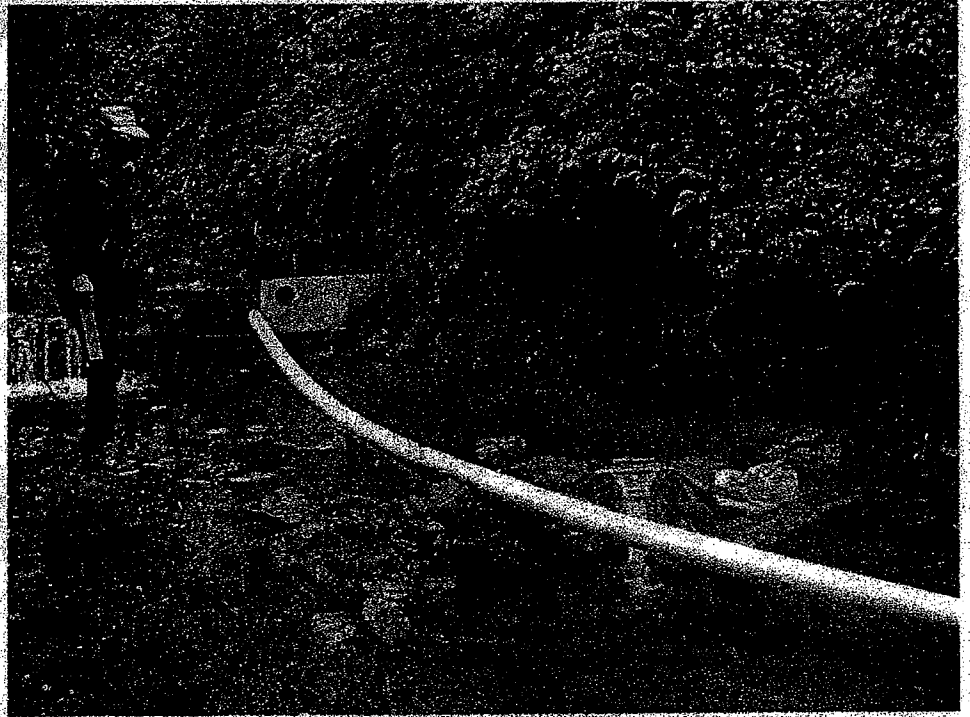
(3) The licensee must bypass a minimum flow of 0.4 cfs or the natural flow in Oak Flat Creek. During the inspection, flow immediately below the diversion dam was measured with a Montana flume. About half of the total flow could be diverted through the 3-inch flume resulting in 0.31 ft. depth of flow. This equals about 0.16 cfs. Although an exact measurement could not be obtained, it appeared that flow below the diversion dam was very close to the minimum of 0.4 cfs.

A fume was placed in the stream immediately below the POD to confirm compliance with the bypass. Due to the width of the stream, only a portion of the flow could be directed through the fume.

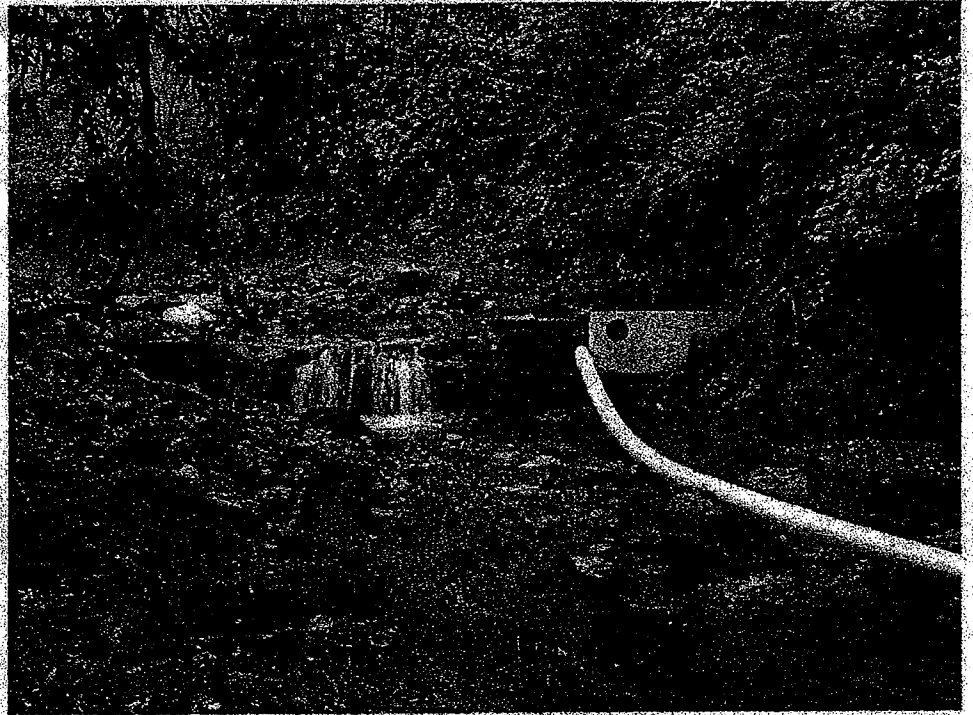
(2) The license is conditioned upon full compliance with Sections 1601, 1603, and/or Section 6100 of Fish and Game Code. The diversion dam on Oak Flat Creek would block fish during the diversion season if fish were present. During the application process the DF&G protested the application and resolved its protest by requiring a bypass flow and limiting the diversion season. The diversion pipe had a loose debris screen but no screen designed to prevent fish from entering the pipe.

Diversion dam and 4-inch PVC pipe at the point of diversion to offstream storage.

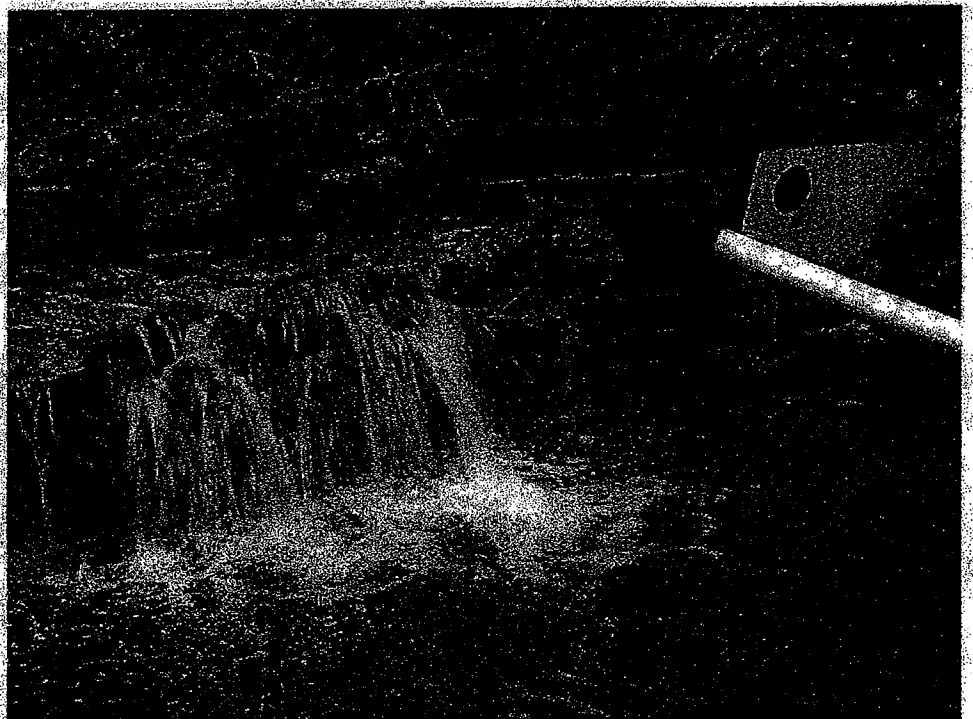
(4) The licensee is required to maintain a measuring device in Oak Flat Creek, capable of measuring the bypass requirement. No device was installed or evident nearby the diversion. A piece of the wooden device that was apparently installed for licensing appeared to be among the scraps of wood used to plug the slot in the diversion dam. The manager was not aware of the bypass requirement prior to the inspection. He has been the manager for about 2 years.

There was no measuring device at the point of diversion to verify the bypass. The gap in the structure was filled with wood pieces that appear to include the original measuring device.

The licensee should be required to have a new device designed and its installation certified by a registered engineer. The device needs to function without supervision due to the remote location of the diversion. The licensee should be advised that further diversions from Oak Flat Creek are subject to ACL and be given a time limit to comply.

A measuring device is required to monitor the bypass at the Oak Flat Creek diversion. The measuring device found at licensing has been removed as of an unknown date. The licensee should be advised to cease diversions from Oak Flat Creek until an approved device is installed. A registered engineer should design the new device.
