**DIVISION OF WATER RIGHTS  
REPORT OF COMPLIANCE INSPECTION**

**APPLICATION:** 26224

**LICENSE:** 12831

**Date of Inspection:** May 4 & 11, 2005

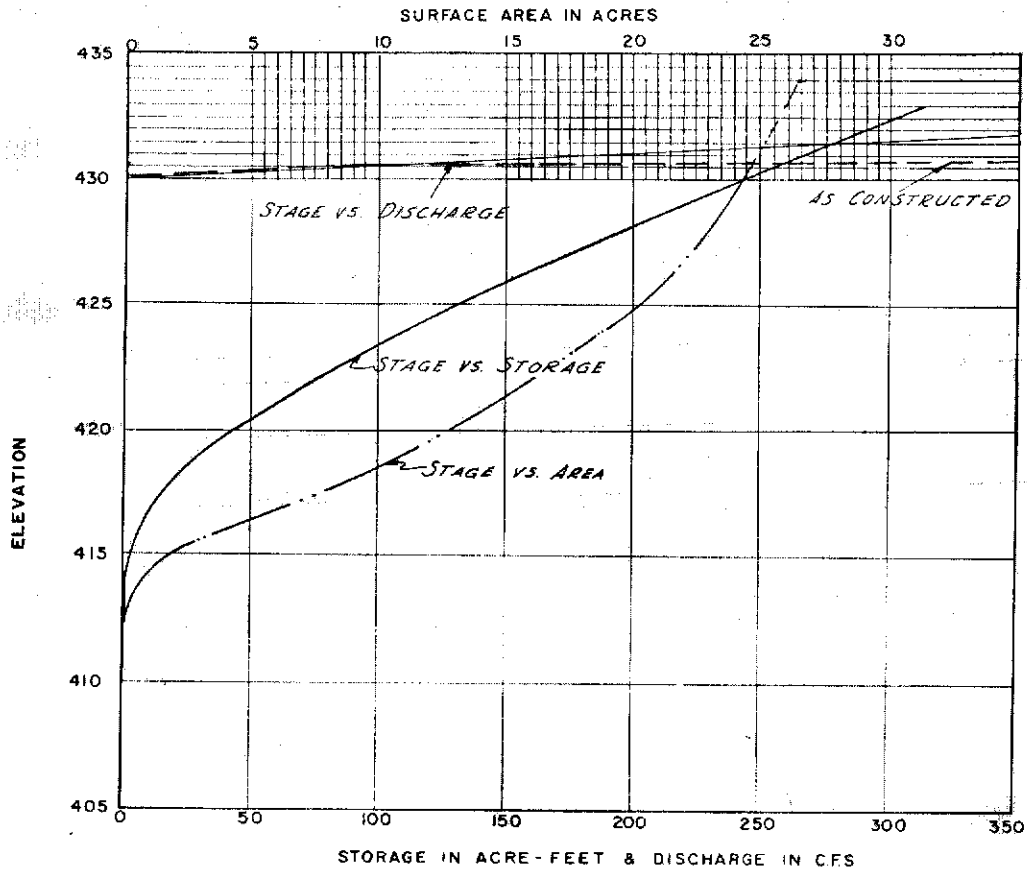
Based on the area capacity curve of the reservoir, a drawdown of 4 feet equals a withdrawal of 92 acre-feet. Average class A pan evaporation data is available for Geyserville from Bulletin 113-3. From October 1 to January 31 the total average evaporation is 7.61 inches and from February 1 to May 31 the amount is 25.68 inches. Assuming an average surface area during refill of 20 acres, evaporation of 7.61 inches is 12.7 ac-ft. When the reservoir is full (25 acre surface area) the evaporation from February 1 to May 31 would be about 53.5 ac-ft. **Therefore the total amount of water taken would be the refill of 92 acre-feet plus the evaporation of about 66 acre-feet for a total of 158 acre-feet.**

Capacity curve from "as-built" plan on file at the Division of Safety of Dams.

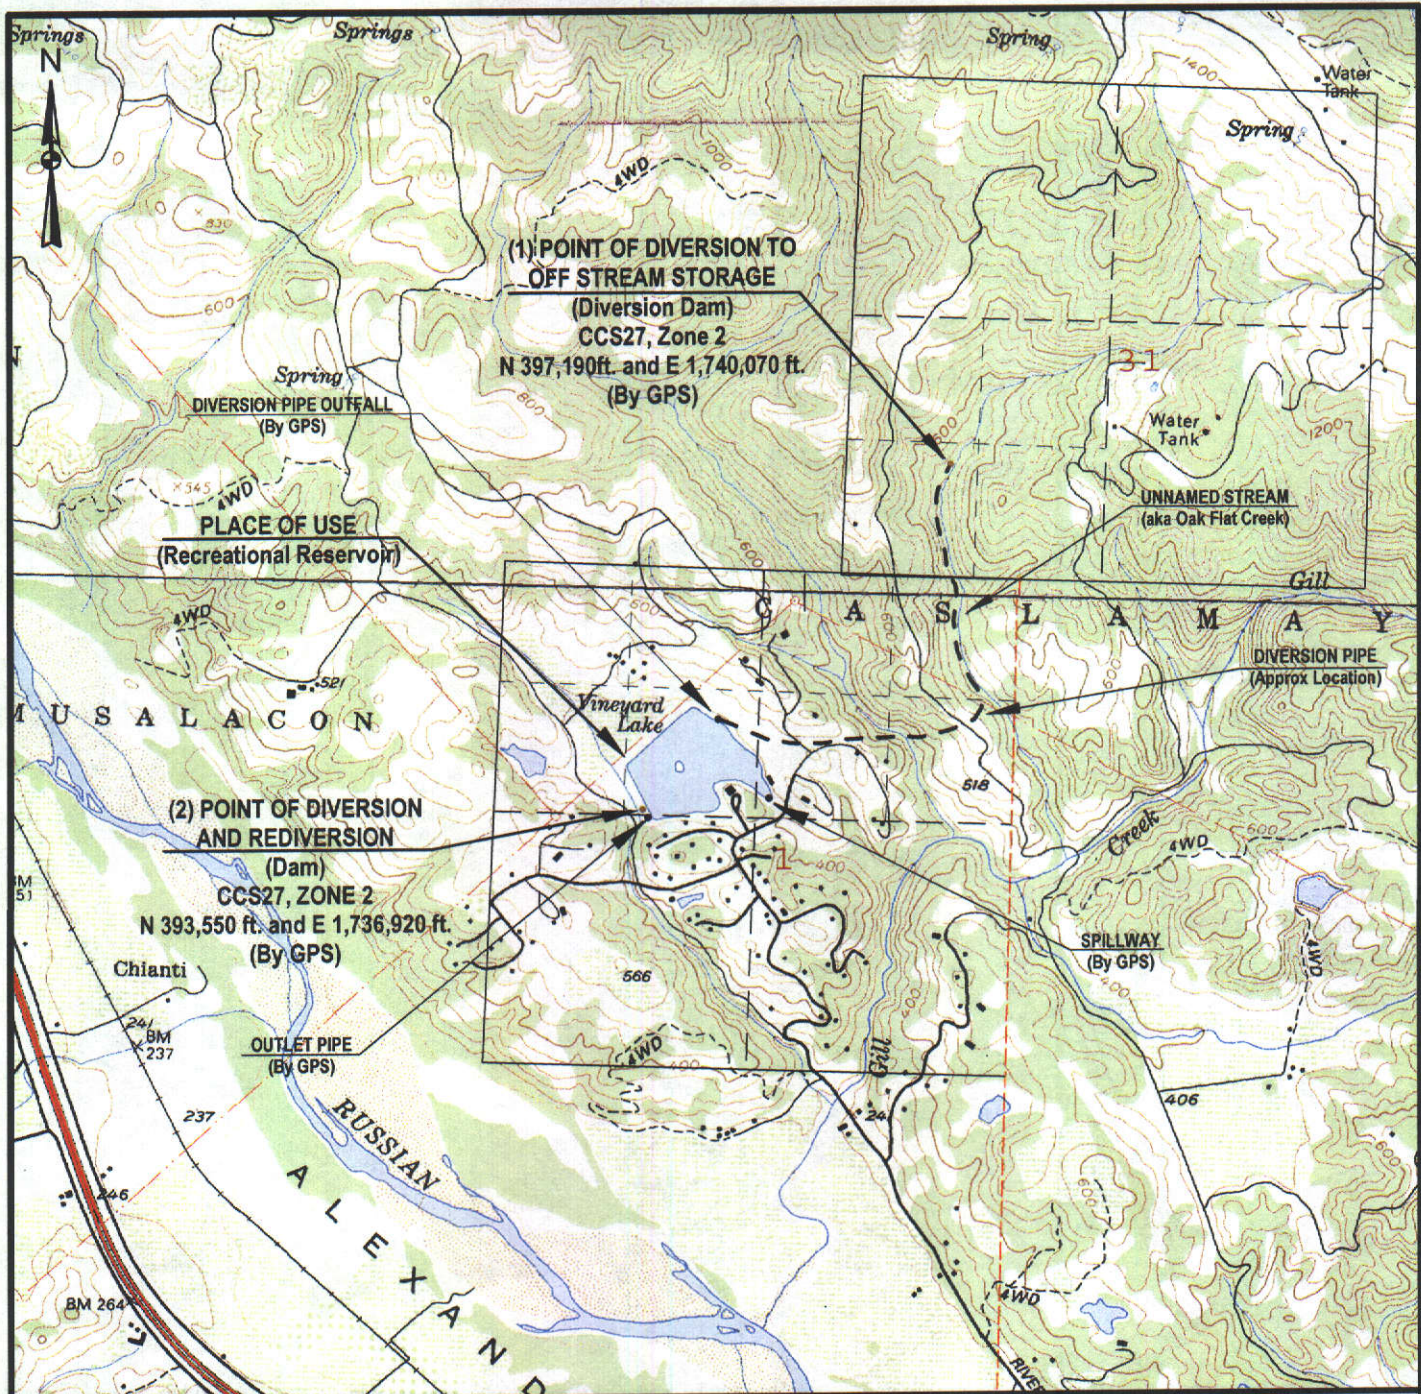
**COMPLIANCE**

The licensed coordinates and coordinates obtained by GPS are sufficiently close and indicate no changes. There is an error in the Township number for POD 1. It appears the description should be T11N instead of T10N, but this depends on how the sections are projected. However, if T10N is correct, the correct section would be 6 and not 31 as licensed. A licensed Land Surveyor prepared the project map and it indicates that POD 1 is in T11N. Another error is that POD 2 at the reservoir is listed as only a point of diversion. It should also be a point of rediversion for water diverted from Oak Flat Creek at POD 1.

Recommend these changes be incorporated in any amended license issued in the future.

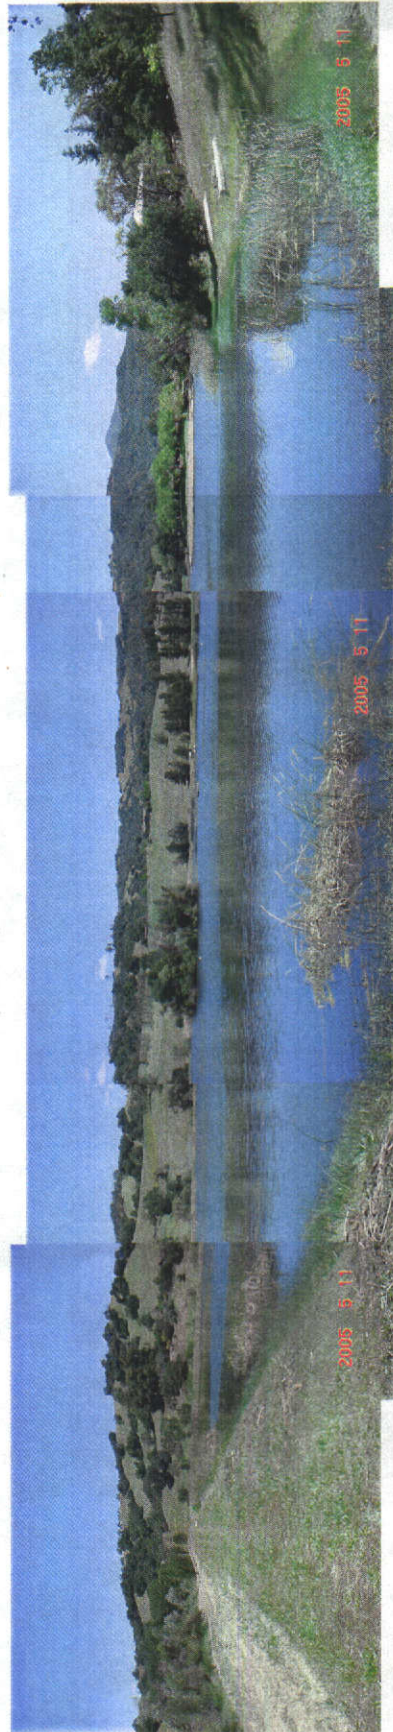
Vineyard Club Lake looking north east from south west corner.

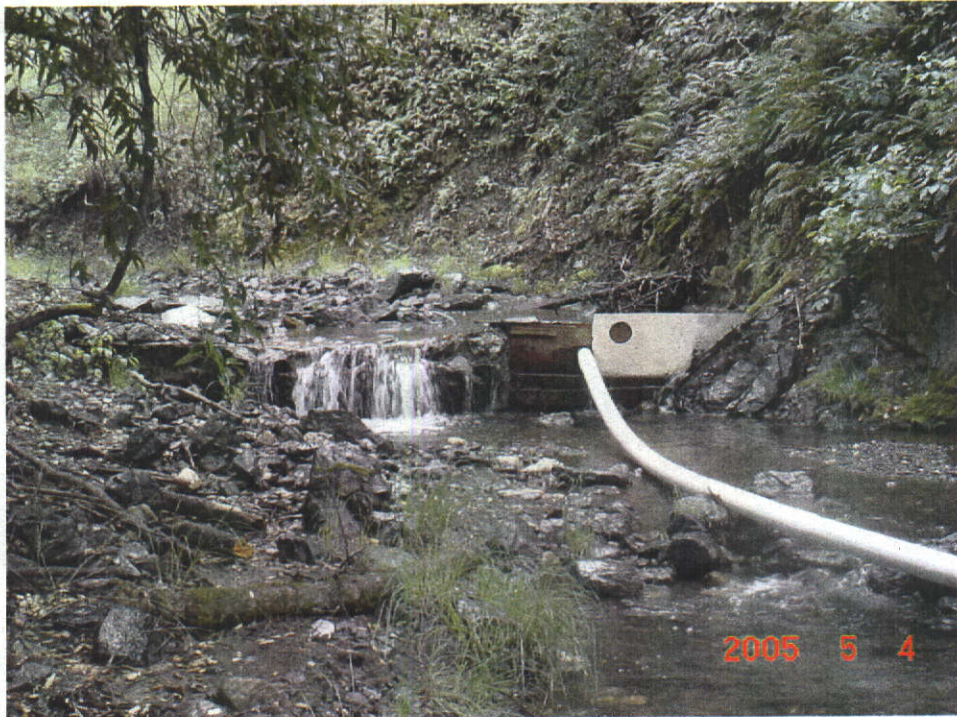
Diversion dam and 4-inch PVC pipe at the point of diversion to offstream storage.

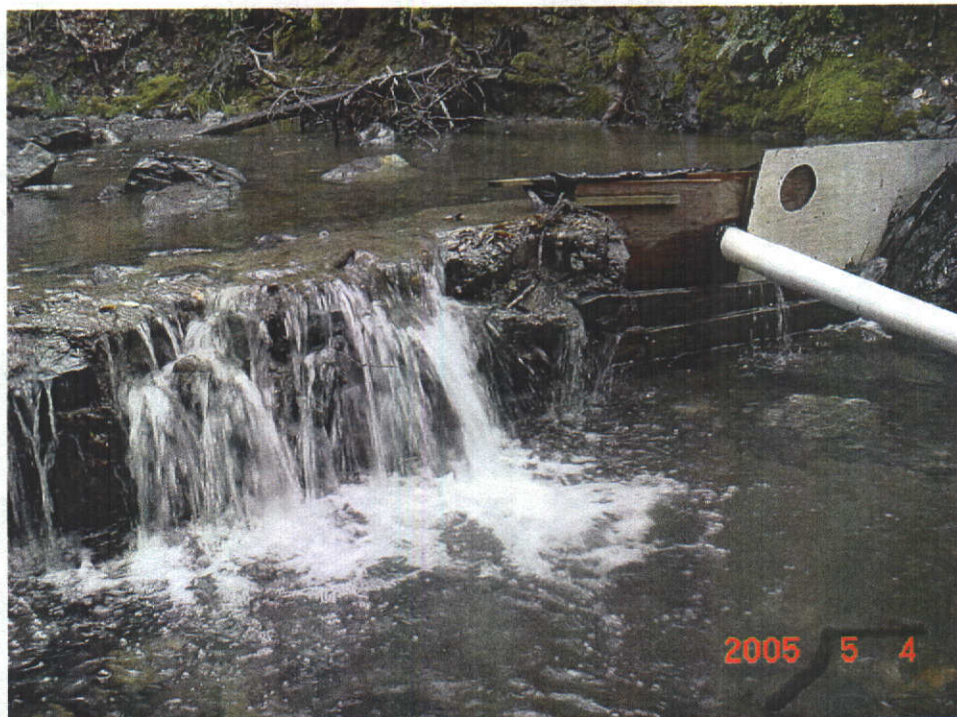
(4) The licensee is required to maintain a measuring device in Oak Flat Creek, capable of measuring the bypass requirement. No device was installed or evident nearby the diversion. A piece of the wooden device that was apparently installed for licensing appeared to be among the scraps of wood used to plug the slot in the diversion dam. The manager was not aware of the bypass requirement prior to the inspection. He has been the manager for about 2 years.

A measuring device is required to monitor the bypass at the Oak Flat Creek diversion. The measuring device found at licensing has been removed as of an unknown date. The licensee should be advised to cease diversions from Oak Flat Creek until an approved device is installed. A registered engineer should design the new device.

There was no measuring device at the point of diversion to verify the bypass. The gap in the diversion dam is filled with wood scraps that appear to include the original measuring device.

The licensee should be required to have a new device designed and its installation certified by a registered engineer. The device needs to function without supervision due to the remote location of the diversion. The licensee should be advised that further diversions from Oak Flat Creek are subject to ACL and be given a time limit to comply.

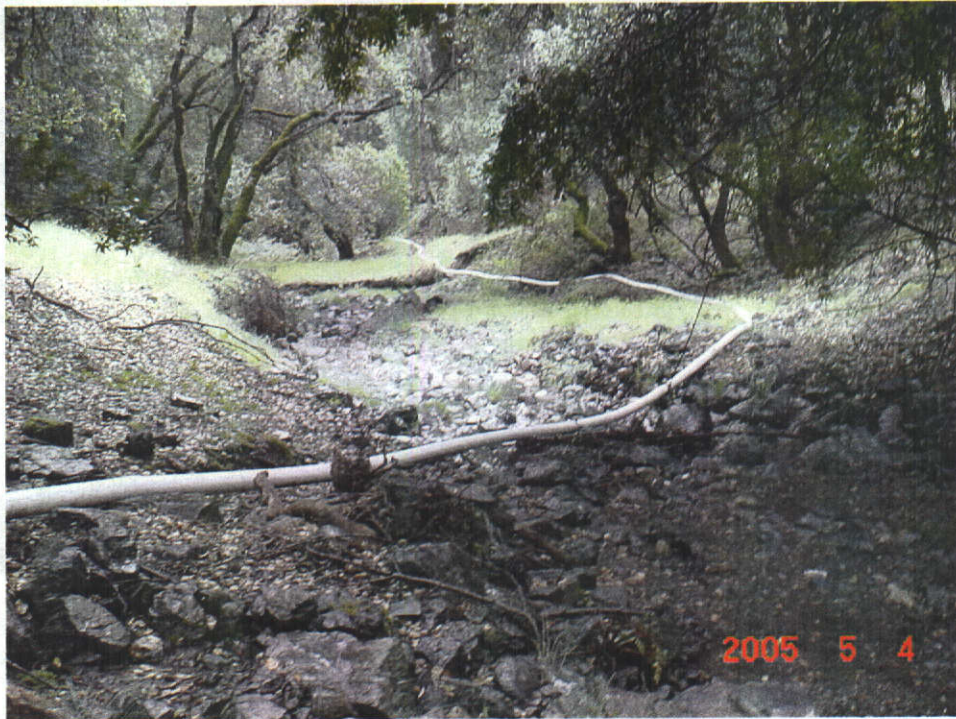
This photograph shows the 4-inch PVC pipe in the streambed immediately below the POD.

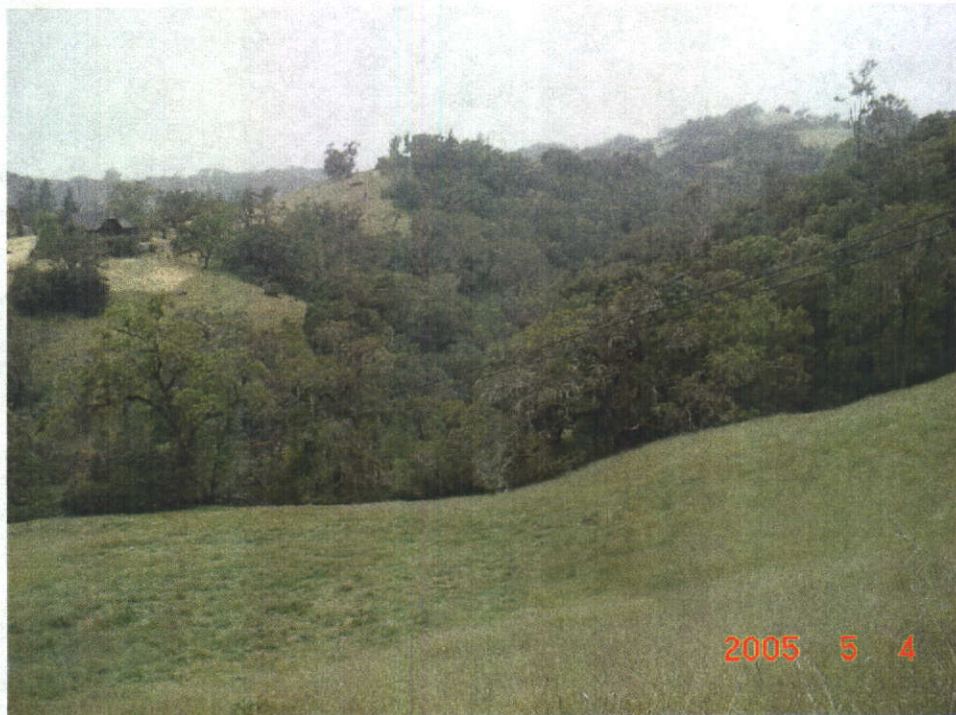
The diversion pipeline crosses this ravine between Oak Creek and the reservoir.

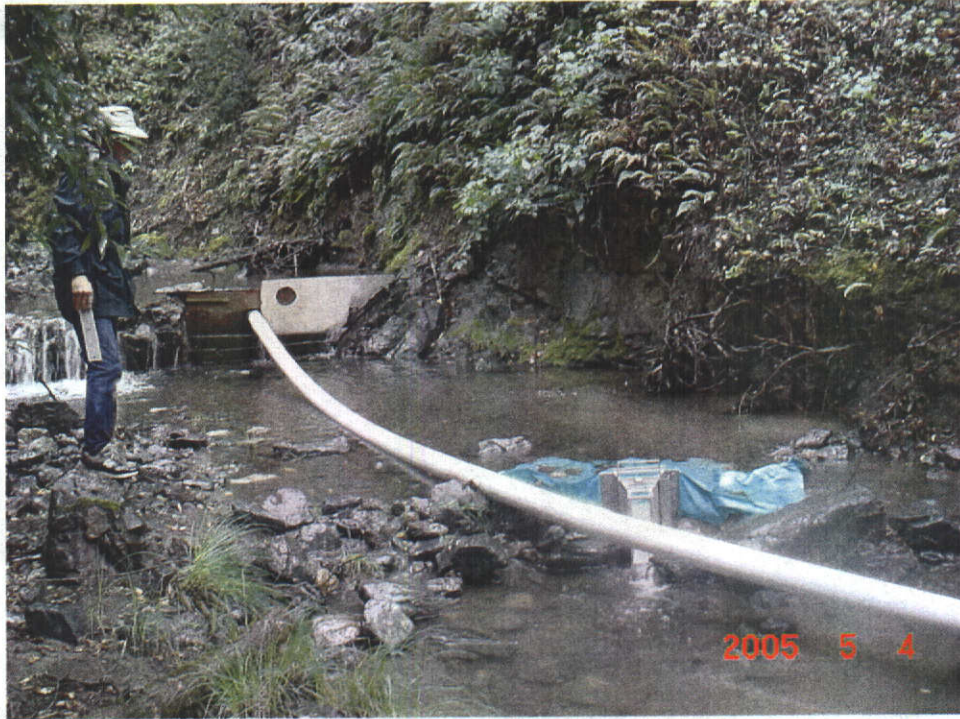
(3) The licensee must bypass a minimum flow of 0.4 cfs or the natural flow in Oak Flat Creek. During the inspection, flow immediately below the diversion dam was measured with a Montana flume. About half of the total flow could be diverted through the 3-inch flume resulting in 0.31 ft. depth of flow. This equals about 0.16 cfs. Although an exact measurement could not be obtained, it appeared that flow below the diversion dam was very close to the minimum of 0.4 cfs.

A flume was placed in the stream immediately below the POD to confirm compliance with the bypass. Due to the width of the stream, only a portion of the flow could be directed through the flume.

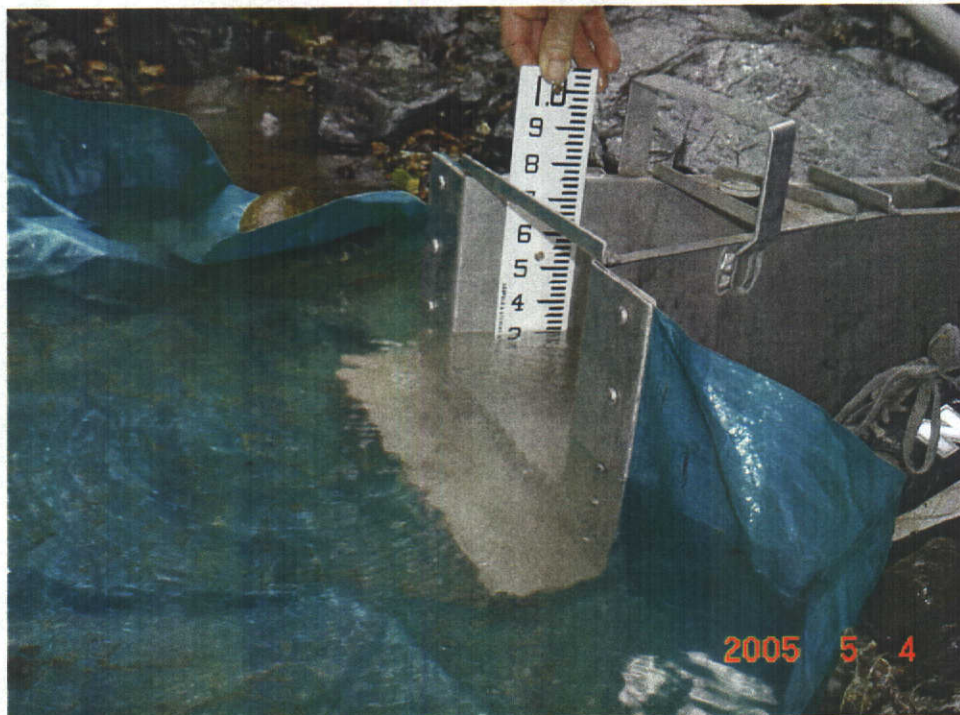
The depth of flow in the 3-inch Montana flume was 0.31 ft. This corresponds to about 0.16 cfs. It appeared that about 50% of the total streamflow was directed through the flume.

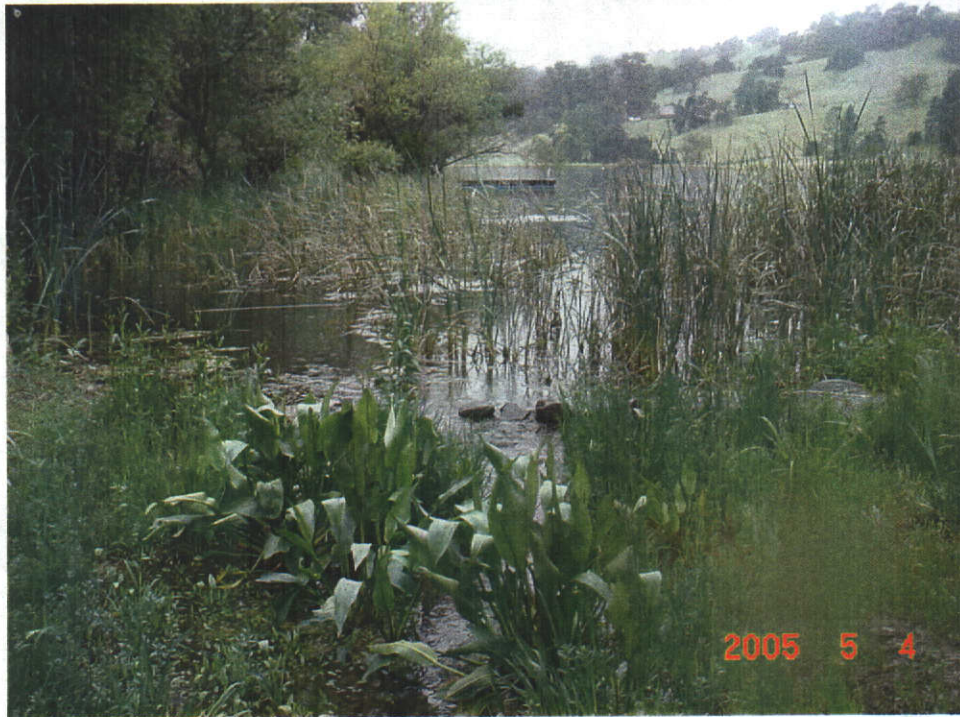
This photograph shows the spillway at the south eastern corner of the reservoir.

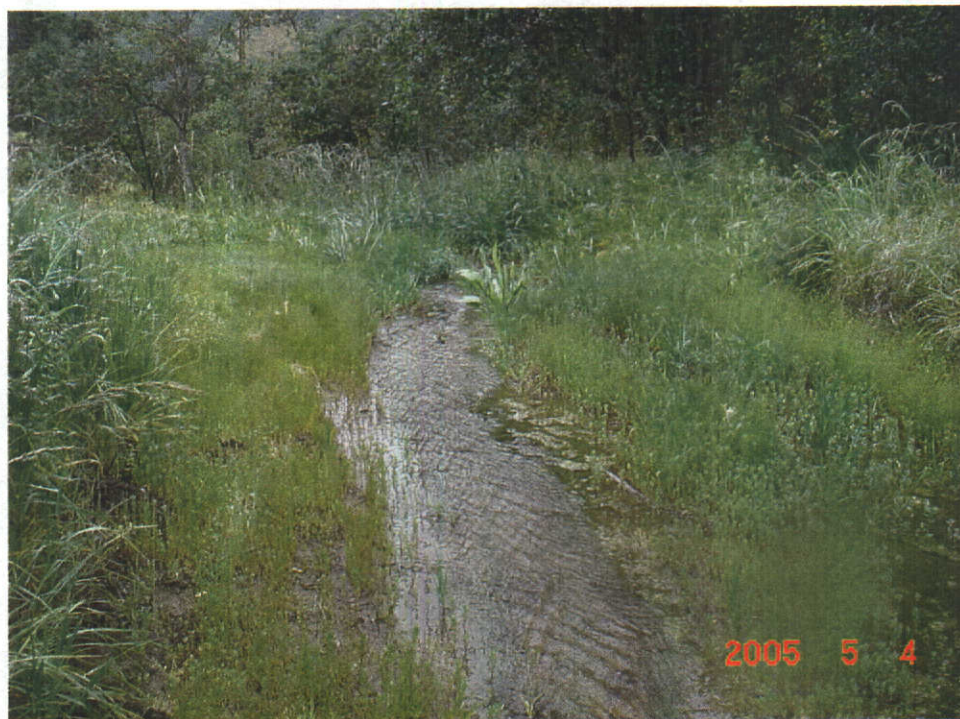
View of flow out the spillway looking downstream. The flow was not measured but appeared to be less than the inflow from the diversion pipe.

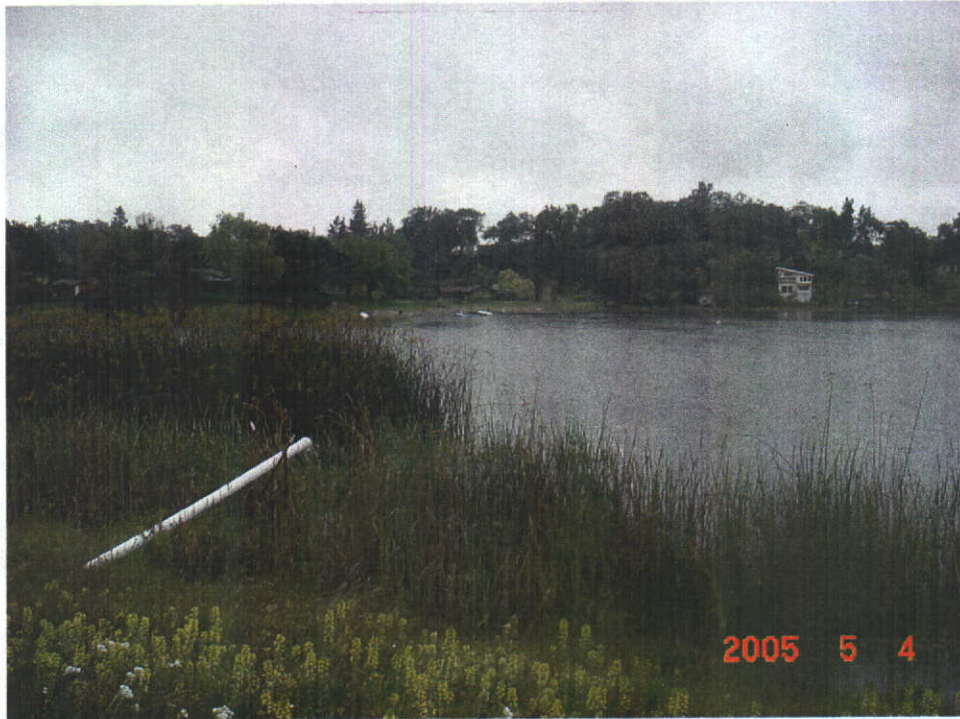
This photograph shows the outlet of the diversion pipe at the reservoir.

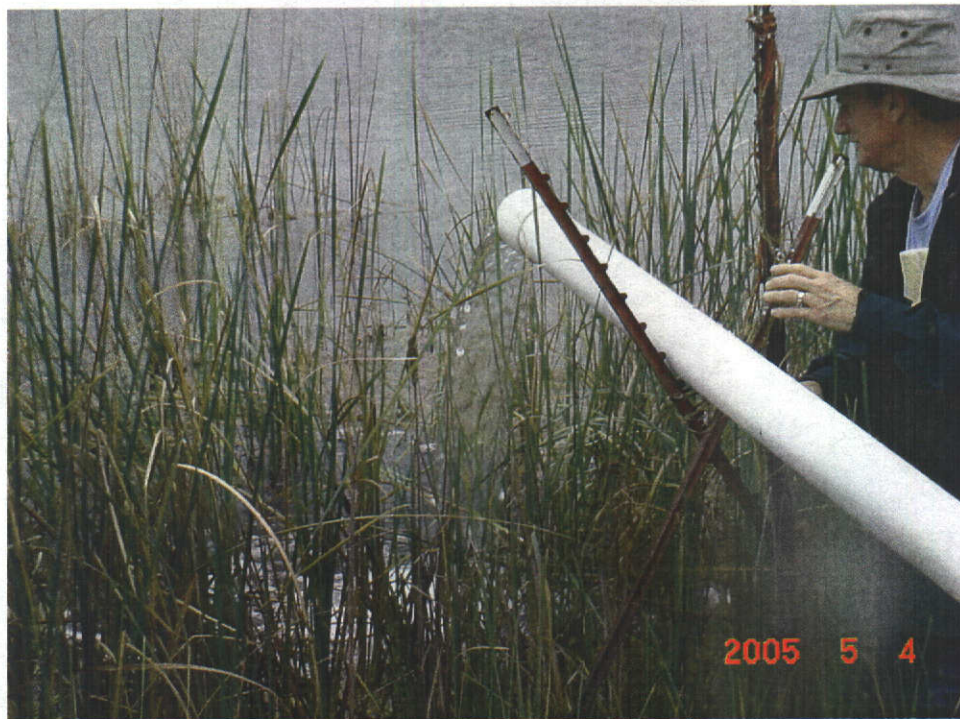
The diversion pipe was filling the lake at about 60 gallons per minute (about 0.13 cfs) based on measurements with a bucket and watch at the diversion pipe's outfall into the lake. This appears to be the maximum diversion rate since the pipe elevation cannot change and the head over the pipe inlet was at the maximum possible given the height of the diversion structure.

With the assistance of the property manager, the flow was measured using a watch and a 2-gallon bucket. The flow filled the bucket in 2 seconds and was therefore about 60 gallons per minute.

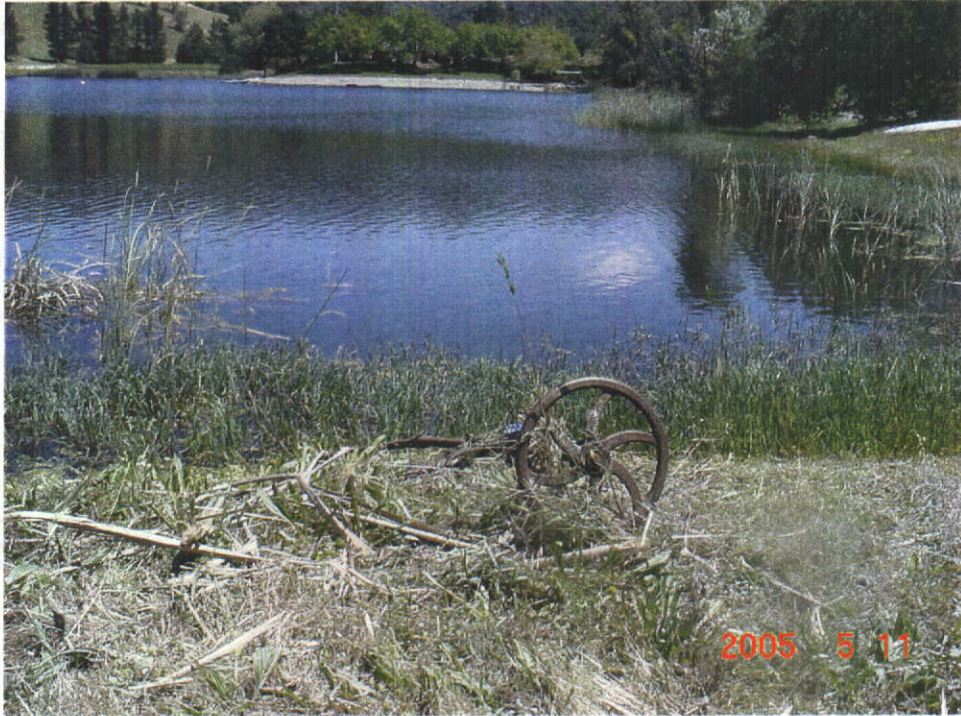
Outlet valve control handle at south west corner of lake.

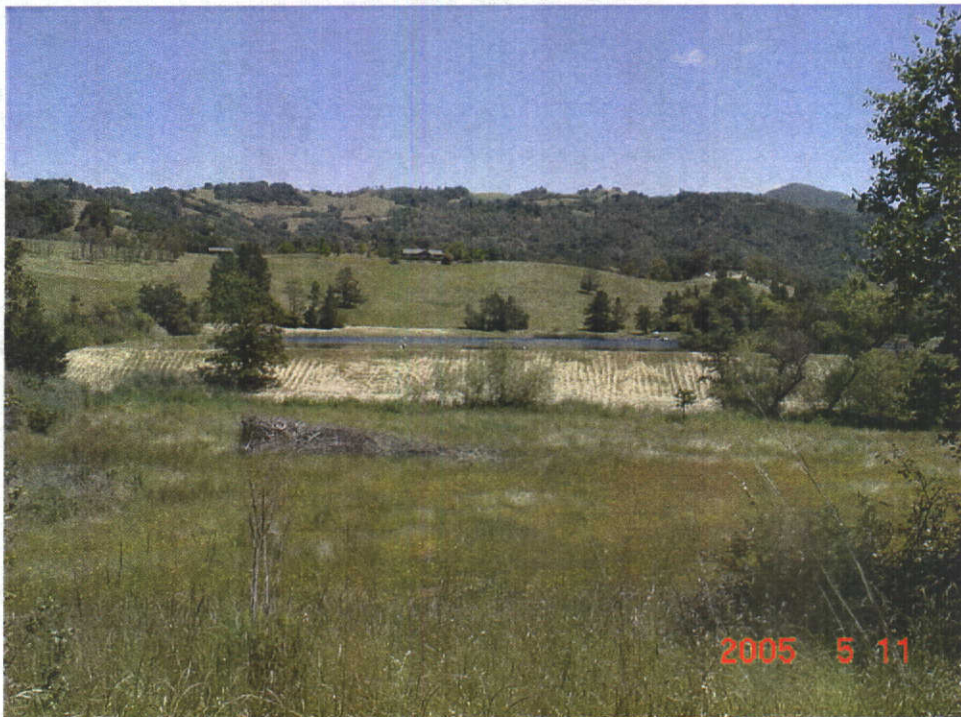
Overall view of the reservoir looking north east from River Road.
