SITE PHOTOGRAPHS (1 of 2) FIGURE 1

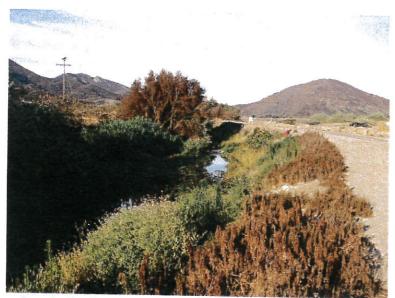
a. Conejo Creek at Camarillo WRP, facing downstream

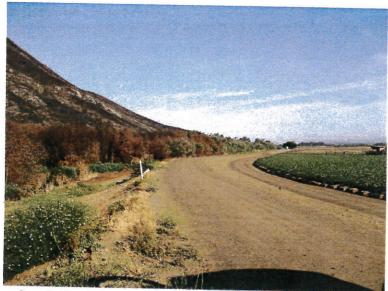
c. Conejo Creek downstream of Pancho Road, note burned trees

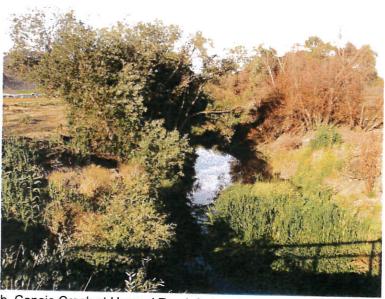
b. Conejo Creek at Howard Road, facing downstream

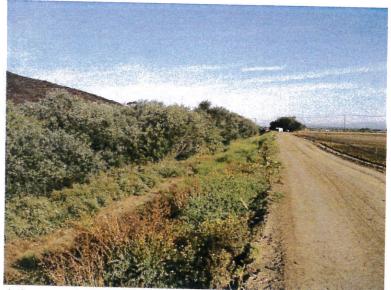
d. Conejo Creek downstream of Pancho Road

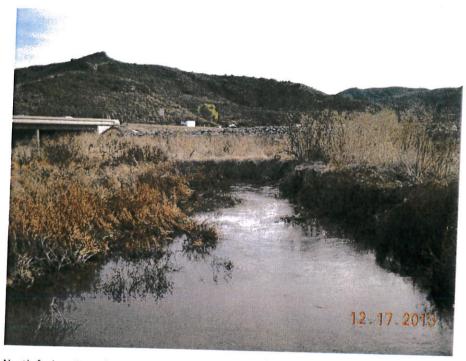
Photo 1. North facing view of Conejo Creek downstream of the Highway 101 Bridge showing creek flows approximately 15 feet wide and one to two feet deep. View facing upstream

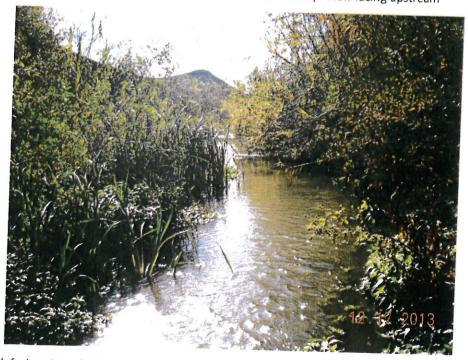
Photo 2. South facing view of Calleguas Creek downstream of Conejo Creek showing creek flows approximately 15 feet wide and one to two feet deep; View facing downstream

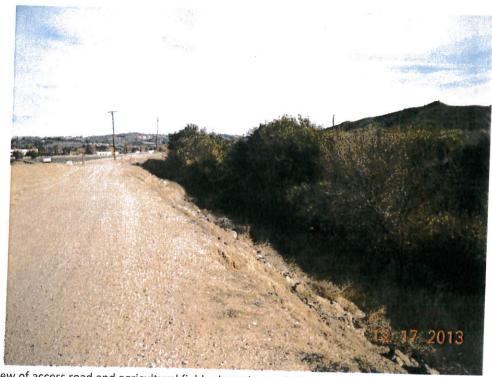
Photo 5. View of access road and agricultural fields along the north bank and riparian zone along the south bank of Conejo Creek upstream of the CWRP. View looking upstream

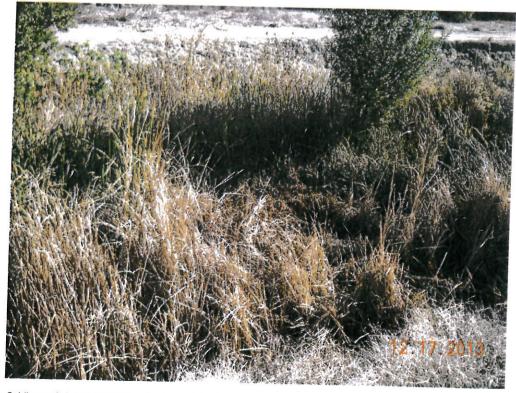
Photo 6. View of the Conejo Creek channel in the upstream section of the survey reach showing the channel completely overgrown with vegetation.

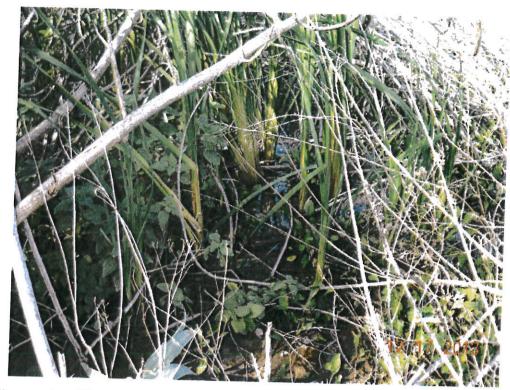
Photo 9. Close-up view of Conejo Creek Channel in an area overgrown with wetland vegetation and depths of one to two inches, which would be an impediment to fish migration

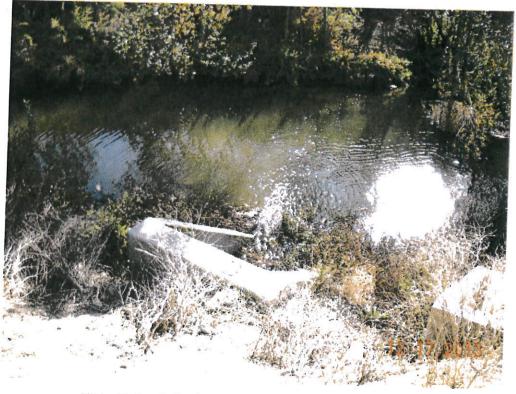
Photo 10. Conejo Creek at the effluent release point of the CWRP

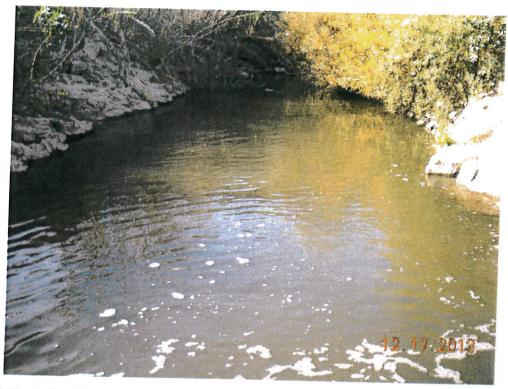
Photo 13. Conejo Creek downstream of the Pancho Road Bridge showing the deep pool below the grade control structure and debris jam. Note high tubidity

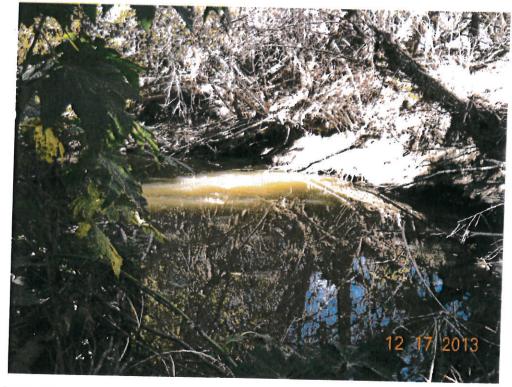
Photo 14. Conejo Creek downstream of the Pancho Road Bridge near the confluence with Calleguas Creek. Note high turbidity, and stagnant slow-moving creek flow

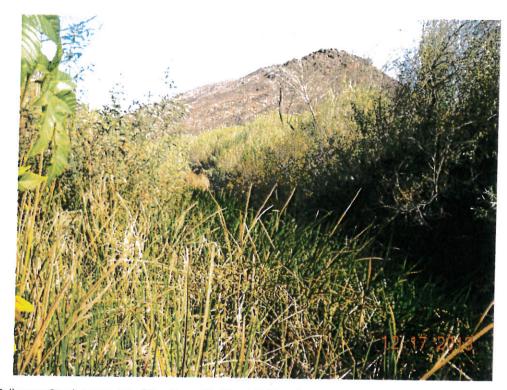
Photo 17. Calleguas Creek upstream of the Camarillo Street Bridge showing wide riparian zone with willow species and cattails.

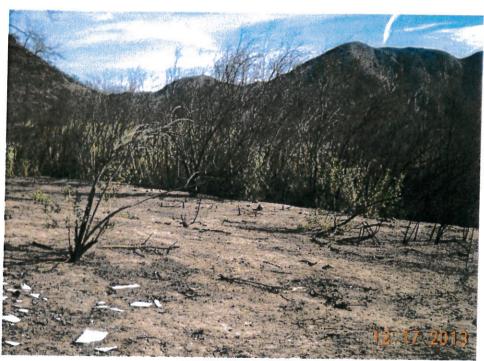
Photo 18. Calleguas Creek downstream of the confluence with Conejo Creek showing willow riparian vegetation burnt by the Springs Fire of 2013, and rapid recolonization by *Arundo* along the creek

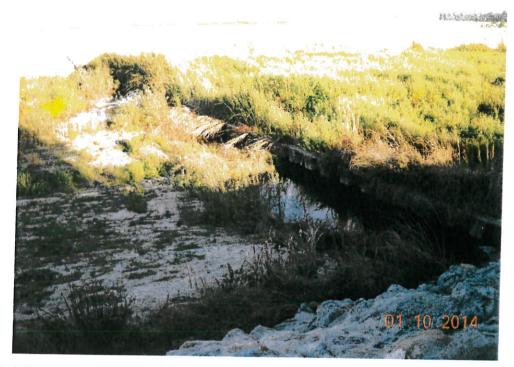
Photo 21. Calleguas Creek downstream of the Old Lewis Road Bridge showing grade control structure that is a fish migration impediment

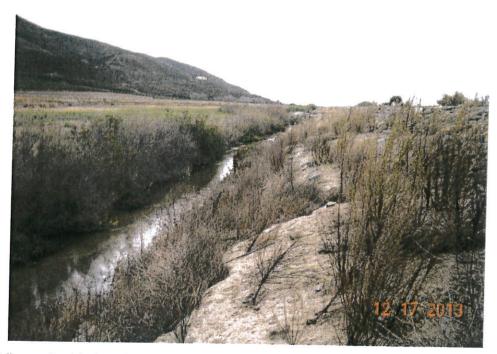
Photo 22. Calleguas Creek looking downstream towards the State Route 1 Bridge showing shallow slow-moving flows and fine sandy substrate
