**SHR-20****Statement of Verification of Data Contained Within this Document**

Screen prints of reference maps regarding Water Quality Concerns: Arsenic, Mercury, Selenium, and more. Online location of map shows in the screen print for each map.

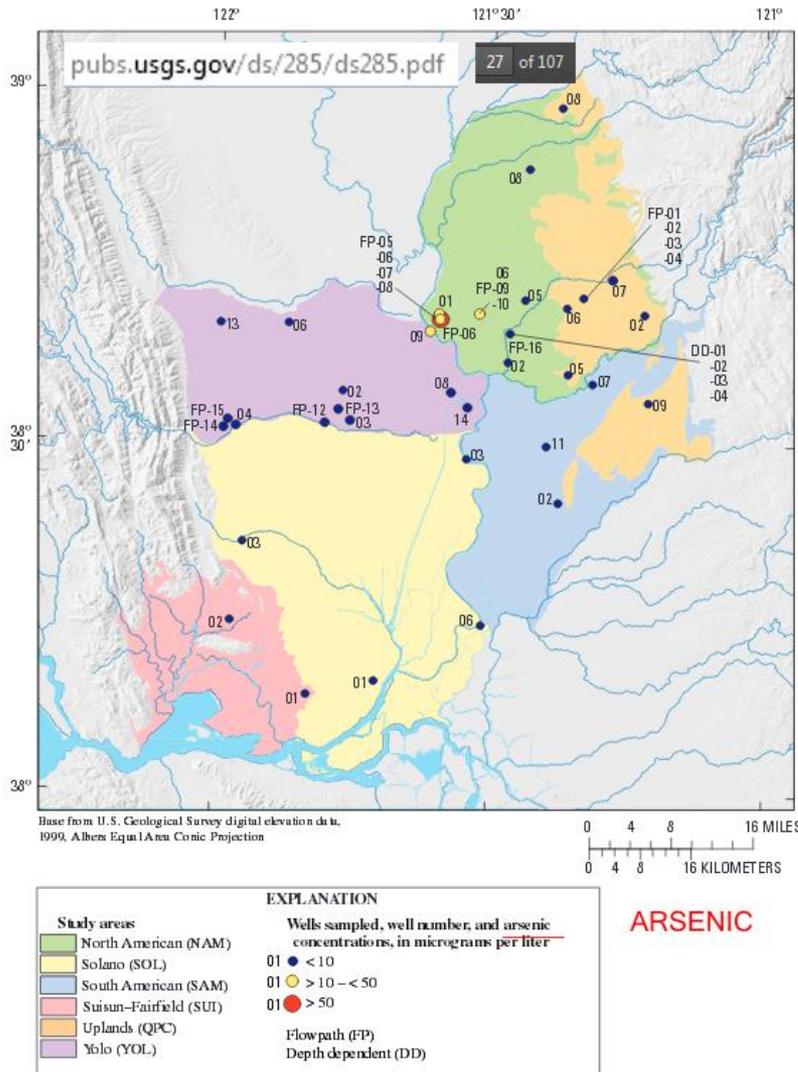
**Figure 5** Arsenic concentrations in ground water in the study areas of the Southern Sacramento Valley Ground-Water Ambient Monitoring and Assessment (GAMA) study unit.

In the 2005 USGS report, wells tested in and around the Delta region resulted in arsenic below the MCL of 10 ppb, as shown on the map to the left

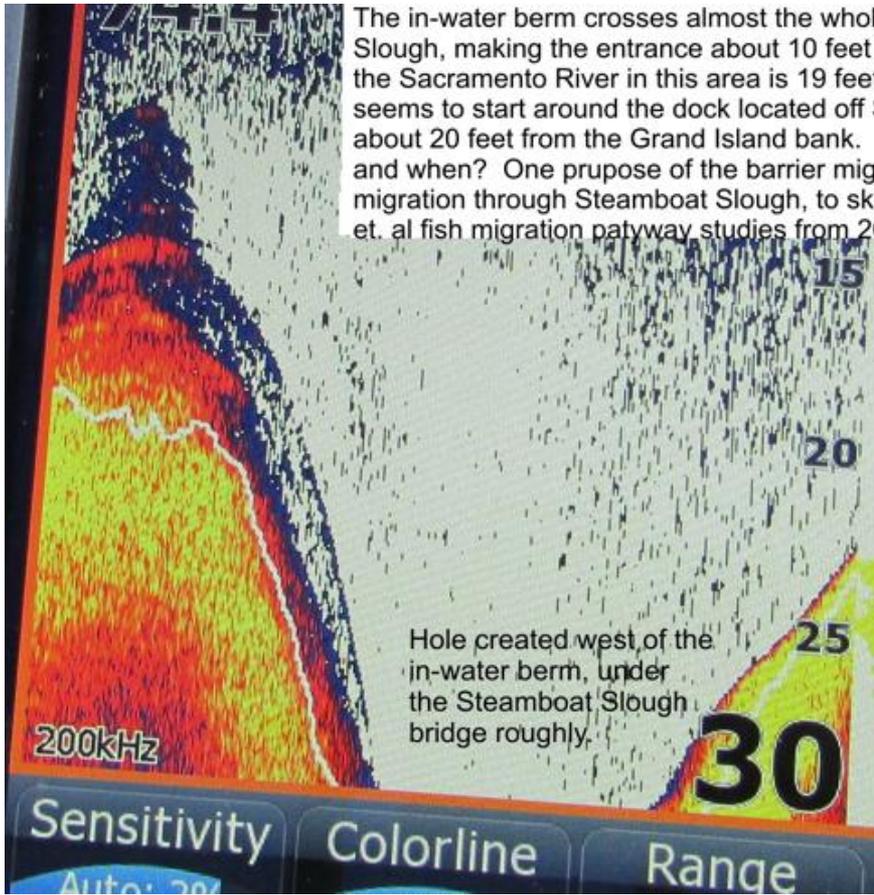
The in-water berm crosses almost the whole entrance to Steamboat Slough, making the entrance about 10 feet deep at low tide, while the Sacramento River in this area is 19 feet or deeper. The berm seems to start around the dock located off Sutter Island, and stop about 20 feet from the Grand Island bank. Who installed this berm and when? One purpose of the barrier might be to block salmon migration through Steamboat Slough, to skew the data of the Perry et. al fish migration pathway studies from 2006 to 2012.

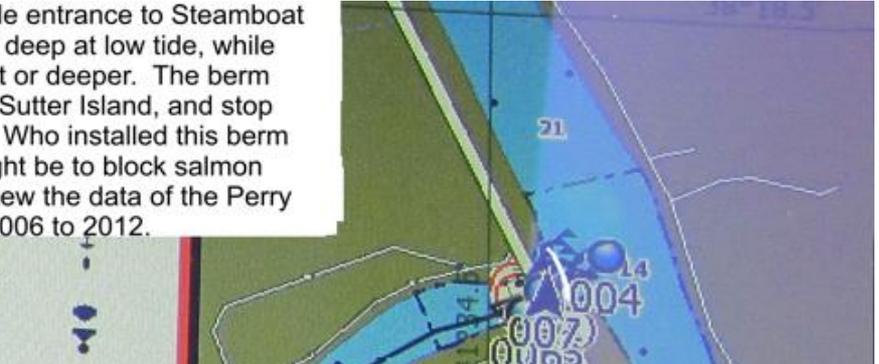
Hole created west of the in-water berm, under the Steamboat Slough bridge roughly.

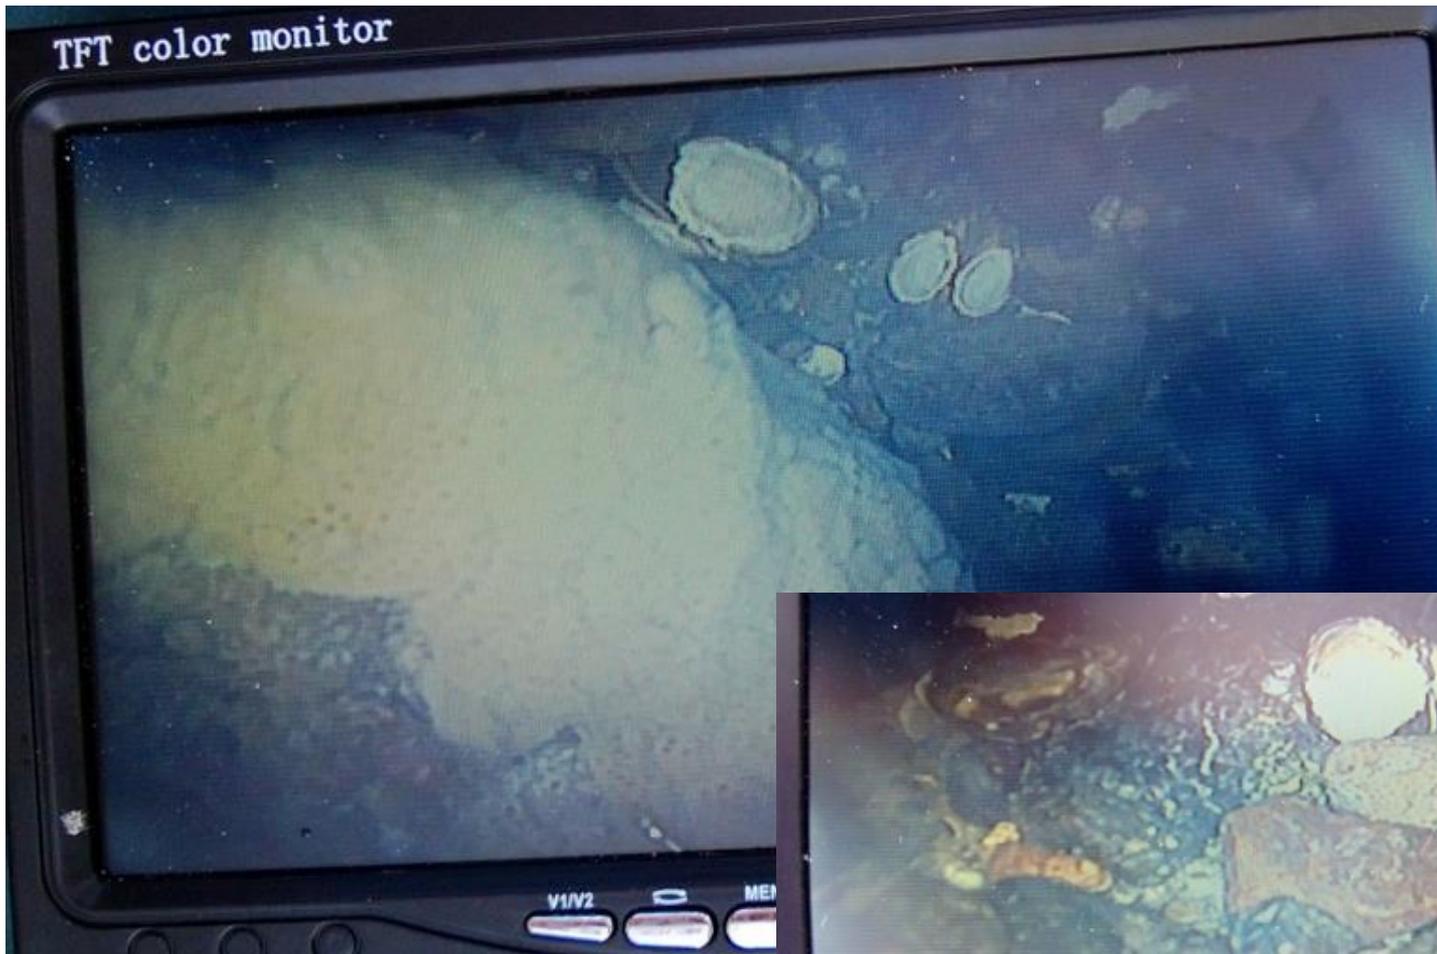
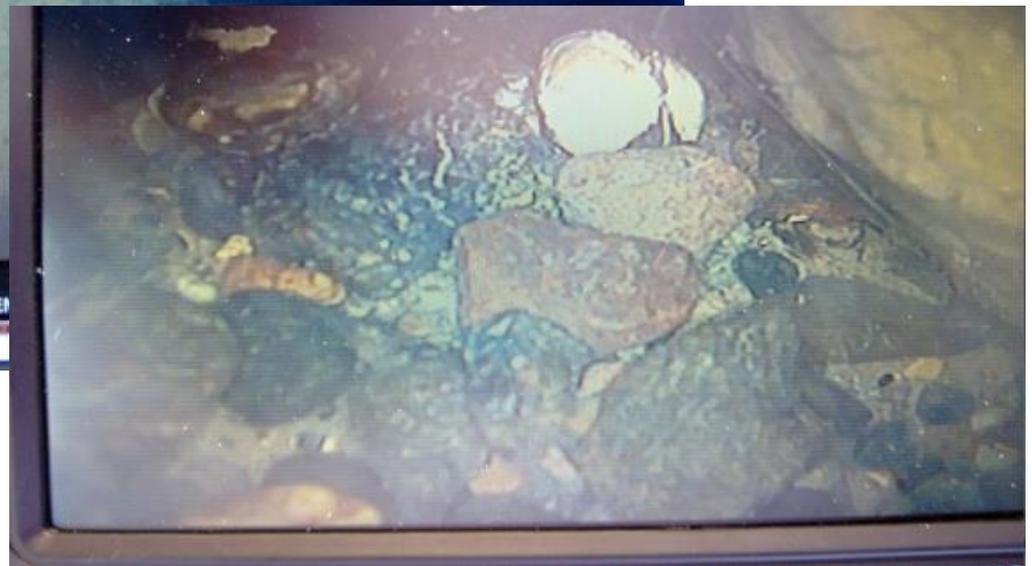
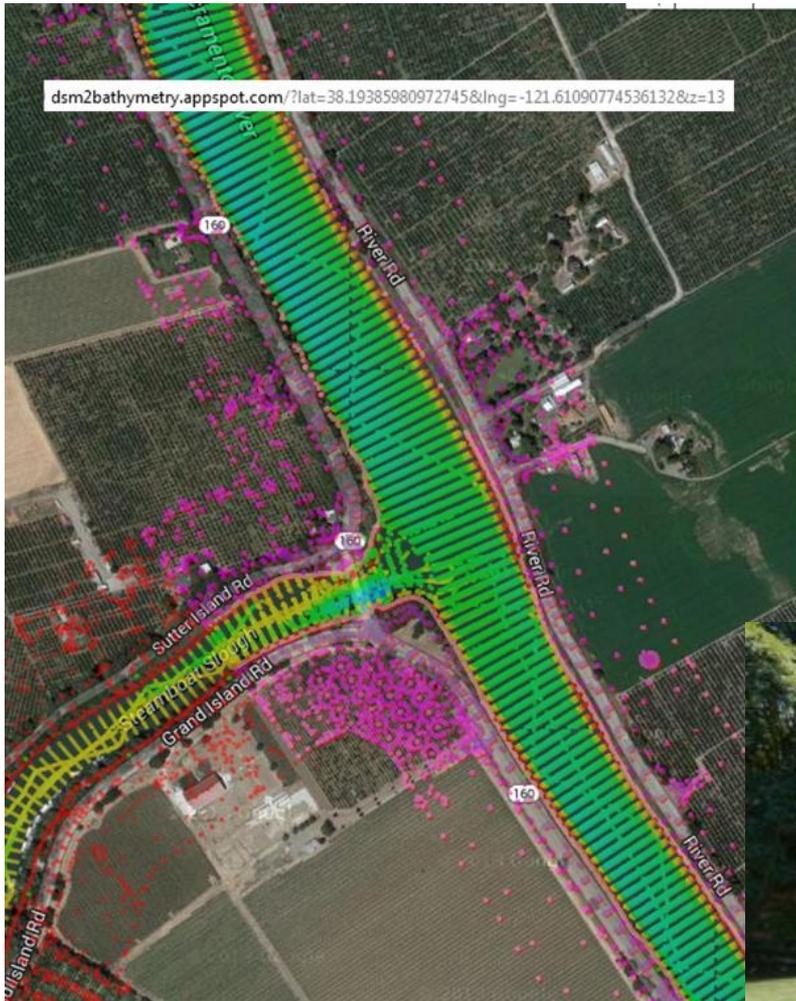
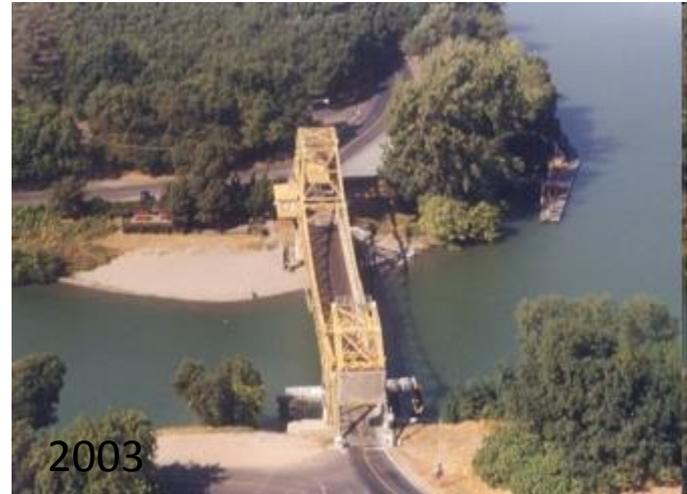
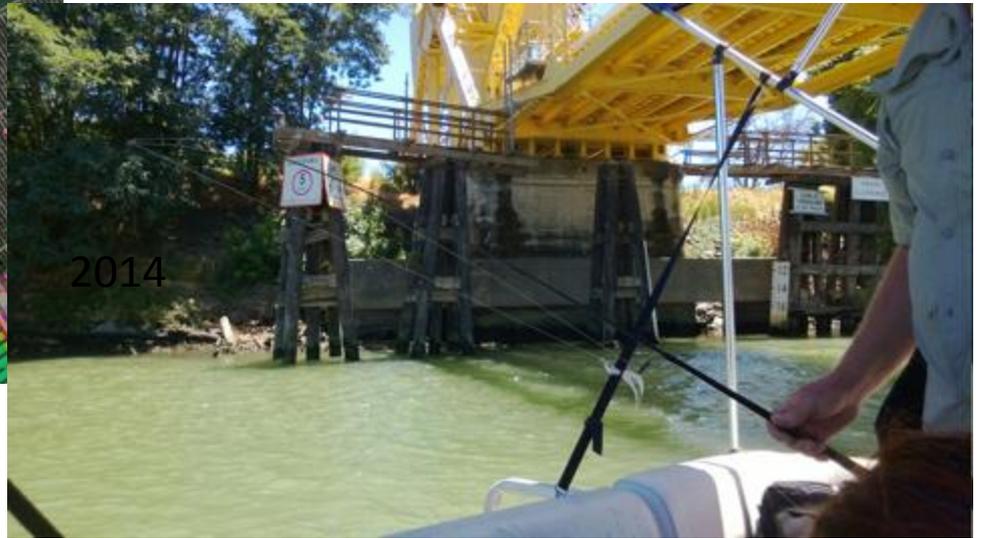
Photos show pour—in-place cement, revertment rock, large river rock not normally found on the river bed In this area of the Delta, and sheer wall which could not be “naturally formed” per Paul Marshall.

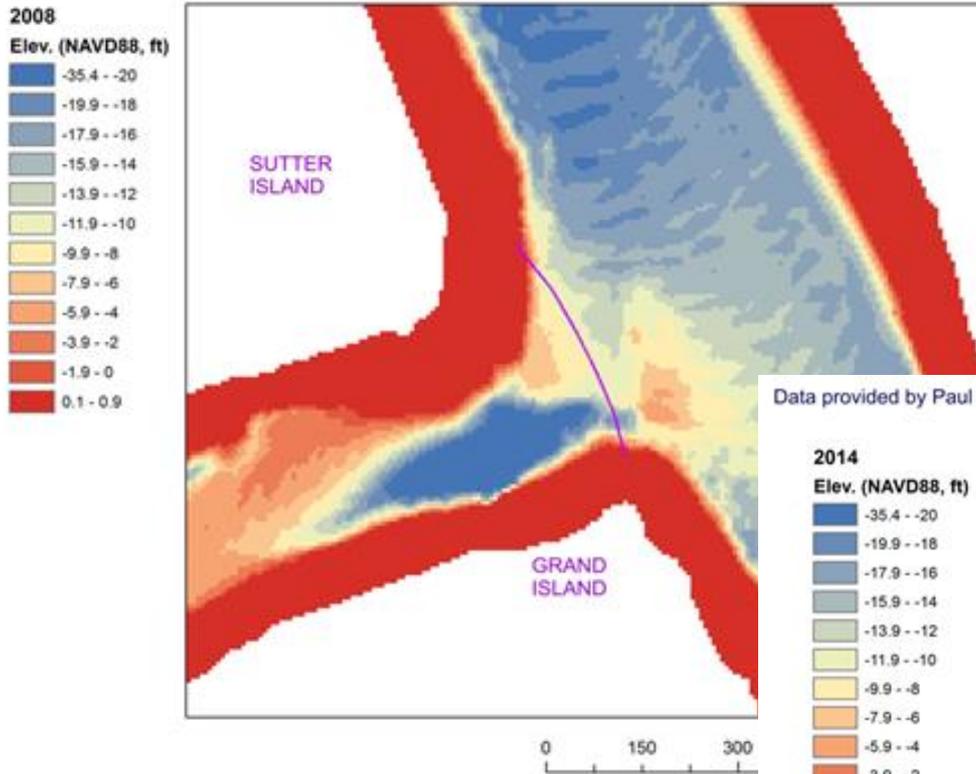
Data provided by Paul Marshall of DWR shows elevations, not water depth. At low tides, Steamboat Slough is 8 to 10 feet Deep as of 2014 and 2015 sidescan sonar survey By SHR team.

Data provided by Paul Marshall, DWR on 6/17/14 Shows berm or shoal, and a very deep hole.

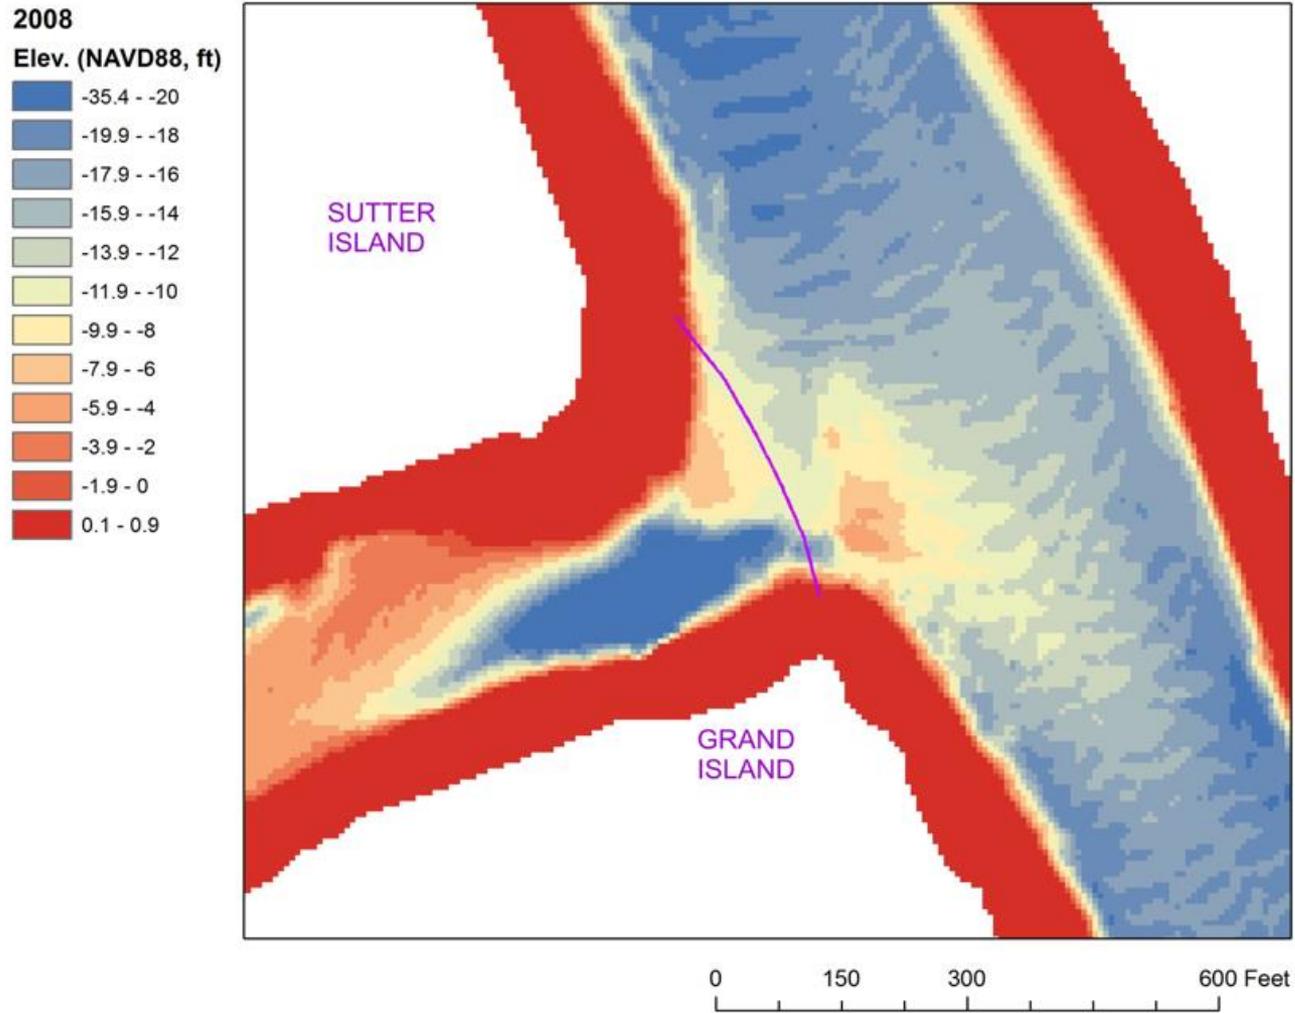
30 to 40 foot deep hole located downstream of the subsurface flow barrier on Steamboat Slough. Hole continues to scour when higher Sacramento River flows enter Steamboat Slough. Deep hole starts under the Steamboat Slough bridge and progresses downriver for at least 50 feet, and is located towards the Grand Island side of the waterway, which might explain the visible ongoing damage to Grand Island levee rock on that side.

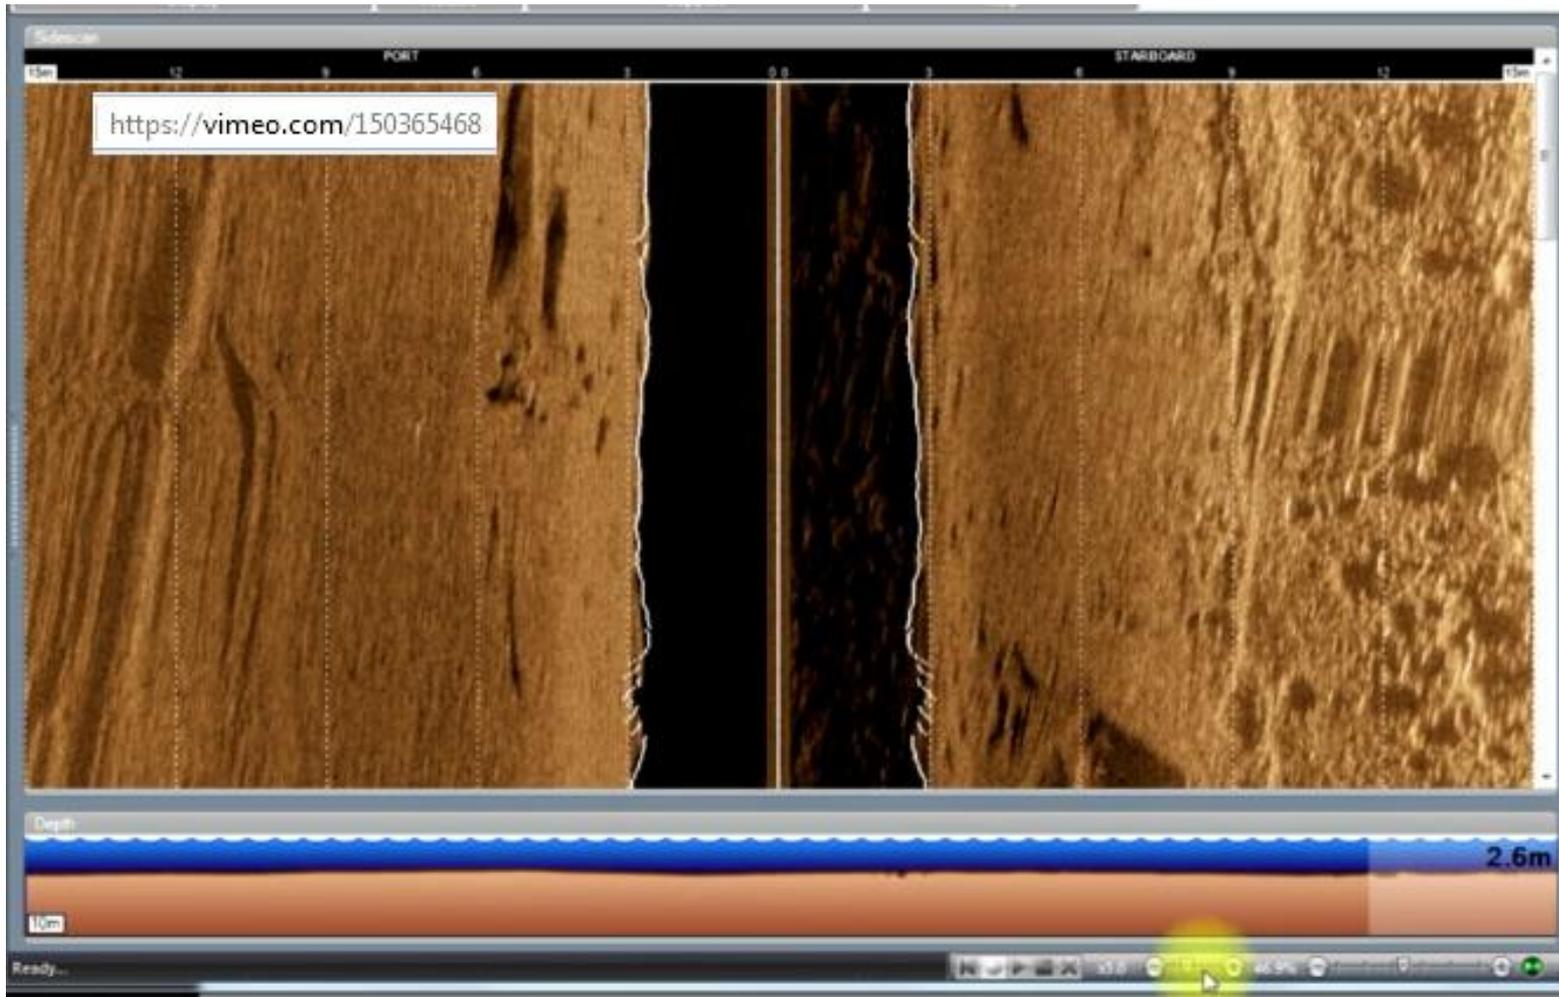
Flow barriers cause silting and shallow water both upstream and downstream of the flow barrier

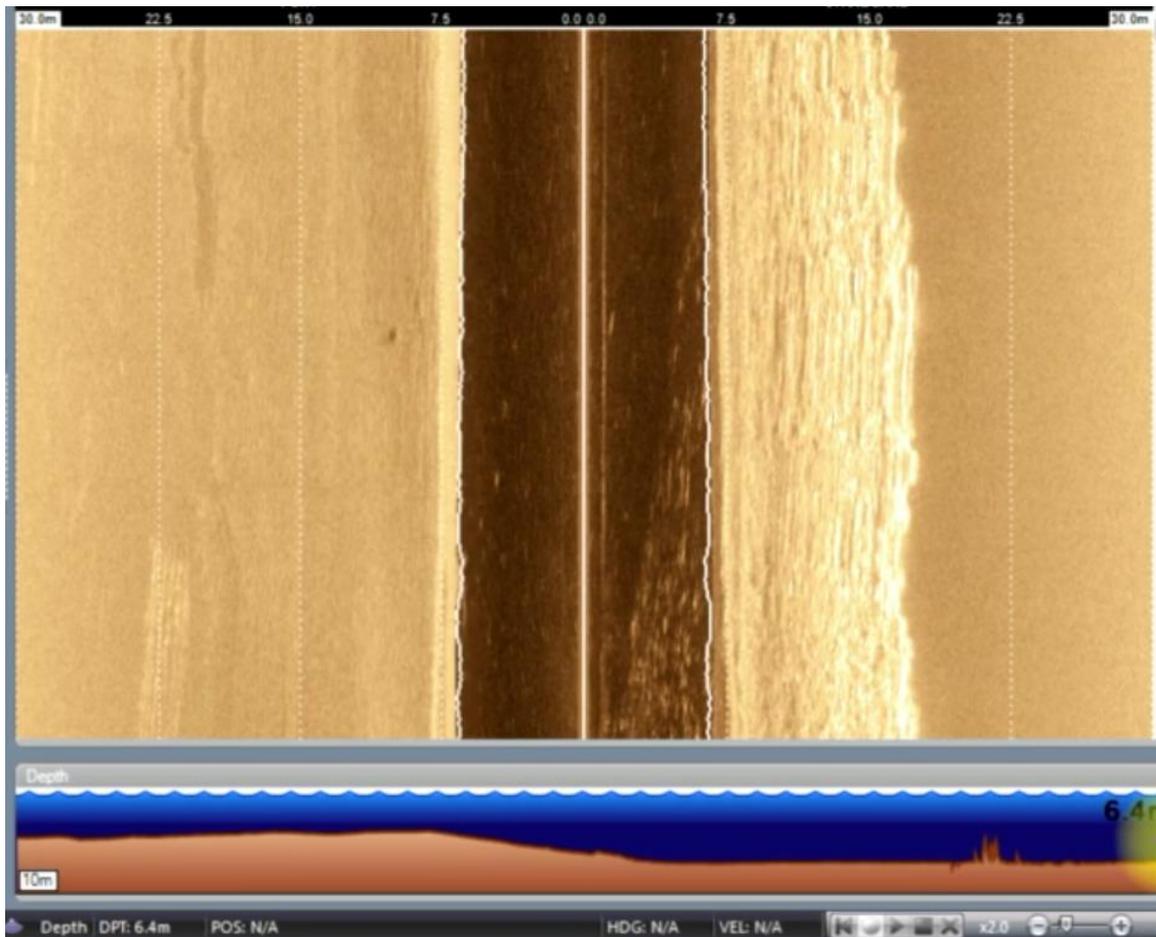
<https://vimeo.com/150367315> Sidescan sonar of Sutter Slough passing by Miner's Slough Confluence, heading downstream on Sutter Slough. This scan shows a deeper hold where the Water is blocked from going into Sutter Slough and instead flows into Miner's Slough, which is Not the normal pattern of flow.

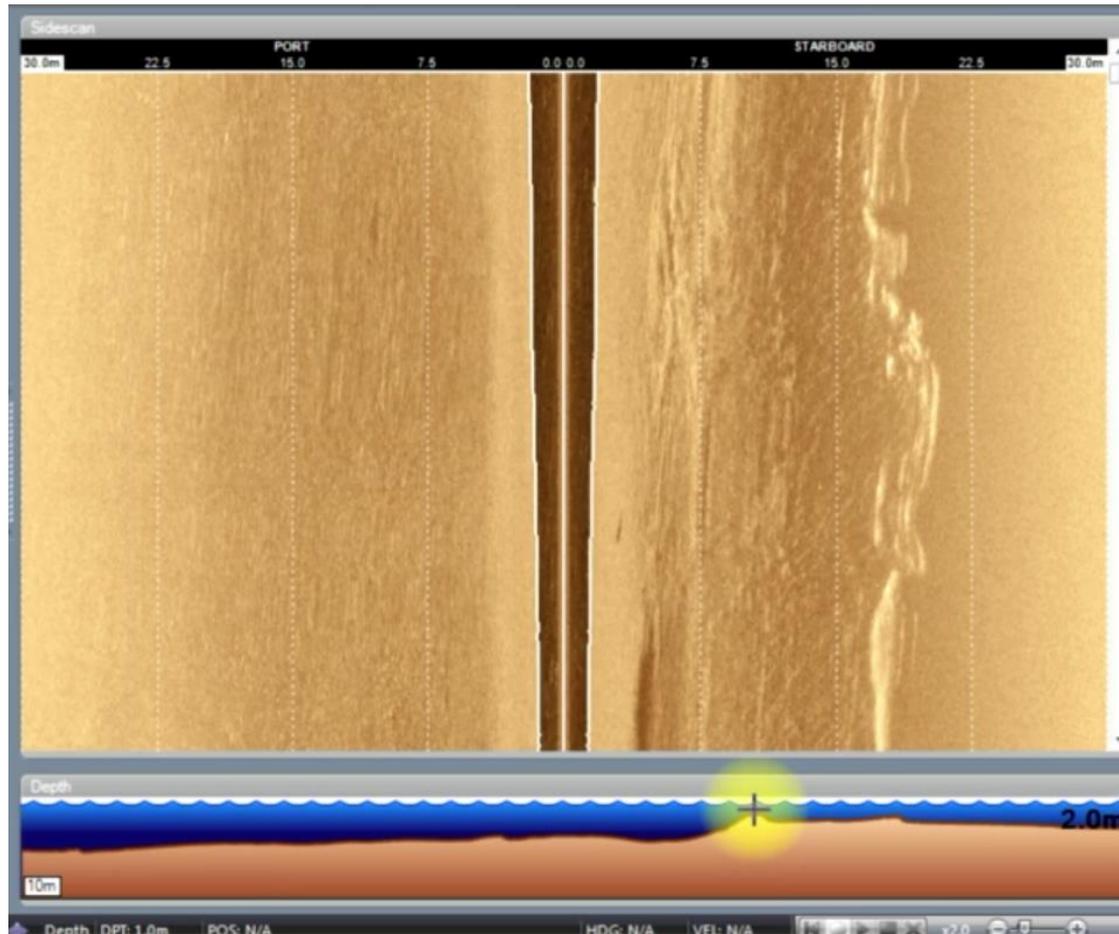
<https://vimeo.com/150367315> Sidescan sonar of Sutter Slough passing by Miner's Slough Confluence, heading downstream on Sutter Slough, blocking flows into Sutter Slough and thereby diverting those flows into Miner's Slough. Location of this flow barrier is adjacent to the newer rock placed on Ryer Island below the confluence of Sutter and Miner Sloughs.
