# RECONNAISSANCE SURVEY OF CRITICAL MIGRATION RIFFLES IN THE BIG SUR RIVER, WITHIN LOWER ANDREW MOLERA STATE PARK, MONTEREY COUNTY, CA

## WITH SPECIAL REFERENCE TO A COMPLEX RIFFLE UPSTREAM OF THE BIG SUR LAGOON

David H. Dettman

4/29/2011

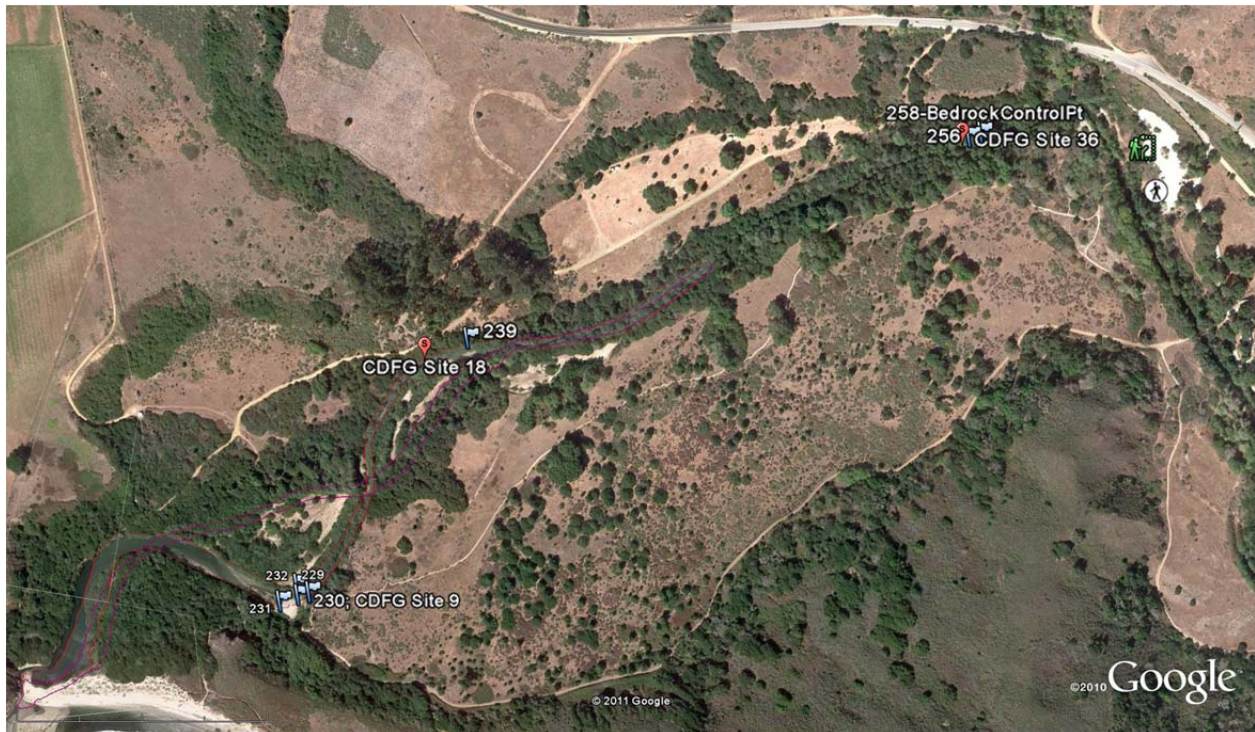
Figure 1: Location of critical riffles for adult migration in the Big Sur River between the ocean and Andrew Molera State Park parking lot. Includes a complex riffle at CDFG Station 9 (waypoint 230), a possible transverse riffle at CDFG Site 18-19 (waypoint 239), and a wide, shallow riffle section at CDFG Site 36 (waypoint 256). Date of survey: April 29, 2011.

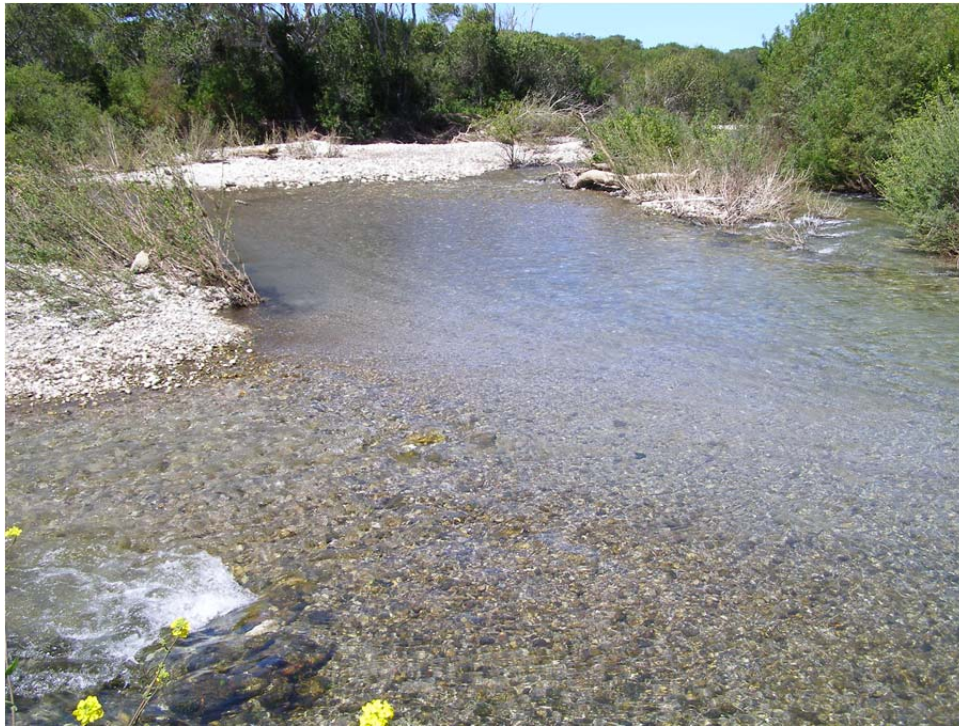
At the most critical riffle the total crest length was approximately 133 feet at 146 cfs, or about 2X to 3X the base channel width at two critical riffles further upstream. As indexed by depth measurements and criteria often used for recommending passage flows, the passage conditions were judged marginal for adult migration at a discharge of 146 cfs. Only 15-16 percent of the overall riffle crest width is covered with depths greater than 0.7 feet; and with a depth criterion of 0.6 feet the percentage ranges from 18 to 28 percent of the crest width. With existing channel conditions adult steelhead would need to negotiate narrow, 5- to 7-foot and 6- to 16-foot wide strings of flow. Fish may be able to physically negotiate the narrow strings of suitable depths, but are probably at risk from higher terrestrial or avian predators. In any case, the flow recommendations that are being developed for adult passage in the lower Big Sur River, as part

of the CDFG's Study Plan, should account for the conditions at this location. Notably, the underlying cause of bank erosion and channel change at this location is probably related to the major channel shift following 1995/98 storms. Until dense vegetation growth returns and the sediment delivery to the channel declines, this location will continue to impede the upstream migration of adult steelhead.

Photo 1: Complex critical riffle located at Waypoints 229-232, CDFG Site No. 9; view looking downstream from the top of the left streambank. Streamflow was estimated at 146 cfs.

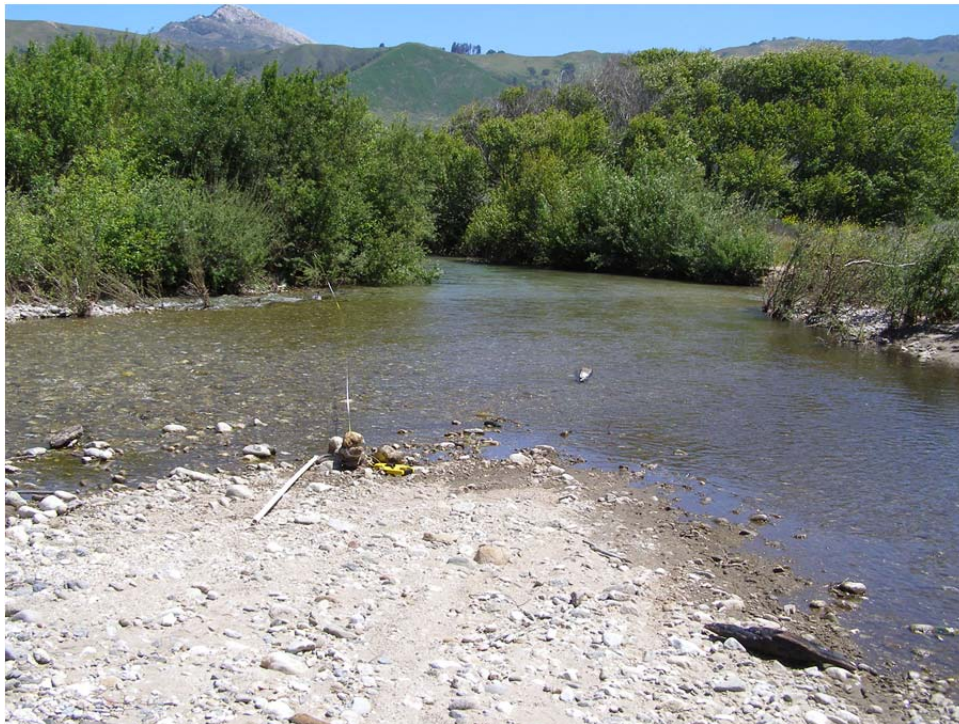
Photo 2: Same location as previous photo, but looking upstream from gravel bar in the middle of channel. One transect used for measuring water depths along the riffle crest is shown.

Transsect Name	Percentage (%) of riffle cross section width with depths >= 0.6 feet depth	Width (ft) of riffle cross section with continuous depth >=0.6 feet	Percentage (%) of riffle cross section width with depths >= 0.7 feet depth	Width (ft) of riffle cross section with continuous depth >=0.7 feet
229 – 230	18	7	13	5
231 – 232	28	16	15	6

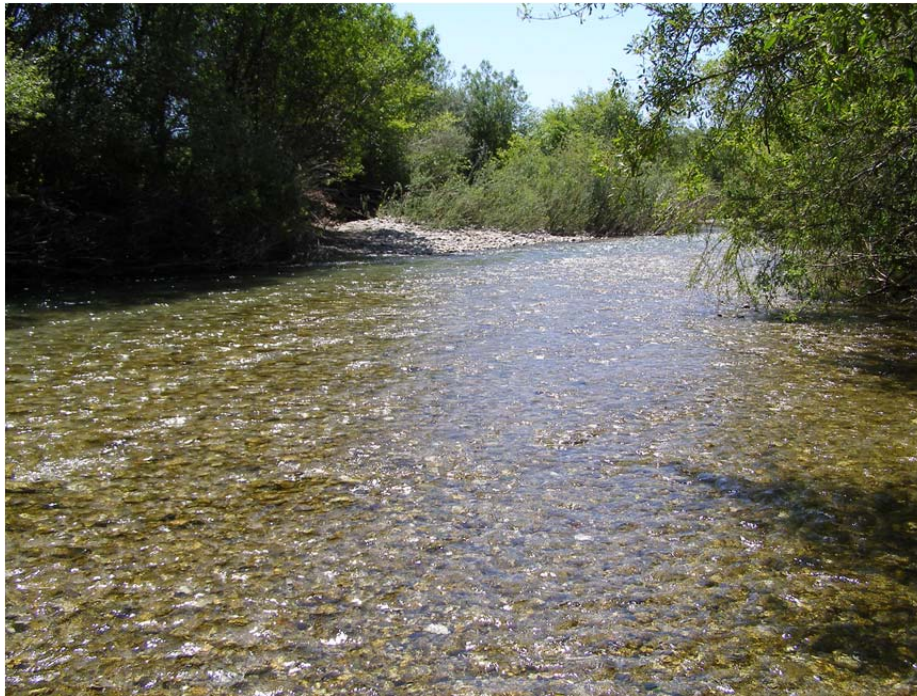
Photo 3: Riffle below Waypoint 239, CDFG Site 19; view looking downstream from right bank to the upper edge of Site 18, located at the gravel bar on the left side of stream and middle back of photo. Overbank flow in an accessory channel from the left side appears to have deposited gravel and cobble bedload at this location. This may set up formation of a transverse, longitudinal riffle crest, with flow breaking to the right as the flow declines.

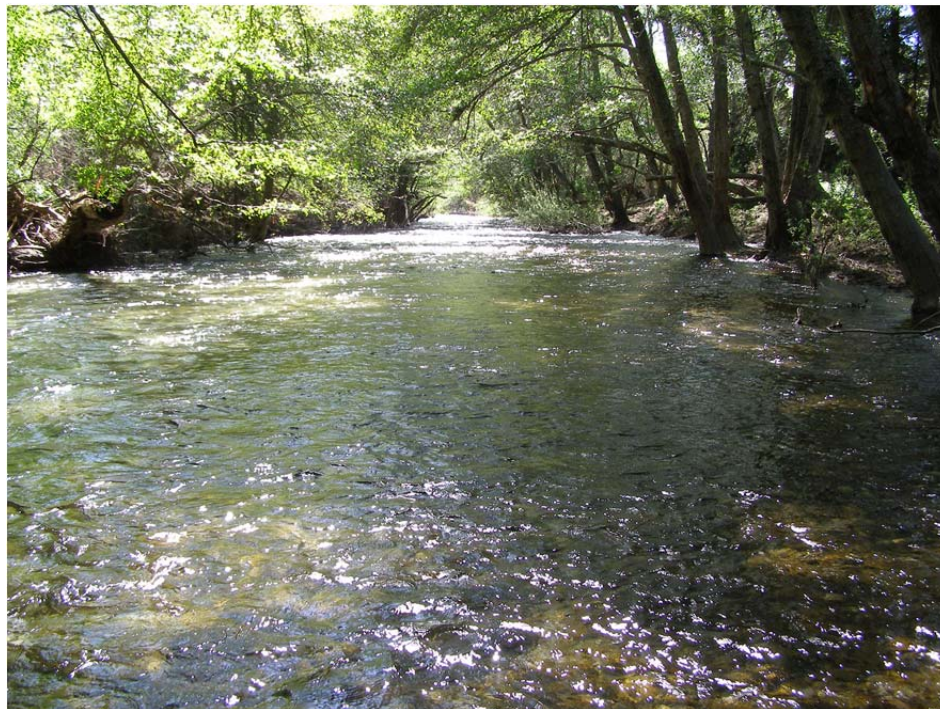
Photo 4: Waypoint 256, CDFG Site 36/T3; view looking downstream, note wide, shallow riffle in this section, summer stream crossing just downstream, streamside trails appear well used in this section.
