Exhibit MMR-04

Photographs of the Hydorelectric Power Plant

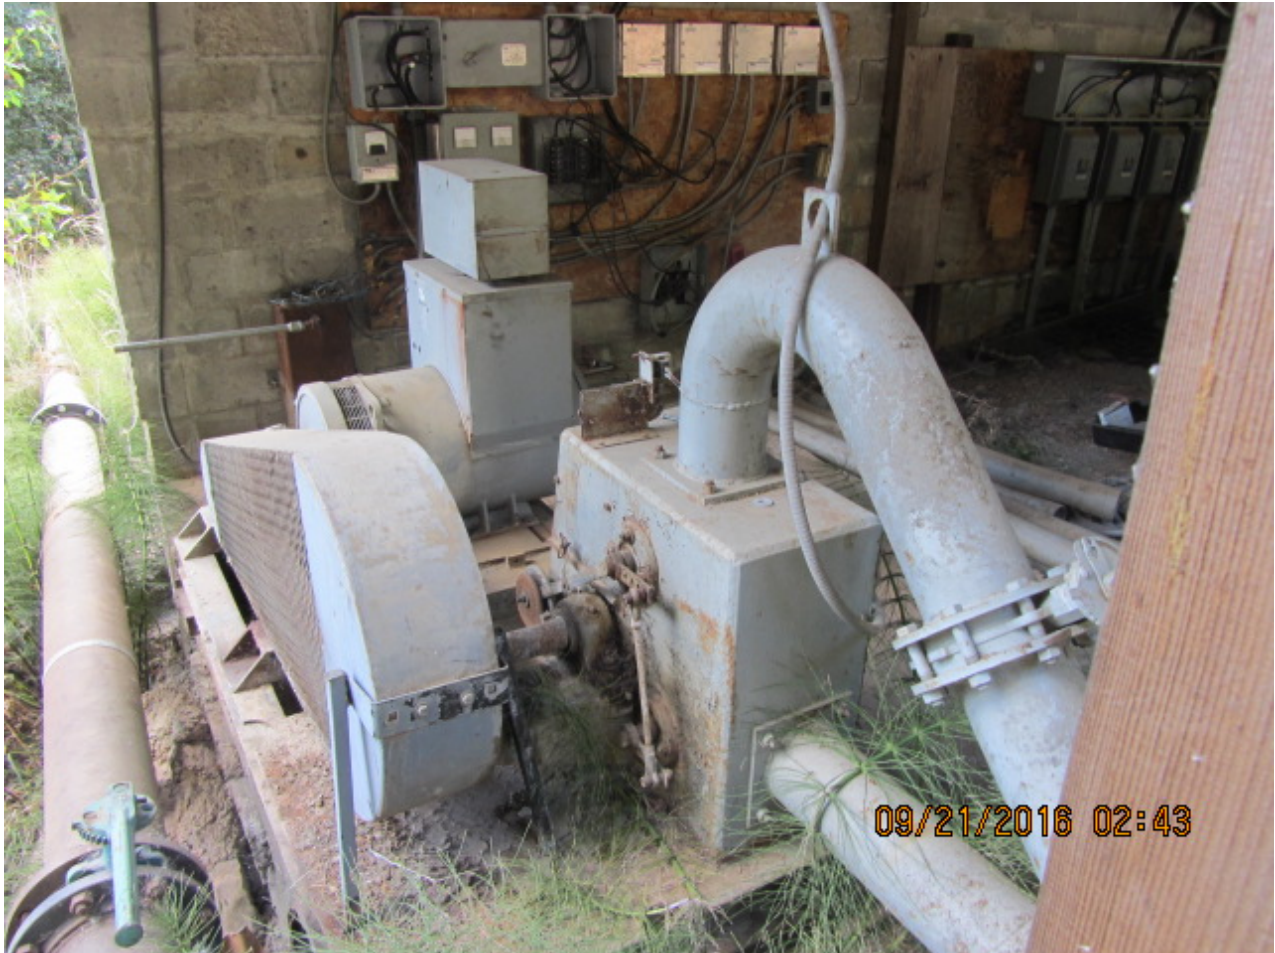
Exhibit MMR-04 Photograph #1 – The hydroelectric powerplant in September 2016

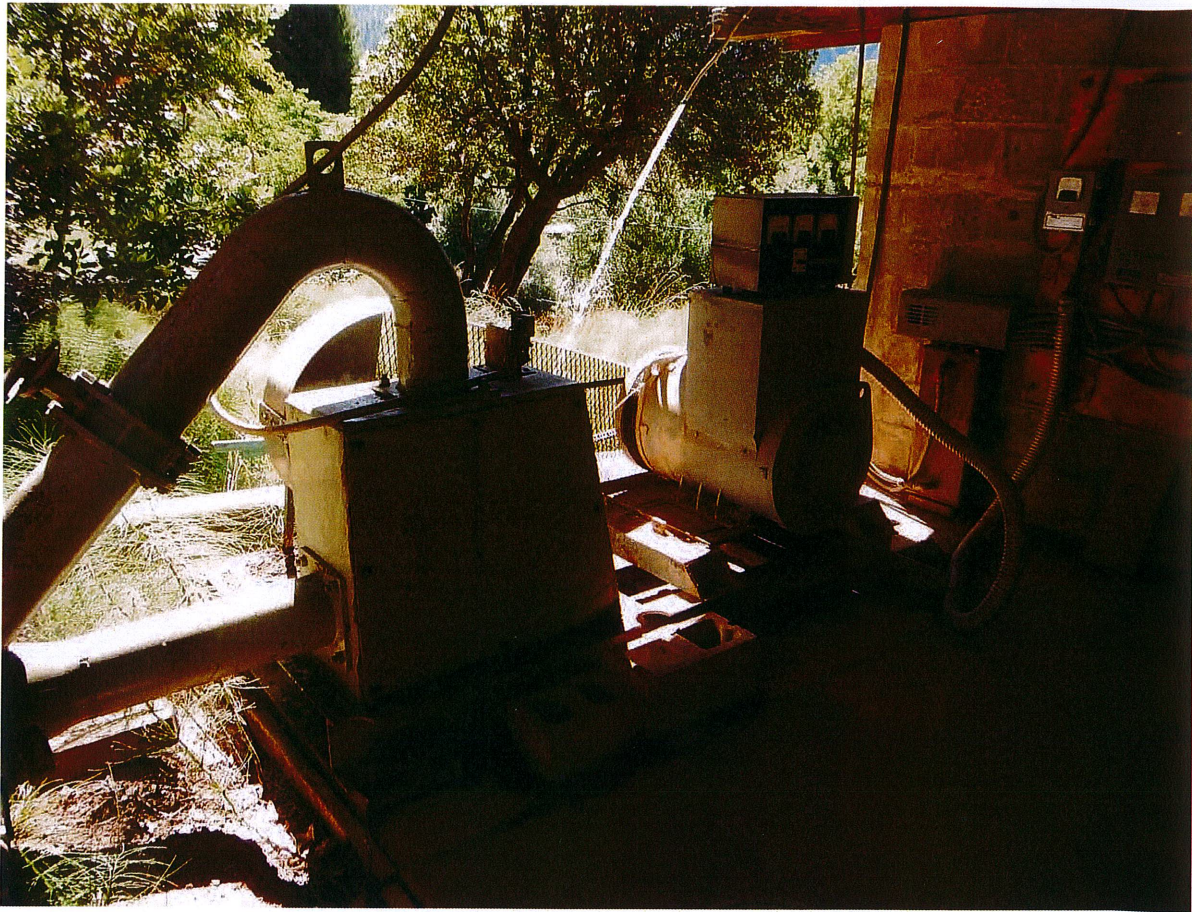
Photograph 4. Micro-hydro power plant diversion flows enter from the pipes on the left of the photograph. Heated effluent from the heat sink resistor is visible near the top of the photograph near the roof beam.
