# **Findings Report for Stanshaw Creek Habitat and Instream Flow Assessment**

**Prepared for the Karuk Tribe**

**Ross Taylor and Associates**

**January 2015**

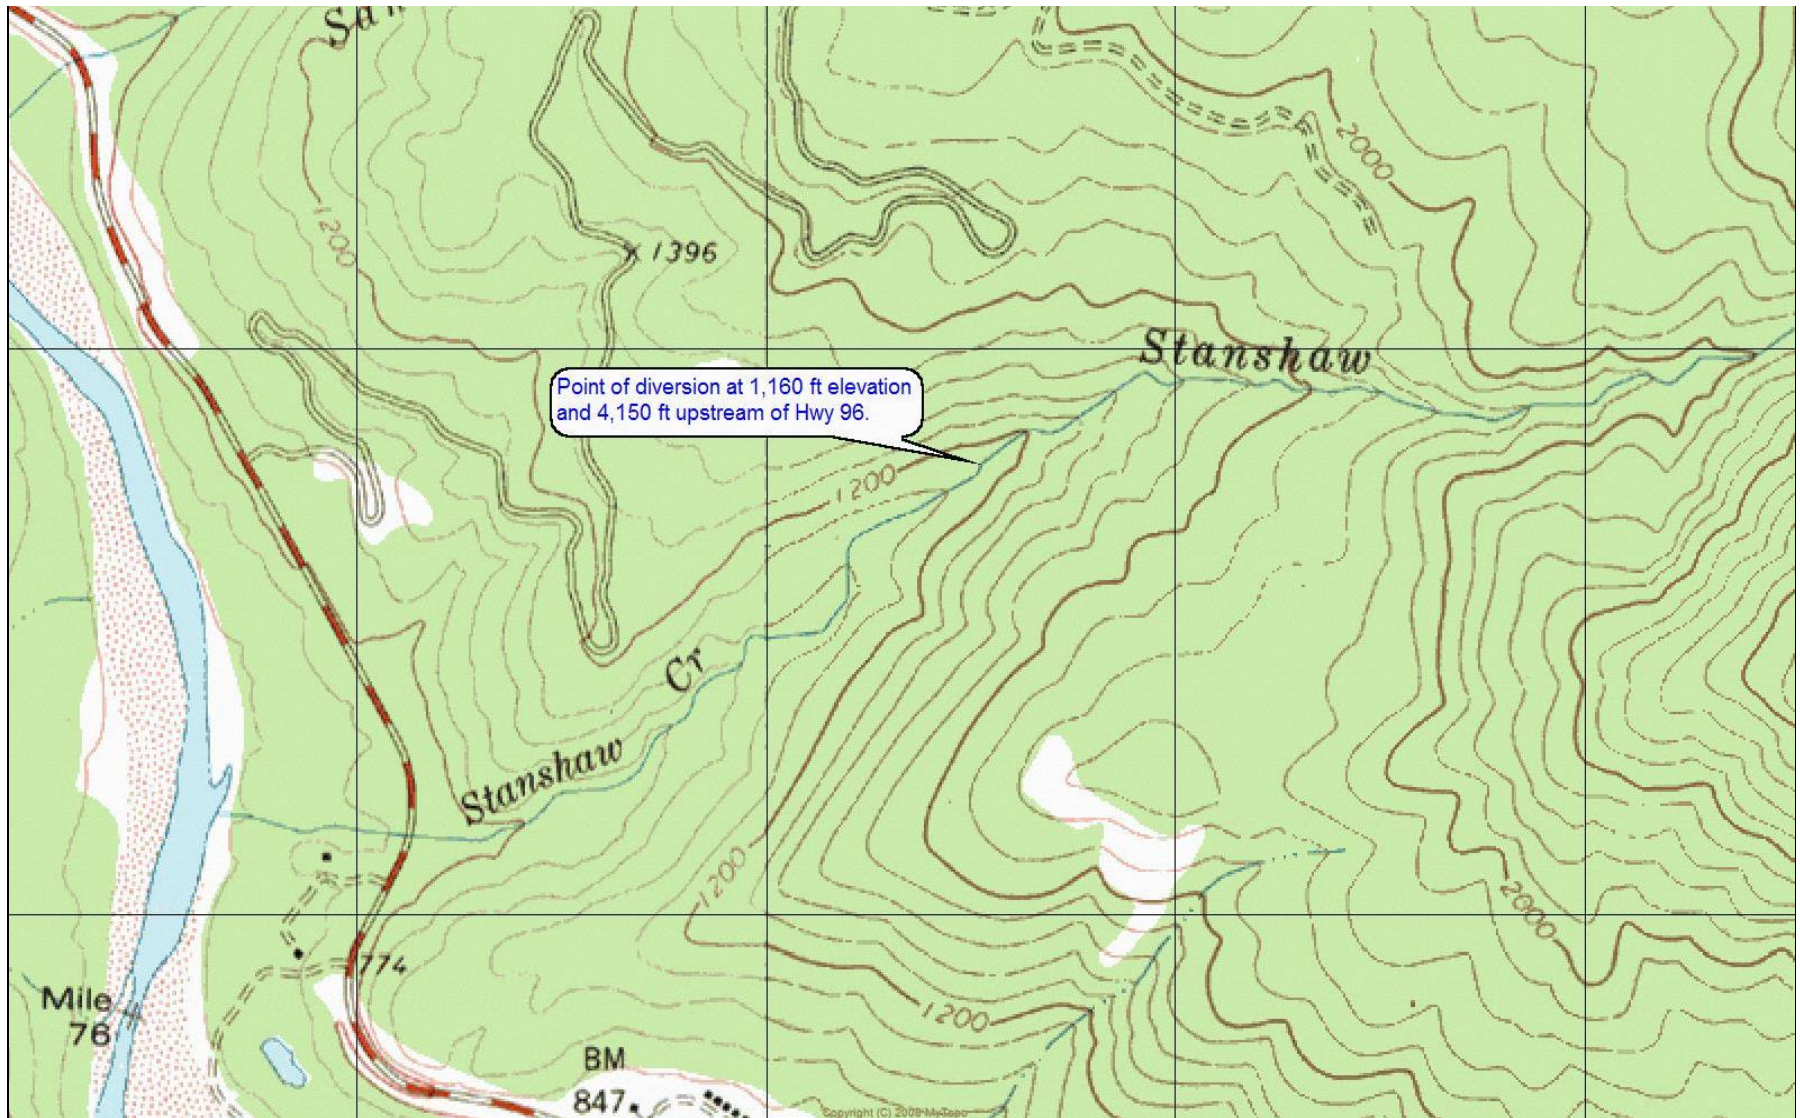
**Figure 1.** Stanshaw Creek and location of the Marble Mountain Ranch’s point of diversion.

Stanshaw Creek is a small tributary of the Klamath River with a drainage area of approximately four square miles (Figure 1). The creek's confluence with the Klamath River is located at N41.4764518; W123.5111116 (Figure 1). Stanshaw Creek has approximately 5,500 feet of potential fish-bearing habitat (up to sustained slope >15% on the USGS topographic map). The first 2,500 feet has a channel slope of approximately 9% and the next 3,000 feet has an overall slope of nearly 11%. The mouth of Stanshaw Creek enters the Klamath River approximately 1,400 feet downstream of Highway 96 (at CalTrans post-mile 8.20).

RTA also inspected the Stanshaw Creek surface water diversion located approximately 4,200 feet upstream of Highway 96. This diversion is maintained and utilized by the Marble Mountain Ranch (MMR) for power generation and other domestic uses. None of the water diverted from Stanshaw Creek by the MMR is returned to Stanshaw Creek; all non-consumptive flow is bypassed into Irving Creek.

Because the MMR diversion is located on U.S. Forest Service property, RTA was able to inspect the diversion during the 11/17/14 stream habitat assessment. Stanshaw Creek was being diverted by the placement of rocks across the channel which shunted nearly all of the surface flow into an open ditch. At the point-of-diversion (POD), the diversion was not screened and RTA conservatively estimated that 80-90% of the surface flow was being diverted into the ditch. Approximately 300 feet of the diversion ditch was inspected and the following was noted: (1) a bypass existed to possibly return excess flow to Stanshaw Creek; however all the diverted flow was going down the ditch and (2) this reach of the ditch had failed in several spots and was crudely repaired with cinder blocks, plastic sheeting and fill material. Leakage and erosion was noted at these locations.

1. Installation of a control gate at the POD so that MMR diverts only their allocated flow. Control gate should also provide the downstream channel its required minimum flows as a priority over the MMR diversion. Diversion at POD should be properly screened.

2. Implement water conservation measures such as: enclose MMR's diversion in a pipe instead of an open ditch, relocate POD farther upstream to create more drop or head pressure, upgrade MMR's hydropower system to a more efficient system, consider other sources of power generation (such as solar during summer when flows are low).
