**SACRAMENTO MUNICIPAL UTILITY DISTRICT
UPPER AMERICAN RIVER PROJECT
(FERC Project No. 2101)**

**PACIFIC GAS AND ELECTRIC COMPANY
CHILI BAR PROJECT
(FERC Project No. 2155)**

**CHANNEL MORPHOLOGY
TECHNICAL REPORT**

APRIL 2005

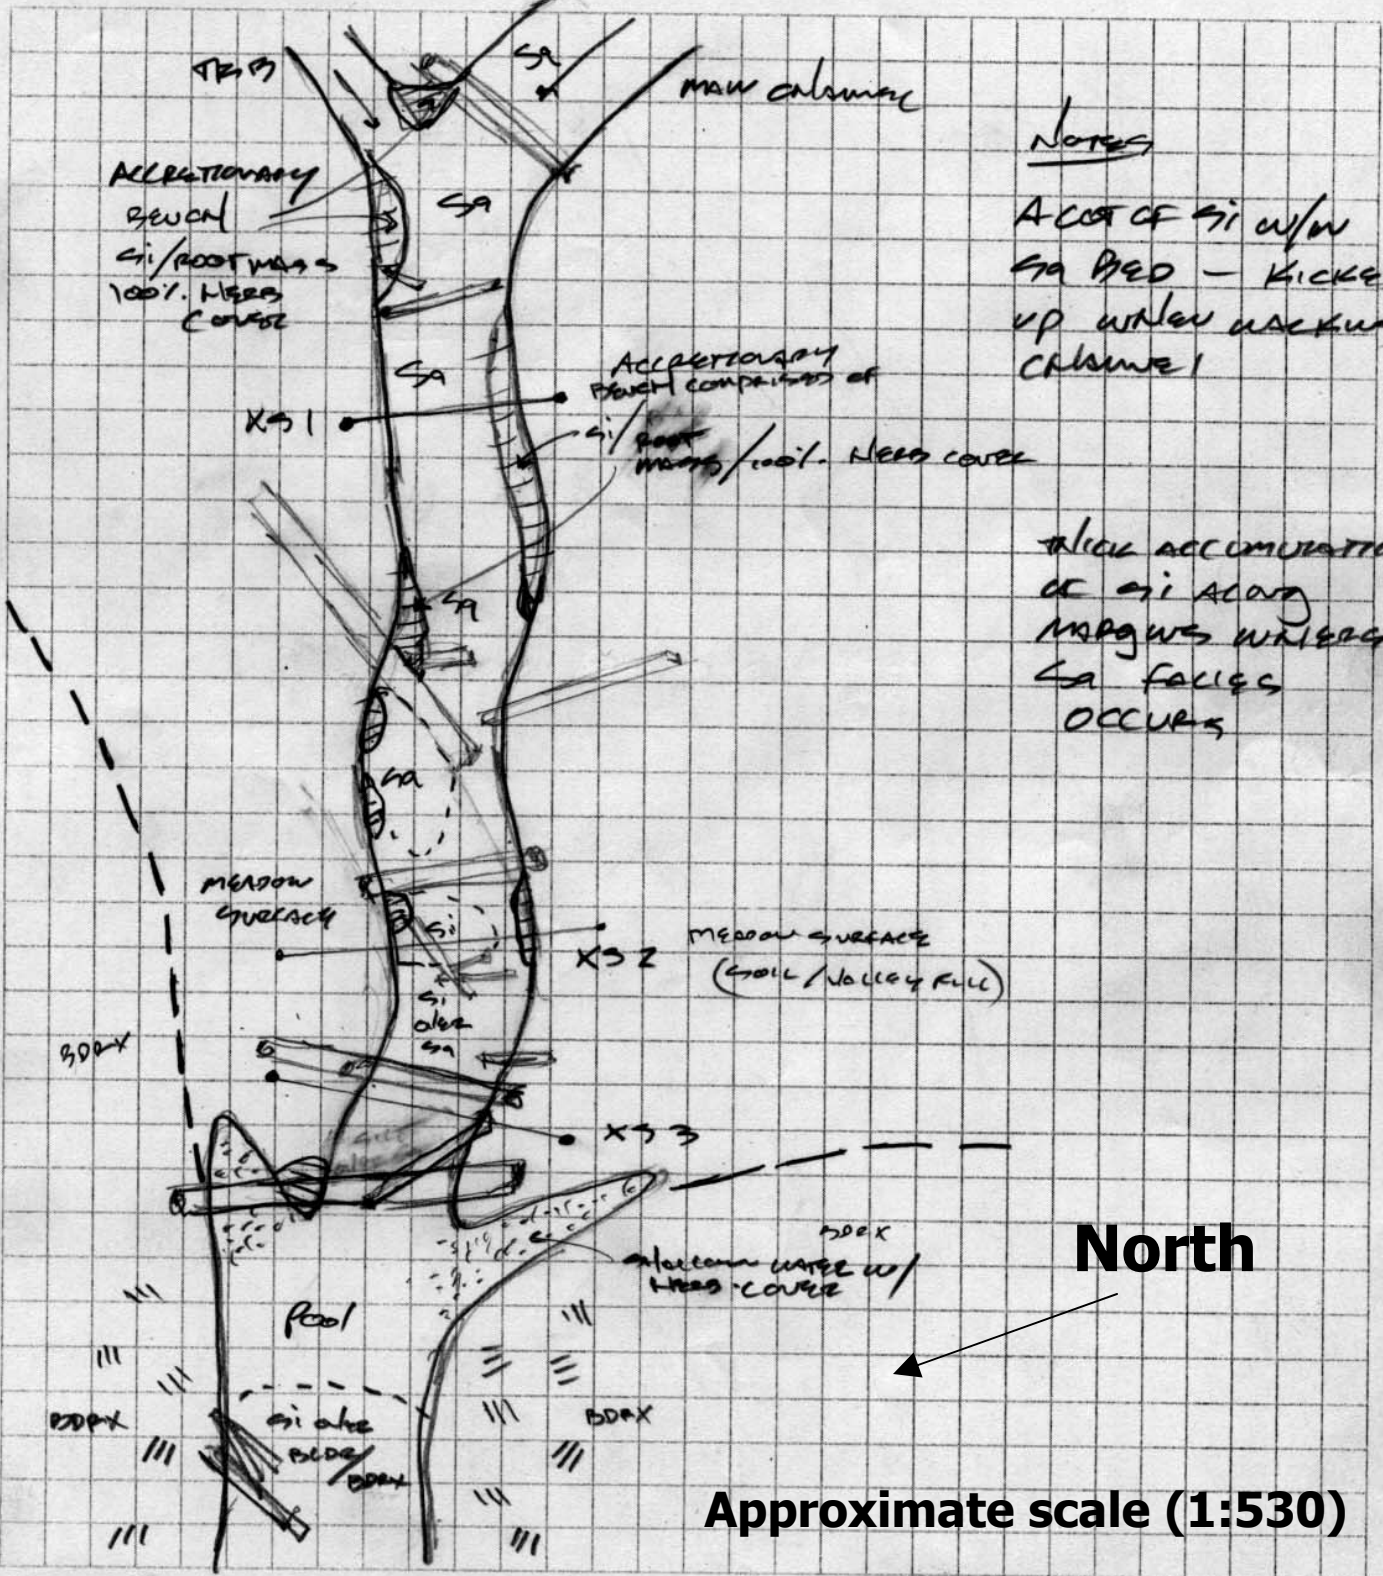
A LOT OF si w/w
SA BED - KICKED
UP WHEN WALKING
CHANNEL

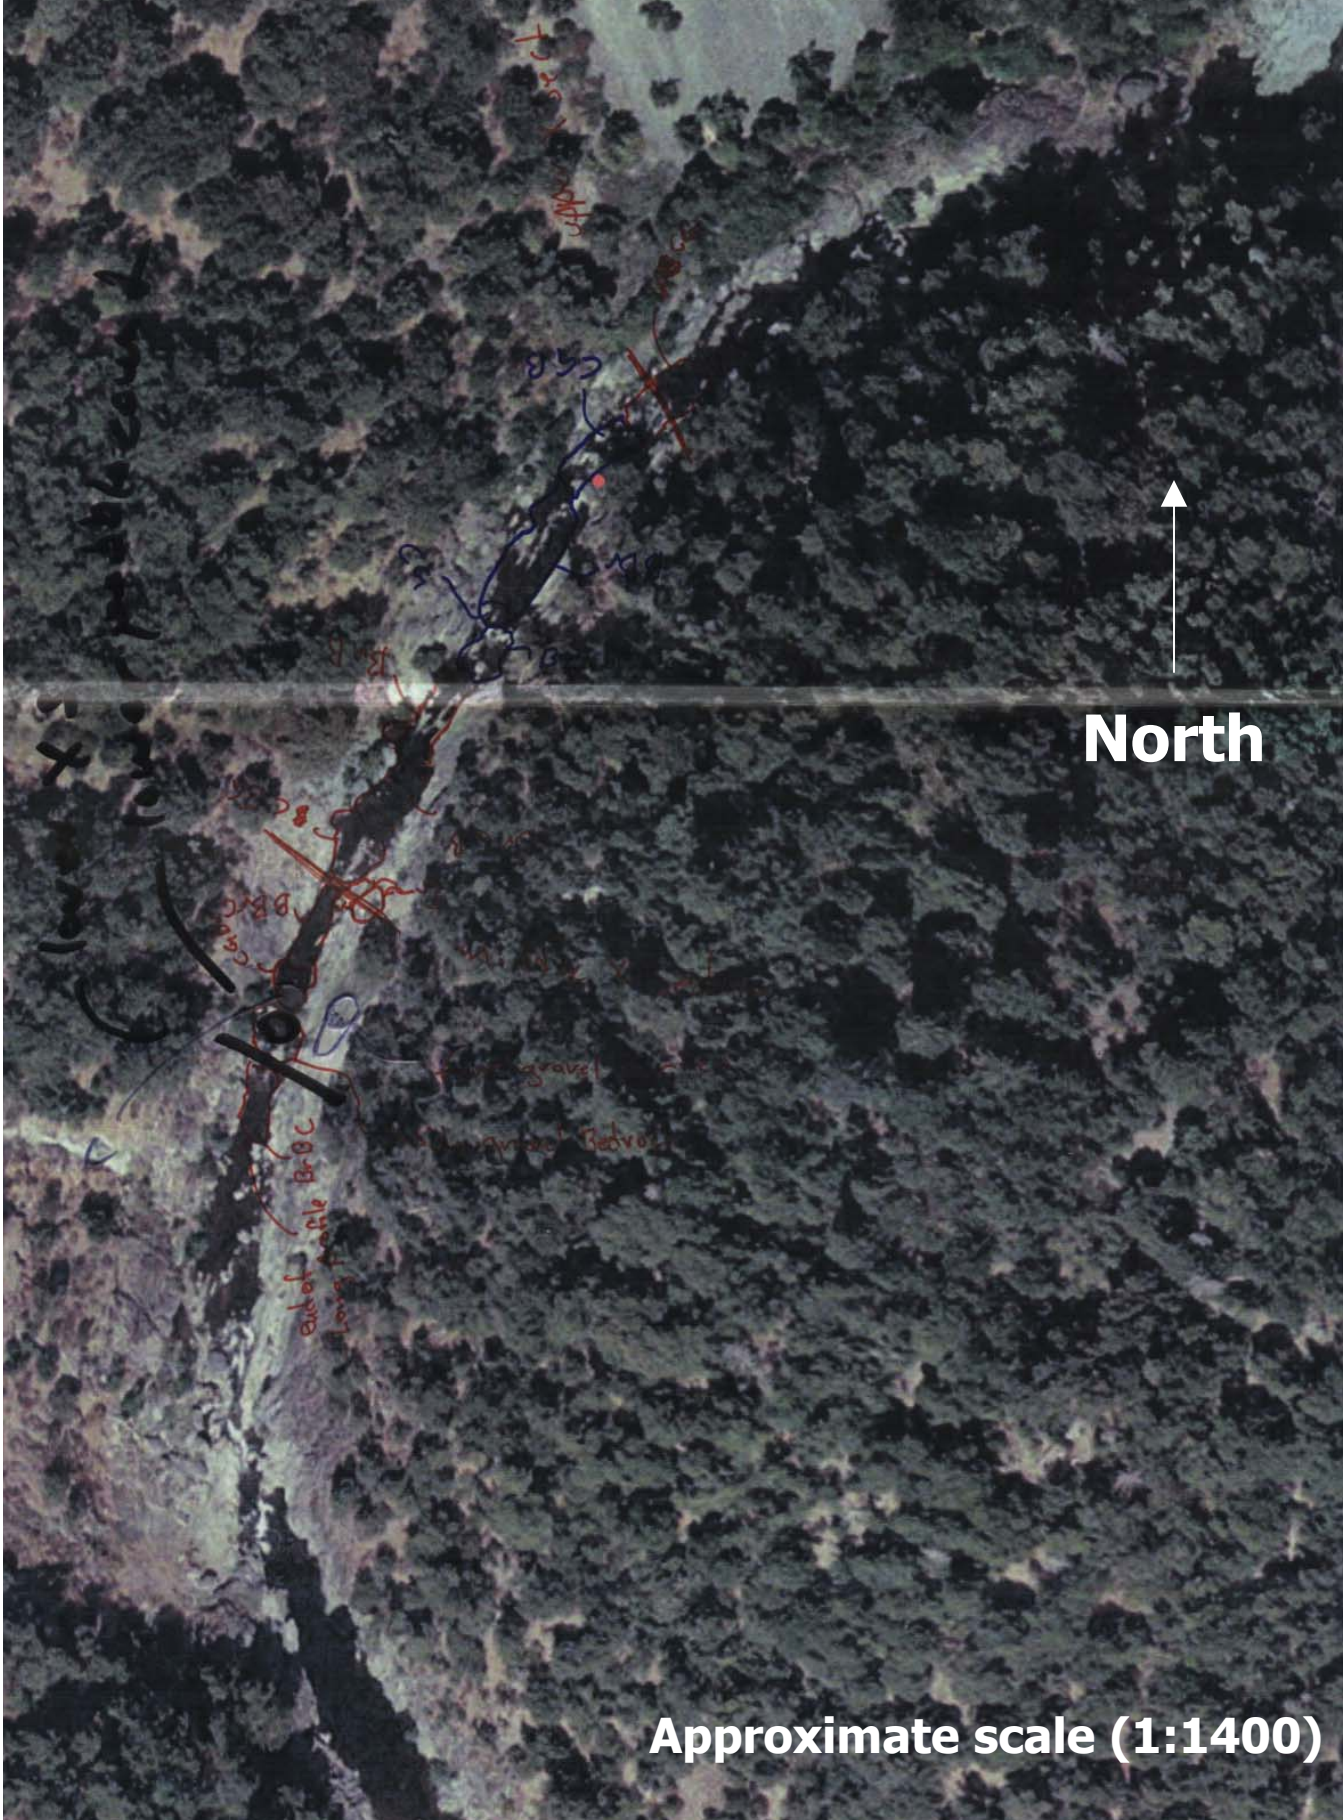
Camino Dam Reach Site (CD-G1)

The Camino Dam Reach Site is bedrock controlled with a predominantly cobble and gravel bed. Bank ledges are composed of gravel. At the upper cross-section is a pool with a cobble bottom, bound at the bottom end by boulders and bedrock outcrops. The middle cross-section is a run with a boulder/gravel channel and bedrock banks. The lower cross-section is located near a pool with cobble bottom. Bedrock forms the banks at the downstream end of the site.
