MITIGATED NEGATIVE DECLARATION & NOTICE OF DETERMINATION

ENVIRONMENTAL DETERMINATION NO. <u>ED01-347</u>

PROJECT/ENTITLEMENT: Pierson Parcel Map; CO01-0070/S000385P...

NOTICE OF VIOLATION; CLEANUP OR ABATEMENT ORDER REQUIREMENTS; GOLDIE LANE PROPERTY; SANTA MARGARITA; SAN LUIS OBISPO COUNTY; WDID# 3 40S319357

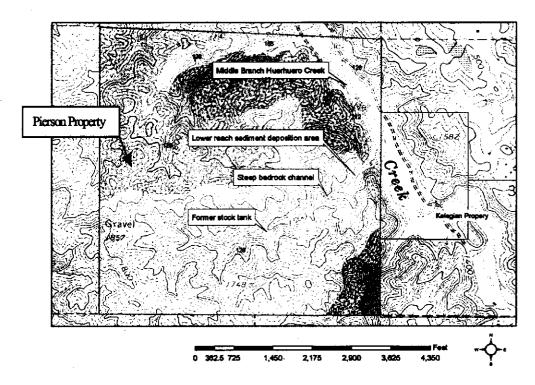
Figure 1 Pierson property showing soil units with 7.5-minute quad background (Soil Map Units on the map correspond to Soil Map Units in Table 1)

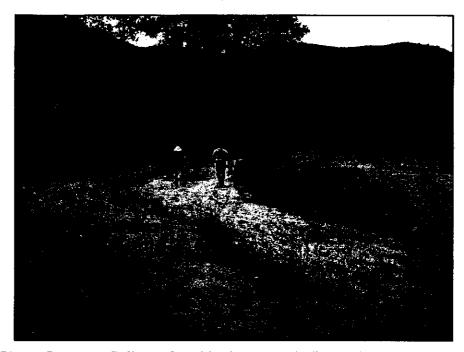
Figure 2 Pierson Property - Sediment deposition in unnamed tributary just upstream of confluence w/Middle Branch Huerhuero Creek (looking upstream)

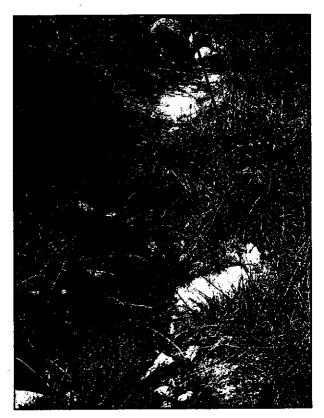
Figure 5 Pierson Property - Small areas of sediment deposition between clear areas - reach located between bedrock channel and former stock tank. Note moisture at bottom of photo. This was the only length of watercourse (approx. 10 feet) observed with surface water.

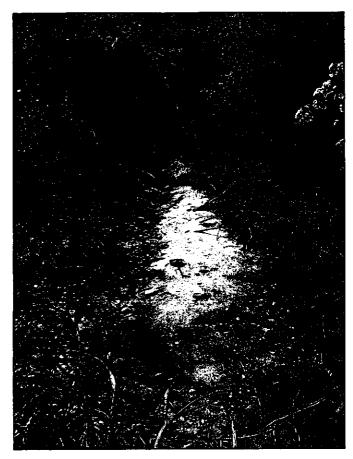
Figure 7 Pierson Property - sediment deposition in side drainage to unnamed tributary just upstream of confluence at former stock tank

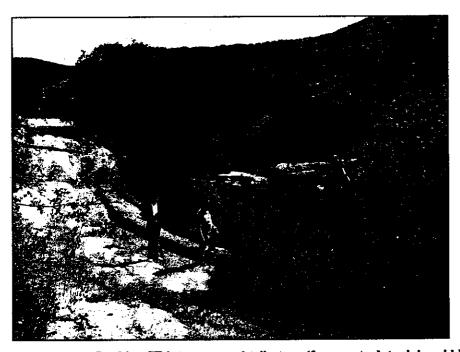
Figure 8 Pierson Property - Looking SE into unnamed tributary (former stock tank in middle distance)

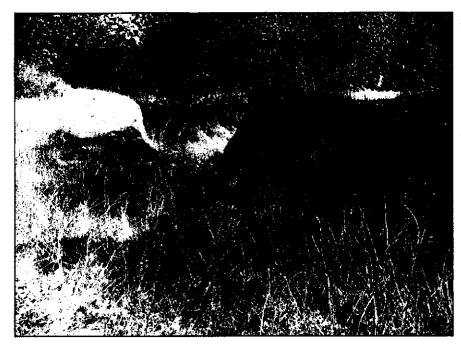
Figure 9 Pierson Property - Earthen dam with breach at former stock tank (looking downstream)

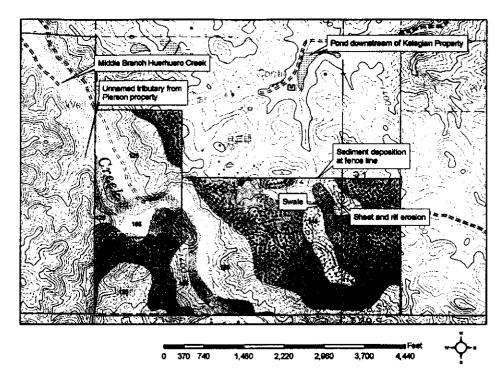
Figure 10 Kelegian property showing soil units with 7.5-minute quad background (Soil Map Units on the map correspond to Soil Map Units in Table 2)

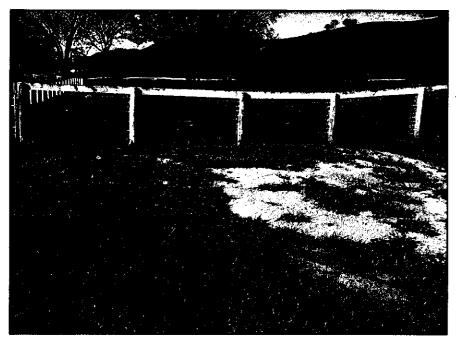
I observed sediment deposits upstream of the fence (see Figure 11) located along the property line. It appears that organic matter was lodged against the fence and acted as a fairly effective barrier to sediment transport. Very little sediment was noted on the adjacent property north of the fence. The sediment deposit is fan shaped with the base located along the fence with a width of approximately 35 feet. The sediment deposit extends uphill from the fence approximately 300 feet (see Figure 12 for upper extent of deposition). Small areas of sediment deposition were observed in the swale above the larger deposit shown in Figure 11 and Figure 12. An example of the grubbed area upstream of the swale, as it appeared prior to revegetation is shown in Figure 13.

Figure 11 Kelegian Property - Sediment deposition along fence line, looking north to adjacent property (Photo: Ryan Lodge March 3, 2003)

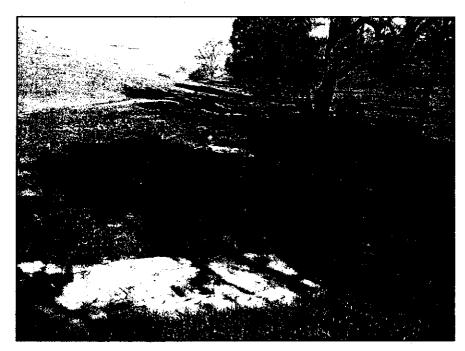
Figure 12 Kelegian Property - Swale upstream of fence line (Photo: Ryan Lodge March 3, 2003)
