TOTAL MAXIMUM DAILY LOAD
TECHNICAL SUPPORT ANALYSIS FOR MERCURY
IMPAIRMENT
OF
CLEAR CREEK AND HERNANDEZ RESERVOIR

Central Coast Regional Water Quality Control Board

February 25, 2004

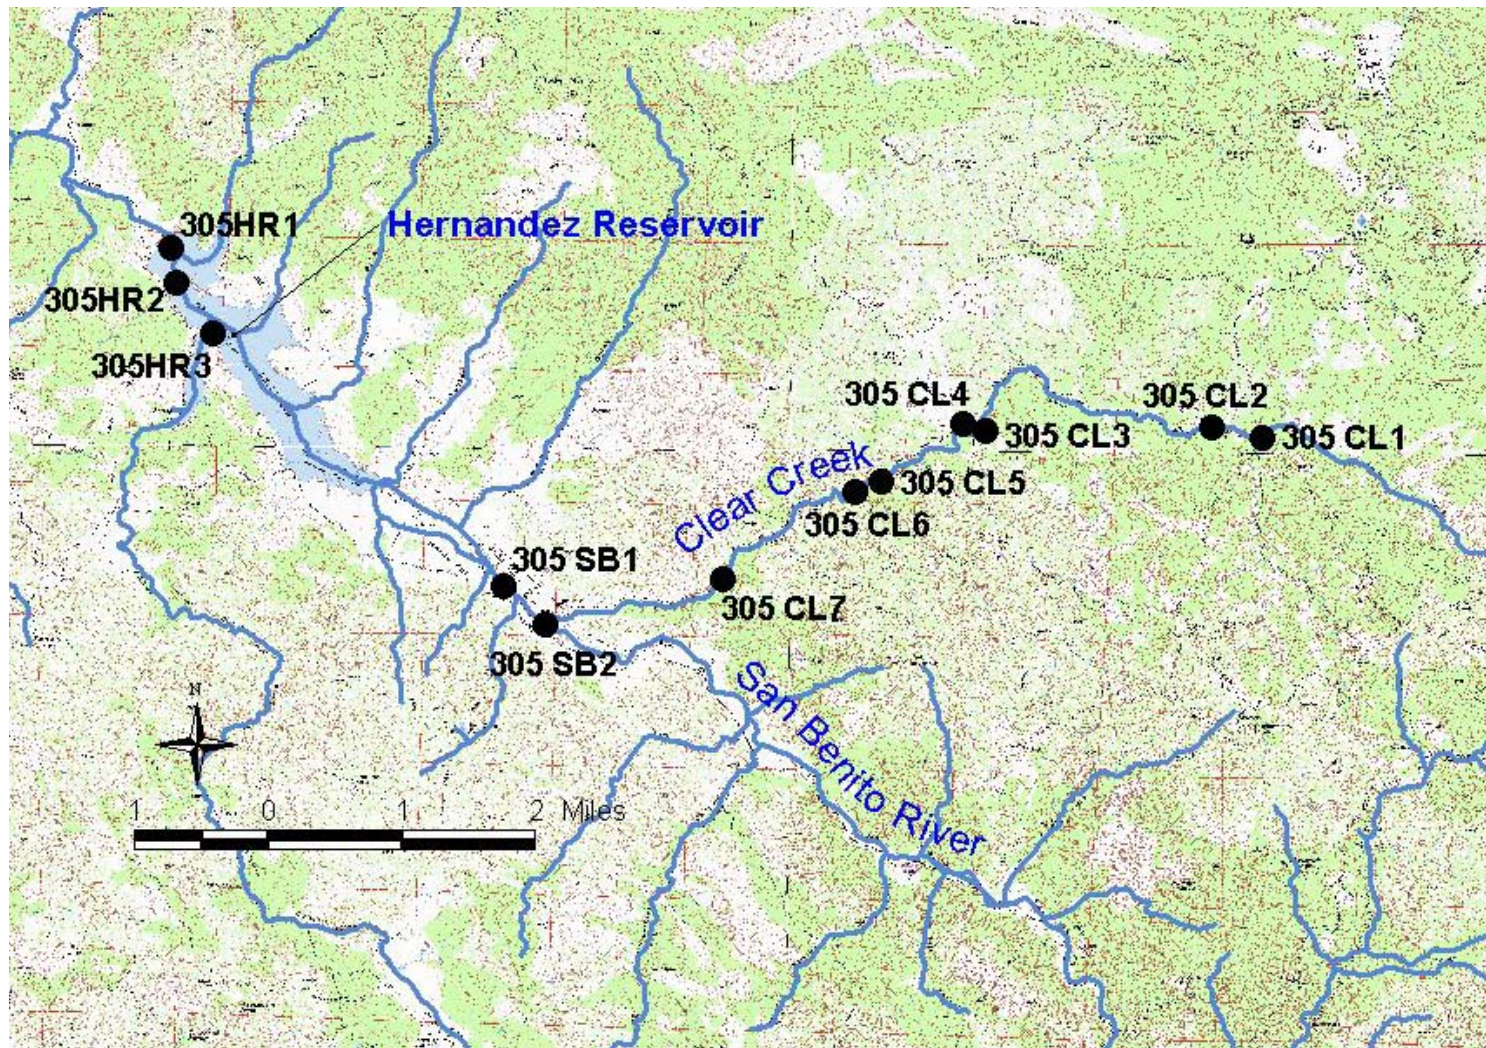
Figure 2. Map of Clear Creek area showing 2002 Sample Locations.

A limited number of samples in the database have been collected from areas upstream of anticipated mercury-rich mineral zones. Locations of samples collected by Regional Board staff in 2002, shown on Figure 2, are numbered 305CL"x" where "x" is a location number along the creek from the upstream site, CL1, to the USGS gage site, CL7. The three locations believed to be upstream of any significant impact from mercury mineralization are: CL1, CL2, and CL3. Maximum values of water and sediment samples from these locations suggest that background conditions in Clear Creek may be slightly less than 0.05 µg/L mercury in water and approximately 0.16 mg/kg mercury in sediment. The Regional Board database also includes two sediment samples from Clear Creek collected in 1998 with mercury levels of 0.18 and 0.19 mg/kg. The US Bureau of Land Management (2002a) has reported a local "background" concentration of mercury in "native bedrock (non-mercury ore)" as 0.2 parts per million (equal to 0.2 mg/kg), although the report does not detail how this number was determined. Considering the Regional Board 2002 samples, CCAMP samples from 1998, and the USBLM report, a reasonable estimated background mercury content of sediments in the Clear Creek watershed is about 0.2 mg/kg, which is slightly above the NOAA TEL (0.174 mg/kg) and well below the NOAA PEL (0.486 mg/kg). Background water column levels of mercury appear to be just below the 0.050 µg/L CTR objective.

For the 2002 sampling, seven locations were selected on Clear Creek and positioned to evaluate potential water quality impacts from the two major categories of activity. Sample locations were mostly located in pairs to evaluate water quality immediately upstream and downstream of a targeted area. For example, sites CL1 and CL2 were located upstream of any mining influences and bracketed an area of extensive OHV activity. Similarly, sample sites CL3 and CL4 were located just upstream and

downstream of side drainages entering the creek in the vicinity of the Alpine mine and the Clear Creek mine. A third set of sample sites, CL5 and CL6, was located in the vicinity of OHV Staging Area Two.

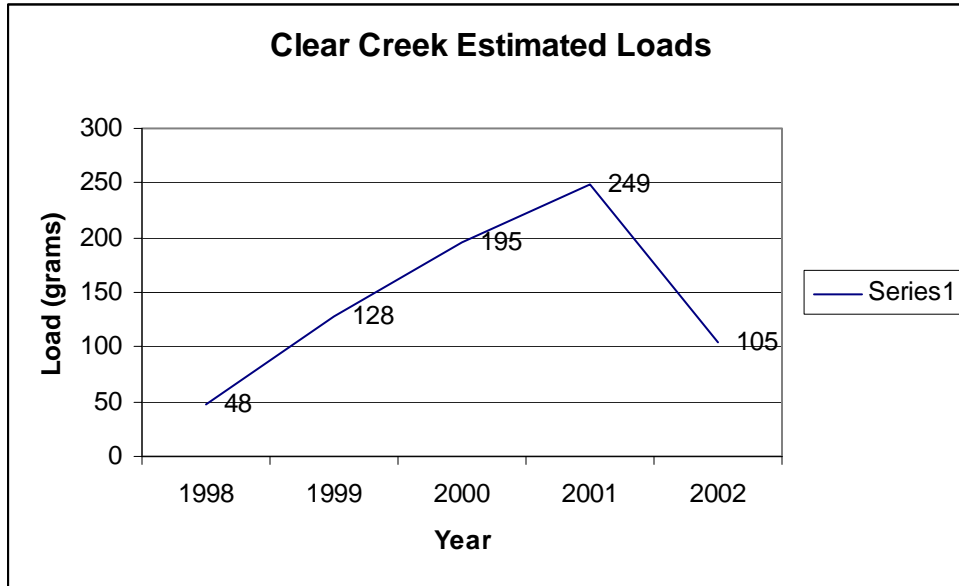
Figure 3. Estimated Clear Creek Loads in Recent Years.

The pattern of the data is a little clearer if some minor assumptions are made and the estimated current loads are plotted. This is shown in Figure 3, where estimated loads from the last 5 years are shown. These estimated loads were calculated using the average flow data shown in Table 4, the water-column mercury level averaged from samples reported in Table 3, or, for those seasons where no water sample data were collected, assuming the water column mercury was at the 0.05 µg/L level. Although this assumption may impact the estimated loads shown in the graph, the fairly consistent timing of sample

From Figure 3, one can see that, although the 2002 estimated load (105 grams) is above the target for Clear Creek (79 grams), the 2002 load estimate is a marked improvement from previous years and suggests that the target load may be reached in the near future.

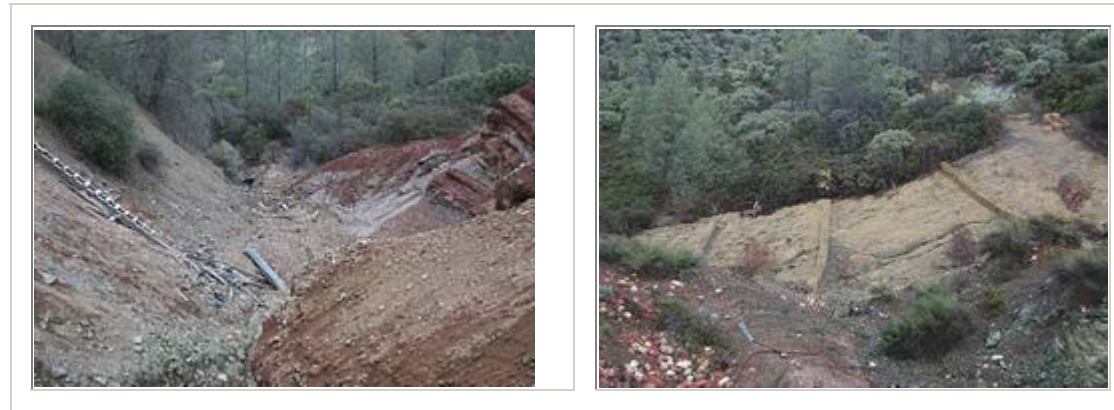
Alpine Millsite before and after cleanup and restoration

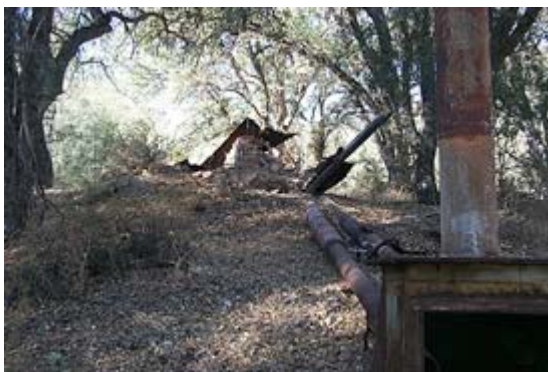
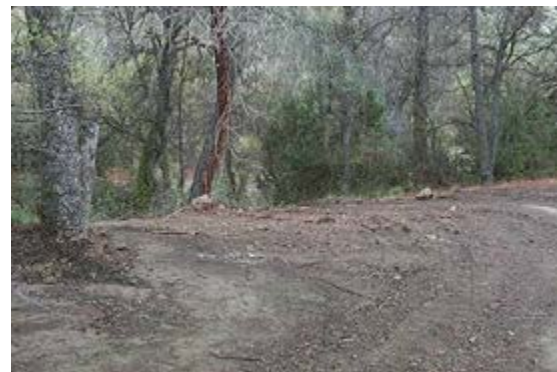
Jade Millsite before and after cleanup and reclamation

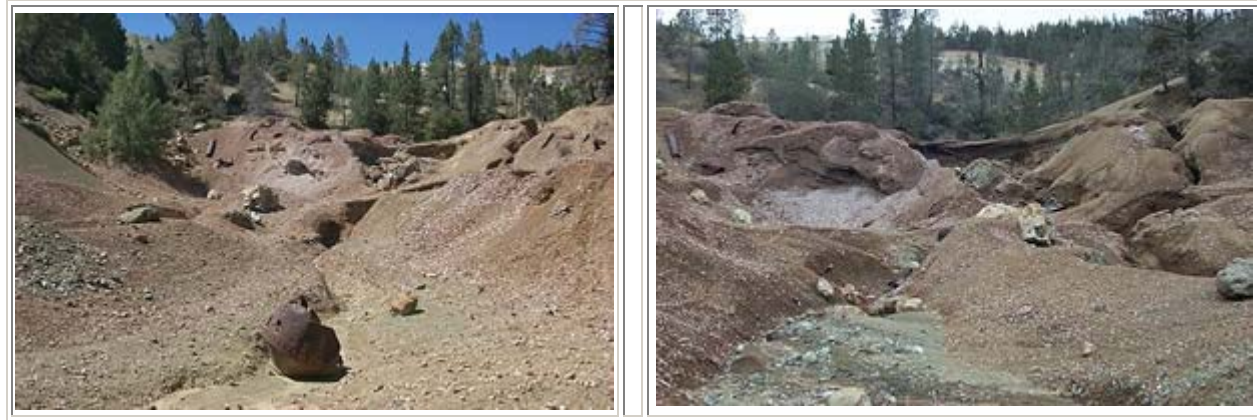
Calcine tailings before reclamation and cleanup

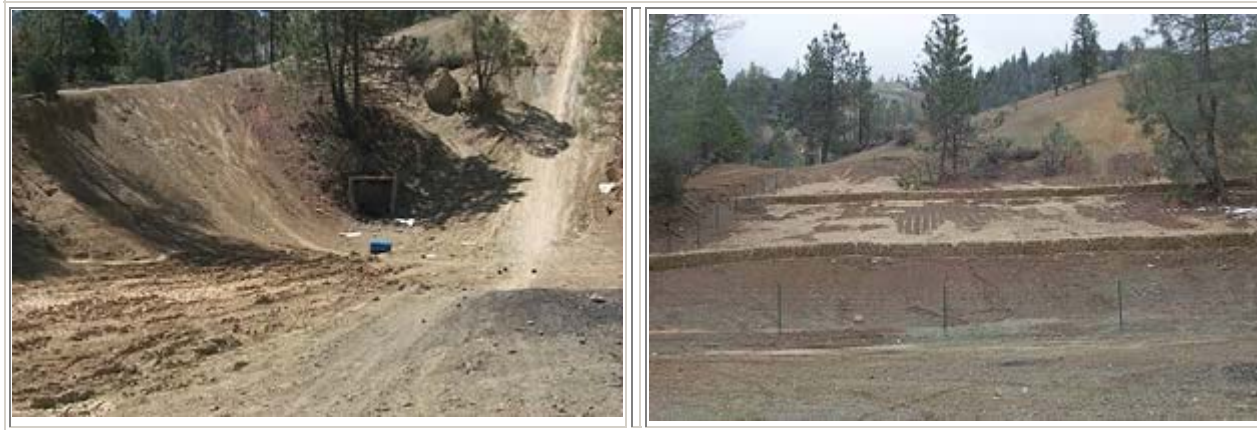
Aurora Repository before and after reclamation
